**BLUESTONE QUARRY WALLS RESTORATION PROJECT**  
**ROBBEN ISLAND**  
**MAPPING AND CONDITION SURVEY OF WALLS**  
**NOVEMBER 2019**

*(AHSA) Archaeological and Heritage Services Africa (Pty) Ltd*

**3. BLUESTONE QUARRY WALLS, ROBBEN ISLAND  
PHOTO CATALOGUE OF WALLS AND COLLAPSED SECTIONS  
NOVEMBER 2019**

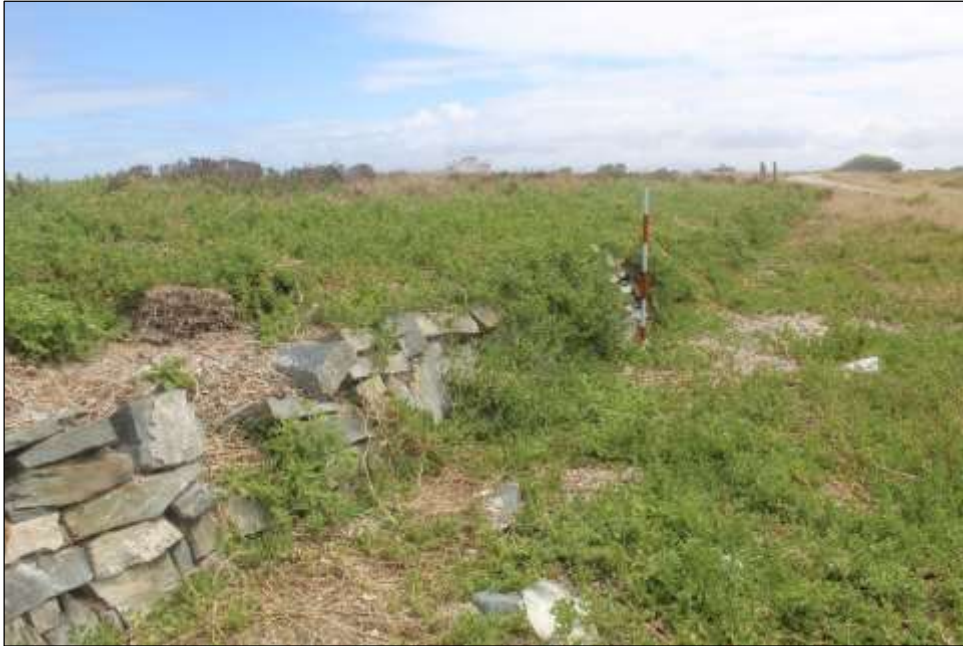
Wall 1, wide view.

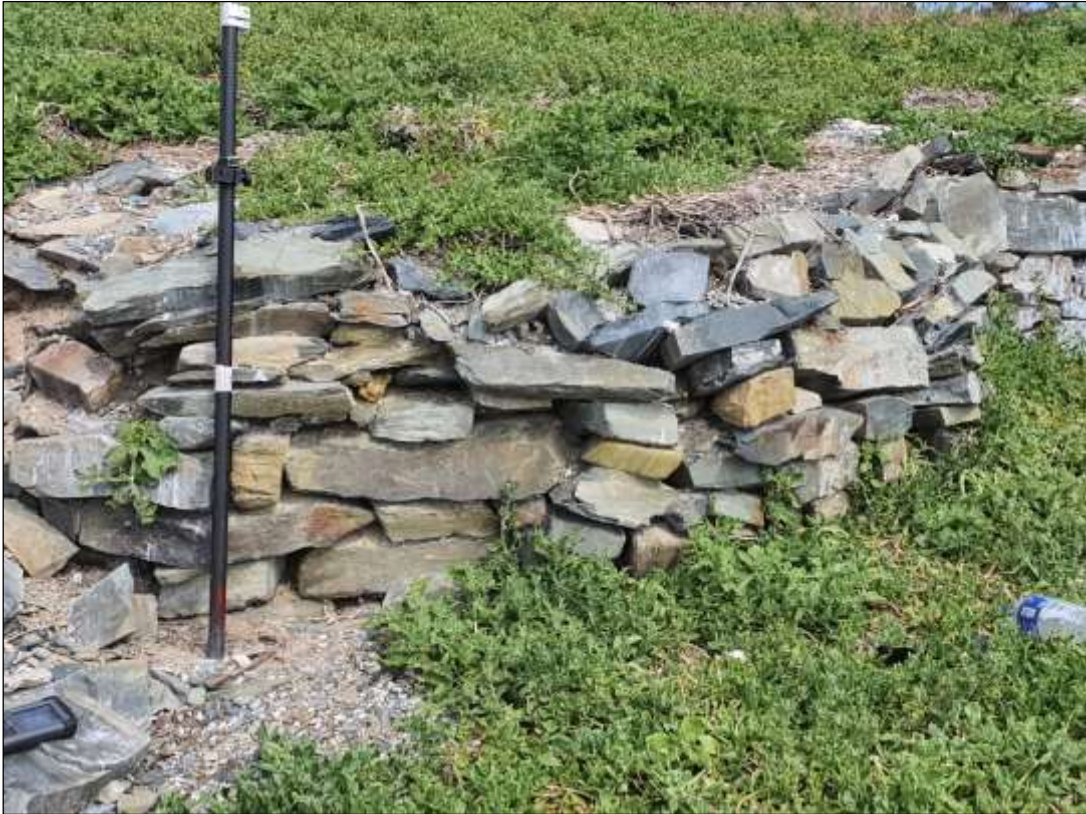
Wall 1b, western section of Wall 1.

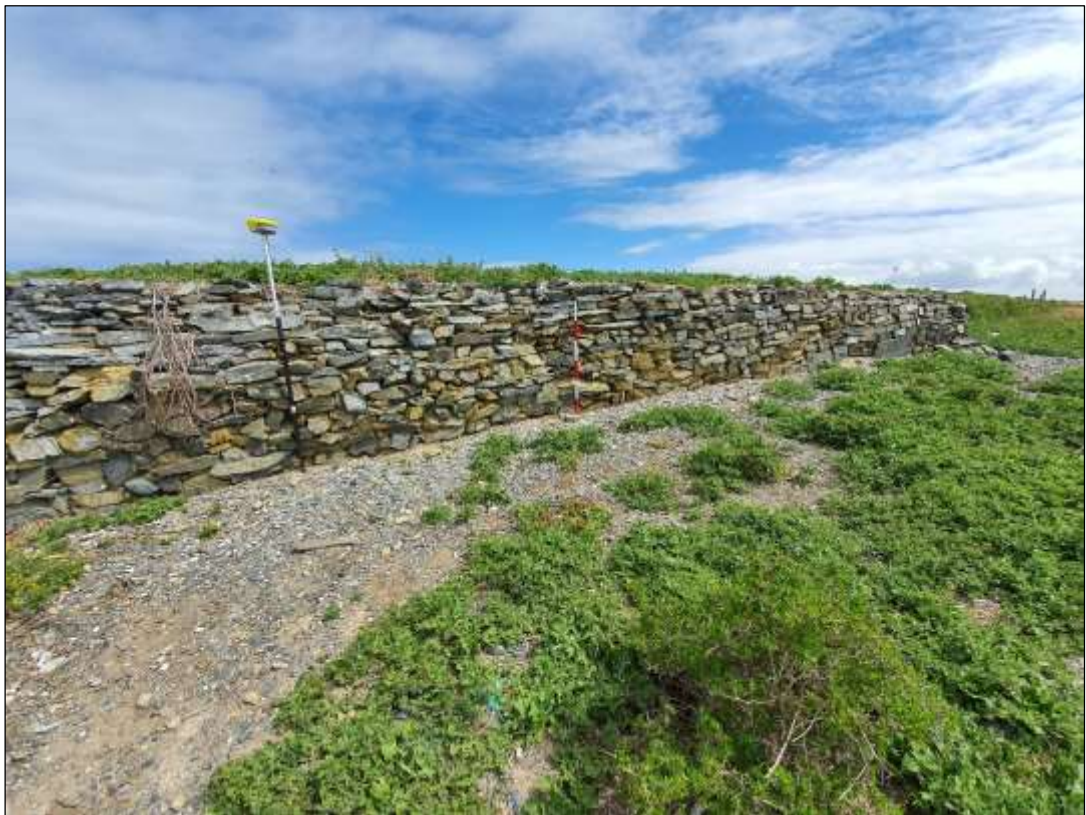
Wall 2, wide view.

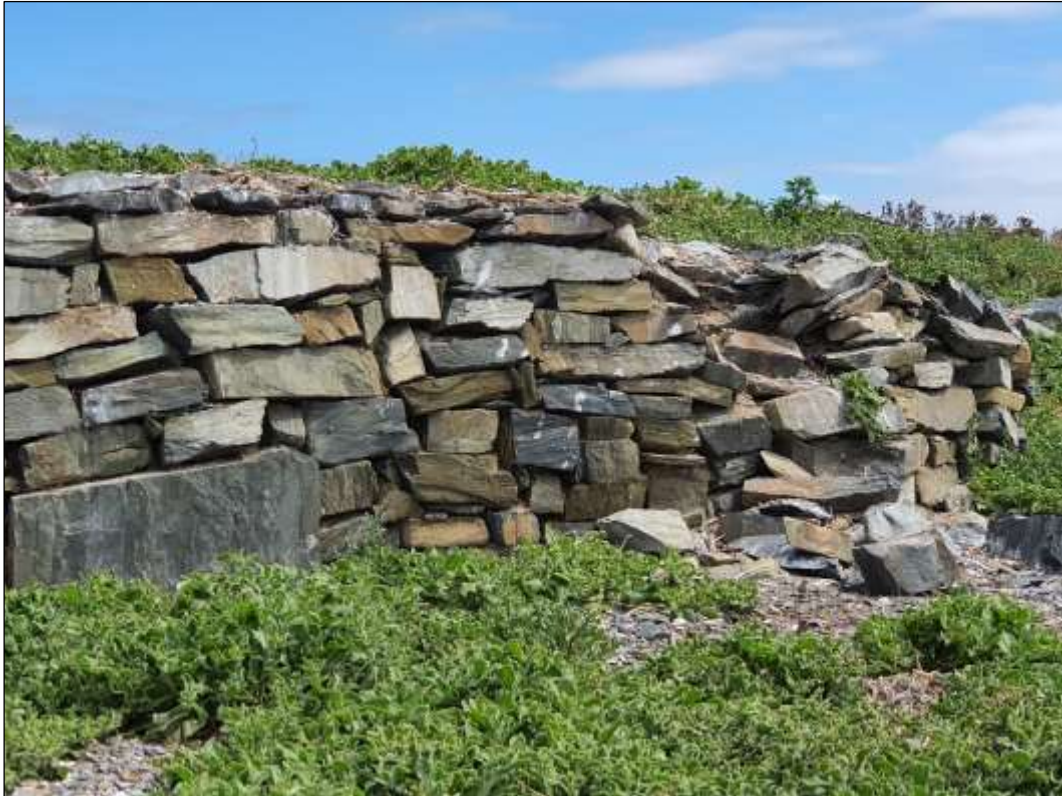
Wall 2a, shows bulge and toppling.

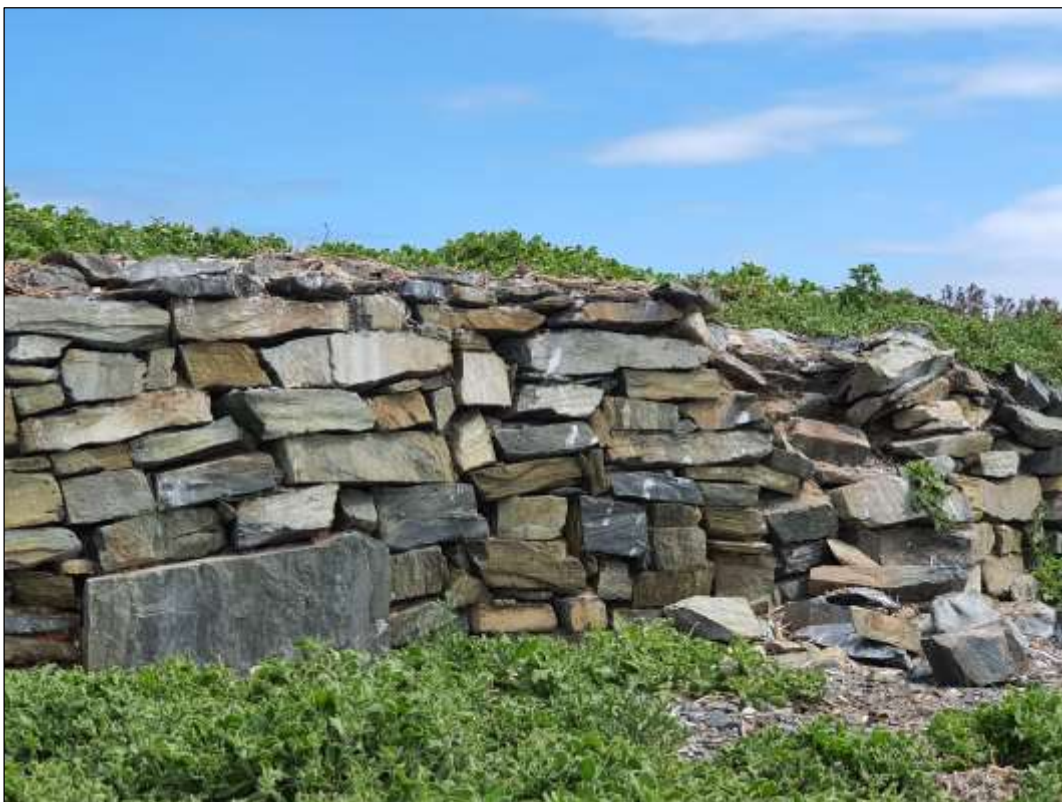
Wall 2b west (right side) of bulge.

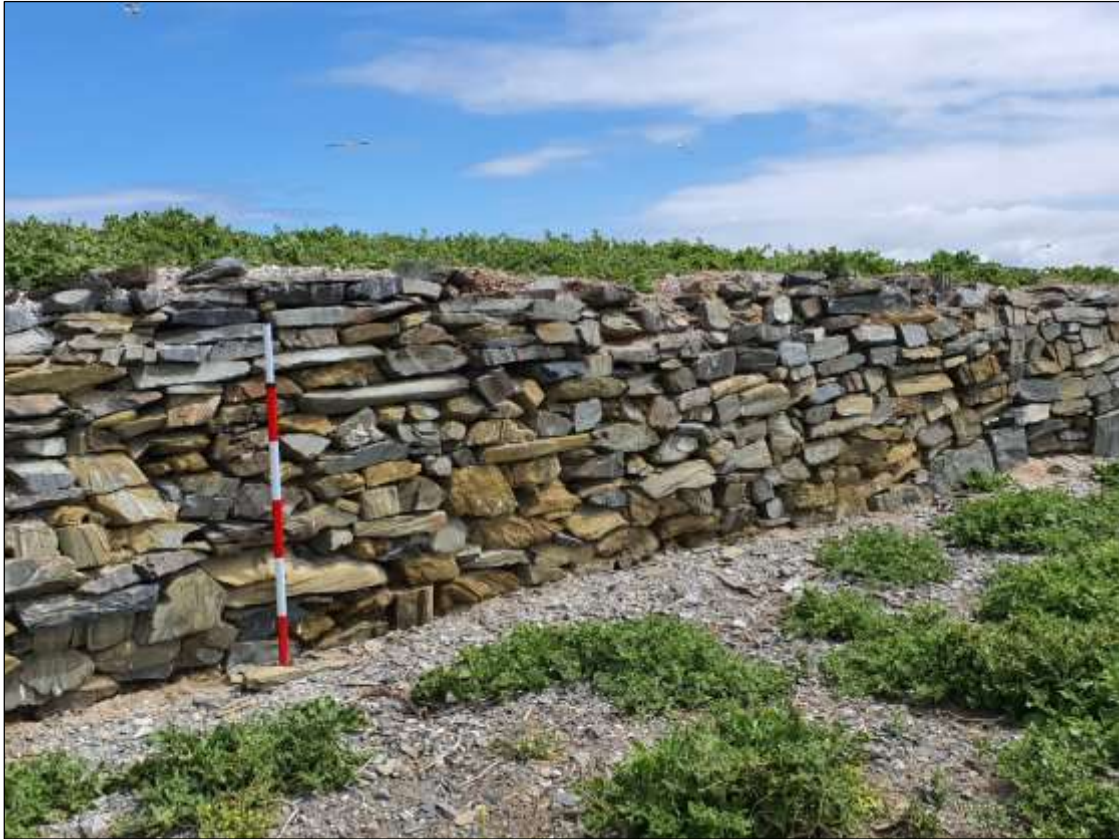
Wall 2bcd (b= right side, d= left side).

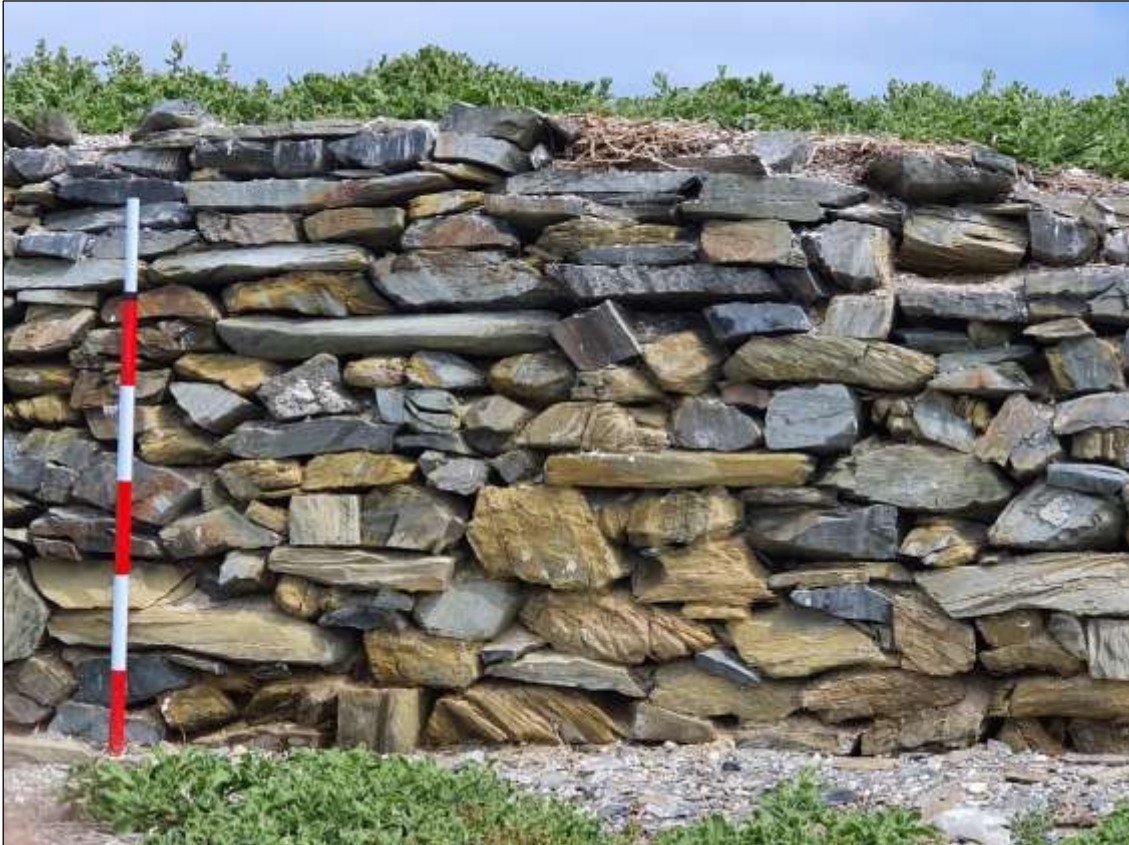
Wall 2e (west of Wall 2d).

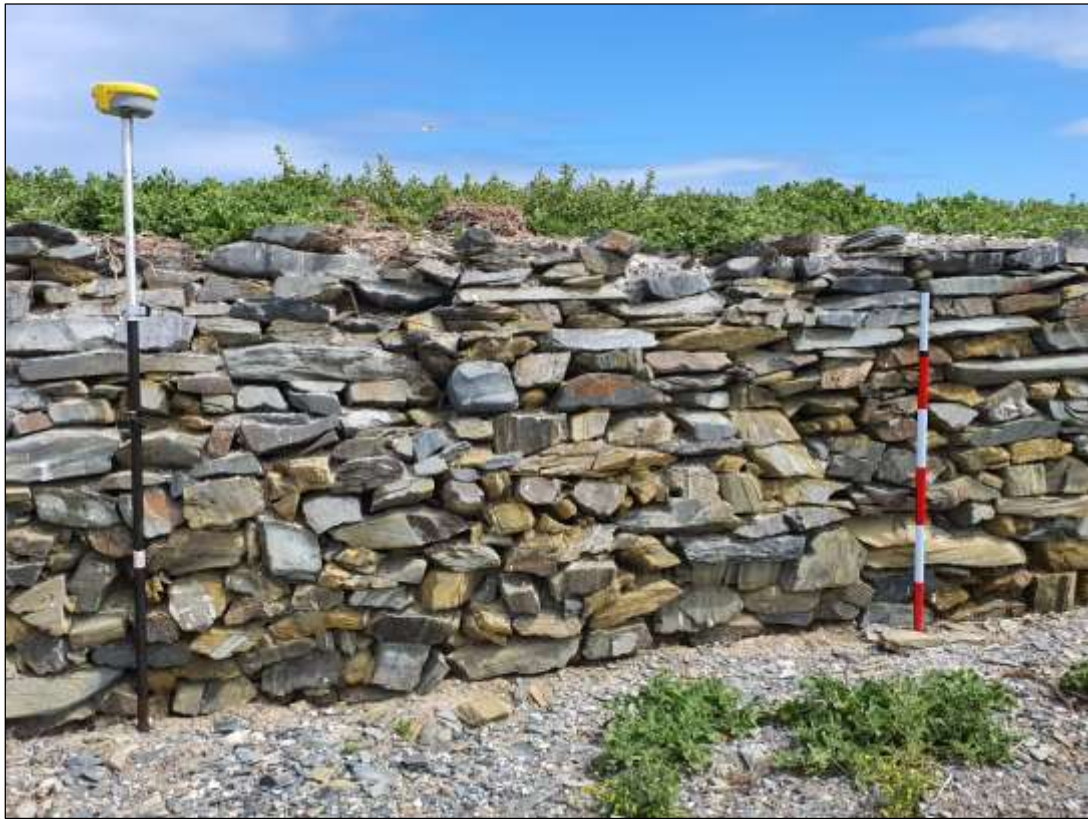
Wall 2f (west of wall 2e).

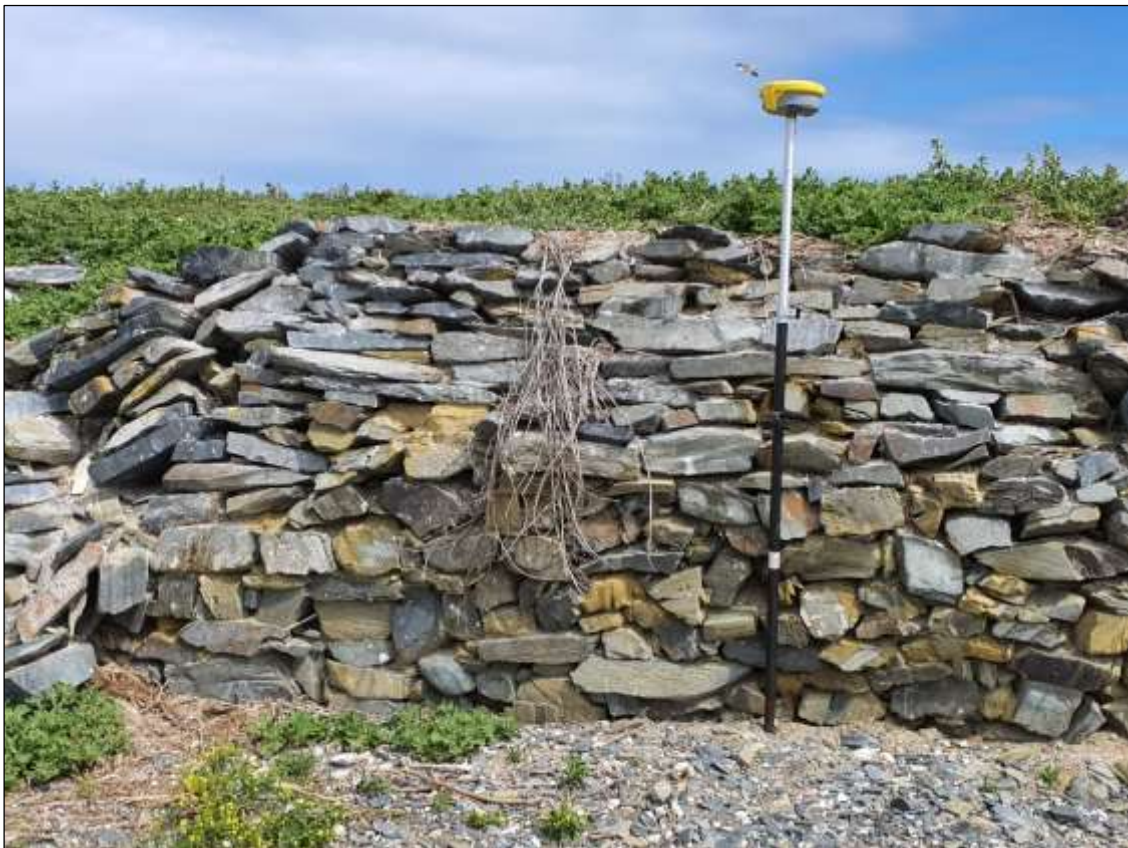
Wall 2g (west of Wall 2f).

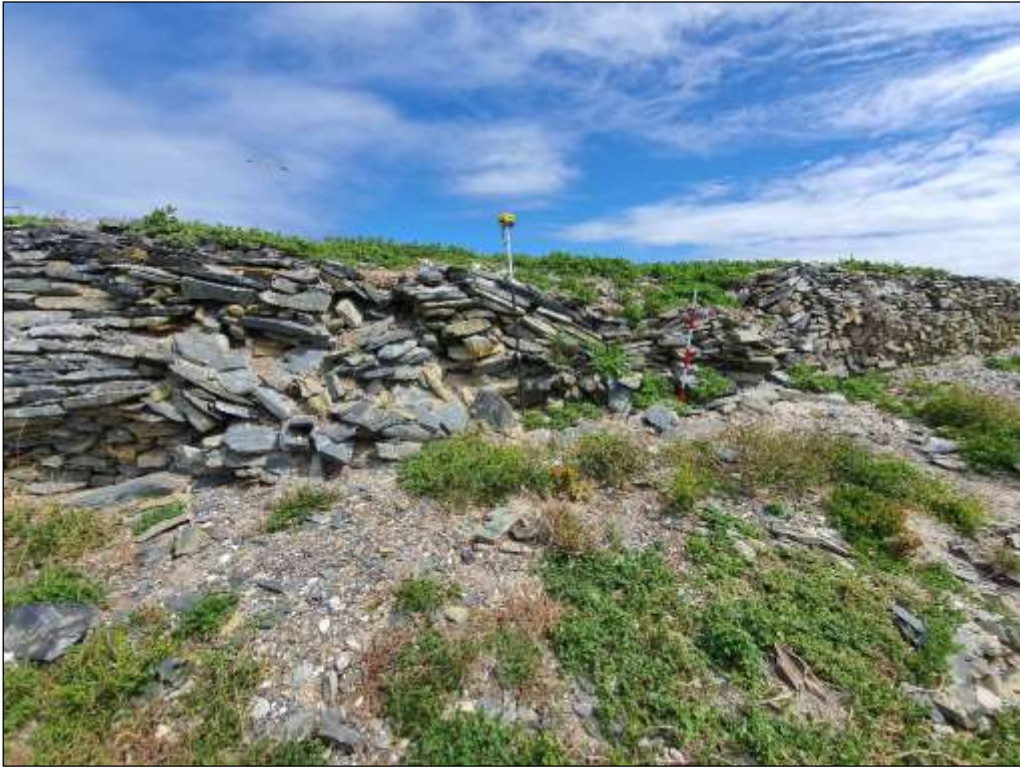
Wall 3, partially collapsed section (west of Wall 2).

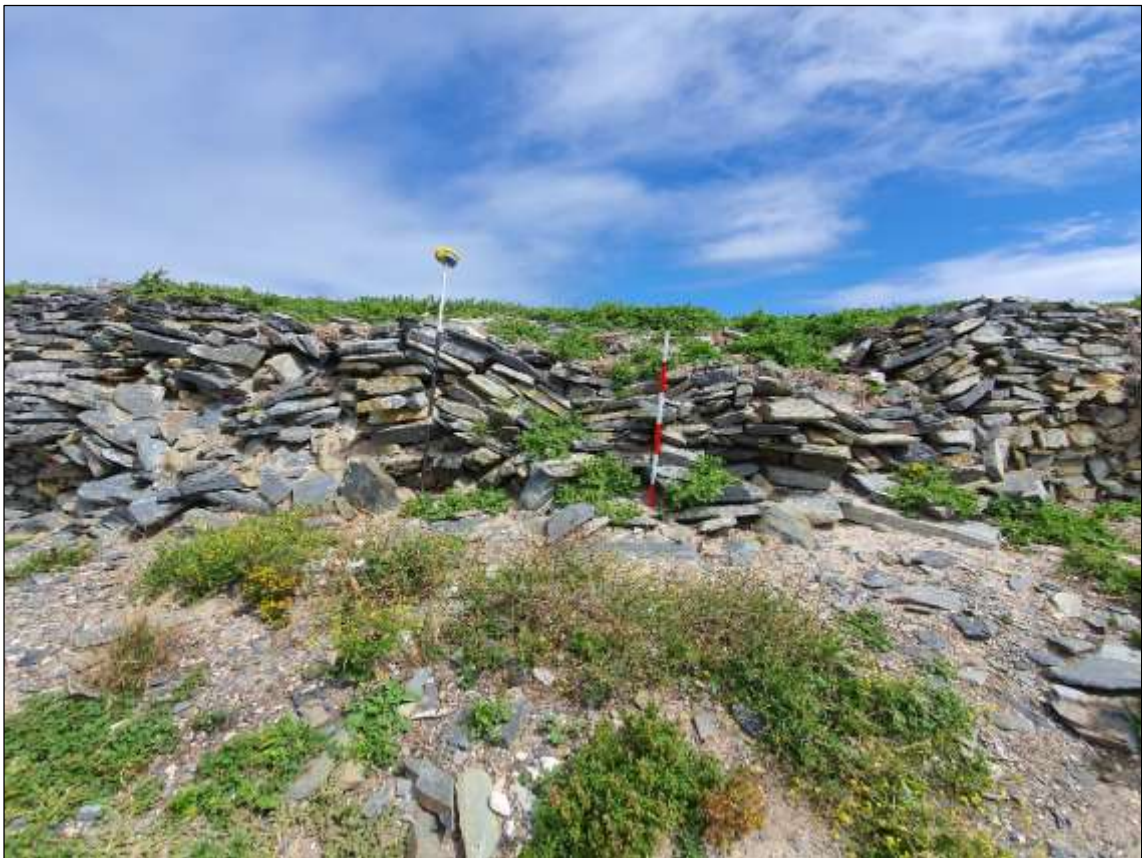
Wall 3, closer view.

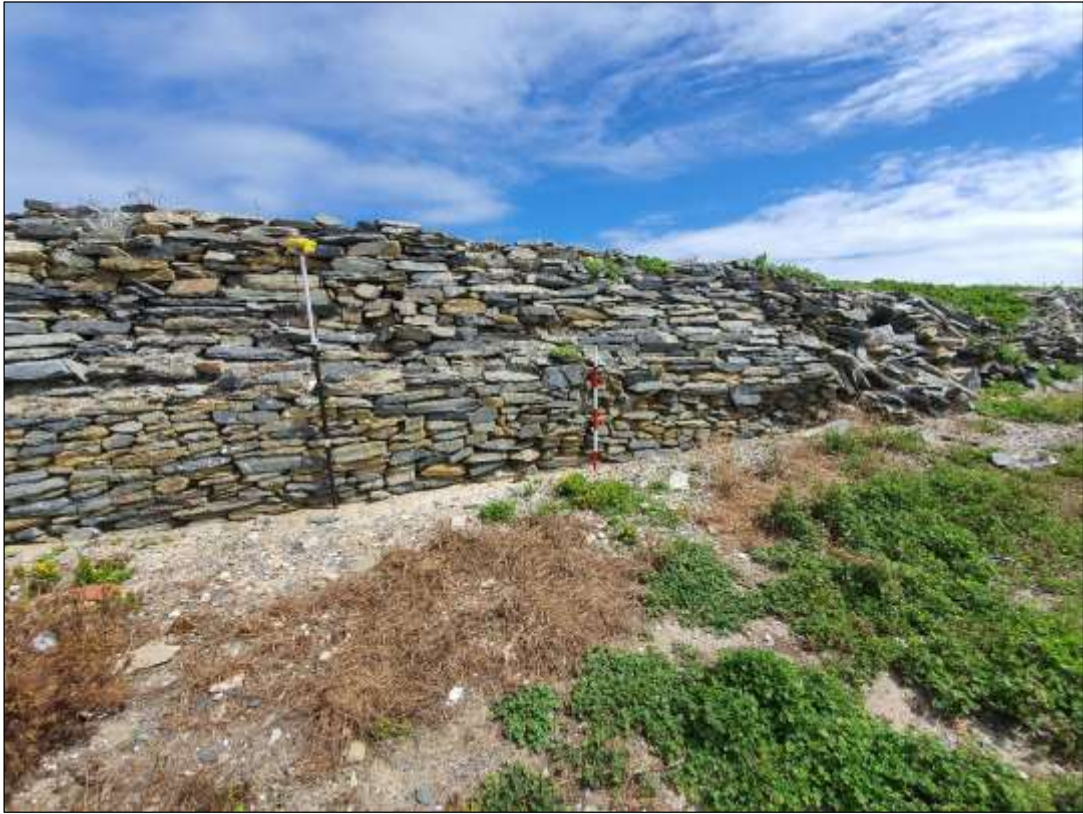
Wall 3a, west of collapse.

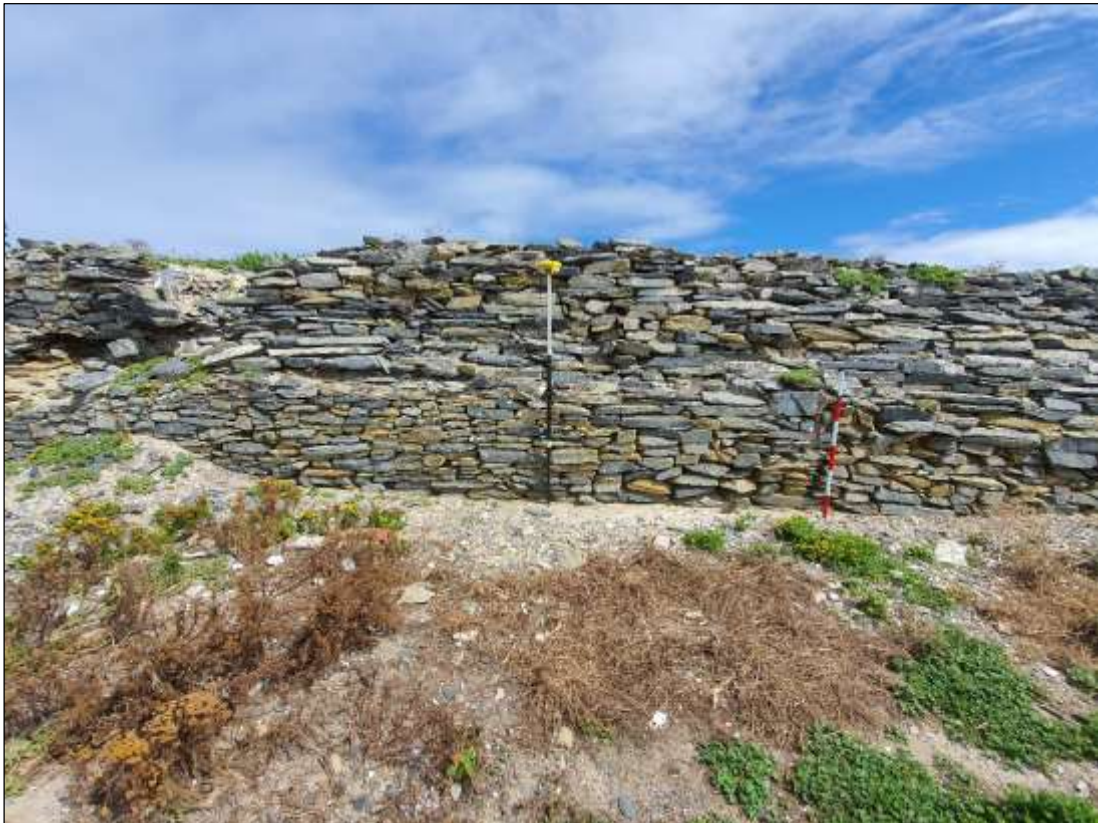
Wall 3b (west of 3a).

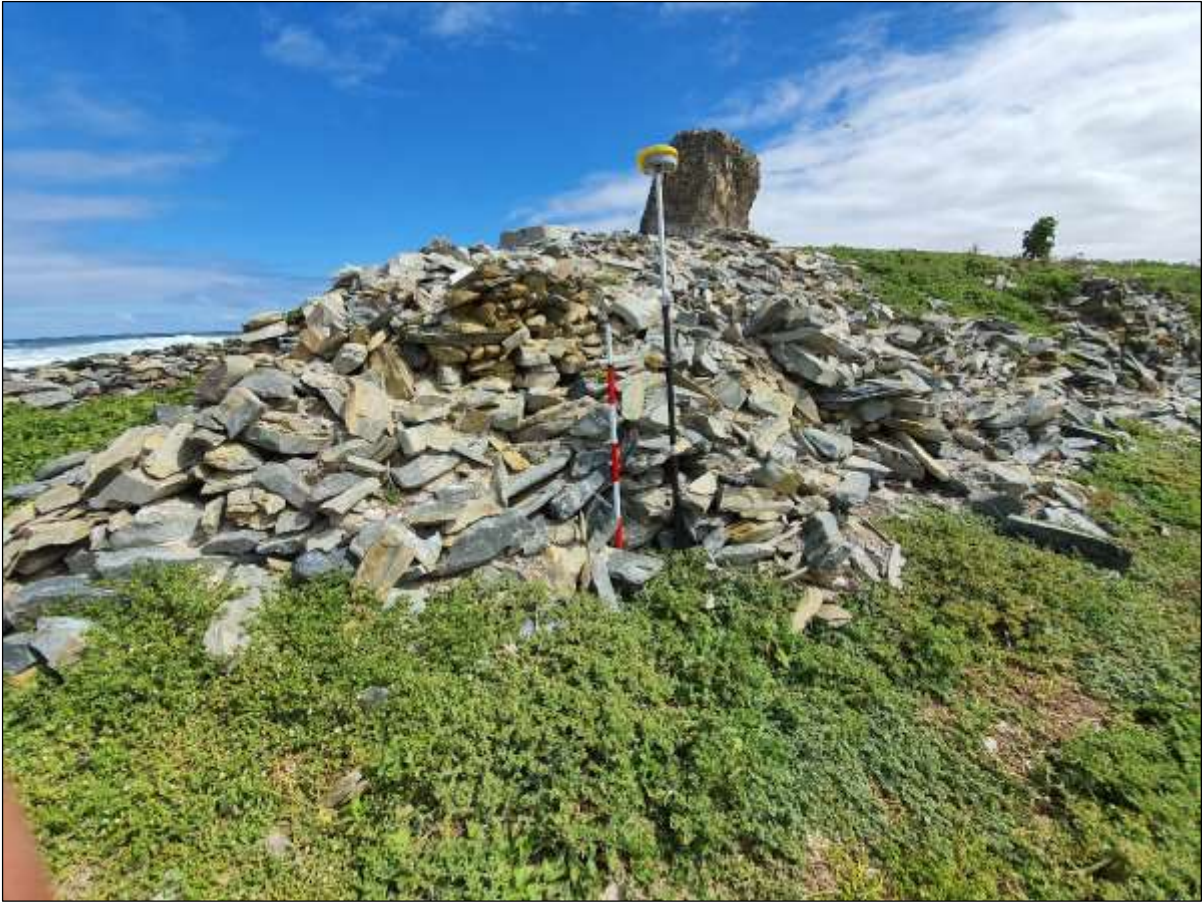
Wall 5, southern end of the Northern Section of the main wall.

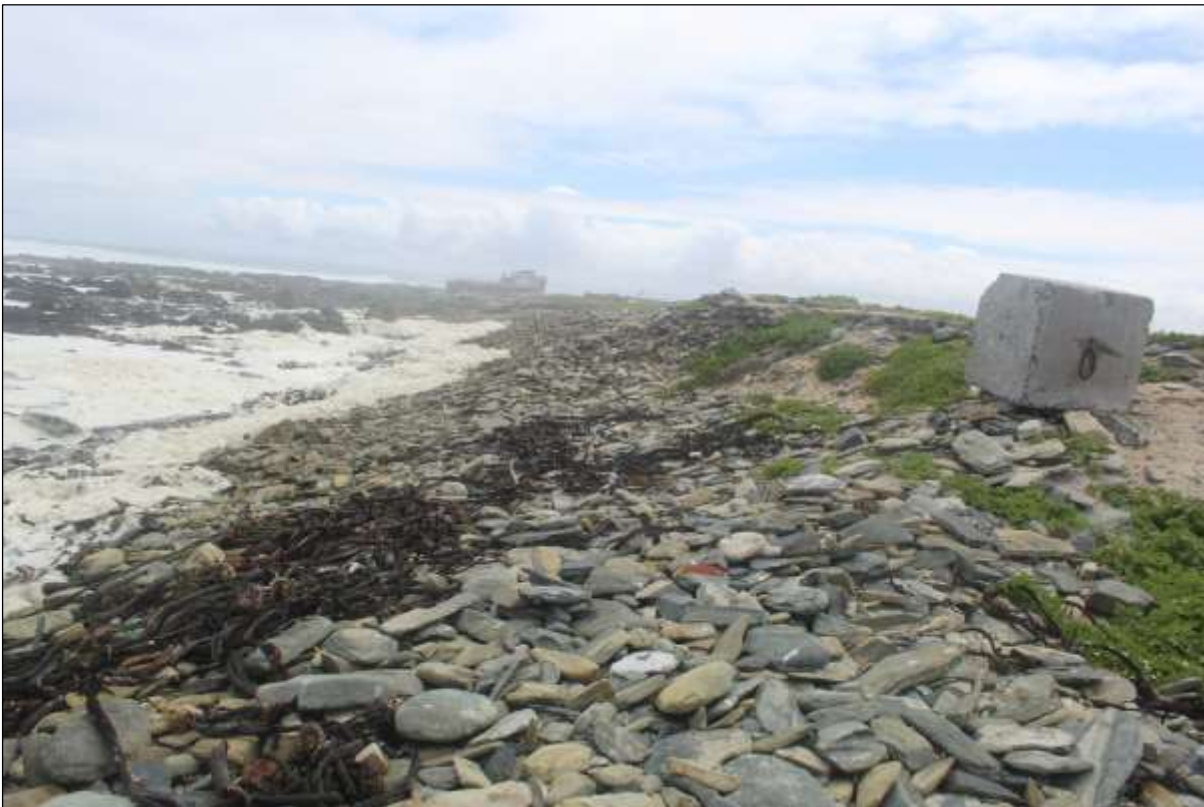
Northern section of the main wall, side facing the sea, close view north.

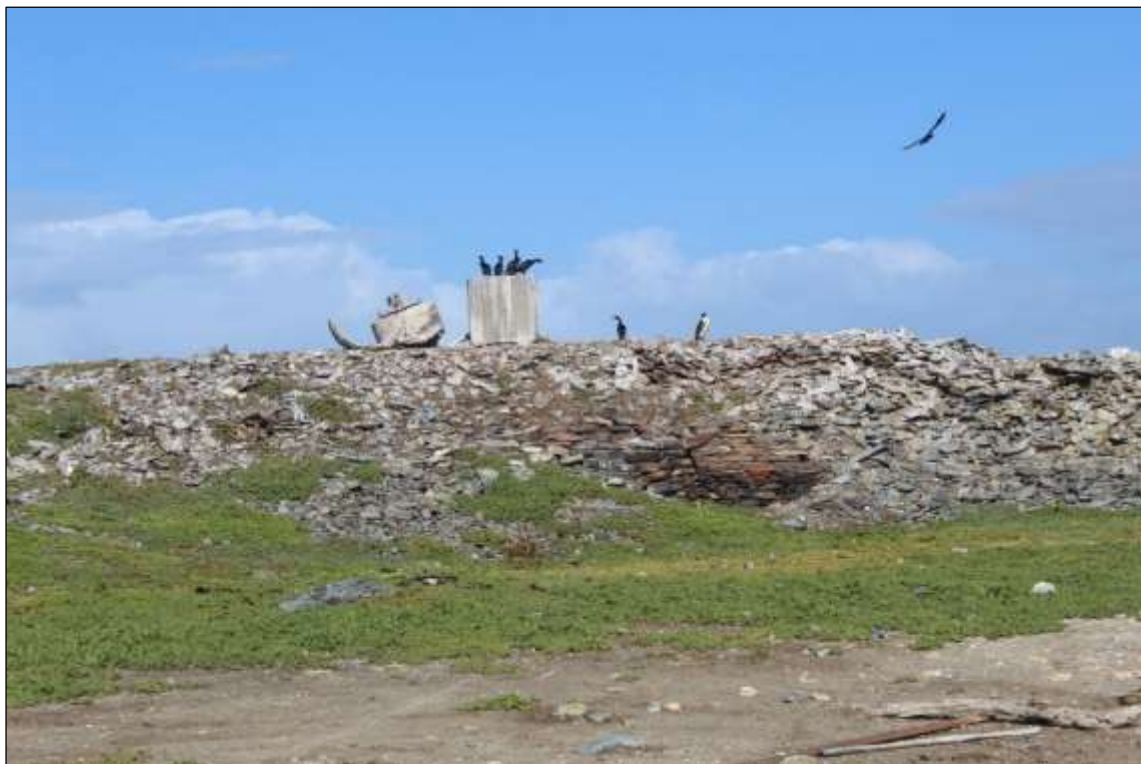
Wall 19, wide view shows collapses on both sides.

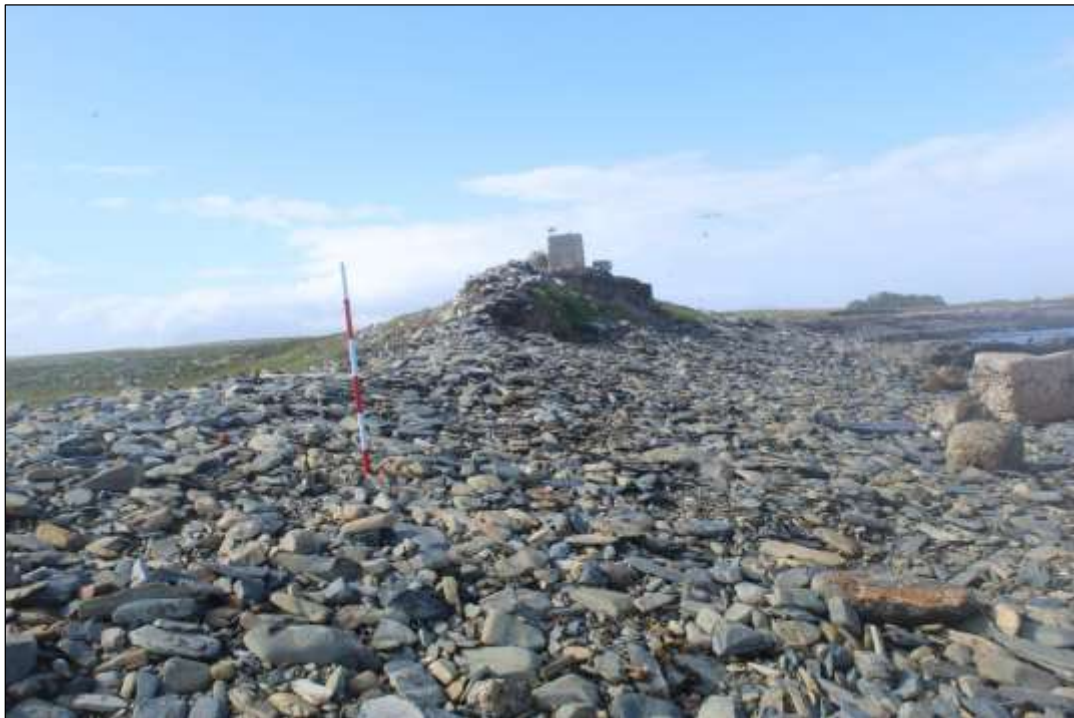
Southern Section of the main wall.

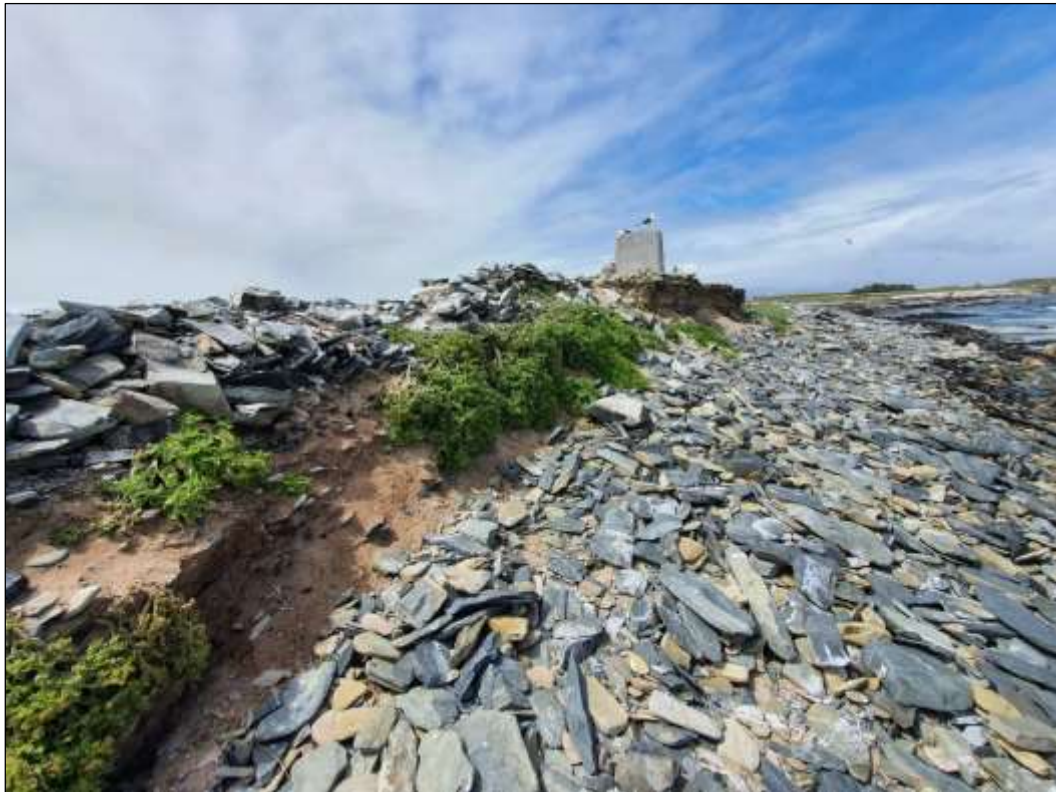
Southern Section of the main wall, side facing the sea, close view south.

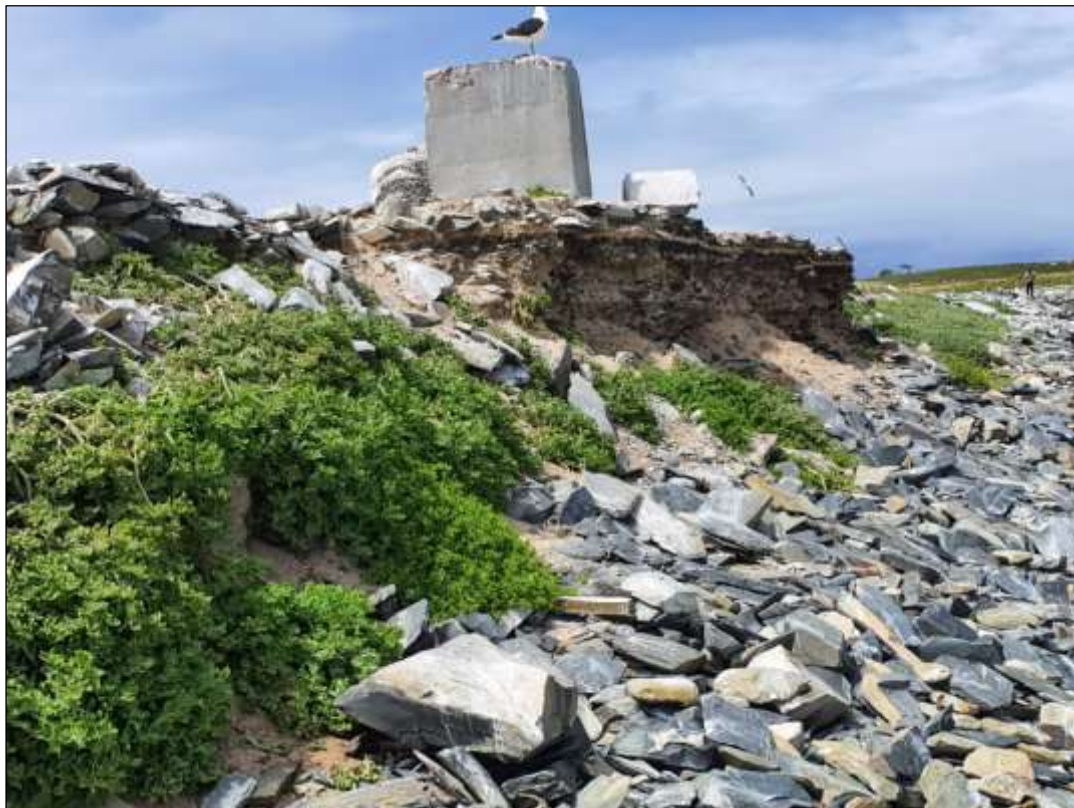
Southern Section of the main wall, side facing the sea, close view south.

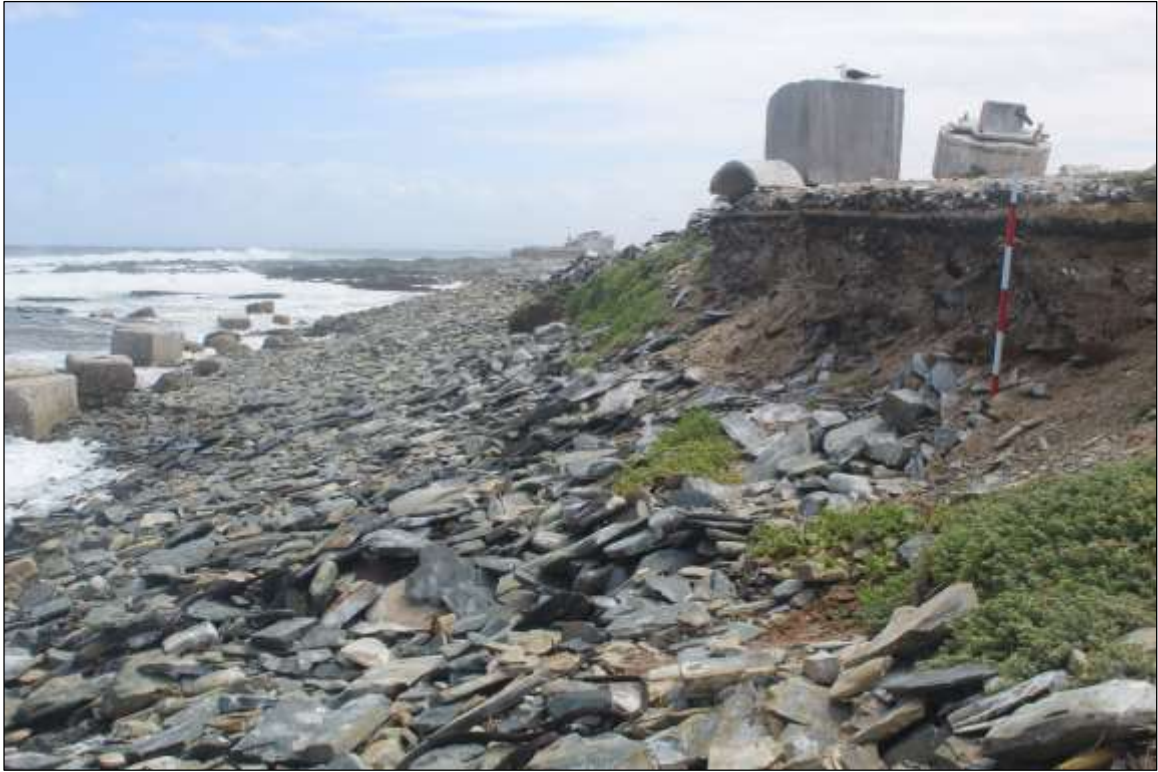
Southern section of the main wall, side facing the sea, close view north.

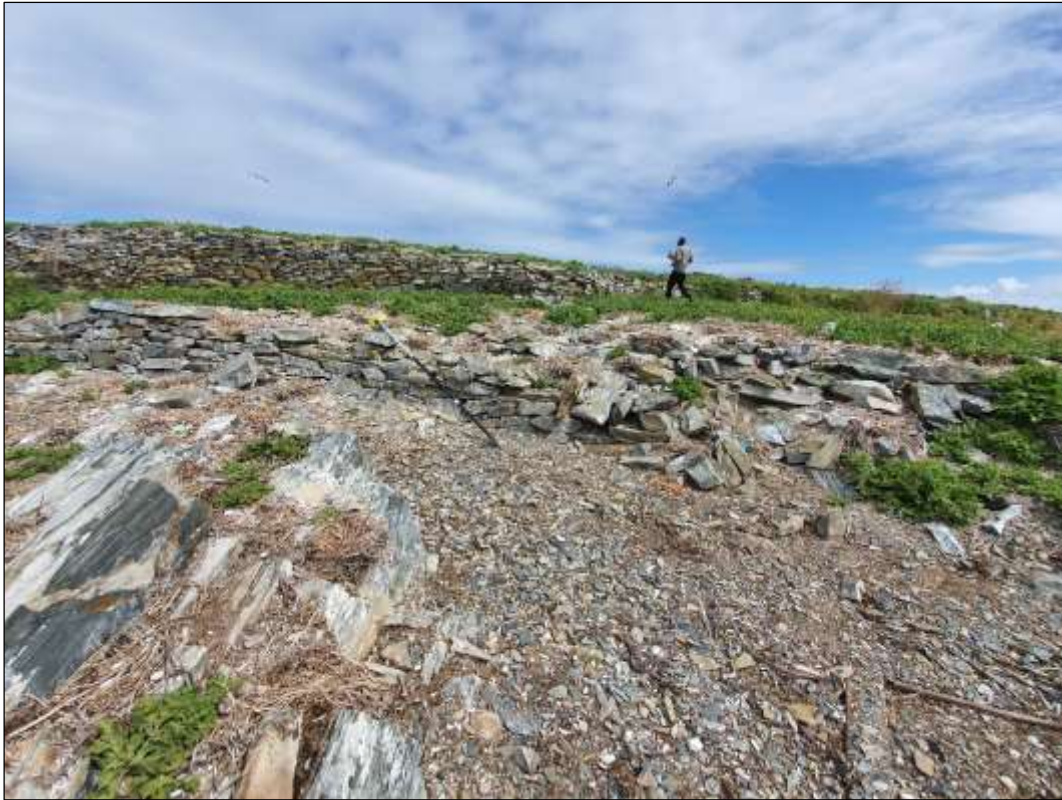
Wall 6, a terrace wall (below) and Wall 2 (above).

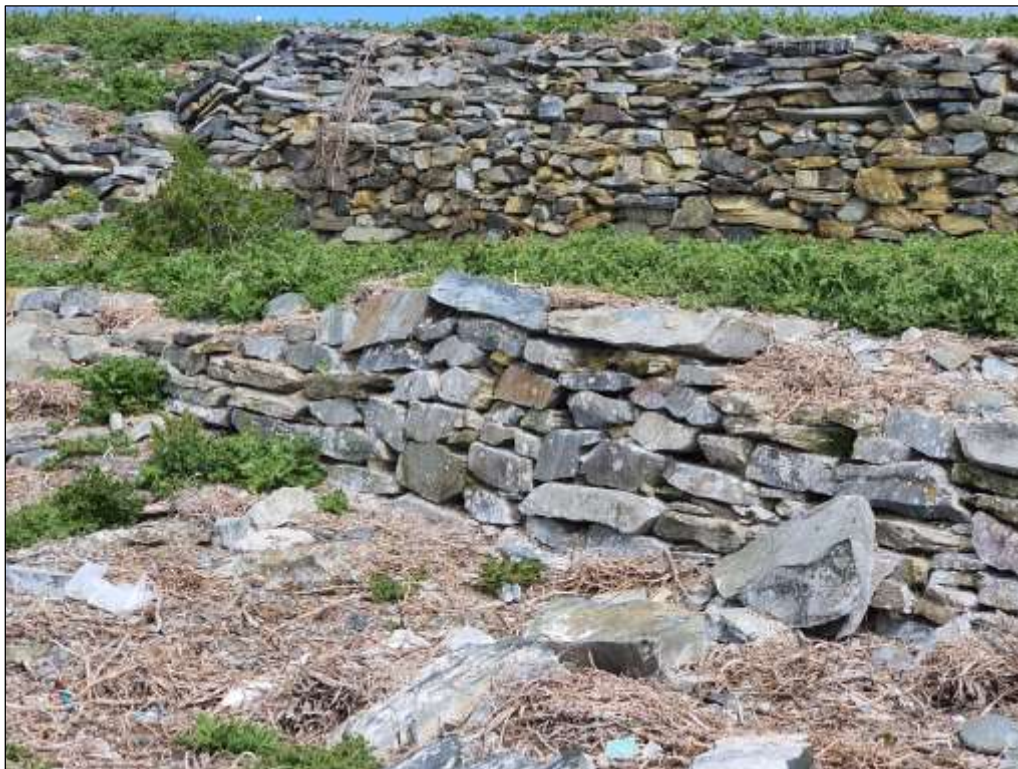
Wall 6, terrace wall below (close-up view) and Wall 2 above.

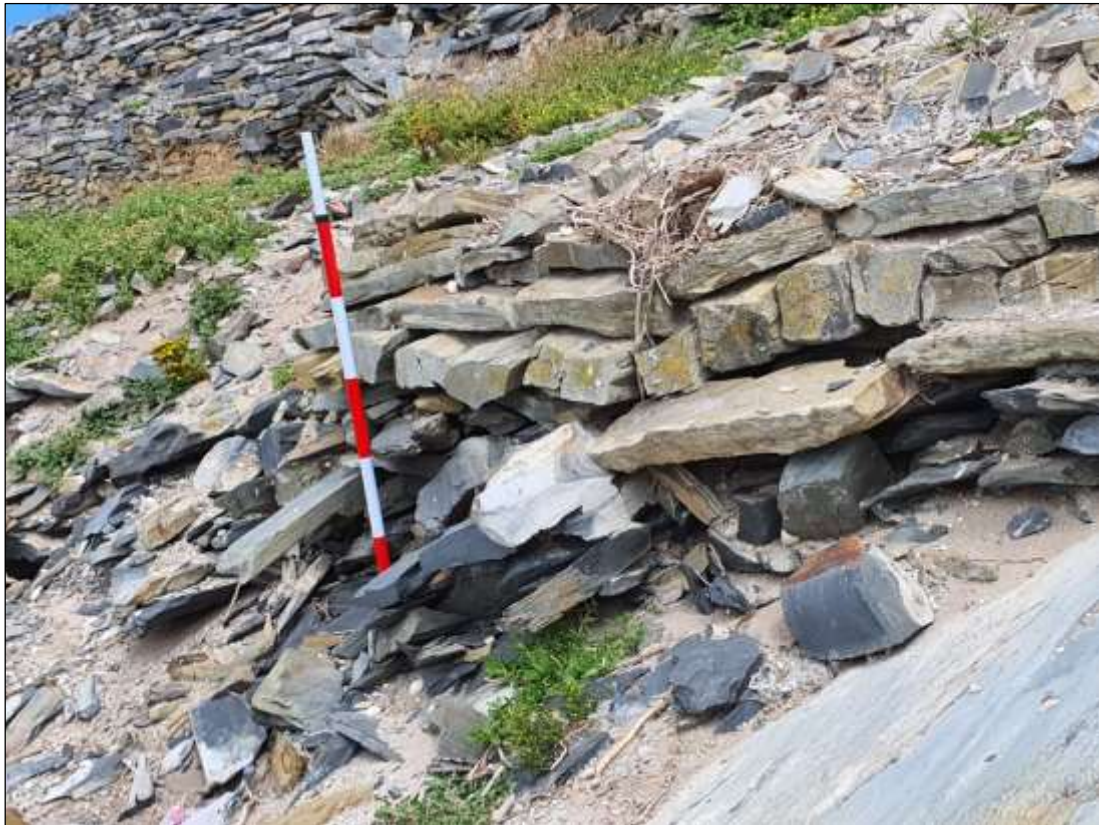
Wall 7, terrace wall, below.

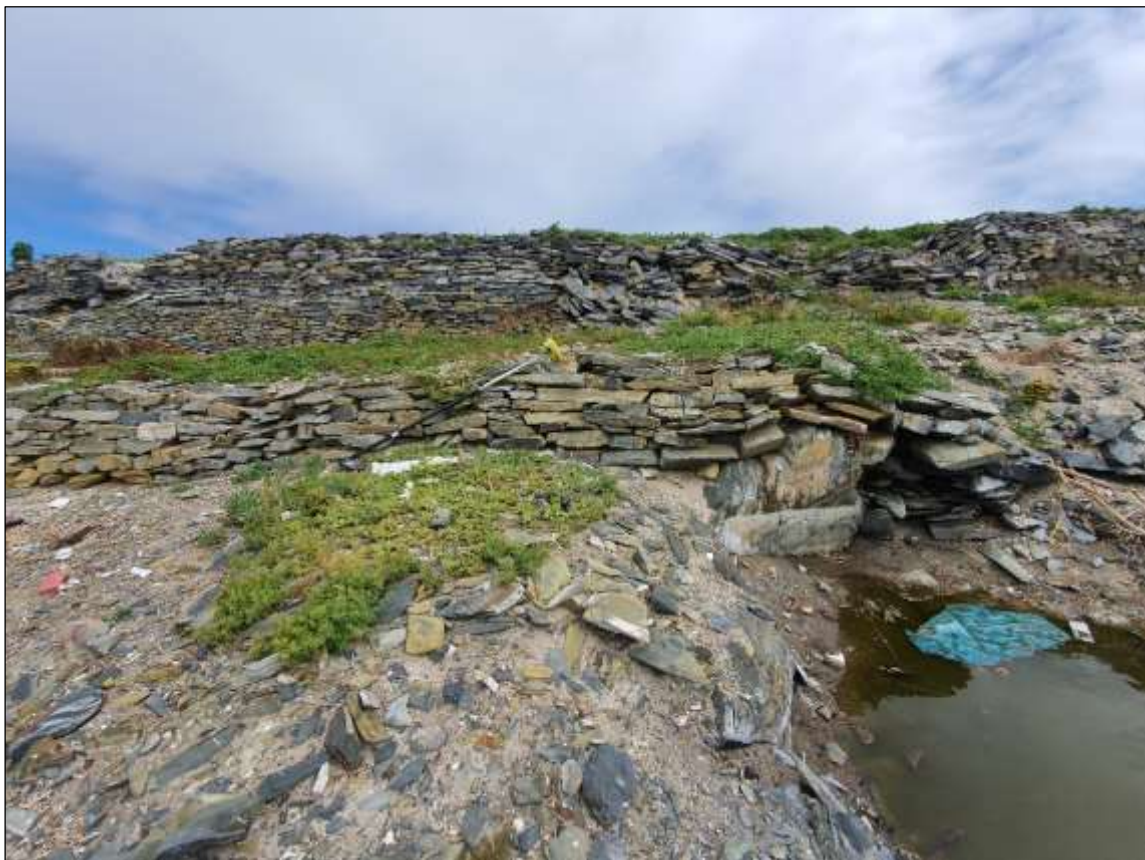
Wall 8, terrace wall (below), wall 3 above.

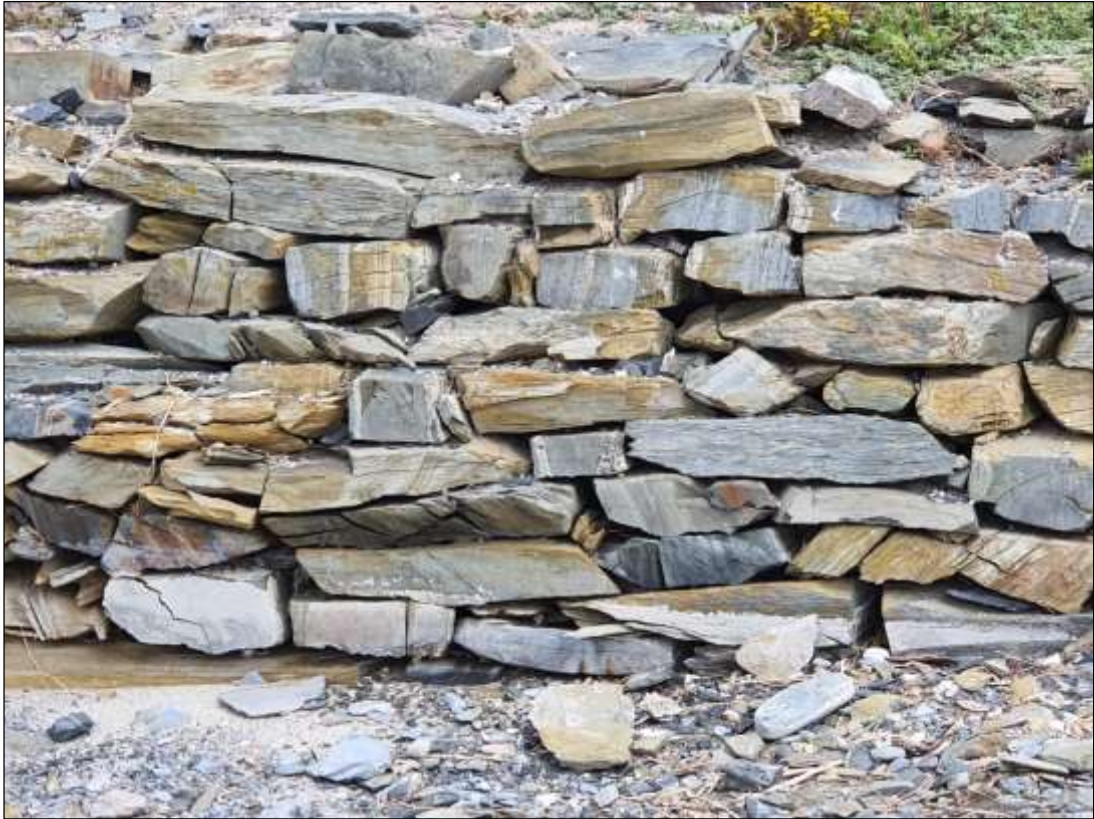
Wall 8, midsection, close-up view.

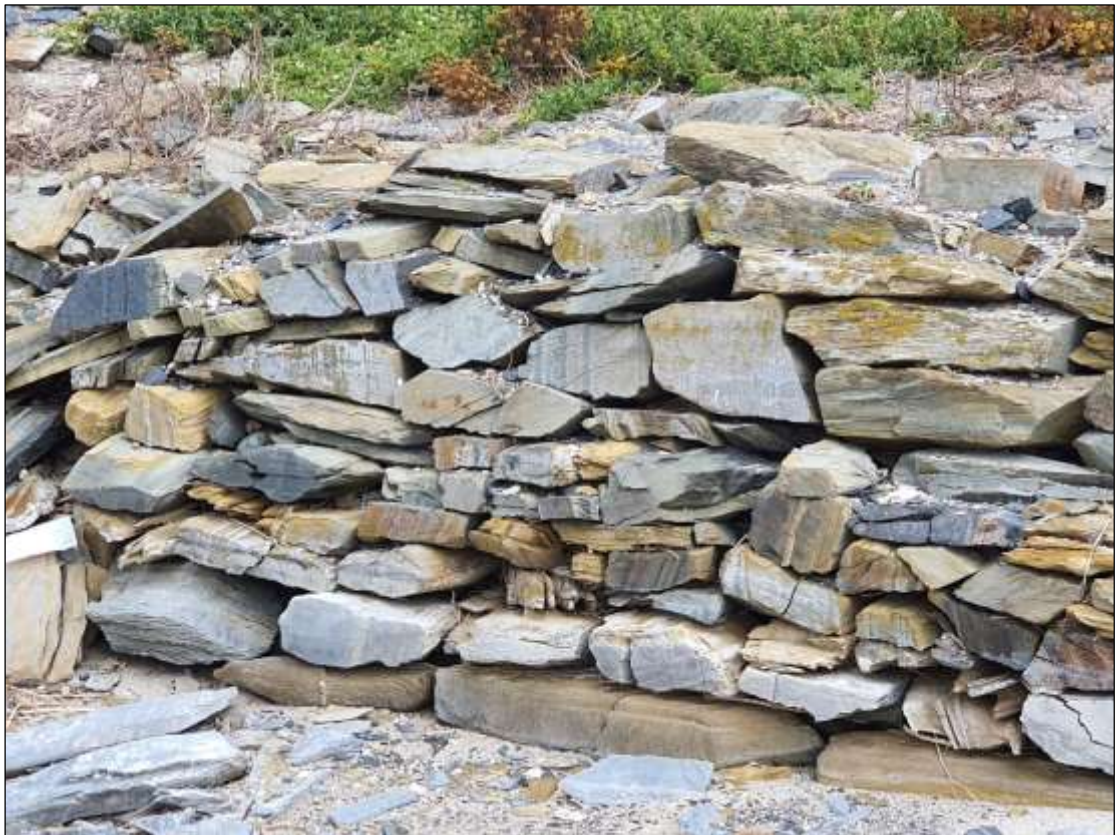
Wall 8, western end.
