**BLUESTONE QUARRY WALLS RESTORATION PROJECT**  
**ROBBEN ISLAND**  
**MAPPING AND CONDITION SURVEY OF WALLS**  
**NOVEMBER 2019**

*(AHSA) Archaeological and Heritage Services Africa (Pty) Ltd*

**3. BLUESTONE QUARRY WALLS, ROBBEN ISLAND  
PHOTO CATALOGUE OF WALLS AND COLLAPSED SECTIONS  
NOVEMBER 2019**

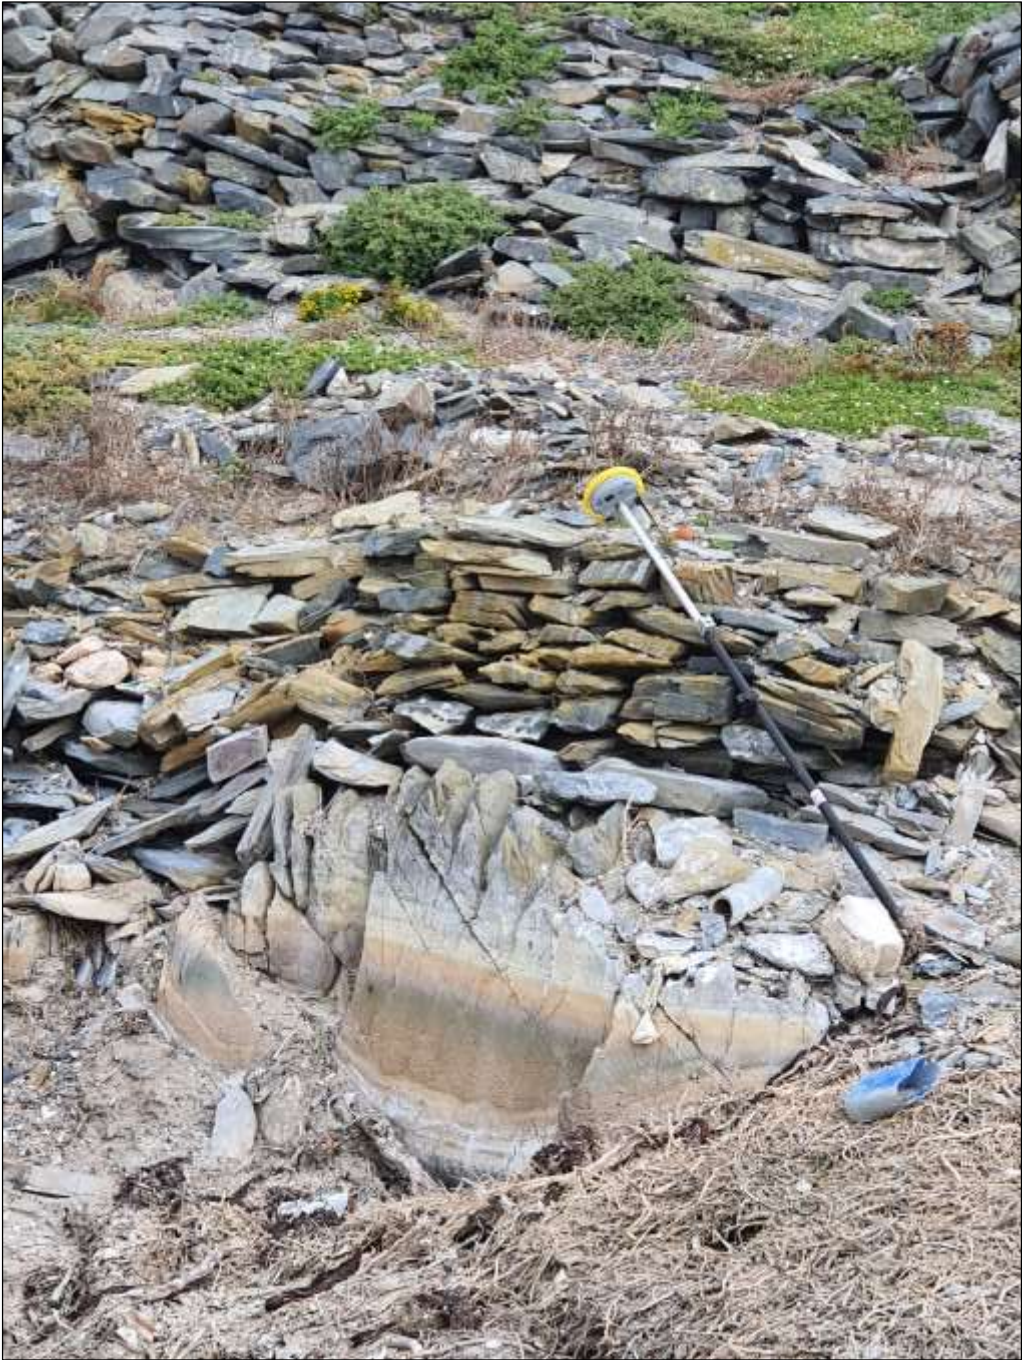
Wall 9 with collapsed ends.

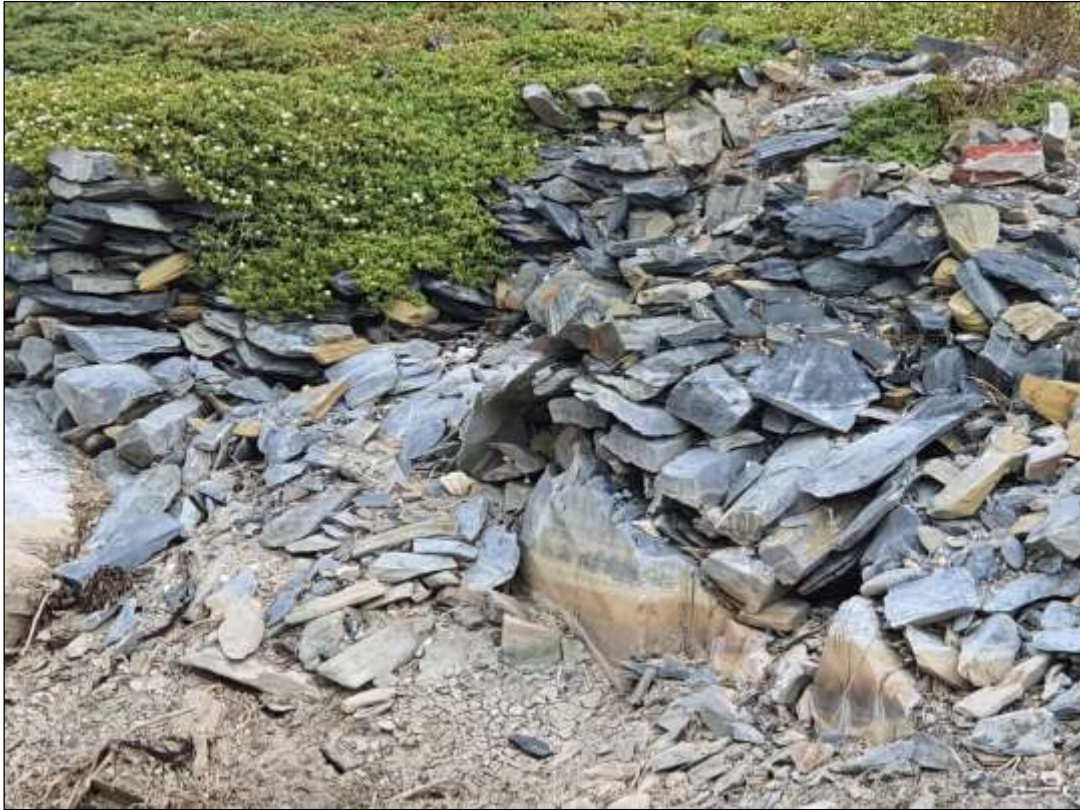
Wall 10, generally collapsed.

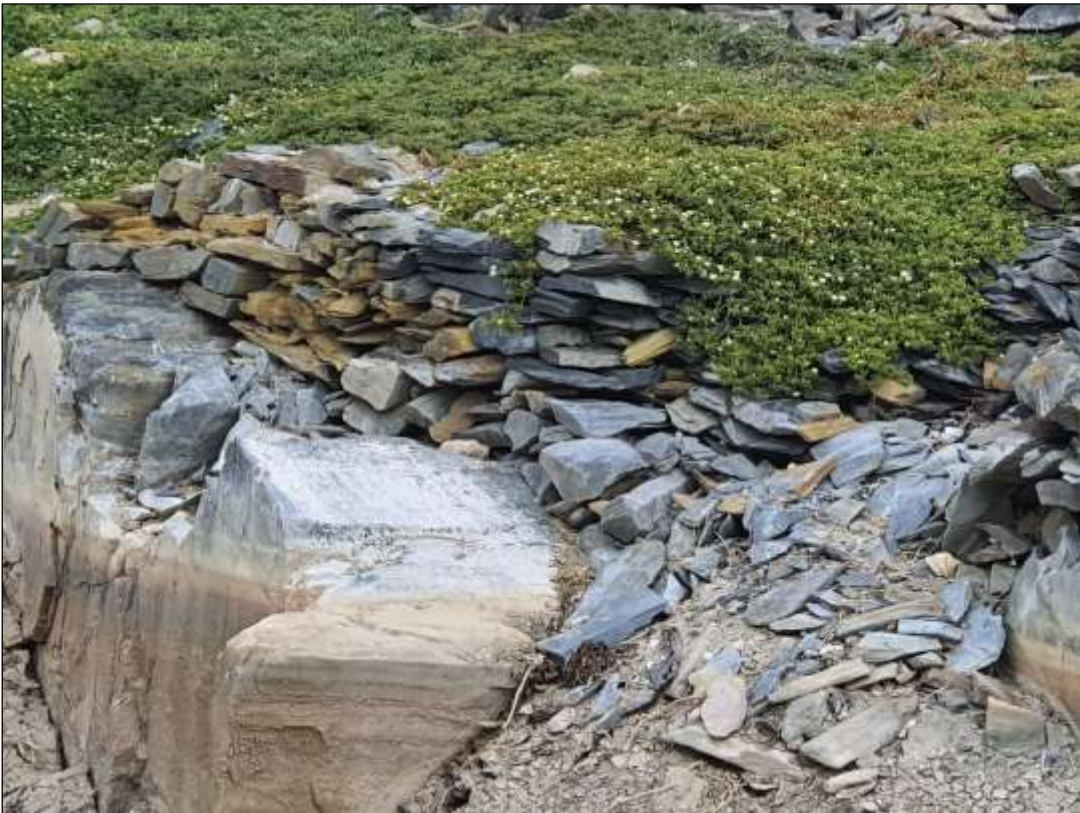
Wall 11, partially collapsed.

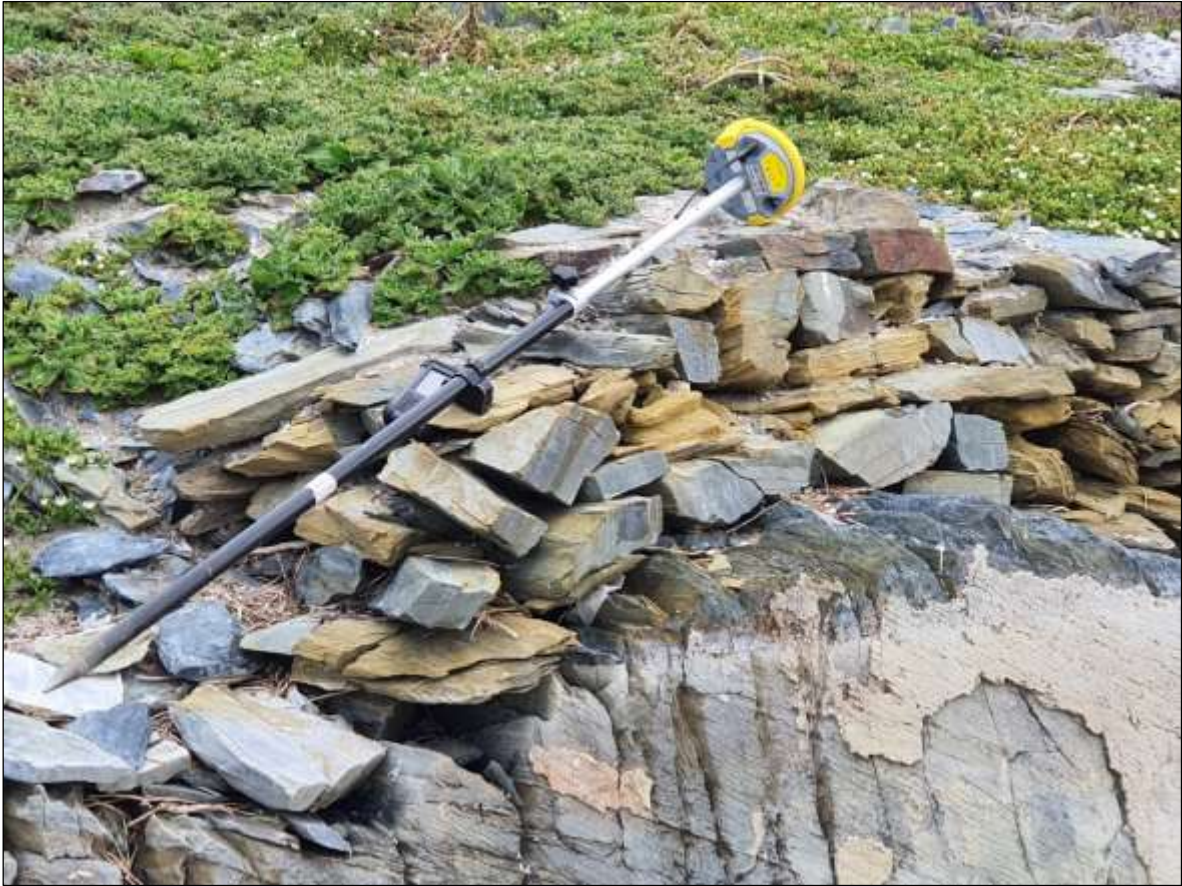
Wall 12, terrace wall, with collapsed ends.

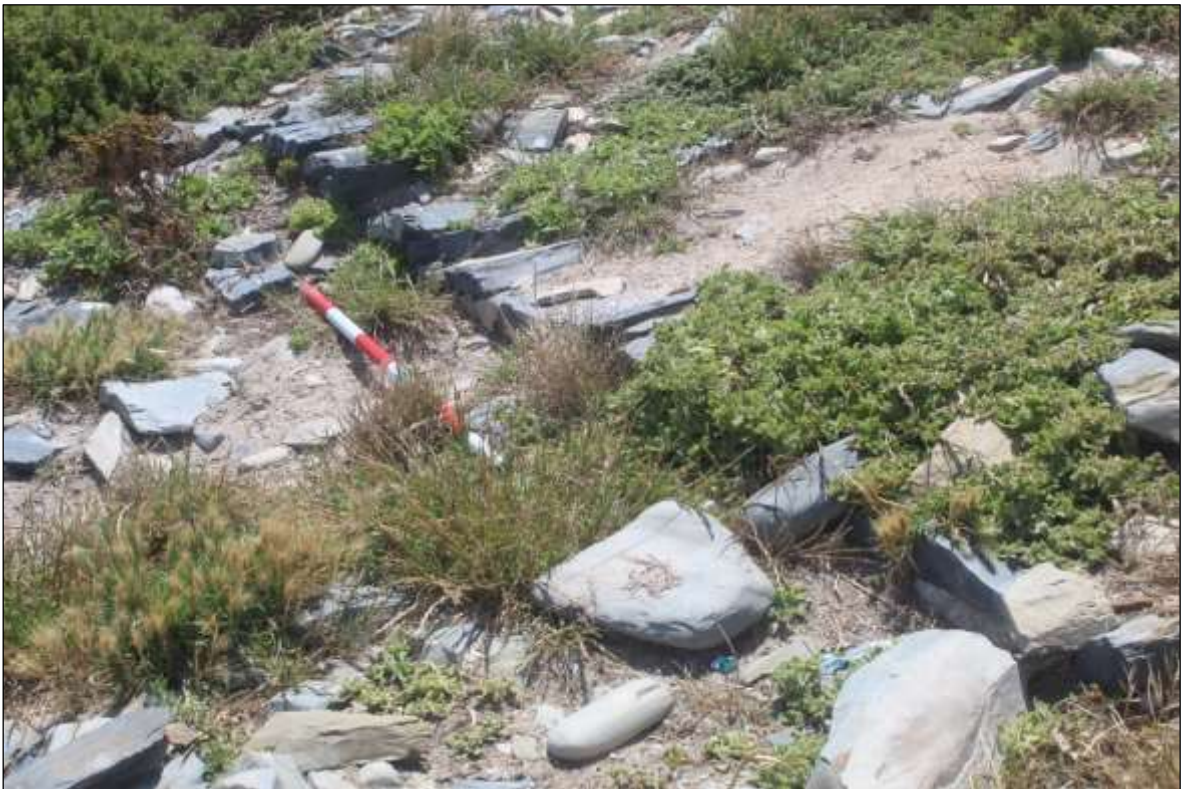
Wall 13, revetment wall, may be partially buried.

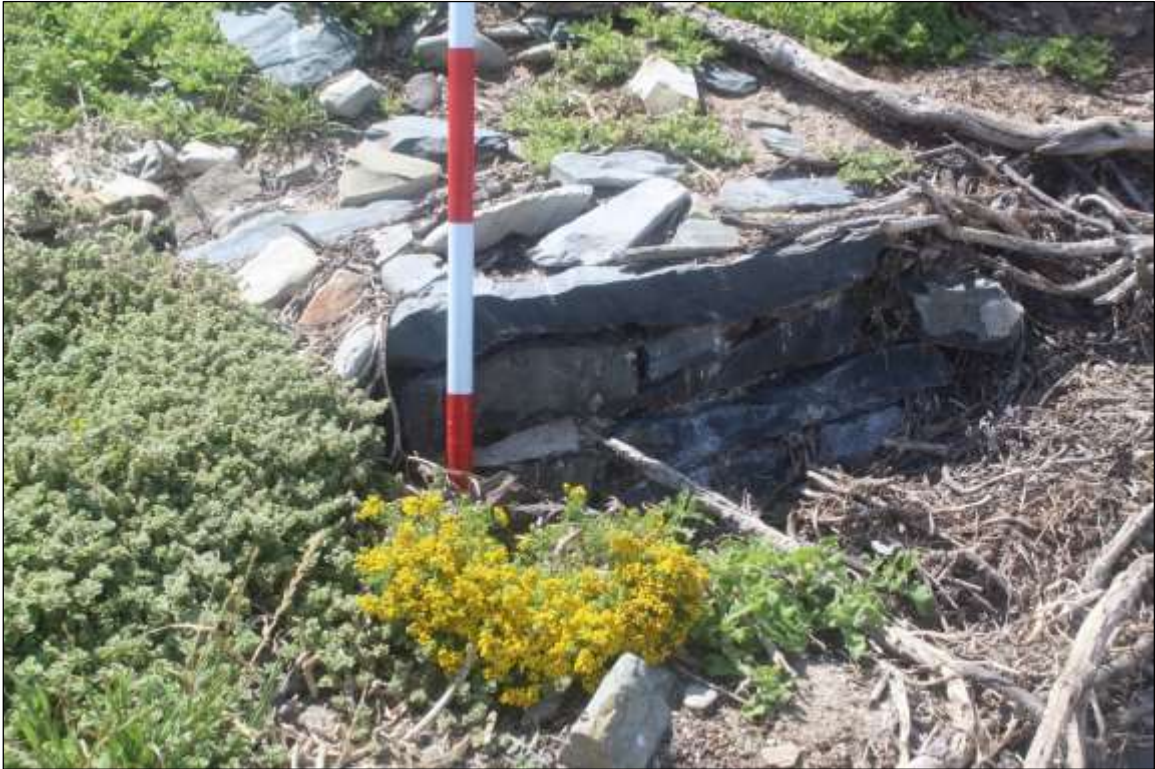
Wall 14, revetment wall.

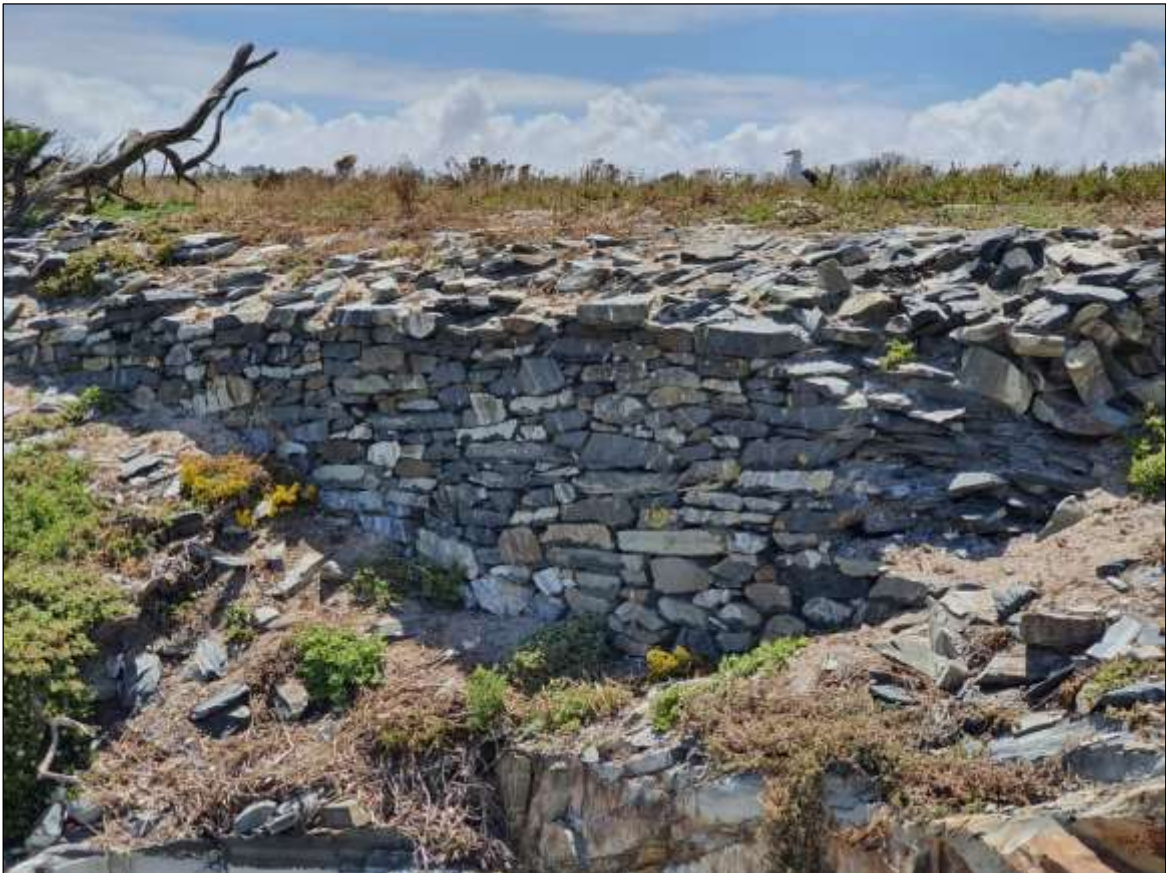
Wall 15, revetment wall, fairly well preserved.

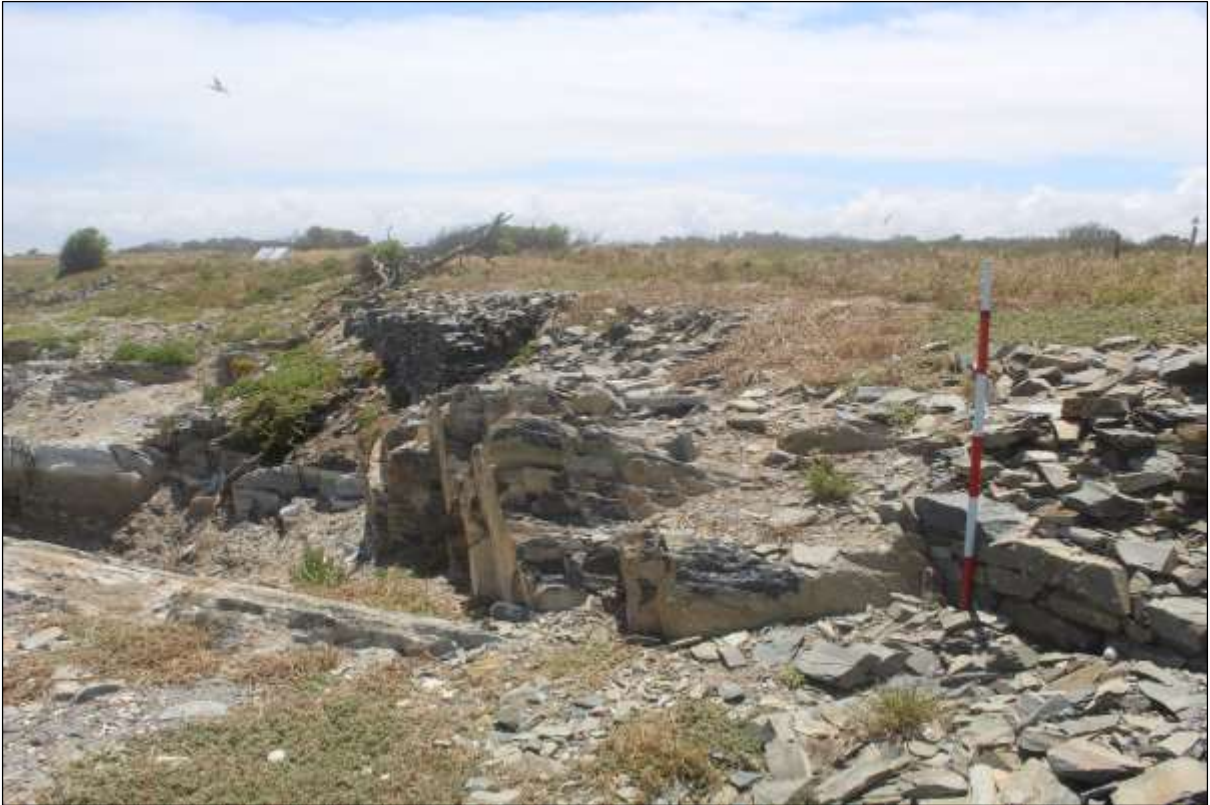
Walls 16 and 15 (to the left), revetment walls.

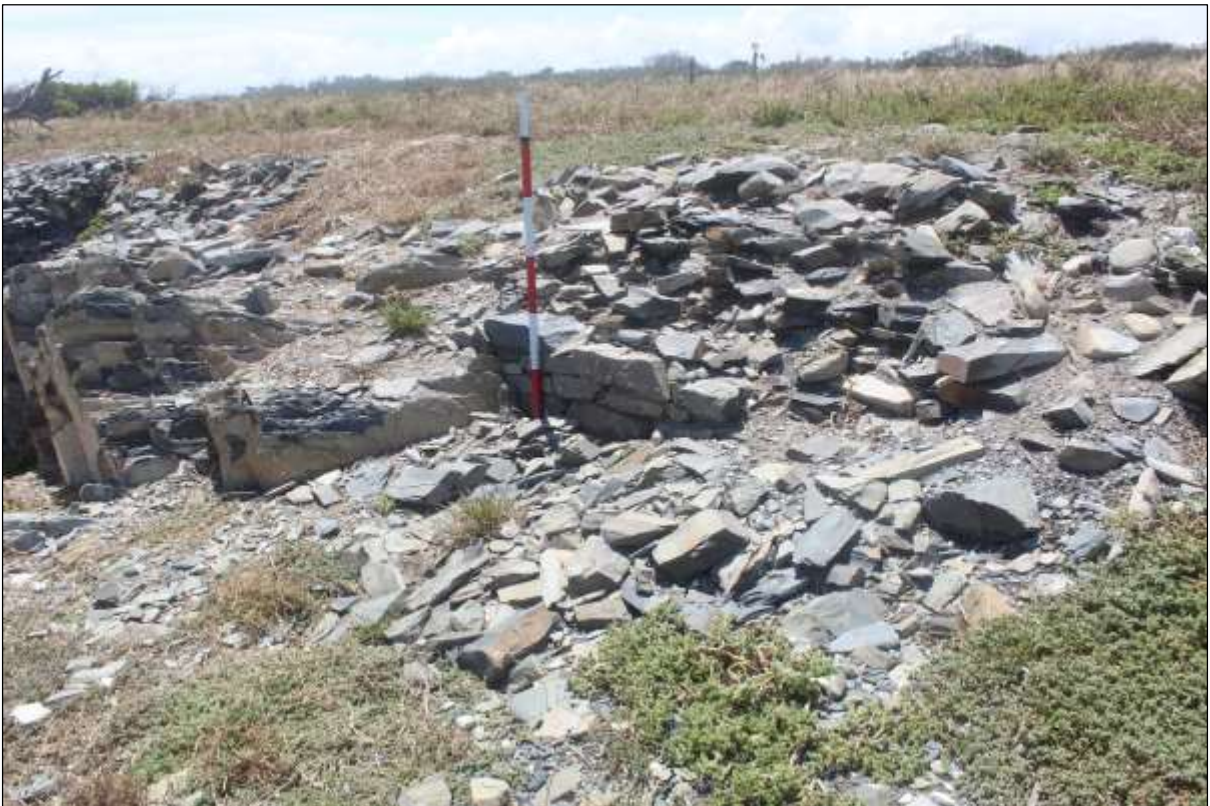
Wall 16, revetment wall.

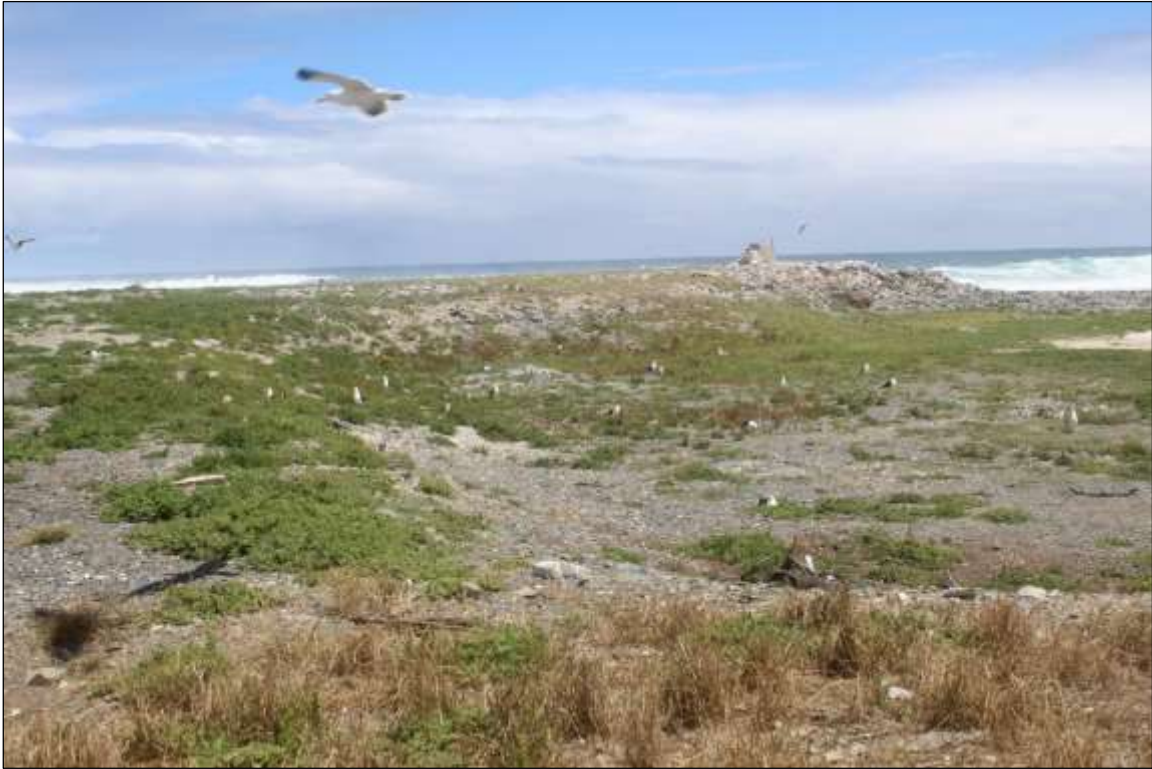
Southern rim of quarry (there are two sections of revetment wall standing).

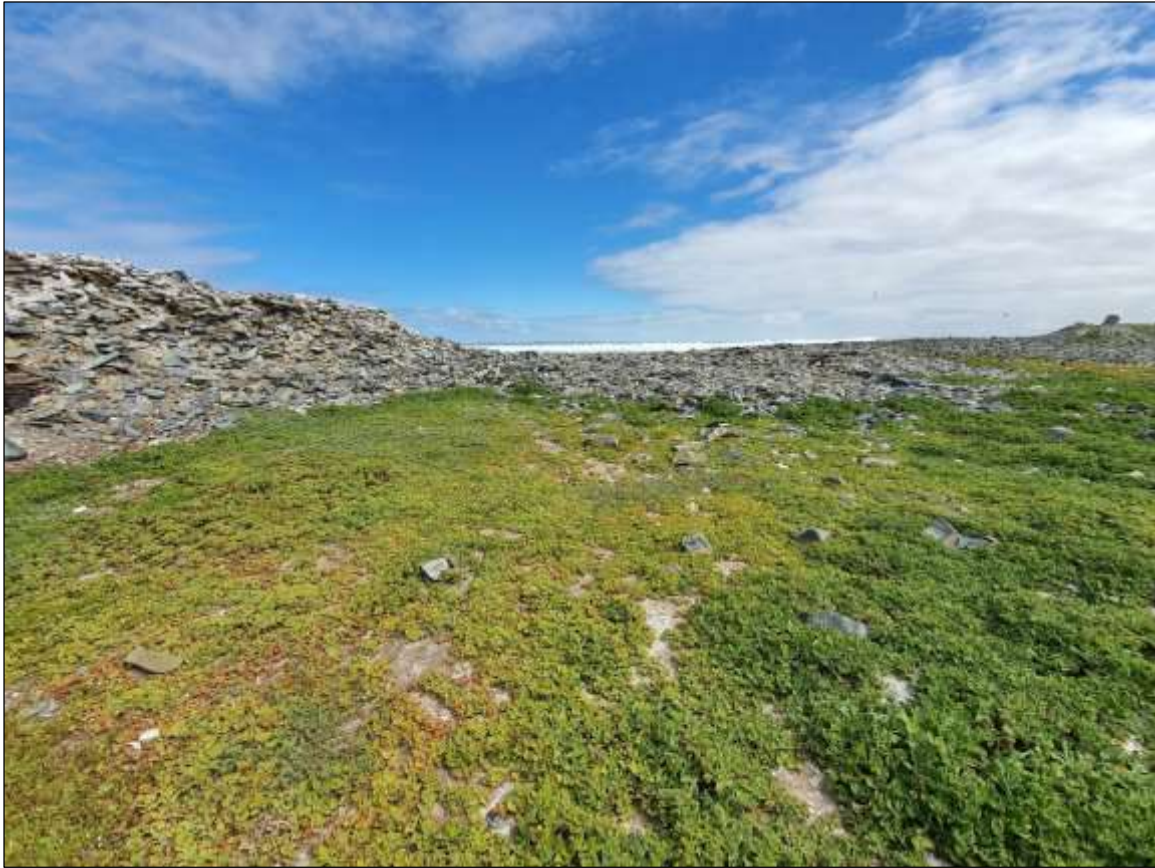
2. To our knowledge the last condition survey was conducted in May 2004, the map of which is included in this report. There is evidence that the site has undergone change in the last 15 years, significantly the collapse of a long section of the main wall along the seashore.

Collapsed mid-section of the main wall.

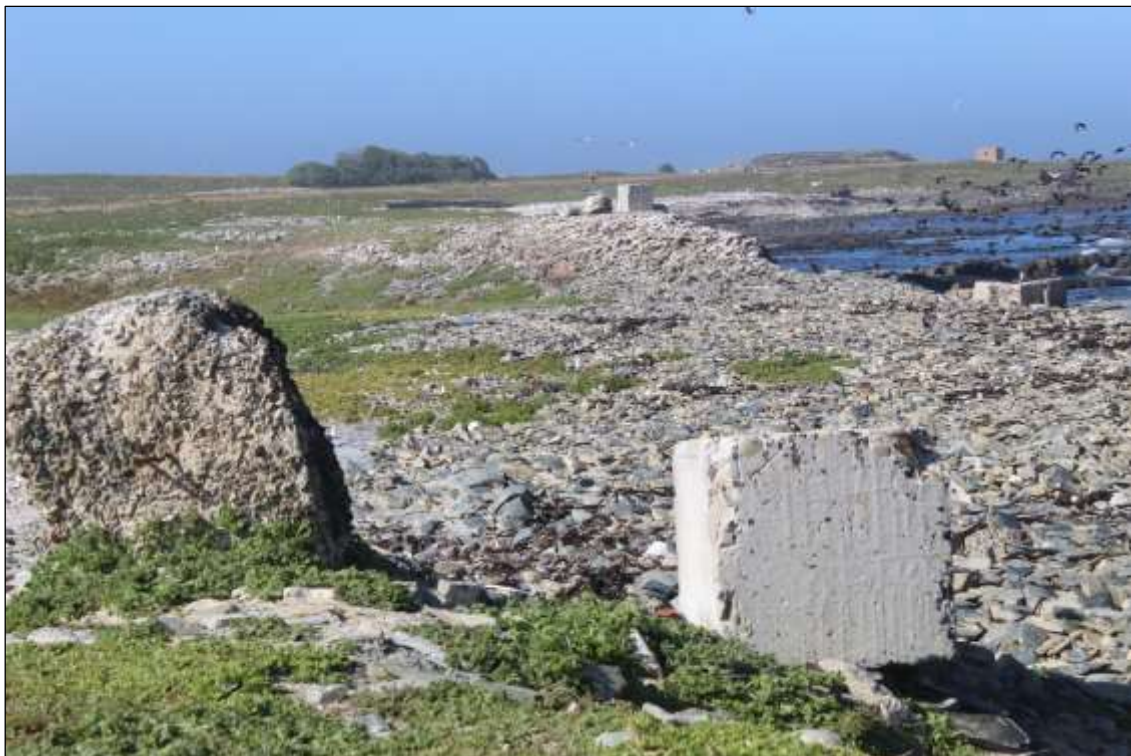
Collapsed mid-section of main wall, view from the north.
