CONDITIONAL ASSESSMENT REPORT

UKZN Chemistry Building,
Golf Road,
Pietermaritzburg,
Kwa-Zulu Natal,
South Africa

Project Title : UKZN Chemistry Building – Conditional Assessment Report

Document Number : 107 - 001 – CAR – RT – 001 - 0.1

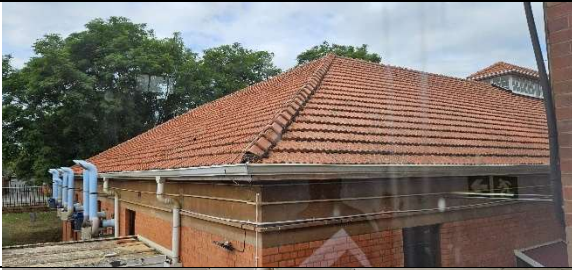
- Clay roof tiles – these are to be replaced as there are a number of cracked and damaged tiles, and finding replacement tiles are very difficult due to the age of the building.

<ul style="list-style-type: none"> • Clay tile roof covering • Roof has warps
2

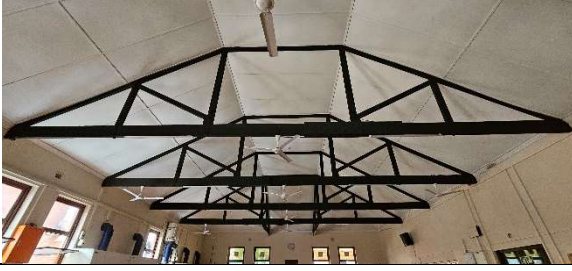
Modified “Double Howe” truss with 2 central panels removed to create a rectangular space in the centre. This section of the building has raked ceilings with the timber tie beams, timber vertical posts and timber diagonal members exposed. The rafters are partially exposed. The purlins were inaccessible to be assessed.

<ul style="list-style-type: none"> • Modified "Double Howe" truss
3

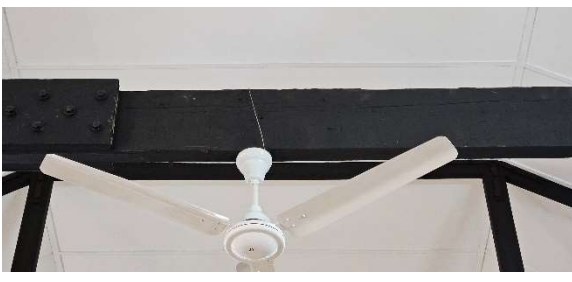
- All tie beams showed creep stress cracks. Evidence of repairs in the form of splicing using steel plates, timber and bolts were observed in an attempt to reduce the spread of further cracking.
- Approximately 40% of the tie beams are cracked.
- Approximately 20% of the diagonal members are separating from the joints at the vertical struts.
- There is evidence of water marks on the ceiling and walls and indicates that the box gutters and roof are leaking.

<ul style="list-style-type: none"> • All tie beams showed creep stress cracks. Evidence of repairs in the form of splicing using steel plates, timber and bolts were observed in an attempt to reduce the spread of further cracking. • Approximately 40% of the tie beams are cracked.
4

The age of the trusses and the extent of stress cracking are indications that these trusses need to be replaced. Furthermore, the removal of the roof covering will cause damage to the purlins. It is therefore recommended that all trusses be replaced in the event of upgrading the roof coverings.

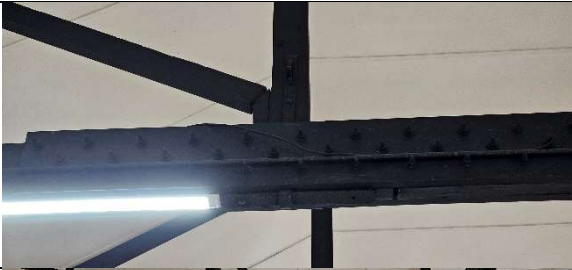
<ul style="list-style-type: none"> • Approximately 20% of the diagonal members are separating from the joints at the vertical struts.
5

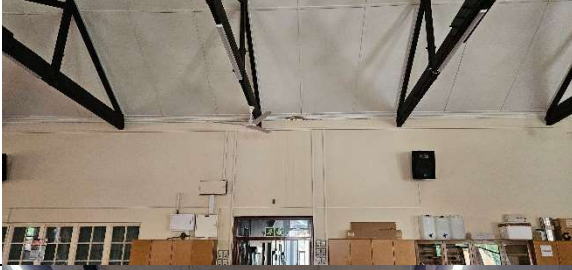
<ul style="list-style-type: none"> • There is evidence of water marks on the ceiling and walls and indicates that the box gutters and roof are leaking.
6

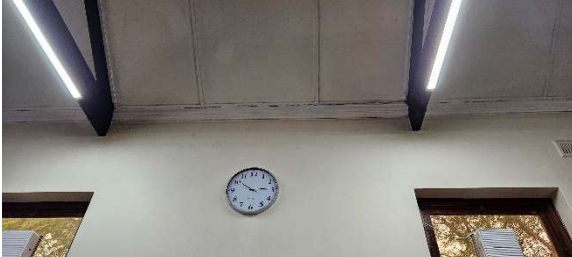
<ul style="list-style-type: none"> • There is evidence of water marks on the ceiling and walls and indicates that the box gutters and roof are leaking.

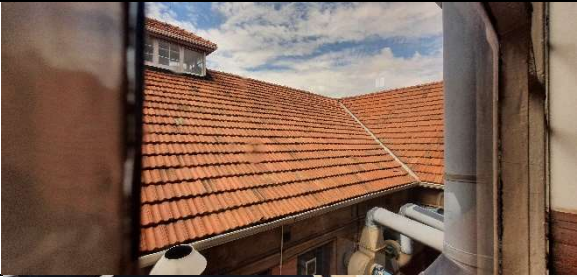
- Clay roof tiles – these are to be replaced as there are a number of cracked and damaged tiles, and finding replacement tiles are very difficult due to the age of the building.

<ul style="list-style-type: none"> • Clay tile roof covering
2

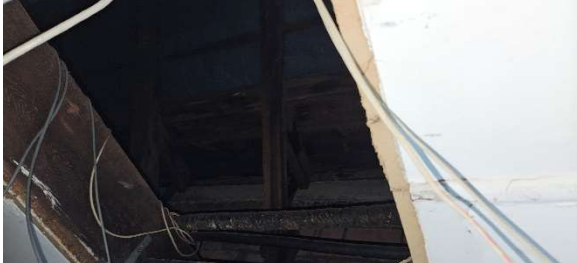
This section of the building has a timber “Double Howe” truss. In general approximately 80% of the timber members are cracked.

<ul style="list-style-type: none"> • "Double Howe" truss • Approximately 80% of the timber members are cracked
3

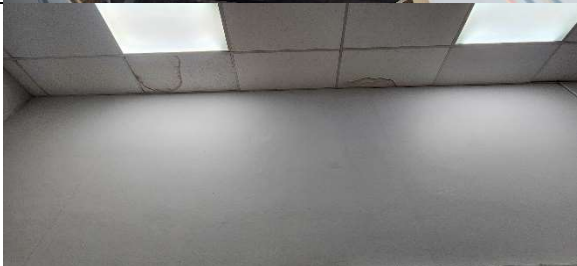
<ul style="list-style-type: none"> • There is evidence of water marks on the ceiling and walls and indicates leaks

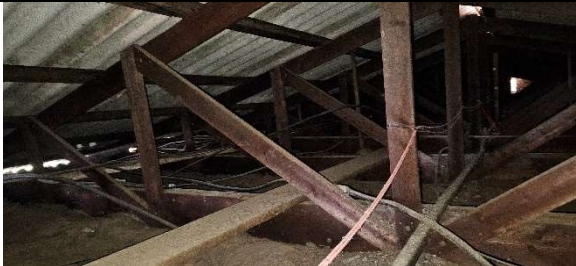
- Asbestos roof sheeting – these are to be replaced.

<ul style="list-style-type: none"> Asbestos roof covering
2

The asbestos roof covering is a health hazard and will need to be replaced in terms of the relevant health and safety acts.

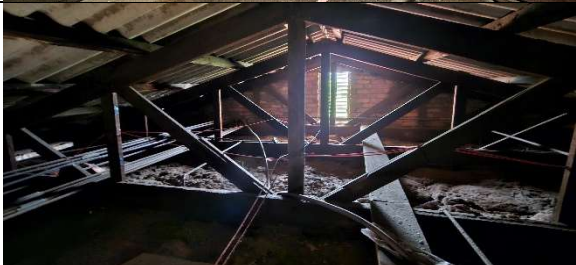
This section of the building has a timber “Double Howe” truss. In general approximately 80% of the timber members are cracked.

<ul style="list-style-type: none"> "Double Howe" truss Approximately 80% of the timber members are cracked
3

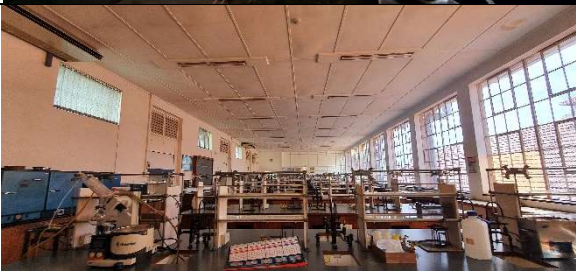
<ul style="list-style-type: none"> There is evidence of water marks on the ceiling and indicates roof leaks

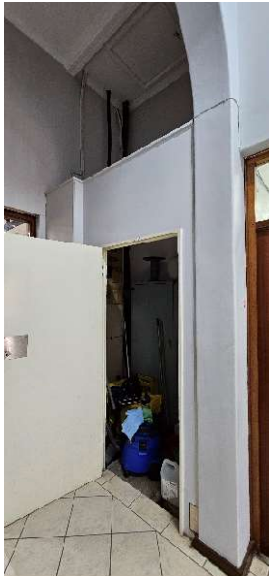
<ul style="list-style-type: none"> • Trap door to access roof space into Building A2 was located above a 380V Distribution Board
2

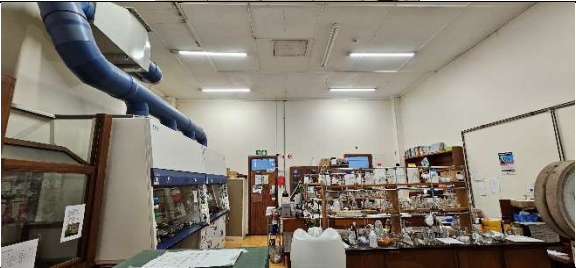
<ul style="list-style-type: none"> • Trap door to access roof space into Building A3 was located in the middle of the laboratory. • The ladder provided was not able to be used safely here.
3

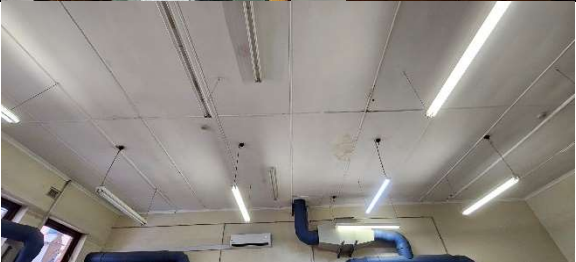
<ul style="list-style-type: none"> • Building A3 - There is evidence of water marks on the ceiling and indicates roof leaks.
