ARCHITECTURAL REPORT

(AMAFA APPLICATION)

St Augustine Hospital Medical Centre 2

PREPARED BY BVA ARCHITECTS – 22 August 2013

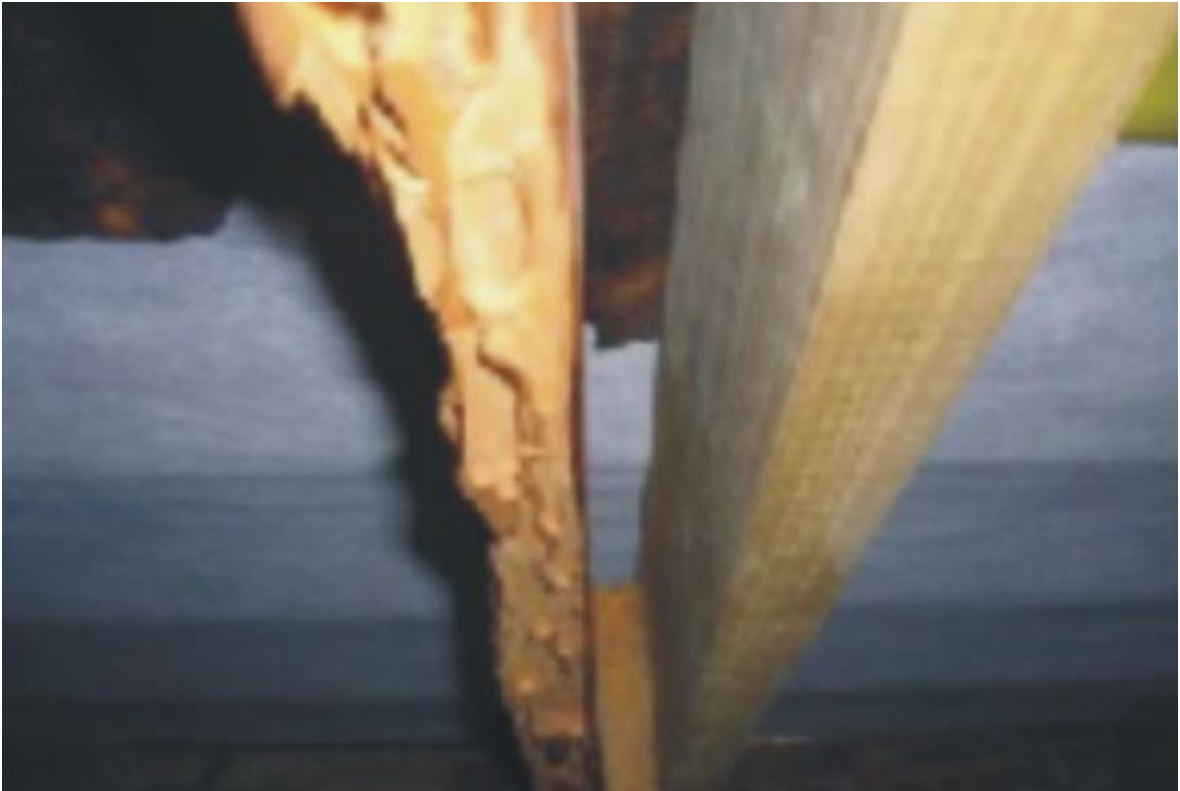
- 2.3 According to the structural engineer's report, the timber used in the building is of an early origin and is unlikely to have been treated for wood borer. The structural engineer's survey (refer to attached document) of the roof and floors has revealed that most areas have been severely damaged due to wood borer infestation and ongoing wood borer activity is quite evident. With further damage, there is a risk of parts of the roof or floor collapsing.

- 3.2 The safety of the occupants of the buildings has become a major concern due to the severe extent of the damage to the trusses and floors, which have been caused by borer infestation (refer to photographs). The risk posed by the trusses or floors falling is becoming increasingly possible and it is becoming imperative to minimize this threat.

Image 9: View of the damaged roof trusses.

- 2.4 As per the structural engineer's recommendation, it is proposed that the existing roof and timber floors in the building are removed in its entirety. The existing roof will be replaced with a new roof to match the existing roof, thereby maintaining the existing aesthetics of the building, externally. The existing timber floors will be removed and replaced with new concrete floor slabs in an attempt to eliminate borer infestation.

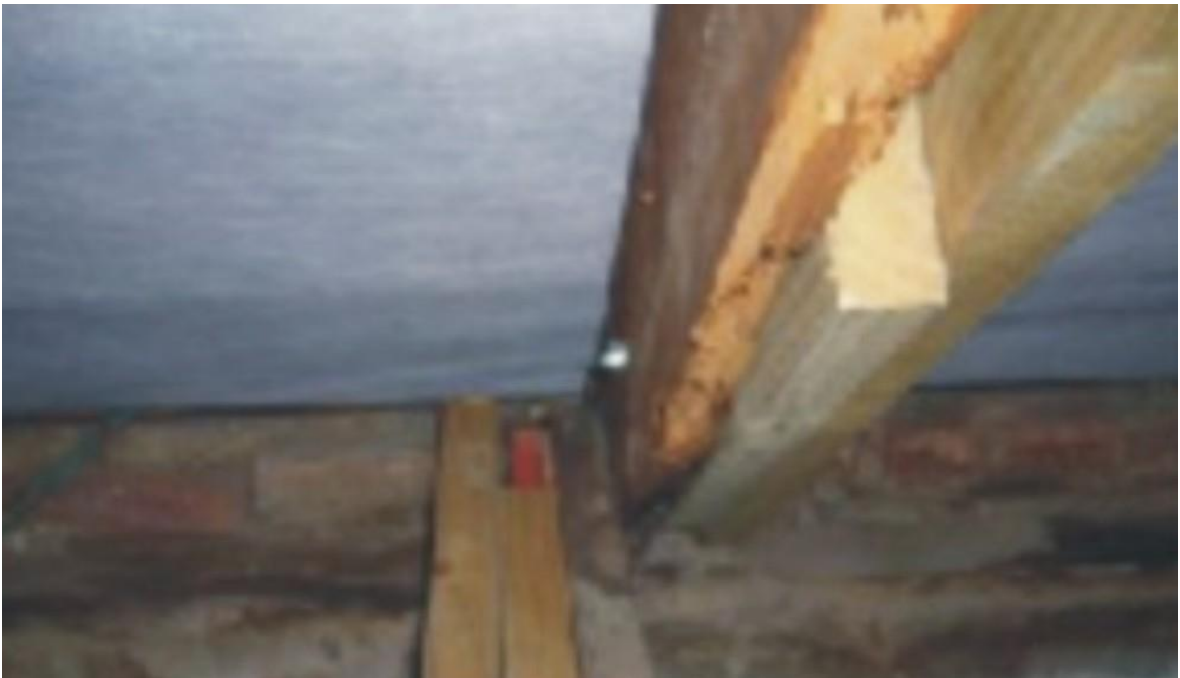
Image 10: View of the damaged roof trusses.
