Initial Inspection Report

Project:	Publicity House Refurbishment of External Fabric
Client:	Msunduzi Municipality and Independent Development Trust

Revision	Date	Prepared By	Checked
-	19 Apr 2013	BR	BR

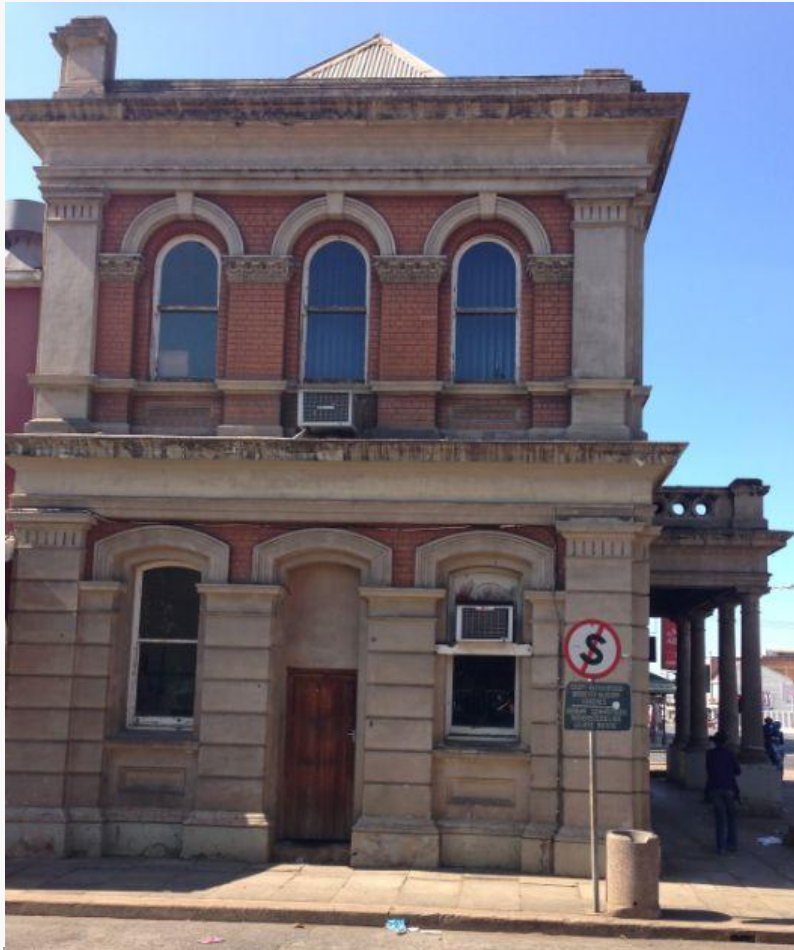
photo 1

Extent of exposed brickwork: to the west, south & east elevations, at 1st floor level and surrounding window heads only at ground floor level. The entire structure however, is most likely in brick with a decorative render finish.

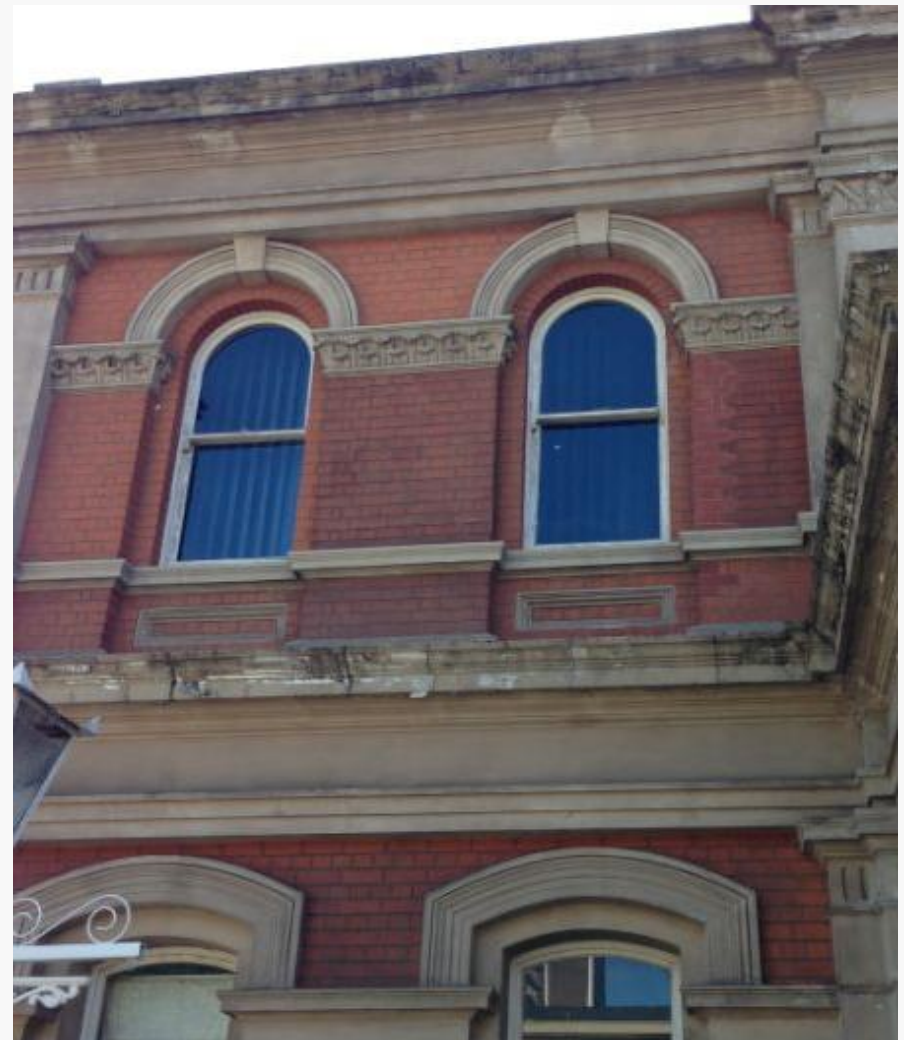
photo 2

The brickwork generally appears to be in good condition, with little evidence of decay or spalling. There is evidence of previous repair work having been carried out to the half-round window heads at 1st floor, and to some of the window reveals, also at 1st floor level.

3.1.2	<p>Repair of Brickwork</p> <p>It is not envisaged that any brick replacement will be required to Publicity House: provided that there is no damp ingress or structural concerns, all bricks should be left alone.</p> <p>Where any significant defects arise e.g. spalling of the fireskin, the first course of action would be the reversing of the brick (rather than replacement) – however, this should not be undertaken where there is a high likelihood that the new face will deteriorate in the same manner as the original face, once exposed to the weather.</p>

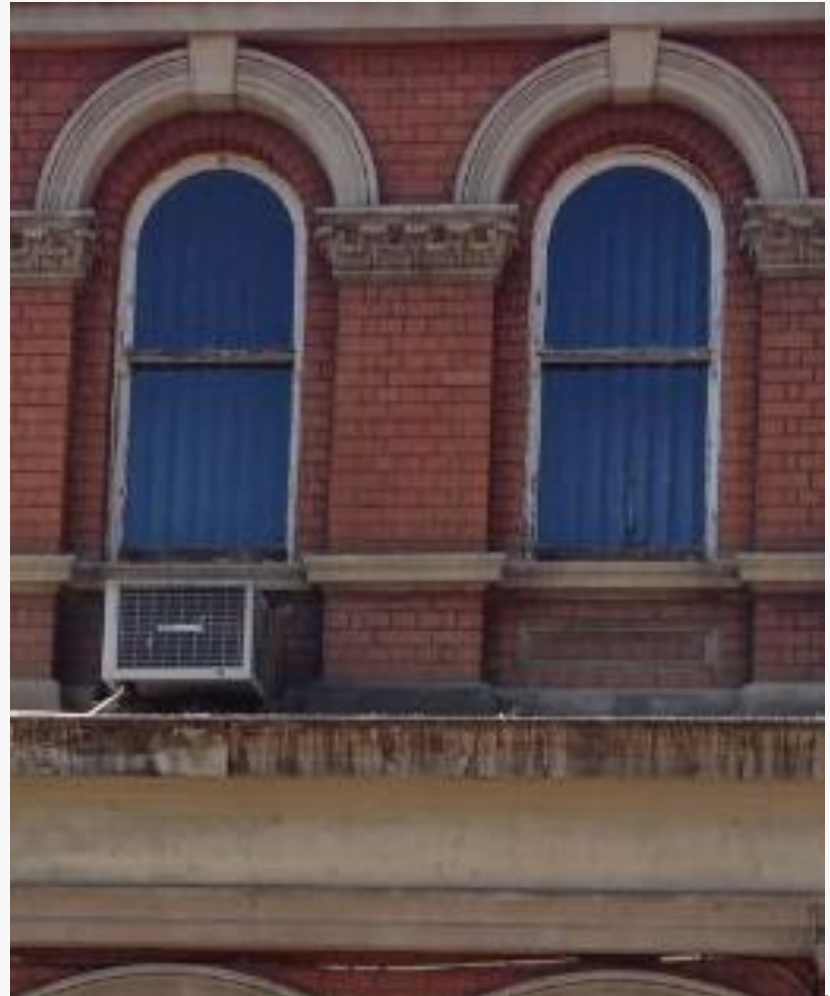
Photo 3

Insensitive insertion of an air-con unit to the southwest elevation – this has destroyed the decorative inlaid brick detail, and render plinth below.

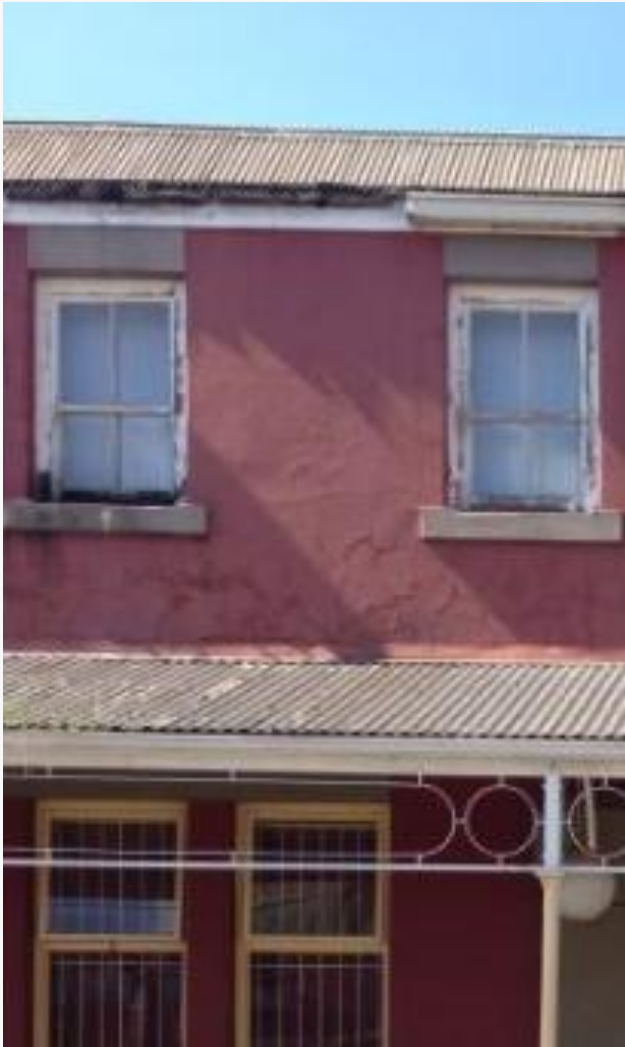
photo 4
Cracking to plaster finish – northwest elevation

3.2.2	<p>Repairs to Renders</p> <p>Only problem areas where plaster is loose and defective need to be redone: the retention of sound work is important for its authenticity and historical value.</p> <p>New render must never be stronger than the background to which it is applied; successive coats must not be thicker or stronger than previous ones. The background and each subsequent coat must be pre-dampened before applying the next, to avoid suction, and coats must not be overly thick. Carrying out work during overdry, windy or very sunny periods should be avoided.</p> <p>PROCEDURE:</p> <p>Cut out defective work to a regular edge, slightly undercutting the top and sides. Ensure an adequate key by raking out joints, scoring background etc.; a mechanical key is more desirable than the use of binding agents, such as PVA. The number of coats applied should ensure that the face of finished work comes flush with that existing: three coat work is usual, with the overall thickness of the render usually being a minimum of 25mm. The first coat is applied to a thickness of 9 – 16mm and combed to give a key for the next coat; remaining coats can be from 6 – 10mm thick.</p> <p>The final coat should be finished with a wooden float and not overworked.</p>

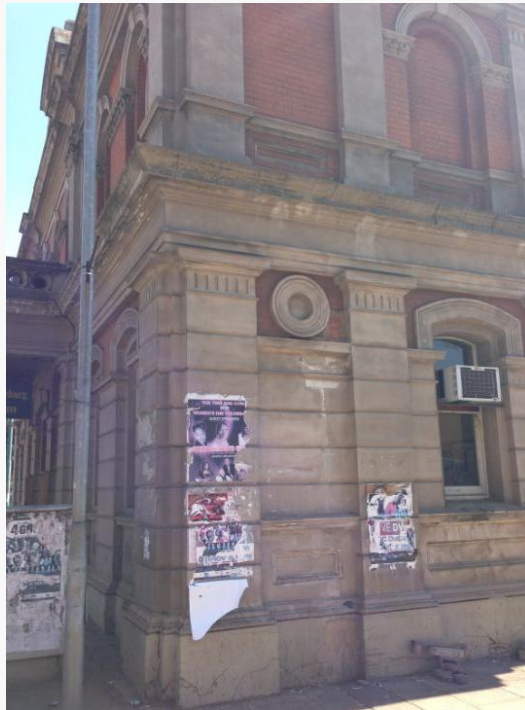
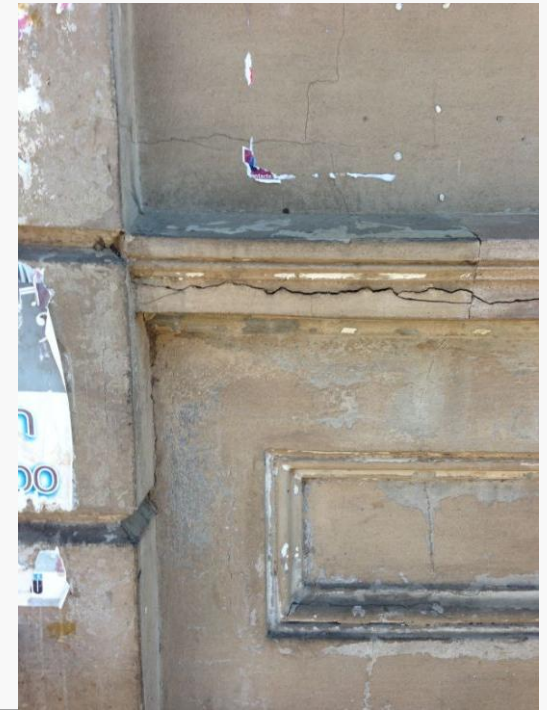
photos 5 & 6
Typical condition of plaster moulding – poorly maintained, significant cracking & frequently covered with layers of signage bills

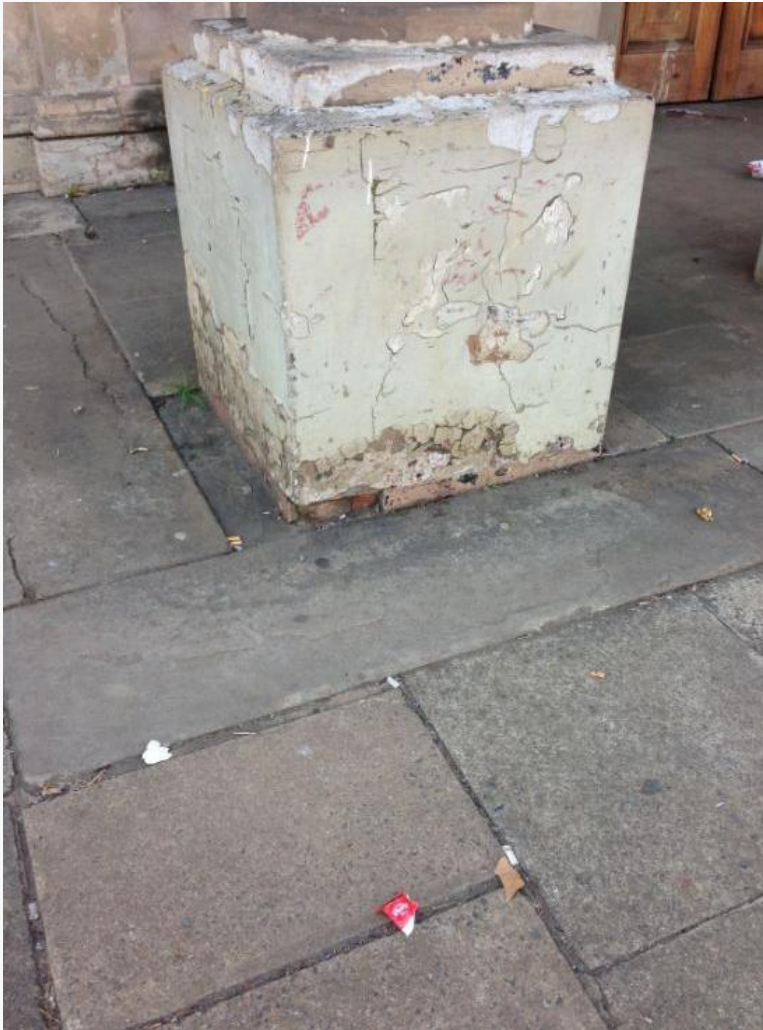
photo 7
Base of column plinth damaged; resultant decay of structure evident

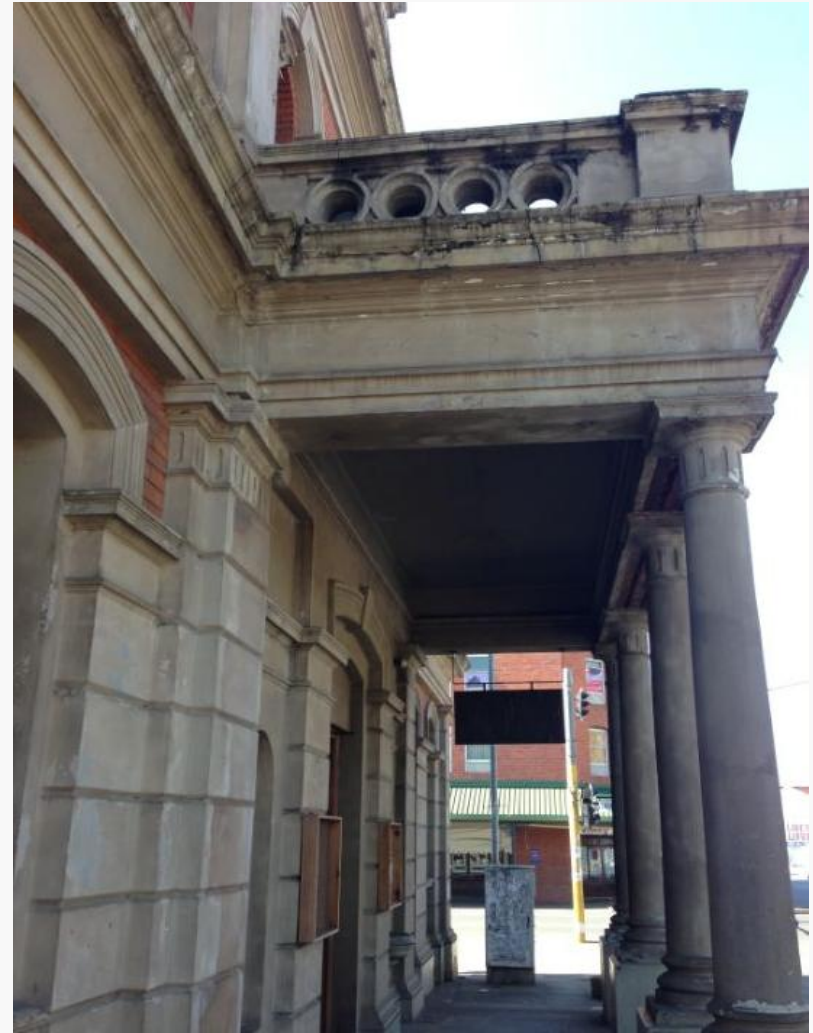
Photo 8
significant cracking to the cornice of the entablature;
general poor maintenance and a lack of cleaning evident

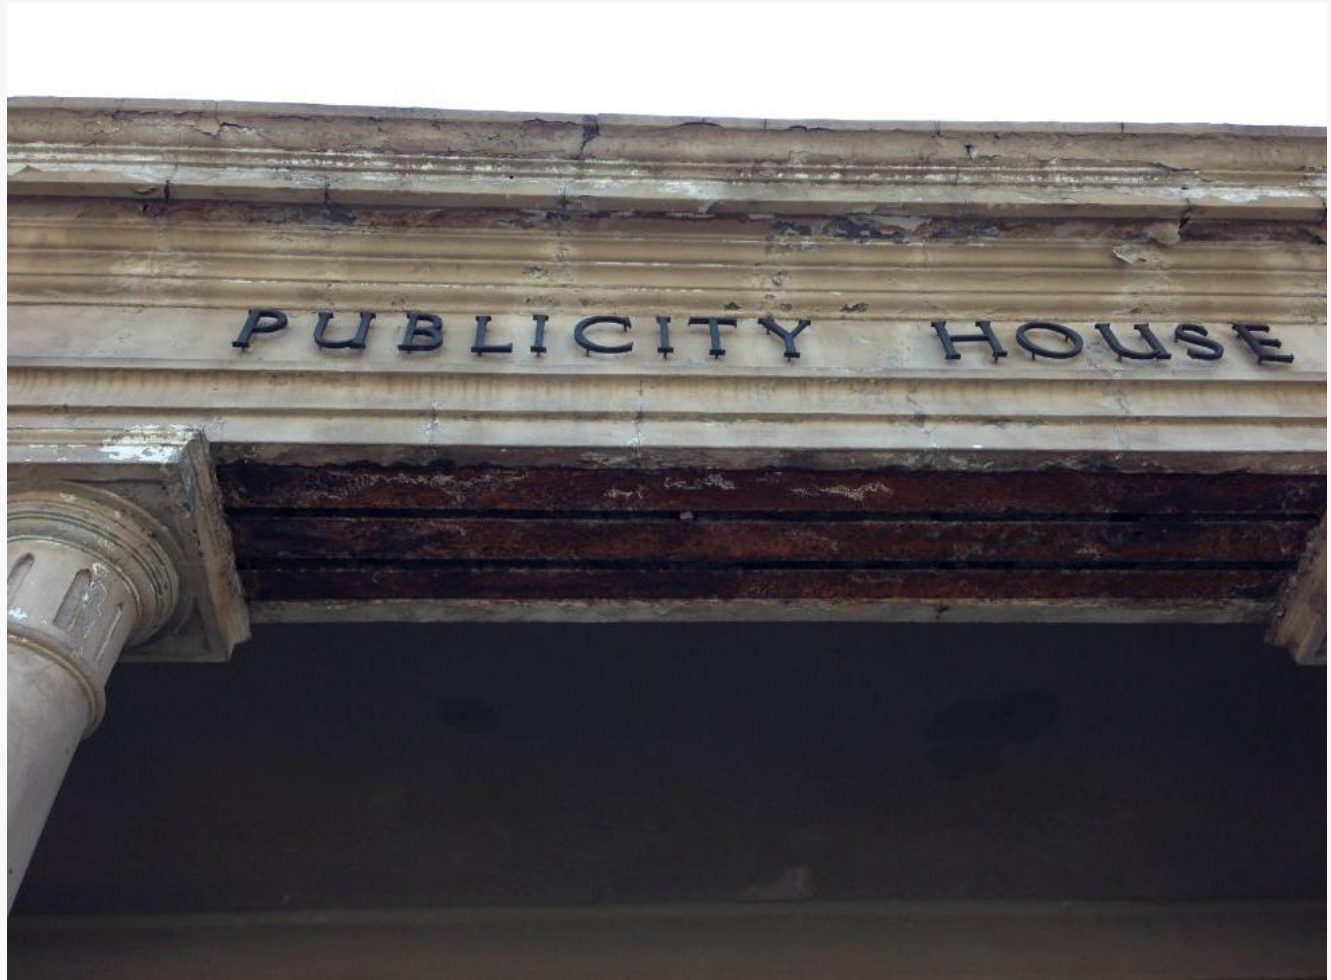
Photo 9

Underside of entablature to entrance portico: render missing, with resultant suspected rusting of steel beams: these will require to be checked by a structural engineer

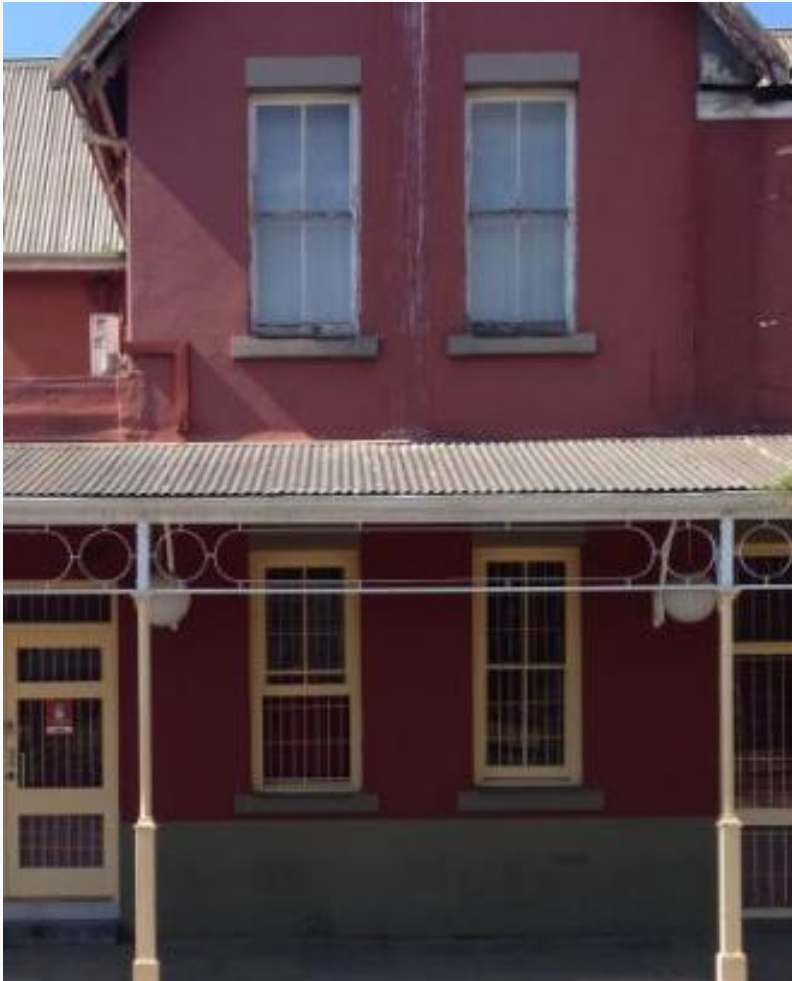
photo 10

Very poor decorative condition of first floor windows – probable decay of susceptible sections of sashes will need repairs

3.3.3	<p>Repair of Timber Windows The integrity of the timber elements of the windows and frames should be tested with the use of a knife or awl – up to 3mm penetration is considered normal; 3-6mm demonstrates sound but ‘thirsty’ timber; more than 6mm demonstrates a problem, and further testing is required to determine the extent of damage. Typically, if there is very little give in the vulnerable lower corners, rails and sills, then the windows are basically in good condition.</p> <p>Where repairs are required, a similar timber should be utilised so as to ensure similar expansion rates; slow-grown timber should be used. Only the decayed timber and a minimum amount of sound timber beside the decay should be cut out, to obtain a strong spliced joint between the old and new timber. The new joint may be reinforced by pegging or screwing using brass screws fixed from the interior. The joint should be angled to throw water to the outside edge of the timber rather than let it creep inwards: the greater the angle, the stronger the repair.</p>

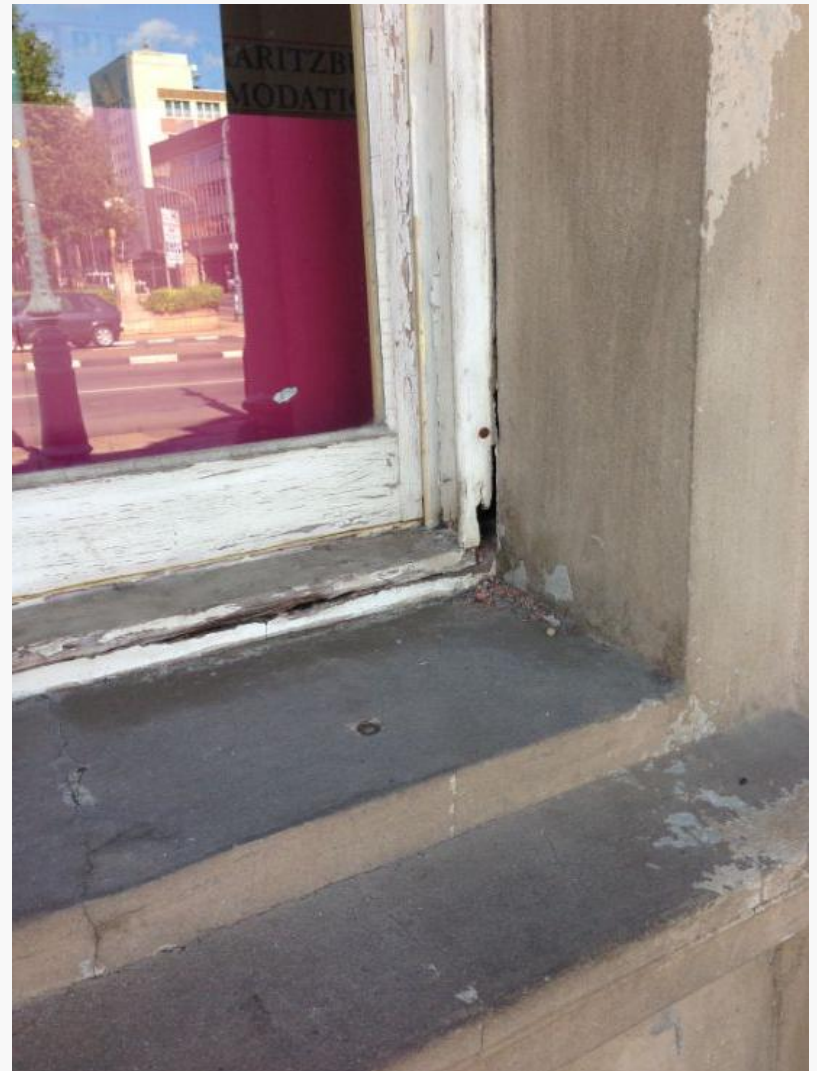
photo 11

Decay of frames – repair works required

Note: cracking of paintwork may suggest presence of lead paint – utmost care to be exercised in its removal/cleaning

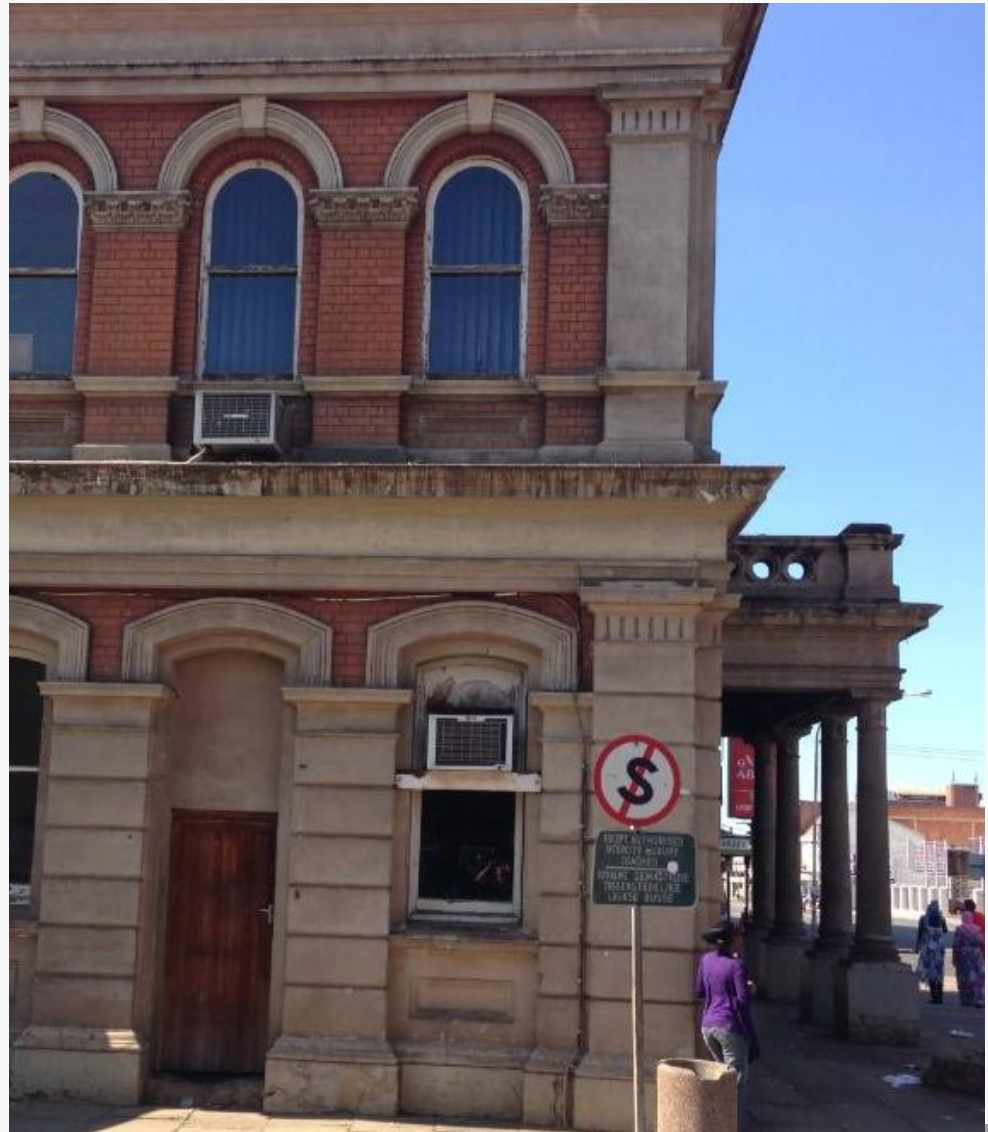
photo 12

Insensitive insertion of air-con unit within the sash, with resultant damage to the window and adjacent render (1 further window similarly affected)

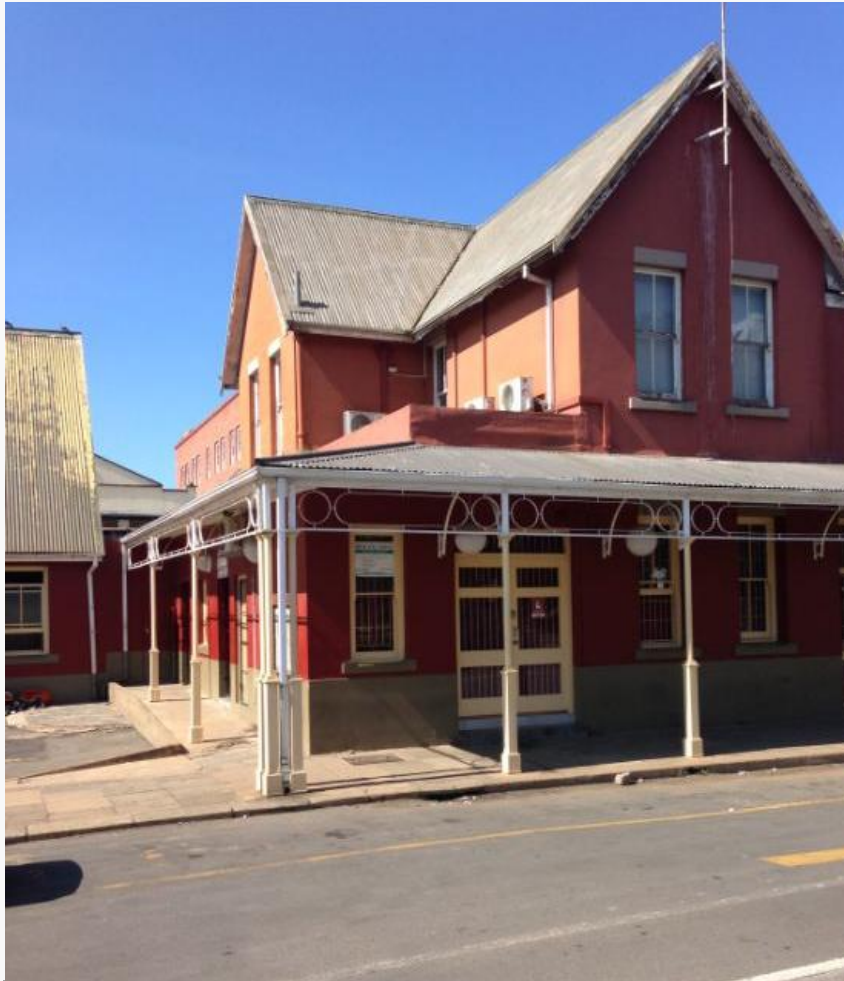
photo 13

Corrugated iron roof finish throughout (note small section of flat-roof above): to rear buildings with exposed rainwater goods (in many cases the original cast-iron is replaced or missing).....

3.4.2	<p>Repair of Roofs</p> <p>Only where there is significant decay of the corrugated iron should the sheets or parts of sheets be replaced. Replacement sheets or part sheet should match the existing in gauge and dimensions.</p> <p>The parapet gutters over the front section of building need to be carefully checked for signs of leaking (particularly evident from the interior).</p>

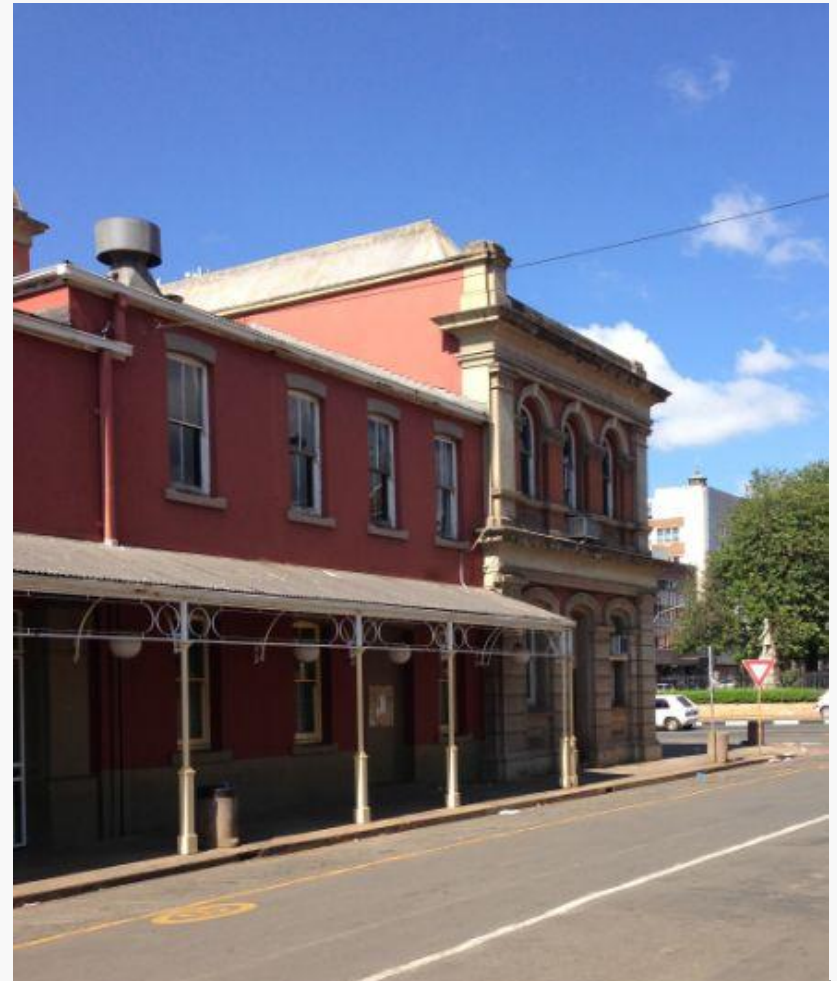
photo 14

.....the roof to the front block is concealed by a parapet, with no visible rainwater drops – concealed/internal downpipes.

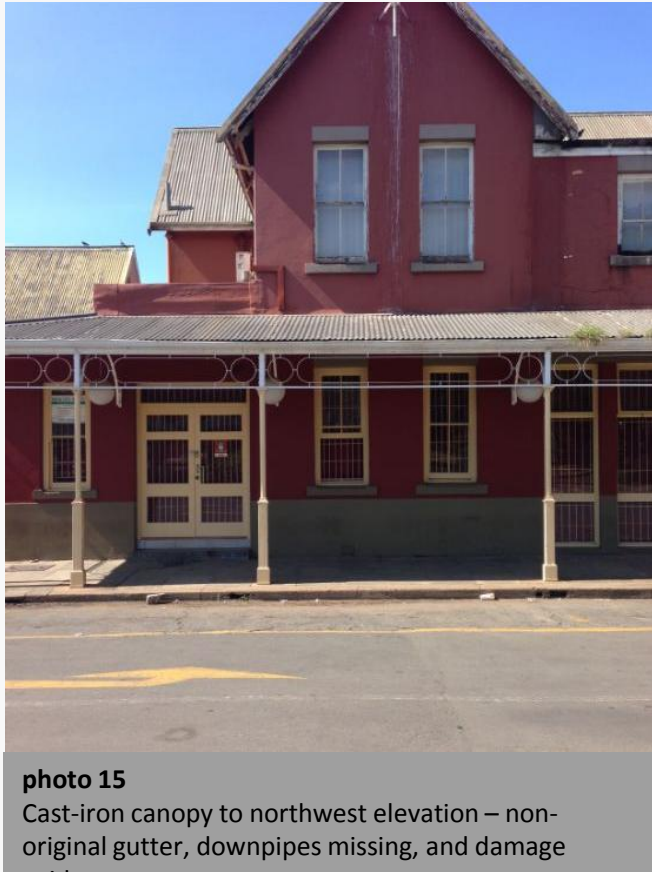
photo 15
Cast-iron canopy to northwest elevation – non-original gutter, downpipes missing, and damage evident

3.4.3	<p>Repair of Rainwater Goods & Cast-Iron Elements</p> <p>Gutters to the rear structures are generally in uPVC, having replaced the original cast-iron gutters. This are generally in poor condition. The rainwater downpipes are a mix of original cast-iron and uPVC replacements. There is significant flora growth in many locations, suggesting a lack of maintenance. Sections of uPVC guttering are missing.</p> <p>It is recommended that replacement cast-iron gutters and downpipes, matching those that are present, should be installed, due to their longevity and durability, when properly maintained.</p> <p>The front section of building has concealed/internal rainwater pipes – no internal inspection for signs of leaking has been undertaken to date; the flat roof over the entrance portico is designed to be drained via a single rainwater pipe, located to the left of the entrance door (viewed looking in) – this is missing entirely.</p> <p>It is recommended that a replacement cast-iron rainwater pipe, similar to those existing or as would have been utilised at the period of construction in such a prominent position, should be installed.</p> <p>CANOPY STRUCTURE to NORTHWEST ELEVATION</p> <p>PVC guttering is in poor condition, and rainwater down pipes are missing; general signs of poor maintenance. The cast-iron structure is generally in good condition, with just one element broken (but remaining insitu), that being in the bay closest to Chief Albert Luthuli Street. This break should be repaired by braze welding.</p> <p>It is recommended that replacement cast-iron gutters and downpipes, similar to those as would have been utilised at the period of construction, should be installed.</p>

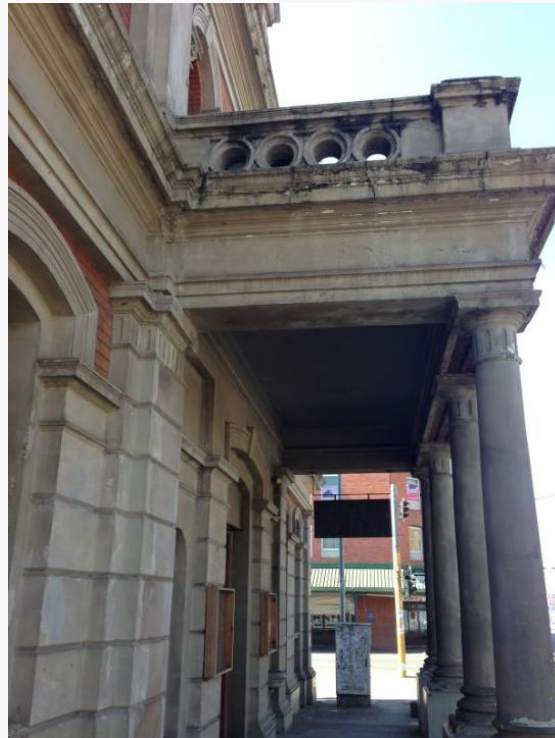
photo 16 above
Flat roof over entrance portico shows significant staining, suggesting poor rainwater management

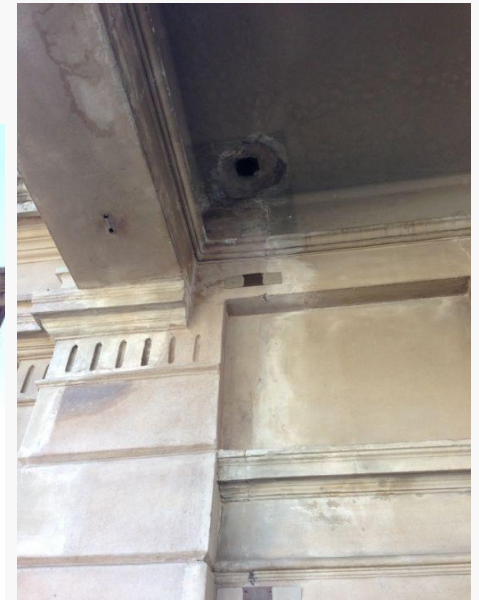
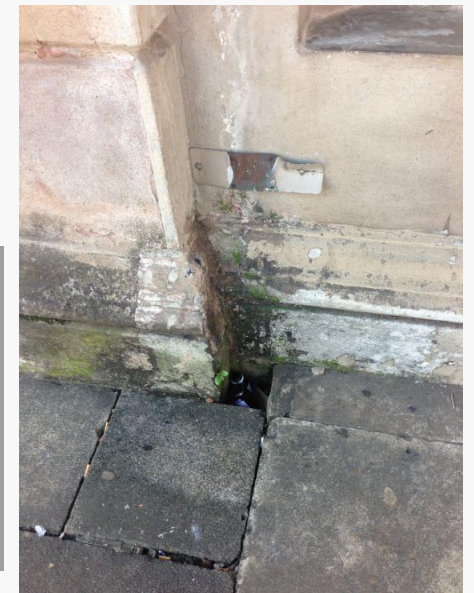
Photos 17 & 18 right
Rainwater down pipe that should be serving the portico roof is missing, leading to damage to the surrounding render
