Savannah Environmental Pty (Ltd)

CONSTRUCTION OF THE PROPOSED WATERBERG PHOTOVOLTAIC PLANT

ROAD IMPACT ASSESSMENT REPORT

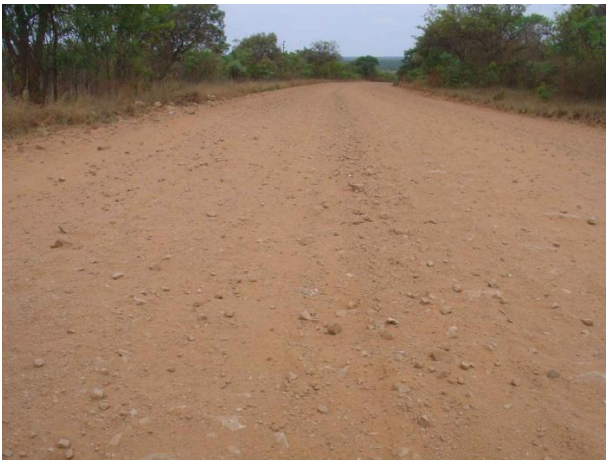
During the site visit it was observed that there is corrugation along the gravel roads of both the alternative routes from Vaalwater. A portion of Road D 2747 had recently been graded and therefore appeared in a fair condition. The remainder of Road D2747, Road D973 and Road D2416 are in a poor condition due to the lack of maintenance, with sections of the roads having extensive corrugation and isolated potholes.

Photo 1 – Gravel on Road D2747

- » Apply a NEW 200mm wearing course to the existing road structure after the roads have been bladed and water mixed in;
- » Cut diagonal drainage furrows (mitre drains) from road shoulder, to drain water away from road edge, at regular intervals and at critical points;
- » Prepare a maintenance schedule for the gravel roads during construction. It is recommended that all the gravel roads used be bladed and watered once a month.

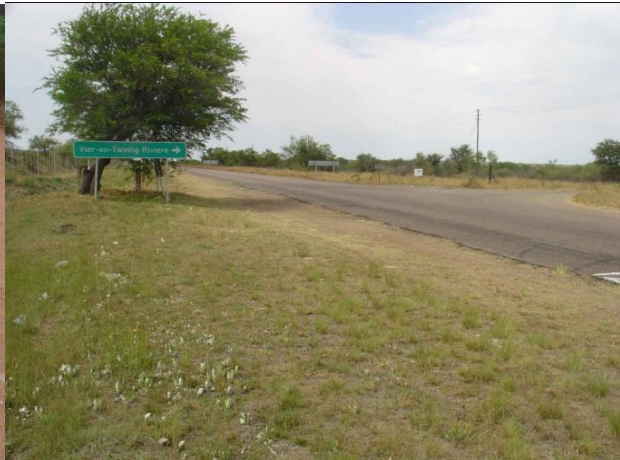
Photo 2 – Intersection D972 and D2747

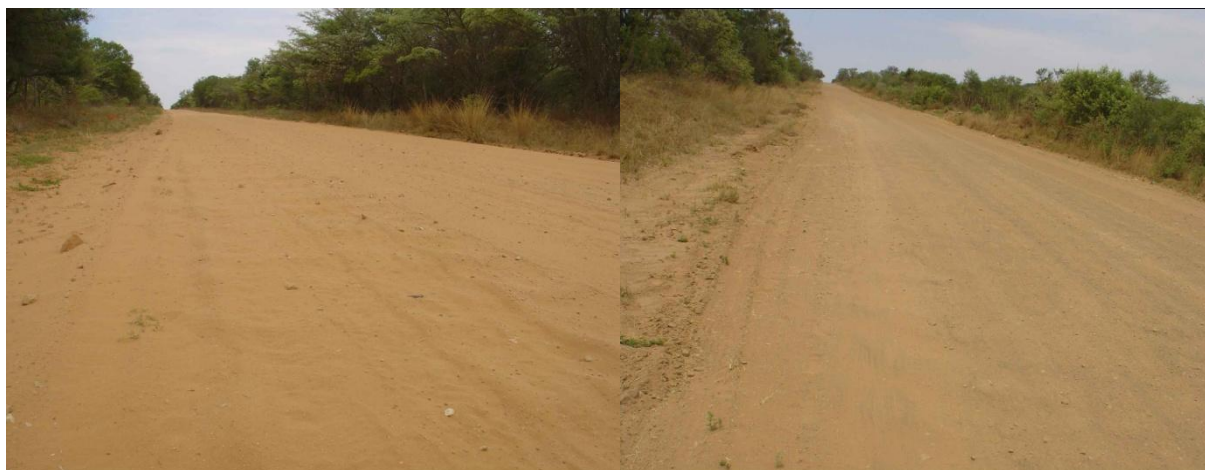
10.6-17 – D2747	Silt and corrugation, Deg5, Ext5 Riding quality bad, dust is severe.
17-18 – D2747	Corrugation Deg5, Ext 5, Riding quality bad,
18-19.1 – D2747	Corrugation Deg5, Ext 5, Riding quality bad

Photo 3 – Silt on Road D2747

Photo 4 – Corrugation on Road D2747
