### **2011-01-18 DPW VILLAGE REGENERATION HOUSES 83,84,85,86**

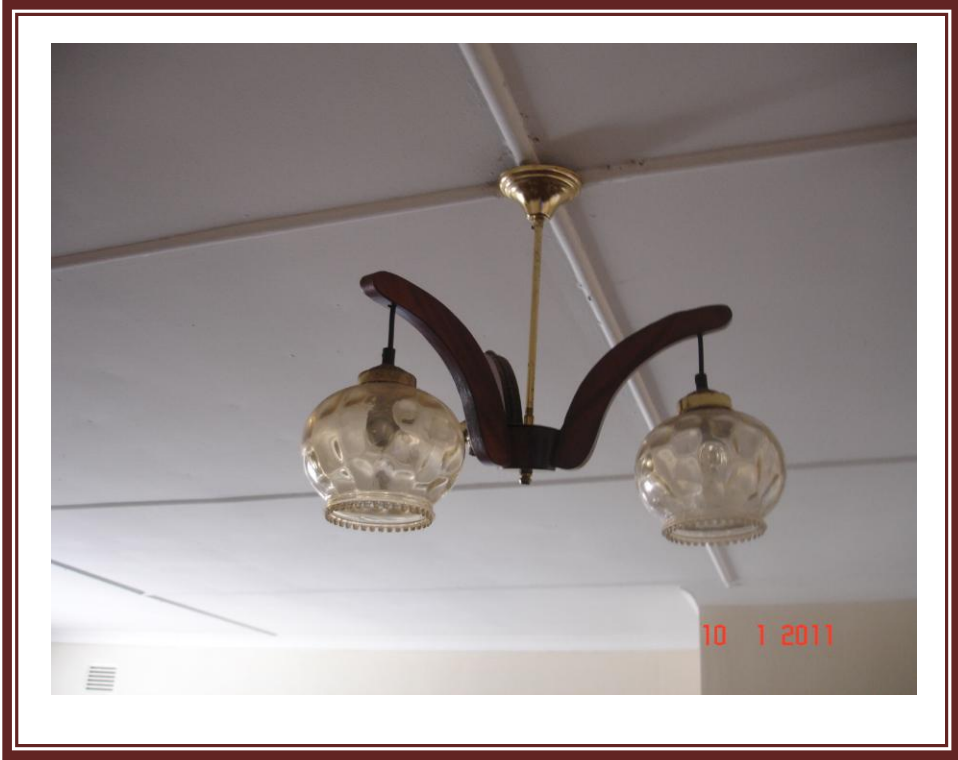
LIGHT  
FITTINGS

The interiors are more significant because the original meranti pelmets, typical 70's light fittings and parquet red teak floors have not been disturbed.

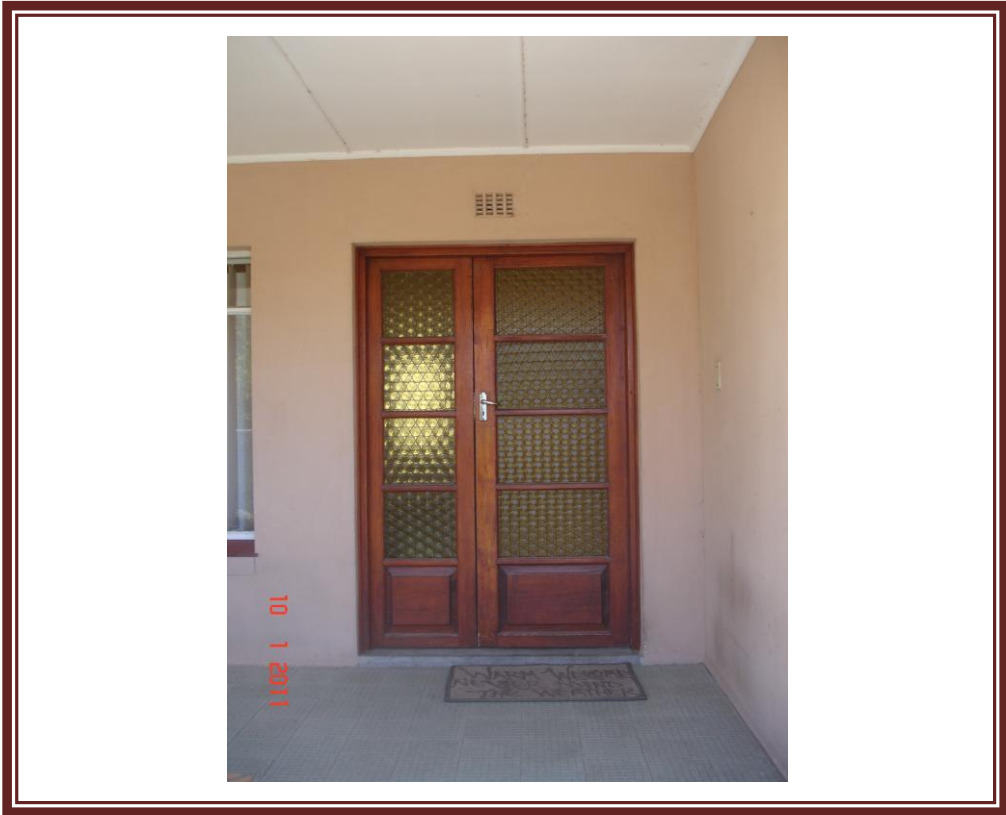
FRONT  
DOOR AND  
VERANDAH  
TILES

The front doors are all meranti and in place with typical stained glass decorative circles. The stoeps all have a greenish tinted masonry tile.
