HERITAGE STATEMENT GARRISON CHURCH ROB BEN ISLAND

1. INTRODUCTION

The heritage statement was commissioned to supplement the permit application to SAHRA in terms of the National Heritage Resources Act, 25 of 1999. Time constraints have not permitted for more in depth research.

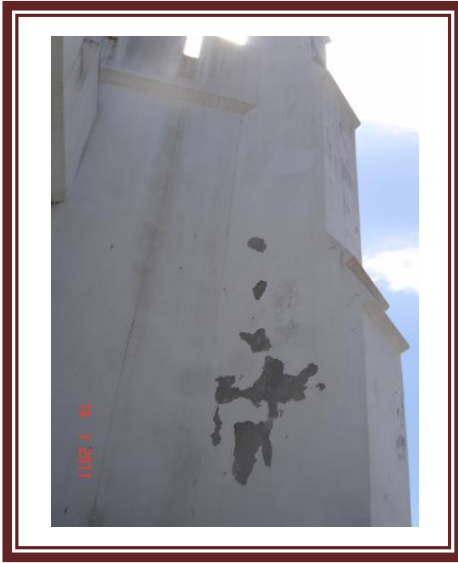
The present state of conservation is poor. The church was restored in its entirety in 2004. In January of 2005 problems were already starting to manifest themselves. Paint and plaster were starting to peel from the inside and outside of the walls. The contractor, Bambana, and a paint specialist inspected the church on 10 February 2005. Samples were apparently taken for testing at the CSIR laboratories at the University of Stellenbosch. It was not possible to trace the results of these tests nor to positively confirm that they were carried out. Opinion of the paint specialist, observers on the island and then Environmental Conservation Coordinator, Shaun Davies, point to the use of salt water for the mixing of the plaster as the main culprit.

In our professional opinion the walls were also not sufficiently dried out and cured at the time for a layer of fast drying acrylic paint to be applied directly to the substrate. In other areas it has also been noted that no primer to painted wooden features was used and that in most instances, like the Bituminous Aluminium paint on the malthoid covering of the roof and box gutters, only one coat of paint had been applied.

Fig. 9.1. Spalling on buttress.

11.1. The interior and exterior of the walls should not be worked on until such time as more thorough research and a better analysis of the problem can be done.

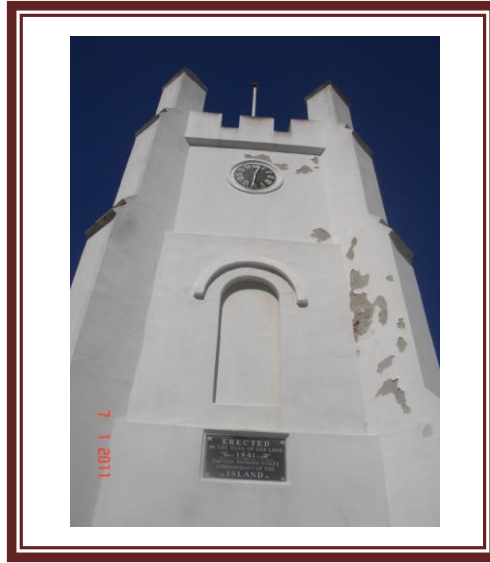
Fig.9.2. Tower east face

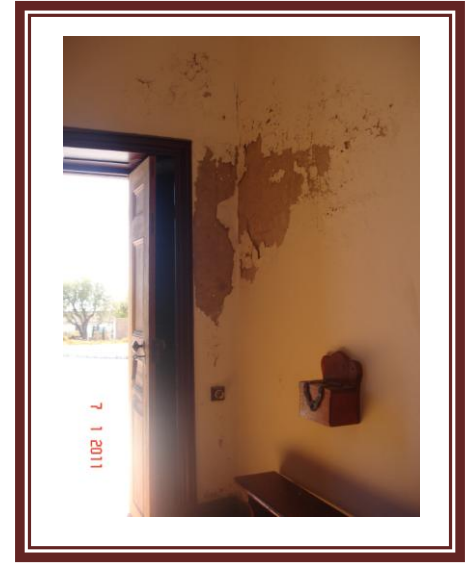
Fig.9.3. Vestibule SE corner

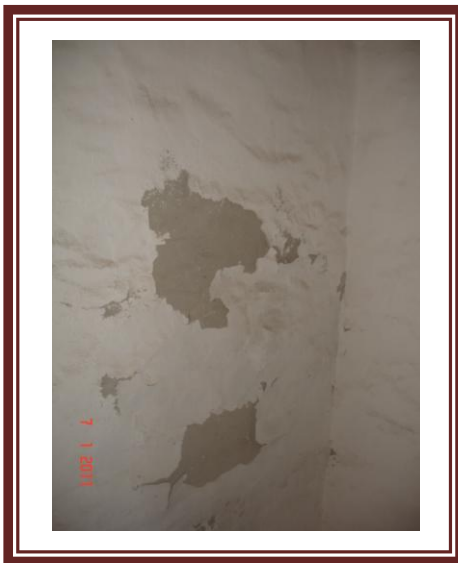
Fig. 9.4. Peeling paint inside tower.

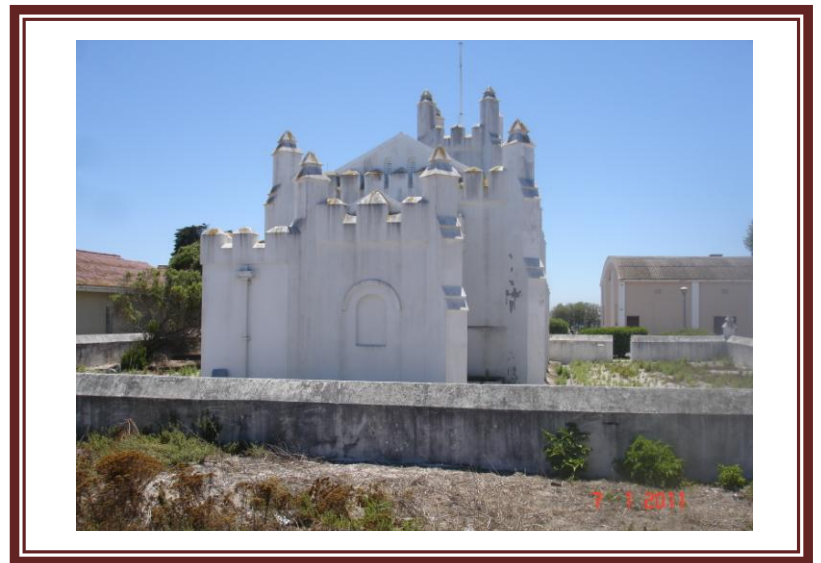
Fig 9 .5. Rear/ west face.

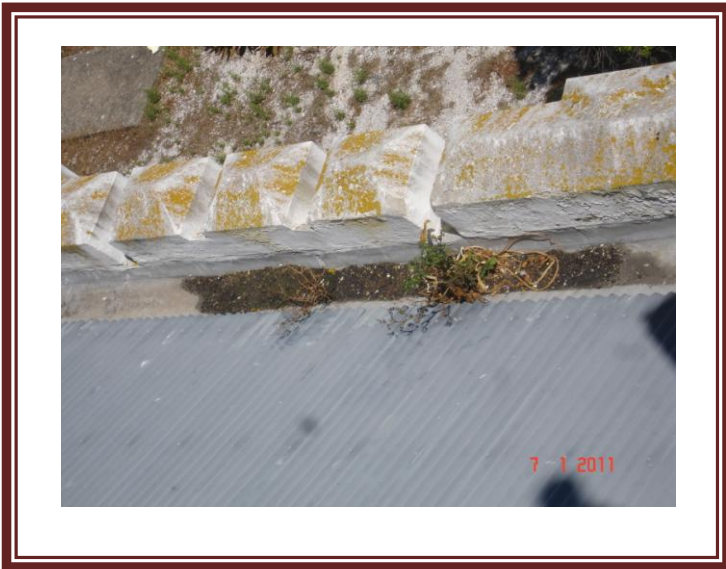
Around the building at intervals are square downpipes from the roof. These and their collection boxes are made of lead, painted white. They discharge onto the ground, and water runs to the furrow described below. The middle downpipe on the right has been blocked for some time, and plants are growing in the soil that has collected in the box gutter at the collection box.

The interior wall on the northern side has suffered from water damage. Poor maintenance by Robben Island Museum saw the gutter on the north face clogged up to such an extent and for a long period of time that weeds had a chance to grow. The resultant damming up of water damaged the crenellation and interior.

Fig.9.6 Blocked box gutter.

11.5. The Maintenance Management Plan must be scrupulously followed and monitored by SAHRA.

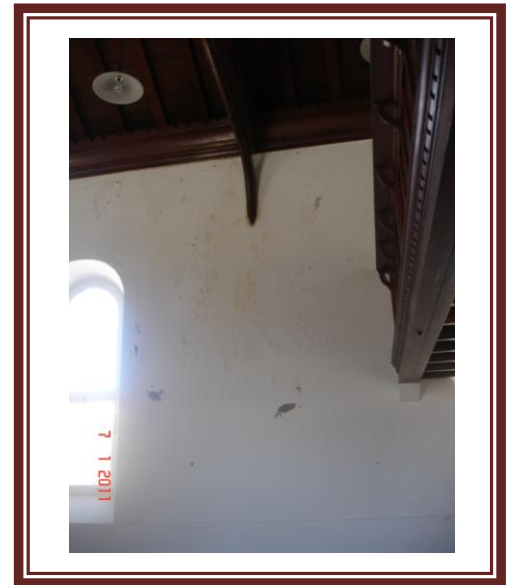
Fig.9.7. Interior water damage.

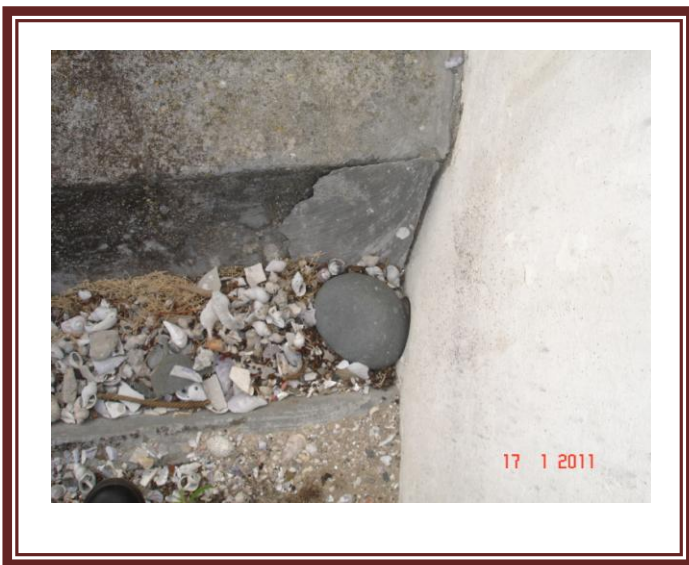
A cement drainage furrow runs right around the sides and back of the church, ending on both sides of the church at the front boundary wall. It is at the base of the walls on the right; on the left (shady) side of the church there is a sloping cement apron from the walls to the furrow. From there a round pipe runs under the perimeter wall and under the pavement to discharge into the furrow along the road. On both sides the mouth of the pipe had been closed with a round stone.

The drainage pipes leading off from the furrows appeared, on a site visit on 17 January 2011 to have been purposefully blocked by large round stones. This is not conducive to the long term

conservation of the building and may have exacerbated the problem with the walls because water has dammed up around the foundations.

Fig.9.8. Large round stone blocking drainage SE corner

11.6. Care should be taken that the drain outlets of the furrows are not blocked.

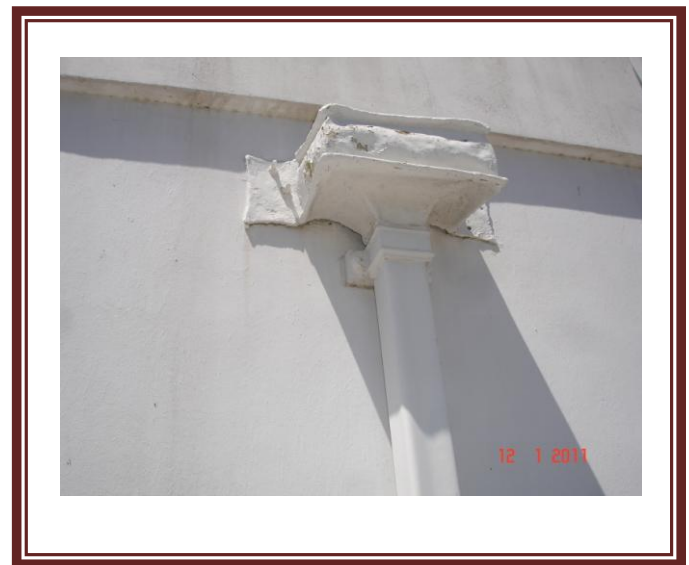
Fig. 9.9. Original beaten lead hopper.
