ROBBEN ISLAND MUSEUM OLD POWER STATION

PRELIMINARY REPORT No. 1: ARCHITECTURAL DESCRIPTION AND STATE OF CONSERVATION.

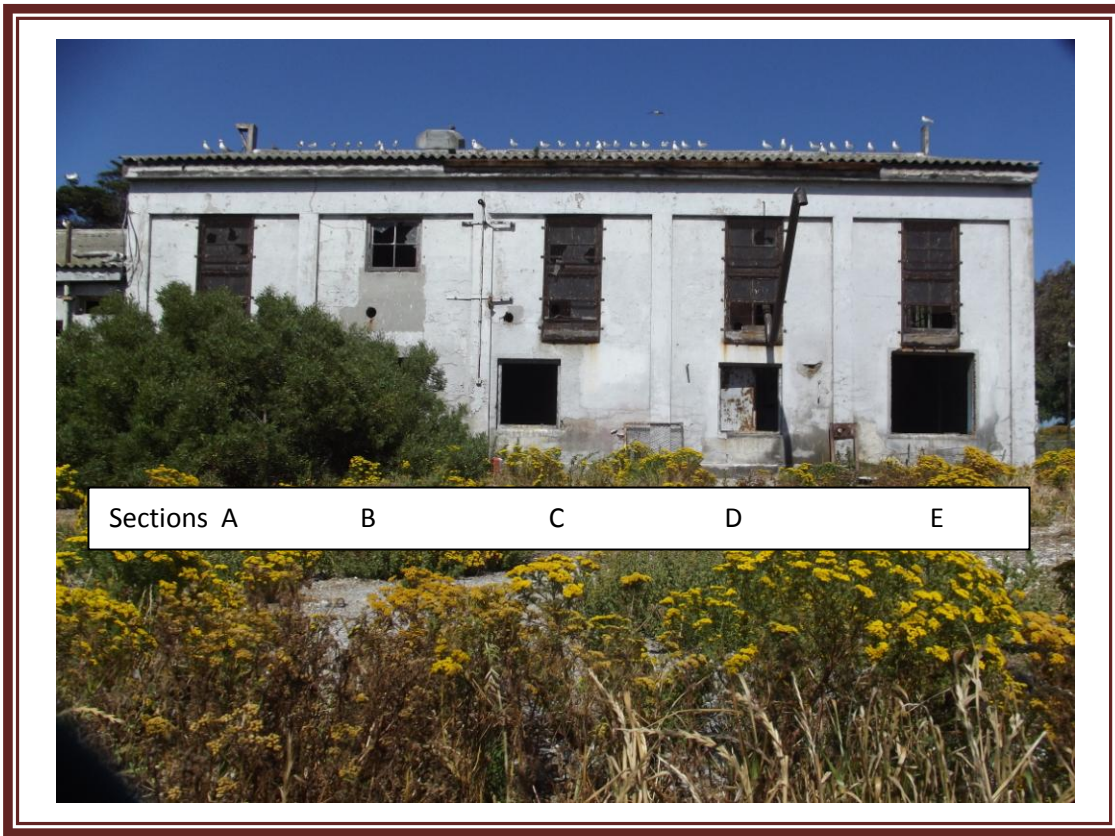
Fig. 3.
Main
building

No visible holes in corrugated asbestos sheeting on both main building and extension. Asbestos airflow to south of main building in good condition. A mounting for a siren erected in ca 1967 is situated on the gable end of the southern wall of the main building.

Oregon pine wood fascia on main building in poor condition. Extension has asbestos fascia in reasonable condition.

Six cast concrete pillars, one on the NE corner, one on the SE corner and 4 more between each corner support a concrete beam. Appears to have yellowish soft clay brick infill between pillars. Splatter plaster is peeling in some places, mostly where later alterations were made. Two holes approximately 25 centimetres in diameter can be seen in sections C and D. These are later alterations to allow for similar stainless steel exhaust pipes as can be seen coming out of window in section B.

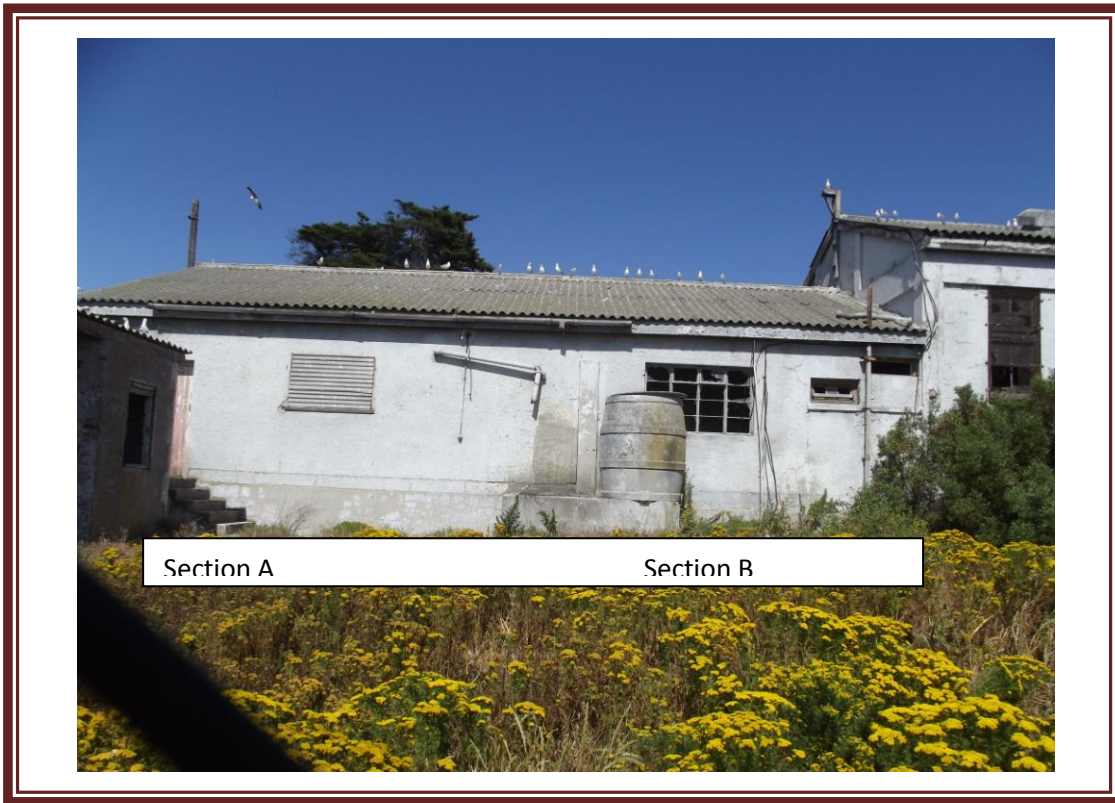
Fig.4.
Extension
to south of
main
building

Two cast concrete pillars, one on SE corner and one approximately two thirds of the way from corner to SE corner of main building. SE corner spalling badly. Section A appears to be an earlier extension to the main building than section B and consists of Robben Island type Breeze blocks between the pillars. These blocks are made from sand, seashells with some Portland cement added. Splatter plaster in relatively good condition apart from the edges with the pillars and the plinth where a definite crack separates the infill from the pillars.

Two small windows made from wood [meranti] in section 1 are for the toilet and men's urinal. They are salvageable. Their style appears to be that of the ca 1950's but more evidence is needed. They are an anomaly to the larger steel window frame. A large standard steel frame window is adjacent to the two wooden windows and may be a later addition to section 1. No glass panes have survived. A smaller window from SA Pine in the second section has been boarded up by corrugated iron sheeting.

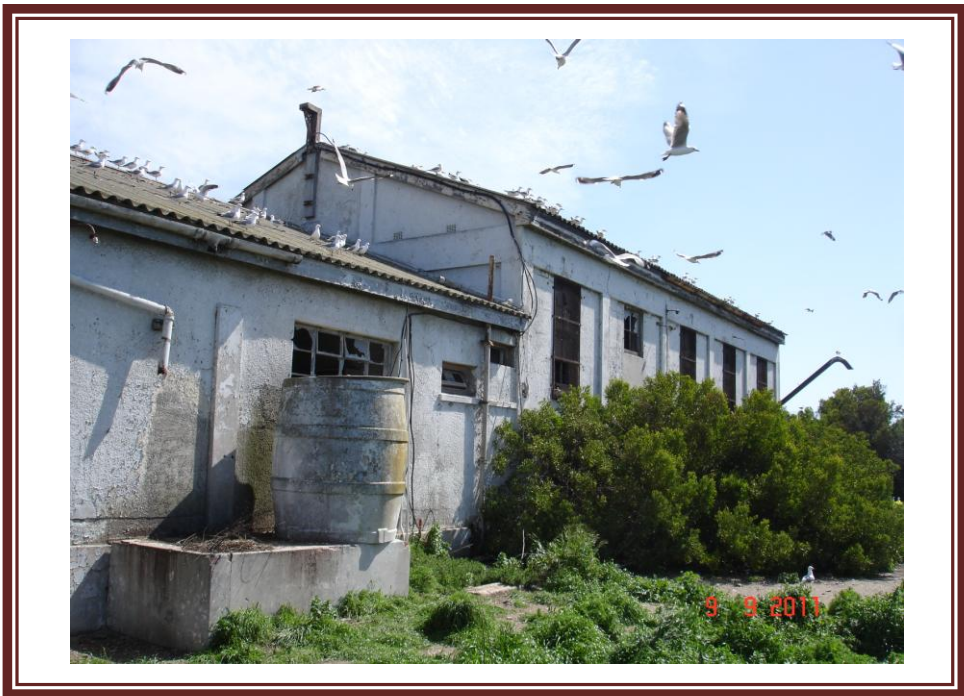
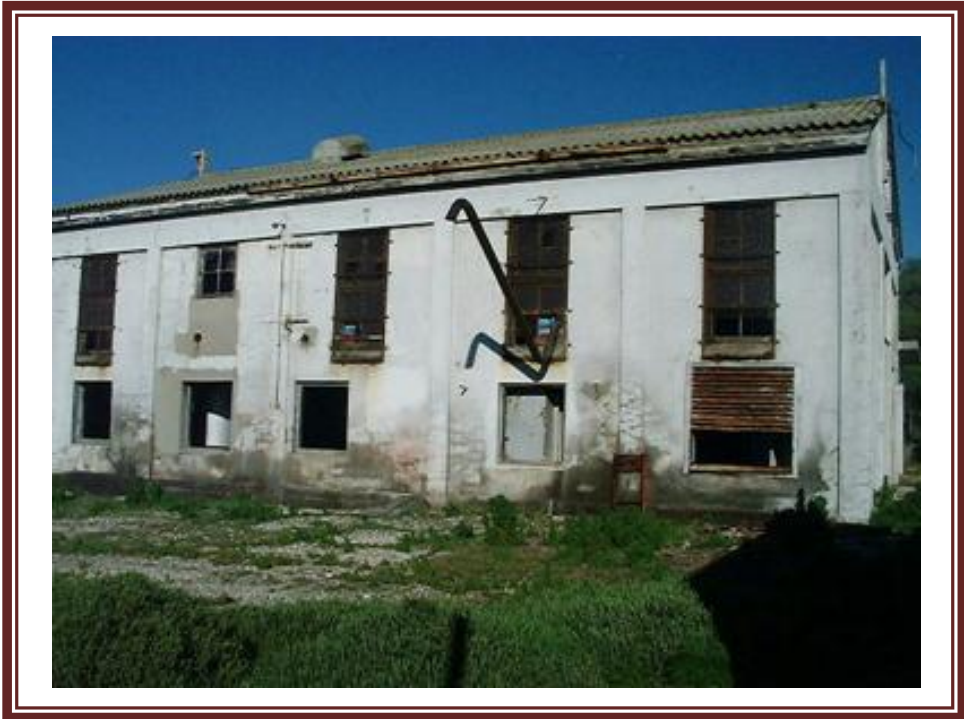
East elevation
main building ca
1996. Note fire
bucket stand and
grill opening in
section E

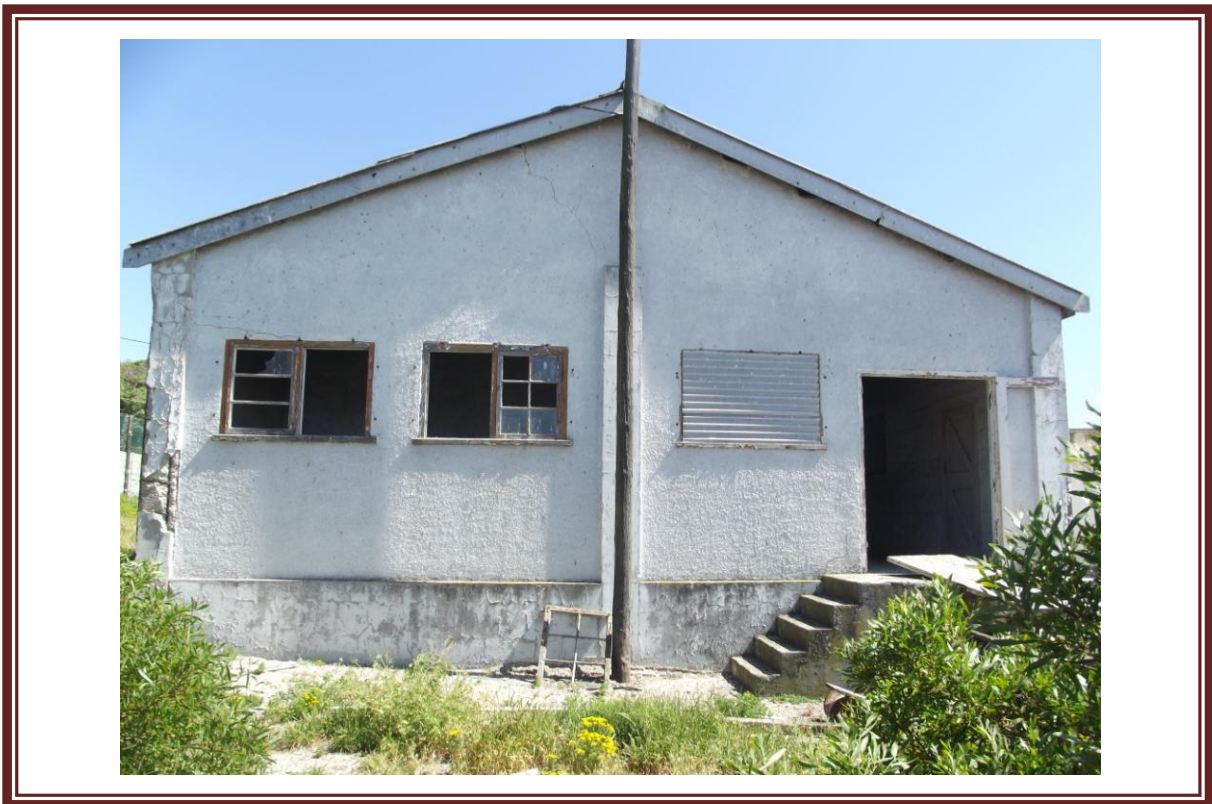
SW corner

Splatter plaster mostly in good condition. Built from Breeze blocks from local materials [Robben Island brick] Both cast concrete corner columns cracking and spalling badly. Central cast concrete column cracked.

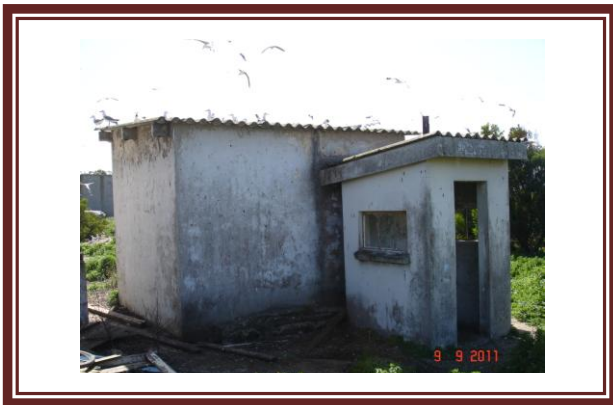
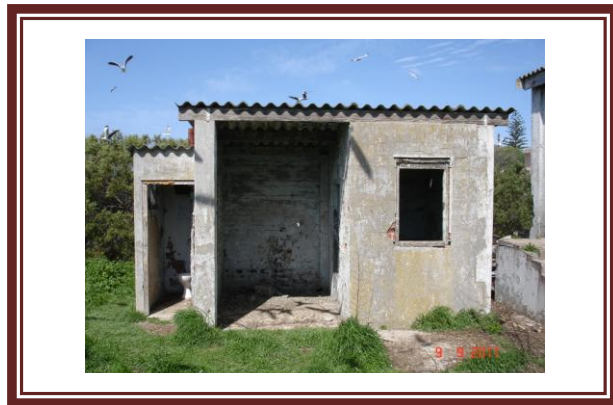
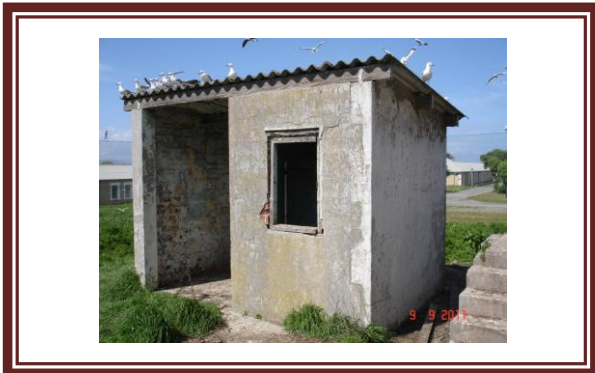
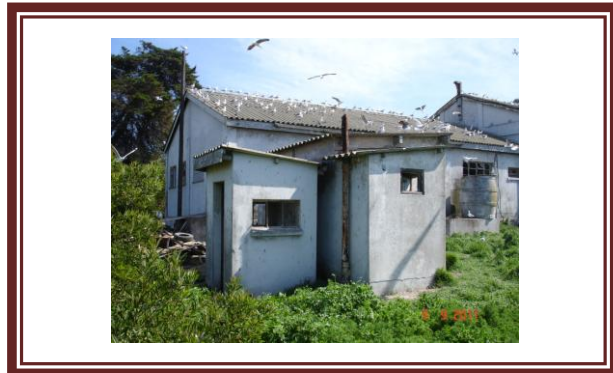
Corrugated asbestos fibre cement in reasonable condition. No gutters or down pipes.

Steel window frames with no glass in guard house in reasonable condition. Wooden SA pine frames with no glass in store and toilet in poor condition.

Walls constructed from red clay brick and plastered. Cracks in plaster and walls. Paint deteriorated.

No doorframe in guard house. Doorframes in store and toilet from SA pine and in poor condition.

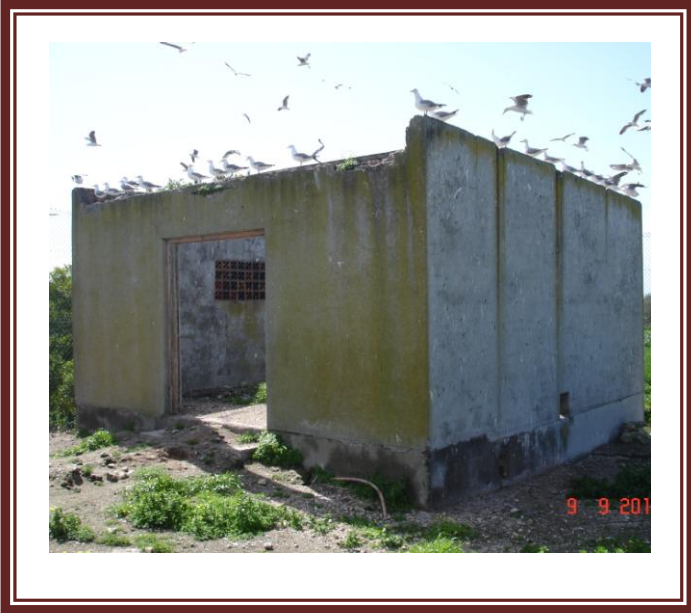
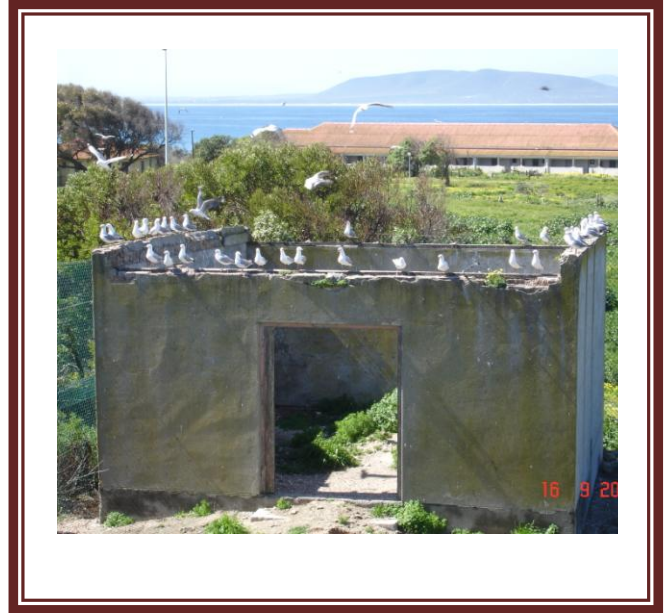
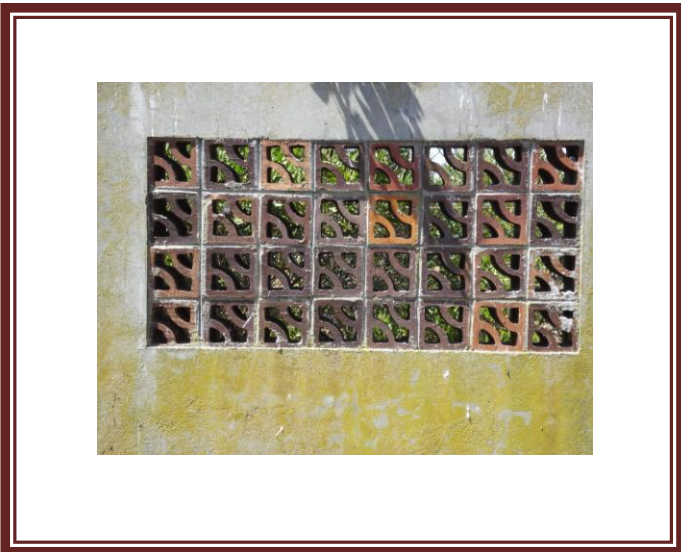
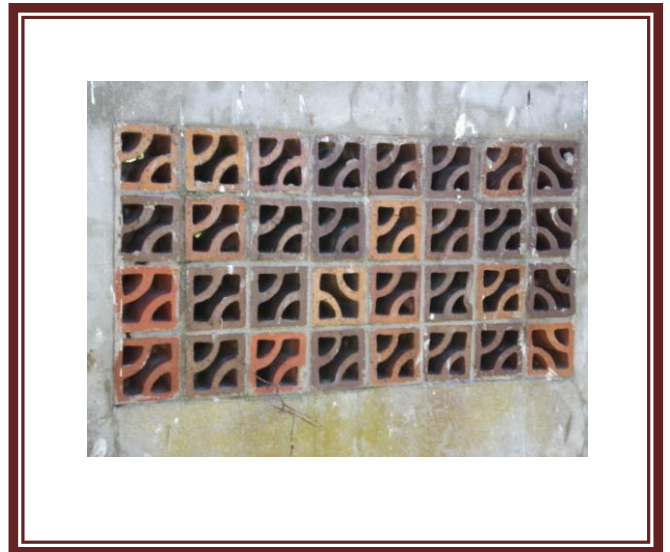
Has no roof and no floor. Rabbit activity in soil of floor. Stairs covered with soil and guano. Walls and plaster in reasonable condition. No windows but has fired clay ventilation bricks on N and E face.
