ROBBEN ISLAND MUSEUM: OLD POWERS STATION

PRELIMINARY REPORT No.4: REINSTATEMENT, RETENTION, REMOVAL, REPLACEMENT AND MODIFICATION OF HISTORIC FABRIC

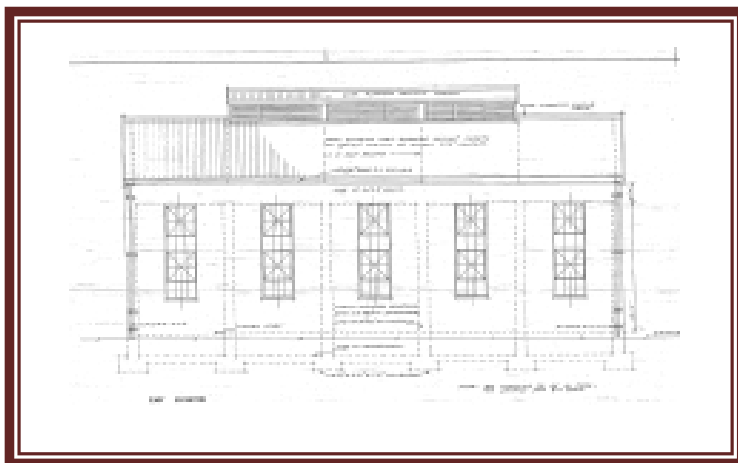
Fig.1. Ca 1963 tracing showing roof ventilator

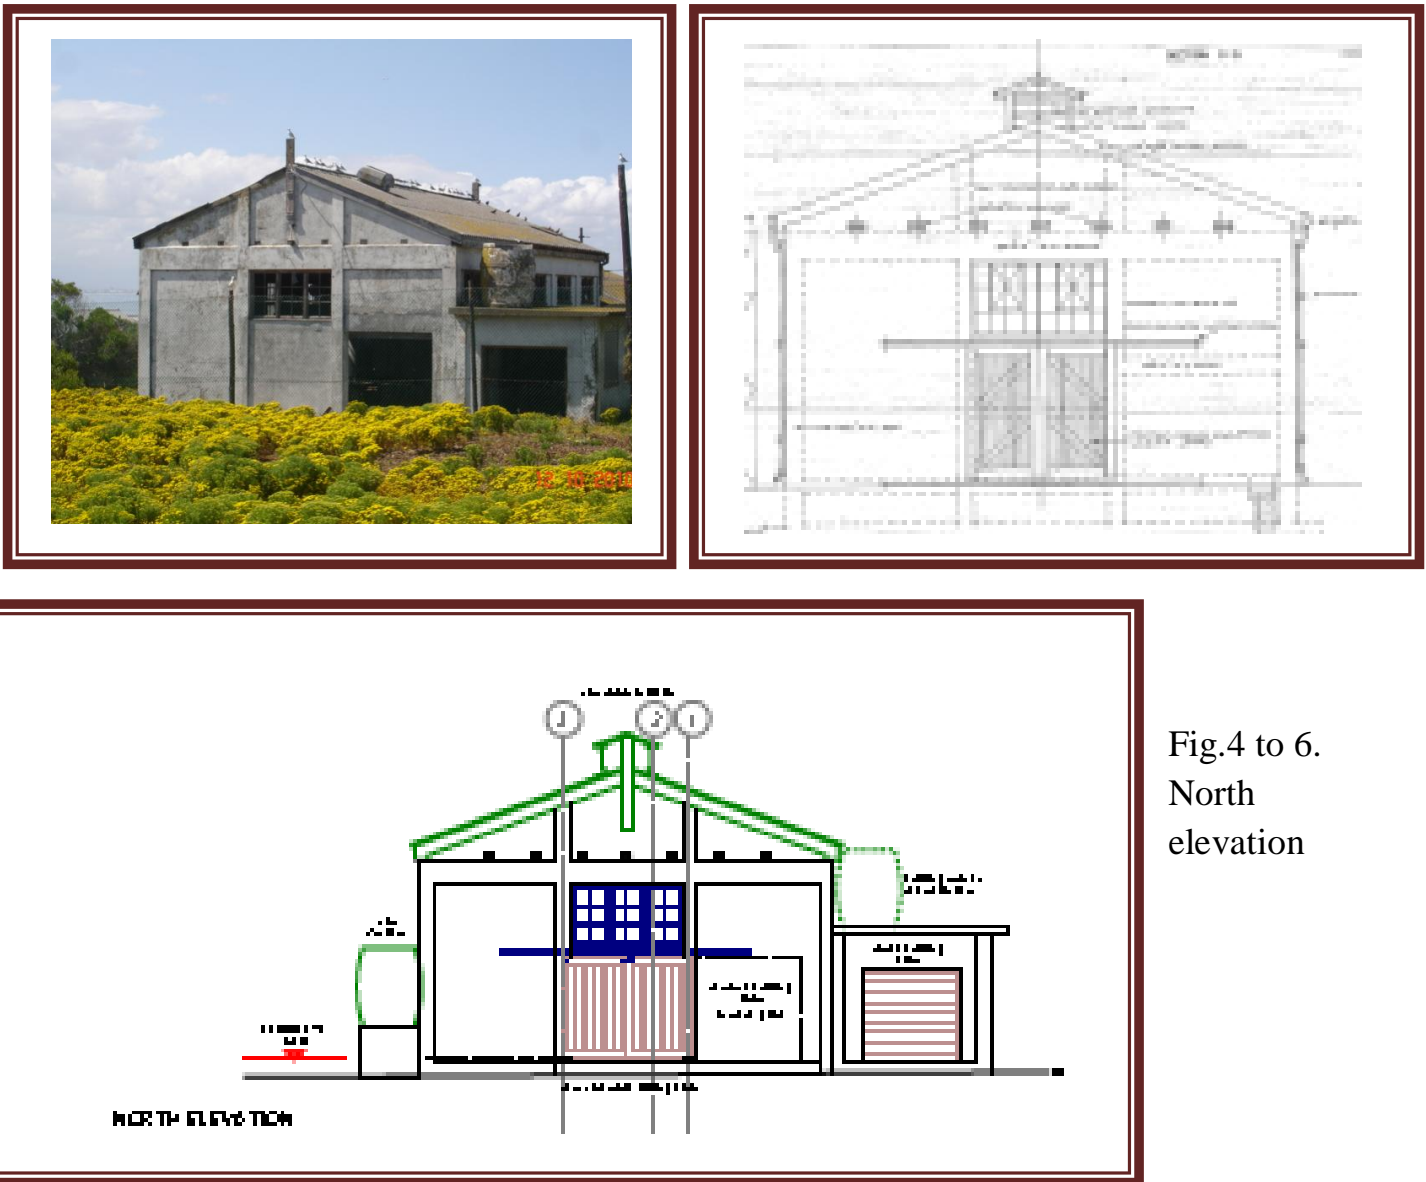
Fig.4 to 6.
North
elevation

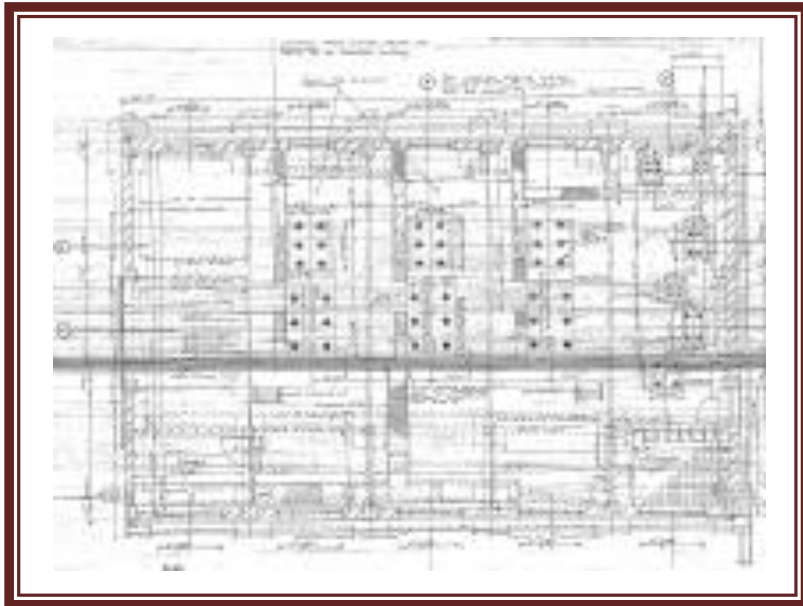
Fig. 12. Showing the 1963 floor plan.

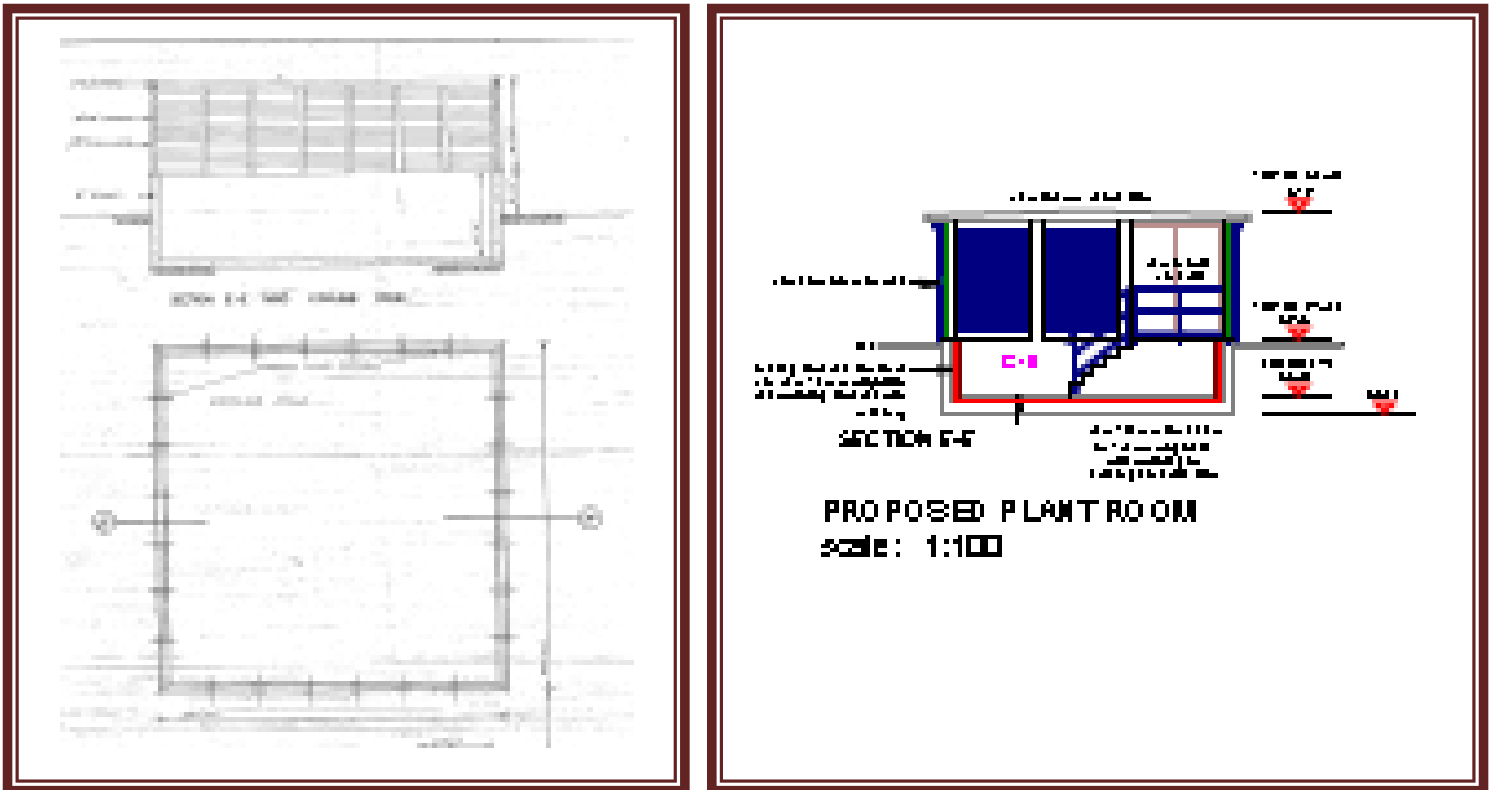
Fig.14. Ca 1963 tracing of cooling pond

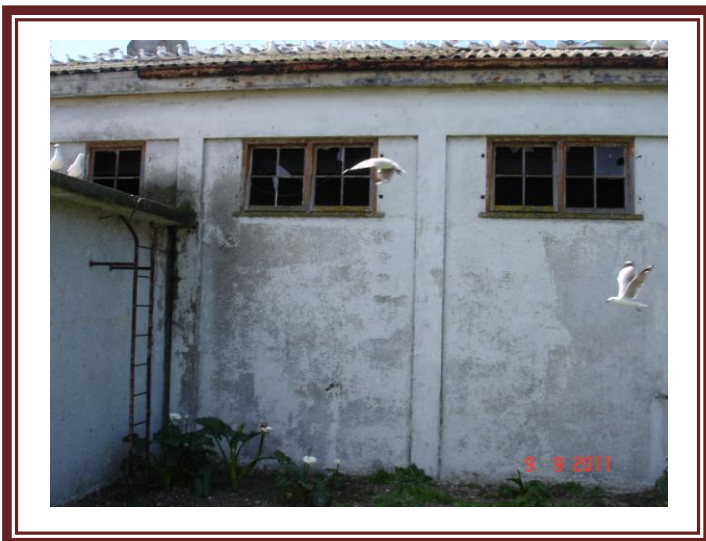
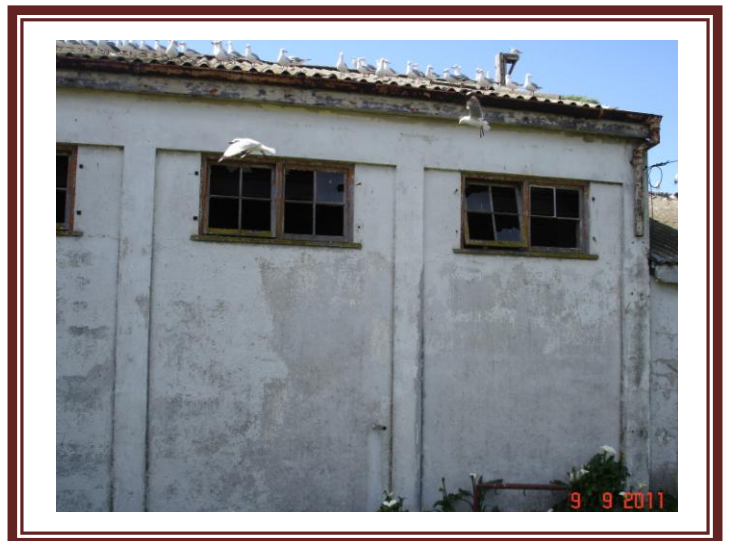
The steel guttering is representative of the earliest part of the historic fabric and must be retained.

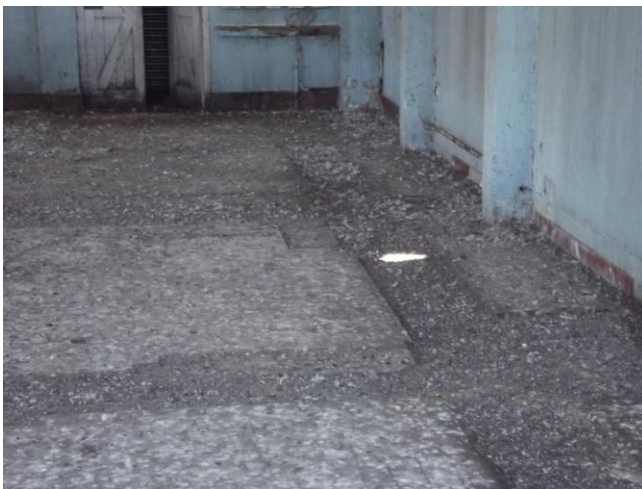
Fig.23. Showing skirting outline with missing tiles.

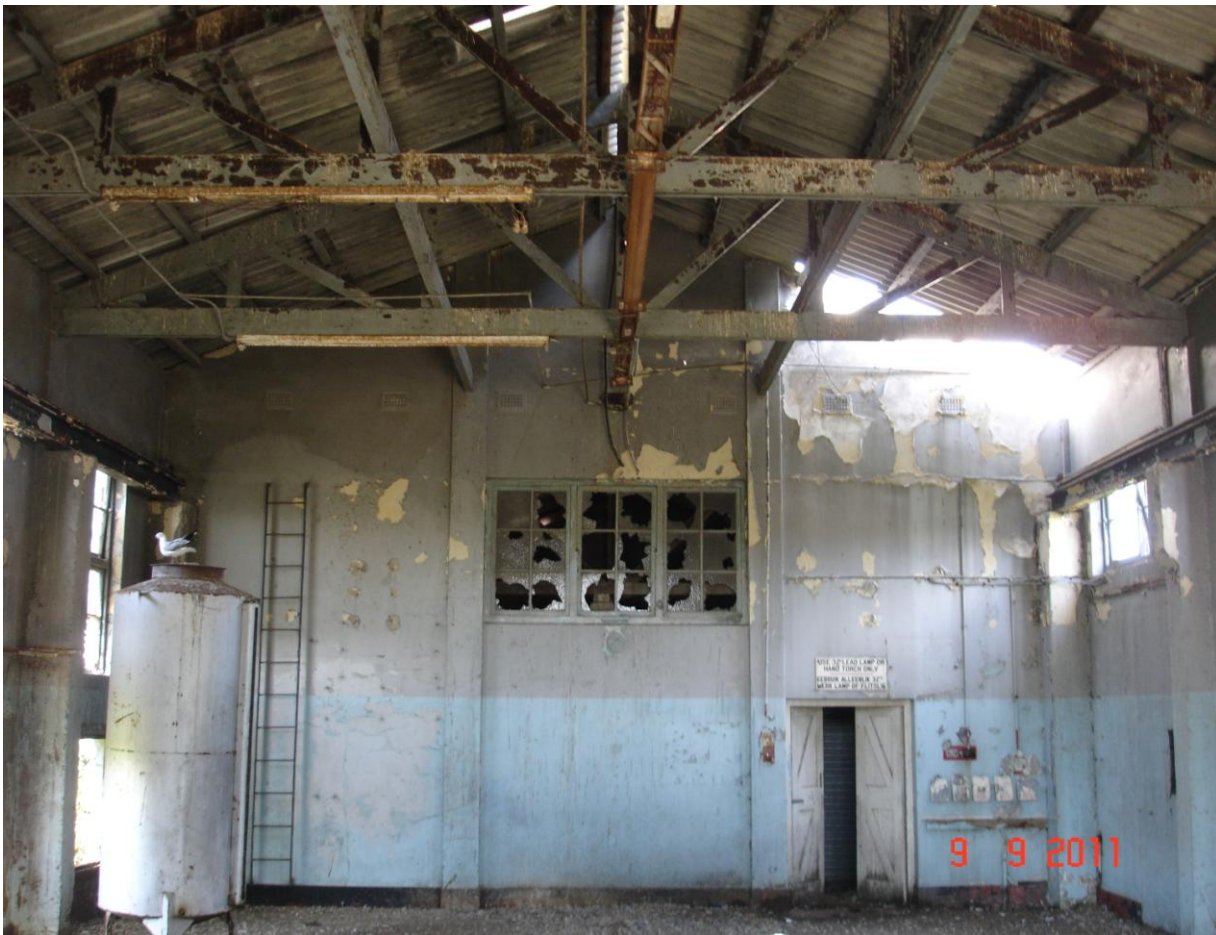
Fig.24. Steel ladder in SE corner.

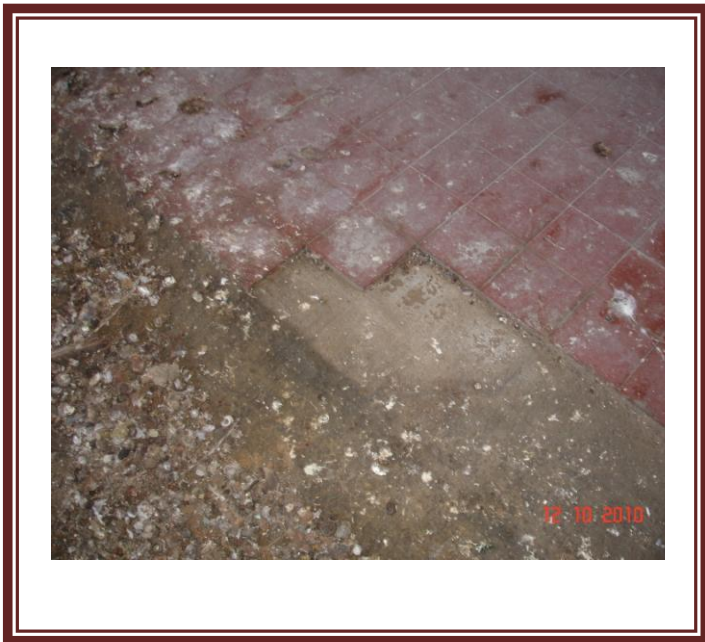
The small square red clay quarry [6” by 6”] tiles are part of the original historic fabric. Careful consideration should be given to their retention. The floor has, however, over time been considerably disturbed. Not enough tiles remain to cover the floor as it would have been. Howard Smith [Architect] suggested that existing tiles should be lifted and the perimeter of the floor be tiled to provide symmetry and compliment the skirting. This is highly recommended.

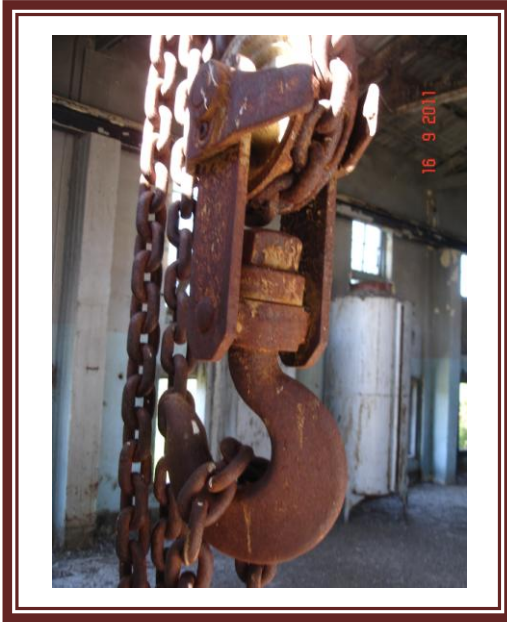
Fig.27 to 29 Hoist and gantry

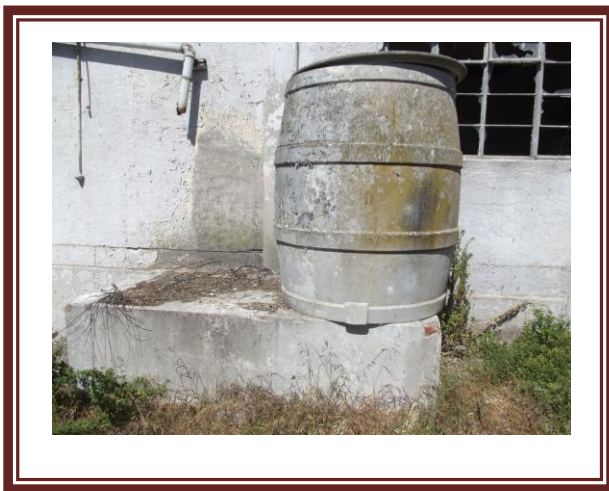
Fig.31.
Left, East
elevation
tank

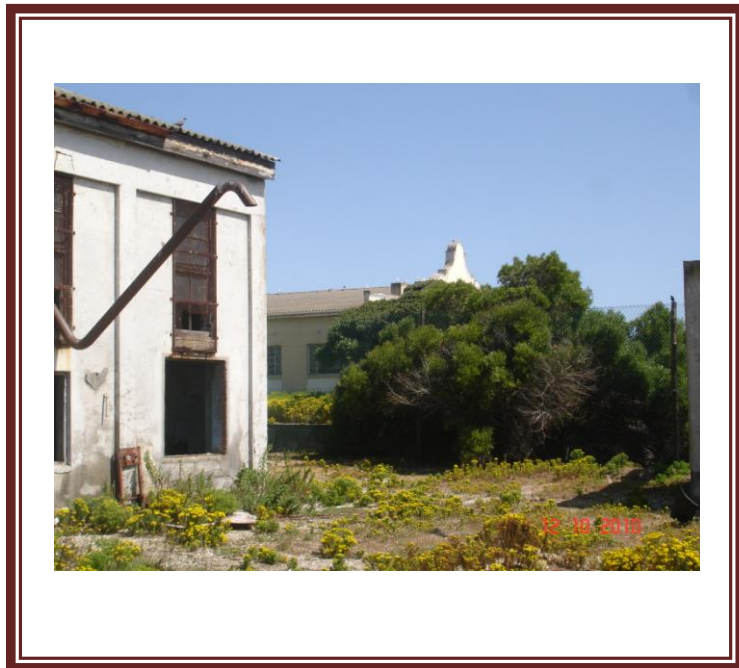
Fig.36. Stainless steel exhaust pipe

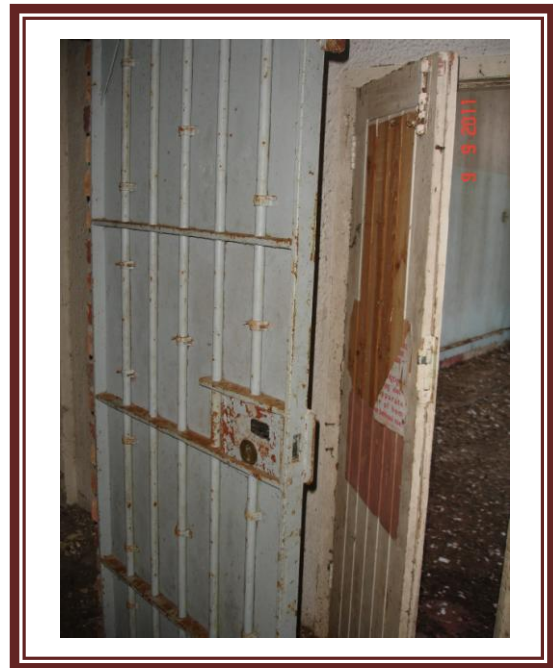
Fig.37. Modified prison door

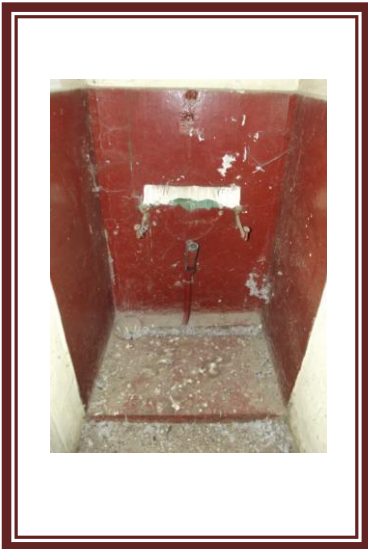
Fig.46. Left, Urinal and wash basin mounting

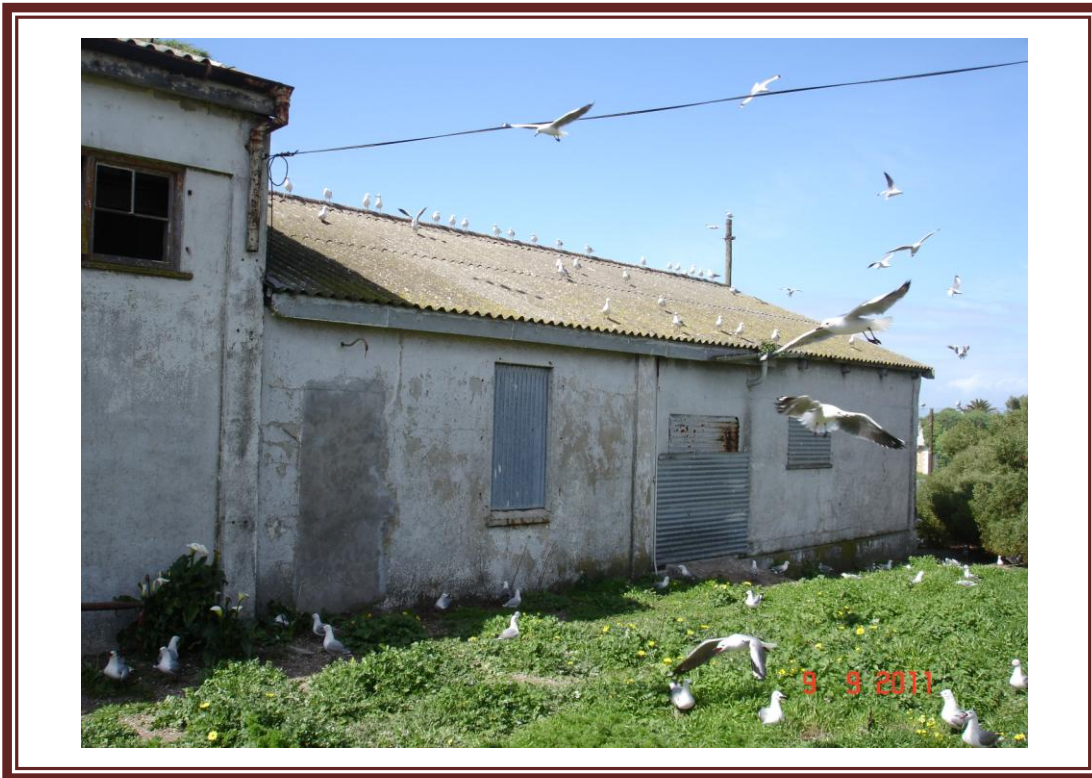
Fig. 55.
Remainder
of gutter
and
downpipe
west face
Extension.

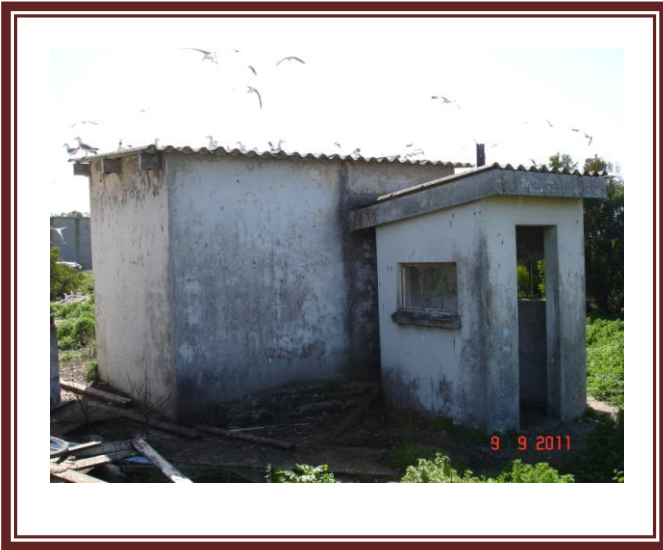
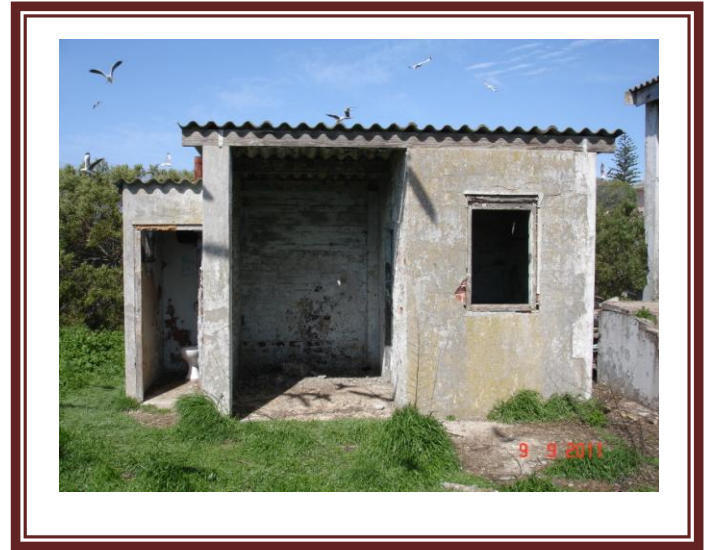
Fig. 56 & 57 Guard house and facilities SE
