ROBBEN ISLAND MUSEUM: OLD POWER STATION [ca. 1941 to 1991]

PRELIMINARY REPORT No. 5: ARTEFACTS RISK ASSESSMENT.

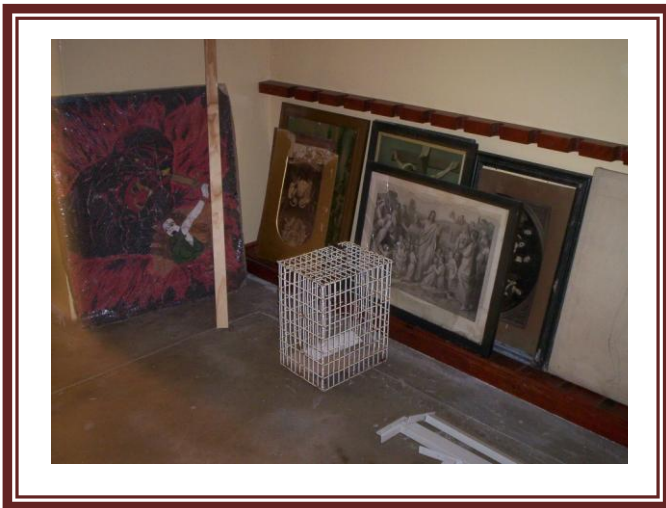
Fig.1. Artworks, Armory

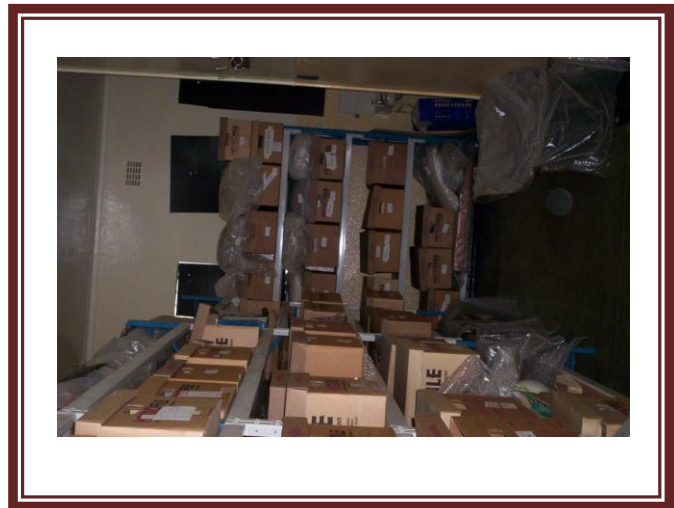
Fig.2. Boxed collections, Armory

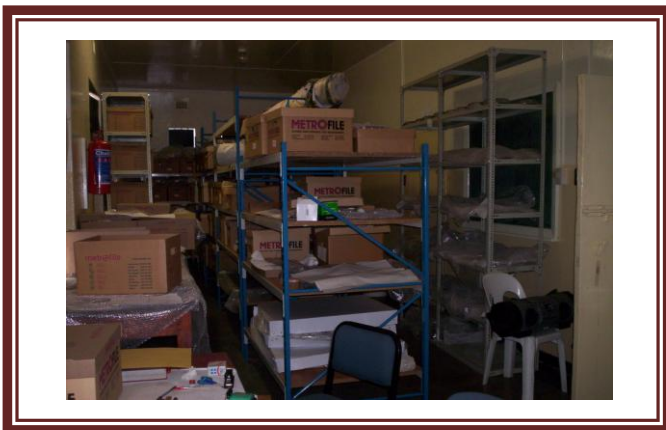
Fig.3. Boxed collections, Armory

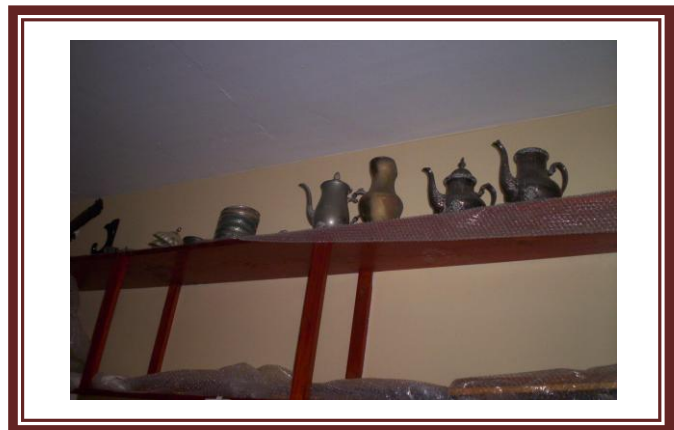
Fig.4. Trophies Armory

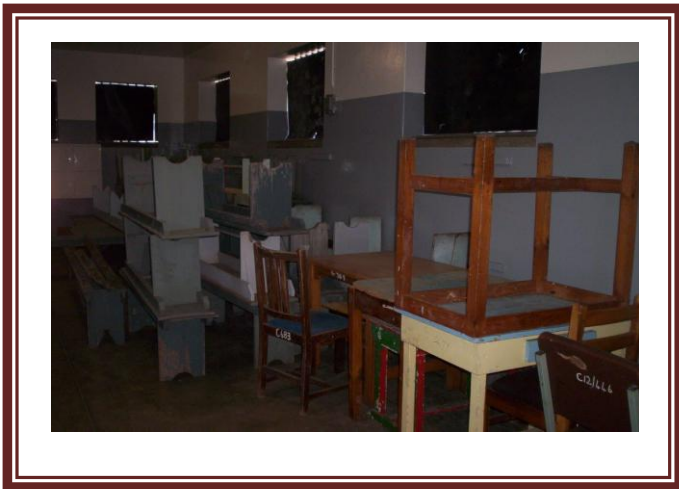
Fig.5. Section E-benches

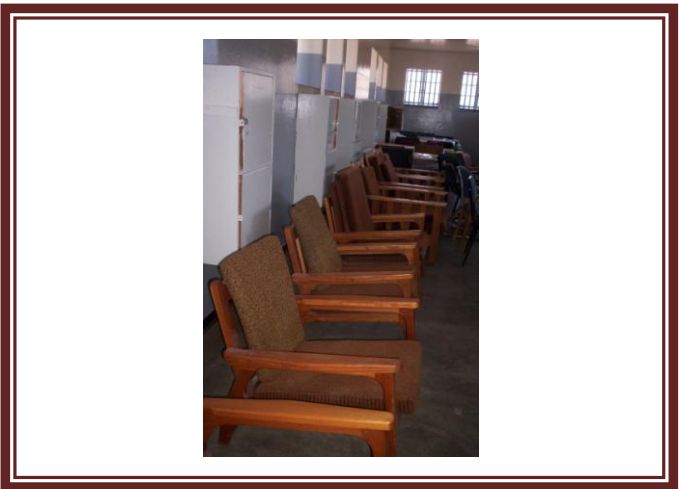
Fig.6. Section E -chairs [ex-club house]

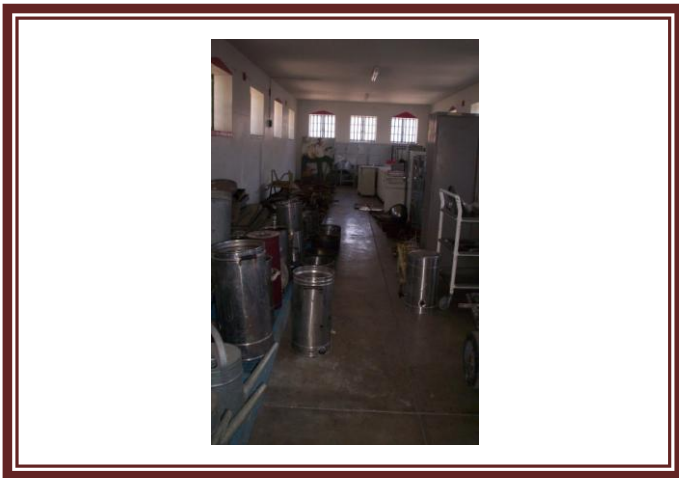
Fig.7. Section E- hospital equipment

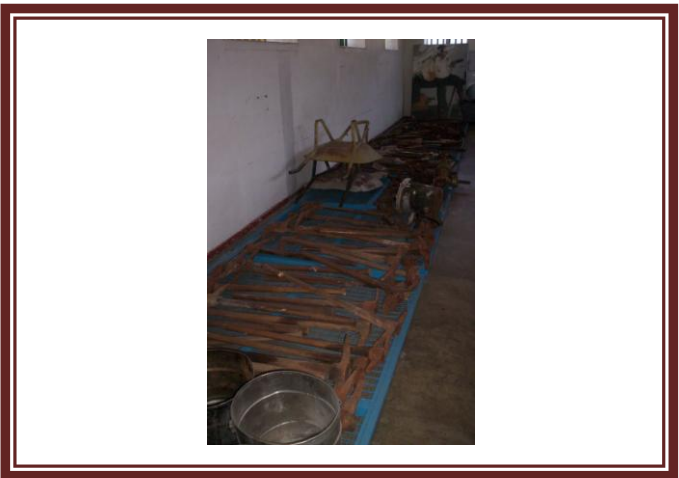
Fig.8. Section E- Implements

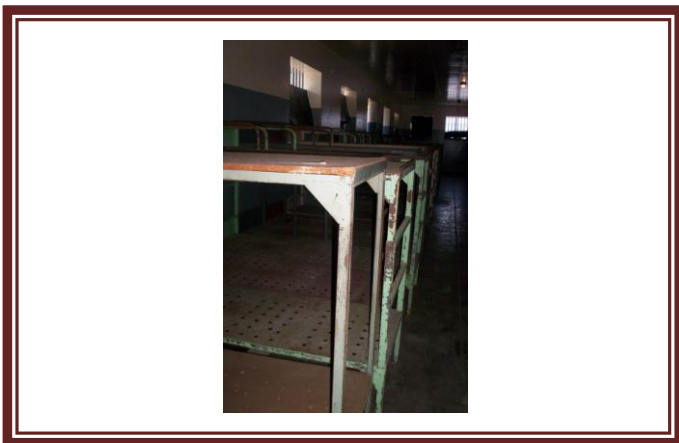
Fig.9. Section E- prison beds

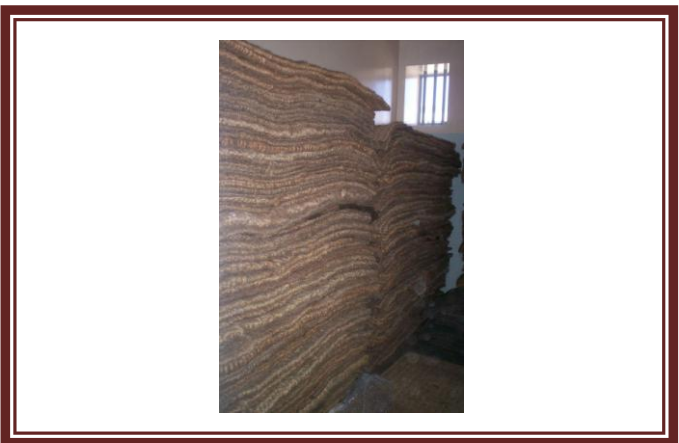
Fig.10. Section E -sisal mats

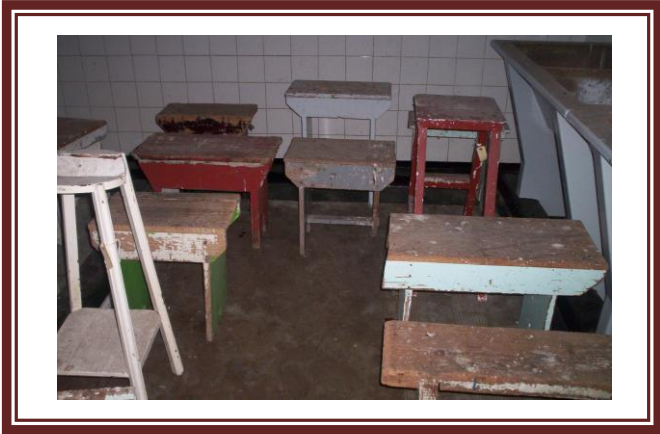
Fig.11. Section E – small wooden benches

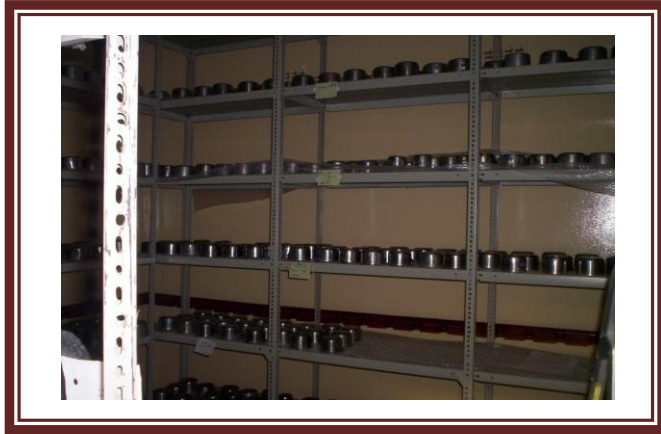
Fig.12. Prison utensils, Armory

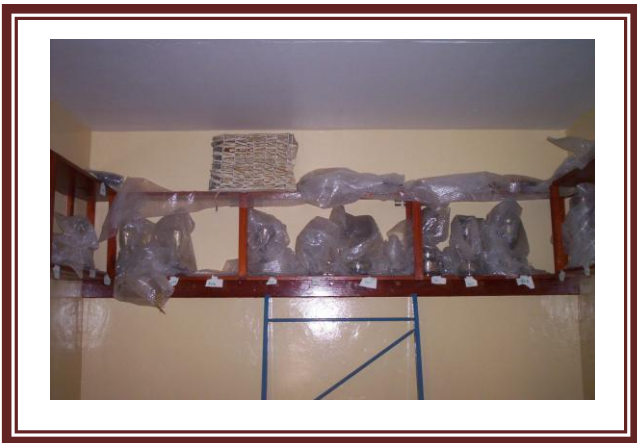
Fig. 13. Trophies, Armory

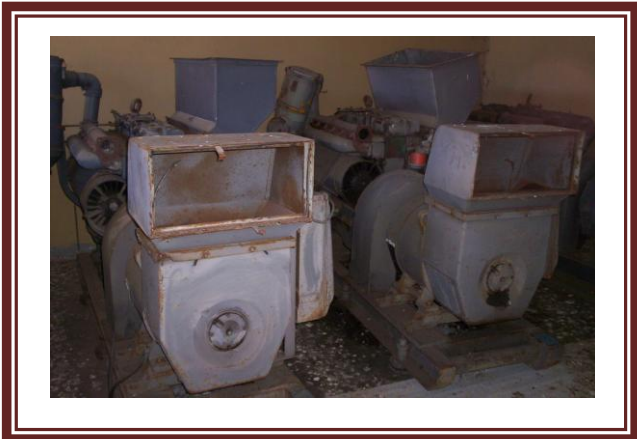
Fig. 14. Lister diesel gensets ca 1968

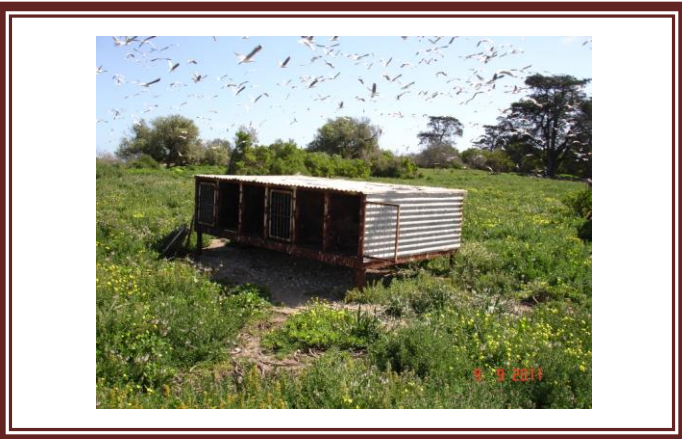
Birds especially have invaded certain sections of the MSP, notably the kitchens and what restoration efforts were made in 2006 are at high risk. Artefacts scattered across the island are at extreme risk, such as the dog kennels removed from the Sobukwe Complex. Rodents also pose an ongoing challenge to the survival of collections in spite of pest control measures.

Fig.15 Dog kennels ex Sobukwe complex

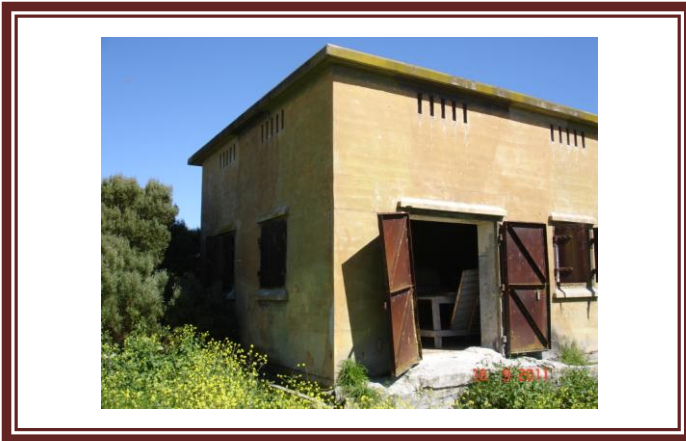
A number of artefacts are housed in scattered places across the island. Lean to's, garages and the armoury near Ou Tronk have been identified as temporary storage facilities. All the sites visited had their doors off their hinges with the concomitant invasion by birds and animals, as well as severe corrosion and weathering.

Fig.16. Entrance to Armory WWII ou Tronk

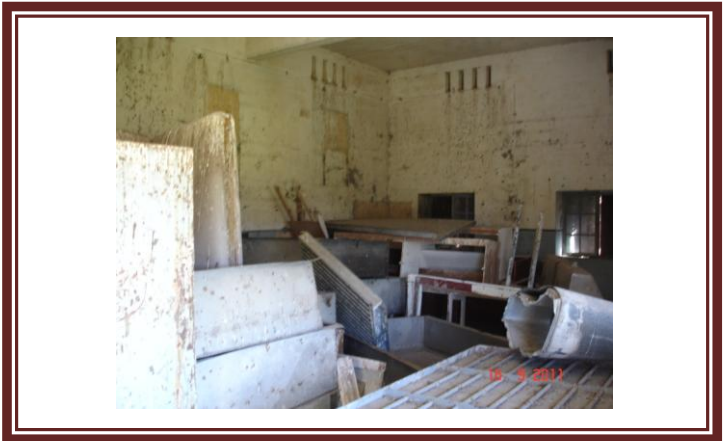
Fig.17. Prison doors and sundry items

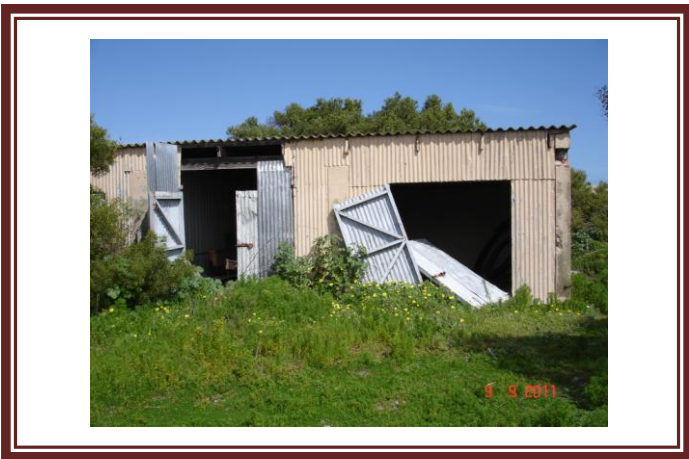
Fig. 18. Entrance to temporary storage

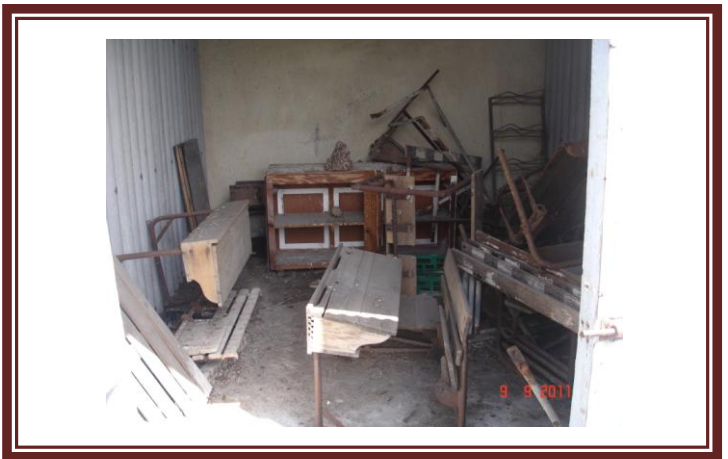
Fig.19. School & sporting equipment inside

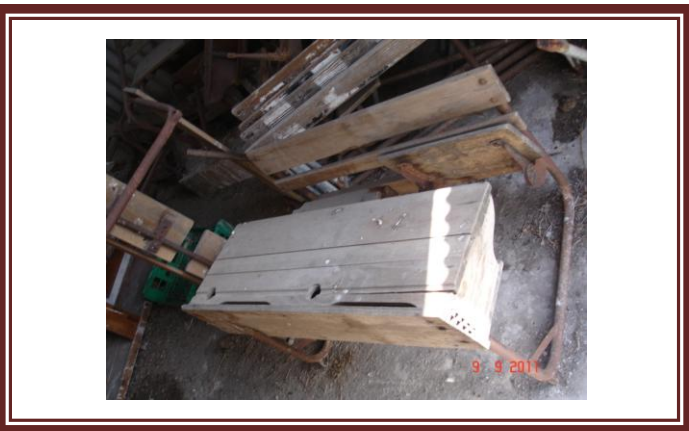
Fig.20. Old school desk.
