2012-01-30 ROBBERN ISLAND MUSEUM RECREATIONAL FACILITIES: ALPHA ONE OBSERVATION

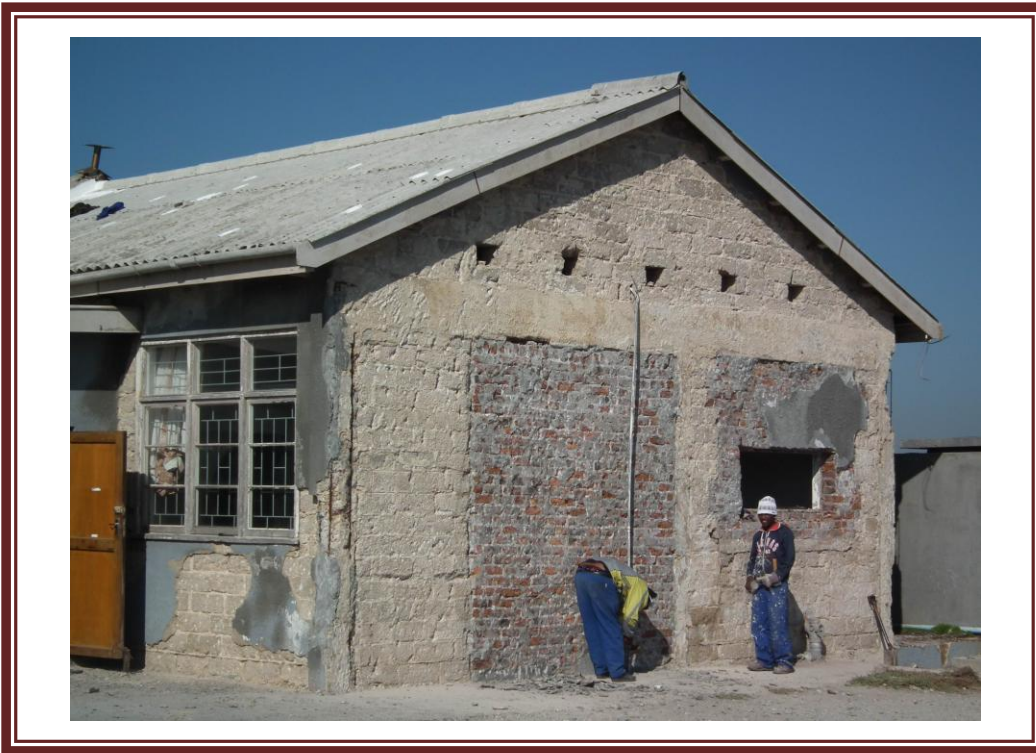
Fig.1. Features revealed after removal of plaster concur with earlier photographic and oral evidence.

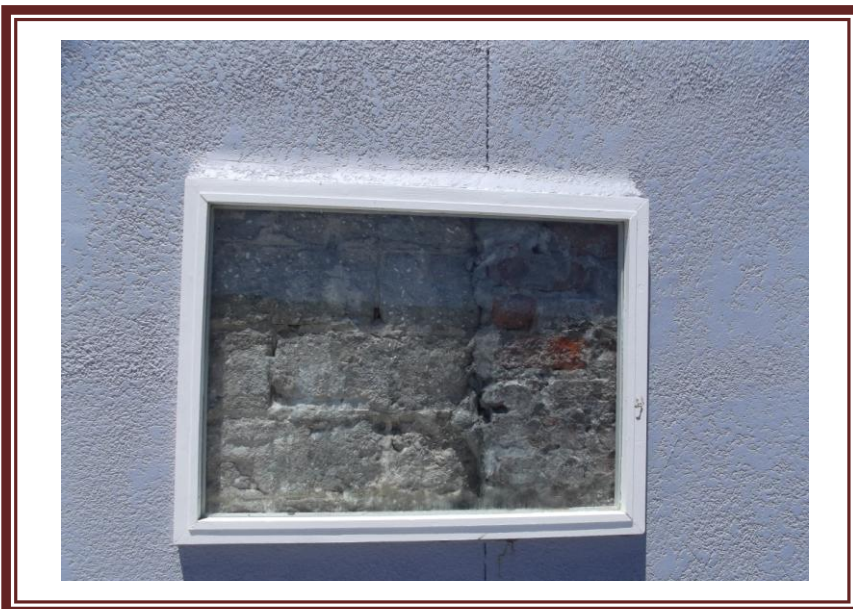
Observations made on 30 January 2012 indicated that the appreciation panel on the SW gable is subject to excessive moisture build up. No ventilation for evaporation could be seen.

Fig.2. Appreciation panel showing different building materials

In discussion with Howard Smith [Architect] on 3 February 2012 resolved that ventilation holes would be drilled as required by original spec to contractor.

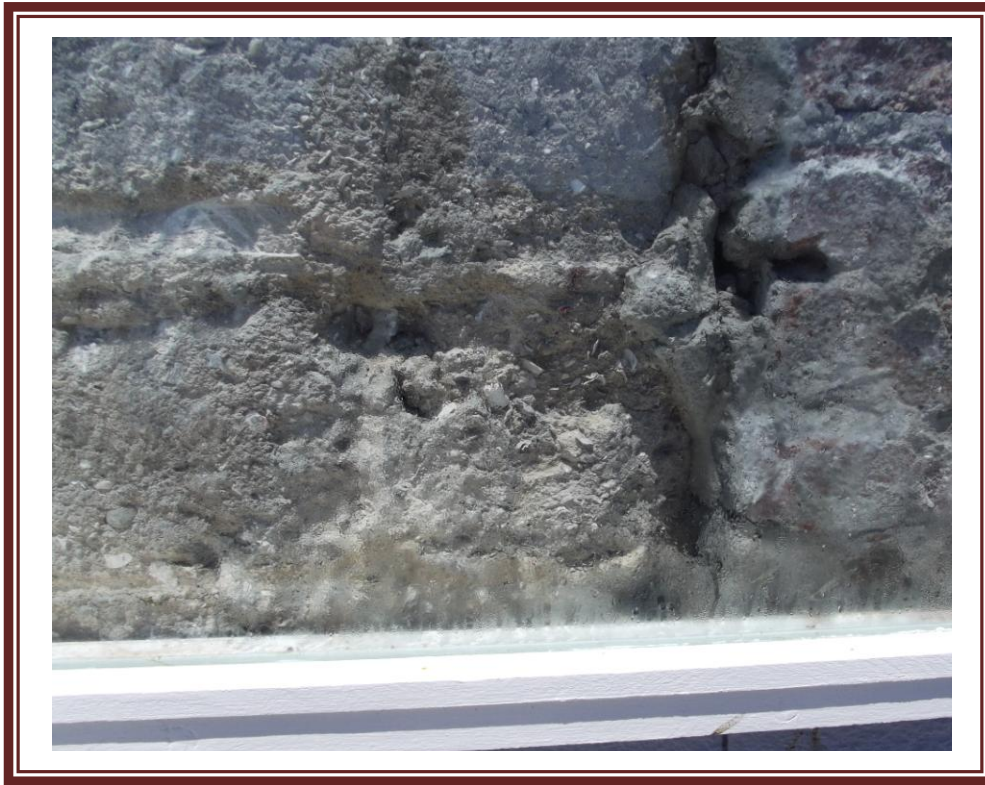
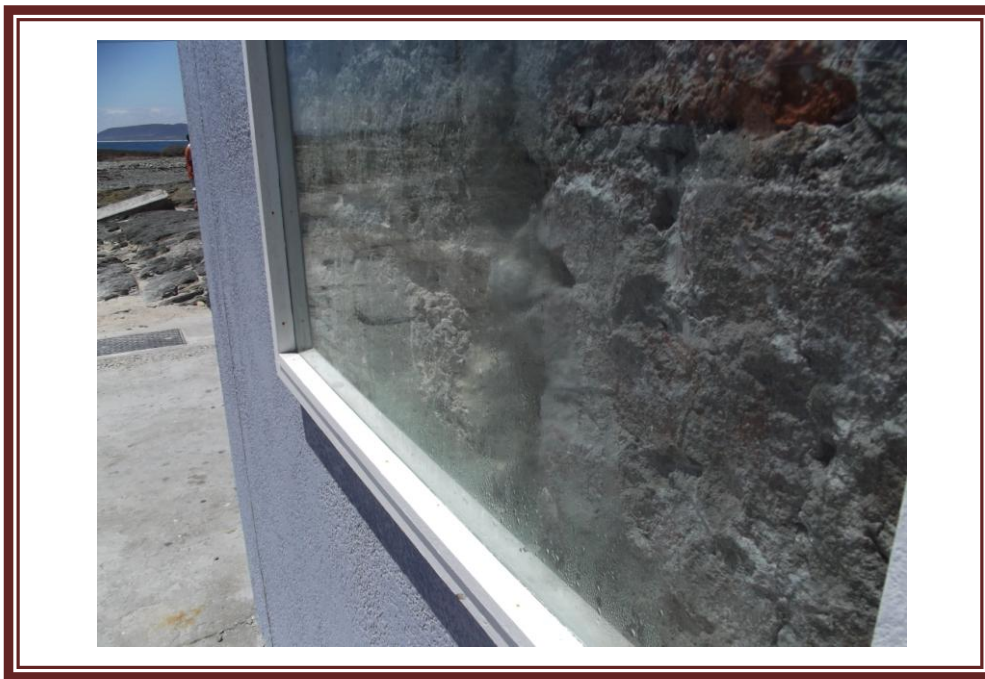
Fig 3 and 4.
Showing moisture
build up.
