ROBBEN ISLAND MUSEUM OLD POWER STATION

REPORT No. 7 FLOORS AND FLOOR TRENCHES

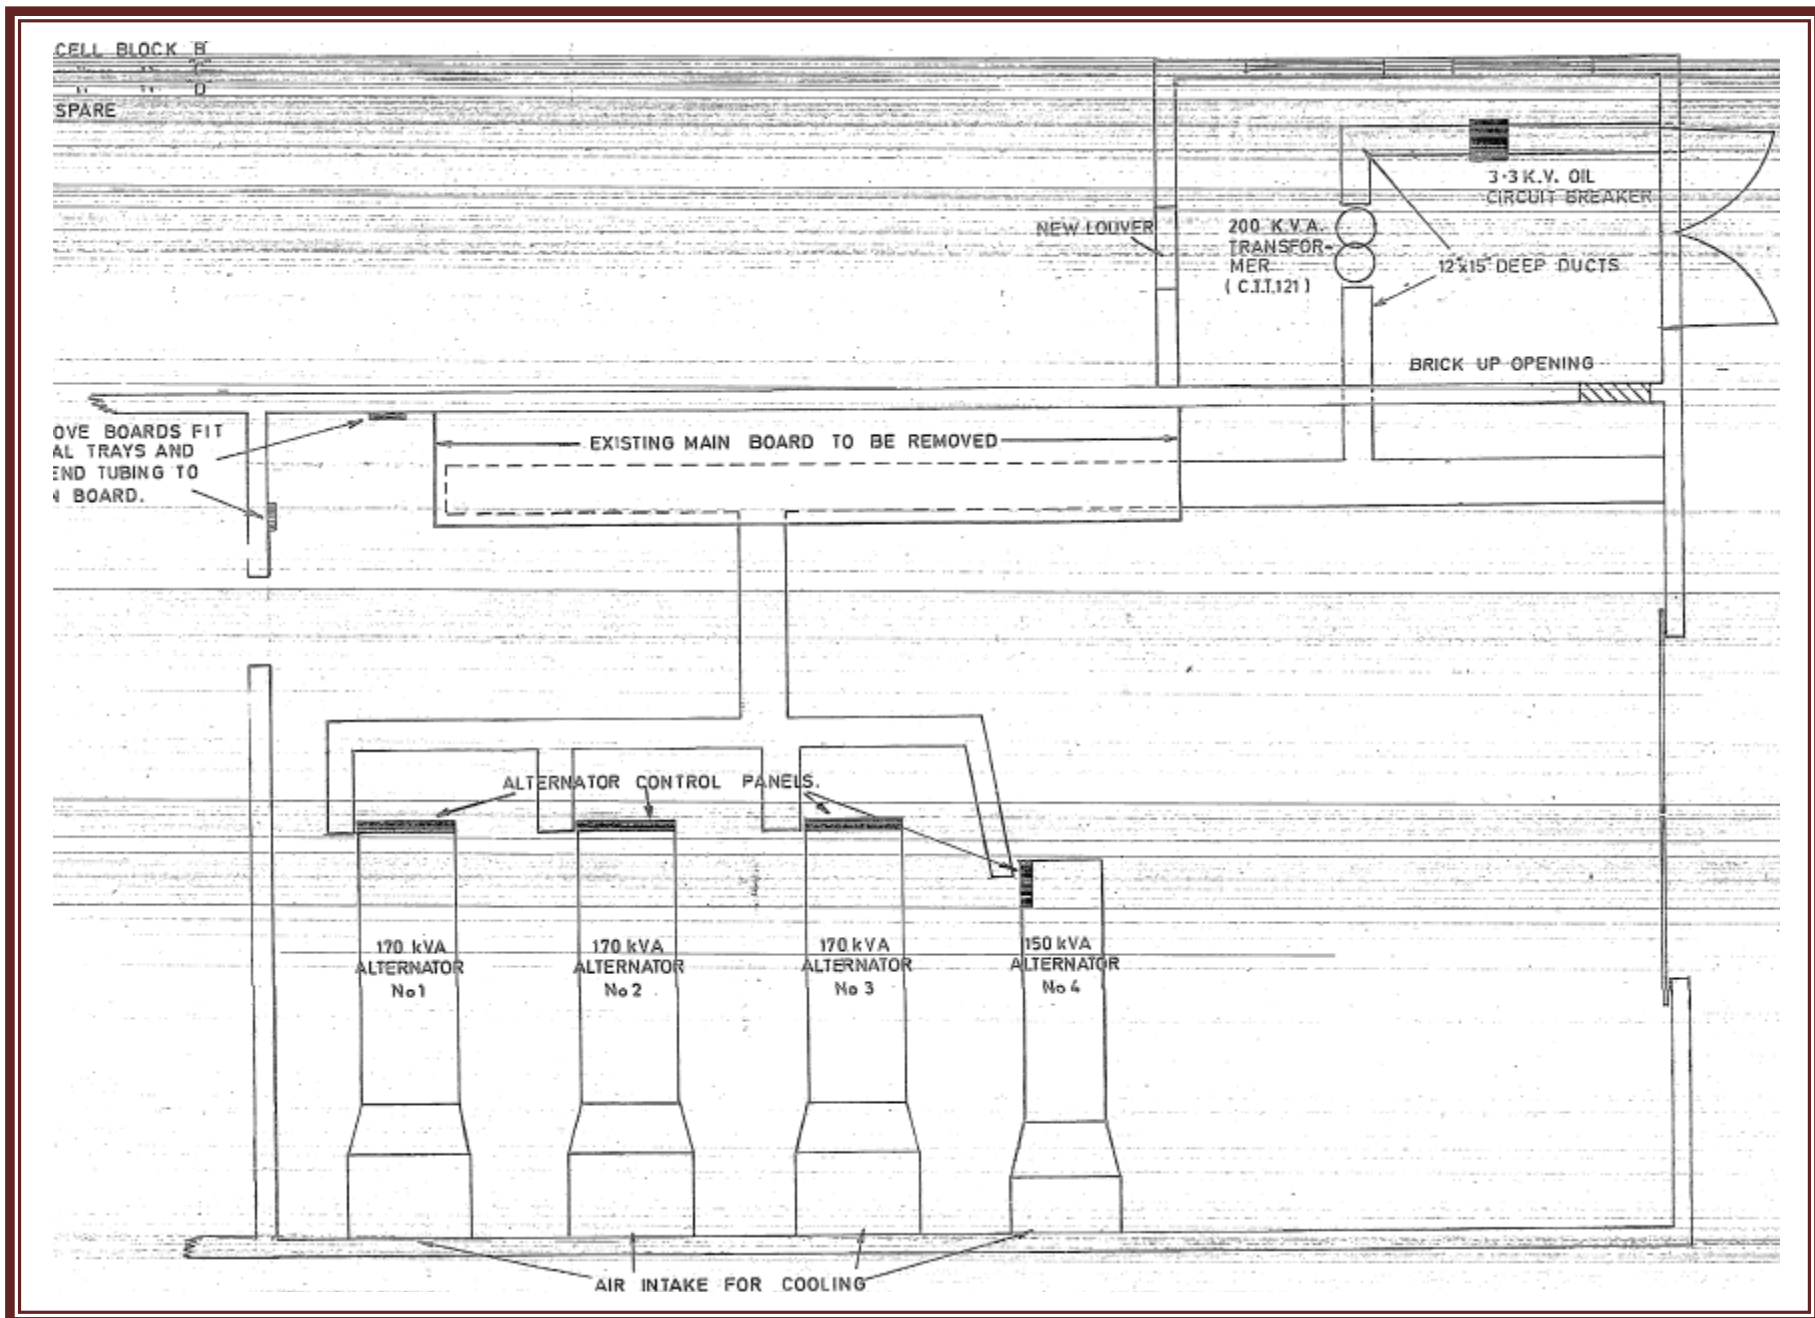
Fig.3. Ca 1970

A later cable trench appears on the northern side of the floor, which appears to have been a modification in the 1970's for a fifth Rolls Royce Diesel Genset to be installed as a back up unit. A correlation to the 1967 plans can also be made with the remainder of the current trenching.

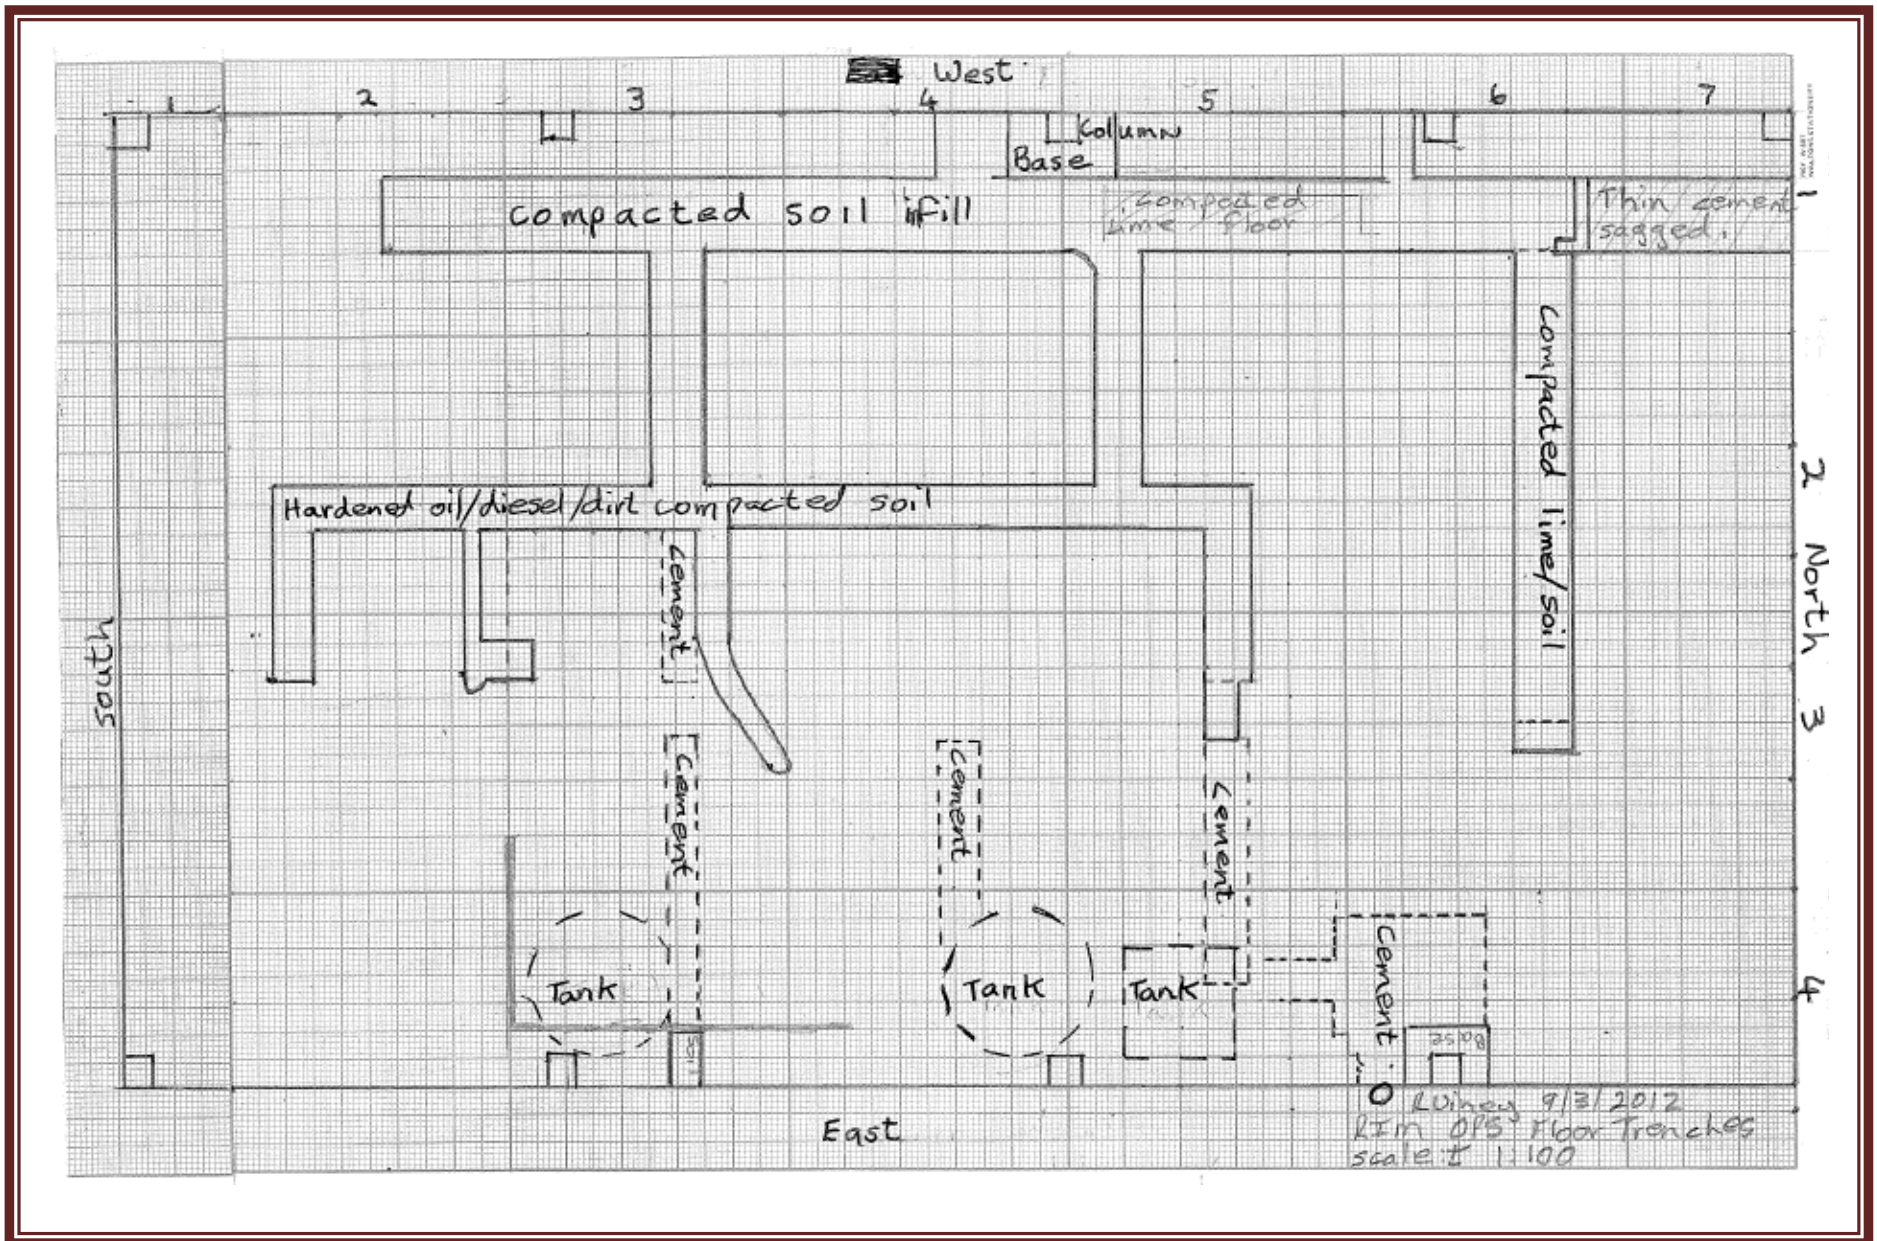
Fig.4.

The pipe trenches on the eastern side, which connected the water pipes from the cooling pond outside were mostly filled with concrete. The central channel was still partially open to the outside and filled with a soil/ lime mix.[refer fig.4]

Opening up of the trenches during construction must be done with heritage supervision.
