ROBBEN ISLAND MUSEUM: OLD POWER STATION

REPORT No.4: REINSTATEMENT, RETENTION, REMOVAL, REPLACEMENT AND MODIFICATION OF HISTORIC FABRIC

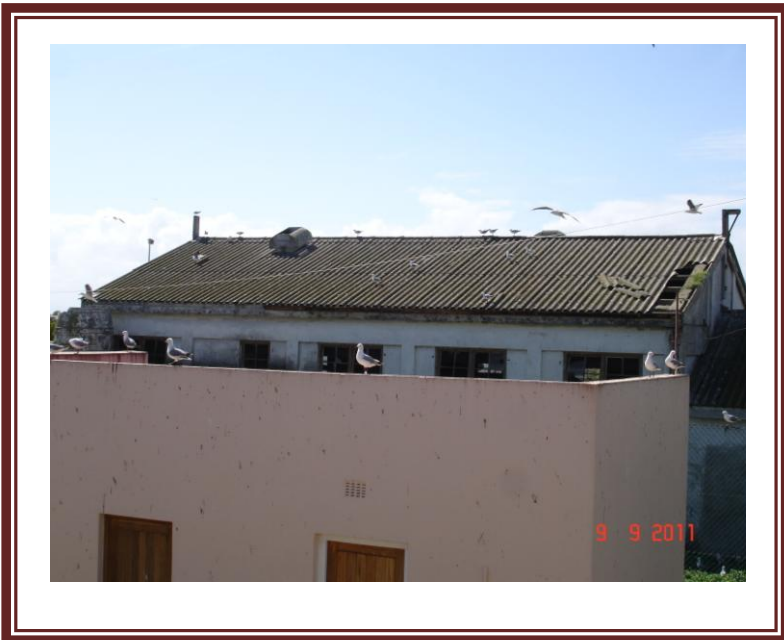
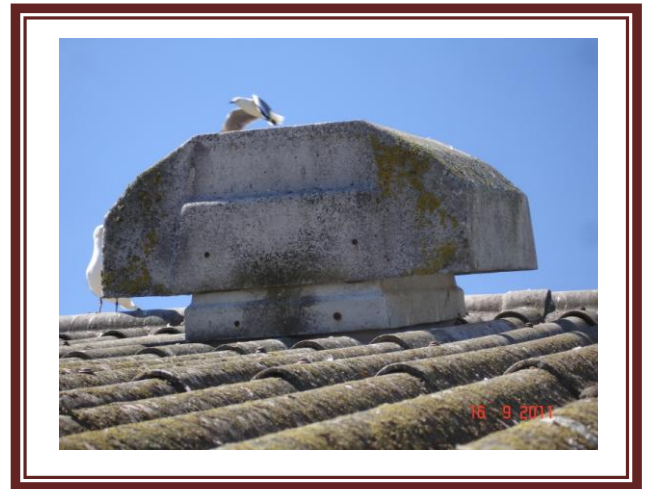
The two current roof ventilators are asbestos fibre cement. One is situated on the SE pitch of the roof approximately on grid line 'B', the second is situated on the NW pitch approximately between grid lines 'D' and 'E'. Both will need to be removed, sealed and placed back in situ. They may only be replaced if matching fibre cement ventilators are available and must be taken into the collection.

Fig.2 & 3. Current roof ventilators ca 1970's or 1980's

Corrugated asbestos roof sheets to be replaced with matching profile fibre cement to reduce asbestos register on Island.

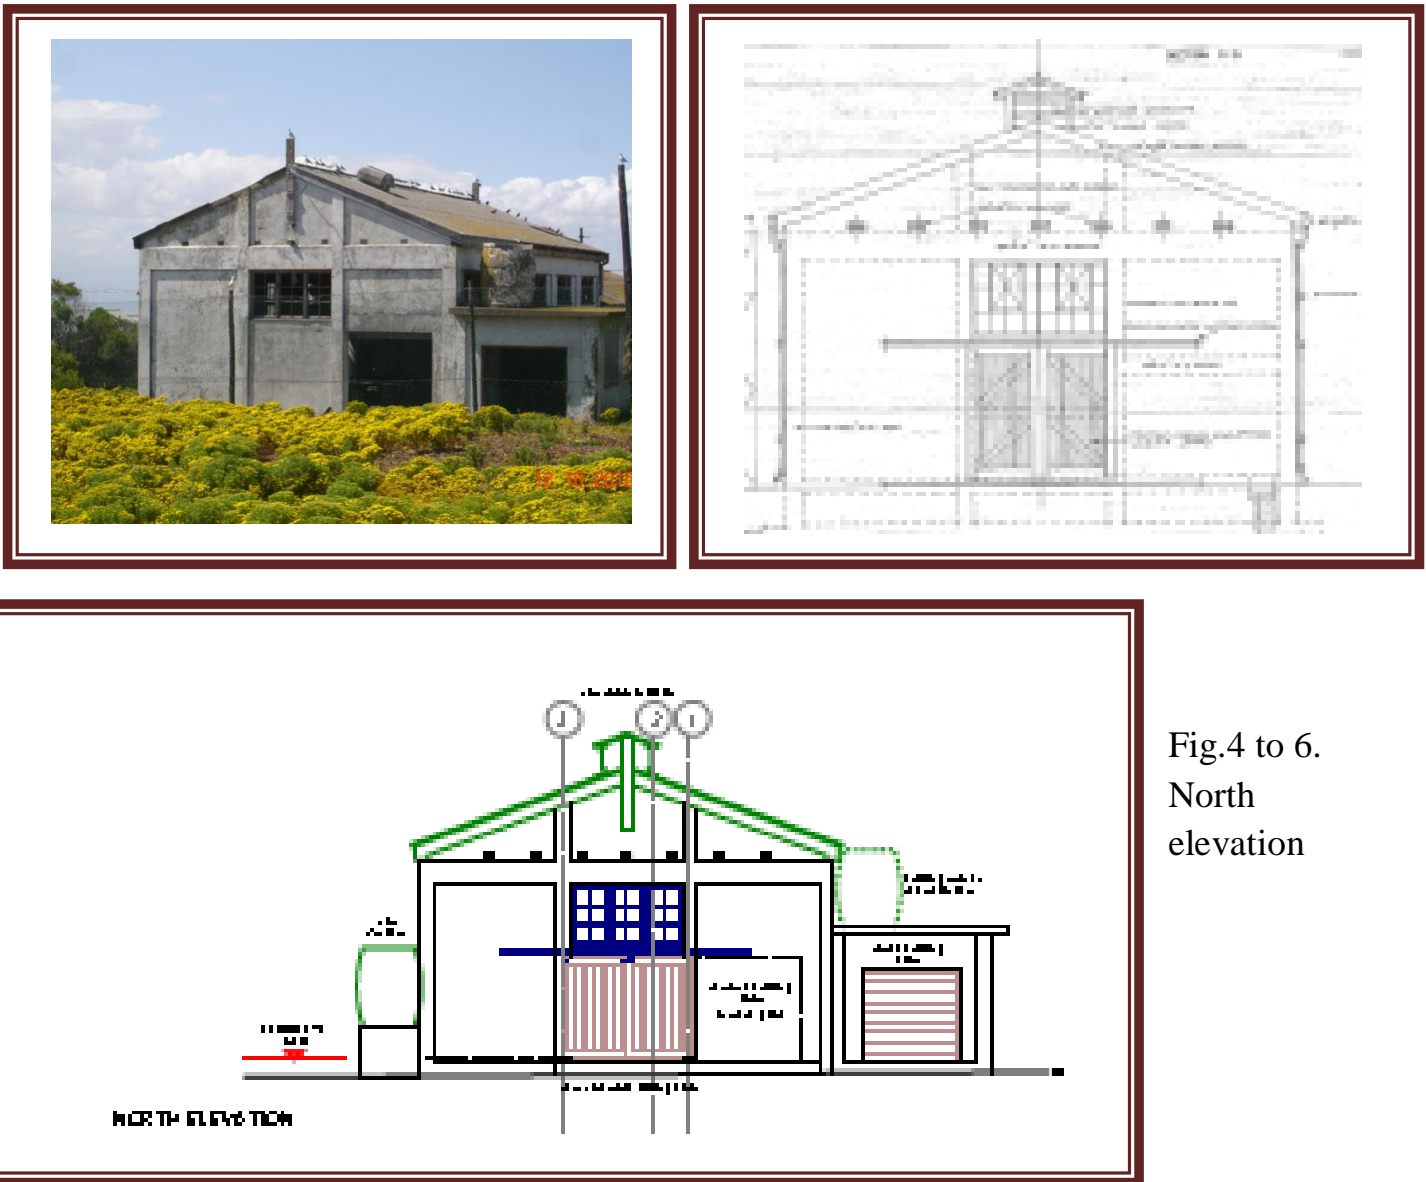
Fig.4 to 6.
North
elevation

The door on the north façade shown in the 1963 architects drawing is to be reopened beneath the central window and the door replicated. This will mean the return of the symmetry of the original design and will allow for better access down a central axis throughout the proposed storage area. The present door ca 1980's would be bricked up. The outline to be scored in the plaster as an interpretation of this part of the history of the place. The door to the ca 1967 to 1970 transformer room to be retained and either repaired or replicated.

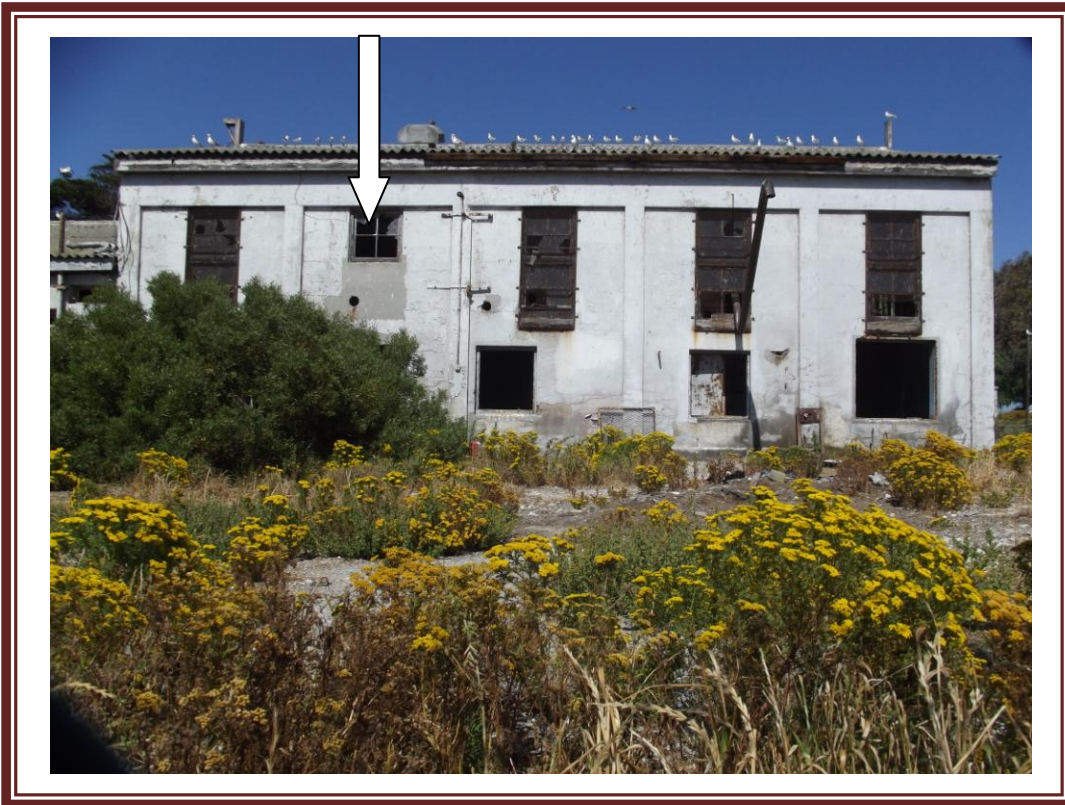
The window between gridline ‘B’ and ‘C’ on the east façade reflects two historical periods and is to remain as is. The lower bricked up part corresponding to the larger window is to be demarcated by differential plaster finish and outline scored in plaster.

Fig. 7. Halved window of ca 1970's conversion in section B-C

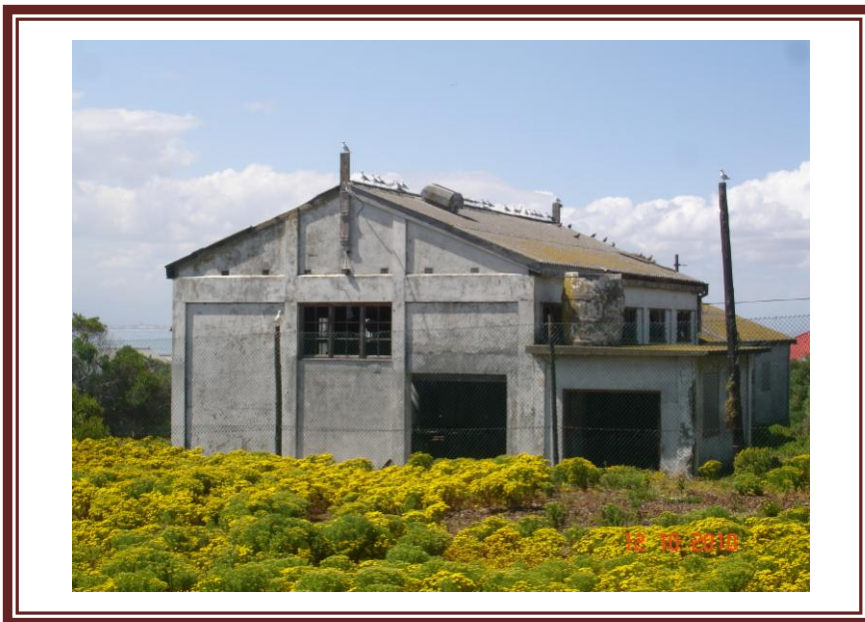
The siren mounting on the southern and northern gable of the double volume building to be retained with necessary repair and decoration.

Fig.17. North gable wooden mounting. South gable siren mounting is discernable.

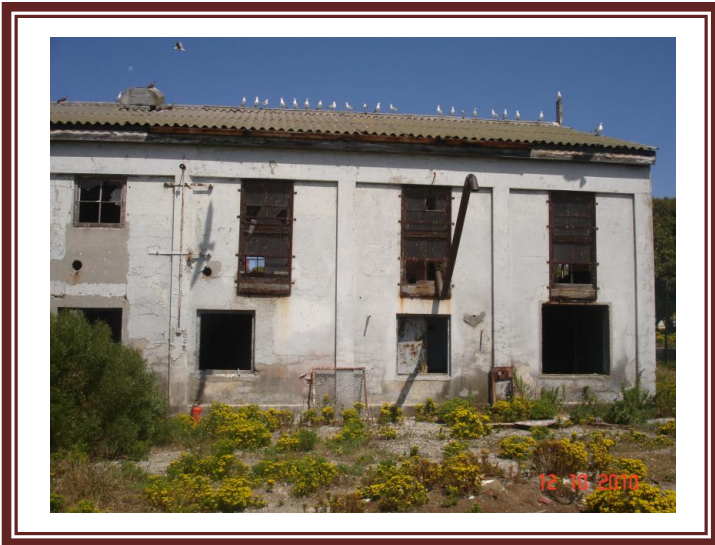
- a. Some ogee steel guttering remains : circa 7m on east, 9m plus 1m downpipe on west. From a durability point of view it would not be wise to re-use these remnants, which should be removed and handed to RIM. The new rainwater gutters and downpipes of the taller part of the building need to be of steel or cast iron components of sections matching the original [replacing ‘like’ for ‘like’]
- b. The remnants of asbestos guttering on the lower part of the building are to be removed and replaced with fibre cement of matching profile.

Fig.18. East elevation with extant section of steel guttering.

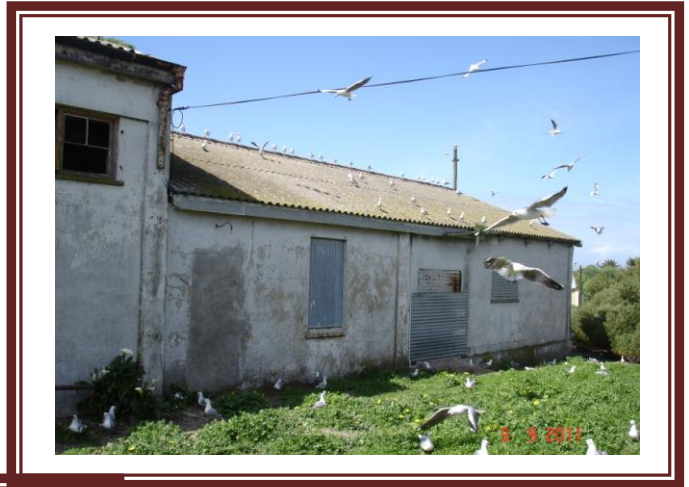
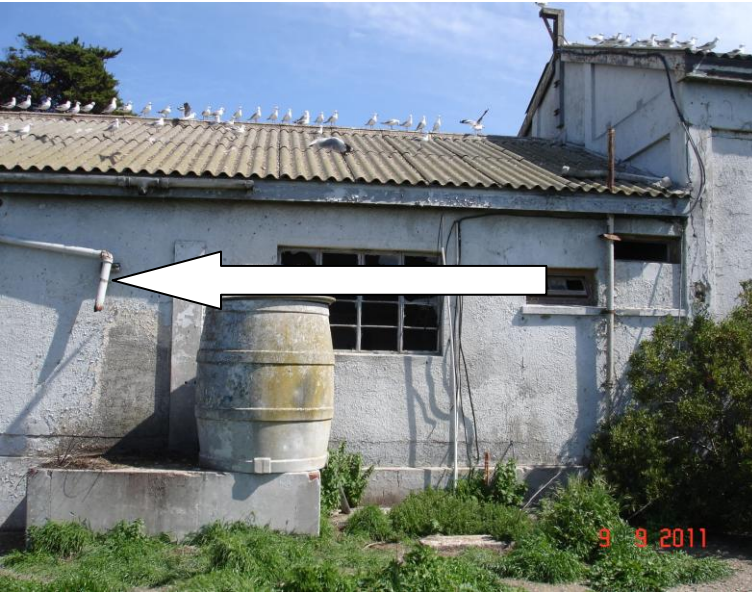
c. A rainwater downpipe on the west elevation ingresses the building where a steel pipe carries the flow of rainwater through the building from west to east, where it drains into a tank. The internal pipe compromises functional requirements of the archive for fire protection and safe environment. It should be recorded, then removed and handed to RIM.

Fig.22. East face showing exit point of western down pipe.

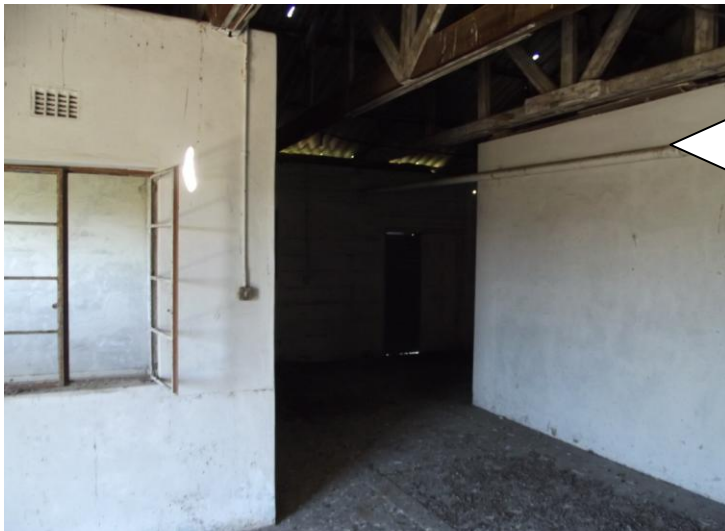
Fig.23. Steel rain water pipe through building.

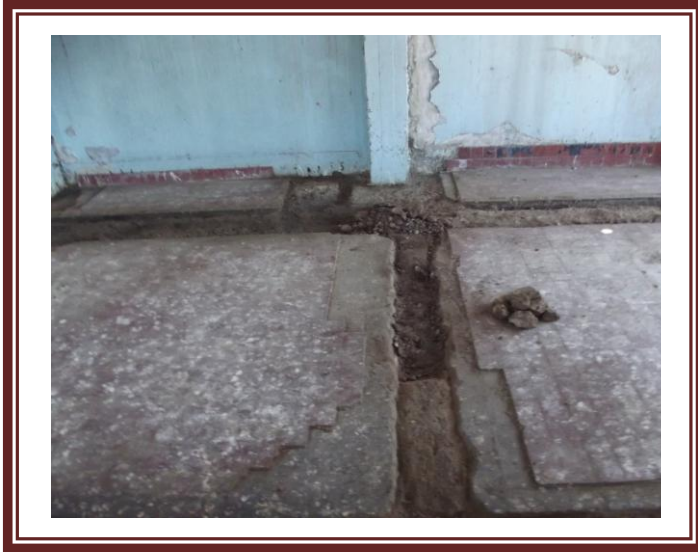
A double row of red clay tiles similar to those on the floor forms a skirting round the interior of the main building. These must be retained and missing tiles be made good from the floor tiles.

Fig.23. Showing skirting outline with missing tiles.

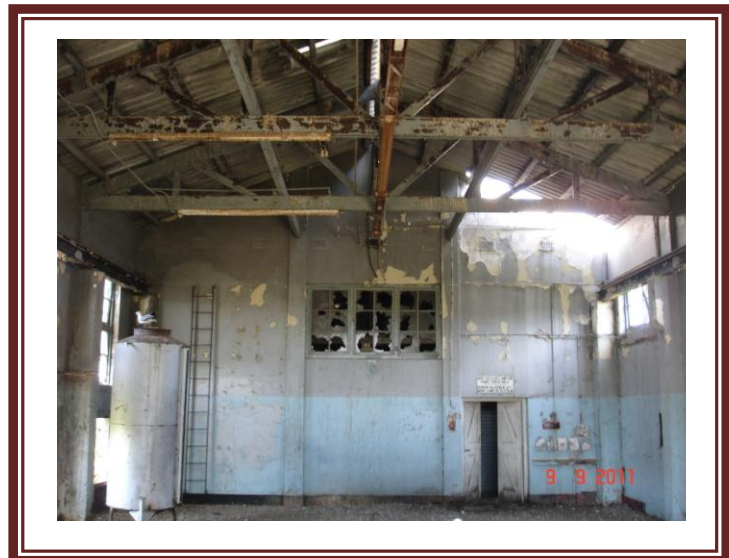
To be salvaged and re-used. In its current position its retention conflicts with the proposed mezzanine level. It should be moved to the North wall diagonally opposite where the double volume space can accommodate it. This position from an interpretive point of view is still compatible with the ladder's original function to provide access to service the gantry crane

Fig.24. Steel ladder in SE corner and double wooden door opposite

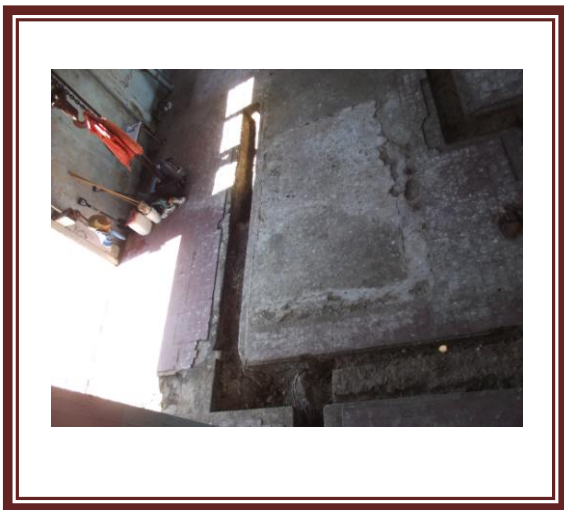
Fig.25. Floor tiles

The original floor of the main room was of 6” square quarry tiles, but is now incomplete. To conserve and indication of the original tiled floor, a perimeter border of between 3 and 6 tiles [depending on number available for re-use] is to be retained/ restored using existing tiles. The remainder of the floor space will be a new floor finish selected for its utility for the proposed new use of the space.

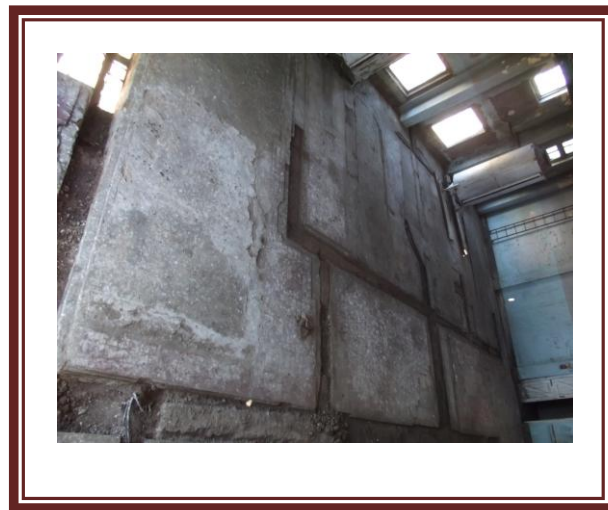
Fig.26. Trenches

Original trench lines be distinguished by a distinct colour or material whether used or not.

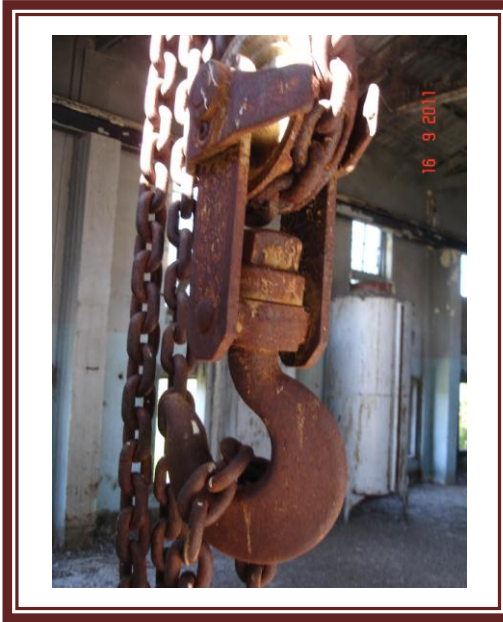
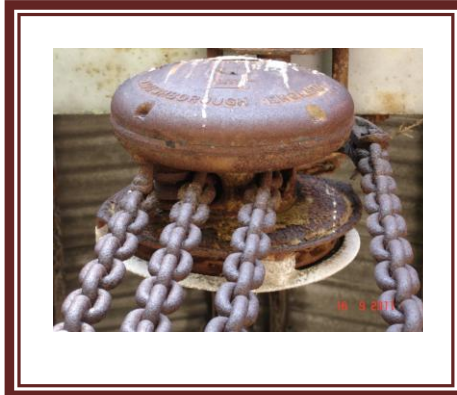
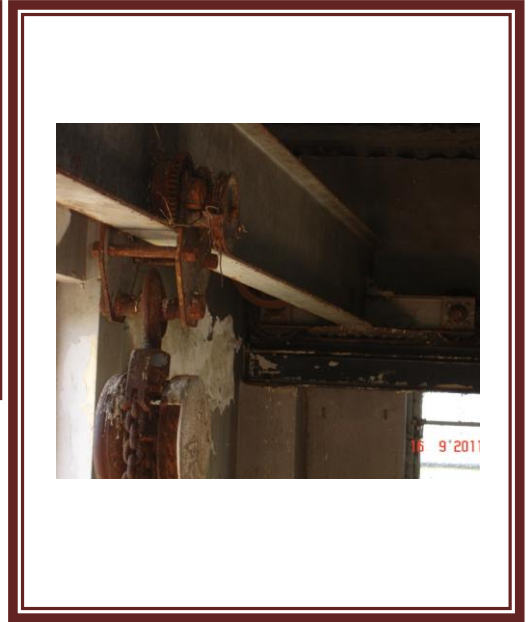
Fig.27 to 29 Hoist and gantry

To be retained, de-rusted and decorated. Chain, pulley and hook component to be located in double volume space but moved along track to out of way adjacent to north wall to west of reinstated entrance.

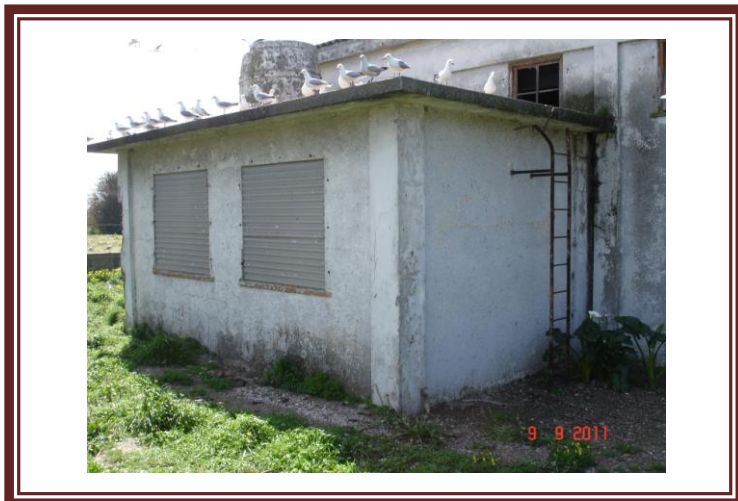
Badly corroded. To be removed and scrapped. A replica in galvanized steel is to be provided and decorated.

Fig.30. Steel ladder on South exterior wall

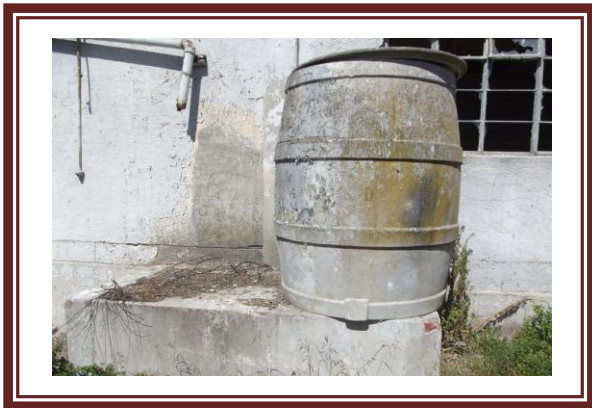
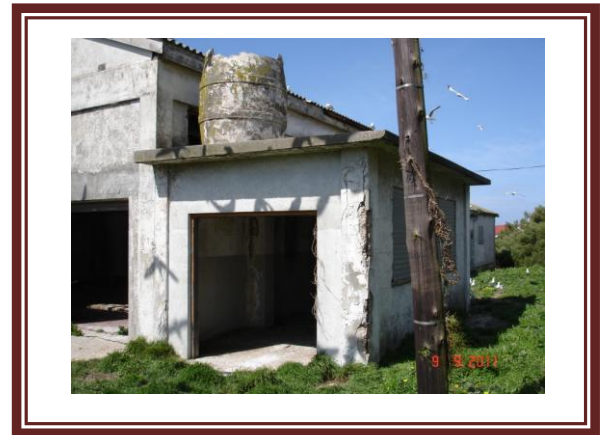
The design concept proposes the reintroduction of the harvesting of rainwater for use in the garden. Two asbestos fibre cement tanks are still extant. The eastern tank is to be replaced with a matching fibre cement tank in its current location. The western tank on the roof of the transformer room must be removed and replaced at ground level with a matching fibre cement replacement. The motivation for the replacement is the requirement to reduce the asbestos register

Fig.31. Left, East elevation tank

Fig.32. Right, tank on roof of transformer room

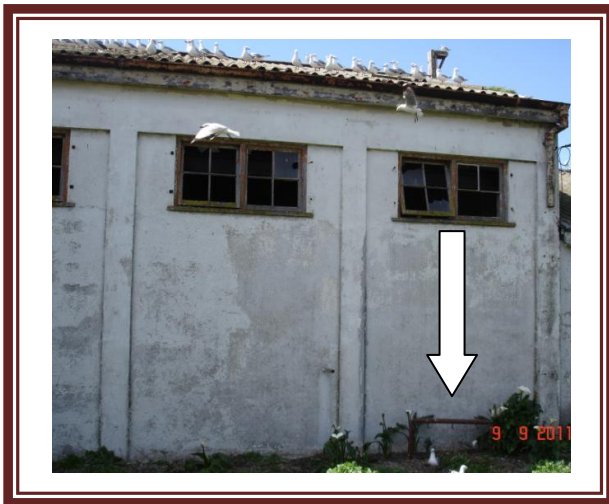
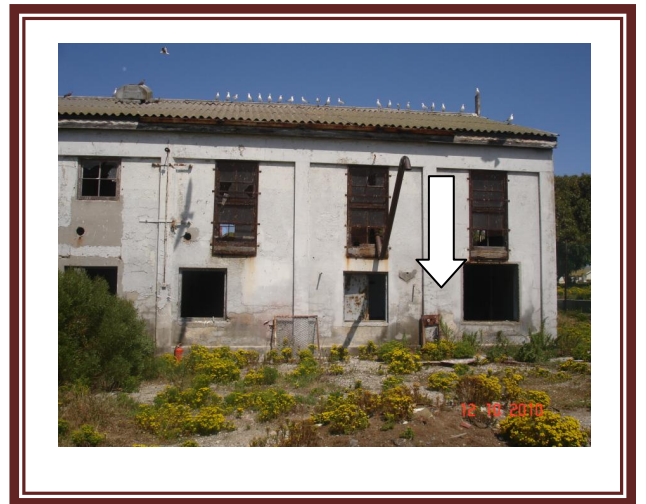
The fire bucket stand on the western side of the building is to be retained. It is corroded at ground level but is to be de-rusted and decorated and fitted into new galvanized steel sleeves set in concrete pads. The fire hose reel stand on the eastern side to be retained. To be removed for derusting and painting and then to be reset in original position. Reel clamps to be greased to prevent corrosion.

Fig.33. Left fire bucket holder west

Fig.34. Right, fire hose reel

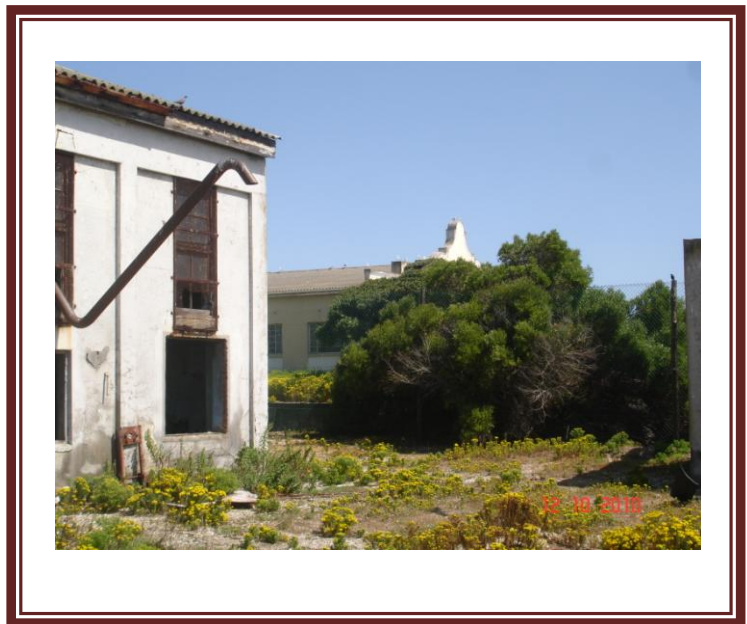
One of the original four remains. This is to be retained but relocated in the middle of the five bays of the east elevation where the hole in the masonry of the original pipe exists and can give sounder weight –bearing support that the window frame which it is currently situated in. Stainless steel pipe to be cleaned and refixed in original vertical position. A top bracket plus an additional bracket as fail-safe to be provided. Grille to be fitted in pipe at exhaust exterior end to prevent bird nesting. Pipe to be cut short at interior end, sealed off and then secured in masonry. Other exhaust pipe penetrations to be identifiable. Two galvanized steel plates to be fitted in two locations in lieu of single window panes where exhaust pipes originally exited the building. Former pipe penetrations to be indicated with painted circles on these plates. Holes in mesh grilles to be repeated in new mesh grilles. Remaining hole in wall to be bricked up, with bricks set back and plaster painted black.

Fig.36. Stainless steel exhaust pipe

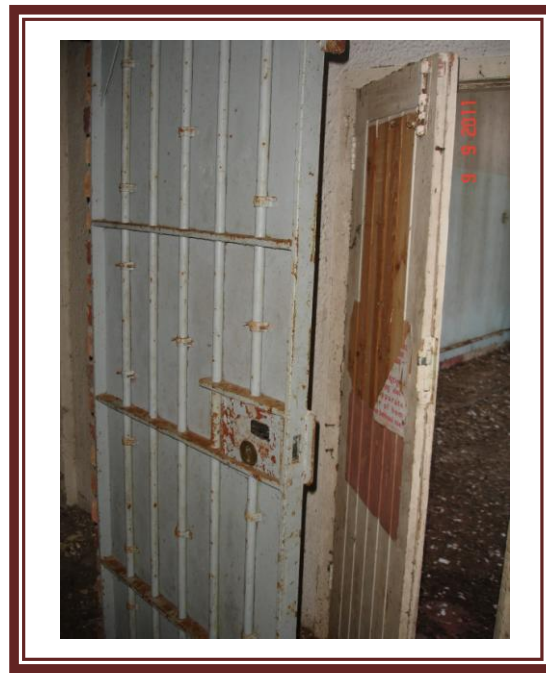
To be retained with lock function and operation to be restored. This store not to be independently fire proofed.

Fig.37. Modified prison door

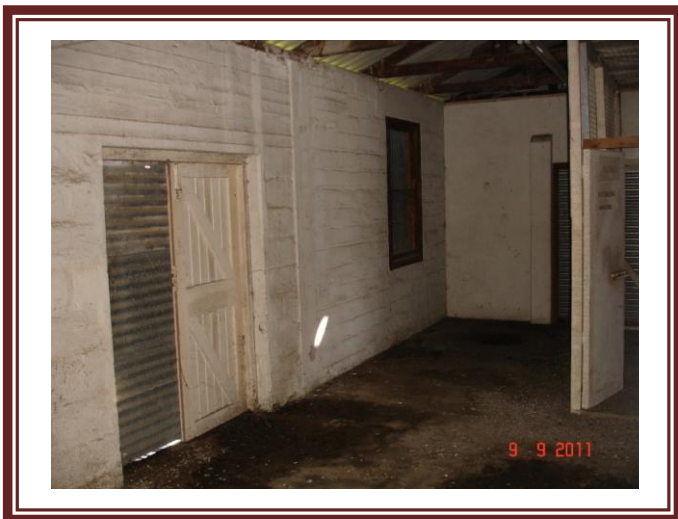
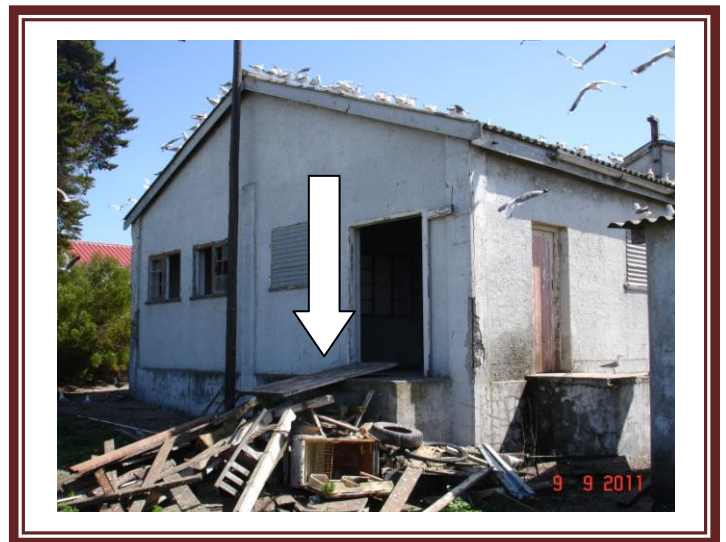
Double doors on West Elevation: doors and frame to be retained, with repair and/or replication as required; then to be fixed shut and bricked up on inner side with outline of position scored in plaster; ventilation to interspace to be allowed for. Double doors on South Elevation: original to be restored/replicated re-using salvaged components. This door does not have any threshold and will need adaptation to provide weatherproofing.

Fig.38. Interior of door boarded up

Fig.39. South entrance with wooden door on its side on staircase

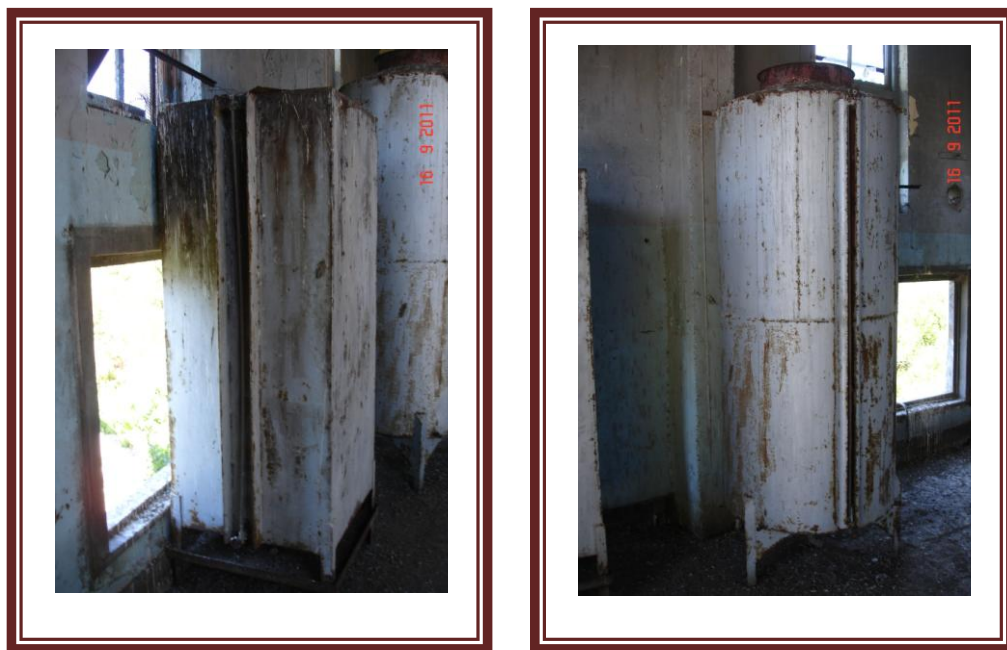
Fig. 44&45.
Diesel tanks

Agreed these must be retained as artifacts and that there was value in maintaining their association with this building. However they cannot remain in building because there is not sufficient height for them beneath the new mezzanine floor, and if placed in the limited double volume area they will obstruct activities in that area; further inside the building they could compromise environmental control objectives of the project.

The tanks are to be placed on the eastern side between the main building and the new proposed plant to be housed inside the cooling pond.

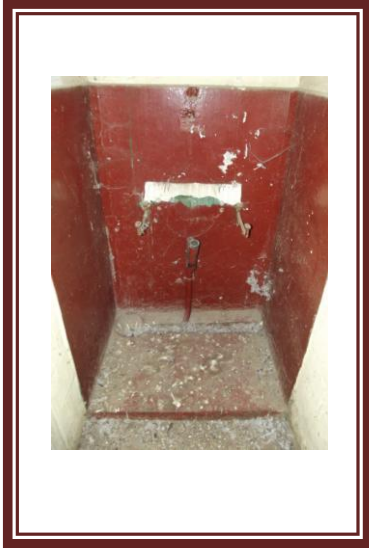
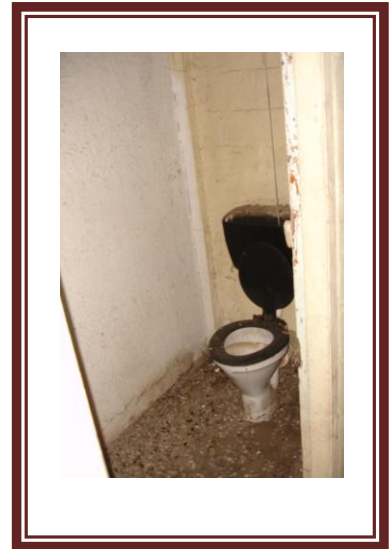
In the space to be remodeled as disabled wc and shower there is an in-situ plastered urinal. While its retention would be of some heritage value, to do so would compromise the proposed uses of the space and contemporary standards of decoration, hygiene and functionality would be compromised. Thus it is accepted that the urinal cannot be retained but it is to be recorded before works in this space

Fig.46. Left, Urinal and wash basin mounting

Fig.47. Right, modern bowl and cistern.

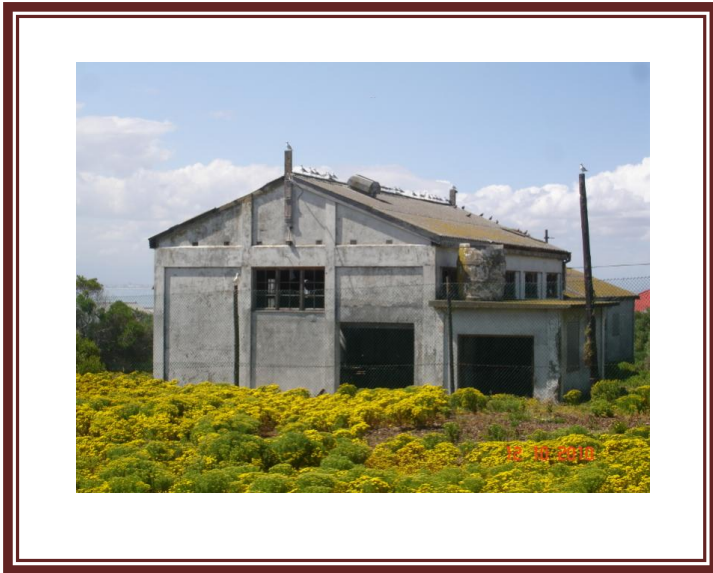
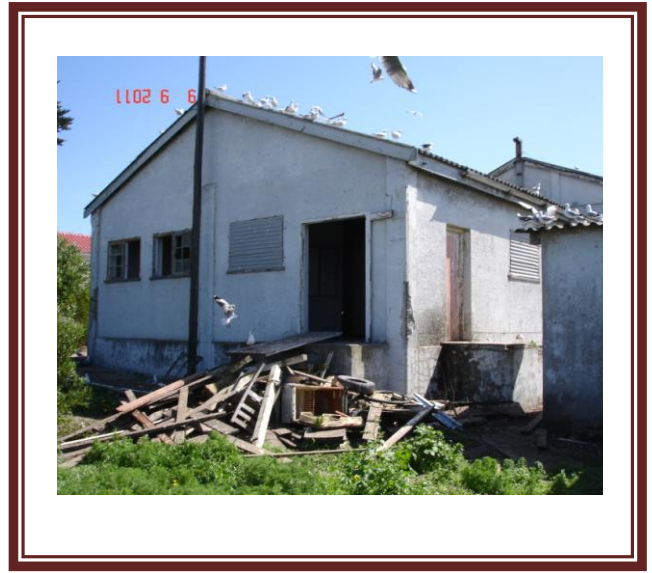
To be retained. There are three, the third just outside boundary fence at NW corner of site. All three are to be creosoted; on the pole adjacent to the North elevation, the grass growing in the split is to be removed; the stainless steel hoop strapping is to be retained.

Fig.49. NE wood pole

Fig.50. South wooden pole

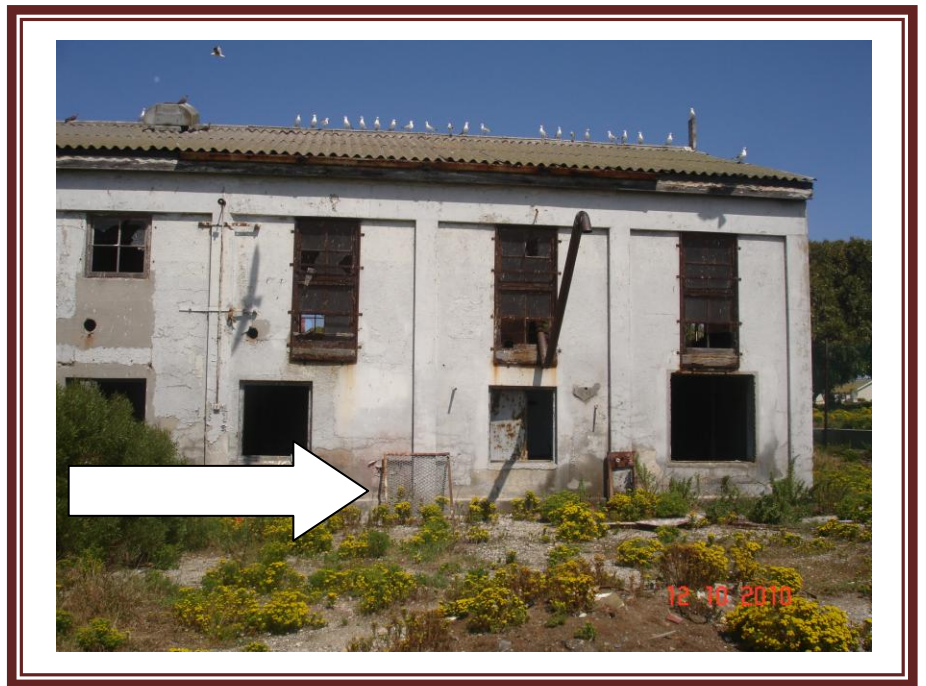
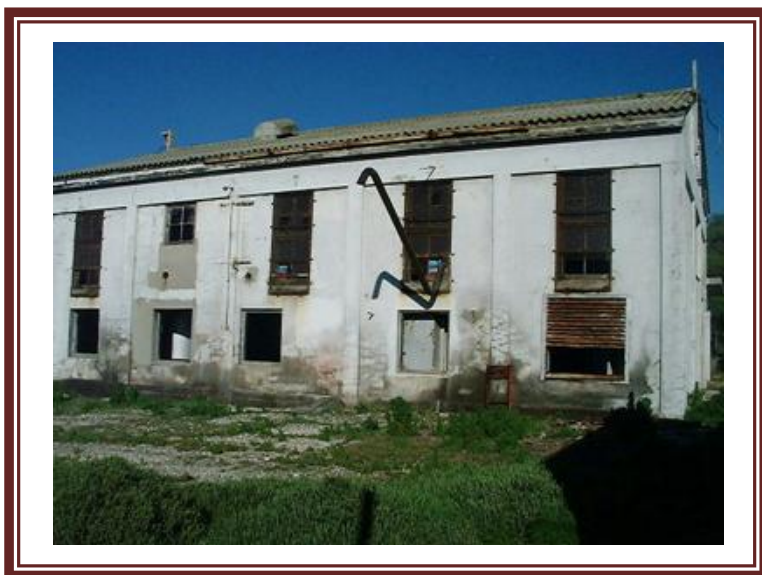
To be bricked up and plastered; external reveals to be retained and internally their outline scored in plaster. The external plaster faces to be painted matt black and salvaged or replica mesh grilles provided and refitted. There is no need to retain the original timber frames which are to be removed and disposed of by the contractor. The northern end opening is slightly larger and had a louvred grille in a frame, not a mesh grille. Remains of this assembly are on site. This opening too is to be bricked up internally as the others. The louvred unit is to be restored or replicated and set in its original position.

Fig.53. Remaining example of steel mesh grille

Fig.54. Louvre still extant as at 1996.

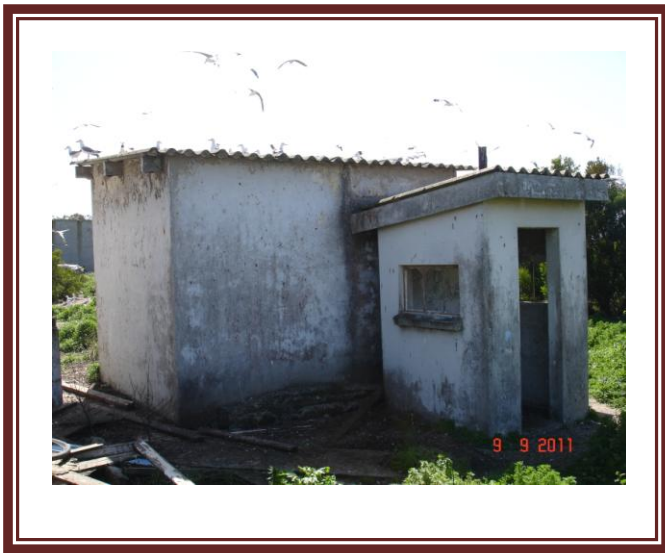
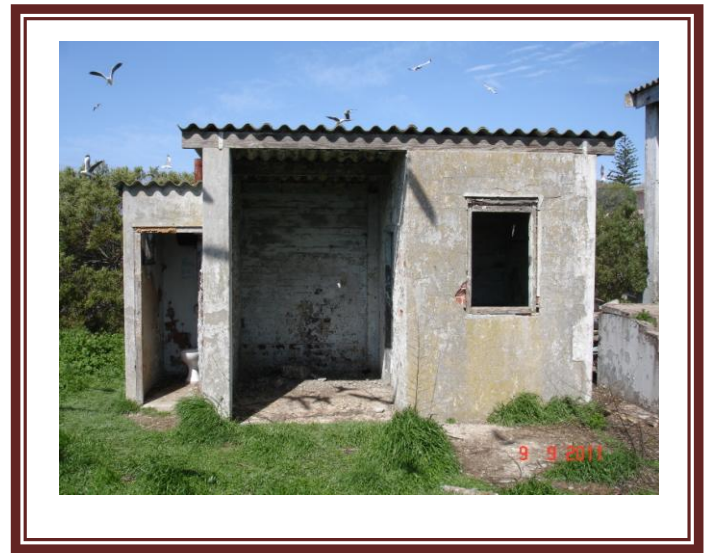
Fig. 56 & 57 Guard house and facilities SE

Roofing, wall, windows and doors to be retained, with necessary repairs being ‘like for like’. There appears to have never been any guttering but there is evidence of a water run-off system on the ground, which is to be retained.

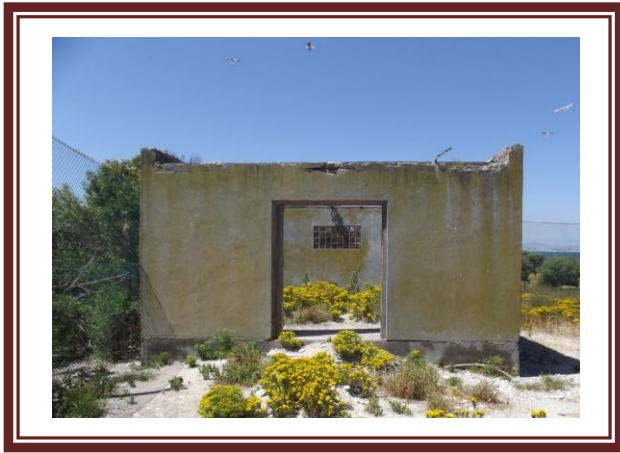
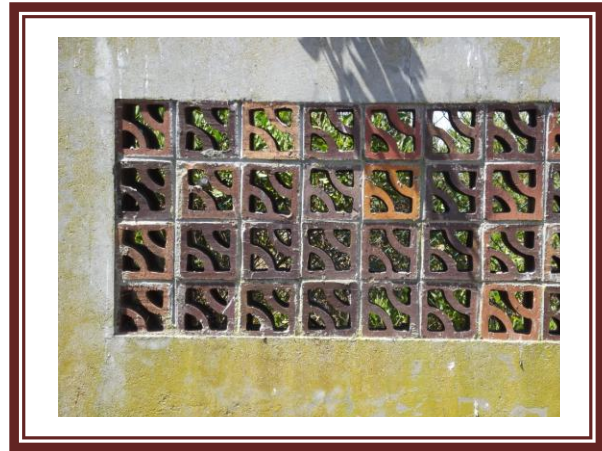
There are two rectangles of double thickness clay brick vent units, on the north and east elevations. The outer panels of vent units are to be retained *in situ*; the inner leafs are to be broken out and replaced with single leaf panels of brickwork to close the opening; then to be plastered internally with scoring to demarcate the position of the former vent area.

Fig.58. Entrance and west face

Fig.59. decorative ventilation interior east wall

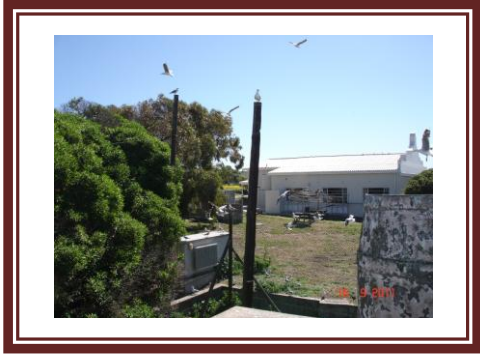
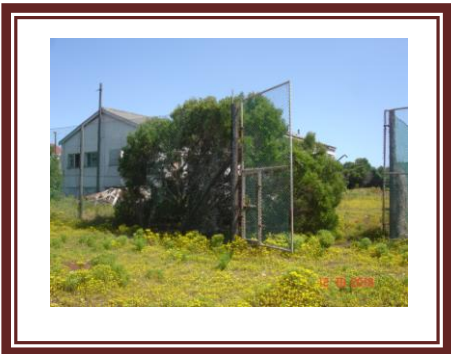
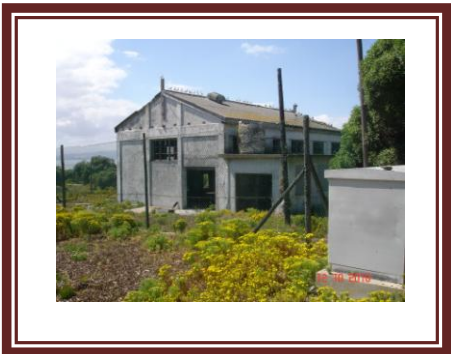
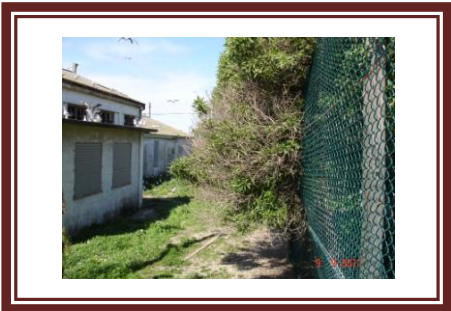
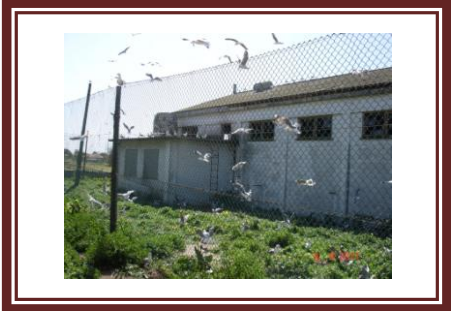
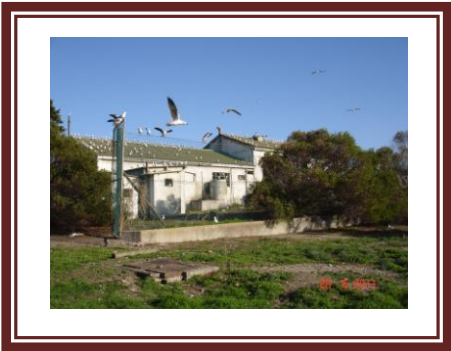
Fig.60 to 66. Fence , gate , retaining walls

To be retained. Draw wires to be renewed, poles to be creosoted and existing mesh panels to be re-hung; extensive repairs to be done to corroded gates, all to match existing.

In good condition generally. Repair to be done at N-E corner (*circa* 2sqm on face), all in matching materials and detail.
