REPORT No. 2: ROBBEN ISLAND BLUE STONE QUARRY; CONCRETE PLATFORM INSIDE QUARRY

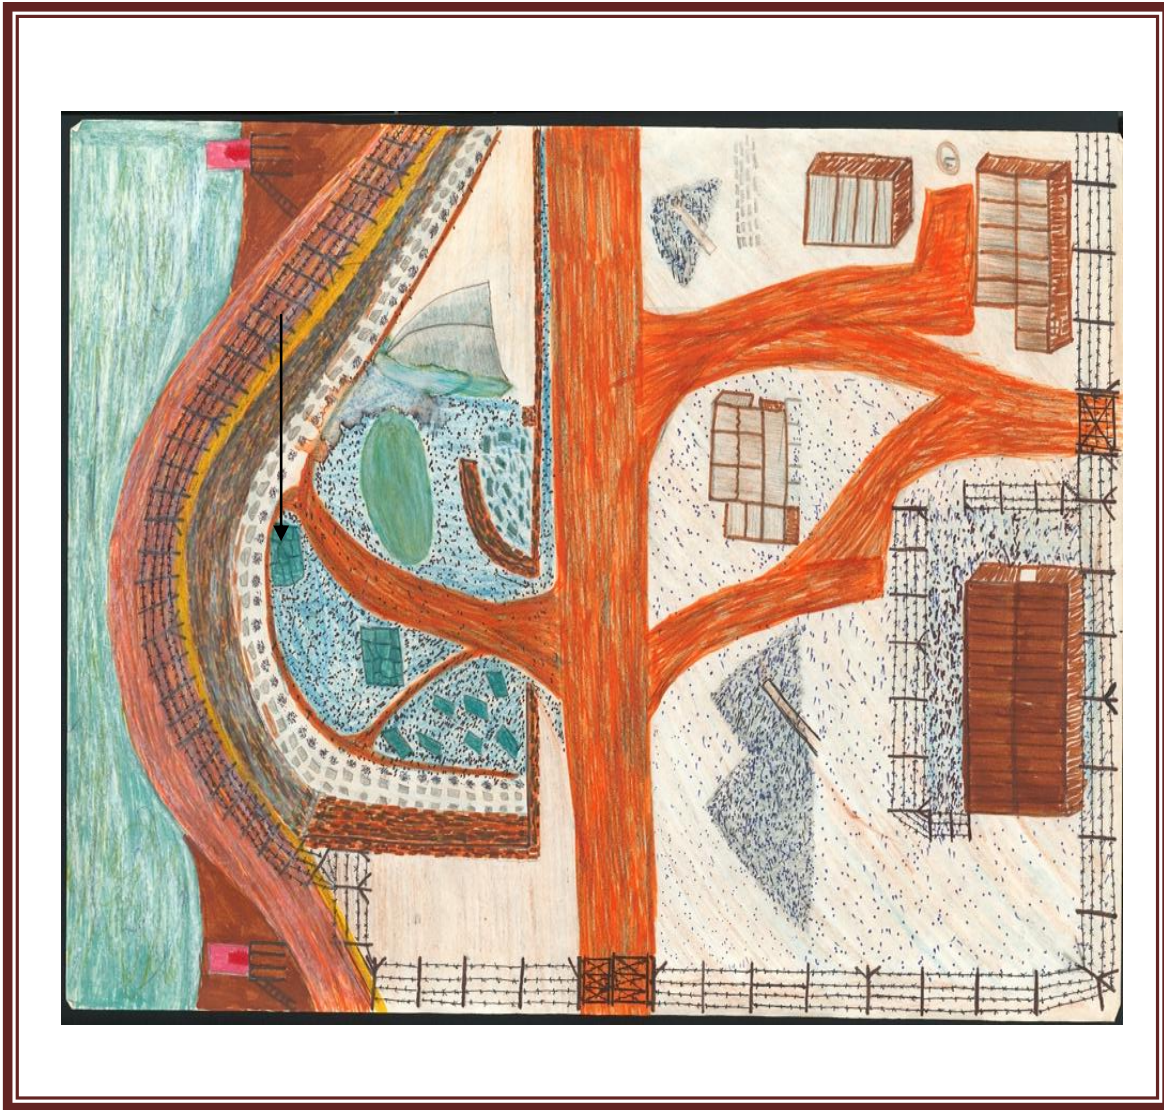
A structure is shown close to the wall in the Babenia drawing when the quarry was active. Ex-political Prisoners also recall an area next to the wall that was used to shelter from the winter winds. The platform may also have been used to make bricks used in the construction of buildings on the Island [Nolobabalo Tongo; pers comm.]

Fig. 1.
Drawing by
Nato
Babenia ca.
1970's
showing a
feature next
to the dyke
inside the
quarry.

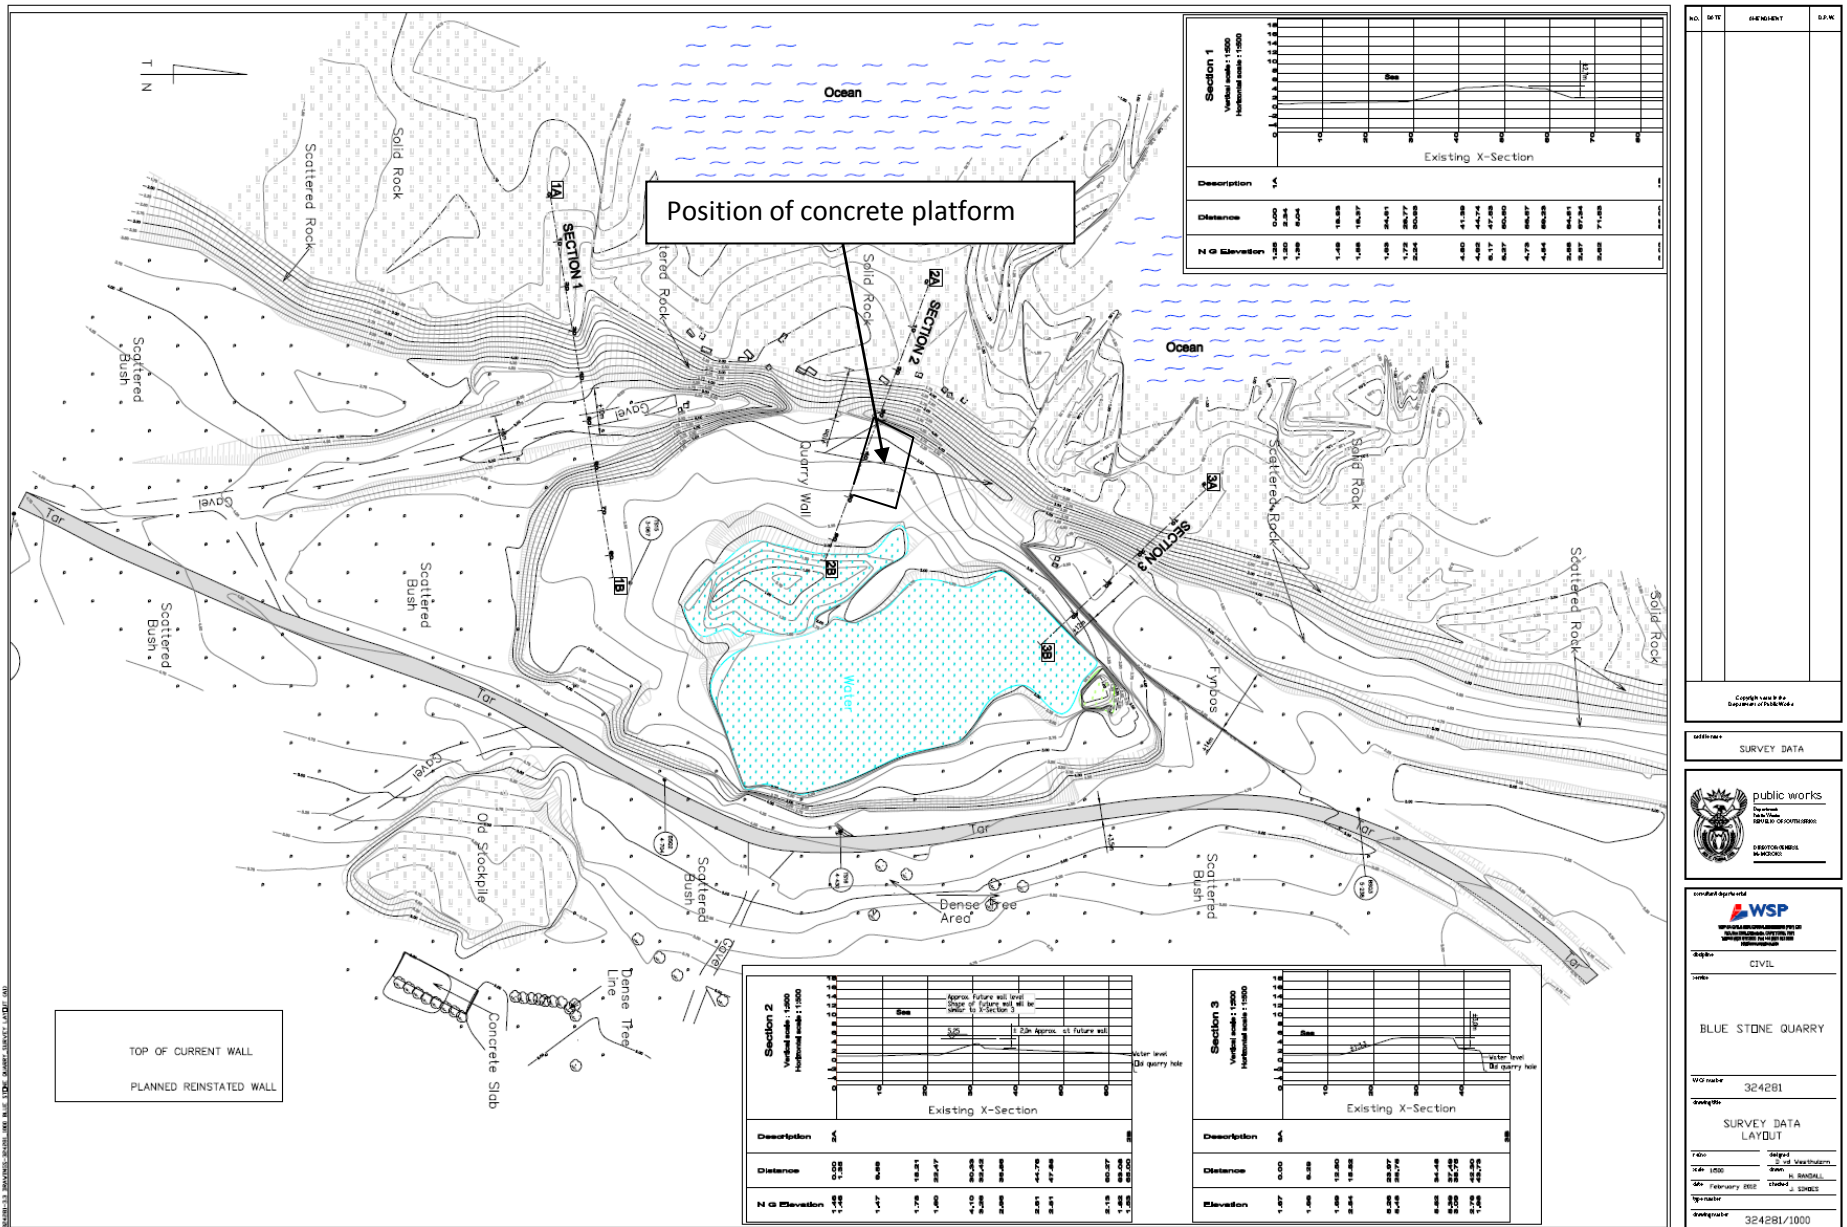
Fig.2. Survey diagram 34281/1000. The concrete platform is situated inside the quarry adjacent to the wall.

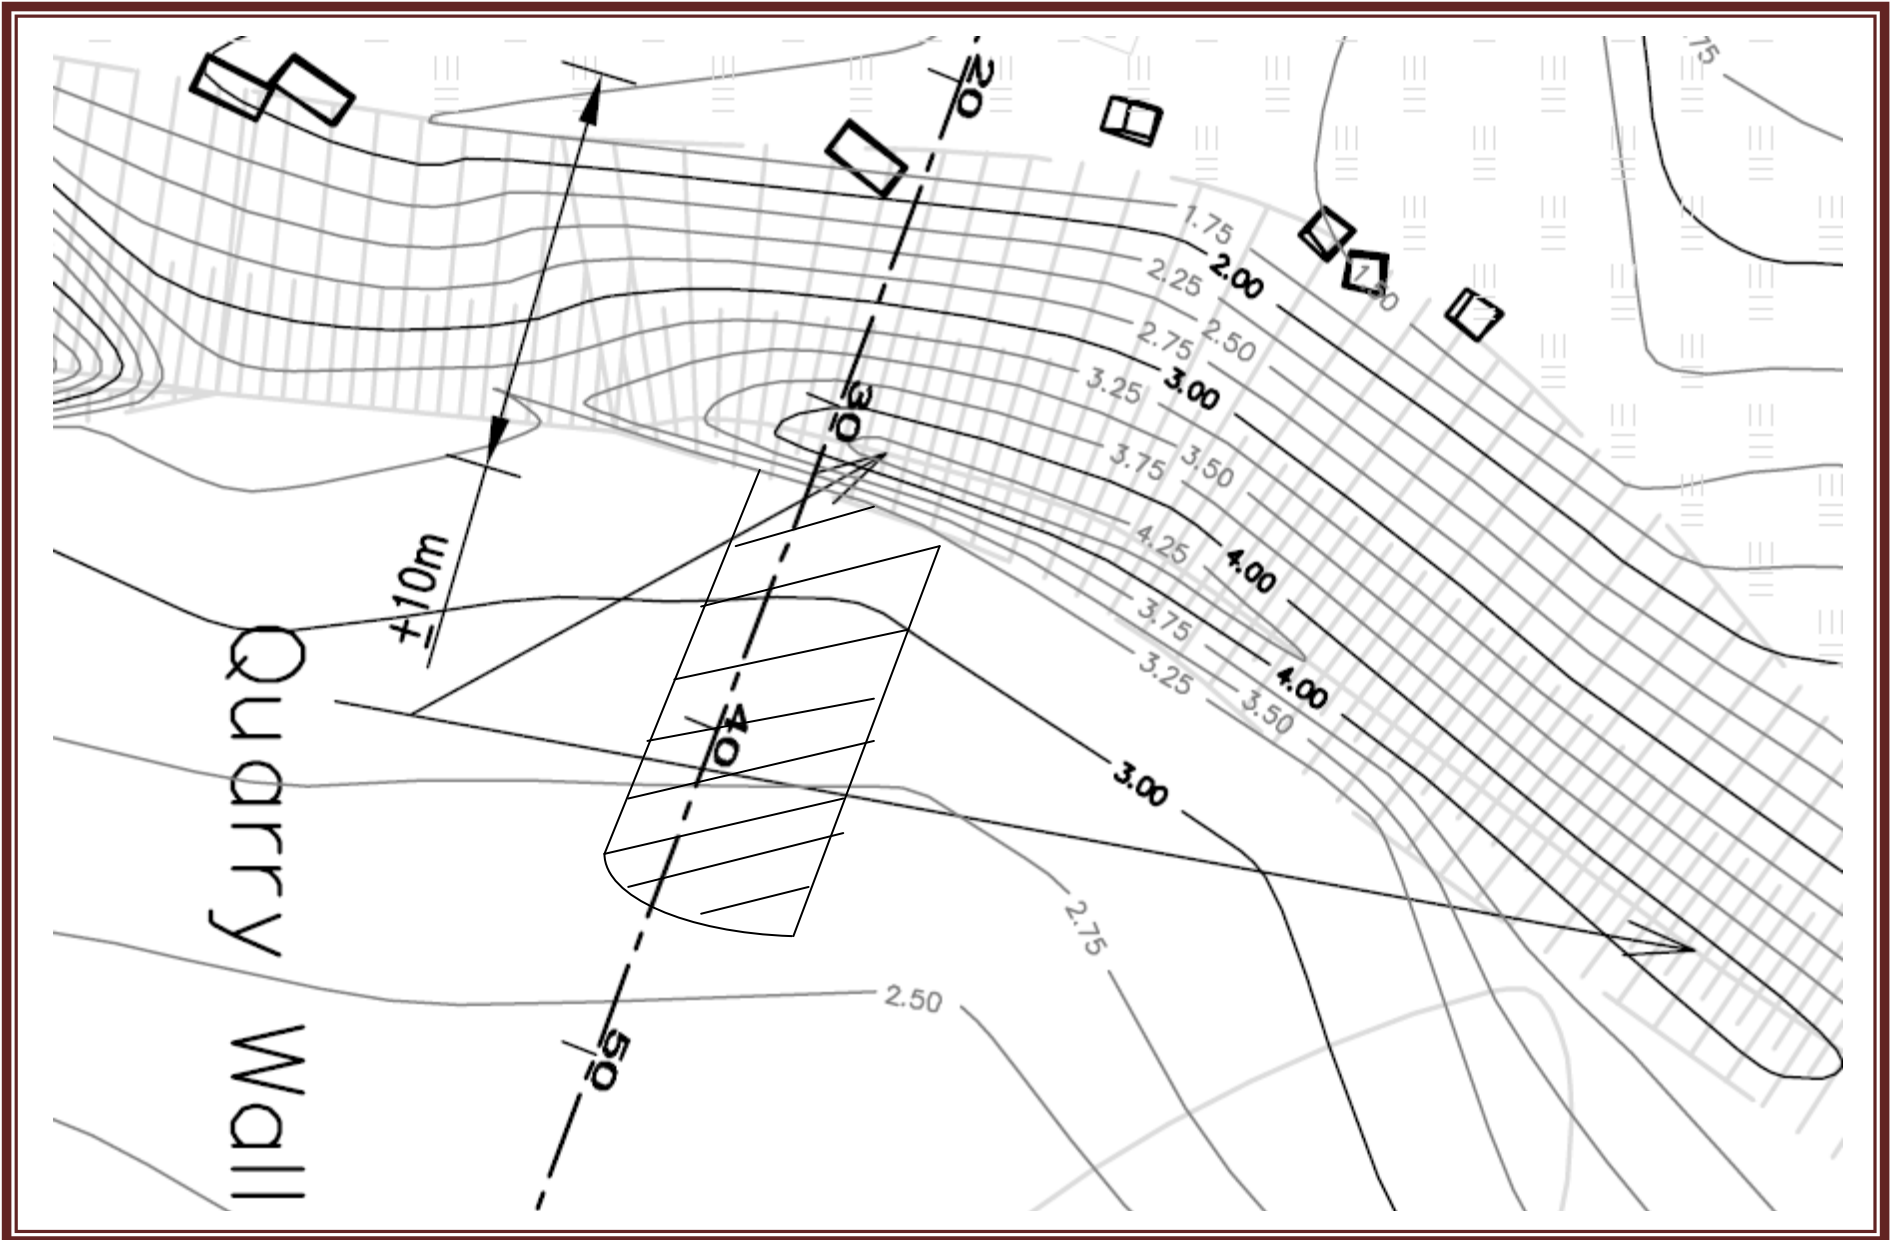
Fig.2.a. Position of slab

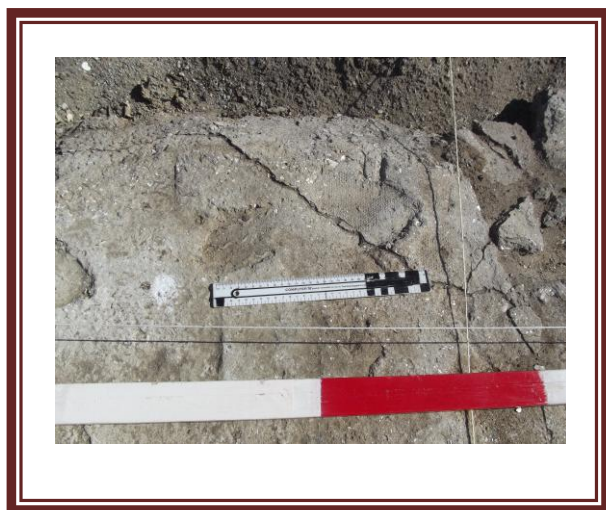
During the excavation a fireplace was found next to the quarry wall in the centre of the concrete platform. Two bricks were also uncovered adjacent to the charcoal of the fireplace. A square post hole was also found approximately 1 metre from the fireplace, which may indicate some sort of shelter for the fire. A set of footprints, with the tyre tread pattern used for the soles of prisoner's shoes, is embedded in the south east corner of the platform.

Fig. 6. Prisoner footprints on SE corner

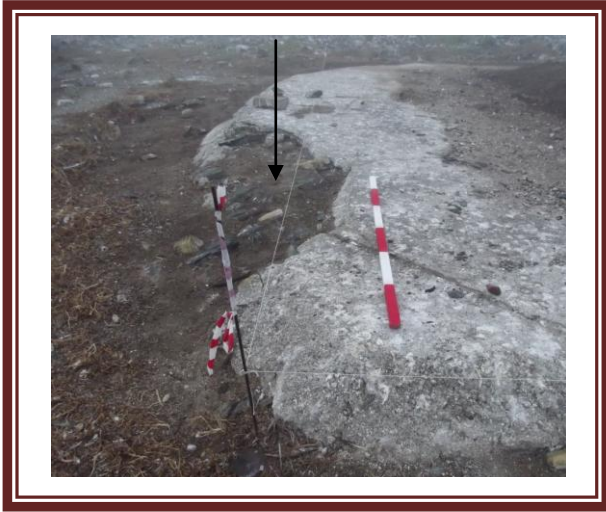
A section of the slab on the NE corner is damaged with the sections embedded in the debris some 6 metres from the NE corner. The damaged section is possible due to a mechanical front loader used when the contractor for the rehabilitation of Murrays Bay harbour pre-empted a SAHRA decision to start work on the quarry in ca 2004/2005. Marks were also made by the machine on a section of the slab. It would also appear as if the slab was cast instages as cracks show where extensions were made. Thickness of the aggregate varies between 10 and 20 cm.

Fig.6. Eastern edge looking from N to S showing damaged section

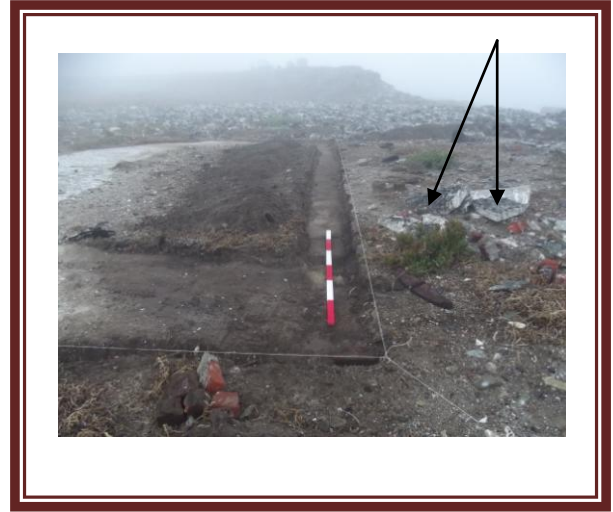
Fig.7. Parts of damaged slab shown adjacent to eastern edge

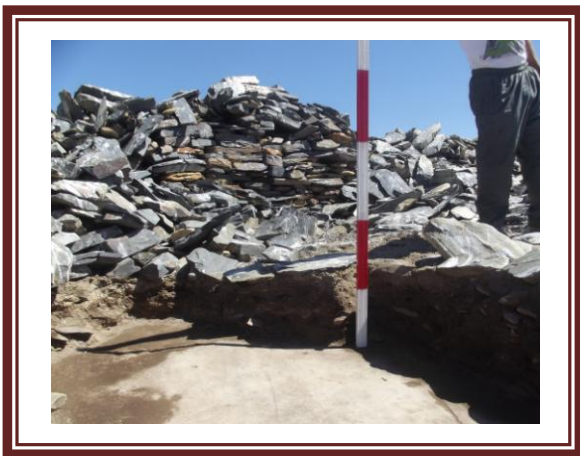
Fig.10. Collapsed walling left in situ

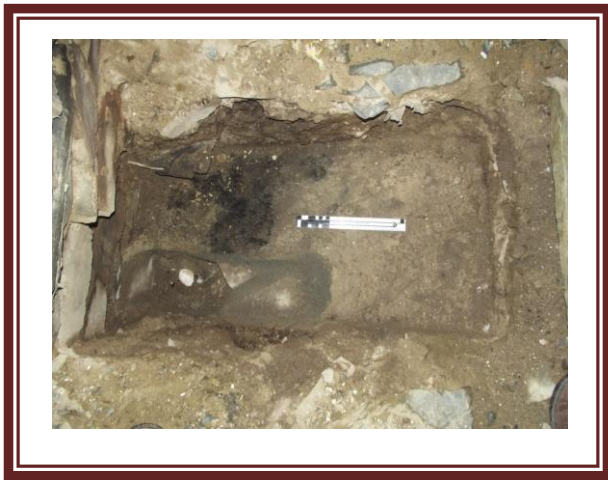
Fig.12. Left. Test excavation adjacent to inside edge of packed dry stone wall showing charcoal, two bricks and the aggregate is compacted lime as opposed to the hard concrete followed on the southern edge towards the wall.

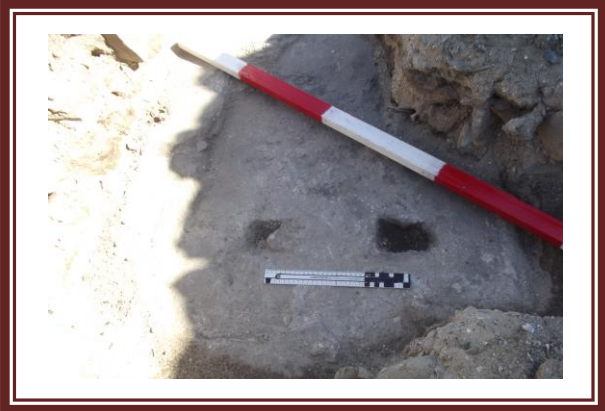
Fig.13. Right. Square post hole close to bricks and charcoal. Aggregate appears to be harder here but deteriorates to friable compacted lime

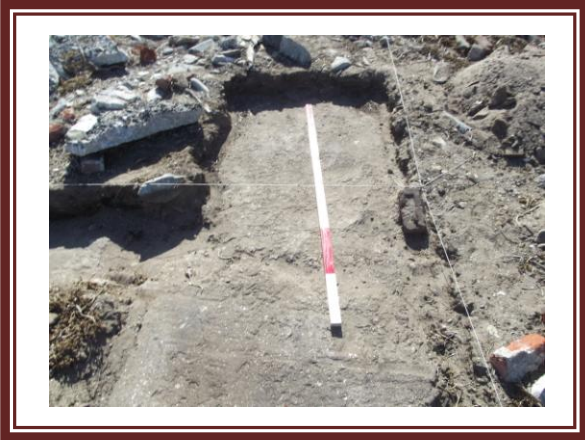
Fig. 14. Left. Following the northern edge towards the wall. Aggregate has become friable compacted lime

The proposed reconstruction of the quarry wall will fully uncover the platform. Some sections of the platform are very friable compacted lime and sensitive to weathering and the build up of bird guano. The harder sections will also be subject to weathering and build up of bird guano once the platform is uncovered.

1. The remaining debris must be removed under supervision of a qualified professional heritage practitioner before any construction work commences.
2. The platform must then be covered with geotextile, the edges sandbagged and the inside filled with sandbags to protect the platform.
3. An alternate use strategy must be looked at.
4. A more permanent solution to the conservation of the platform must be looked at.

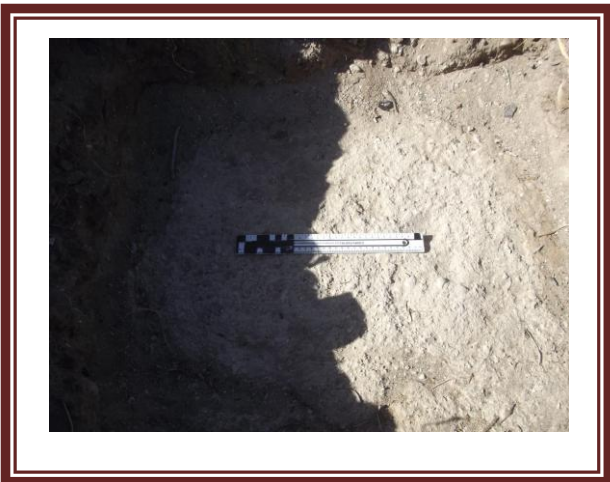
Fig.17. Test excavation showing friable compacted lime surface
