ROBBEN ISLAND MAXIMUM SECURITY PRISON 'A' SECTION: URGENT REQUIREMENT FOR REMEDIAL ACTION TO CONSERVE THE TANGIBLE FABRIC

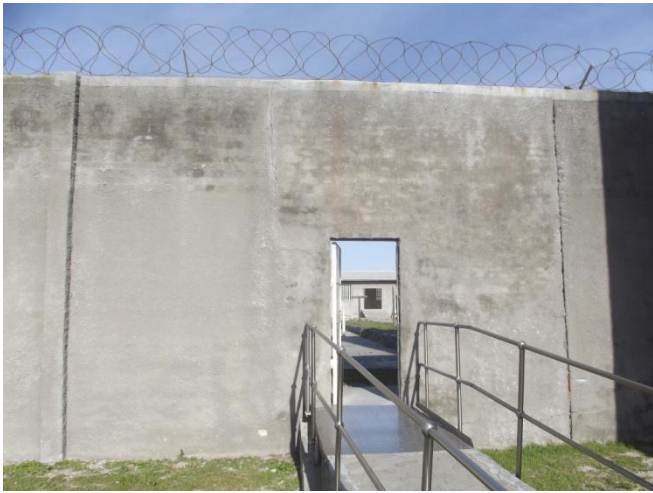
DSCF 4895

The eastern wall visitor exit gate adjacent to the SE tower has seized in place. This threatens the security of the space as well as allowing animal ingress. See image 4895.

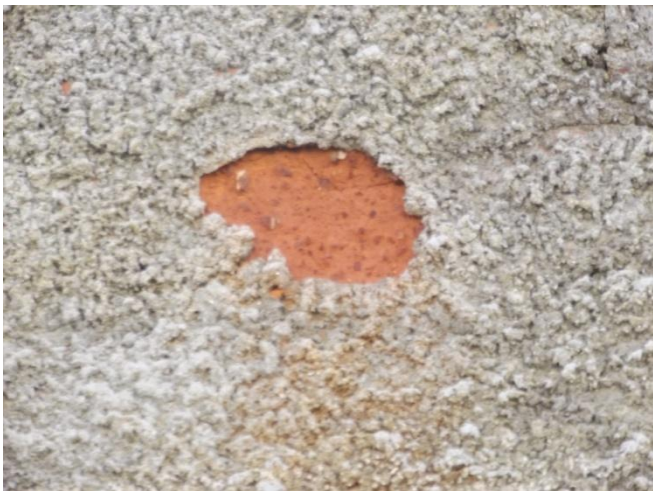
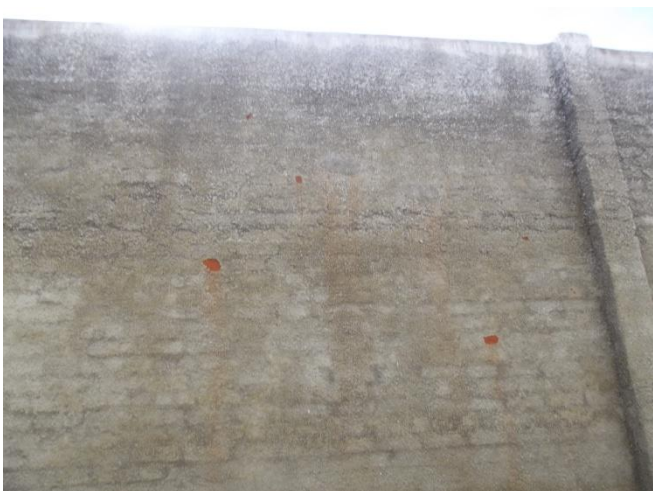
These walls are constructed from friable soft red clay bricks with a hard splatter plaster. The splatter plaster is subject to peeling from the soft brick as the materials are not compatible. With the 2008 repairs the splatter plaster was redone. The plaster was renewed regularly during the prison period as it protects the soft inside bricks. Small patches of plaster are deteriorating and require urgent attention before further deterioration. See images 5076 and 5077.

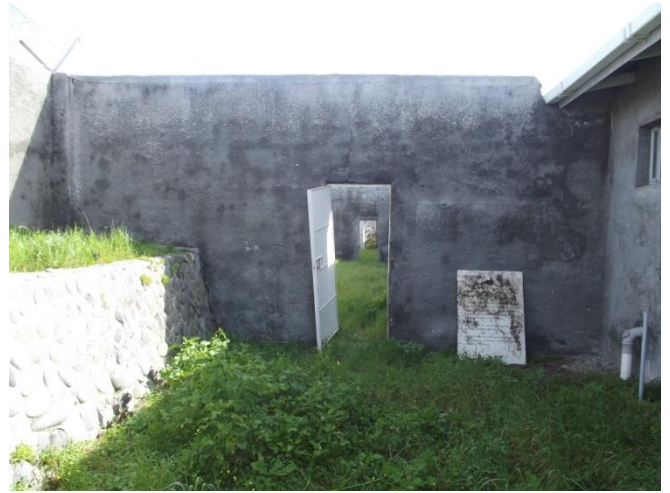
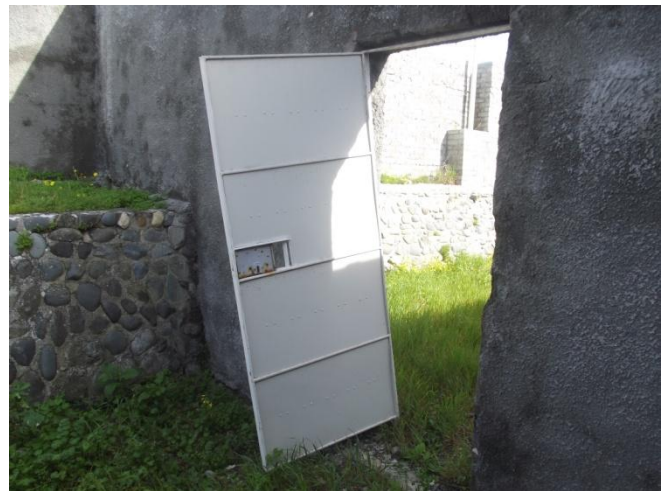
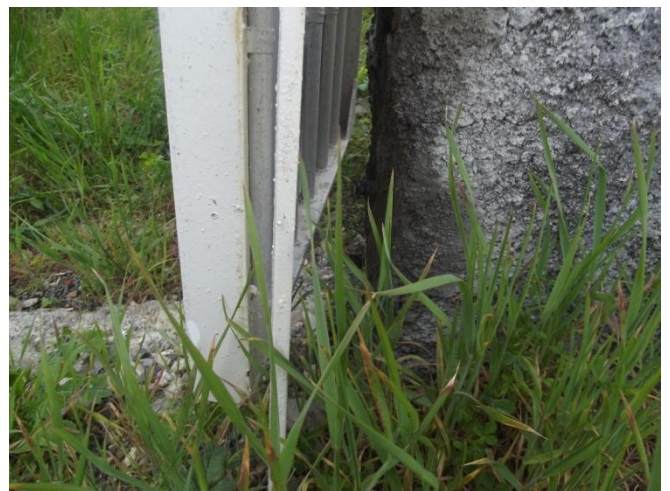
The gates are rusting and all have seized on their hinges. This has resulted in either the hinges detaching from the frame or the collapse of the frame. See images 5110, 5113 and 5114.

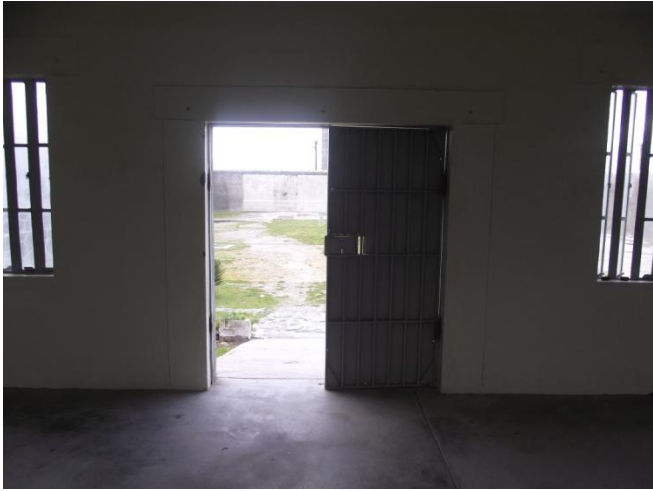
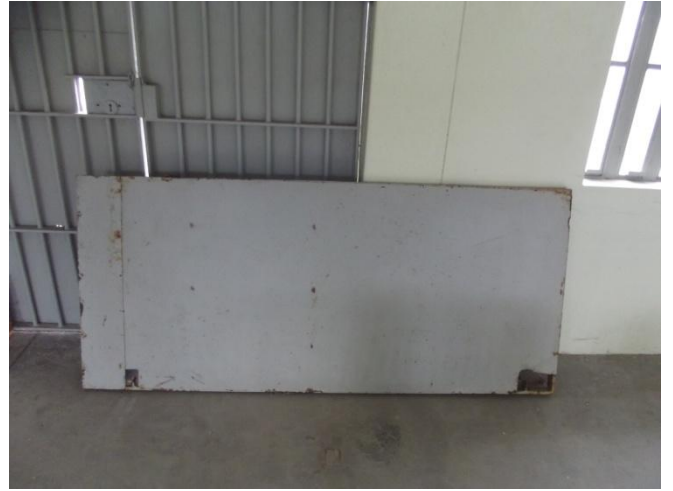
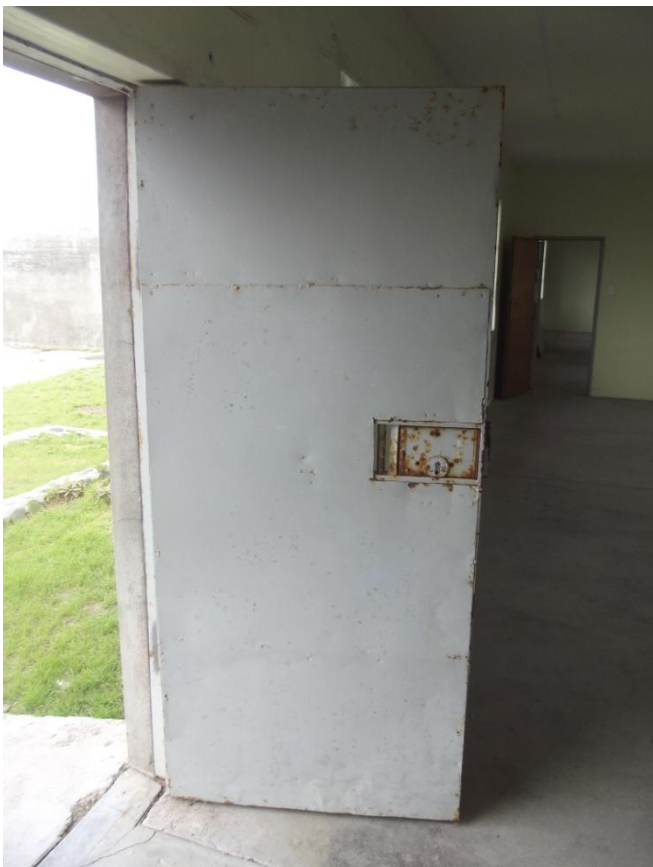
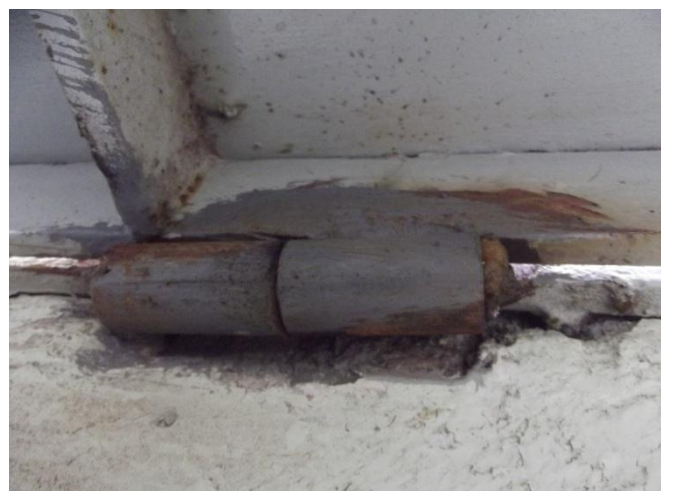
One panel of the double door of Recreation Area 01 has come off its hinges and is stored on its side. The bullet hinges were placed on the windowsill at the time of the photographic survey. These were handed to the collections staff for safe keeping. The opening places the interior at risk from weather and animals.

The second panel is still functional but the hinges are rusting and are at risk of detaching. Images 5894, 5895, 5925, 5932 and 5933.

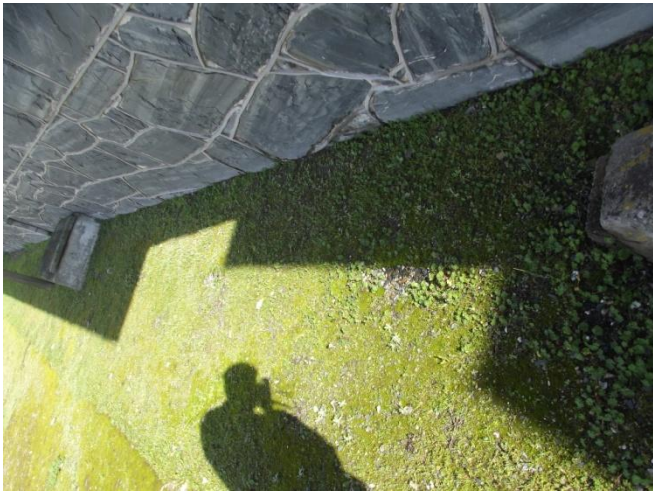
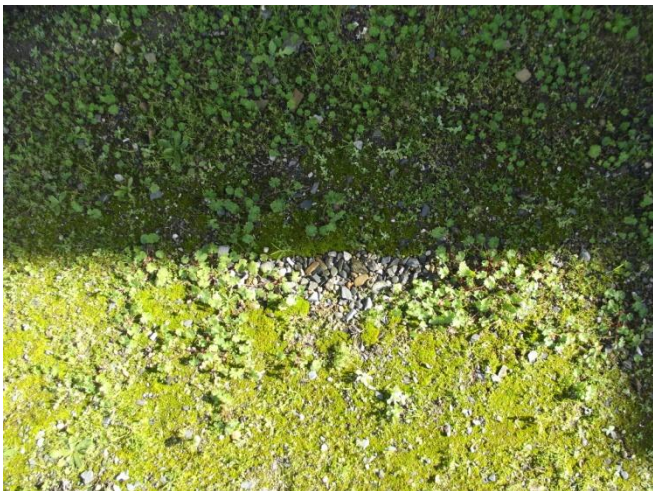
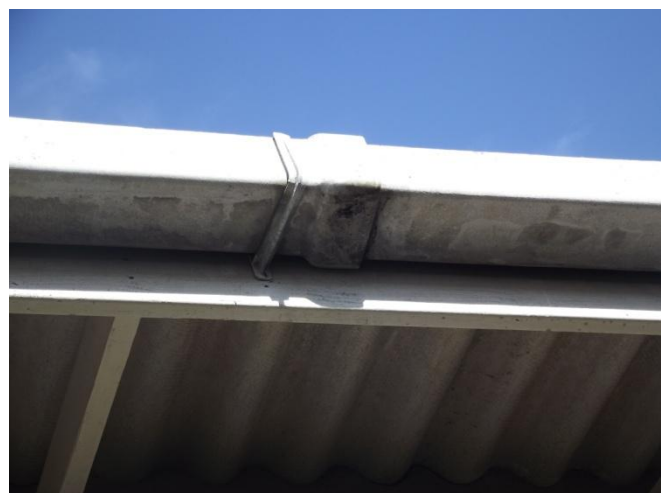
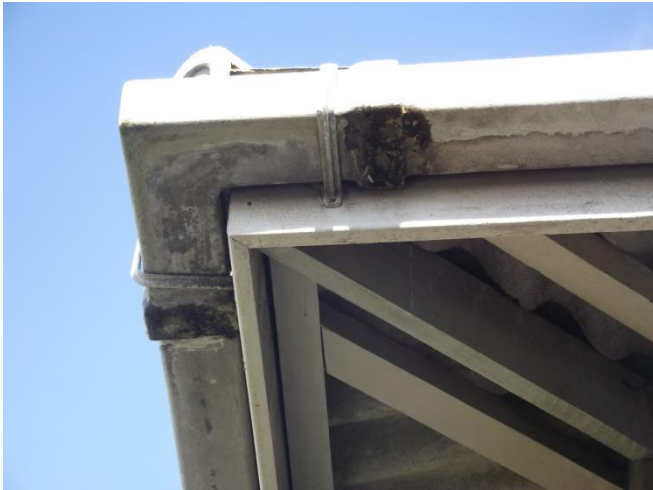
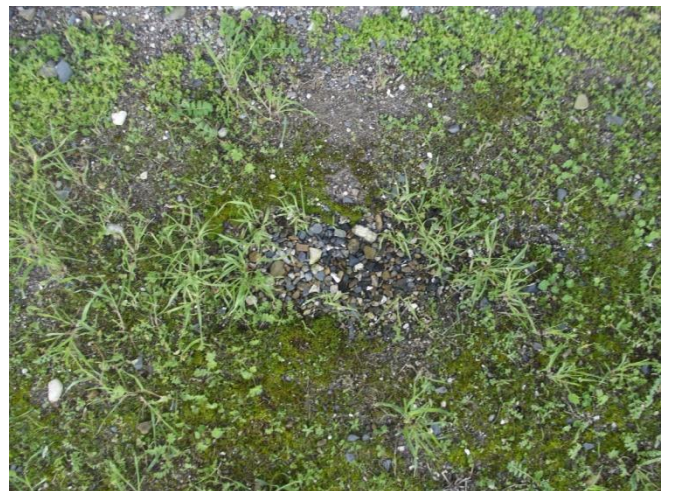
Gutter seams need to be resealed. Distinct drip lines can be seen under each gutter seam. There is no provision for runoff and water drains into the soil close to the walls. See image 6545, 6546, 6550, 6551, 6556.

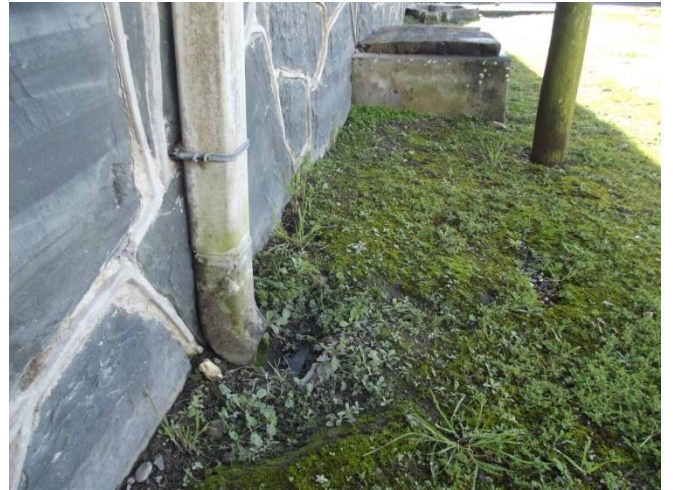
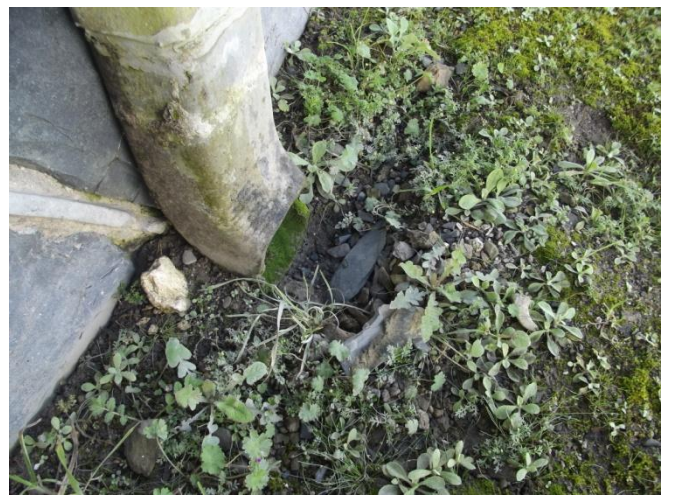
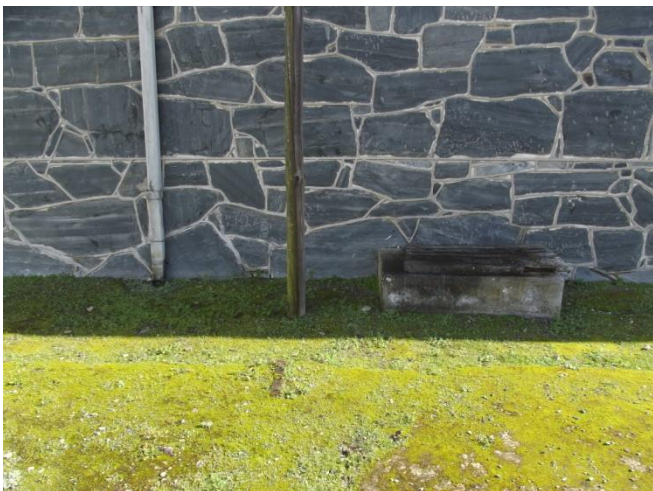
Down pipes on the western and southern side sides have no runoff and water seeps straight into the soils adjacent to the walls. This may be one of the causes of the damp outside and inside the walls. Longer term remedial action requires the installation of water channels. While this may affect the authenticity of the elements the longer term conservation of the fabric must be considered. [see images 6553, 6554, 6555]

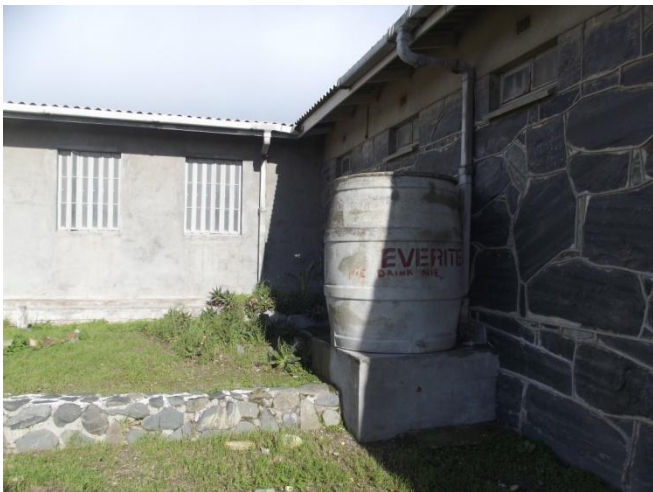
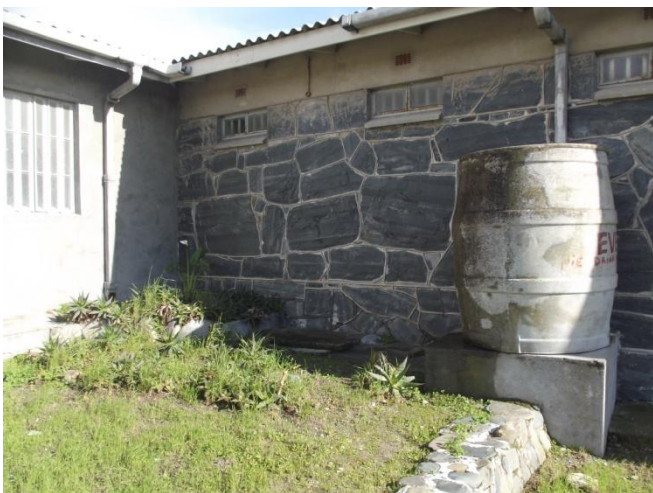
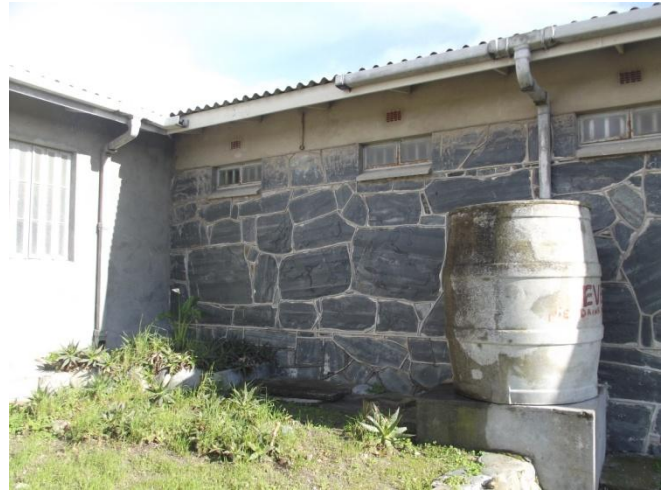
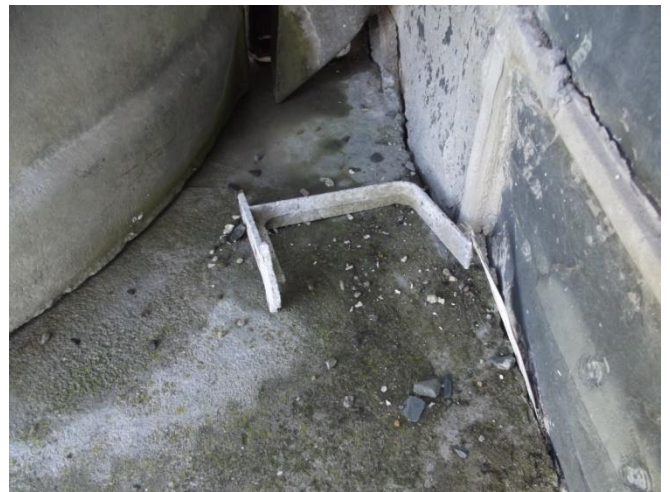
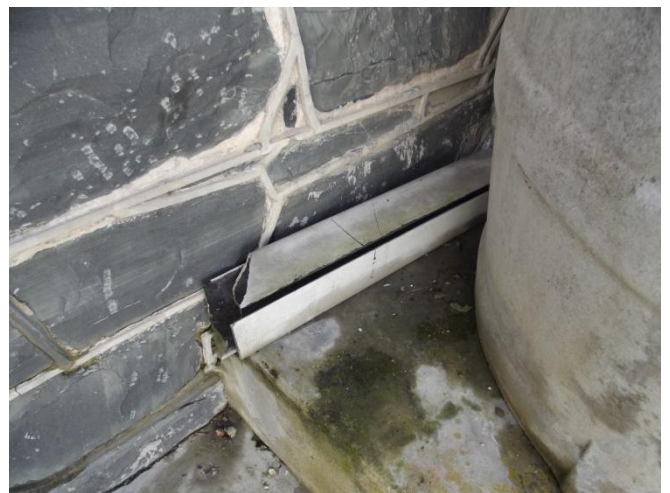
A section of gutter on the southern facade of approximately 2 metres has fallen off the fascia. The gutter has been placed between the wall and water tank. [Images, 6558, 6559, 6560, 6561, 6562] Water drains directly into the soils. The concrete platform for the water tank and the garden retaining wall has the effect of damming up water. [See images 6563 to 6567] The result has been rising damp on the interior of the southern walls of cells 12 and 13. [Images 6570 to 6574]

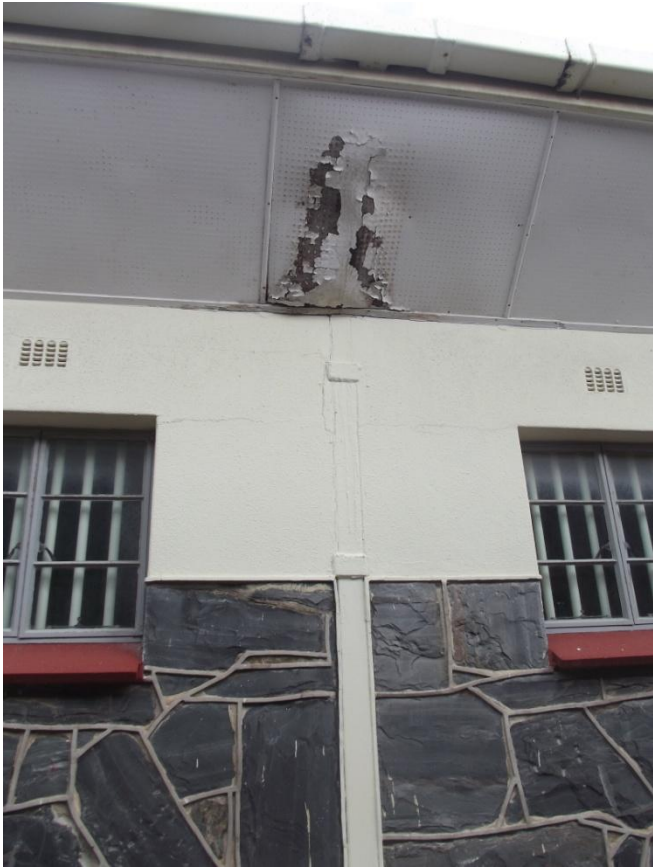
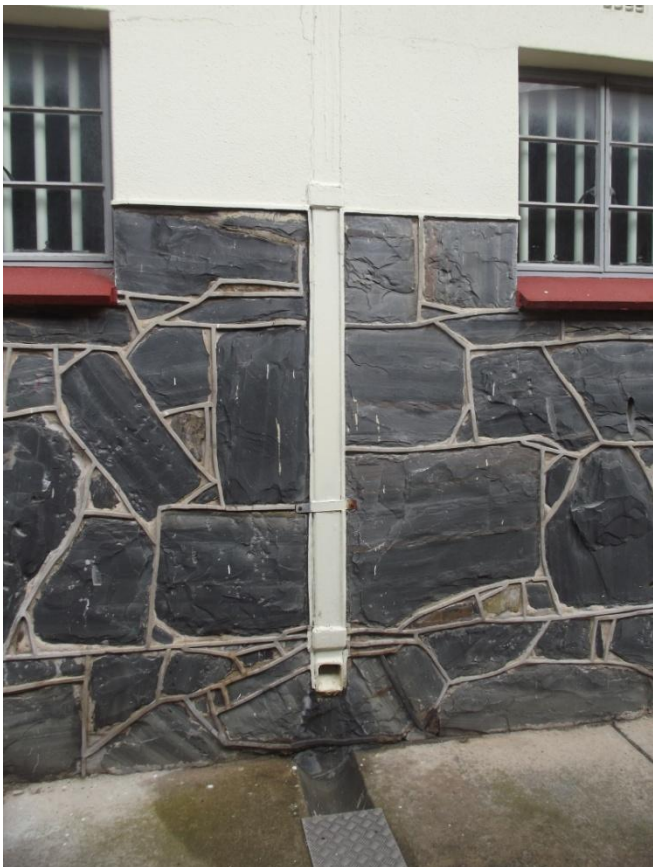
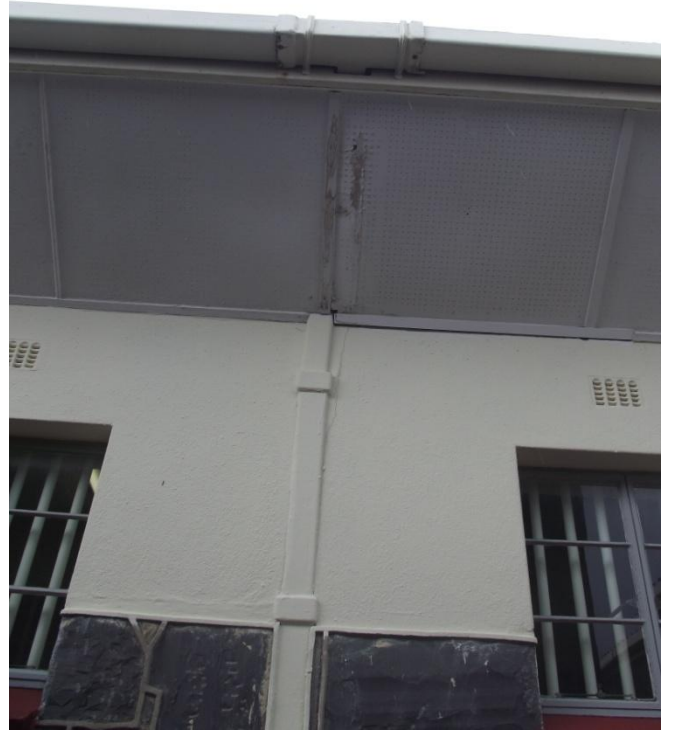
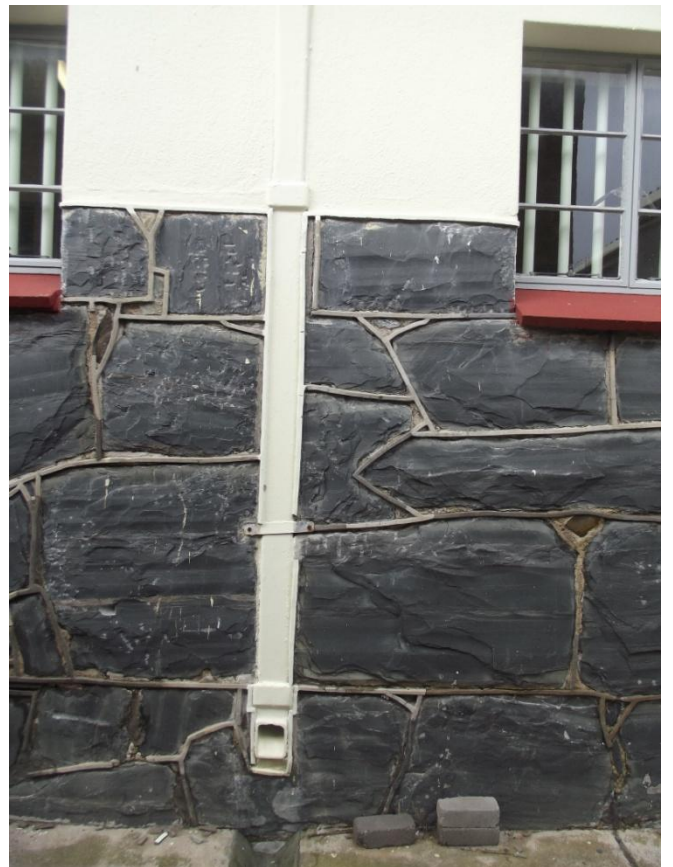
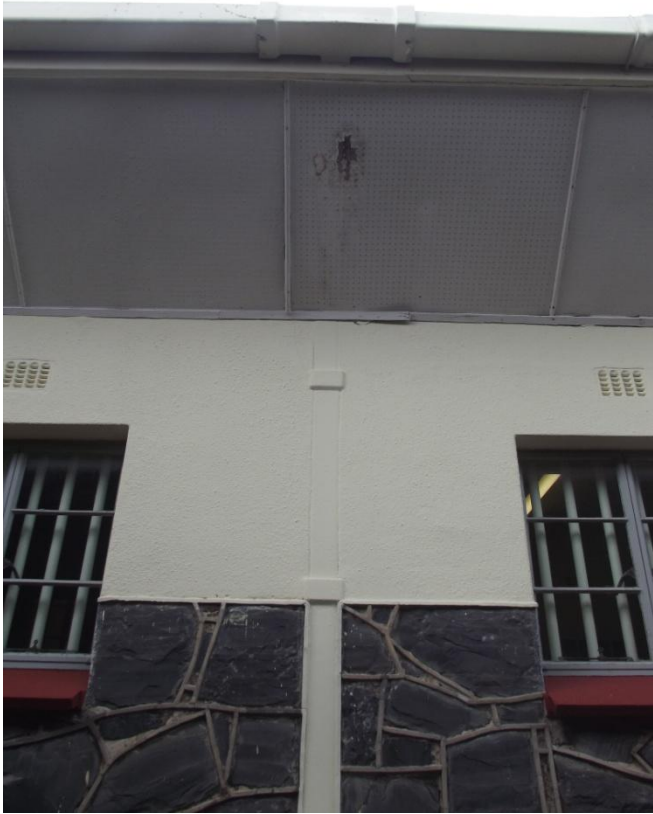
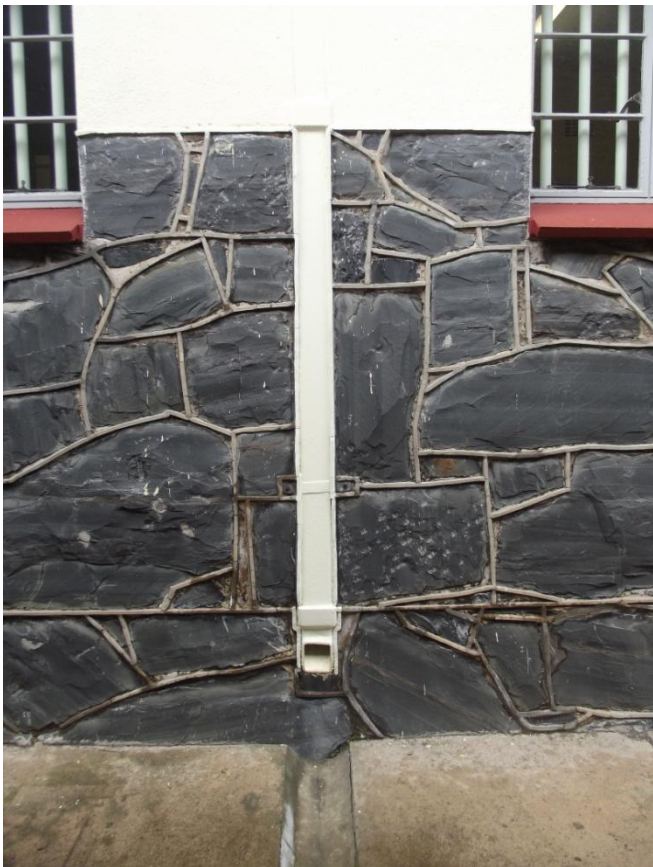
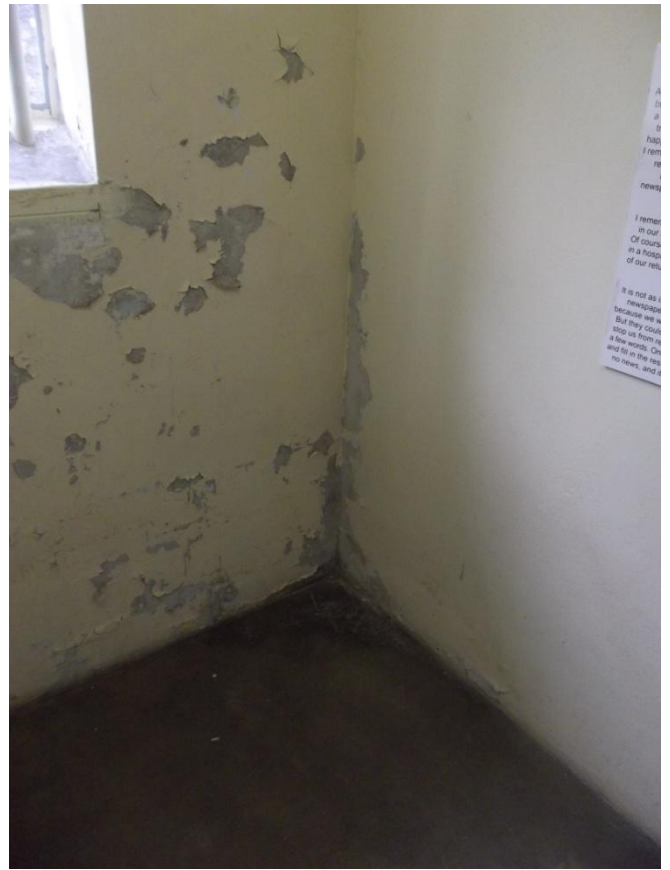
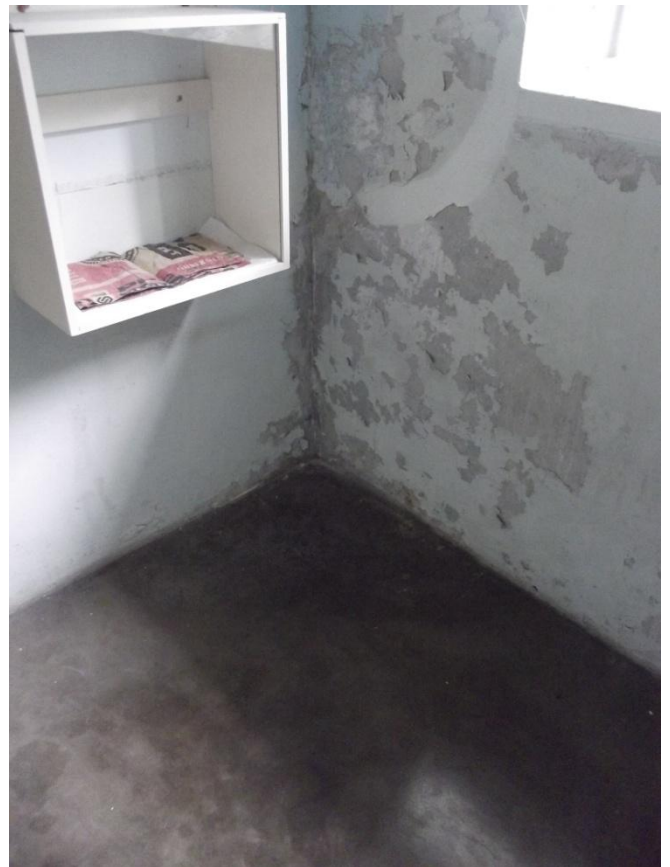
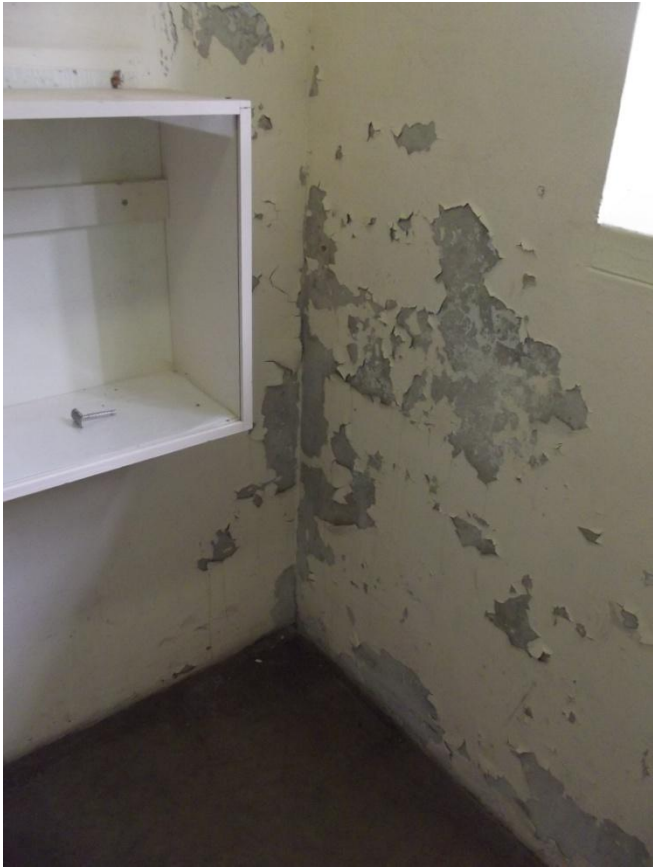
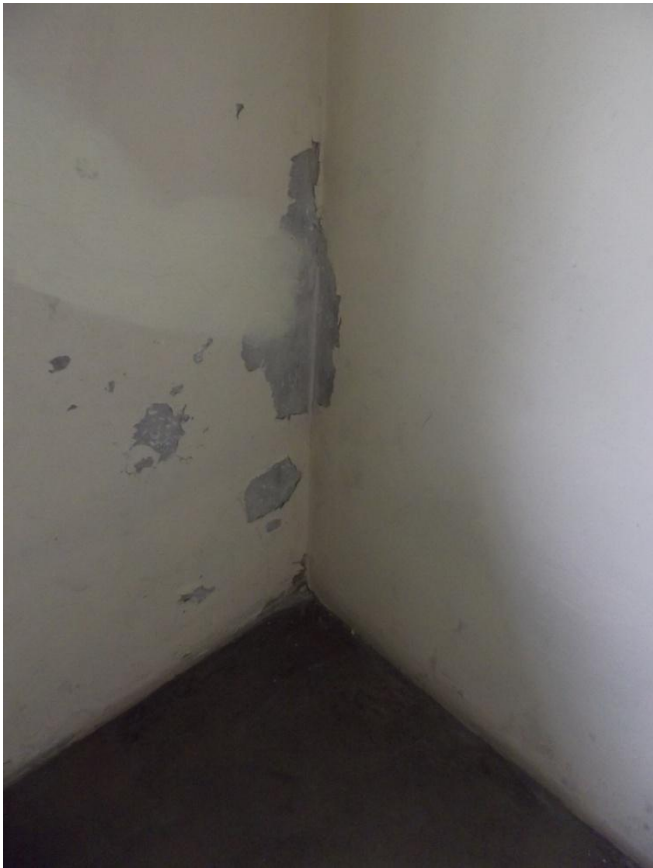
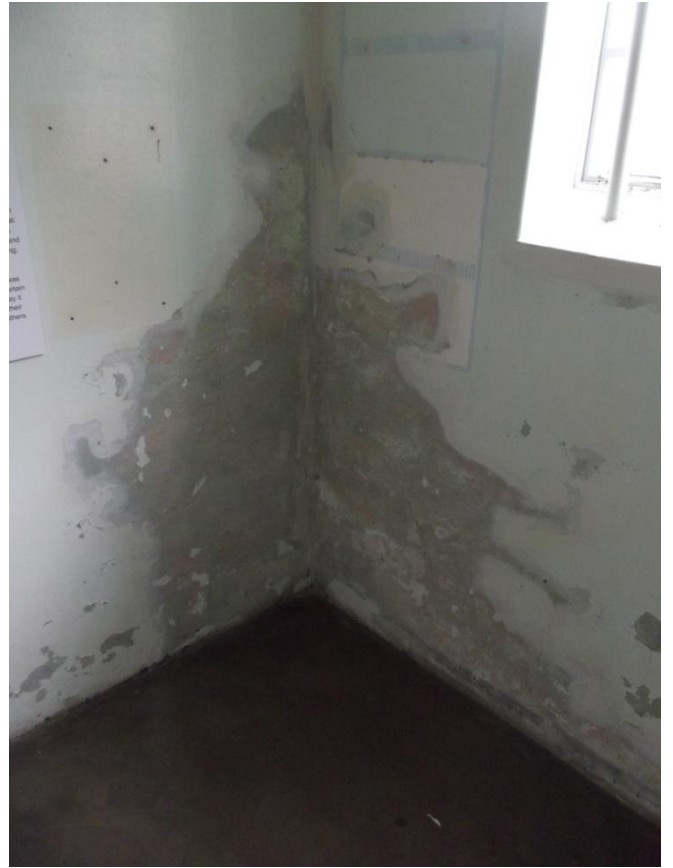
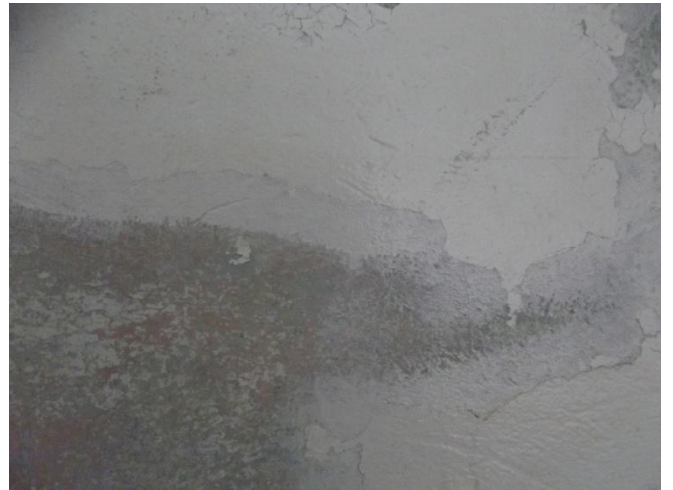
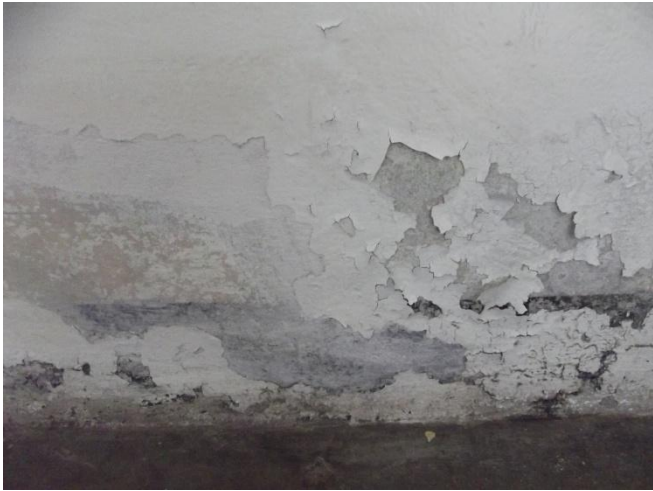
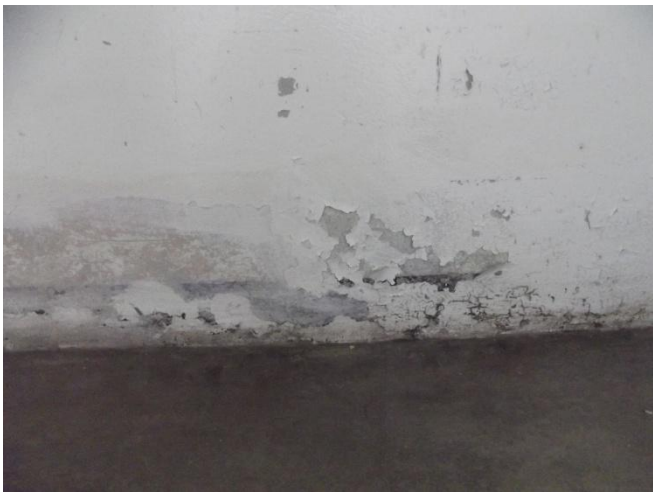
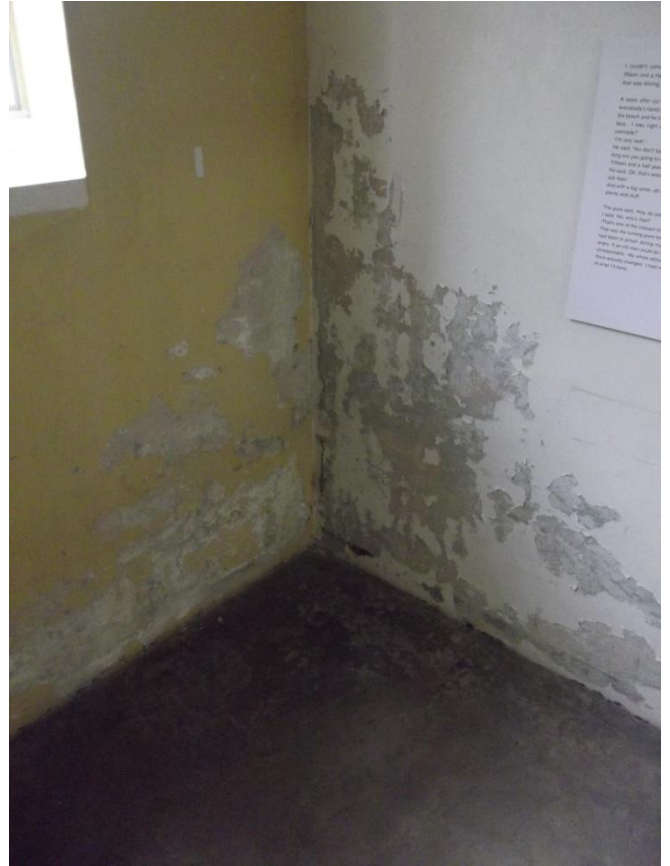
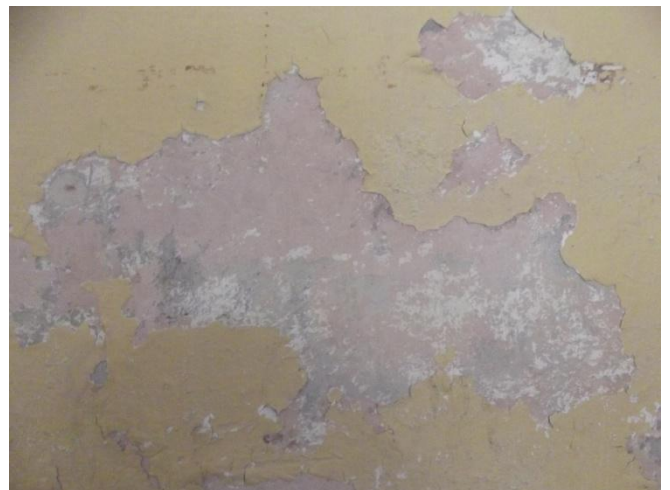
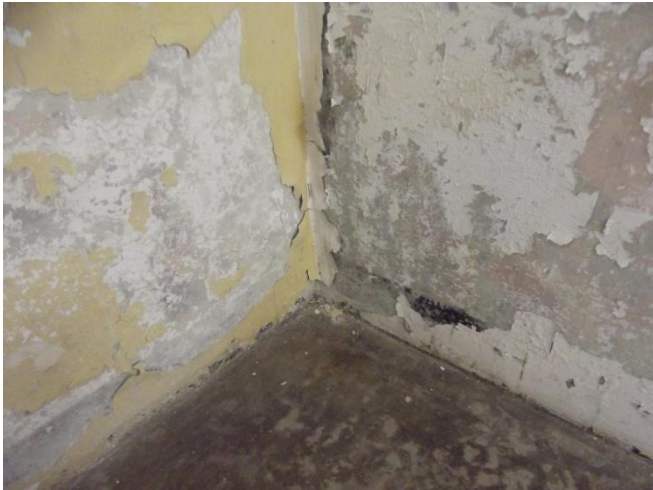
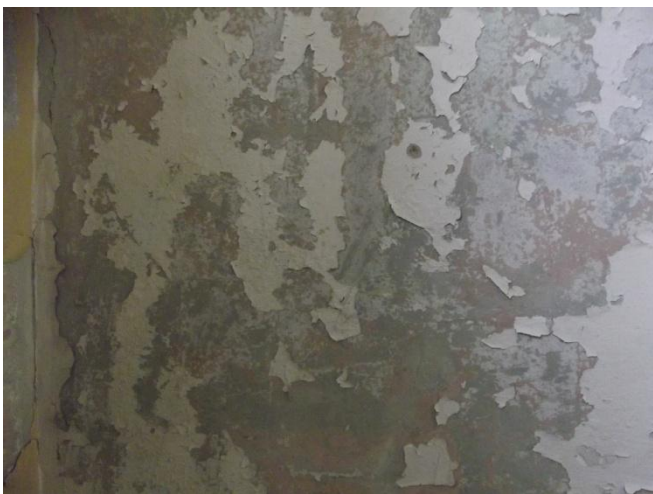
Down pipes on the northern side courtyards are leaking and are causing acute damage on the interior corners of cells 04, 06, 16, 18, 29 and 31. [See images 6622 to 6640]

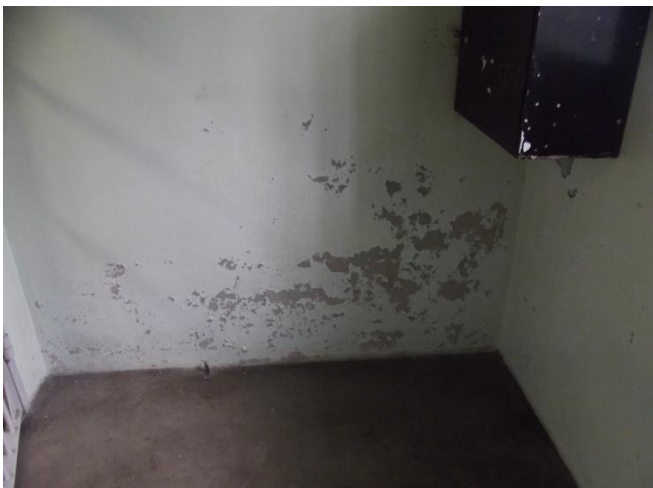
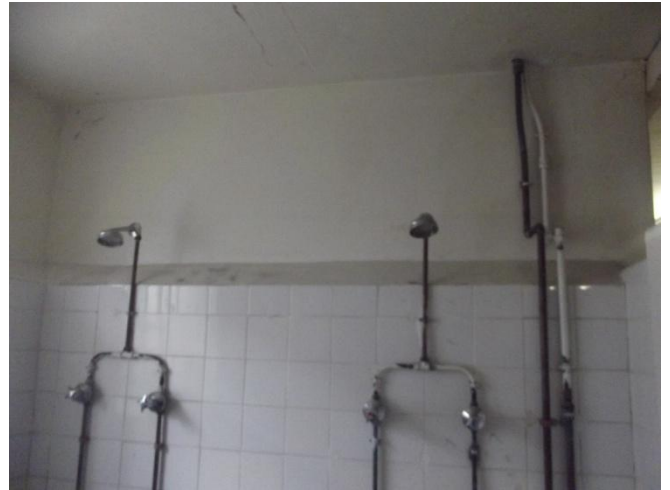
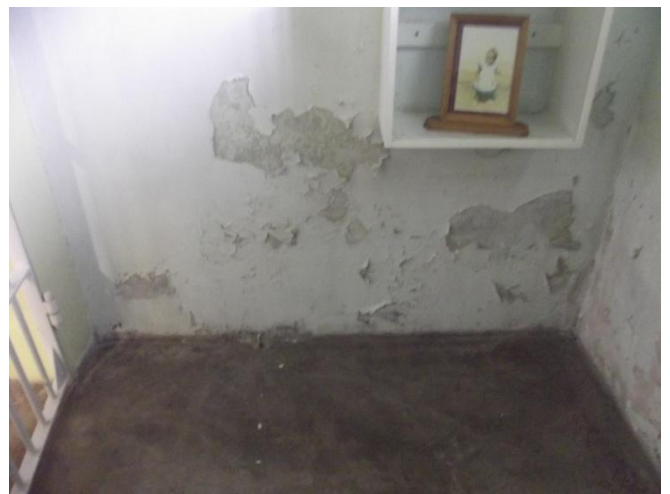
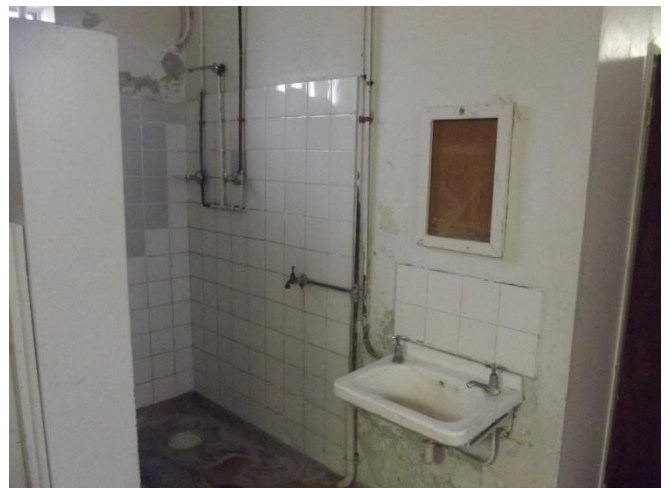
A problem area that is not part of this urgent repair is the ablutions in the N-S corridor. Moisture has affected the adjacent cells but more invasive investigation will be required to isolate the source. [see images 6640 to 6643.
