23 April 2014
473791

NMBM Electricity and Energy Unit
PO Box 369
PORT ELIZABETH
6000

BRICKMAKERS KLOOF SUBSTATION-STRUCTURAL ASSESSMENT REPORT

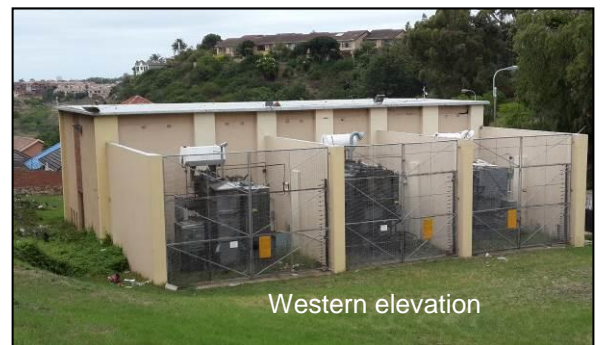
SRK were appointed by the NMBM on 14 February 2014 for the civil and structural design and construction services pertaining to the repairs and maintenance of the Brickmakers Kloof Substation. The Substation is situated in Brickmakers Kloof Road. The building appears to be more than 60 years old and is considered a heritage building. See photograph 1 below.

Photograph 1-Western elevation of sub-station building

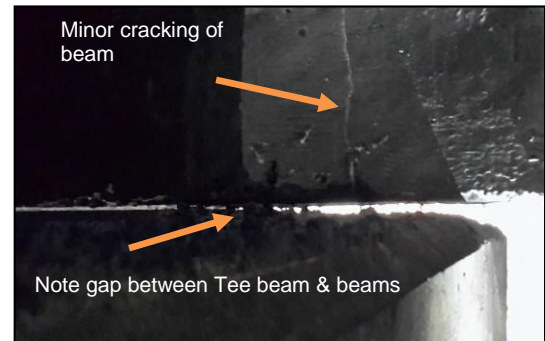
Photograph 2: Note gap between beams ~ 10 mm

Inspections were carried out on both ends of the Tee Beam support mechanism. In both cases it is evident that this structure does not support the concrete roof structure. From observations it appears that the gap varies by ~ 10 mm to 20 mm respectively. See photographs 2 and 3 respectively.

It was also observed that hairline cracks are evident on the supporting roof beams.

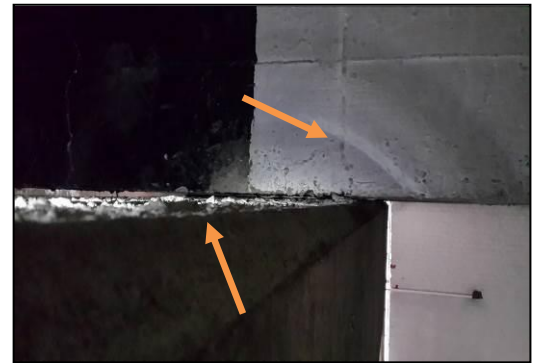
Photograph 3- Note gap between beams ~ 20 mm

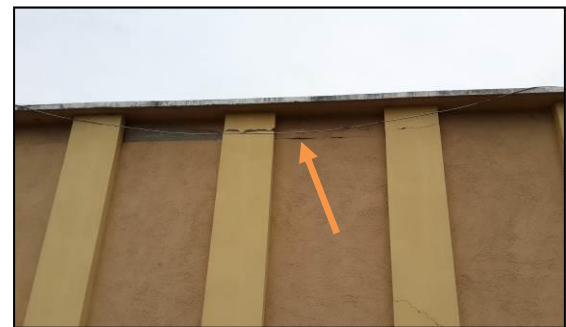
From observations, it is clear that the eastern support load bearing wall has buckled in the vertical plane. This deformation is noted between the concrete and brickwork interfaces notably at midspan. A horizontal shift of ~75 mm appears to have developed at midspan. It was further observed that only one slip joint exist between these two interfaces. See photograph 4 and 5 respectively.

Photograph 4-Eastern Elevation-Note Defect

The long term serviceability of the load bearing wall (eastern elevation) is unsafe for its deemed purpose and should be repaired as soon as possible. It is recommended that the wall be replaced and stabilised with two concrete columns equally spaced and formed integral with the roof ring beam. A slip joint is to be provided between the internal Tee beam and caulked up to ensure load transfer. Expansion joints must be provided between the new concrete and brickwork interfaces. All defective slip joint must be repaired.

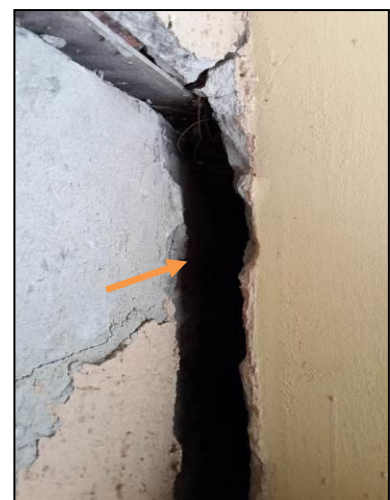
Photograph 5- Note 75 mm movement

If the load bearing wall is considered to be a vertical beam, the maximum deflection must not exceed 1/360. As measured onsite, this wall has deflected ~ 75 mm, with the vertical height ~ 6 m, the maximum allowable deflection has been exceeded by a factor of 4.5. As this is the case, this element exceeds its serviceability threshold. See photograph 5.

Vertical movement joints are not apparent within the load bearing brickwork walls. Seasonal movement and age of structure have increased stresses within the brickwork resulting in horizontal movement.

The absence of vertical joints has allowed the structure to deflect resulting in the serviceability of the structure being compromised.
