YOUR REF.: WCS: 045965
OUR REF.: 2023-Architectural Report-
Newcastle Justice Complex

4 August, 2023

WCS: 045965: NEWCASTLE JUSTICE: HERITAGE BUILDINGS: ARCHITECTURAL REPORT

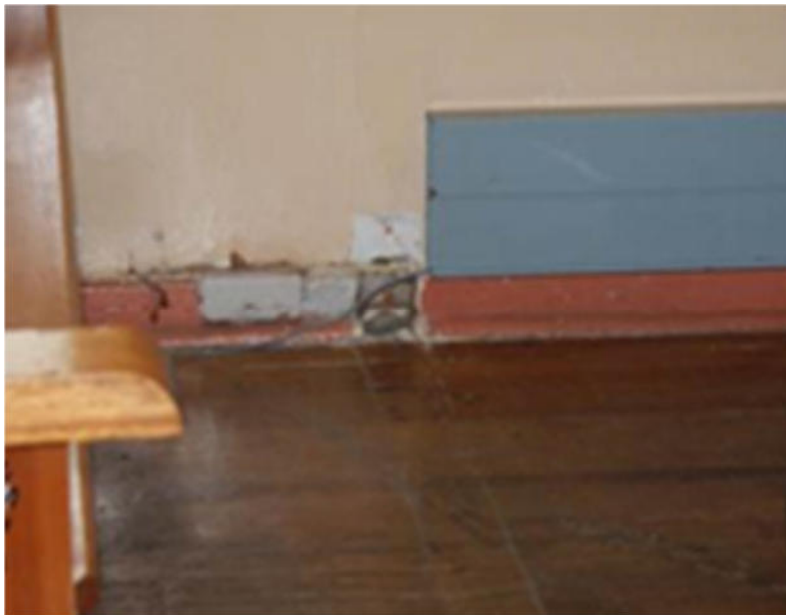
Damaged skirting)

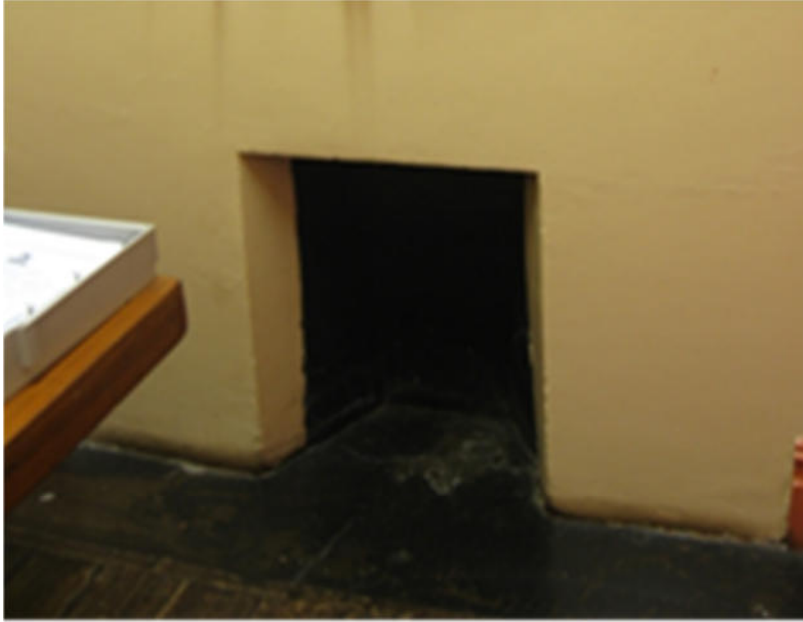
1. The fire places along with the mantelpieces have been removed.
2. A new wall and door has been installed into the current Magistrates office.
3. The safe has been damaged and there was a new door added on the outside office. Some of the doors have retained the original ironmongery and we want to use this to match new door handles and locks.
4. Some parts of the skirting have been removed to fit electrical cables or power skirting.
5. Some of the ceiling panels will need replacement due to visible water damage.
6. Some door thresholds will need replacing as the timber is badly damaged.

(Fire Place)

Restore the fire places timber mantle pieces to match photographs. Architectural drawings indicated dimensions and correct position. Mantle pieces to be sourced from the National Museum in Bloemfontein for possible matching elements.

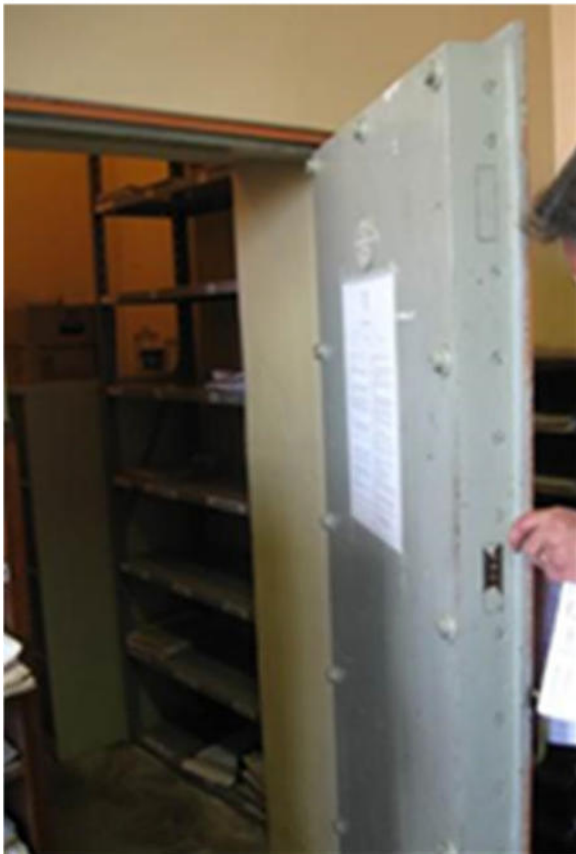
(Chubb safe)

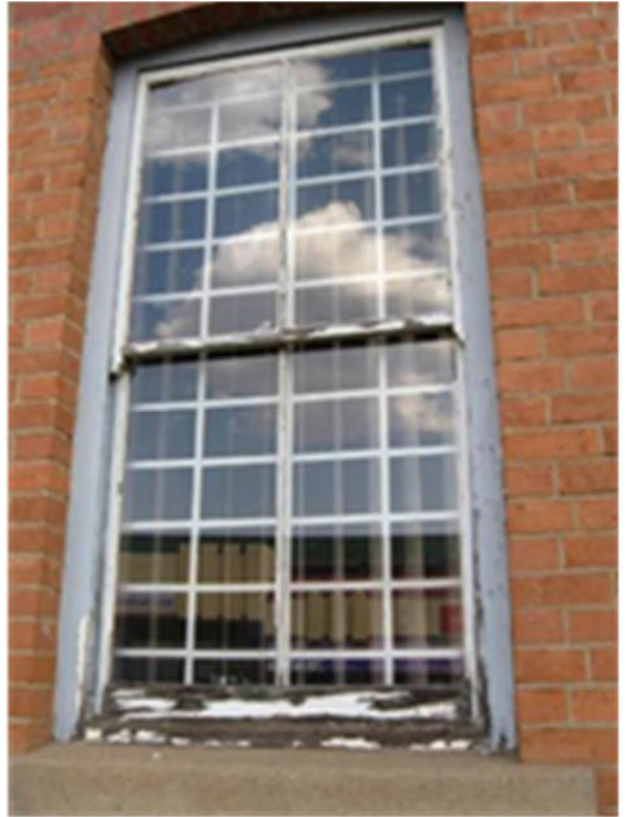
Windows on the Western and Northern sides are severely damaged and weathered.

Windows on the Northern and Western facade to be removed and replaced. All new timber windows to match the profile of the existing windows.

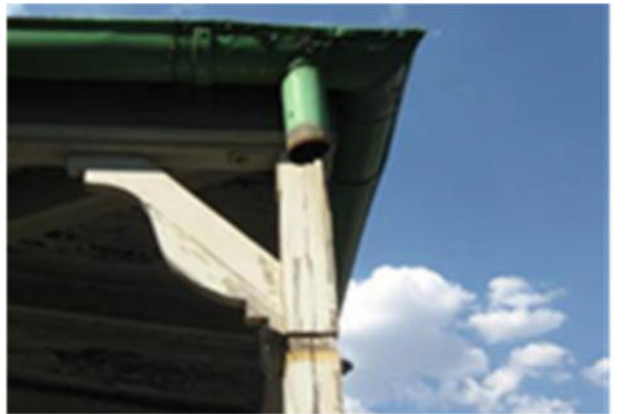
Steel Gutters and downpipes are damaged, removed or hanging loose. These will need to be replaced.

All gutters and downpipes to be replaced due to evidence of severe rust and weather damage.

To be replaced with seamless aluminium gutter and downpipes, with Chromadek finish on outside. Colour to match roof sheeting.

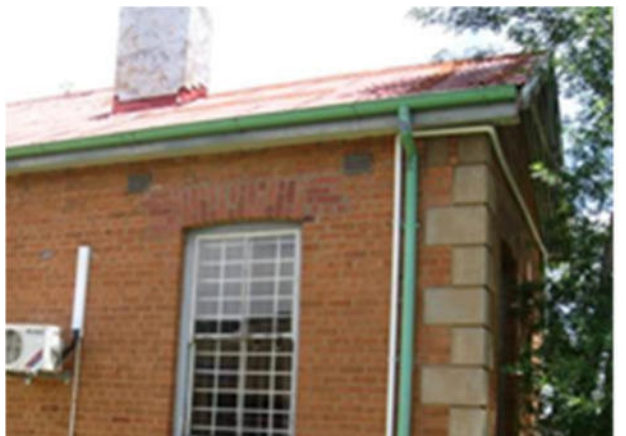
The timber fascias and bargeboards are badly weathered and will need to be replaced by timber elements to match existing.

All fascias and barge boards will need to be replaced. These will be modelled on site and replace with new timber fascias to match the existing profile.

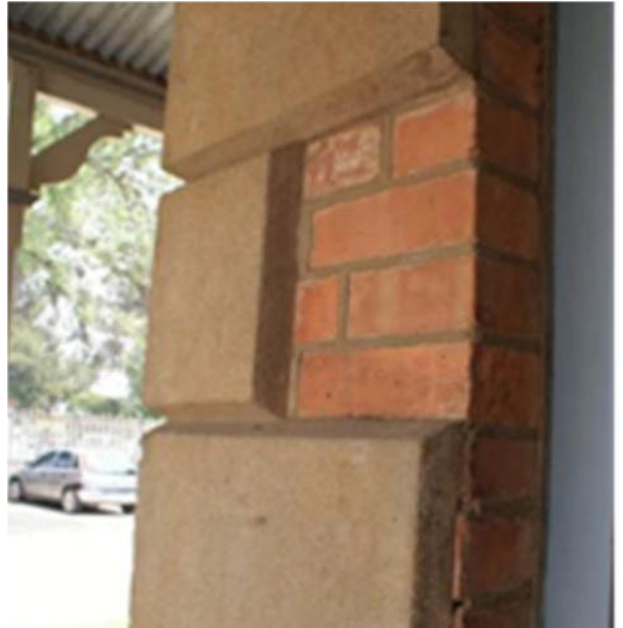
Sandstone cladding is in a fair condition and will only need cleaning.

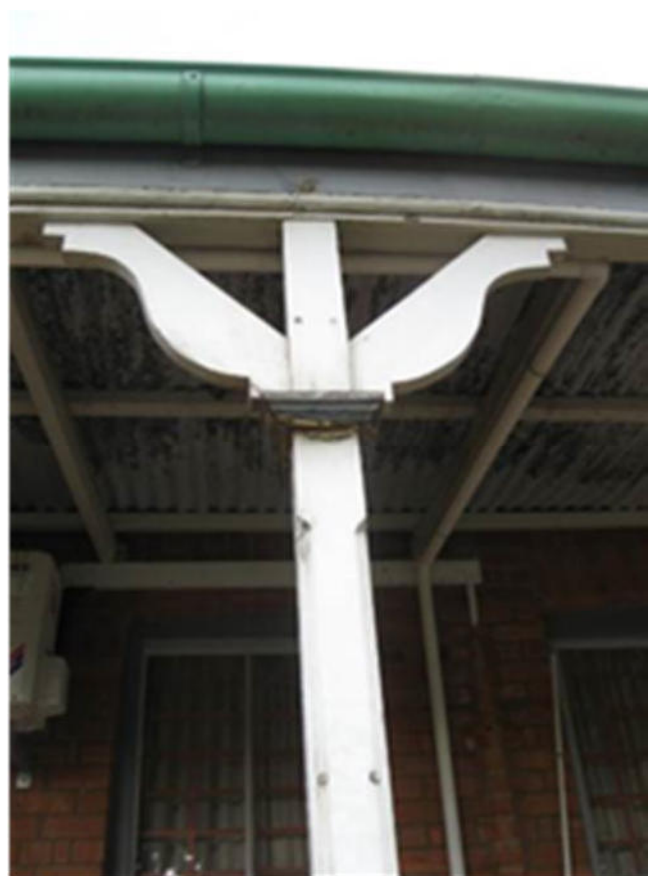
The timber columns will need to be replaced as there are signs of weathering and in some instances the timber has splintered.

All timber and steel columns to be replaced. The profile of the detail on the columns to be reproduced to match existing timber columns.

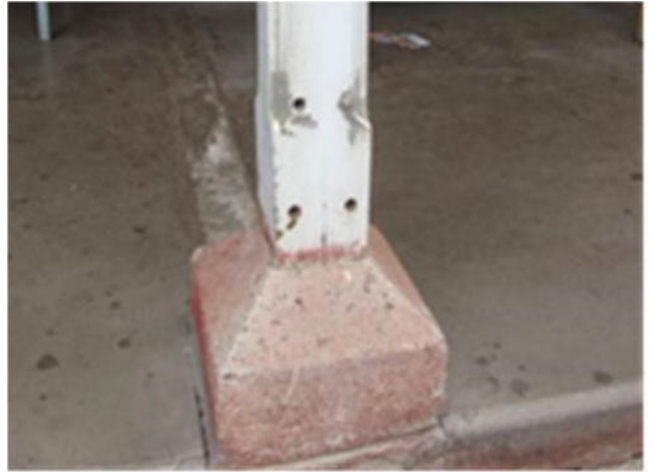
The column bases should also be removed carefully, sanded down and repainted.

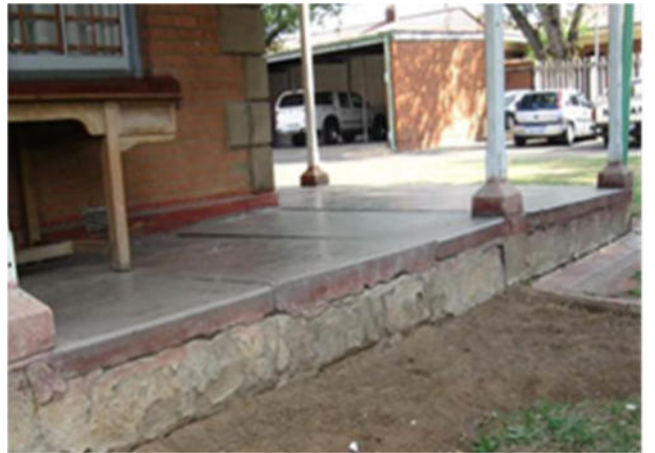
The veranda floor will need to be removed due to bad cracks in the concrete. Expansion joints should be kept in the same position when new concrete floor is cast.

Remove damaged screed on floor of the veranda. Take care not to damage column footings and place formwork in place. Concrete to be cast on site and the finish to be smooth.

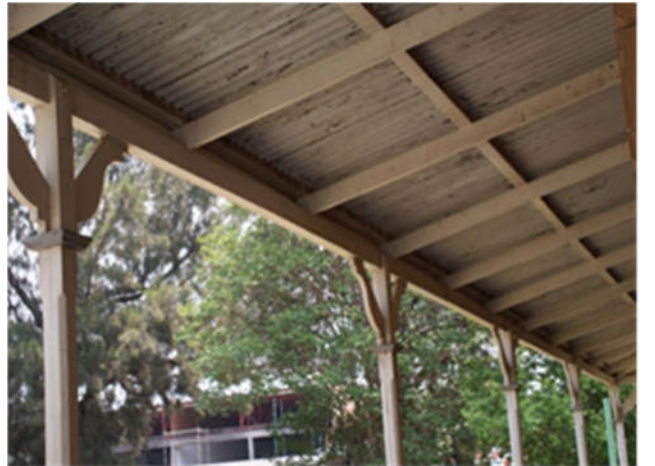
All timber beams and purlins on veranda roof should be checked for rot and structural failure. On inspection these elements looked fine but should be rechecked as soon as the contractor is on site.

Damaged Verandah beams and purlins to be measured, removed and replaced with appropriate hardwood timber beams (preferably Meranti beams).

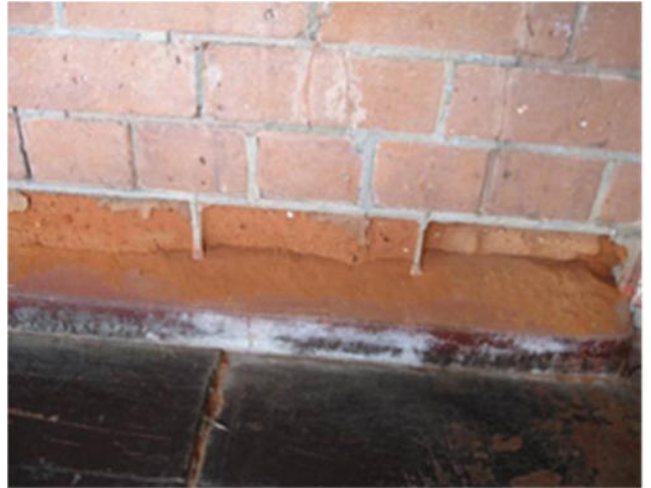
Some of the brickwork on the outside is showing signs of disintegrating. These powdery bricks should be removed and replace with bricks to match existing building.

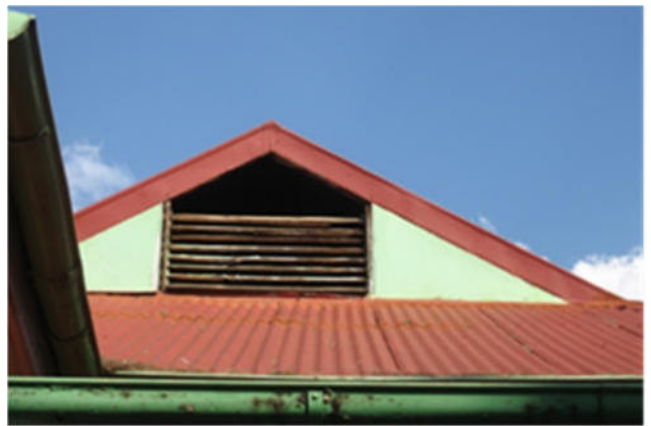
The roof vents have been closed at some stage apparently due to bird infestation and should be reopened. These timber vents are badly damaged and weathered and will be replaced by new timber vents (horizontal timber slats). Care will also need to be taken to ensure that birds do not nest in the roof.

Remove metal sheeting covering existing roof vent. Install flyscreen on the inside of the roof vent. Remove badly damaged and weathered timber slats of the roof vent. All timber slats to be replaced with new timber slats (approved timber, e.g. Meranti), matching existing and primed and painted before installation.

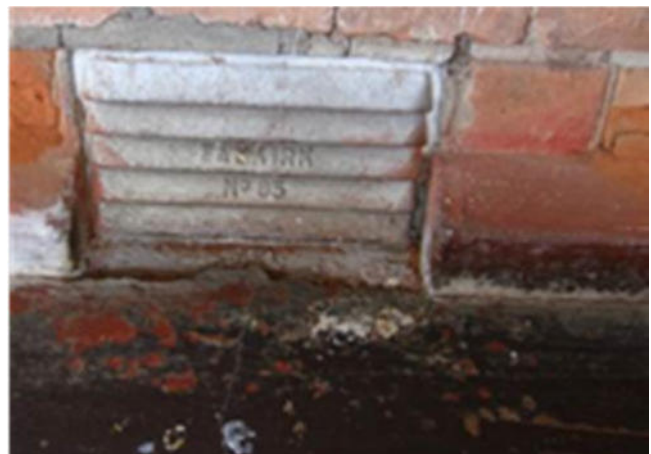
All floor vents will need to be checked and cleaned from any plant materials.

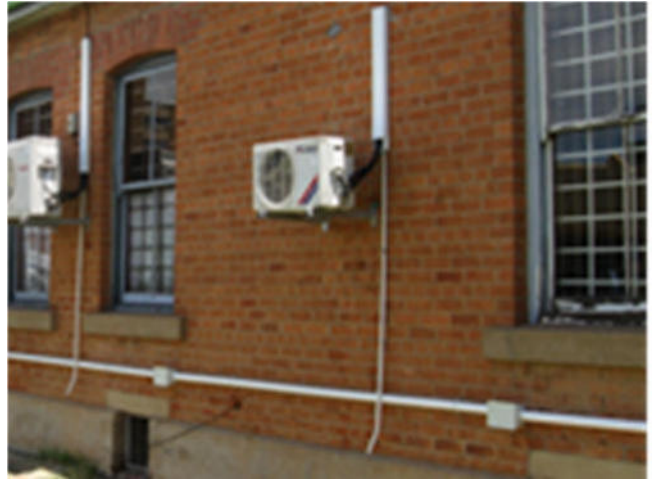
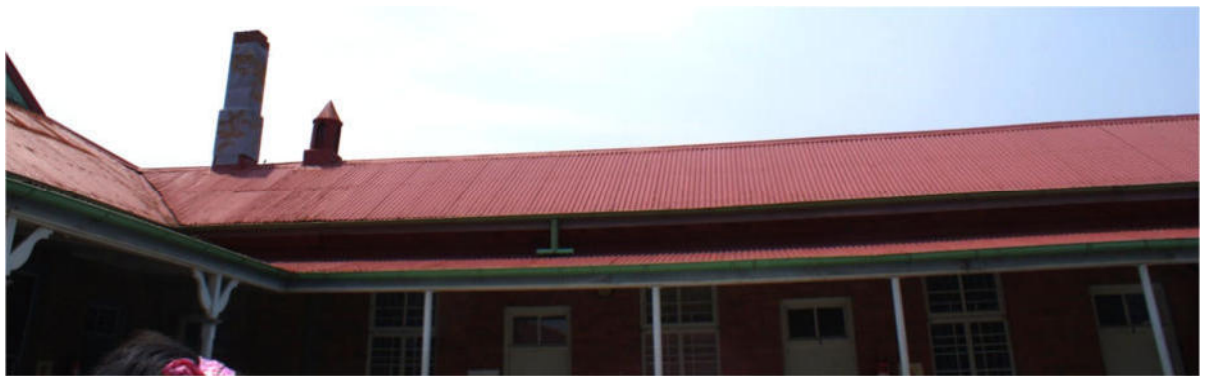
Air-conditioning units and visible pipework.

Metal roof sheeting on the addition is in a good condition and will only need to be sanded down and loose roof nails; possible leaks and rust damage.

All mechanical equipment such as air-conditioning units and piping to be removed from exterior walls. Holes and damaged bricks to be replaced with matching materials.

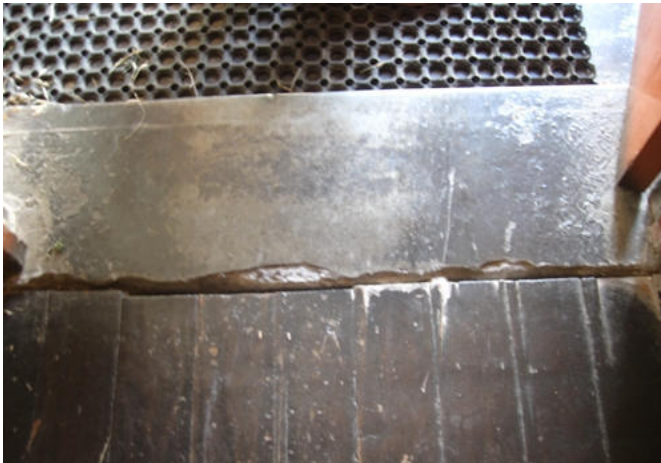
The threshold at the entrance door to the Court Room area is damaged. Repair by installing new pieces of timber floor planking and repairing the concrete step at the outside. Install a brass weatherbar strip at the connection between timber and concrete.

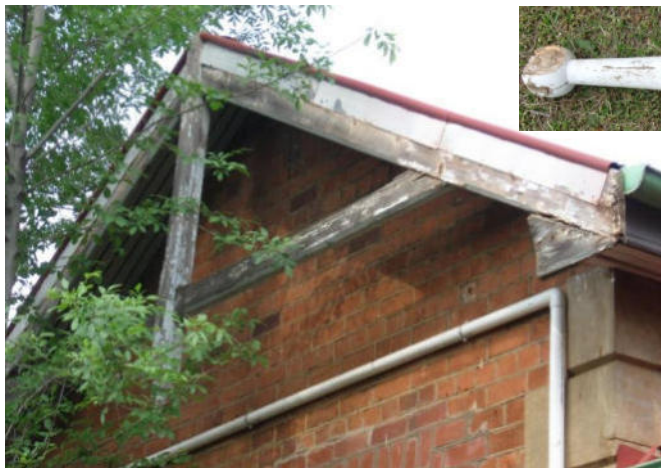
The roof finial was found broken off and on the ground in front of the building. Remove all damaged and badly weathered timber from this structure. Replace all timber beams and posts with new approved timber elements.

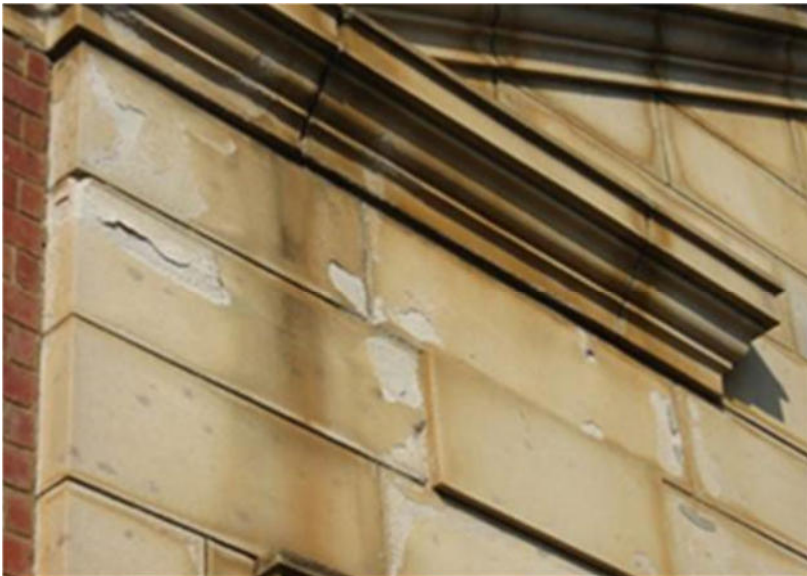
Some of the Sandstone cladding on the main entrance façade has eroded to some degree and will need to be restored. There are also some floor vents at the Cash Hall that have completely disintegrated. Although the Cash Hall's timber floor has been replaced with a concrete floor (presumably in 2002) these floor vents will need to be replaced.

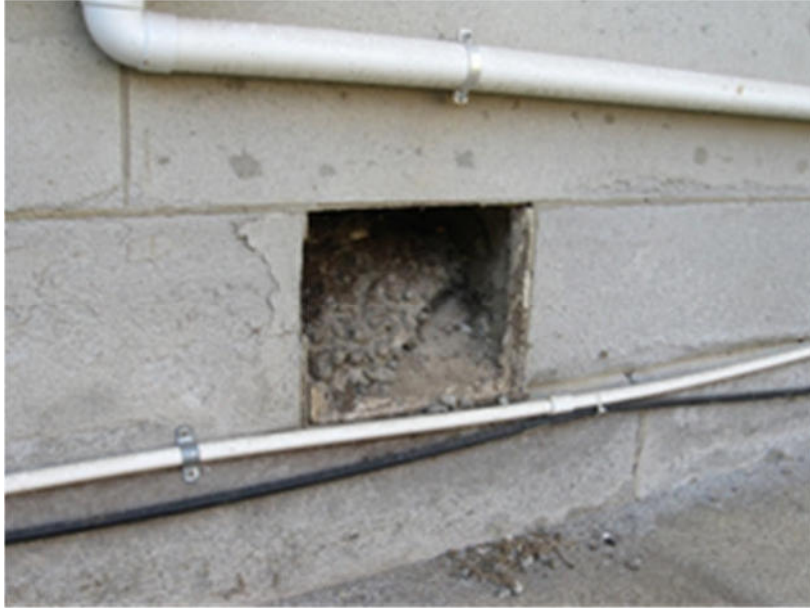
Damaged floor vent

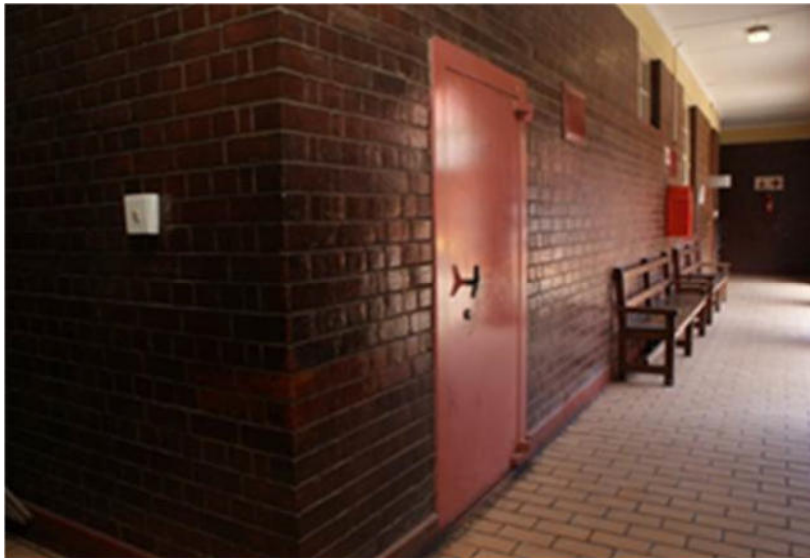
Door

The building is in a very good condition and only minor maintenance will need to be done. Cleaning of gutters, sanding down of doors and timber floors and replacing of some ironmongery is needed, some of the doors will need to be replaced and paraplegic ramp does not conform to the SANS10400 norms.

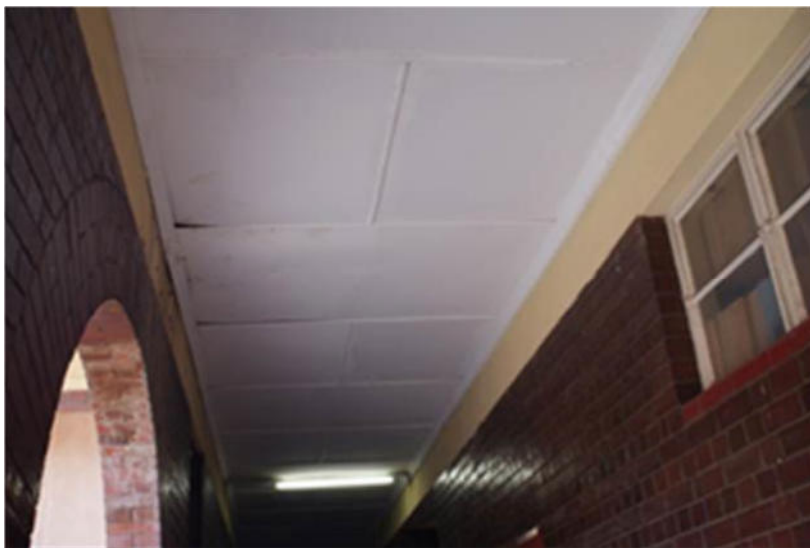
Other maintenance items include the repair of ceilings and cornices, chipped and cracked tiles as well as damaged concrete channels and steps on the outside of the building.

Damaged ceilings

Remove existing ceilings, and replace with 12.5 mm Gypsum plastered ceiling and Provide 45x19mm Purpose-made Hardwood cornice.

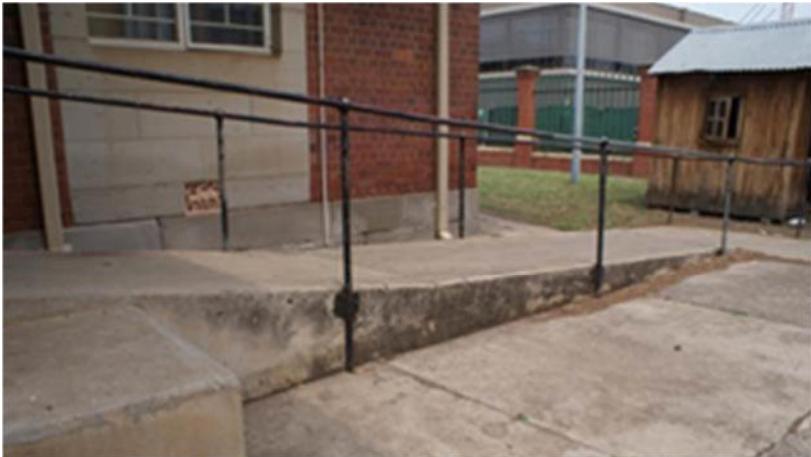
The paraplegic ramp does not conform to the SANS0400 requirements, the ramp will be removed and replaced.
