ROOM NO.4 - FIRST FLOOR (NORTH WING)		ROOM NAME - ROOM 4

PROJECT:
 Proposed alterations & refurbishment of the old Natal Command headquarters at 191 Snell Parade, Durban. battery beach , PTN 2 of 12696 durban

DRAWING TITLE:
 ROOM AND OFFICE DATA SHEETS

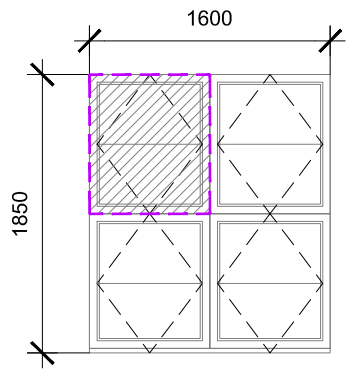
r4/W4

WINDOW: R4/W4
 General note:
 All window frames & casements to be fixed where damaged. Filled, sanded & sealed as per specifications.

Replace (4 off) missing window handles with brass window combination stay & fastener 300mm
 NB: fix with brass screws
 Hinges: Window hinges to be inspected, serviced or replaced if required with brass butt hinge and brass screws or equally approved

Replace (1 off) missing timber window sash and glazing to match existing
 replace glazing with 6mm toughened safety glass or equally approved as per SANS10400 part N

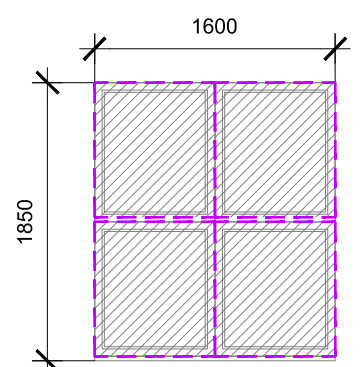
r5e/W4

WINDOW: R5e/W4
 General note:
 All window frames & casements to be fixed where damaged. Filled, sanded & sealed as per specifications.

Replace (4 off) missing window handles with brass window combination stay & fastener 300mm
 NB: fix with brass screws
 Hinges: Window hinges to be inspected, serviced or replaced if required with brass butt hinge and brass screws or equally approved

Replace (4off) missing timber window sash and glazing to match existing
 replace glazing with 6mm toughened safety glass or equally approved as per SANS10400 part N

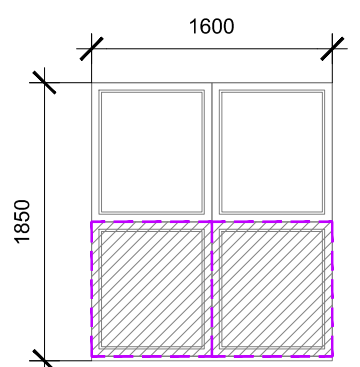
r5f/W4

WINDOW: R5f/W4
 General note:
 All window frames & casements to be fixed where damaged. Filled, sanded & sealed as per specifications.

Replace (4 off) missing window handles with brass window combination stay & fastener 300mm
 NB: fix with brass screws
 Hinges: Window hinges to be inspected, serviced or replaced if required with brass butt hinge and brass screws or equally approved

Replace (4off) missing timber window sash and glazing to match existing
 replace glazing with 6mm toughened safety glass or equally approved as per SANS10400 part N

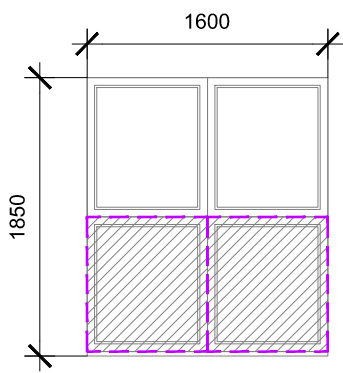
r5a/W4

WINDOW: R5a/W4

General note:
 All window frames & casements to be fixed where damaged.
 Filled, sanded & sealed as per specifications.

Replace (4 off) missing window handles with brass window combination stay & fastener 300mm
 NB: fix with brass screws
 Hinges: Window hinges to be inspected, serviced or replaced if required with brass butt hinge and brass screws or equally approved

Replace (2off) missing timber window sash and glazing to match existing
 replace glazing with 6mm toughened safety glass or equally approved as per SANS10400 part N

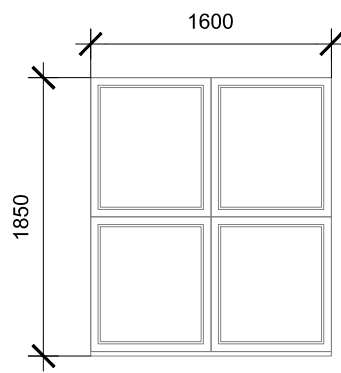
r5b/W4

WINDOW: R5b/W4

General note:
 All window frames & casements to be fixed where damaged.
 Filled, sanded & sealed as per specifications.

Replace (4 off) missing window handles with brass window combination stay & fastener 300mm
 NB: fix with brass screws
 Hinges: Window hinges to be inspected, serviced or replaced if required with brass butt hinge and brass screws or equally approved

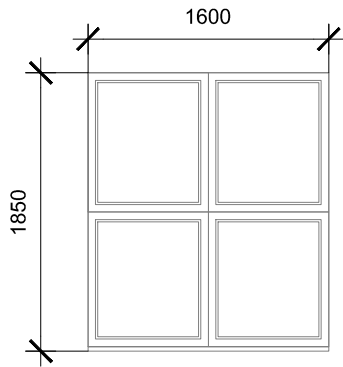
r5c/W4

WINDOW: R5c/W4

General note:
 All window frames & casements to be fixed where damaged.
 Filled, sanded & sealed as per specifications.

Replace (4 off) missing window handles with brass window combination stay & fastener 300mm
 NB: fix with brass screws
 Hinges: Window hinges to be inspected, serviced or replaced if required with brass butt hinge and brass screws or equally approved

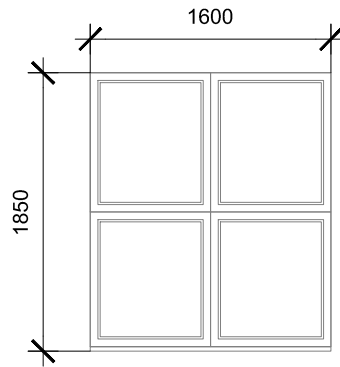
r5d/W4

WINDOW: R5d/W4

General note:
 All window frames & casements to be fixed where damaged.
 Filled, sanded & sealed as per specifications.

Replace (4 off) missing window handles with brass window combination stay & fastener 300mm
 NB: fix with brass screws
 Hinges: Window hinges to be inspected, serviced or replaced if required with brass butt hinge and brass screws or equally approved

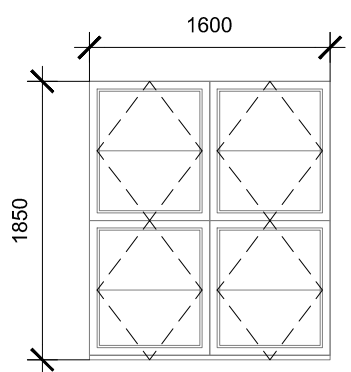
r6a/W4

WINDOW: R6a/W4
 General note:
 All window frames & casements to be fixed where damaged.
 Filled, sanded & sealed as per specifications.

Replace (4 off) missing window handles with brass window combination stay & fastener 300mm
 NB: fix with brass screws
 Hinges: Window hinges to be inspected, serviced or replaced if required with brass butt hinge and brass screws or equally approved

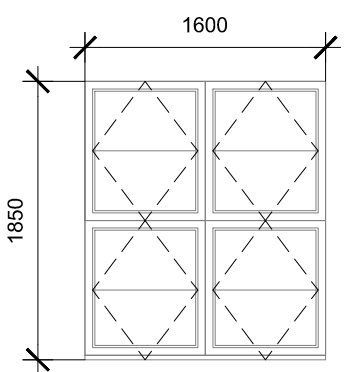
r6b/W4

WINDOW: R6b/W4
 General note:
 All window frames & casements to be fixed where damaged.
 Filled, sanded & sealed as per specifications.

Replace (4 off) missing window handles with brass window combination stay & fastener 300mm
 NB: fix with brass screws
 Hinges: Window hinges to be inspected, serviced or replaced if required with brass butt hinge and brass screws or equally approved

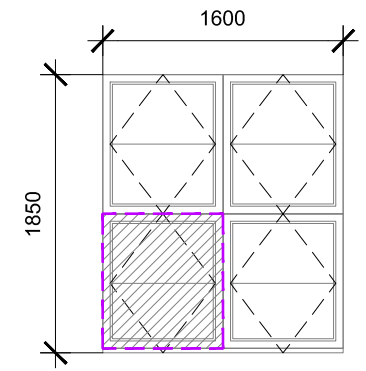
r6c/W4

WINDOW: R6c/W4
 General note:
 All window frames & casements to be fixed where damaged.
 Filled, sanded & sealed as per specifications.

Replace (4 off) missing window handles with brass window combination stay & fastener 300mm
 NB: fix with brass screws
 Hinges: Window hinges to be inspected, serviced or replaced if required with brass butt hinge and brass screws or equally approved

Replace (1 off) missing timber window sash and glazing to match existing
 replace glazing with 6mm toughened safety glass or equally approved as per SANS10400 part N

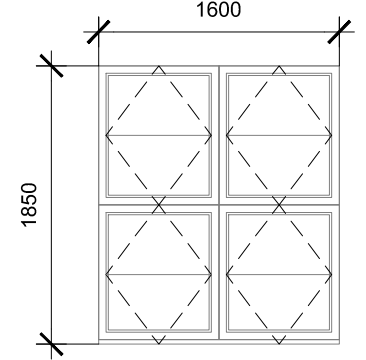
r6d/W4

WINDOW: R6d/W4
 General note:
 All window frames & casements to be fixed where damaged.
 Filled, sanded & sealed as per specifications.

Replace (4 off) missing window handles with brass window combination stay & fastener 300mm
 NB: fix with brass screws
 Hinges: Window hinges to be inspected, serviced or replaced if required with brass butt hinge and brass screws or equally approved

Replace (1 off) missing timber window sash and glazing to match existing
 replace glazing with 6mm toughened safety glass or equally approved as per SANS10400 part N

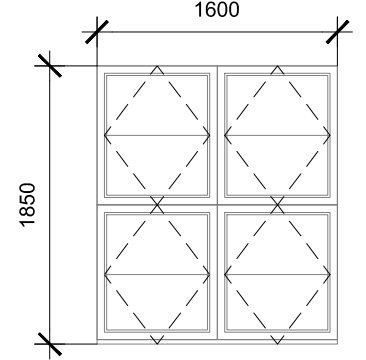
r6e/W4

WINDOW: R6e/W4
 General note:
 All window frames & casements to be fixed where damaged.
 Filled, sanded & sealed as per specifications.

Replace (4 off) missing window handles with brass window combination stay & fastener 300mm
 NB: fix with brass screws
 Hinges: Window hinges to be inspected, serviced or replaced if required with brass butt hinge and brass screws or equally approved

Replace (1 off) missing timber window sash and glazing to match existing
 replace glazing with 6mm toughened safety glass or equally approved as per SANS10400 part N

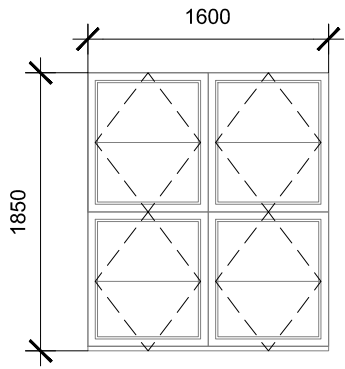
r7a/W4

WINDOW: R7a/W4
 General note:
 All window frames & casements to be fixed where damaged. Filled, sanded & sealed as per specifications.

Replace (4 off) missing window handles with brass window combination stay & fastener 300mm
 NB: fix with brass screws
 Hinges: Window hinges to be inspected, serviced or replaced if required with brass butt hinge and brass screws or equally approved

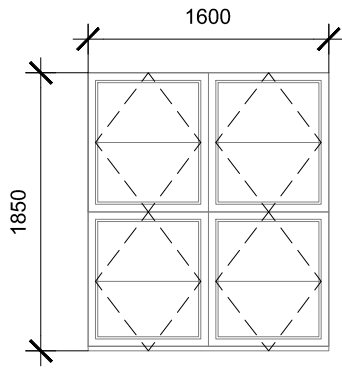
r7b/W4

WINDOW: R7b/W4
 General note:
 All window frames & casements to be fixed where damaged. Filled, sanded & sealed as per specifications.

Replace (4 off) missing window handles with brass window combination stay & fastener 300mm
 NB: fix with brass screws
 Hinges: Window hinges to be inspected, serviced or replaced if required with brass butt hinge and brass screws or equally approved

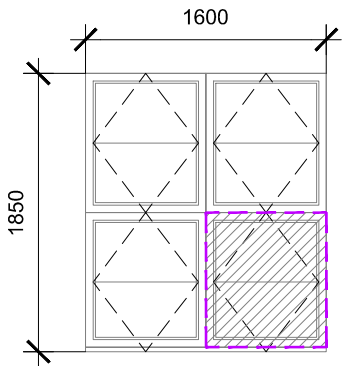
r7c/W4

WINDOW: R7c/W4
 General note:
 All window frames & casements to be fixed where damaged. Filled, sanded & sealed as per specifications.

Replace (4 off) missing window handles with brass window combination stay & fastener 300mm
 NB: fix with brass screws
 Hinges: Window hinges to be inspected, serviced or replaced if required with brass butt hinge and brass screws or equally approved

Replace (1 off) missing timber window sash and glazing to match existing
 replace glazing with 6mm toughened safety glass or equally approved as per SANS10400 part N

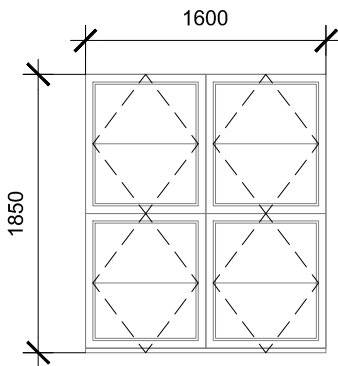
r7d/W4

WINDOW: R7d/W4
 General note:
 All window frames & casements to be fixed where damaged. Filled, sanded & sealed as per specifications.

Replace (4 off) missing window handles with brass window combination stay & fastener 300mm
 NB: fix with brass screws
 Hinges: Window hinges to be inspected, serviced or replaced if required with brass butt hinge and brass screws or equally approved

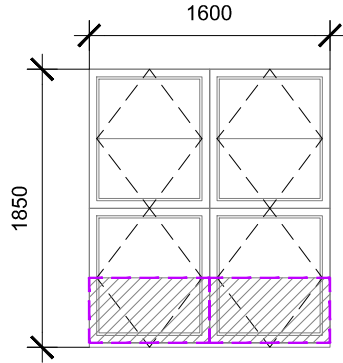
r8/W4

WINDOW: R8/W4

General note:
All window frames & casements to be fixed where damaged. Filled, sanded & sealed as per specifications.

Replace (4 off) missing window handles with brass window combination stay & fastener 300mm
NB: fix with brass screws

Hinges: Window hinges to be inspected, serviced or replaced if required with brass butt hinge and brass screws or equally approved

Replace (2off) missing glazing panes to match existing
replace glazing with 6mm toughened safety glass or equally approved as per SANS10400 part N

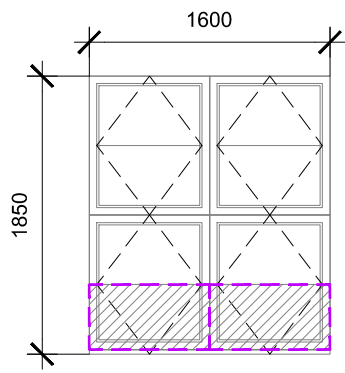
r9/W4

WINDOW: R9/W4

General note:
All window frames & casements to be fixed where damaged.
Filled, sanded & sealed as per specifications.

Replace (4 off) missing window handles with brass window combination stay & fastener 300mm
NB: fix with brass screws
Hinges: Window hinges to be inspected, serviced or replaced if required with brass butt hinge and brass screws or equally approved

Replace (2off) missing glazing panes to match existing
replace glazing with 6mm toughened safety glass or equally approved as per SANS10400 part N

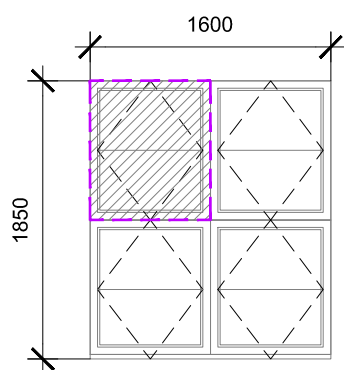
WINDOW: R3/W4

General note:

All window frames & casements to be fixed where damaged. Filled, sanded & sealed as per specifications.

Replace (4 off) missing window handles with brass window combination stay & fastener 300mm
 NB: fix with brass screws
 Hinges: Window hinges to be inspected, serviced or replaced if required with brass butt hinge and brass screws or equally approved

Replace (1 off) missing timber window sash and glazing to match existing
 replace glazing with 6mm toughened safety glass or equally approved as per SANS10400 part N
