PROJECT:
 Proposed alterations & refurbishment of the old Natal Command headquarters at 191 Snell Parade, Durban. battery beach , PTN 2 of 12696 durban

DRAWING TITLE:
 ROOM AND OFFICE DATA SHEETS

DRWG.No:
 21126

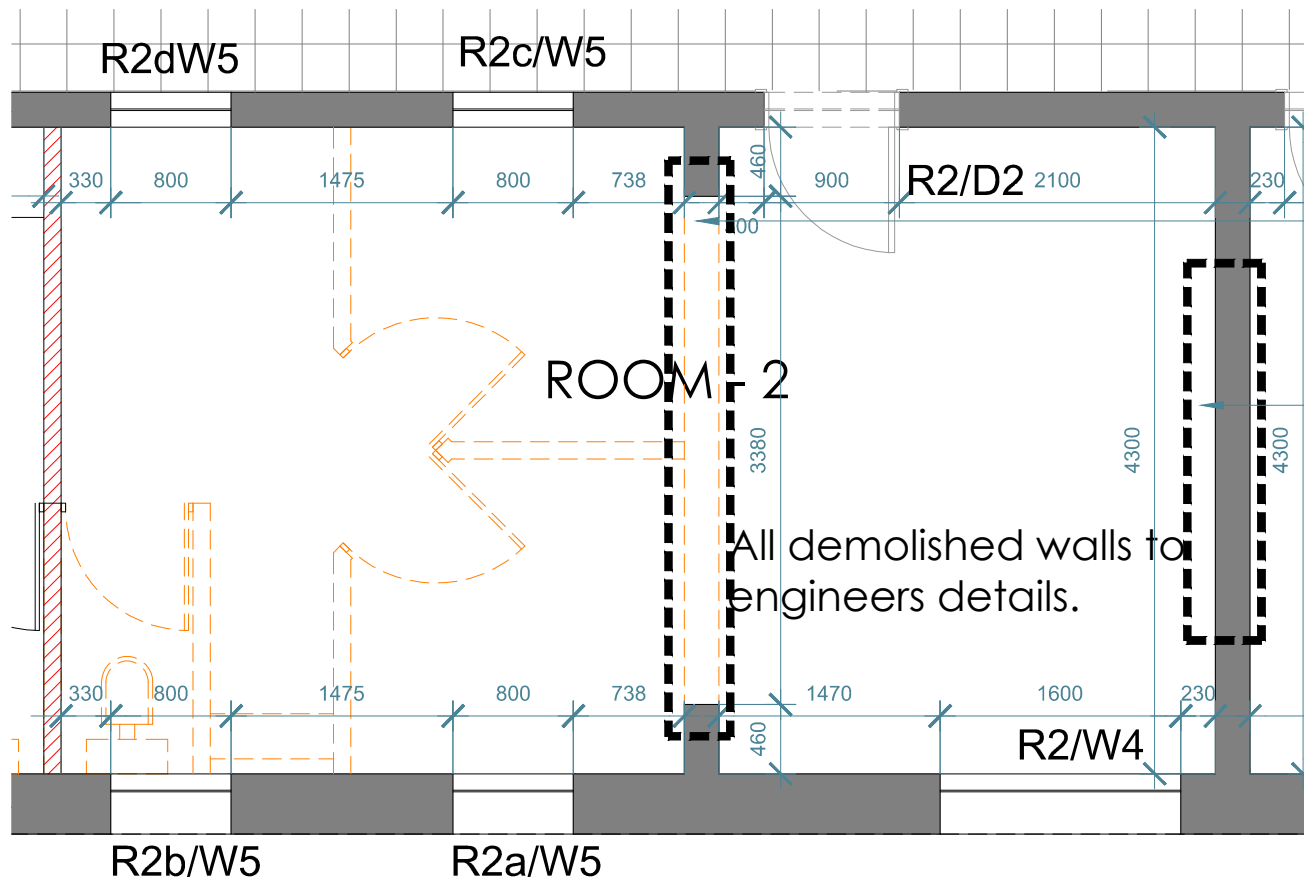
ex. dado rails and skirting to be removed in its entire salvaged and store on site to be reused

ex. wall paneling to be removed in its entire - 10m²

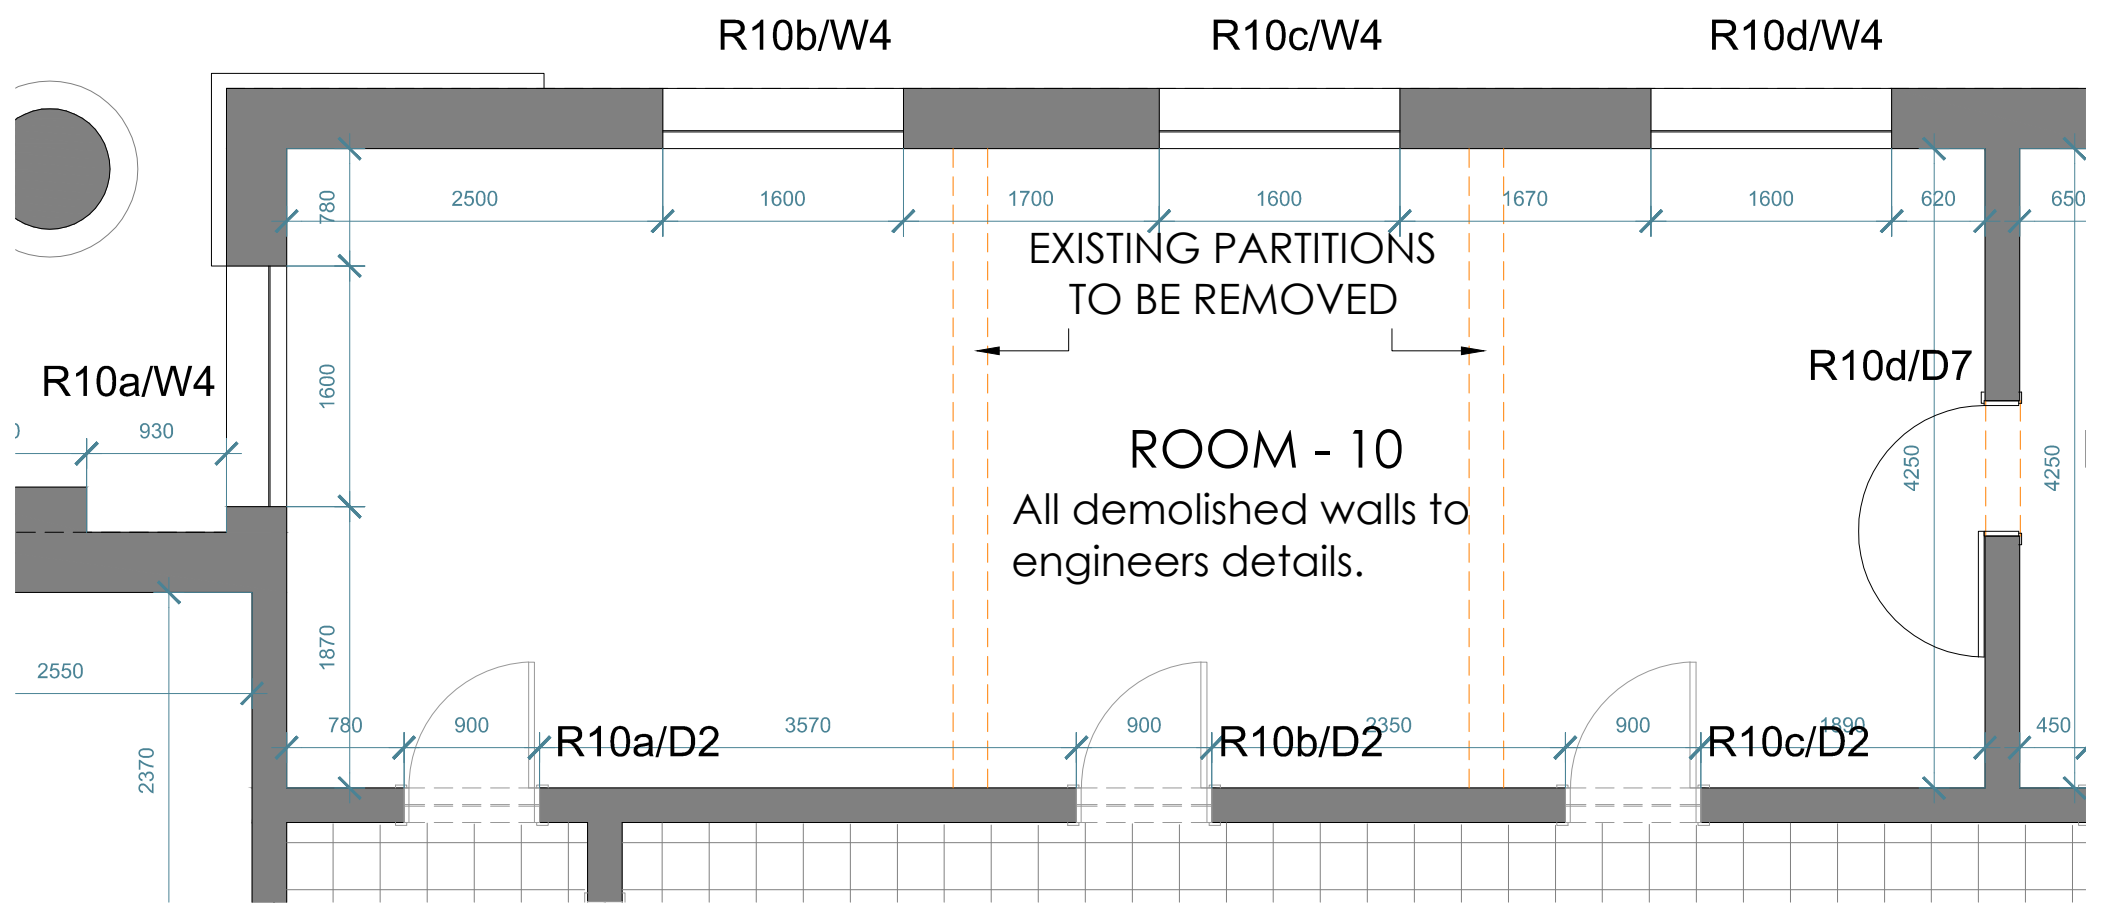
FLOOR FINISH • ex. vinyl floor sheeting to be remove in its entire , floor to be repaired and filled were required to receive new finish as per architects spec. -47.98sqm

SKIRTING • Skirting: Ex. skirting to be inspected for wood rot & water damage. Replace damaged skirting with salvaged.
Sand, repair & seal as per specification

WALL FINISH • Existing plaster & paint:
- Walls to be scraped, treated, fill all imperfections.
- Walls to receive new finish as per specifications

DADO RAILS • Dado rail: Ex. dado rail to be inspected for wood rot & water damage. Replace damaged dado rails with salvaged.
Sand, repair & seal as per specification.

WINDOW • Existing Timber Window Frames:
- Timber window frames to be inspected for wood rot and water damage.
- Affected mullions to be removed and replaces to match.
- All damage and broken glass to be replaced with 6mm toughened safety glass as per sans 10400 Part N or equally approved my specialist
- Window hinges to be replaced with brass type hinge and secured with brass screws as per schedule
Window handles:
Window handles to be replaced with brass type handles to match existing and fixed with brass screws as per schedule
Windowsill :
- Windowsill to be inspected for damage ,and replaced were required
- Affected sills to be removed and replaces to match.

DOOR • Timber door frames to be inspected for wood rot and water damage.
door frames to be repaired with salvaged and made good to match ex.
Doors: Refer to door detail

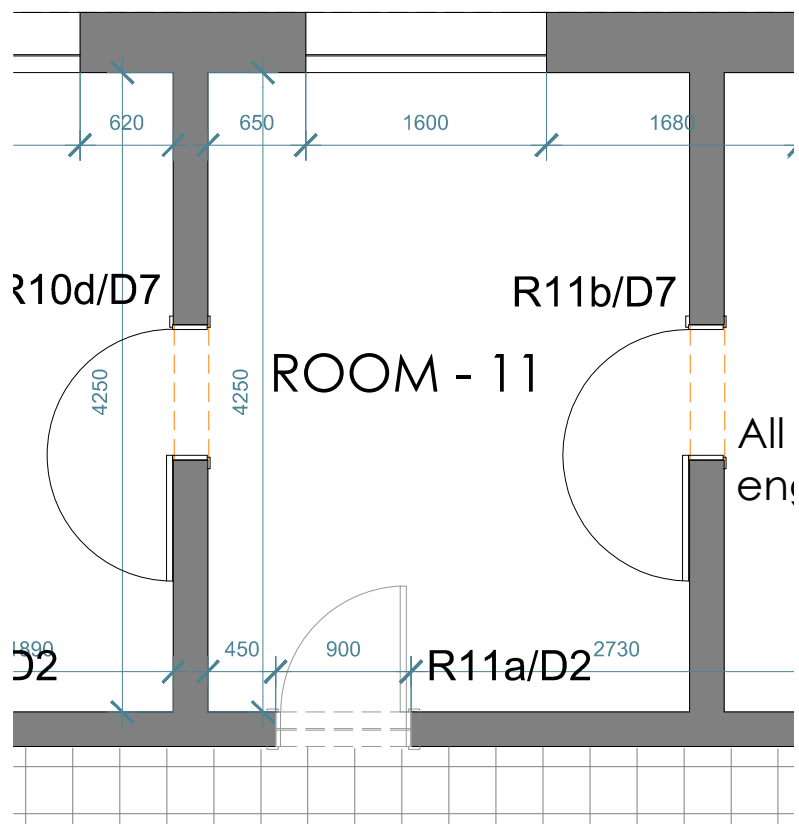
WINDOW: R11/W4
 General note:
 All window frames & casements to be fixed where damaged. Filled, sanded & sealed as per specifications.

Replace (4 off) missing window handles with brass window combination stay & fastener 300mm
 NB: fix with brass screws
 Hinges: Window hinges to be inspected, serviced or replaced if required with brass butt hinge and brass screws or equally approved

Replace (2off) glazing to match existing replace glazing with 6mm toughened safety glass or equally approved as per SANS10400 part N

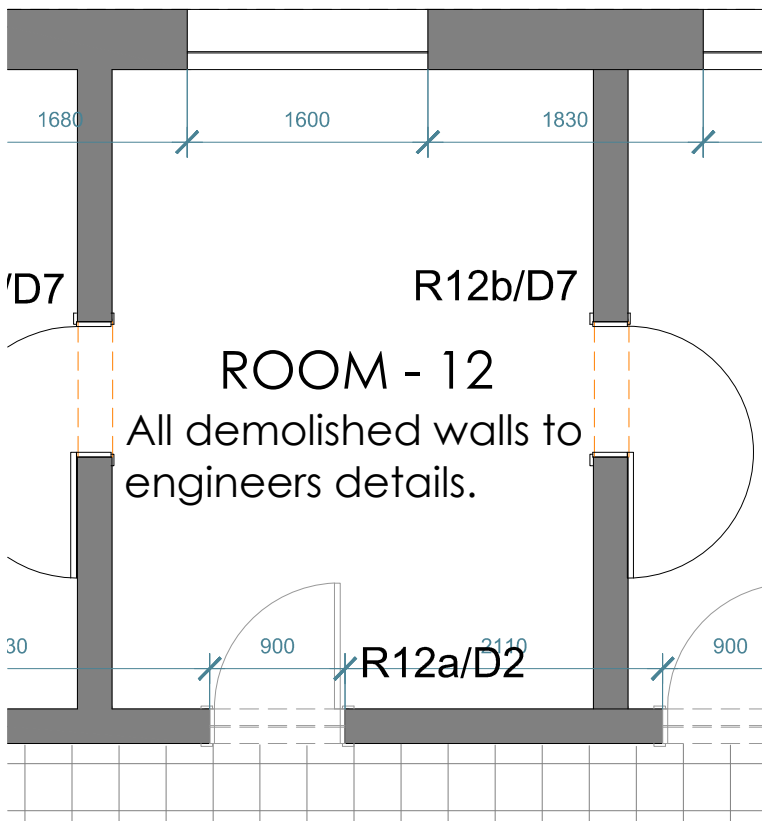
WINDOW: R12/W4
General note:
All window frames & casements to be fixed where damaged.
Filled, sanded & sealed as per specifications.

Replace (4 off) missing window handles with brass window combination stay & fastener 300mm
NB: fix with brass screws
Hinges: Window hinges to be inspected, serviced or replaced if required with brass butt hinge and brass screws or equally approved

Replace (5off) glazing to match existing
replace glazing with 6mm toughened safety glass or equally approved as per SANS10400 part N

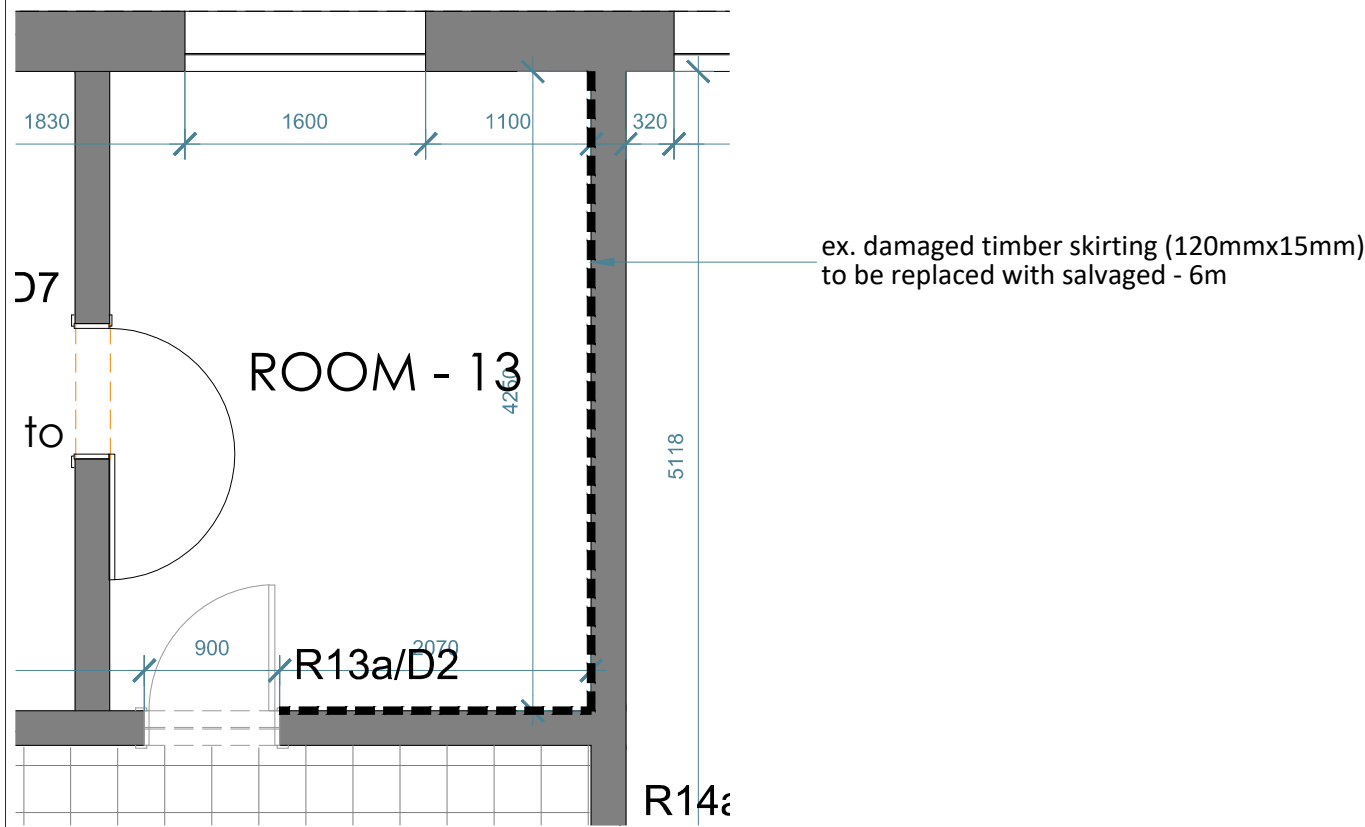
WINDOW: R13/W4
 General note:
 All window frames & casements to be fixed where damaged.
 Filled, sanded & sealed as per specifications.

Replace (4 off) missing window handles with brass window combination stay & fastener 300mm
 NB: fix with brass screws
 Hinges: Window hinges to be inspected, serviced or replaced if required with brass butt hinge and brass screws or equally approved

Replace (2off) glazing to match existing
 replace glazing with 6mm toughened safety glass or equally approved as per SANS10400 part N
