December 2009

**MATLA COAL LIMITED**

# **Matla Colliery Mine 2: Development of Rehabilitation Measures for Panels 6, 7 and 8**

**Report Number:** 11978-9326-1

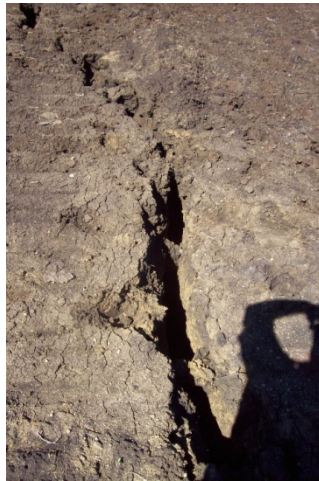
These drivers are presented in a conceptual model in Figure 1. Figure 2 presents a photograph of a crack where fill material has fallen into the void as a result of continued settling and lack of support below the fill material. Figure 3 presents a photograph of where the crack has opened as a result of water ingress into the crack. Figure 4 shows the pooling of water in the slight depression of the crack which in time will wash the fill material down the crack and opening it. Figure 5 shows an aerial view of cracks that have been washed open. Lateral cracks in the geological material also occur but these have been successfully covered through the movement of soil.

*Figure 2: Crack where fill material has fallen into the void*

- Continue filling the cracks as is currently the case.
- Use clay material to fill cracks while compacting the clay, as is being practiced in the wetland area.
- Excavate the crack areas that have opened with an excavator. Insert a bidim geotextile material into the void. Slowly fill with soil / clay material while carefully compacting the material held up by the bidim material.
- Chip rock material from the nick point of the sandstone into the cracks shaping the edge down. Then fill with graded gravel material. Place the bidim layer on this and fill with gravel which may or may not have a drain in. Place soil to act as a growth medium on top.
- Place a small bund wall to keep water from running into the cracks on the pillar area. Ponding of water on the top should however be prevented. This can be combined with any of the above methods of rehabilitation.

Crack backfilling needs to take place against a limiting boundary of sorts, so that some degree of compaction of the backfill can be achieved, and the backfill material is prevented from falling through into deeper recesses. Currently there is no clear understanding of the crack geometry as only surface assessments have been conducted. Designing a sustainable fill method is therefore difficult and at this stage only preliminary ideas are presented. More information on shape and depth of the crack is required to design the best possible methodology. This design would include a soil assessment, geotechnical material assessment and materials balance to obtain the most appropriate design and materials required.

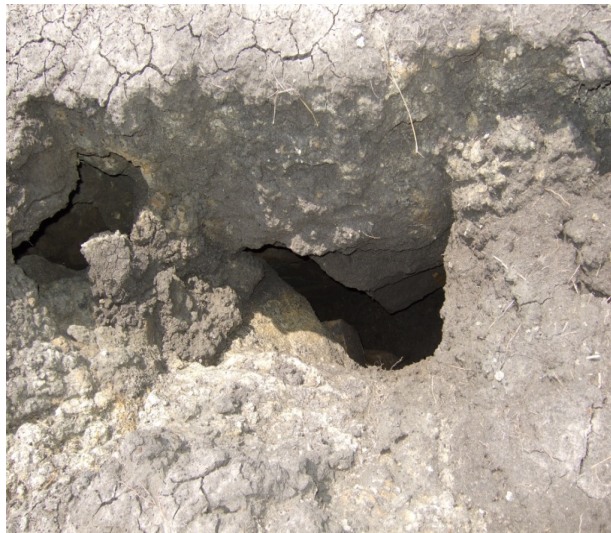
*Figure 3: Crack where fill material was washed into the void*

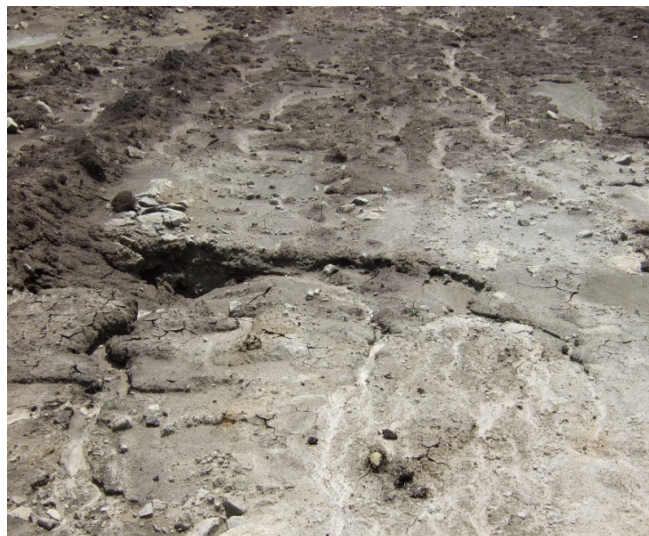
*Figure 4: Slight collection of water which will result in soil material being washed into the void*

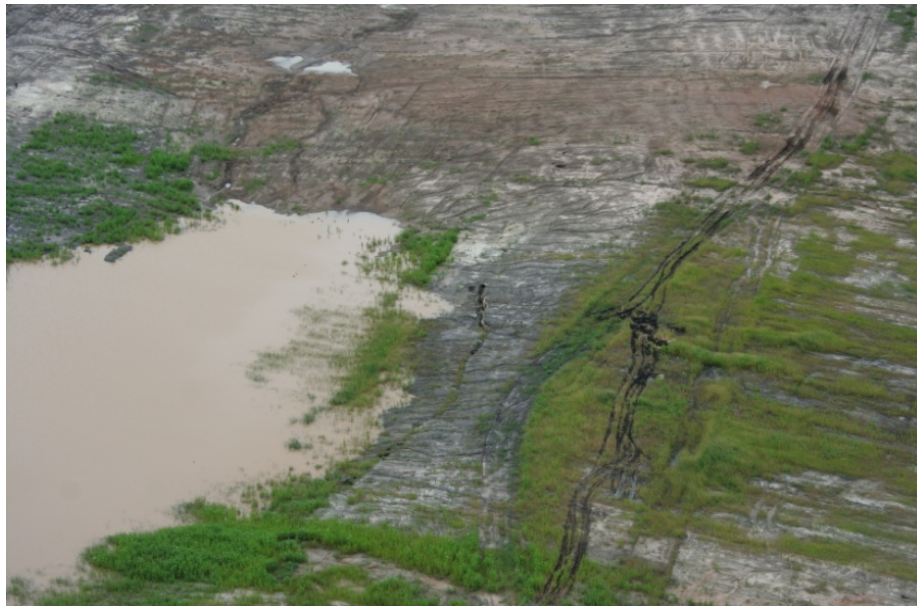
*Figure 5: Aerial view of continued crack formation*

While the crack design is being completed treatment of further cracking in the areas already treated should be conducted using an excavator (such as a TLB) in order to limit the area of future surface disturbance (this is already the mine's plan and intention). The effort and disturbance should thus be concentrated along the crack lines, with treatment of those areas where crack development occurs (areas of instability). Areas where the cracks have already been effectively closed up using the dozing method can be left, unless they start to show signs of collapse, in which case they can be treated on a localized basis. Regular inspection of the crack-lines will be required, particularly after rains, so that areas where crack-development is starting can be identified and treated at an early stage.

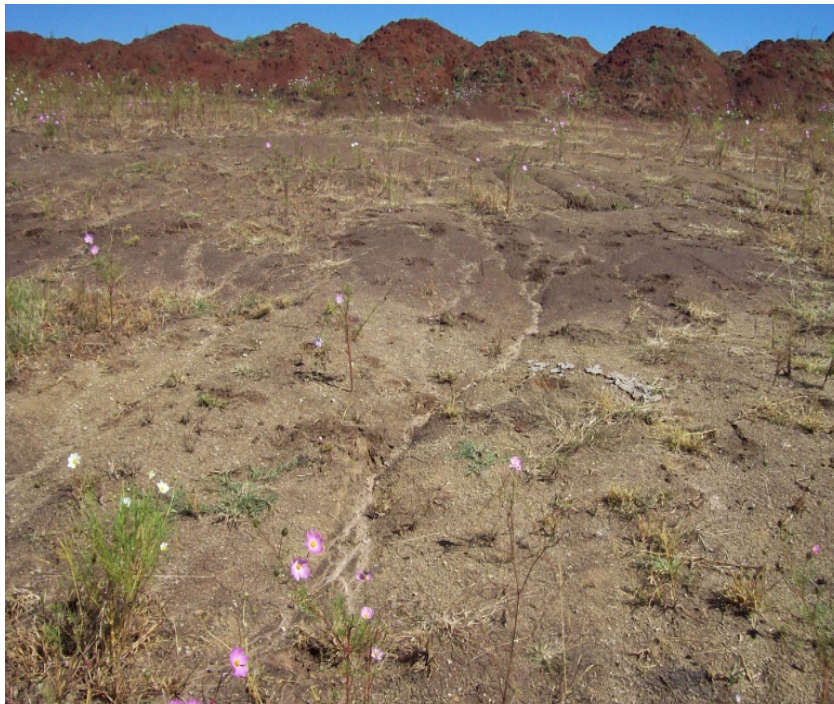
Rill and gully erosion are the two main types of erosion on the goaf areas (Figure 6 and 7).

*Figure 6: Rill erosion on side slopes*

The soil-covered areas need to be tilled on contour using a large tractor and cultivator / tiller, in order to provide a rough rilled surface. It will be necessary to establish soil fertility requirements through soil-testing, but it is anticipated that a moderate lime application (5 tons per hectare?) and a general balanced fertilizer application (2:3:2[22] or 3:2:1[25] at 500 kg/ha?) will be required. Soil testing should identify if there are any soil nutrient deficiencies, or if any particular elements need to be supplemented. Local experience with rehabilitation or local agricultural practices can also be used to guide soil amendment and fertilization requirements.

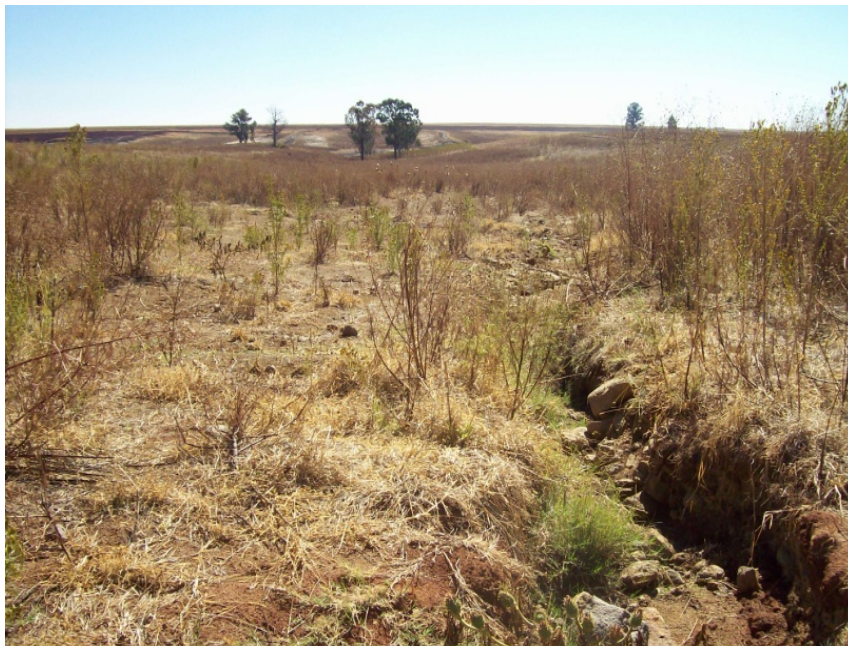
*Figure 7: Gully erosion on main drainage lines*

Although it is a general requirement that rehabilitated areas should be left free-draining, it is recommended that a series of small ponds be left along the drainage lines to serve as sediment traps, to reduce the speed of run-off flow, and allow the establishment of wetland vegetation such as *Typha capensis* (bulrushes) and sedges which will have a filtering and cleaning effect on water quality.

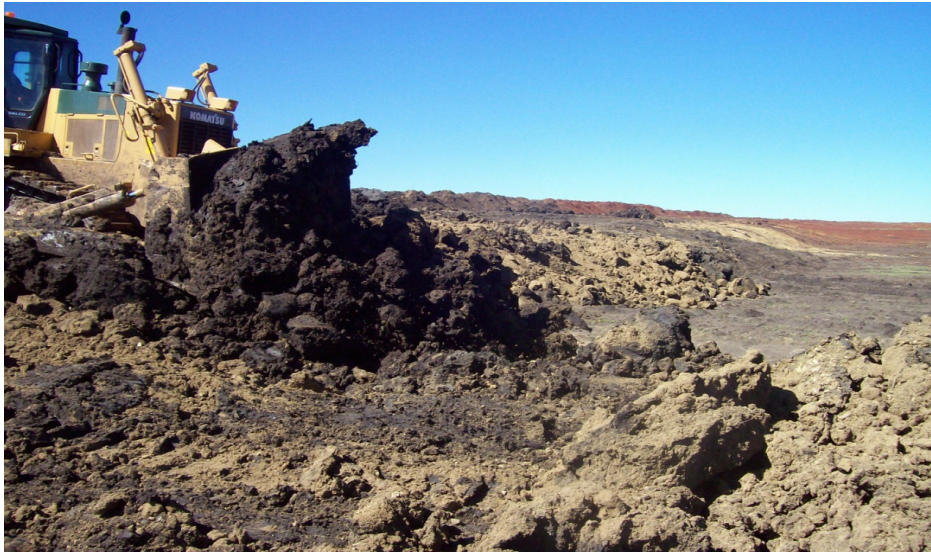
Figure 8 shows the mixing that occurred during soil movement and Figure 9 the effect of this mixing of soil on weed growth.

*Figure 8: Soil mixing during soil movement*

The topsoil (organically rich A soil horizon) was not stripped and stockpiled separately from the sub-soil, and as a result the replaced soil is a mixture of top- and sub-soil, and also appears to be a mosaic of different soil types (oxidized ferralitic soils [red] and dark bottomland soils). In order to reduce the loss of soil through erosion, it is necessary to actively establish vegetation, to speed up the establishment process. This will best be achieved through the use of agricultural equipment and the establishment of a quick-growing pasture grass cover. The establishment of contours will not be feasible due to poor contour precision and differential settlement of the subsidence. Contours will then result in pooling and subsequent erosion. Increasing the surface roughness should be sufficient to control the slope length.

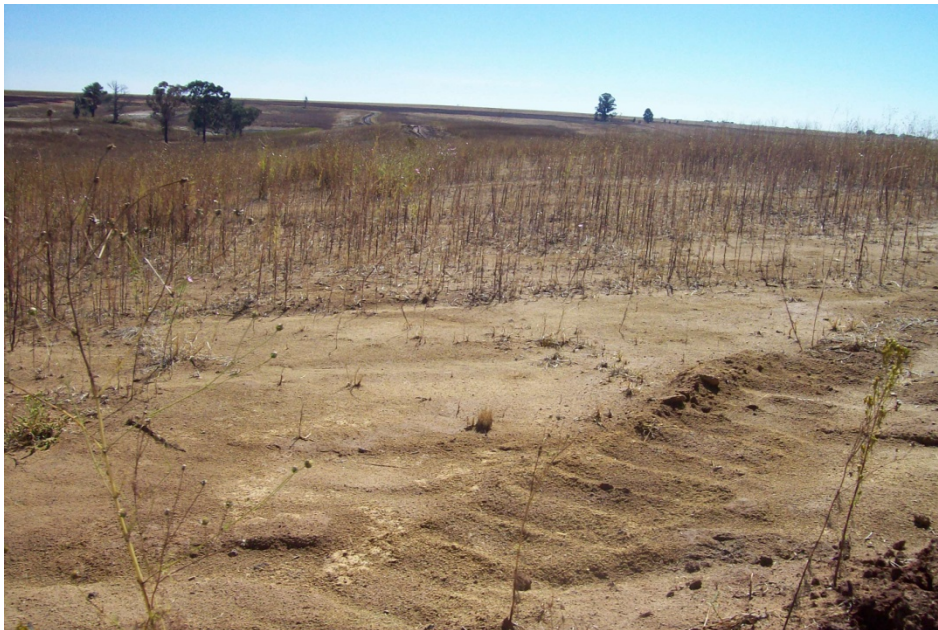
*Figure 9: Poor vegetation establishment on areas where subsoil has been placed on surface*
