Structural Assessment: 24 Parry Road

Client: Homii

28 April 2022

Project number	220403			
Report number	220403-A-RPT-001			
Internal report No.	220403-A-RPT-001

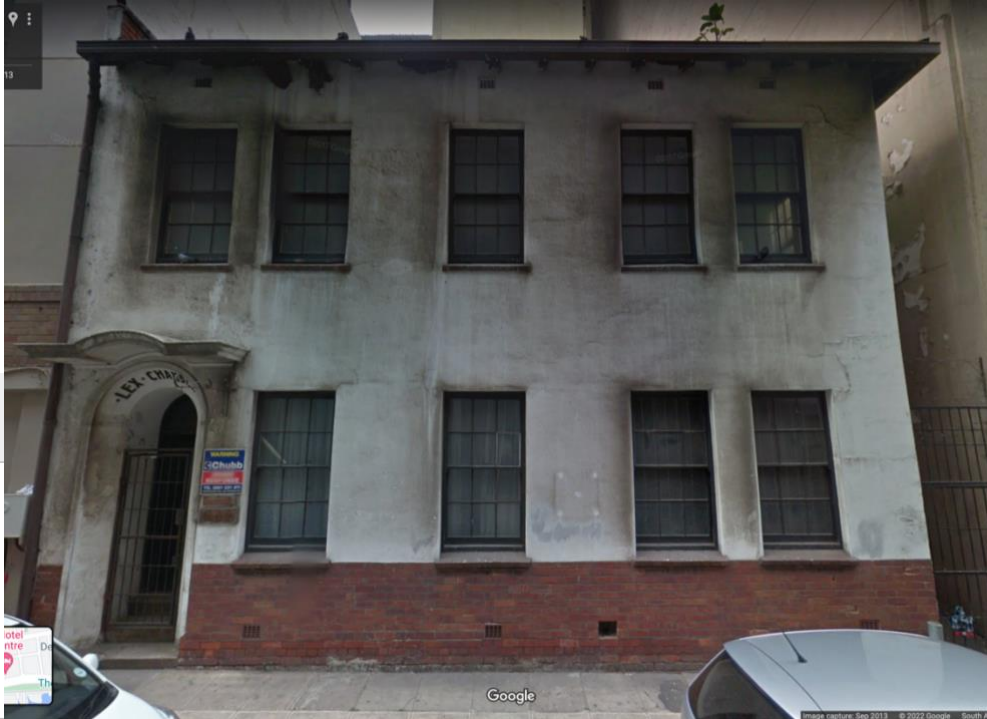
Figure 1: 24 Parry street building

The exterior of the building does not display any structural cracking or evidence of settlement. The paintwork displays water damage due to broken gutters and lack of maintenance (see Figure 1). The overall lower brickwork does not display any cracking indicating that there is no significant settlement in the foundation, however the foundations could not be exposed to verify this. The building does display several broken windows and plaster cracking. The external gutters show significant damage and a large portion of the roof drainage system is either damaged or completely broken.

The building exterior did not any signs of deflections or structural cracks, therefore there is no significant structural interventions to undertake. From the observations noted, most of the defects noted where aesthetic in nature. It is recommended that new gutters and downpipes are built along with the construction of the roof structure, and the filling of any cracks or spalling with a structural concrete repair mortar.

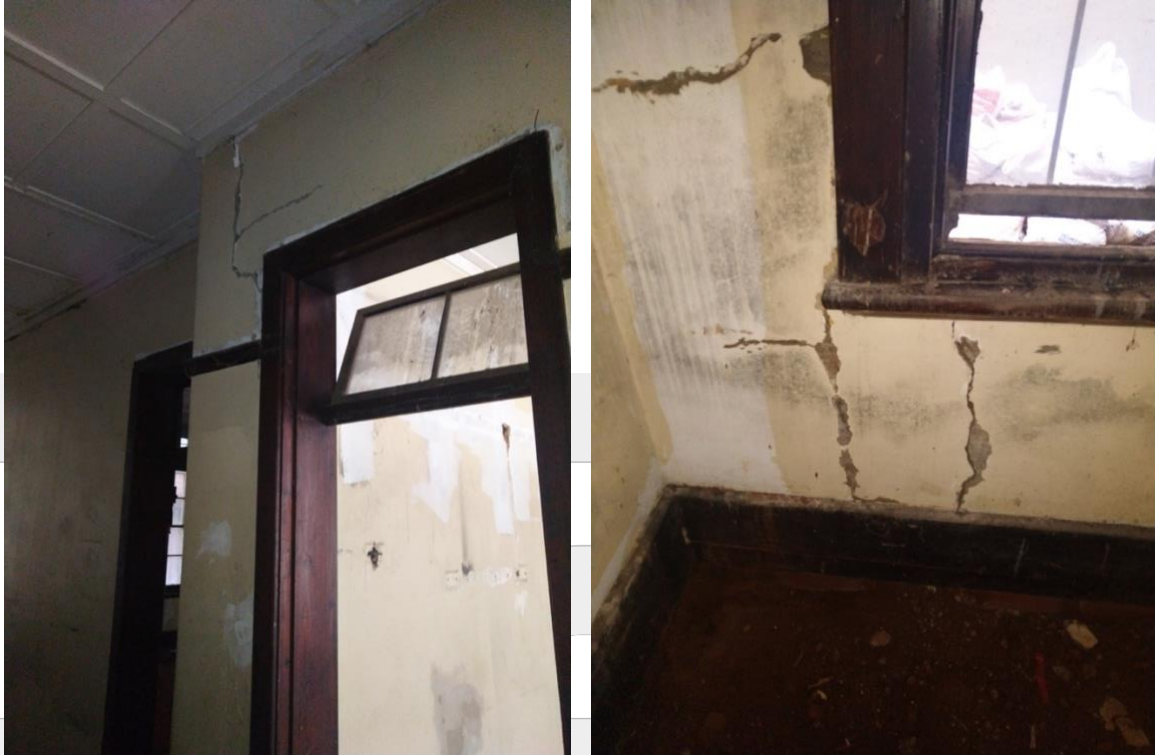
Figure 3: Cracks on ground floor doorways and windows

The ground requires the construction of a concrete surface bed that would provide a suitable functional surface within the building. The ventilation holes left under the crawl space can be sealed to ensure that water ingress and pests are prevented, however other ventilation measures will have to be implemented in accordance with national building standards. The ground floor walls cracks are to be repaired with a suitable

concrete repair mortar, in areas in which cracks exceed 5mm, the brickwork would have to be redone and lintels installed to provide additional strength to the brickwork.

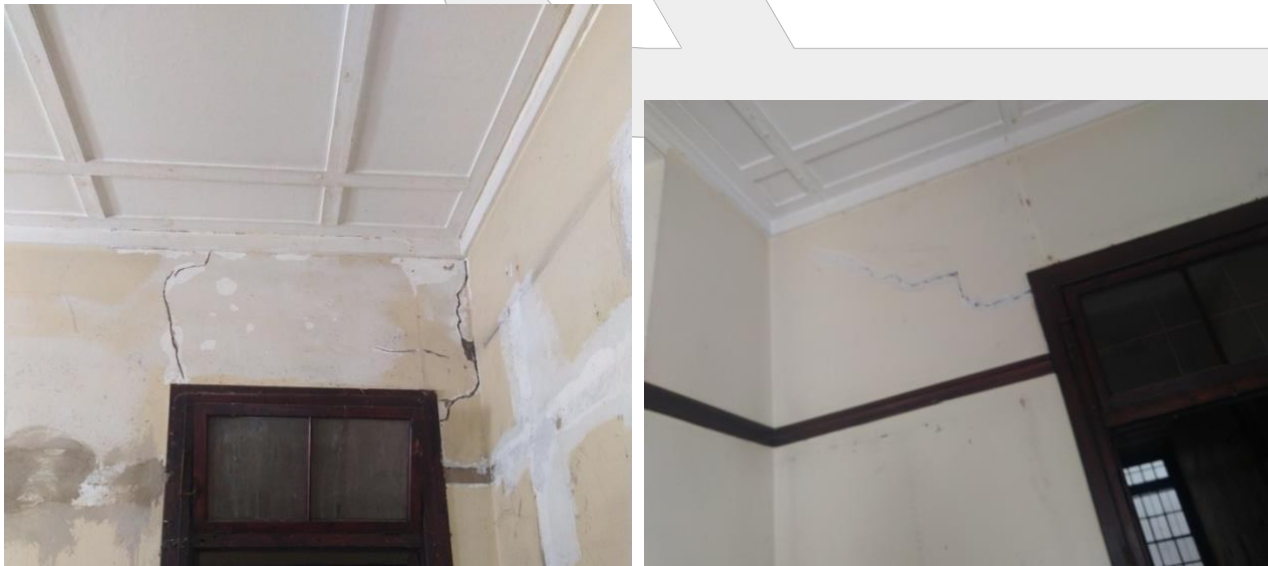
Figure 4: Cracks over the ground floor doorways

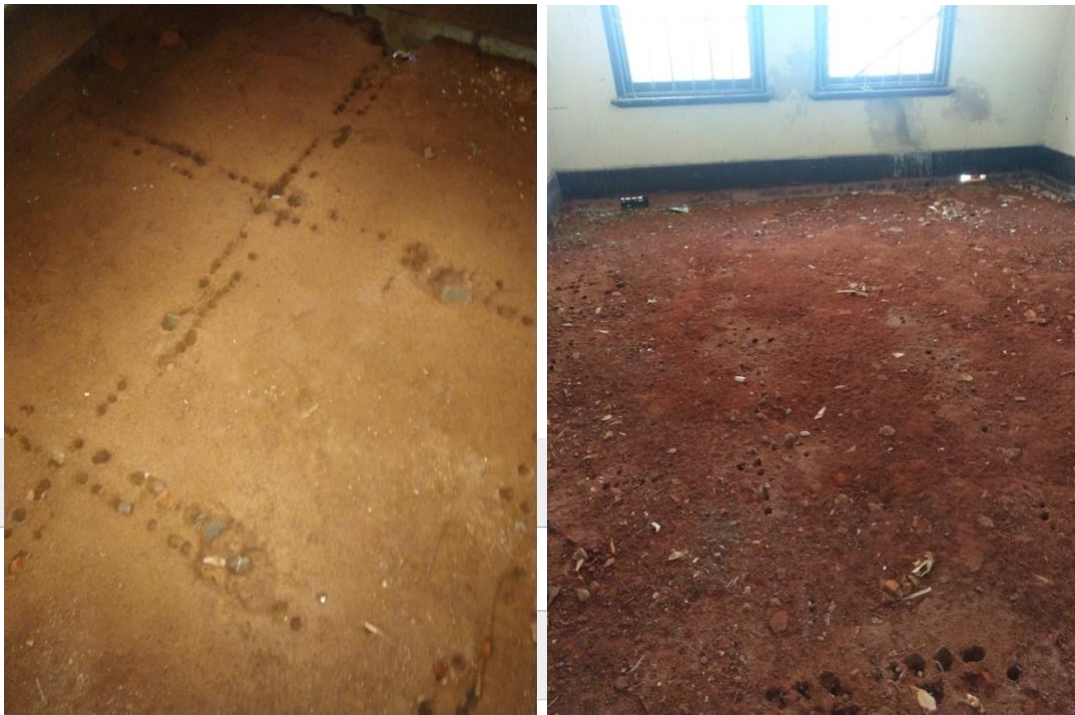
The flooring on the ground floor was removed due to damage and pest infestation. The underlying area under the existing flooring is uncompacted Berea red sand (Figure 5). It was noted that ventilation slots were present in the crawlspace to allow for ventilation under the floorboards (Figure 5). The partition walls display significant cracks above most doorways and under windows which may indicate that localized settlement may have occurred, or the doorways were constructed without lintels or load transfer beams present over the doorways (Figure 3). The consistent ingress of water to the ground floor may have compounded the effect of foundation settlement due to the continued expansion and contraction effects of expansive soils (Figure 5). The staircase leading to the first floor shows considerable damage due to material degradation and water damage (Figure 6). The supporting beams are intact in certain sections however the overall stability of the stairs is not fit for purpose and poses a safety risk for any persons taking occupation of the building.

Figure 5: Traces of water ingress on ground floor

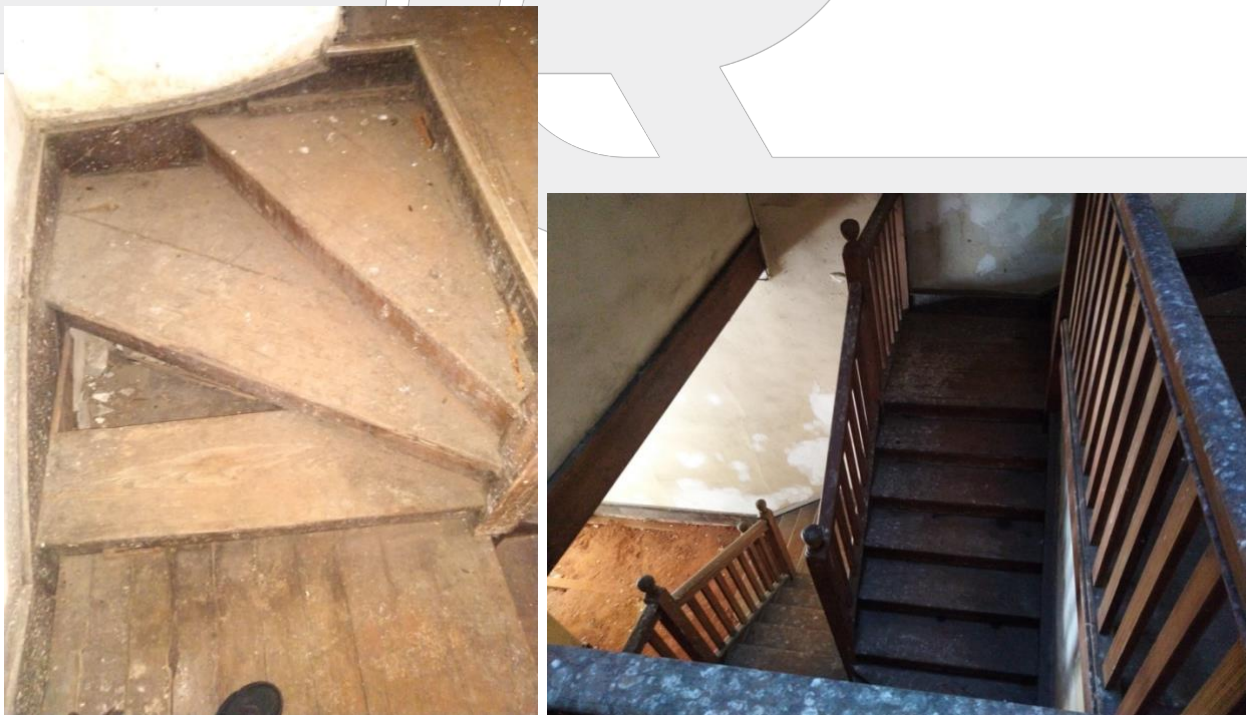
Figure 6: Damage to existing wooden staircase

It is further recommended that the existing staircase be demolished and rebuilt to current engineering and safety standards. The staircase as it is, has numerous structural inadequacies and is a potential safety hazard.

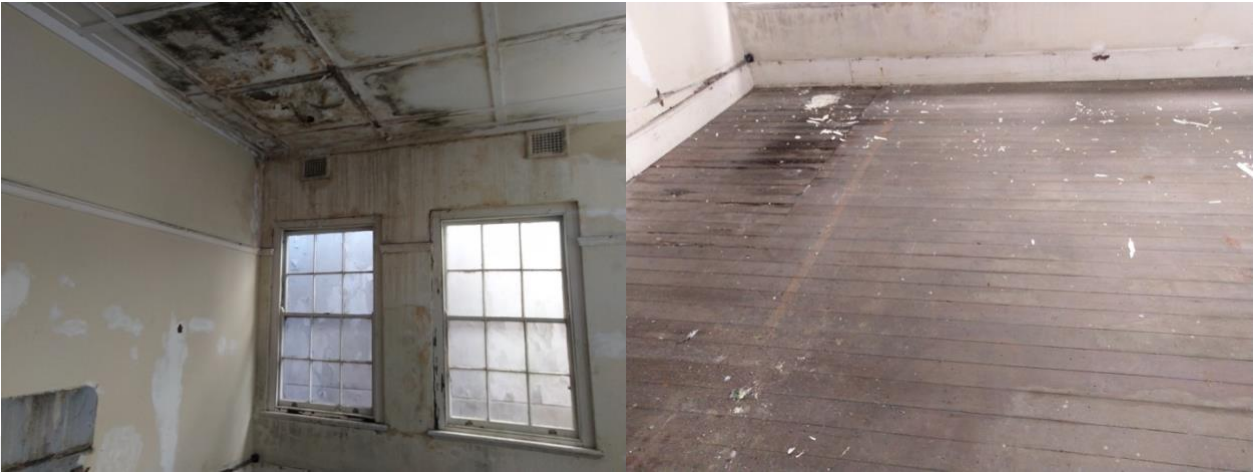
The first-floor flooring is a mix of concrete floors in the bathroom area and wooden floors in the rooms. The existing wooden flooring shows signs of fire damage, and wear and tear (Figure 7). The current floor beams could not be assessed fully as the ceiling boards are intact, however the floor does not have any noticeable deflections or failures thus indicating that the floor beams are intact and can support itself. The partition walls do not show any signs of cracks however plaster cracks are apparent due to the lack of maintenance and the consistent water ingress (Figure 8). The ceiling and floorboards show significant water damage which will affect the overall structural strength of the material (Figure 9). The extent of the water damage may also decrease the carrying capacity of the supporting beams and its connections.

Figure 7: Ceiling water damage and floor fire damage on first floor

The first floor flooring is in poor condition. The water and wear and tear damage is extensive. It is therefore recommended that the existing flooring be removed and reinstated. The supporting beams for the first floor would have to be assessed to verify if it will be capable to withstand any additional loads applied to it, however the water damage that the beams incurred will have to be taken into account as the age and damage will impact the performance of the beams. It is recommended that the beams be removed and replaced with current beams that would perform to the specified standard.

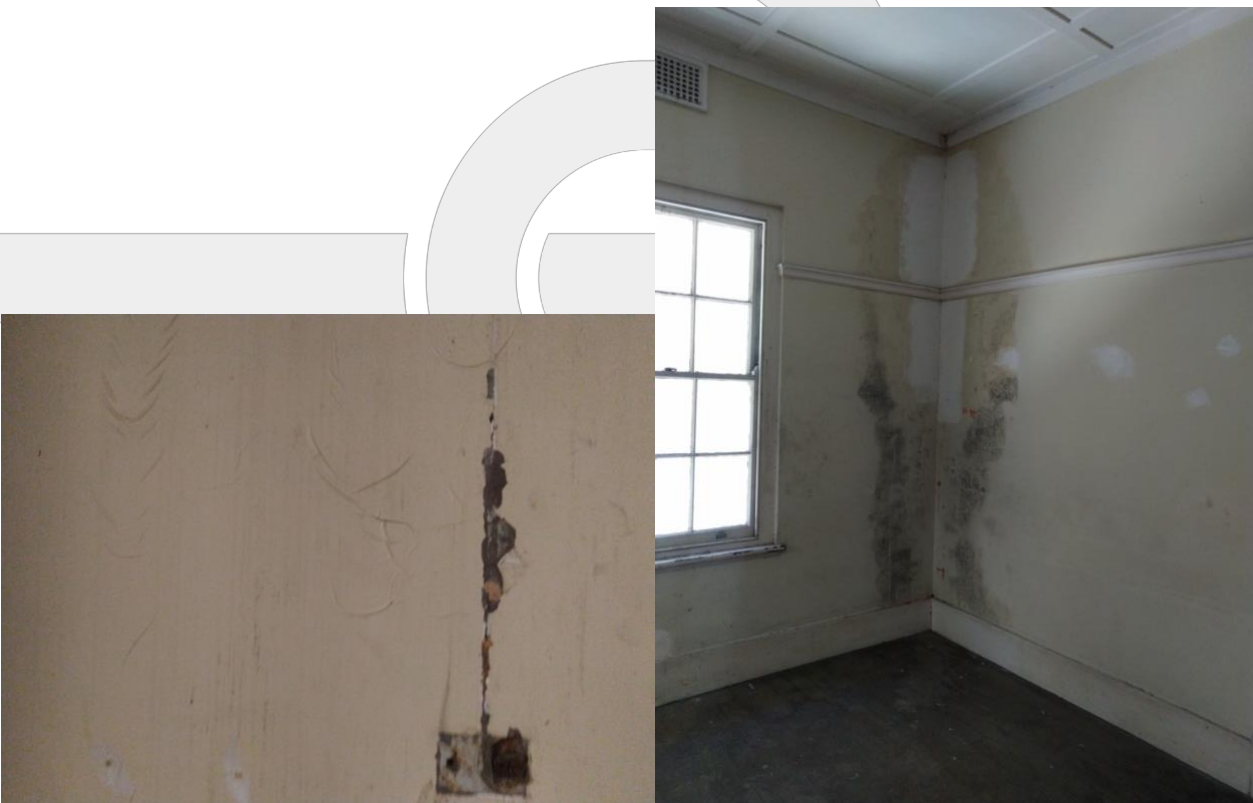
Figure 8: Further water damage noted on first floor

The internal partitioning walls do not show any significant cracks however the water damage to the walls is extensive. The water damage will have an impact on the plaster and overall strength of the plaster, therefore remedial work will be necessary to ensure that the walls are water tight and that minor cracks are repaired.

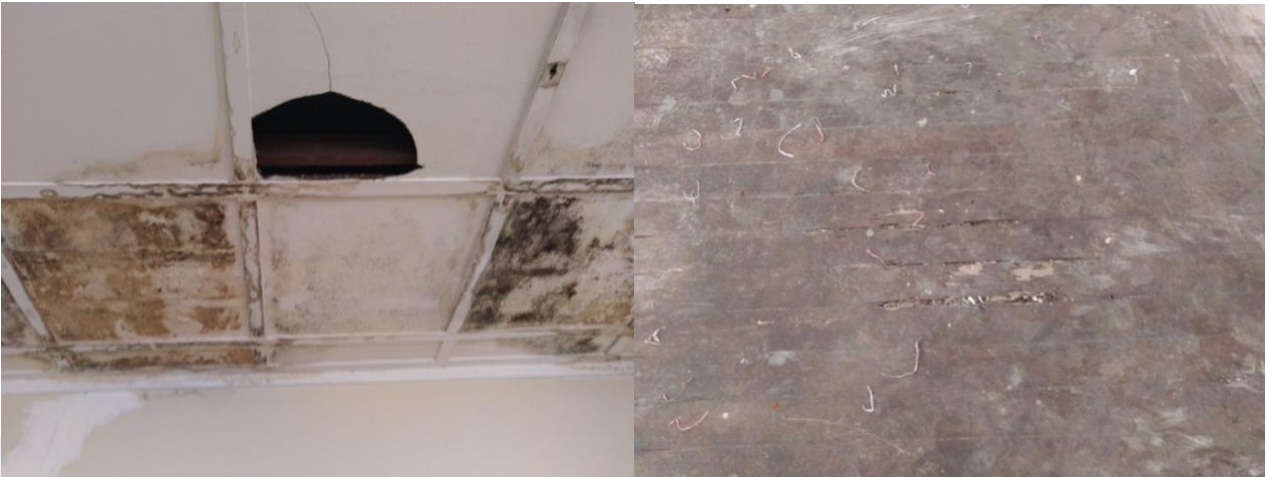
Figure 9: Ceiling damage and floor damage on the first floor

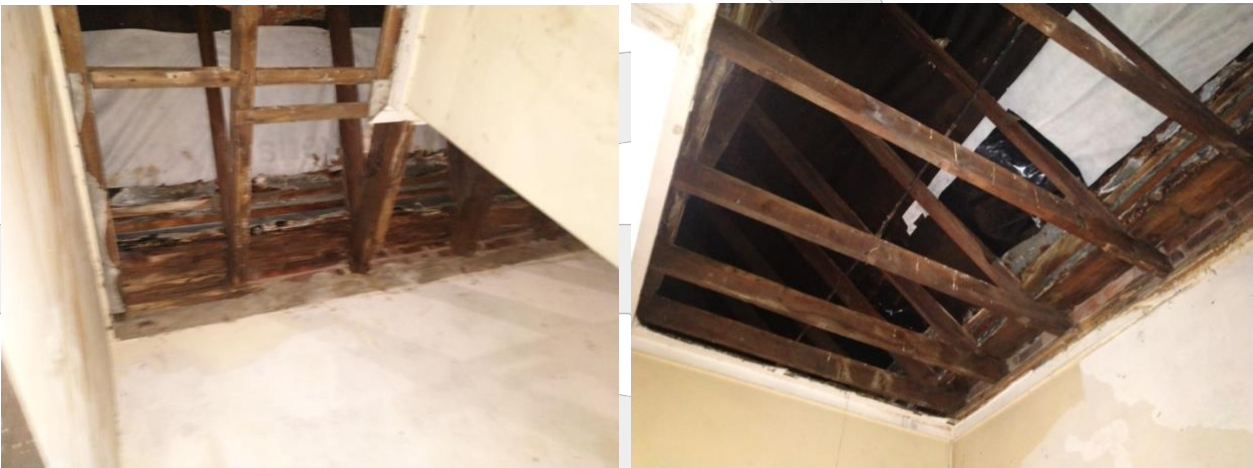
The roof shows signs of severe degradation and can be classified as unsafe for occupation. The roof sheeting is in poor condition and displays severe corrosion. The sheeting connections has failed in central areas of the roof and along the perimeter of the roof. The resulting failure of the roof sheeting led to the water damage to the supporting roof trusses (Figure 10). The roof trusses are in poor condition and shows signs of water damage, and damage due to lack of maintenance (Figure 11). The condition of the roof truss will pose a danger if any additional loading is imposed on the structure and the failure of the internal gutters will further compound the damage as time goes on. The internal roof rafters are also in poor condition and may result in further failures if left unchanged.

Figure 10: General condition of roof trusses and damage noted

The roof structure is in extremely poor condition with several failures noted, which resulted in extensive water damage to the building. The roof structure, as it is, cannot be deemed structurally stable. Taking into account the current state of the roof structure and the prolonged exposure to the elements and wildlife, it is recommended that the roof be completely removed and reinstated to modern standards. The internal gutters are also to be removed and reconstructed to conform modern practices. The connections between the sheeting and the purlins shows signs of failure. The resulting failure could be due to corrosion, which will potentially require removal and reinstatement of the entire roof sheeting.

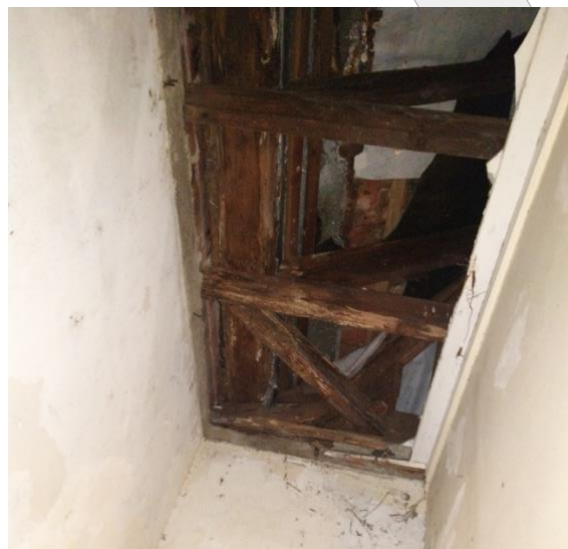
Figure 11: Water damage and wood rot observed in certain areas of trusses
