# BRAMIN

13 July 2022  
Our Ref: 22631

**DESCRIPTION OF WORK** : **STRUCTURAL REPORT TO EXISTING BUILDING**  
**ADDRESS** : **ERF 6325 DURBAN,  
26 CLARK ROAD,  
BULWER.**

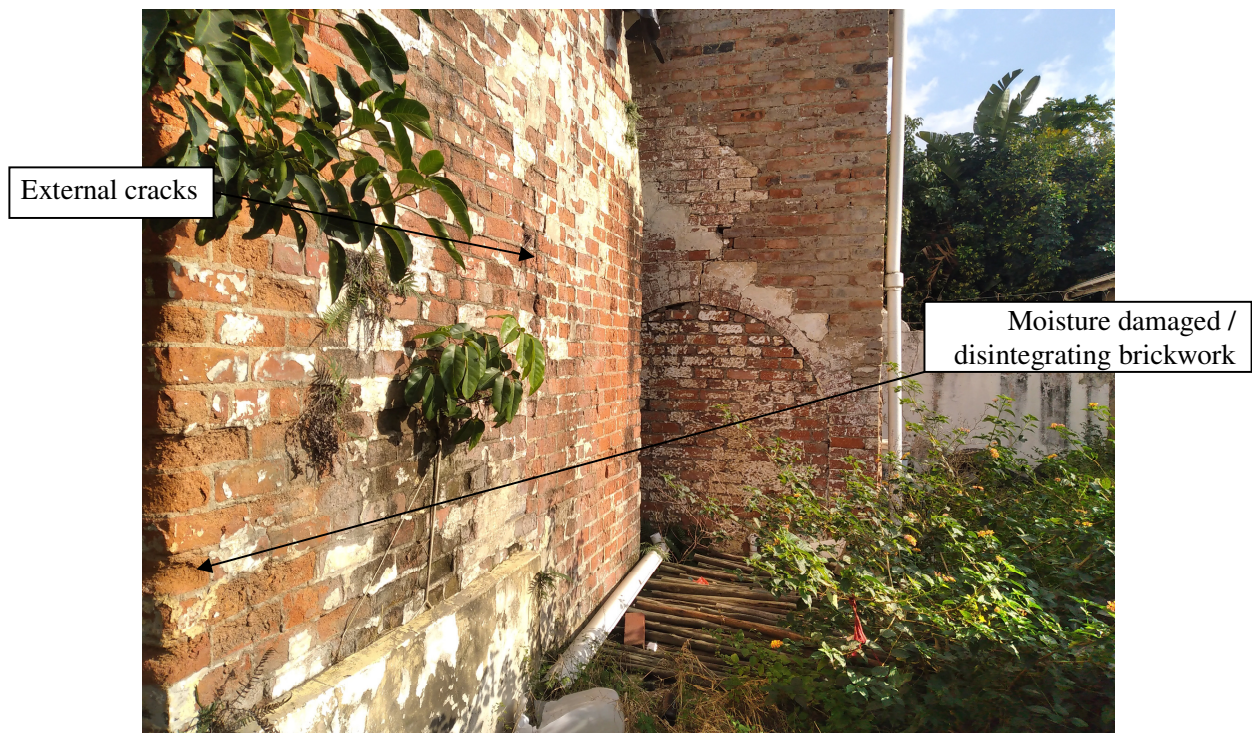
Broken gutters/  
downpipes

- The building does not comply with current regulation.
- Roof structure is required to be removed and replaced.
- Flooring is required to be removed and replaced.
- Foundation is to be underpinned, preferable removed and replaced.
- Stormwater management is to be put into place.
- The above clearly highlights the need for the structure to be demolished for a new development.

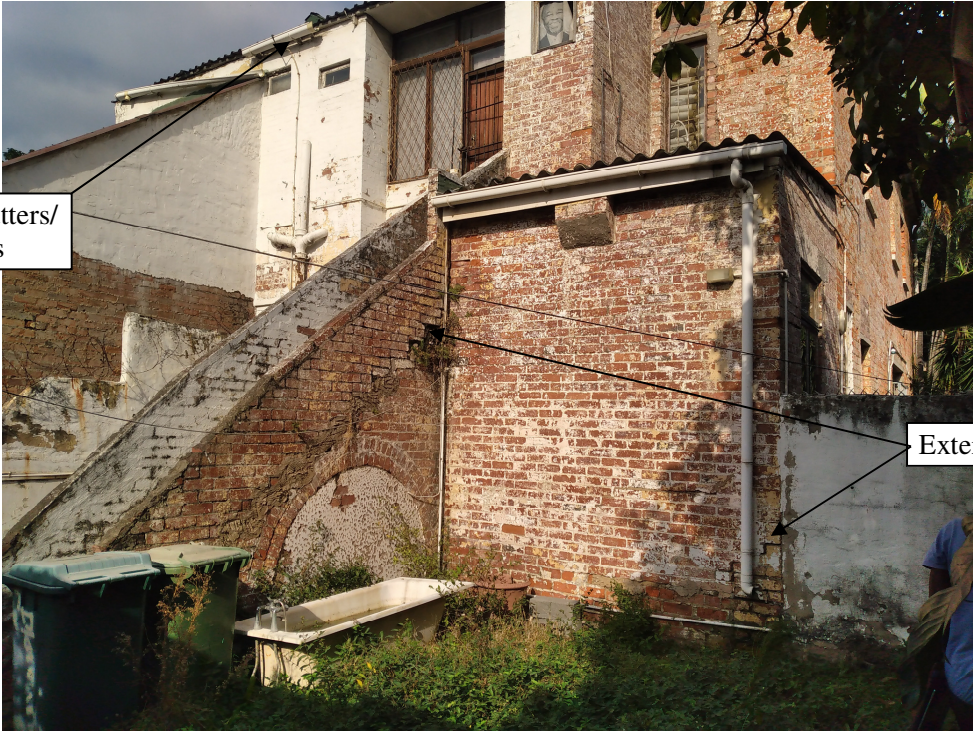
External cracks
