# BRAMIN

**DESCRIPTION OF WORK** : **STRUCTURAL REPORT TO EXISTING BUILDING**

**ADDRESS** : **ERF 6325 DURBAN,  
26 CLARK ROAD,  
BULWER.**

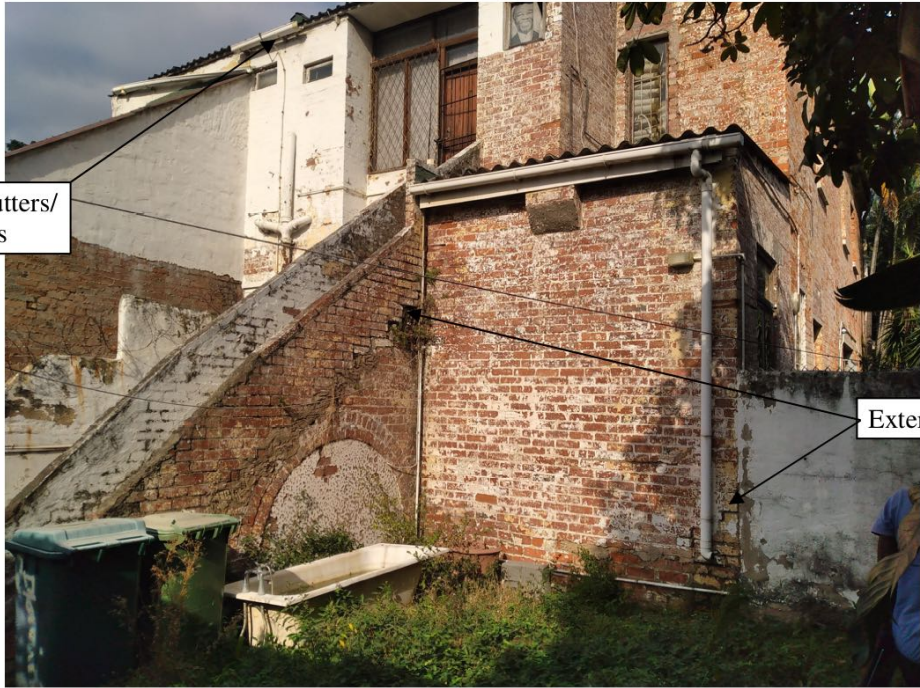
Broken gutters/  
downpipes
