230 CURRIE RD DARD REPAIRS & RENOVATIONS DURBAN

DESIGN, PROJECT MANAGEMENT & CONSTRUCTION OF DEPARTMENT OF AGRICULTURE & RURAL DEVELOPMENT RESTORATION PROJECT

SITE INSPECTION REPORT

CIVIL AND STRUCTURAL WORKS

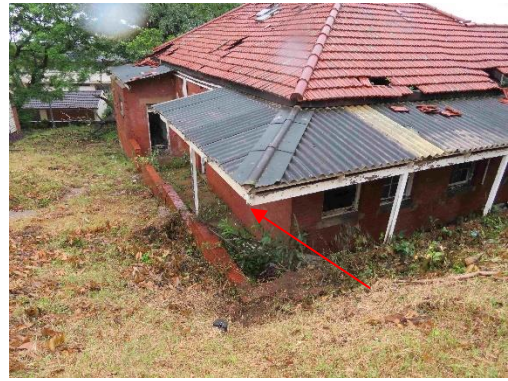
The walkway roof was observed to be of asbestos material hence a health hazard and must therefore be removed as per current OHS requirements. The timber structure for this roof is also collapsing.

Photo 2: Missing Walkway Roof Corner Timber Column

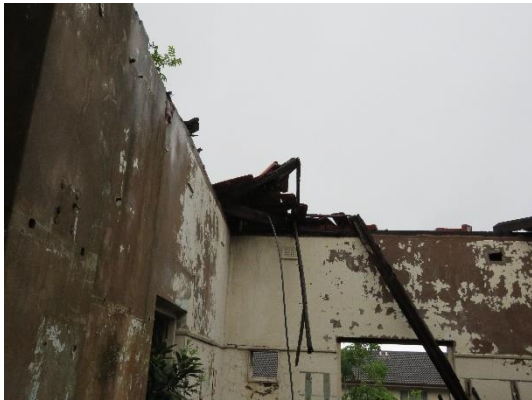
The timber roof structures and coverings for the building have largely collapsed due to decay and rotting of the structure. See photos 1 to 4.

Photo 3: Completely Collapsed Roof Structure

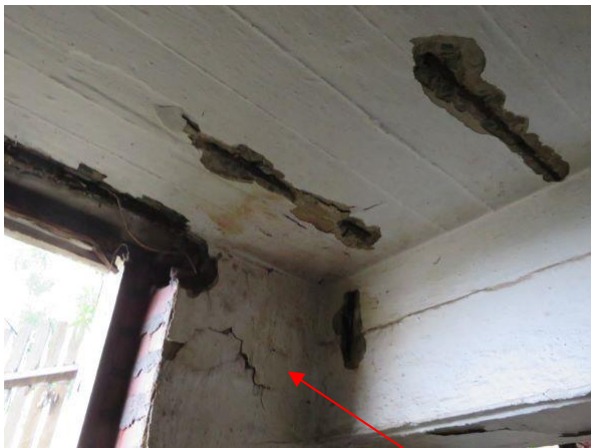
There are numerous concrete elements where signs of structural deterioration was noted. See photos 5 to 16. The defects include spalling of concrete, rusting of reinforcement and cracks on beams and slabs. We could not determine whether these cracks extend to the top of the slabs as there was no access due to the floor finishes (suspended timber floor) at the ground floor level.

Photo 5: Spalling of Concrete – Basement Roof Slab

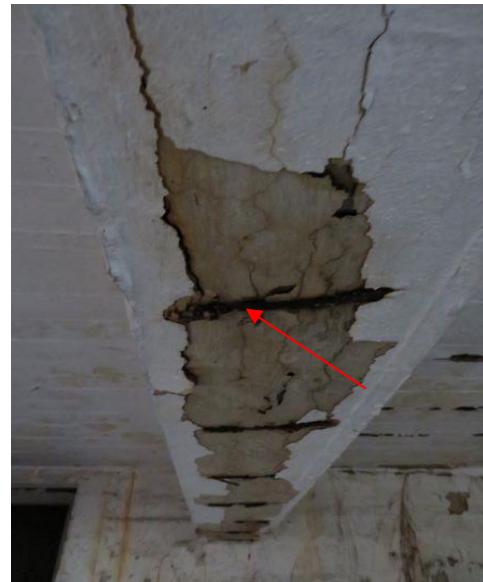
Photo 6: Spalling of Concrete and Rusting Rebar – Basement Roof Beam

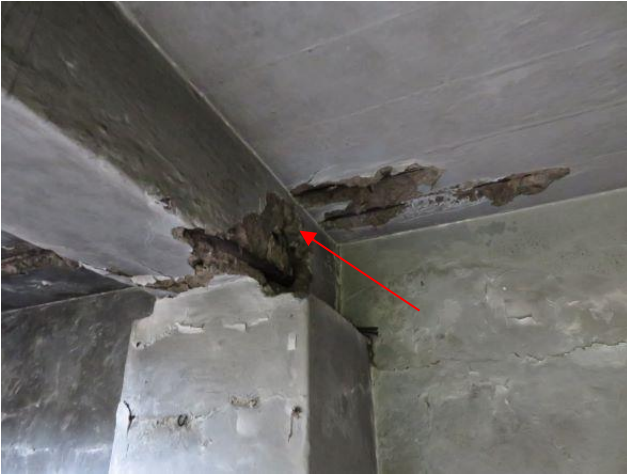
Photo 7: Spalling Concrete and Failure of Beam / Column Connection

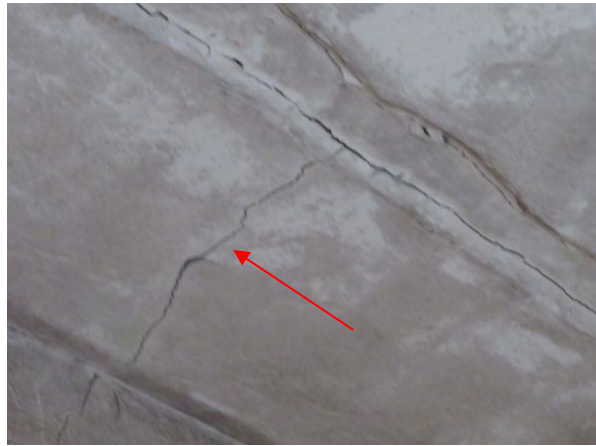
Photo 8: Cracked Roof RC Beam

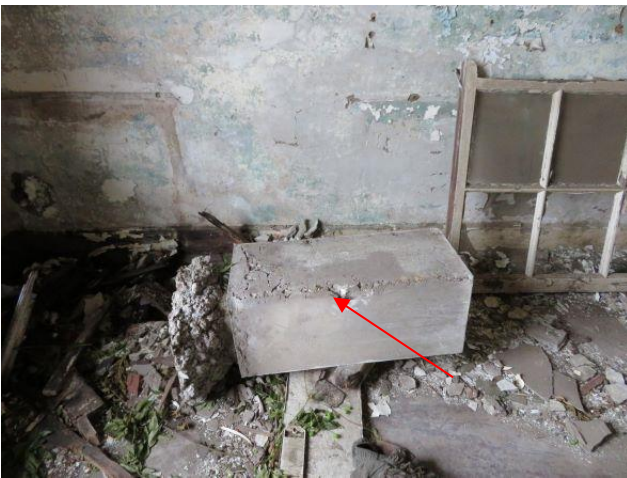
Photo 9: Collapsed RC Element

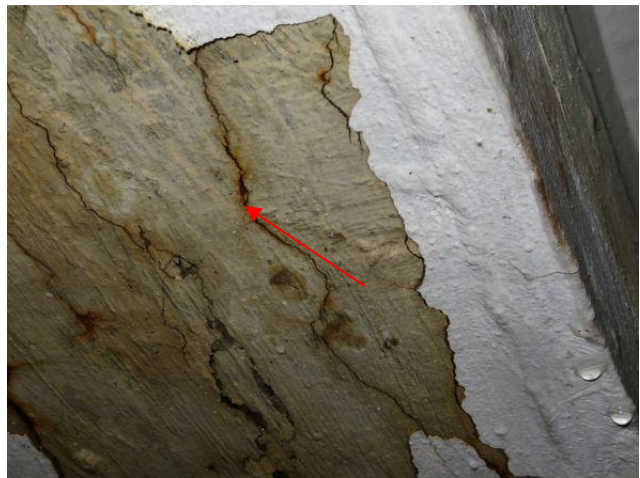
Water ingress is a very serious problem affecting the building. It was raining on the day of the inspection and the suspended slab for the basement was very damp and evidence of water ingress could be seen.

Photo 10: Signs of Water Ingress through RC Slab and Beams

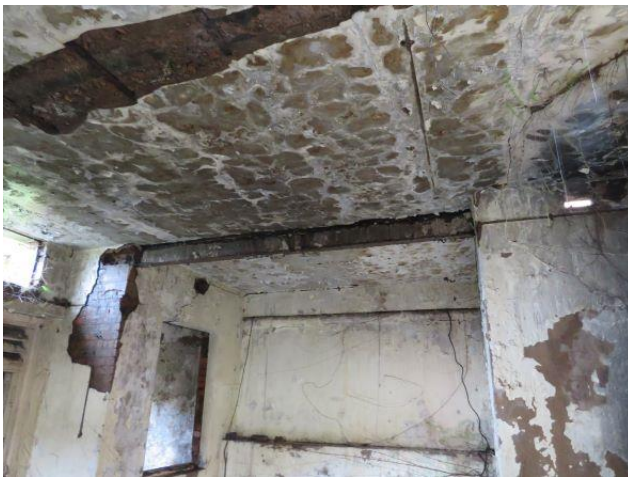
Photo 11: Very Poor Condition of RC Slab Soffit Signs of Water Ingress through RC Slab

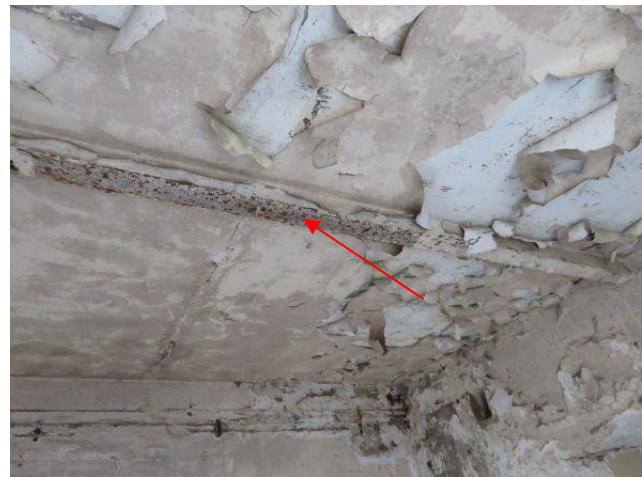
Photo 12: Very Poor Condition of RC Slab Soffit & Rusting Steel Elements

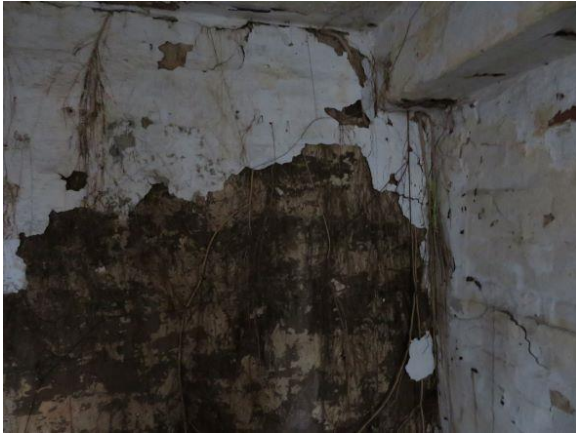
exposure of the walls to inclement weather for an extended period of time. There are also waterproofing problems on the basement walls. Rising damp on walls was also noted. A number of walls have also been damaged during theft of fittings. See photos 13 to 18.

Photo 13: Water damage to basement walls

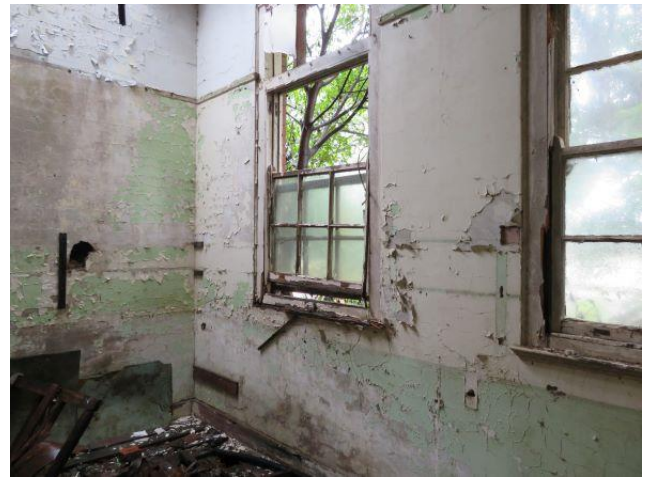
Photo 14: Water damage to walls

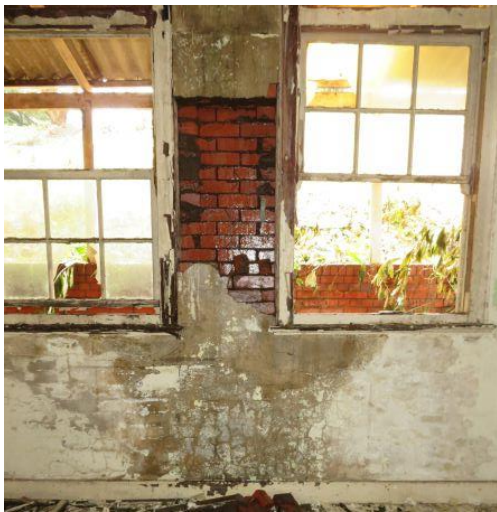
Photo 15: Damaged Internal Walls

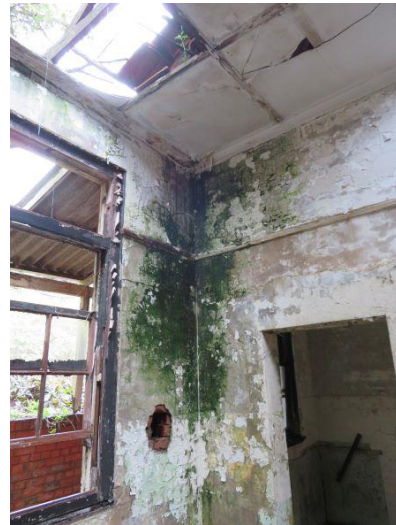
Photo 16: Water damage to walls (noted green mold on walls)

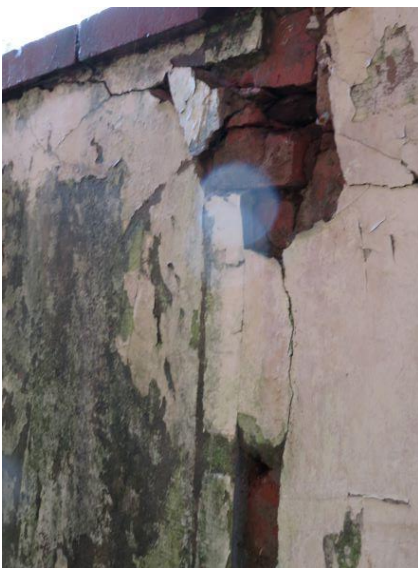
Photo 17: Major Cracks on Walls; Green mold on walls

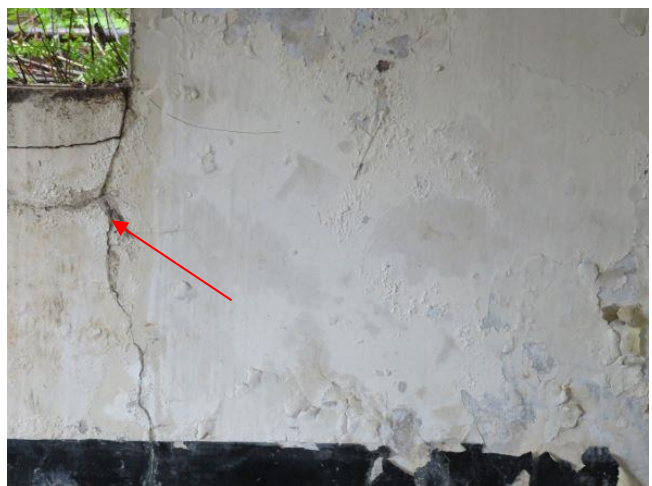
Photo 18: Major Cracks on Walls; Rising damp on walls

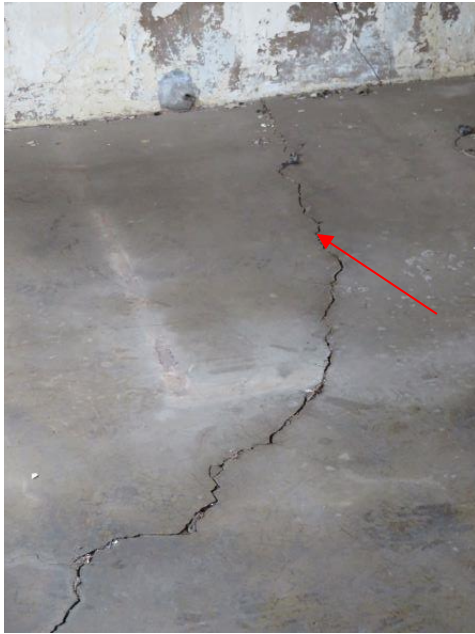
Photo 19: Major Crack on the Surface Bed

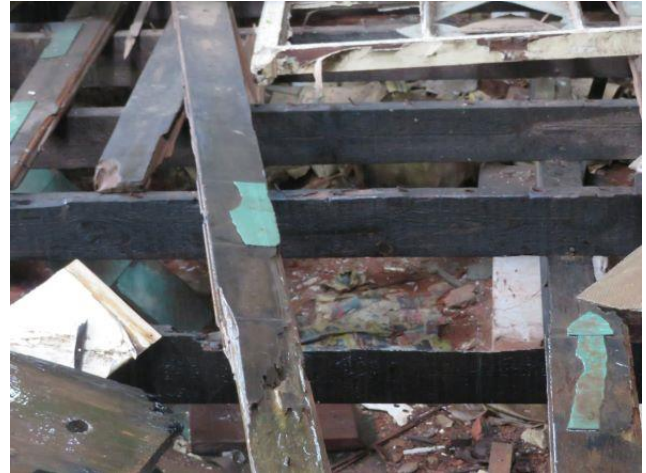
Extensive damage was noted on the suspended timber for the ground floor areas. The timber has rotten and collapsed in most areas. Certain areas of the floors are inaccessible due to this collapse. See photo 20.

Photo 20: Collapsed Timber Floor

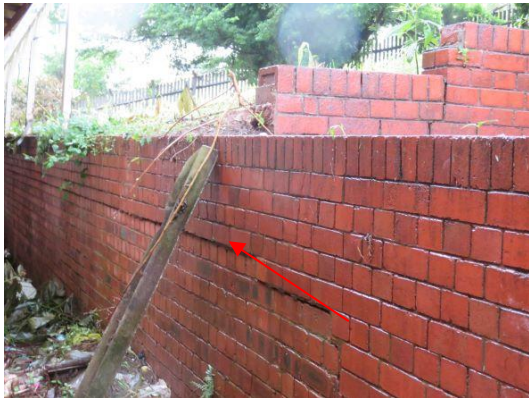
The facebrick retaining wall at the front of the building was noted to have horizontal cracks indicating push out by the retained earth.

Photo 21: Horizontal Cracks on Brick Retaining Wall

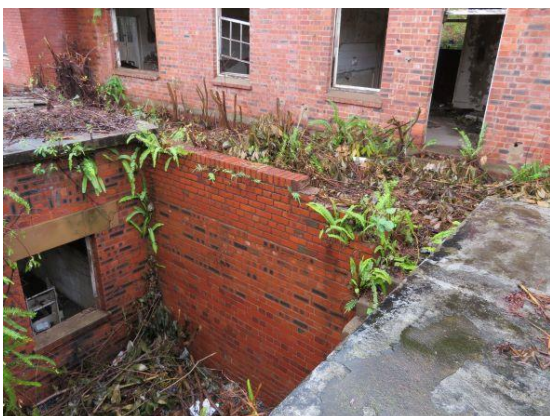
Photo 23: Roof slab showing poor condition (Debris and vegetation on top of slab)

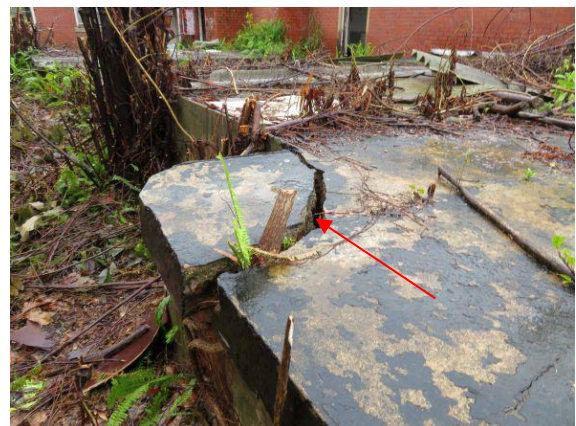
Photo 24: Roof slab showing poor condition (Cracks on slab)

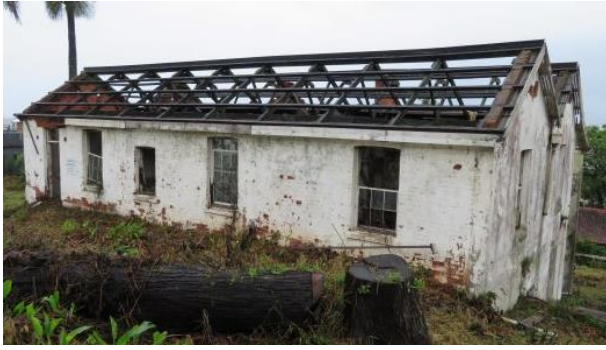
The roof coverings for the building are non-existent leaving the entire structure exposed to inclement weather for extended period of time. Timber roof structures are collapsing due to decay and rotting of the timber. See photos 25 to 28.

Photo 25: Bare roof structure without roof sheeting

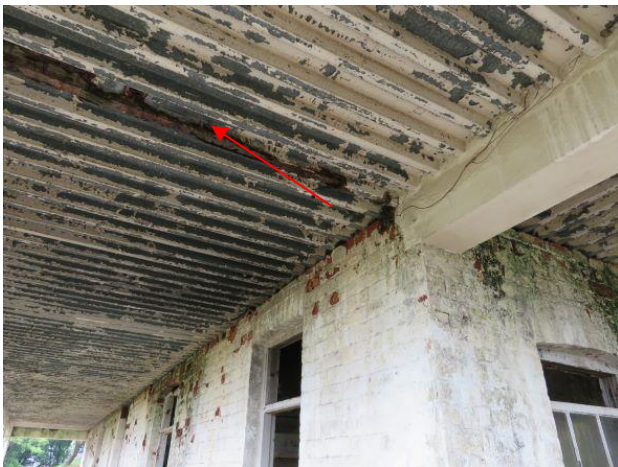
Numerous concrete elements with signs of structural deterioration were noted. See photos 29 to 34. The defects include spalling of concrete, rusting of reinforcement and composite steel deck and cracks on slabs, beams and columns. The slab cracks were noticeable across the entire span of the slab and at regular intervals. We also could not determine whether the suspended slabs cracks extend to the top of the slabs as there was no access from above due to collapsed walkway at the first floor level.

Photo 29: Rusting Composite Slab Steel Deck

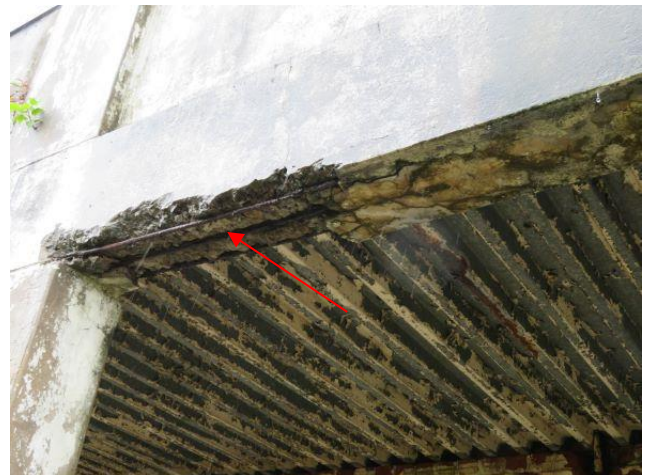
Photo 30: Spalling Concrete & Rusting Composite Slab Steel Deck

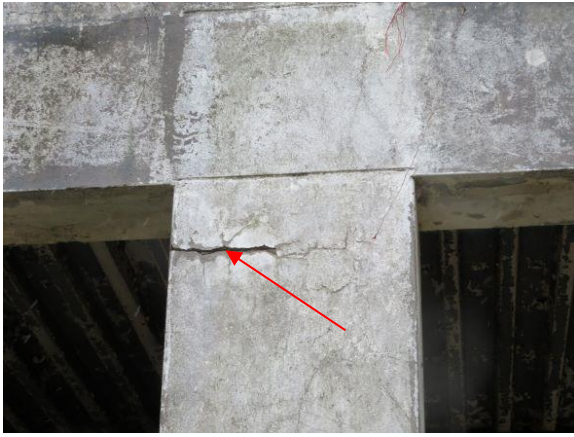
Photo 31: Cracking Beam / Column Connection

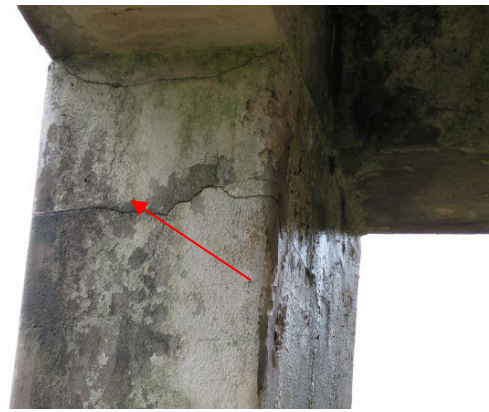
Photo 32: Cracking Beam / Column Connection

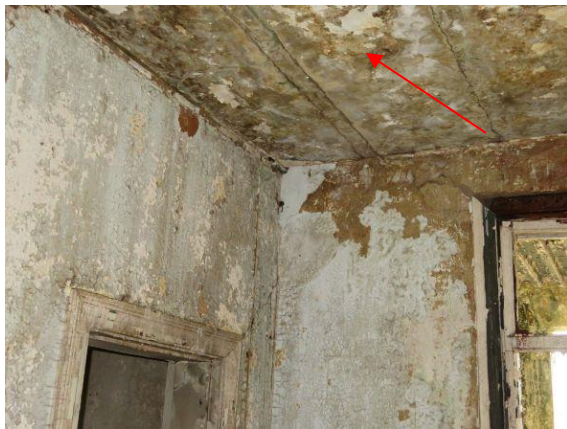
Water ingress is a very serious problem affecting the building. It was raining on the day of the inspection and the suspended slabs for the first floor slabs were very damp and evidence of water ingress could be seen from below.

Photo 33: Very Poor Condition of RC Slab Soffit Signs of Cracks and Water Ingress through Slab

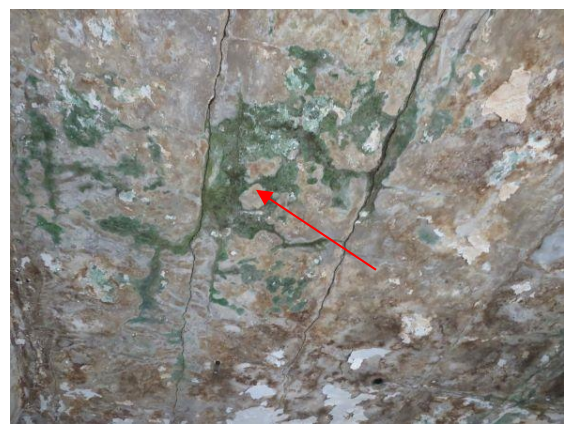
Photo 34: Very Poor Condition of RC Slab Soffit Signs of Cracks and Water Ingress through Slab

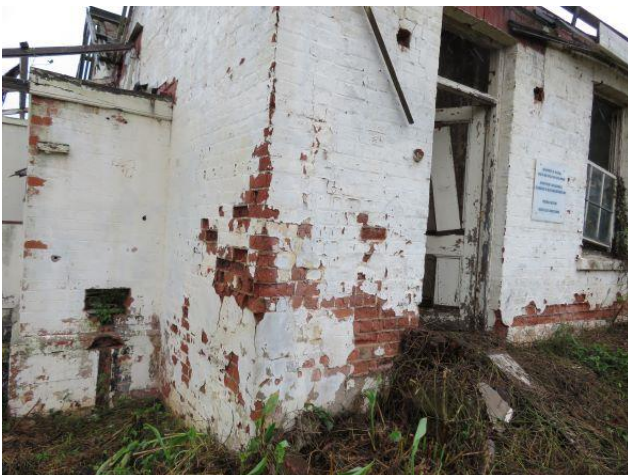
Most of the building walls are in a very poor condition. See photos 35 to 40. Major cracks were noted on numerous walls across the building. Water damage to walls was also noted on numerous walls. The bricks for the walls were observed to be deteriorating by spalling (surface flake off) as a result of the water damage. Signs of rising damp on the walls was noted.

Photo 35: Typical External Wall – Disintegrating Walls and Rising Damp Signs

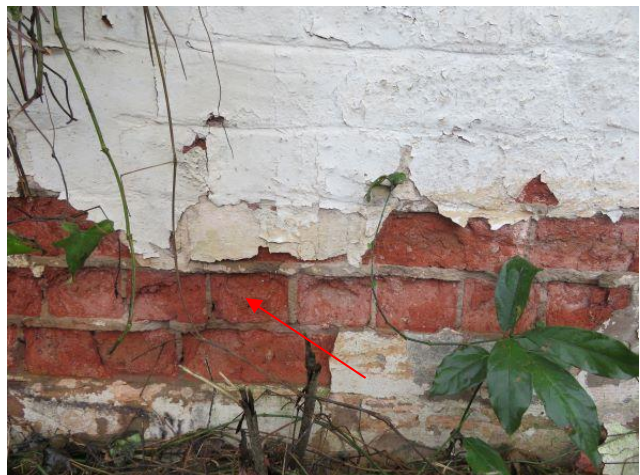
Photo 36: Disintegrating Brick Walls

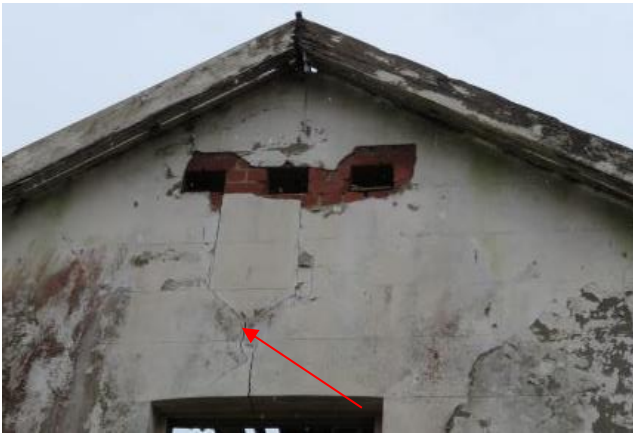
Photo 37: Major Cracks on Gable Wall

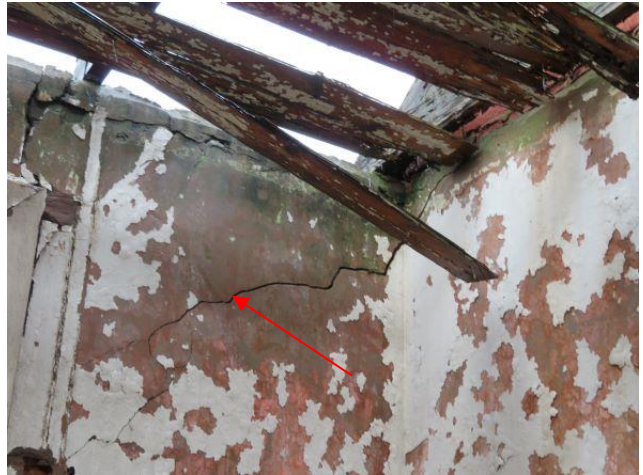
Photo 38: Major Cracks on Internal Wall

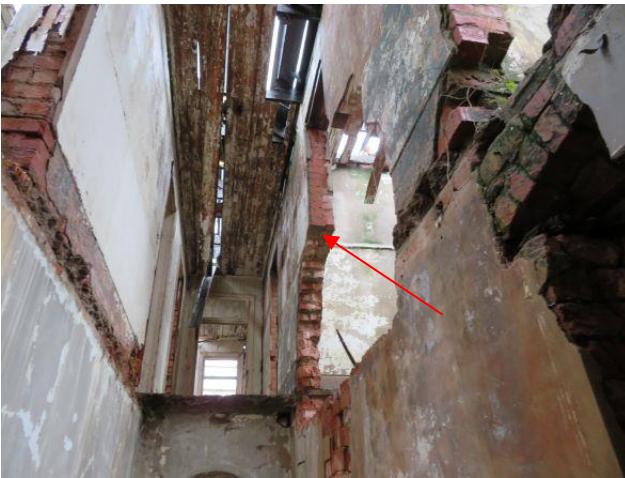
Photo 39: Unsupported Sections of Walls Due to Collapsed / Vandalised Support System

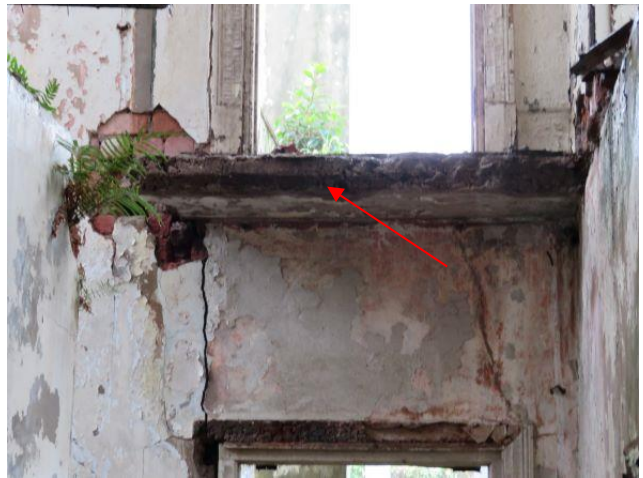
Photo 40: Collapsed walkway slab & Failing lintel system

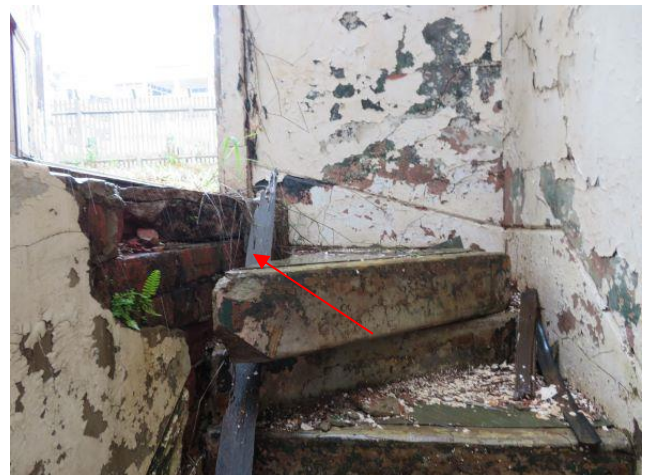
Photo 42: Collapsing Stair Steps (Note poor condition of external wall)

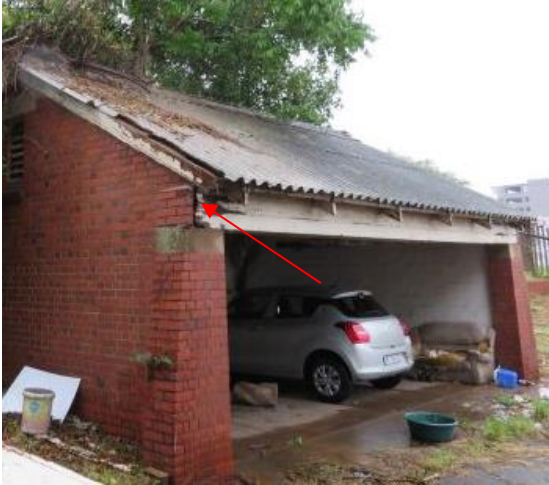
Like the two main buildings, this building is also falling into a serious state of disrepair. See photos 43 to 50. Timber roof structure is showing signs of decay and rotting of the timber. The roof covering is of asbestos material hence a health hazard.

Photo 43: Timber beam showing signs of rotting (Note asbestos roof sheeting)

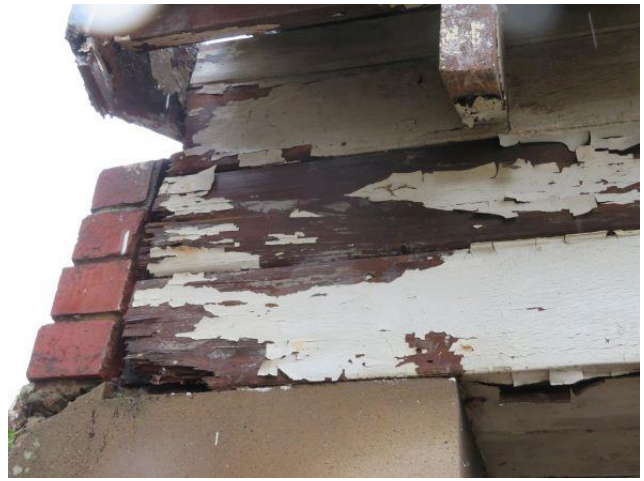
Photo 44: Timber beam showing signs of rotting

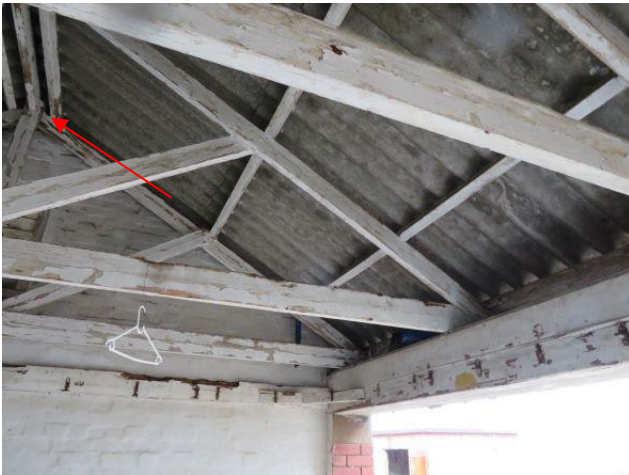
Photo 45: Timber showing signs of rotting

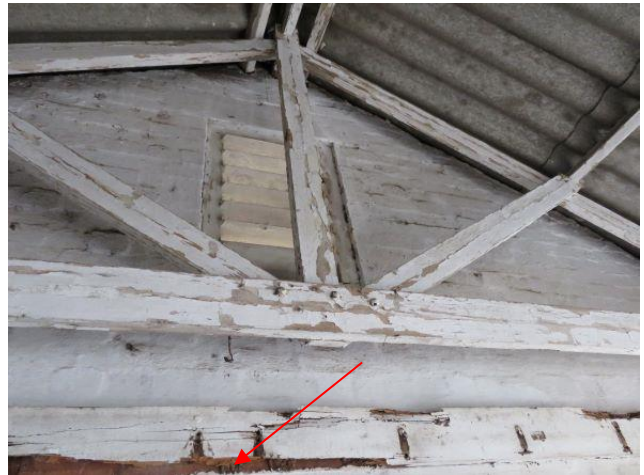
Photo 46: Timber showing signs of rotting

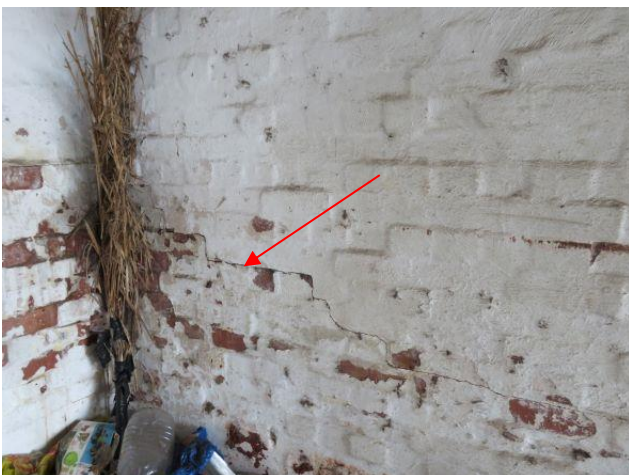
Photo 47: Major cracks on side wall

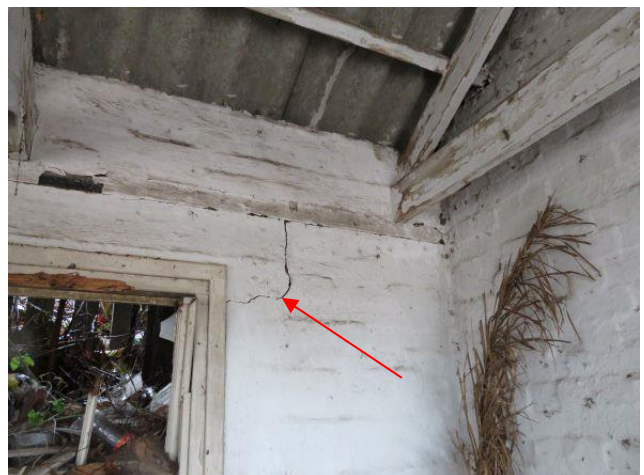
Photo 48: Major cracks on back wall

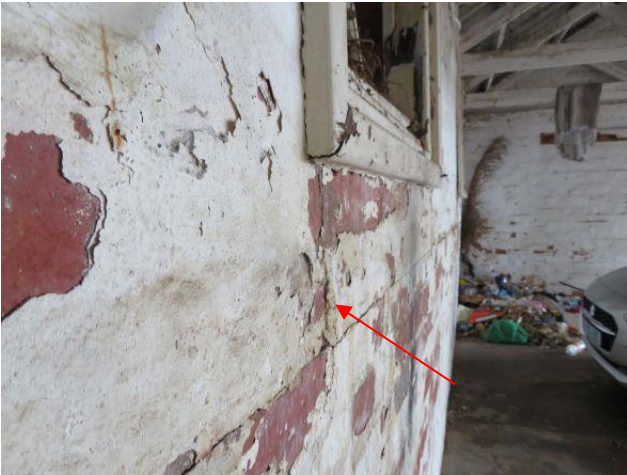
The rear wall of the building, which serves as retaining wall, has bulged out at mid-height and cracks have also developed on the wall. Numerous wall cracks were also noted on other walls. Rising damp on walls was also noted.

Photo 49: Major cracks on retaining (back) wall (bulging)

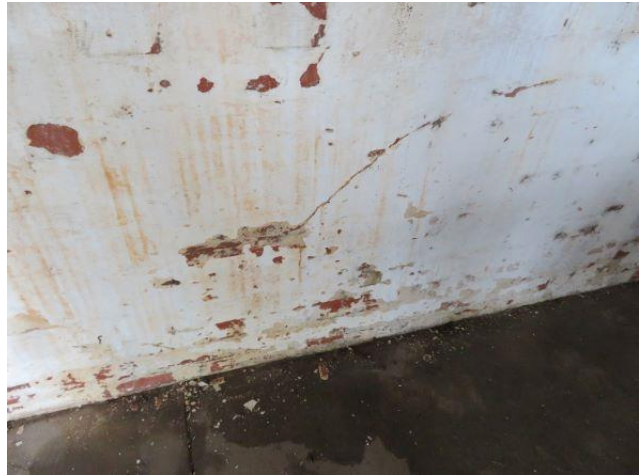
Photo 50: Signs of rising damp on back wall

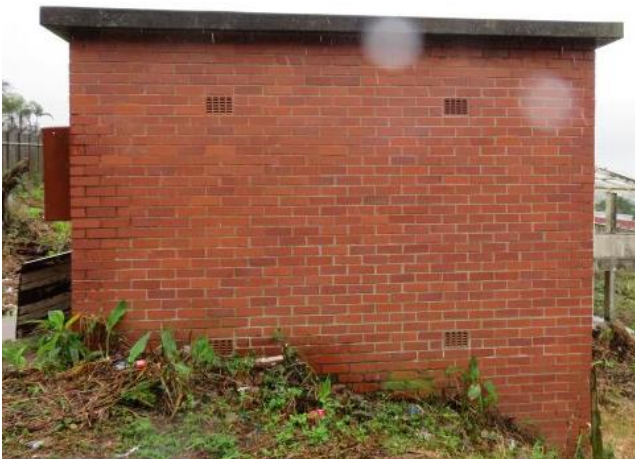
Photo 51: Typical Brick Wall Condition (fairly good)

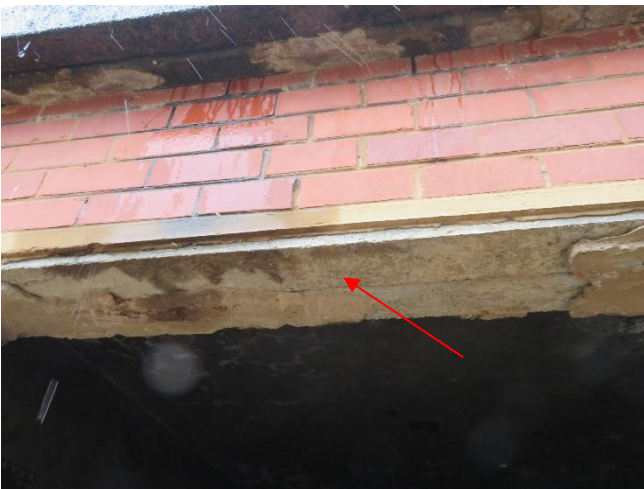
This is the only building that is in a fairly good condition on this site. See photos 51 to 54. The only defects noted related to roof slab waterproofing problems and a damaged lintel beam above the main door opening.

Photo 53: Signs of Lintel Deflection (Plaster delaminating)

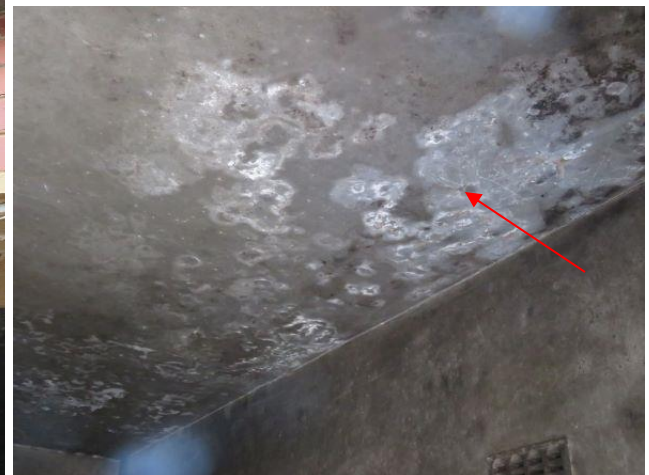
Photo 54: Signs of water ingress on RC roof slab

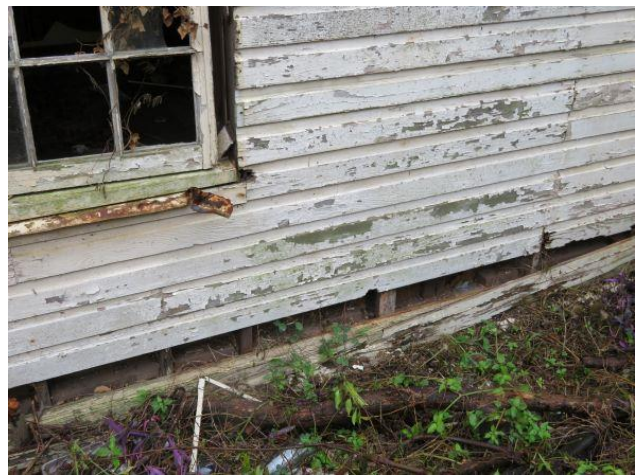
This is a temporary timber structure that is also in a very poor condition. See photos 55 to 60. The defects mainly relate to decay and rotting of the timber. The roof covering is of asbestos material hence a health hazard.

Photo 58: Poor Interior Condition of the Structure

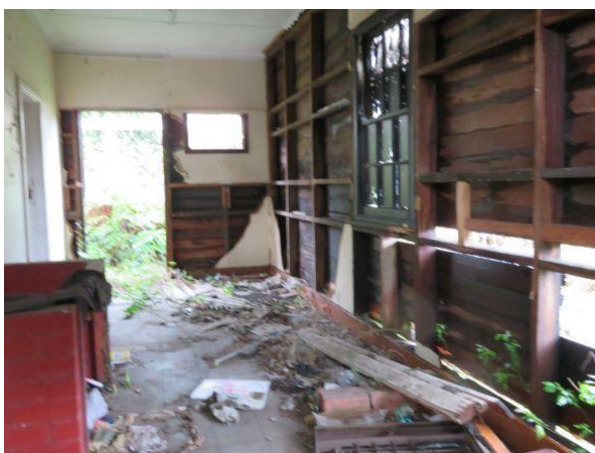
Photo 59: Poor Interior Condition of the Structure

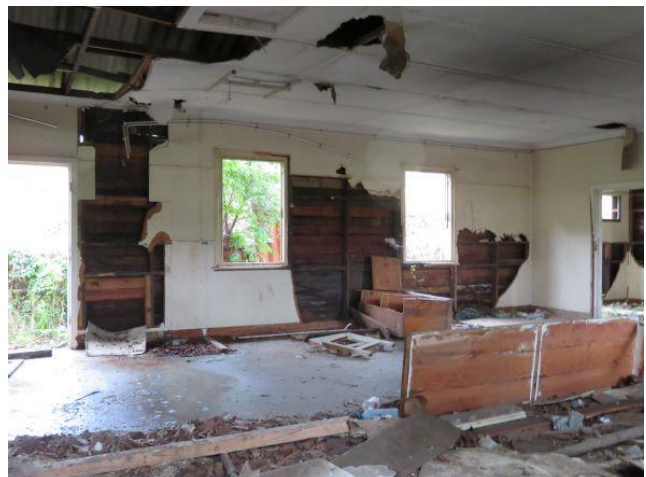
Photo 60: Poor Interior Condition of the Structure

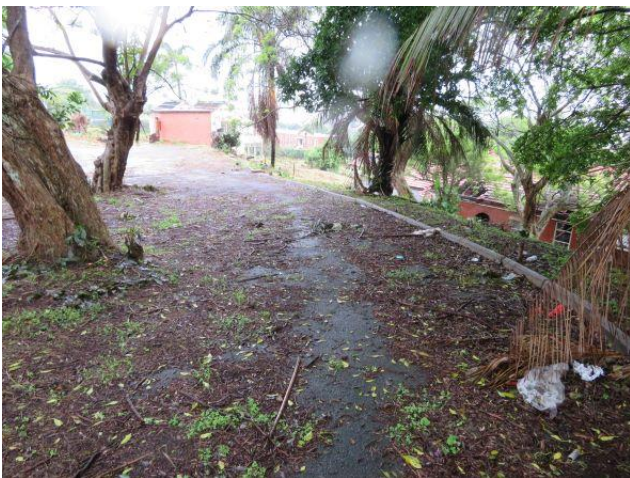
The tarred driveway that links both access gates is showing signs of surface failure with numerous crocodile cracks. There is vegetation growth on the road due to lack of maintenance of the road. See photos 61 to 64.

Photo 63: Typical Driveway Condition

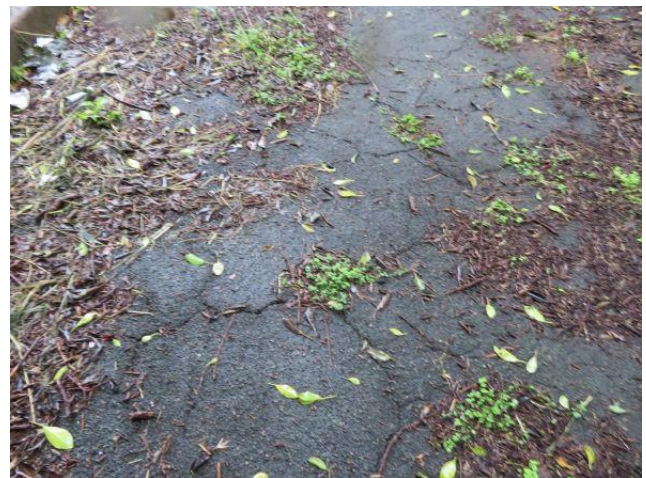
Photo 64: Typical Driveway Surfacing Condition

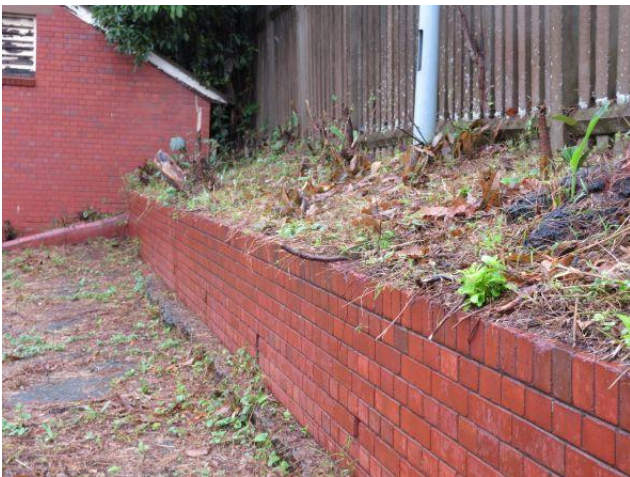
Majority of the walls are being undermined by trees behind the walls resulting in cracks. The brick retaining wall along the driveway by the main gate has a vertical crack over the full wall height. The foundations for this wall are also exposed. See photos 65 to 66.

Photo 65: Retaining wall by Main Gate (Note exposed foundations)

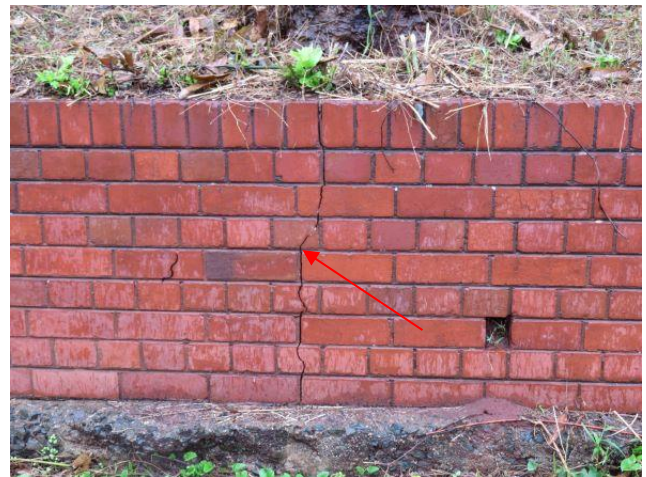
Photo 66: Crack on brick retaining wall
