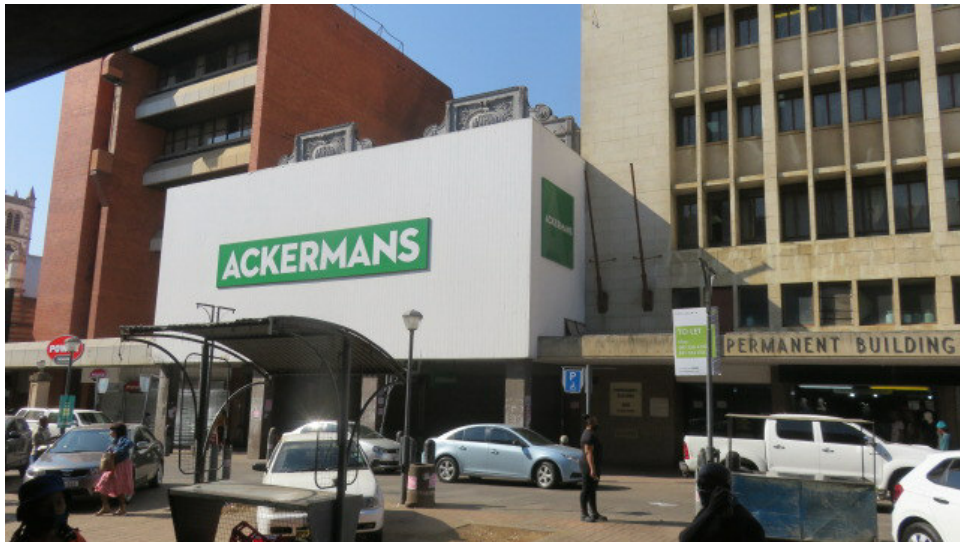
Plate 2 - Modern facade to structure.JPG

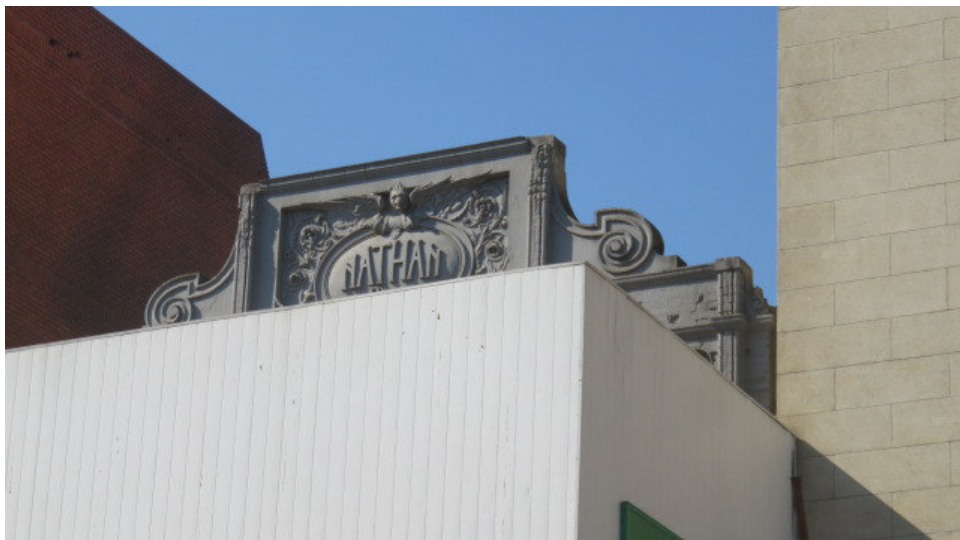
Plate 3 - Remains of previous plaster mouldings to front facade.JPG

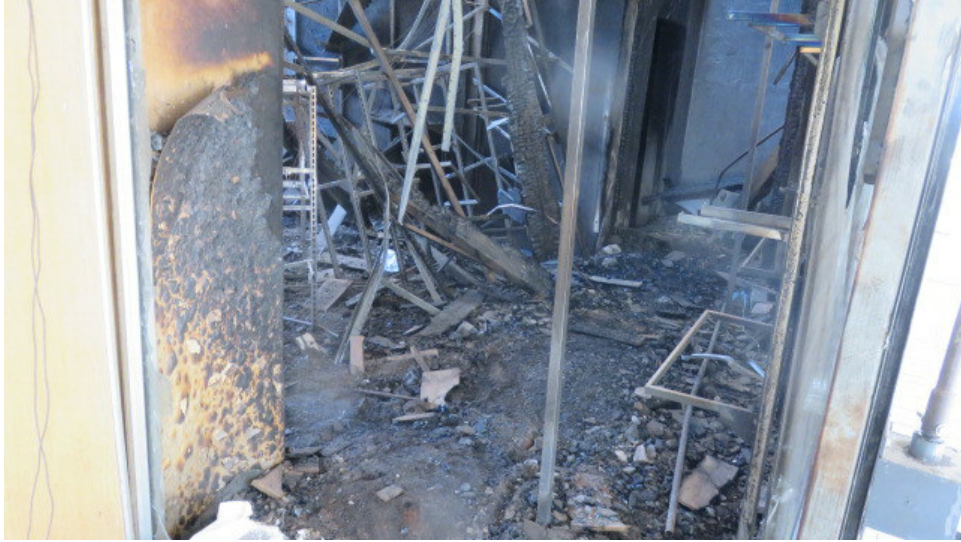
Plate 4 - Damaged interior.JPG

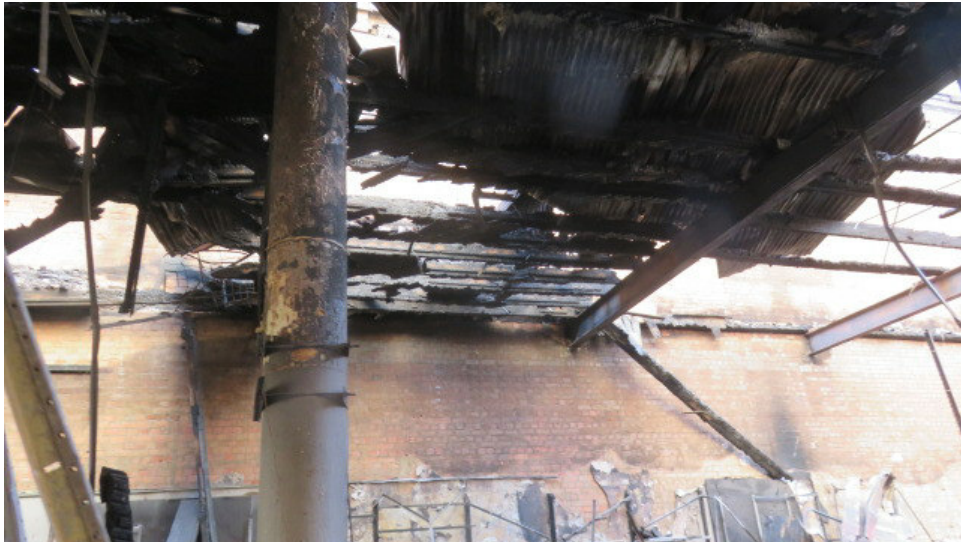
Plate 5 - Damaged mezzanine.JPG

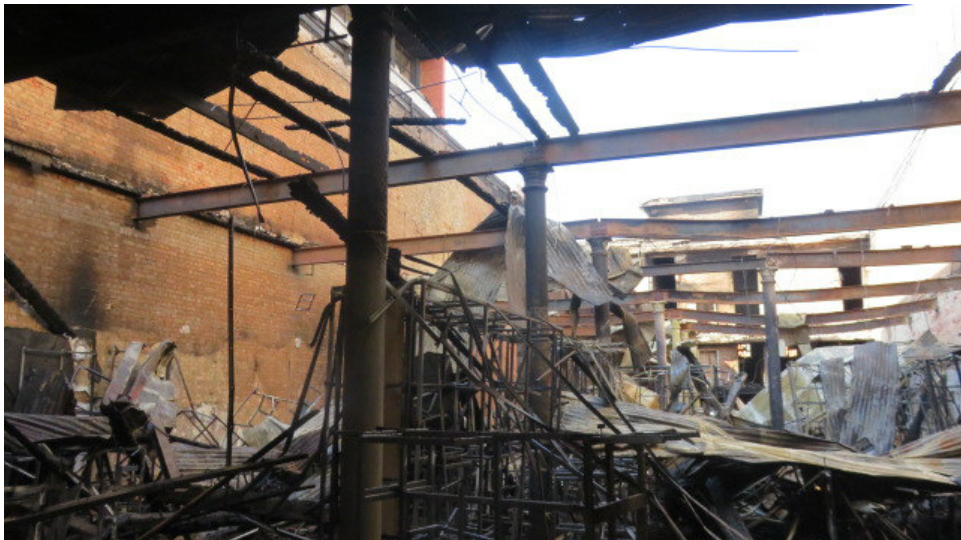
Plate 6 - Compromised beams that supported the mezzanine timber floor.JPG

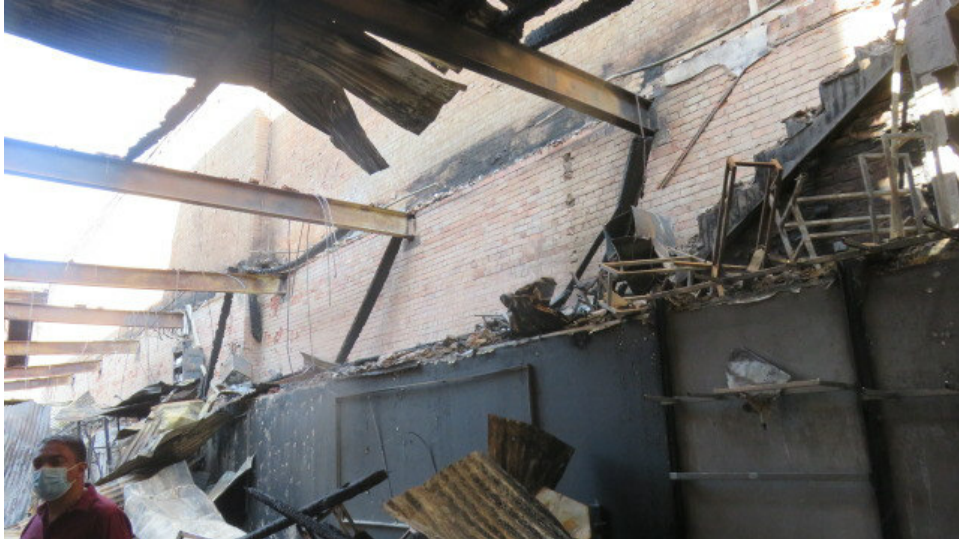
Plate 7 - Steel beams built into side walls.JPG

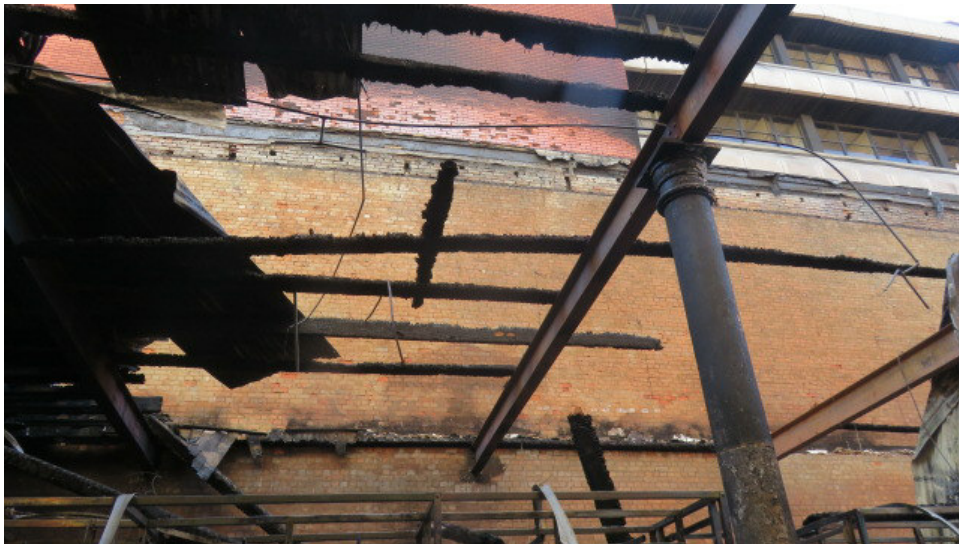
Plate 8 - Side walls adjacent to neighbouring structures.JPG

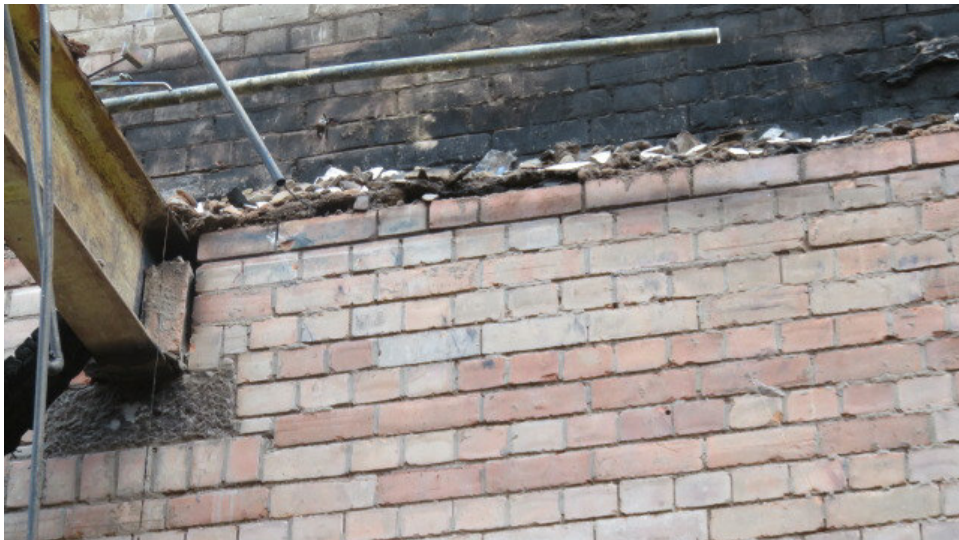
Plate 9 - Steel beam supported on concrete pads.JPG

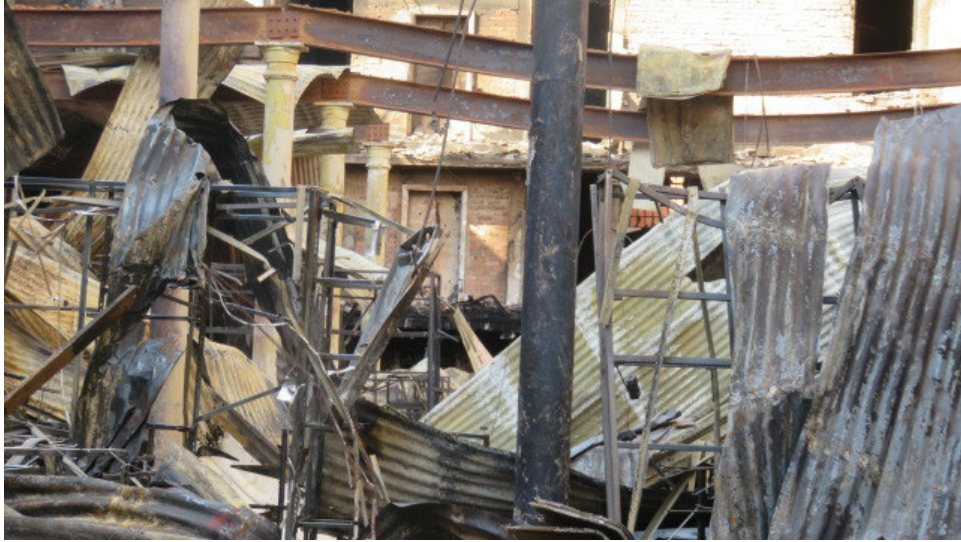
Plate 10 - Typical internal damage.JPG

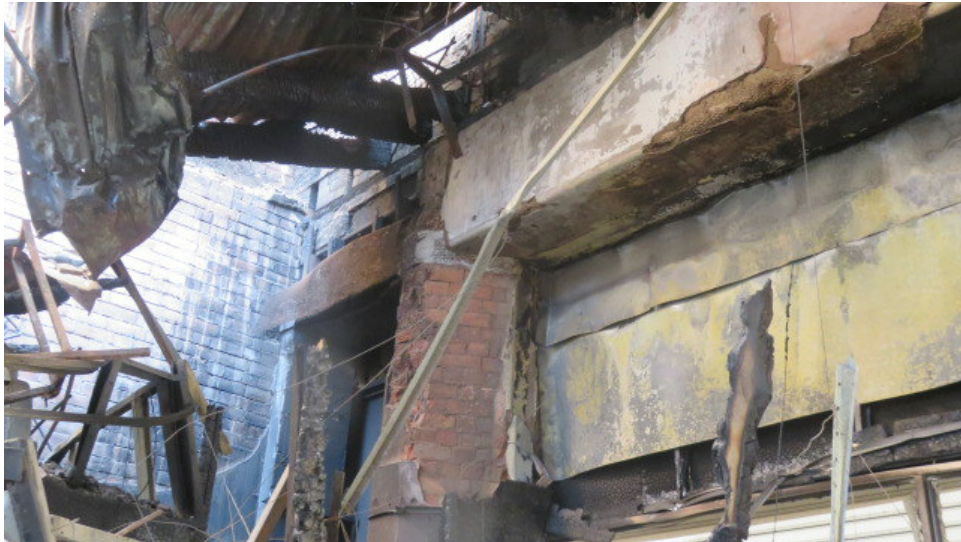
Plate 11 - Steel beams incorporated in front facade.JPG

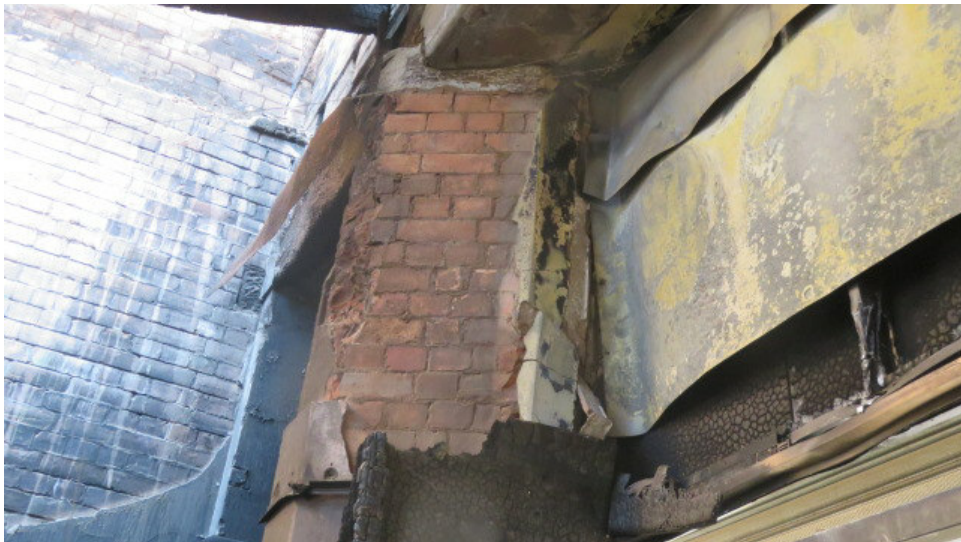
Plate 12 - Spalled brick piers that form part of the front facade.JPG

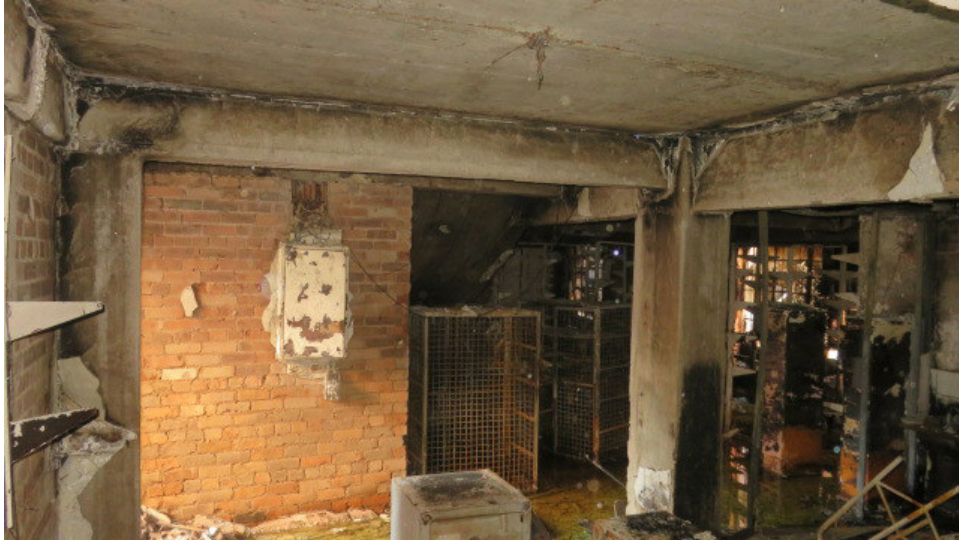
Plate 13 - Rear storage area with reinforced concrete columns beams and slab.JPG

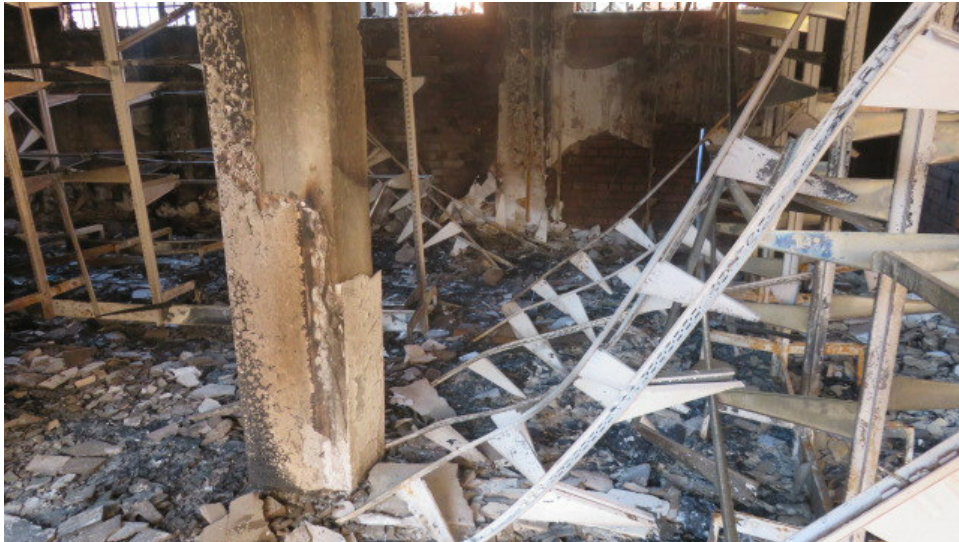
Plate 14 - Spalled plaster around concrete columns.JPG

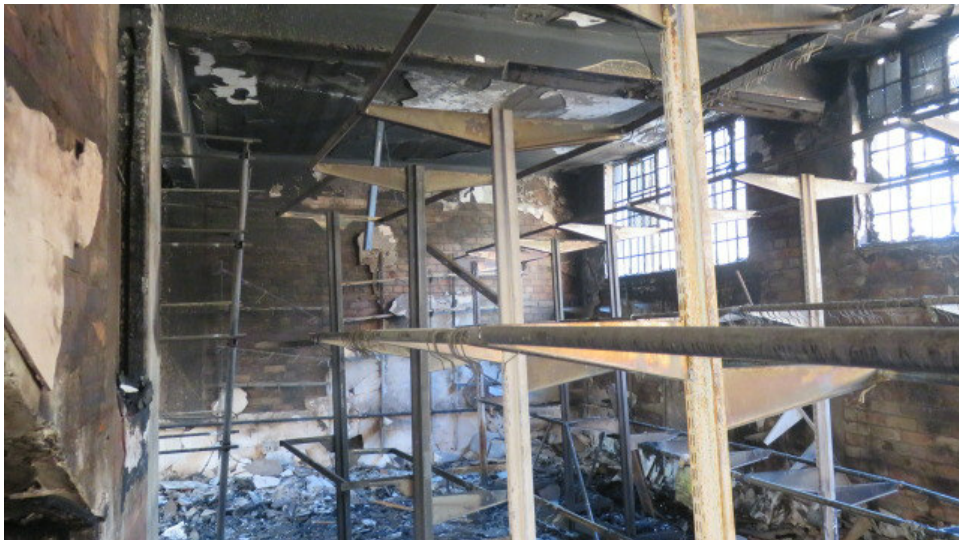
Plate 15 - Rear storage area beneath concrete beams and slabs with spalled plaster.JPG

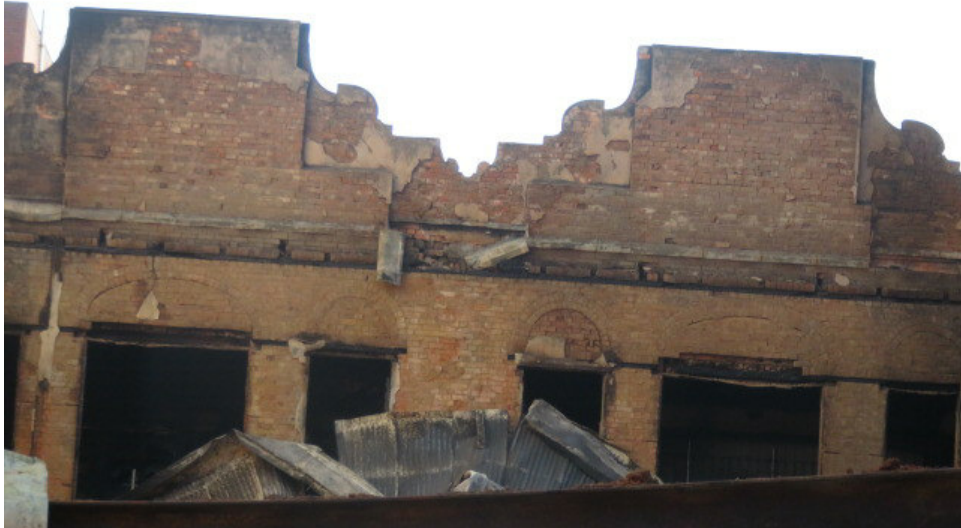
Plate 16 - Rear gable compromised.JPG

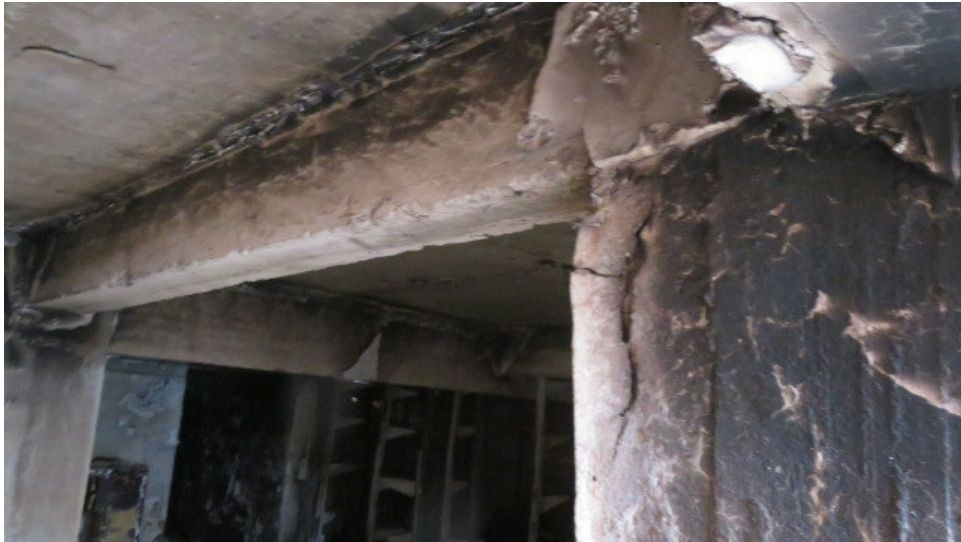
Plate 17 - Compromised walls at rear storage area.JPG

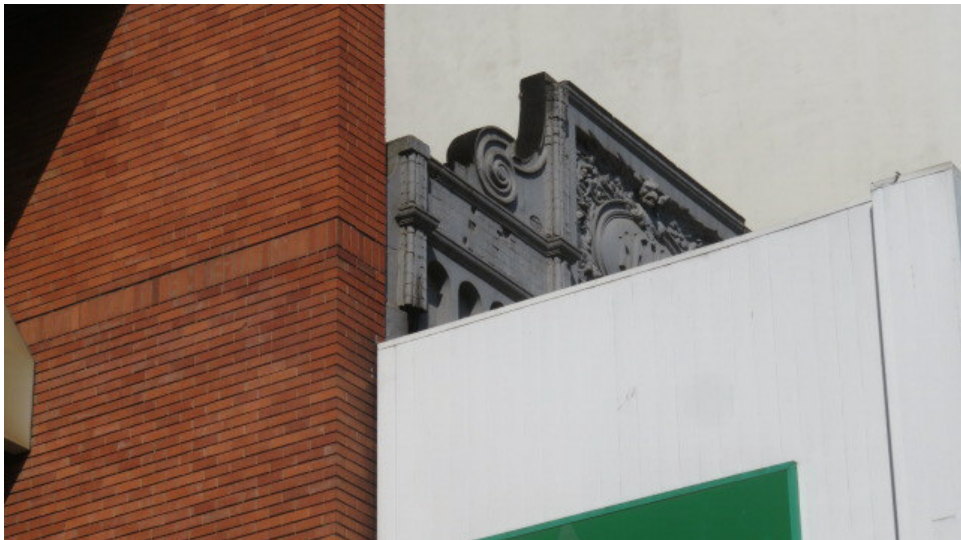
Plate 18 - Remains of plaster moulding behind new modern front facade.JPG

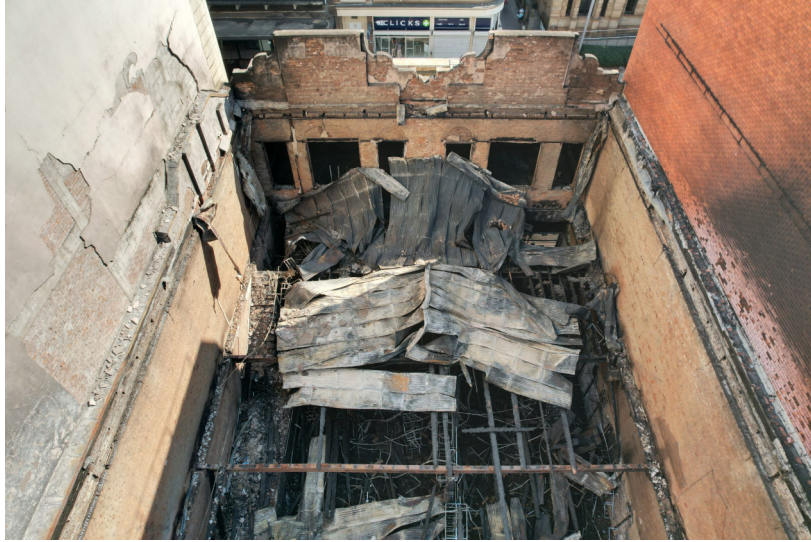
Plate19 - Drone photograph indicates the extensive damage to the complex.JPG

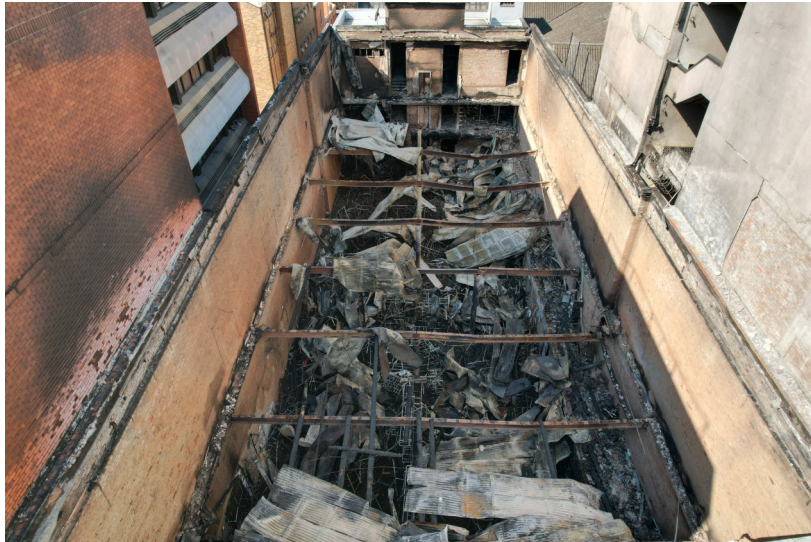
Plate 20 - Drone photograph indicates details of side walls.JPG

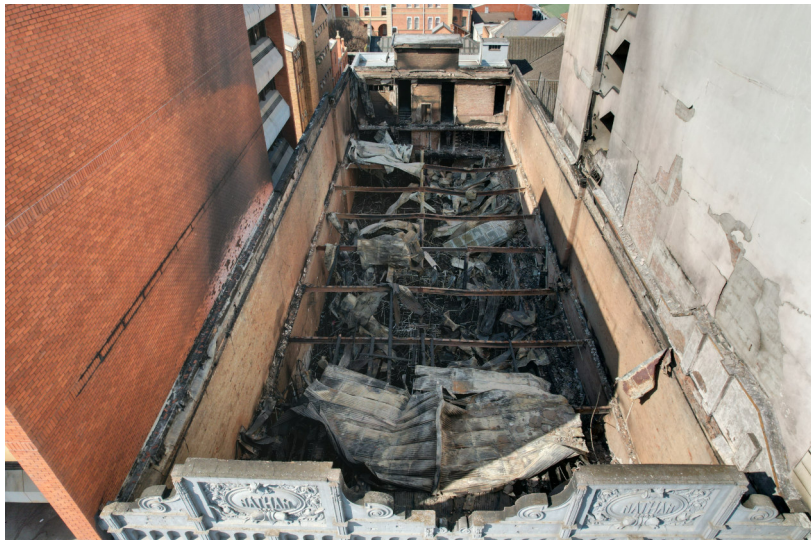
Plate 21 - Drone photograph indicating extensive fire damage.JPG
