31 March 2022

RESTORATION OF OUTBUILDING 1 AT 258 WAKESLEIGH ROAD BELLAIR

REPORT ON STRUCTURAL DEFECTS AND RECOMMENDATIONS FOR REMEDIAL WORK

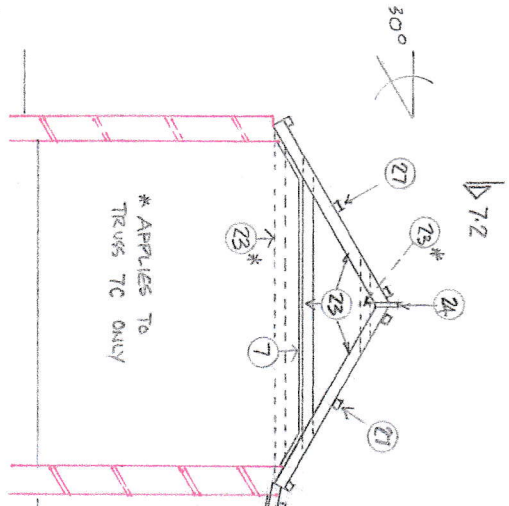
SECTION 7.1 (1:50)
(TRUSSES 7B & 7C)

The cross section through the roof together with the measured and inferred Oregon Pine timber sizes are shown on schedule RR/7 .

The 230 x 22 ridge beam is not present above most of Store 1 despite the top chord truss rafters being notched for such a ridge beam . The ridge beam is slightly laterally distorted at off-set rafter positions

Several rafters have deep (up to 50 mm) notchings out of either the top or bottom surfaces ..

There are two locations above Ablu 1/Store 1 where the west roof slope rafters are offset relative to the east roof slope rafters ; the ridge beam having to transfer both vertical and horizontal forces to the adjacent fully configured trusses .

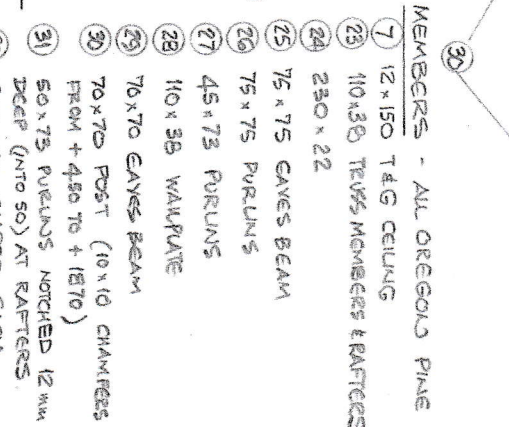
SECTION 7.2 (1:50)

The roof covering is asbestos sheeting of a profile similar to that of Everite Bigsix . The ceilings are 12 x 150 mm T& G boards fixed to the underside of the roof truss bottom chords . The construction of the timber roof trusses (type 7A) is shown on schedule RR/7 . The purlin size and spacings are shown in section 7.2 of the schedule . All timber is Oregon Pine .
