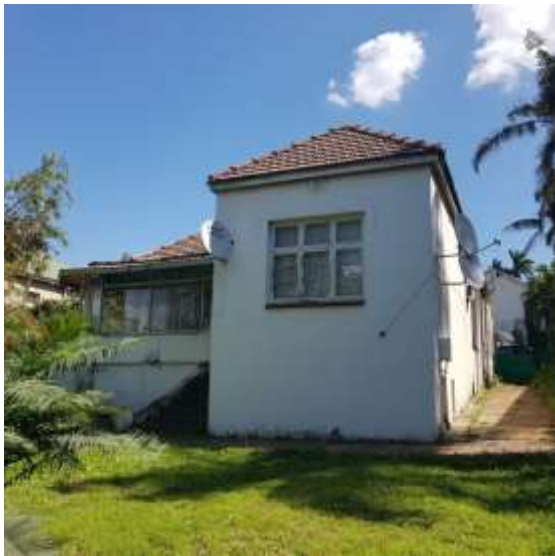
East elevation to Problem Mkhize Road.

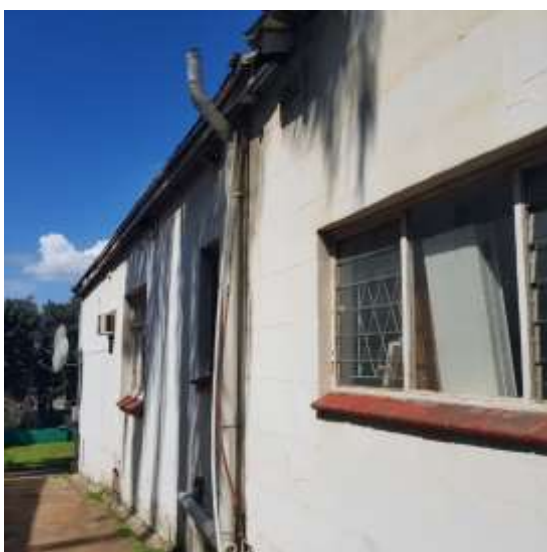
North elevation.

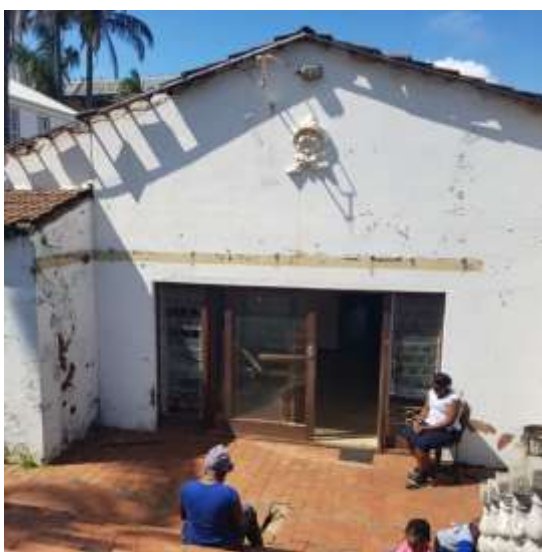
West elevation.

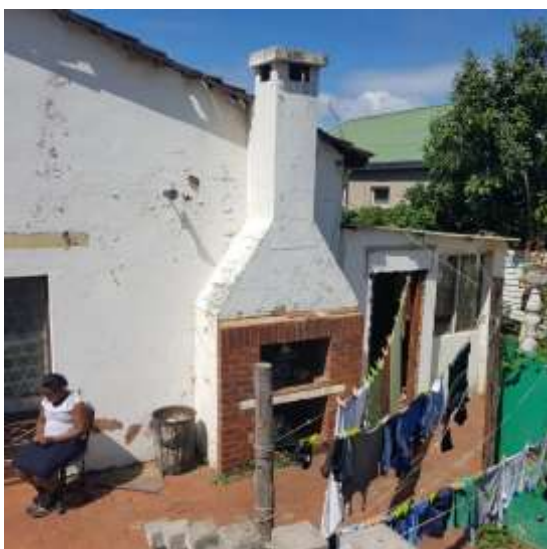
West elevation.

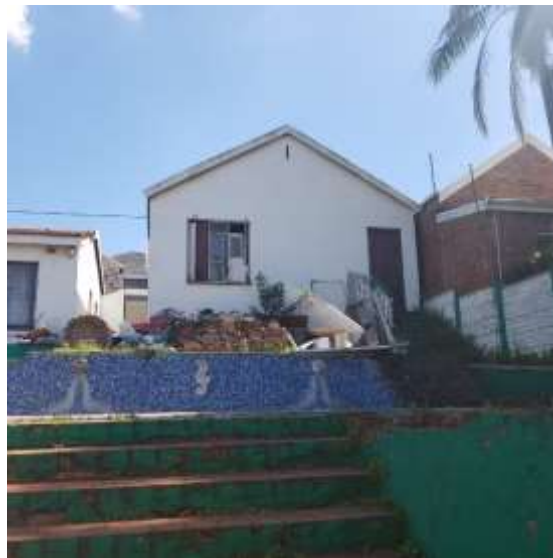
More recent outbuildings.

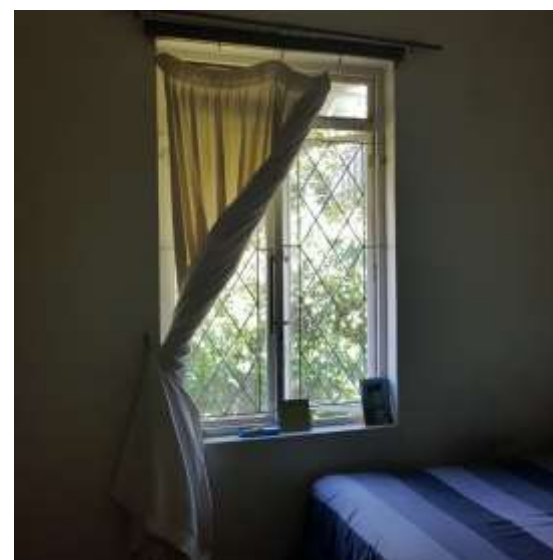
Original window.

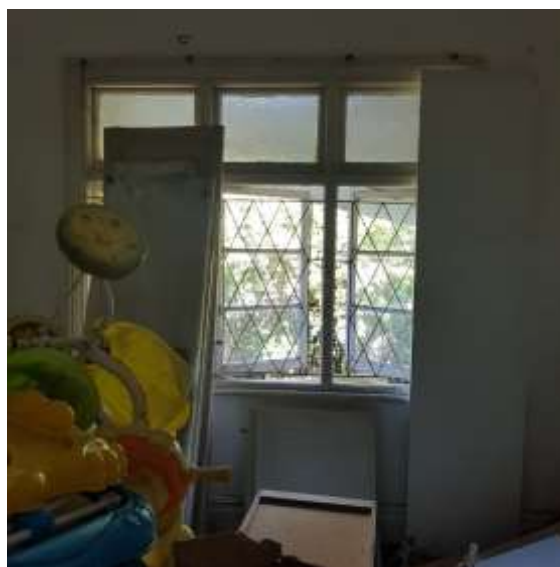
Enclosed front veranda.

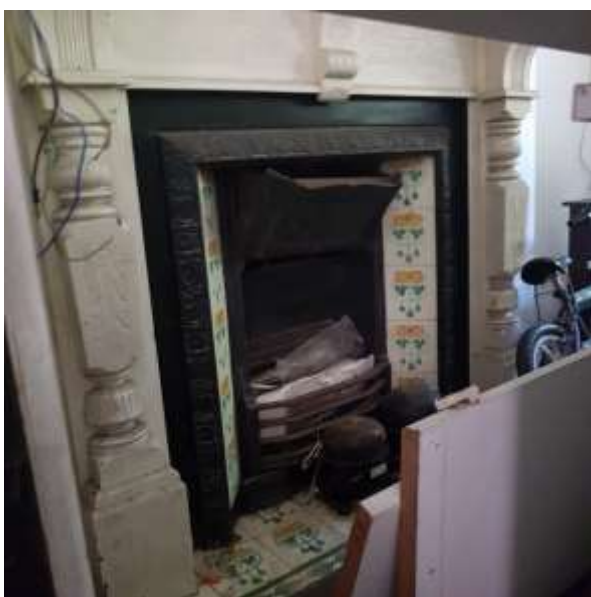
Edwardian fireplace which should be recycled.
