296 Effingham Rd, Redhill
AMAFA Demolition Application
Catalogue of Images

1. Images of Existing House

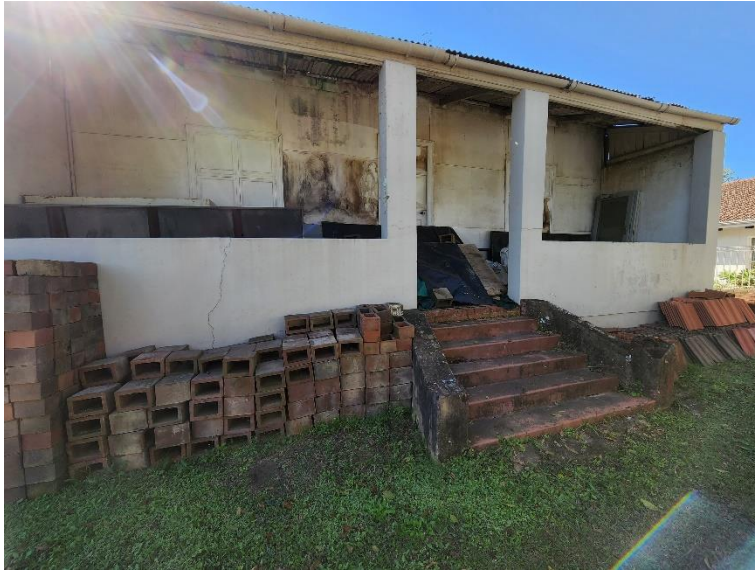
Image 1: Existing front elevation of the house which faces Effingham Rd. There is significant water damage to the walls and roof. There is also cracking to the walls.

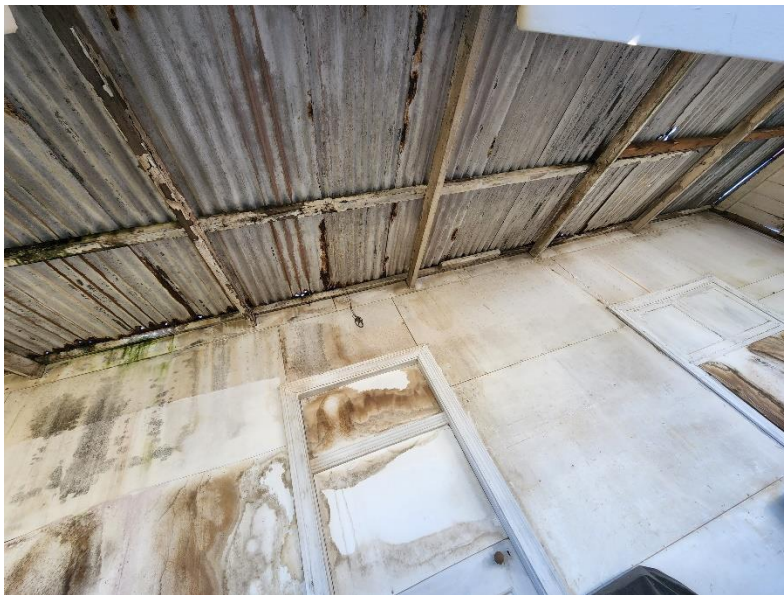
Image 2: Close up of front elevation showing damage to the door, walls and roof. Many of the doors and windows have been boarded up due to extensive damage, mainly caused by water over an extended period of time.

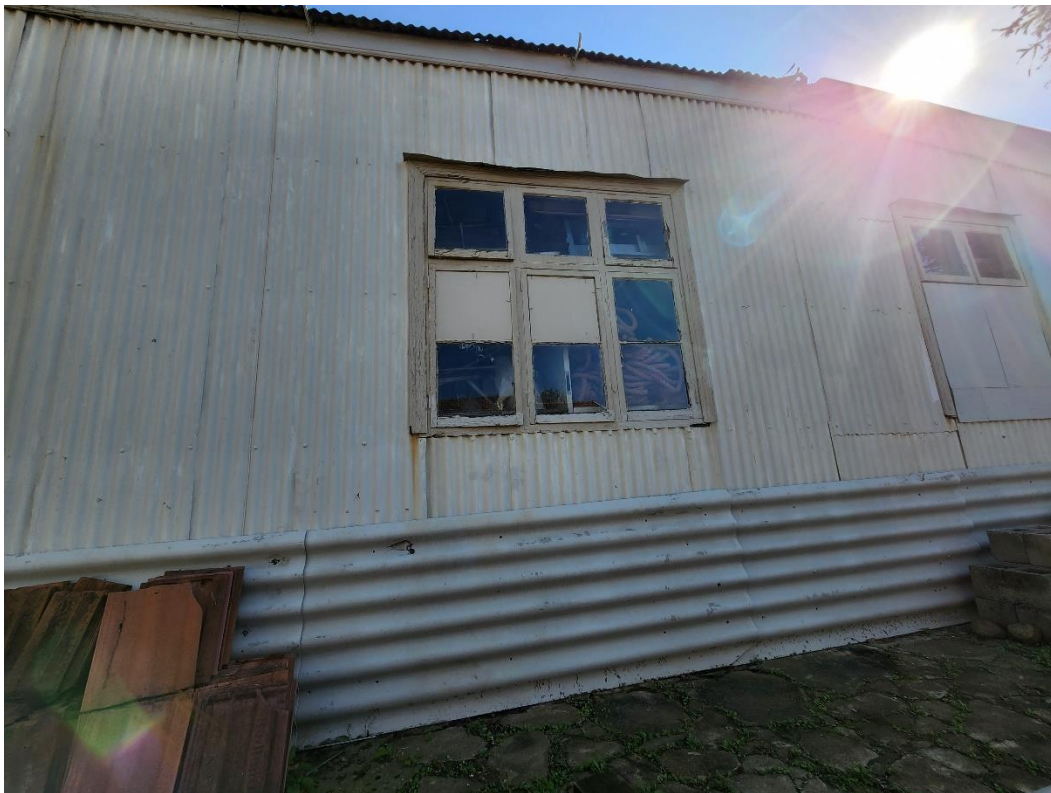
Image 4: Side elevation which faces the neighbouring property. Cottage pane windows are in poor condition.

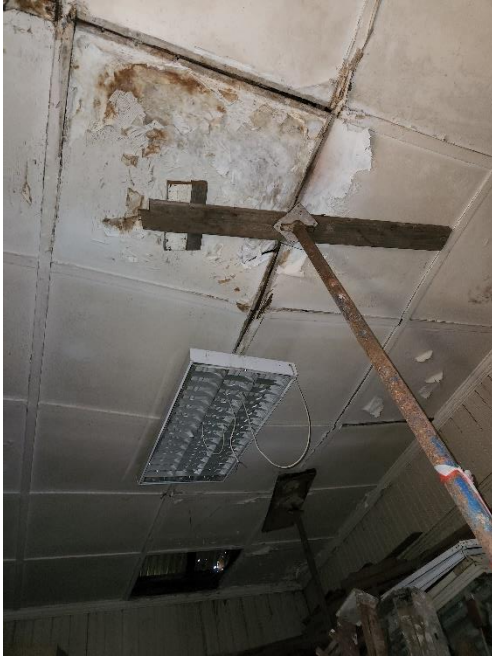
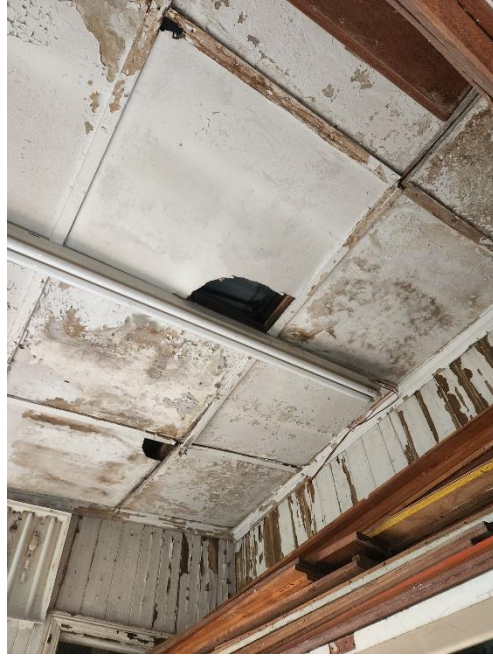
Image 5 and 6: As illustrated in the image above the roof and ceilings are severely damaged and are currently being supported by props. The roof has been damaged by both borer and water, and the ceilings have also been damaged by water. The degree of damage poses a hazard and has made the building unsafe for occupation. There are many holes in the ceiling boards.

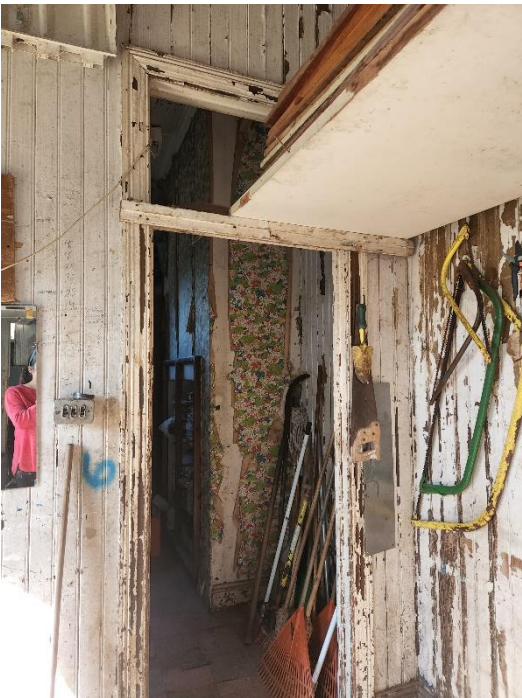
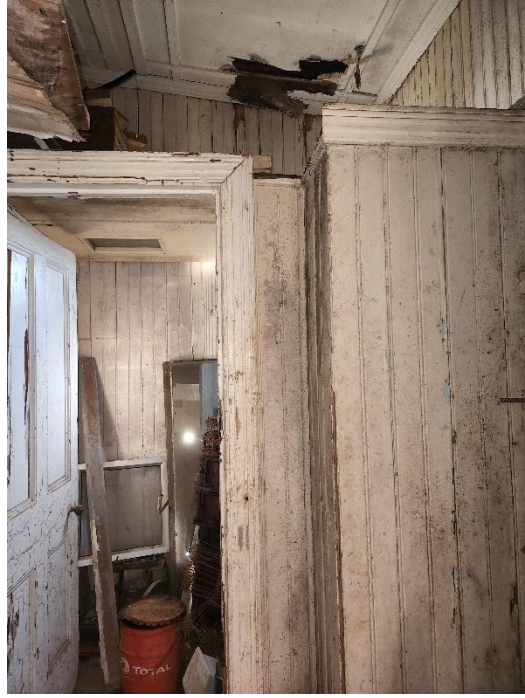
Image 7 and 8: Damage to internal walls and Ceilings

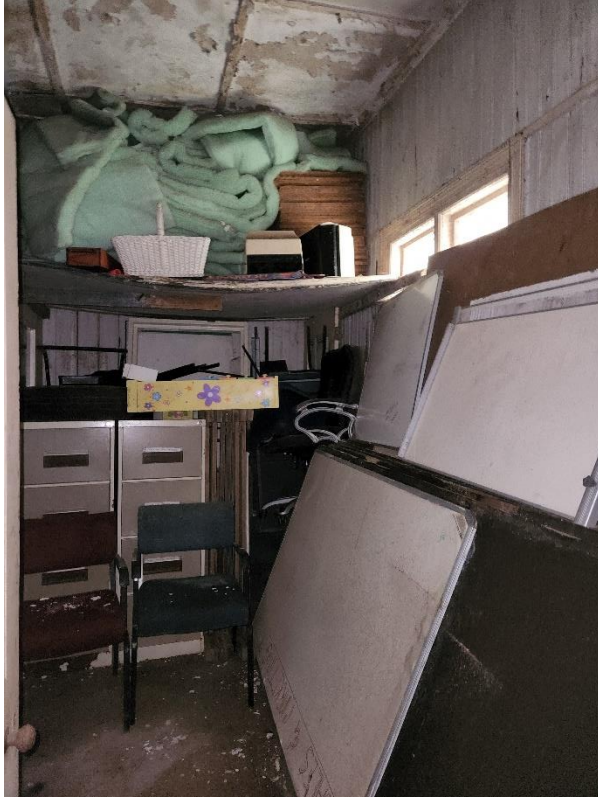
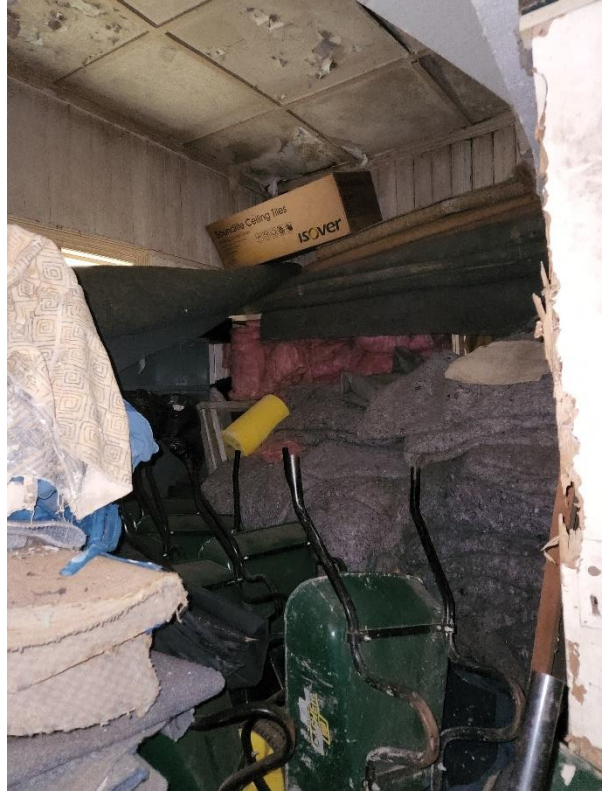
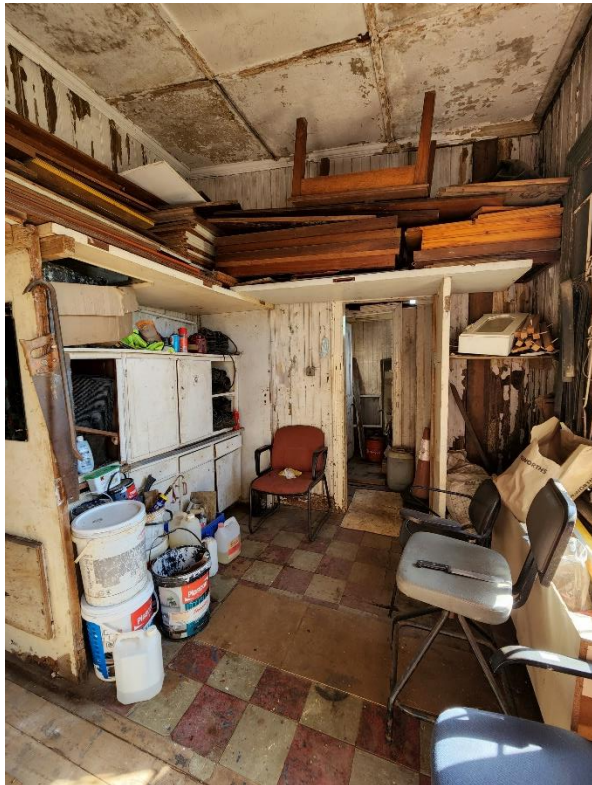
Image 9, 10 and 11: Damage to internal walls and Ceilings
