PHOTO REPORT: 101 & 105 BOTANIC GARDENS ROAD

PROPOSED DEMOLITION TO ACCOMMODATE NEW STUDENT HOUSING DEVELOPMENT AT 101 BOTANIC GARDENS RD, PORTION 12 (OF 2) OF ERF 2292 DURBAN & 105 BOTANIC GARDENS RD, PORTION 2 OF ERF 2292 DURBAN.

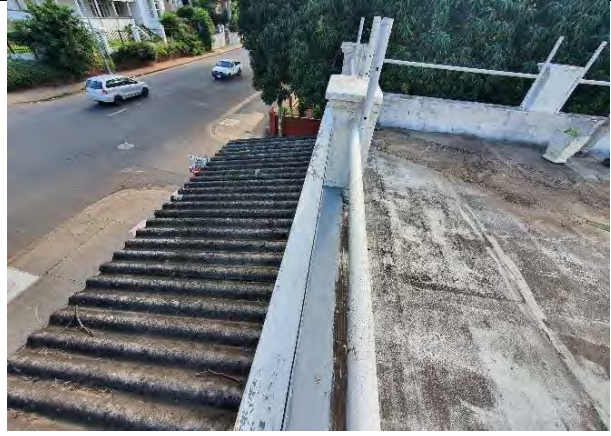
Figure 1.12: Existing asbestos roof

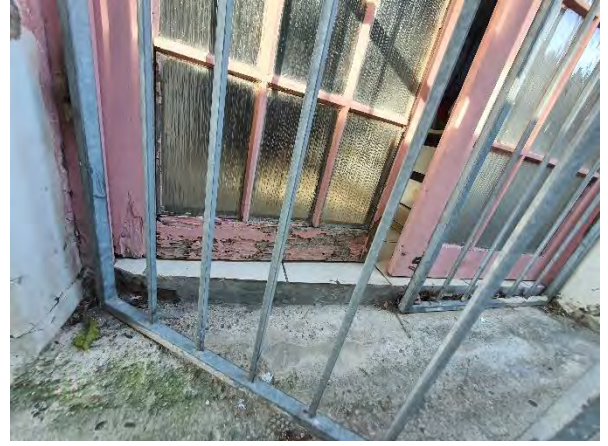
Figure 2.10: Existing door and wooden frames rotted

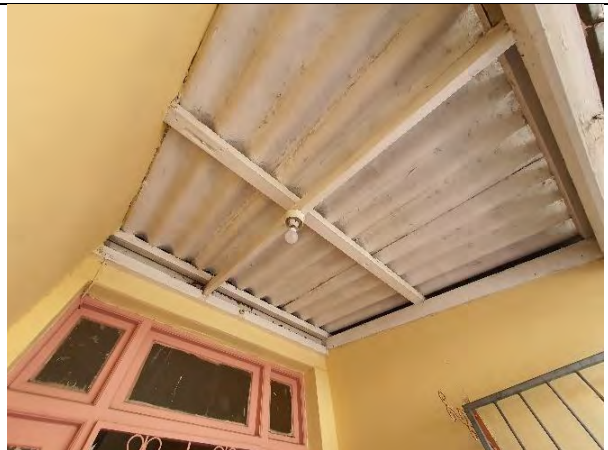
Figure 2.12: Existing asbestos roofing over entrance

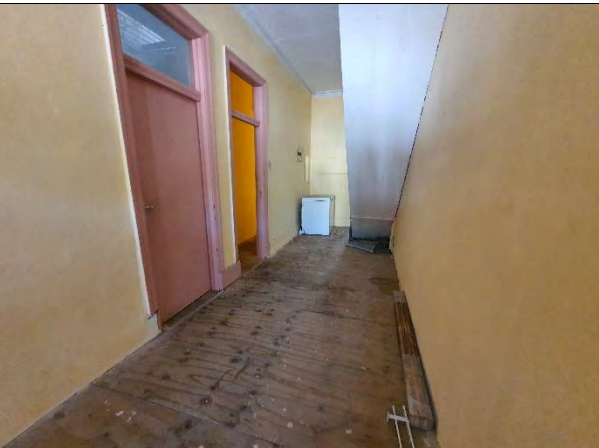
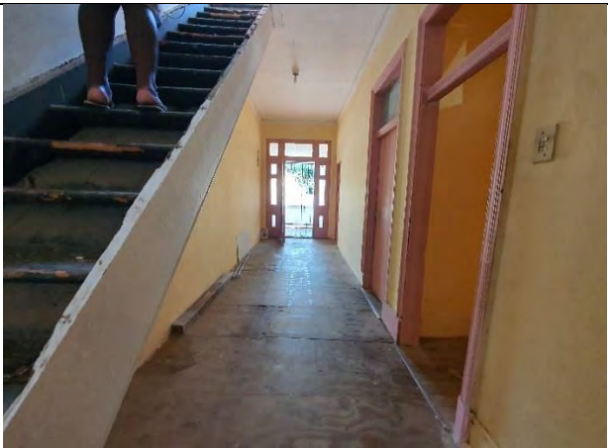
Figure 2.13: Existing oregon pine floors removed & replace with plywood sheets

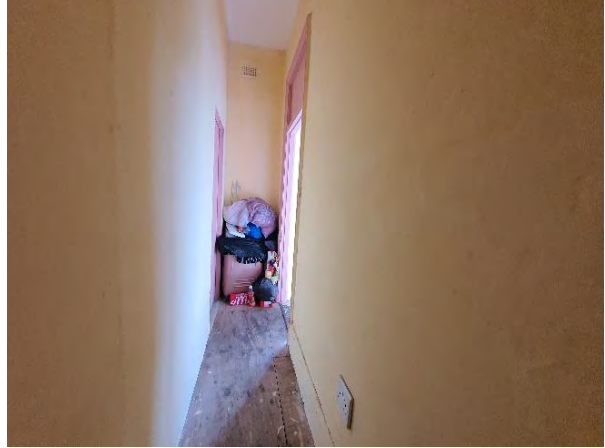
Figure 2.15: Existing wooden staircase to roof

Figure 2.16: Existing passage widths non compliant to fire regulations due to drywall installations.

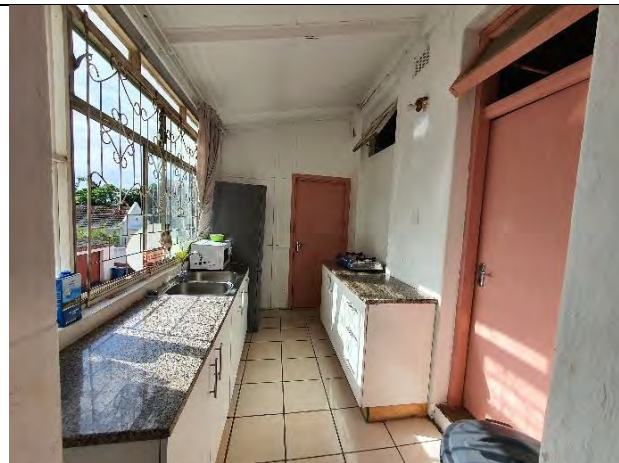
Figure 2.17: Existing verandah enclosed to create kitchen

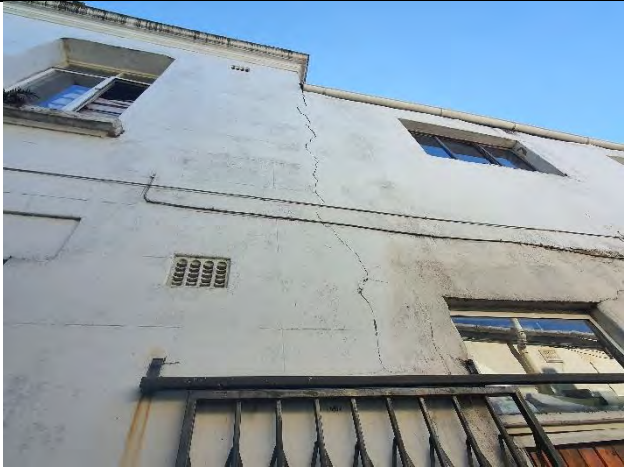
Figure 3.1: Cracks on rear elevation where balcony is enclosed

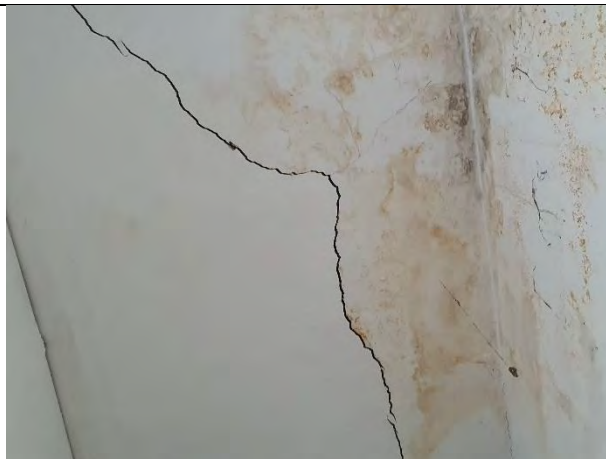
Figure 3.8: Cracks on structural party wall between 105 & 101

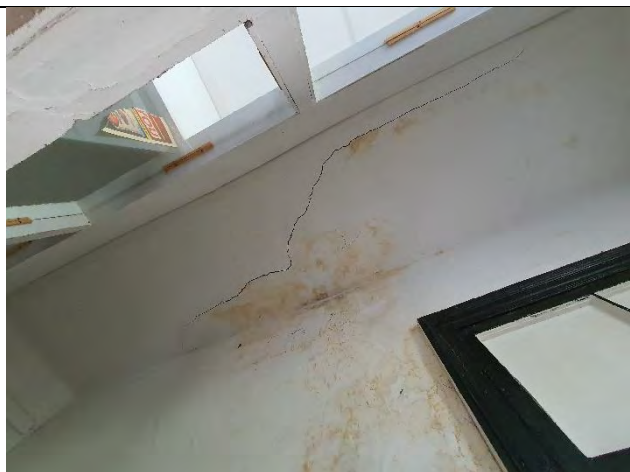
Figure 3.9: Structural cracks to internal walls & slab

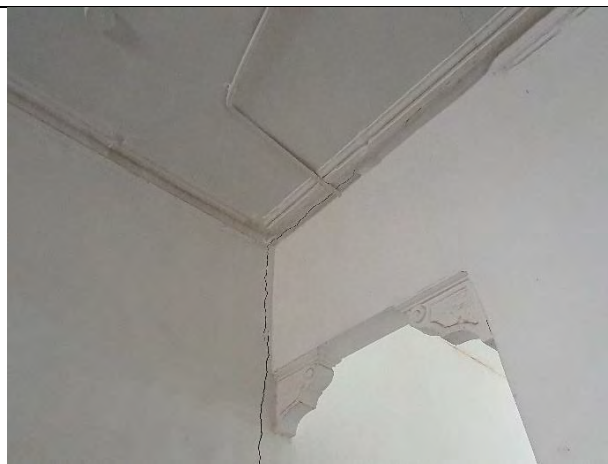
Figure 3.10: Structural cracks to internal walls

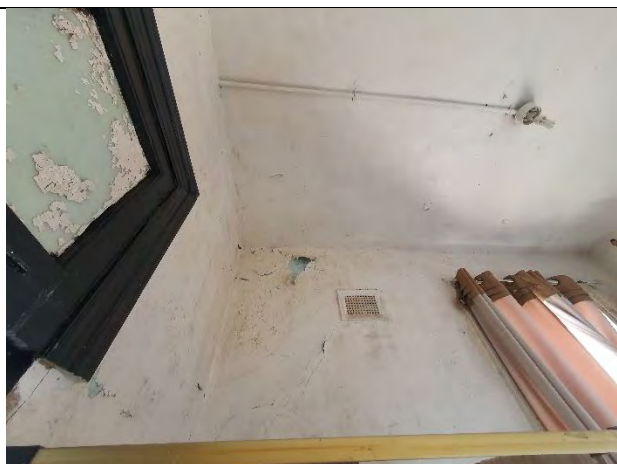
Figure 3.11: Water damage to walls & soffit from roof slab leaks

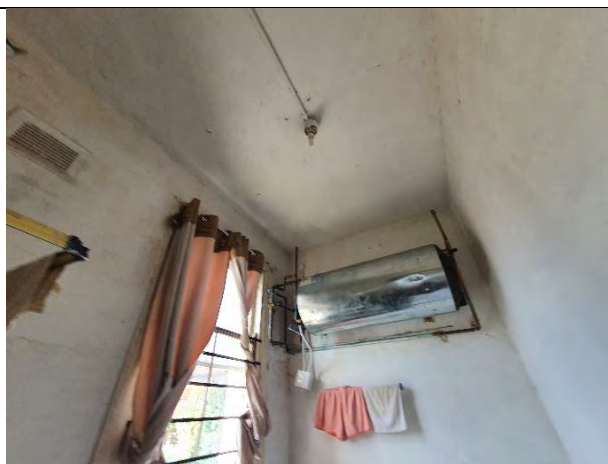
Figure 3.12: As per 3.9

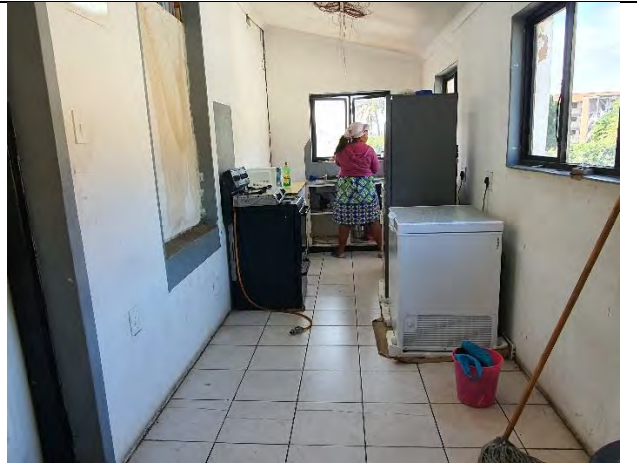
Figure 3.14: Verandha enclosed to create upper ground floor kitchen

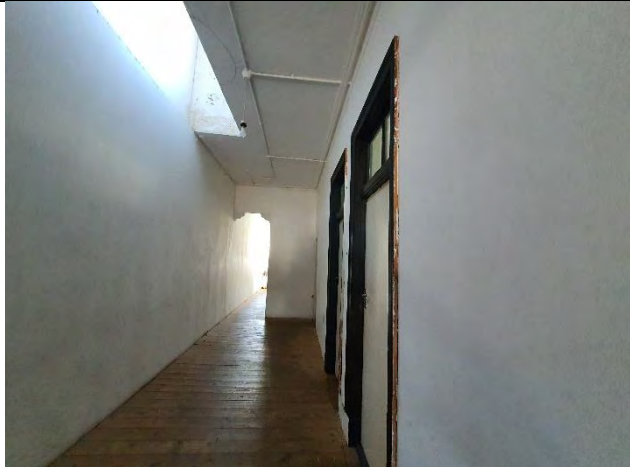
Figure 3.15: Existing entrance passage. Stair to roof removed

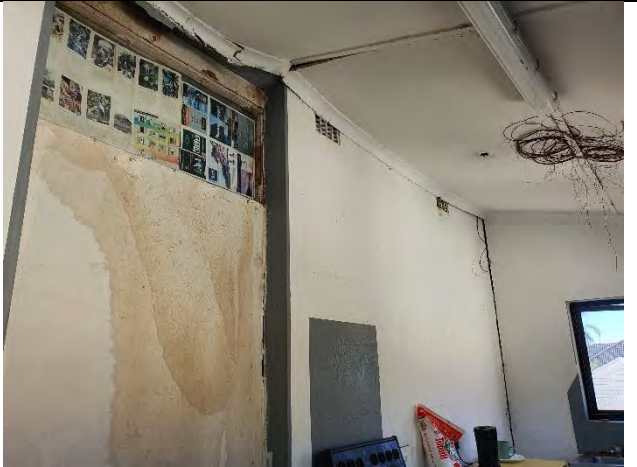
Figure 3.16: Condition of existing ceilings & drywalls
