1. INTRODUCTION

**Jagersfontein Developments
Underground Recce No1 and 2 M.R.S.
Shaft
Final Report**

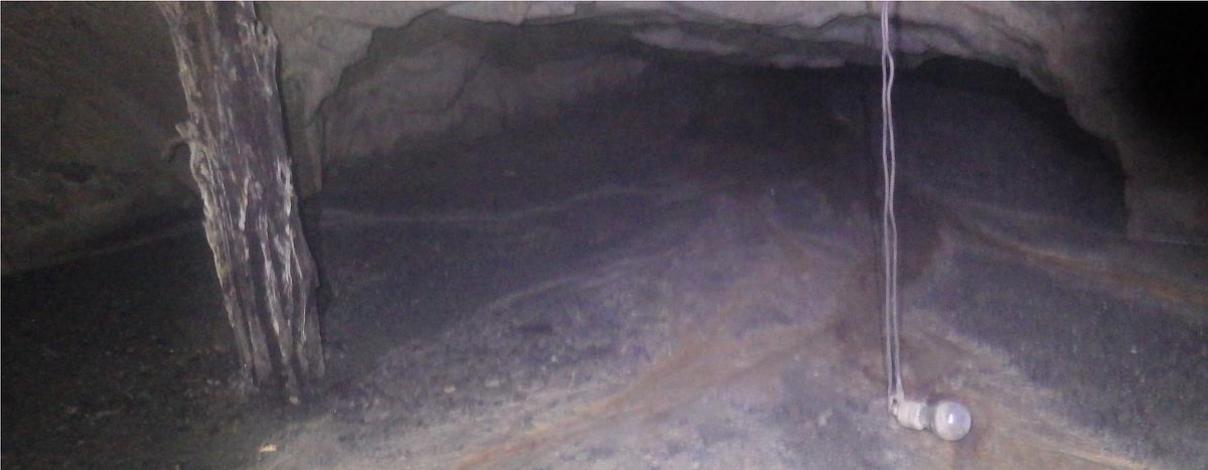
This picture is of 154 Level over run at the 34 degree incline towards the pit. Hand lashing must be conducted at this position to be able to get to the access point.

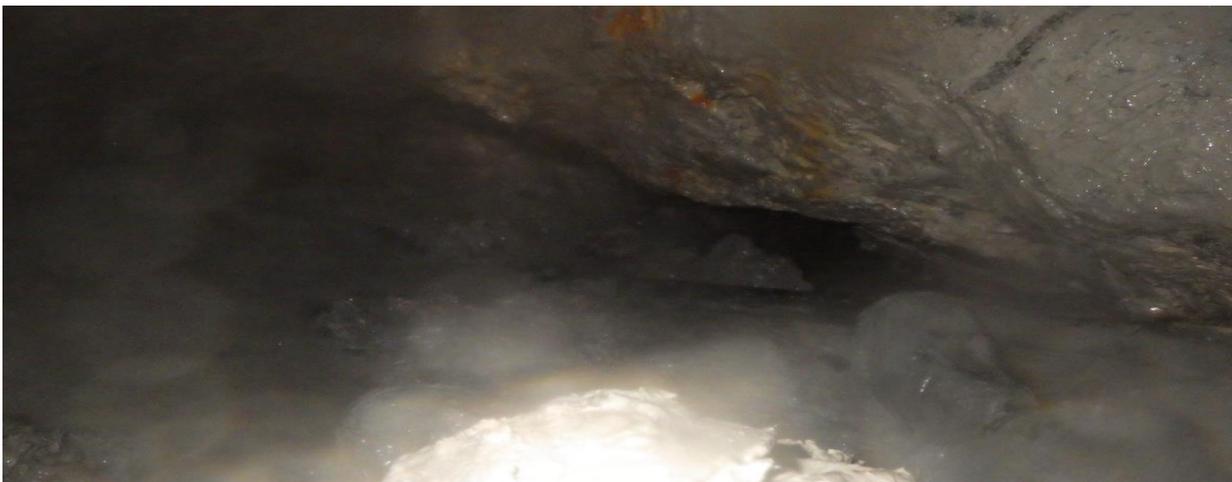
Water was intersected and a spindle pump was used to remove the water . We managed to dig a trench for access as indicated above.

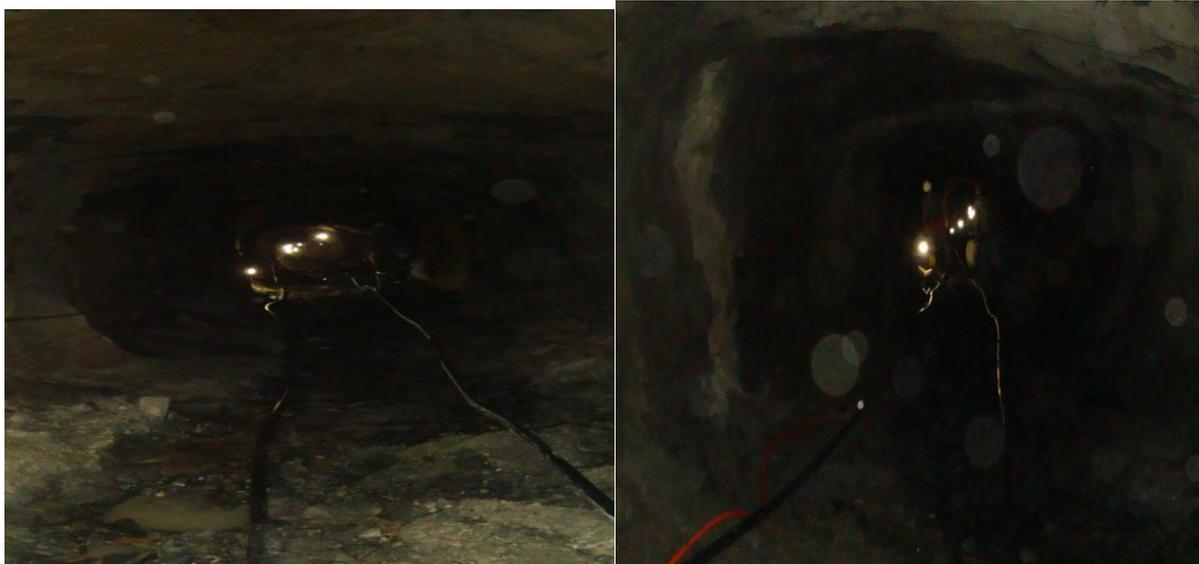
The trench provided access up to the fall of ground intersection, bad hanging wall and side wall conditions clearly visible and a total collapse of surrounding development ends.

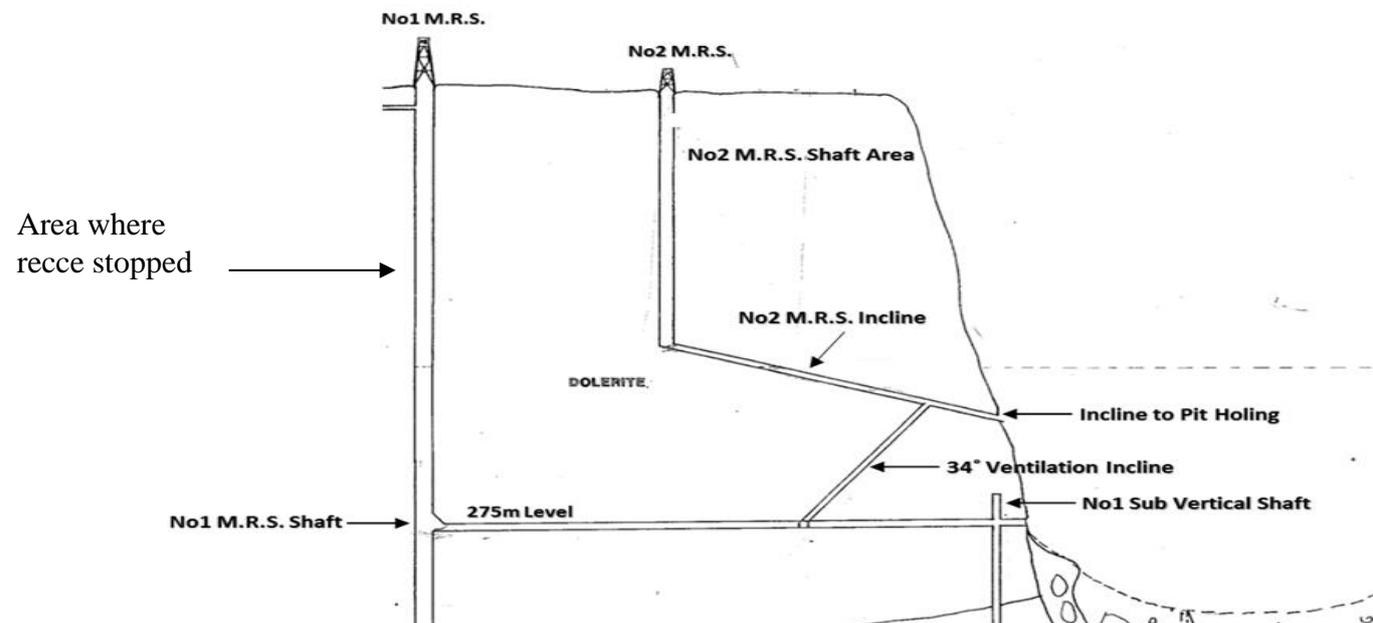
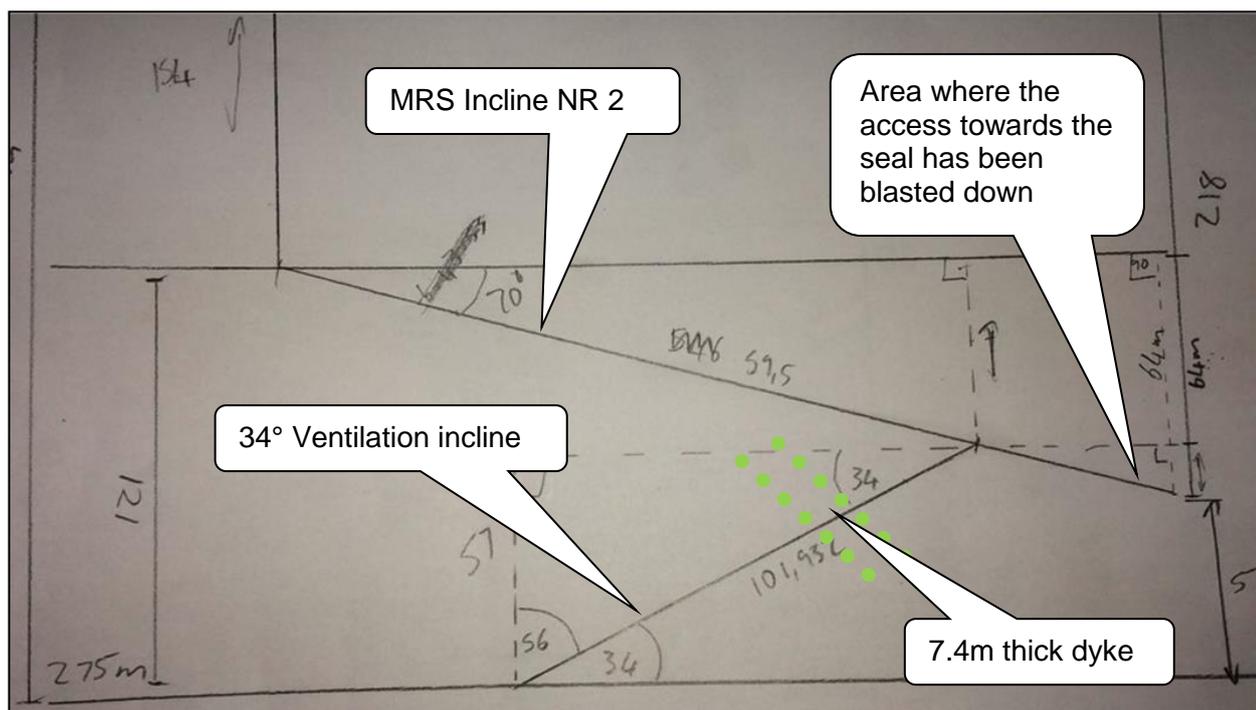
Figure 1: Section view for the first two (2) levels from the sub-shaft.

Mud and tailings created a plug 134m down the 34 degree ventilation incline, this together with possible induced blasting practices created the plug. The available plans do not correspond with the underground measurements; the plans indicated that the access point of 275 level was supposed to be intersected at 101,9m.

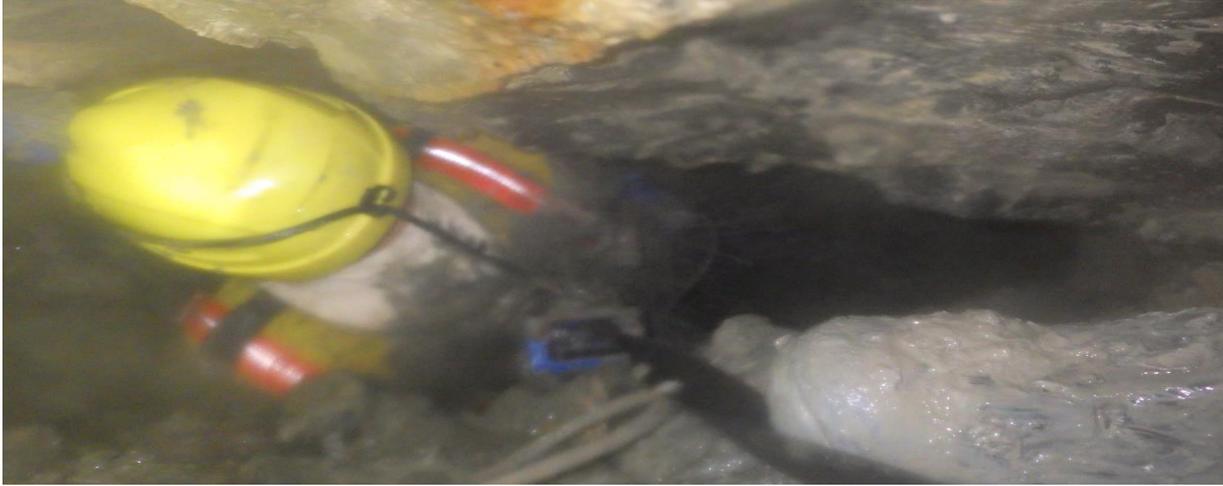
34 Degree mud loading taking place.

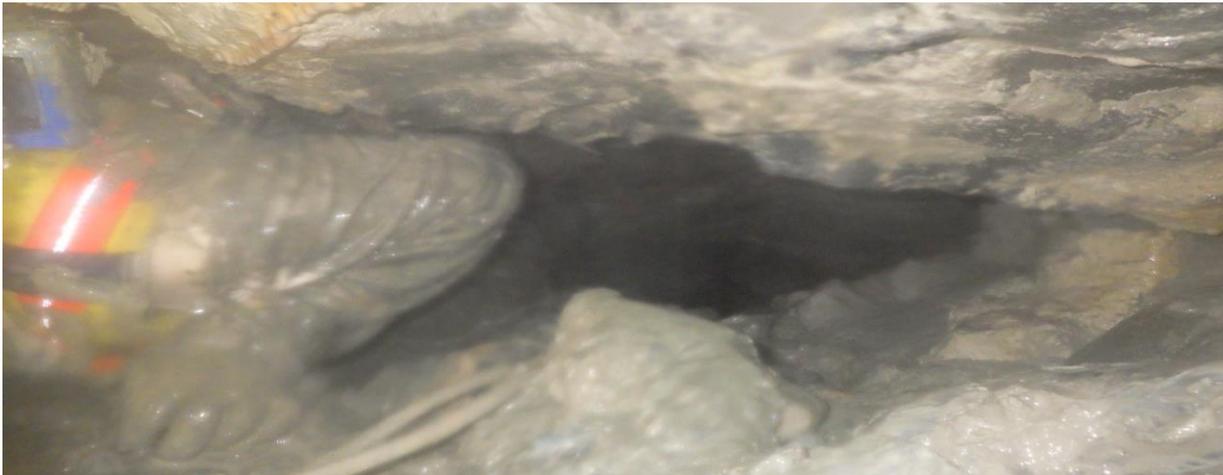
Continuous mud and water flowing down 34 degree incline.

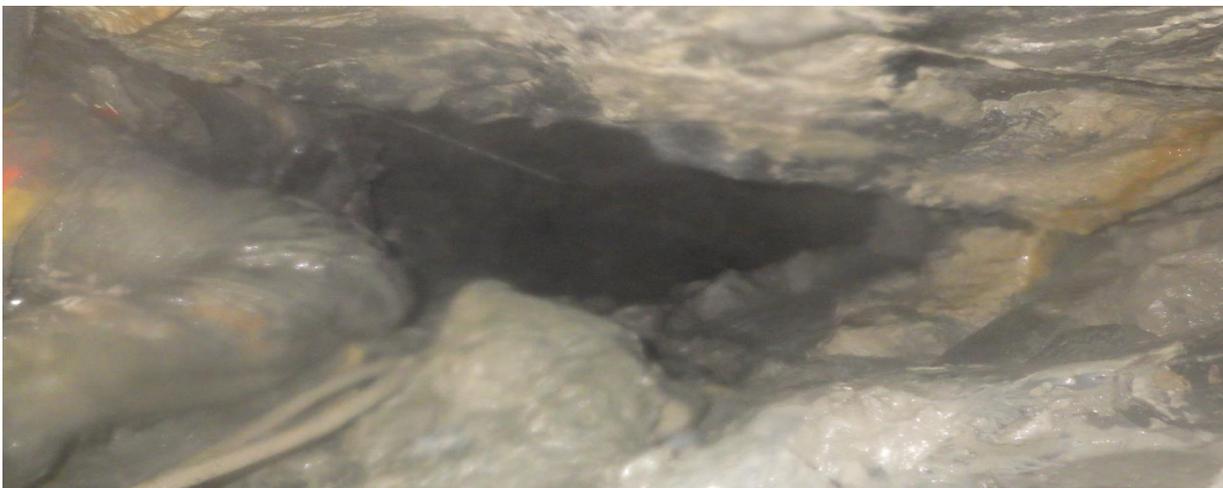
Large rocks was intersected and signs of blasting accesories observed.

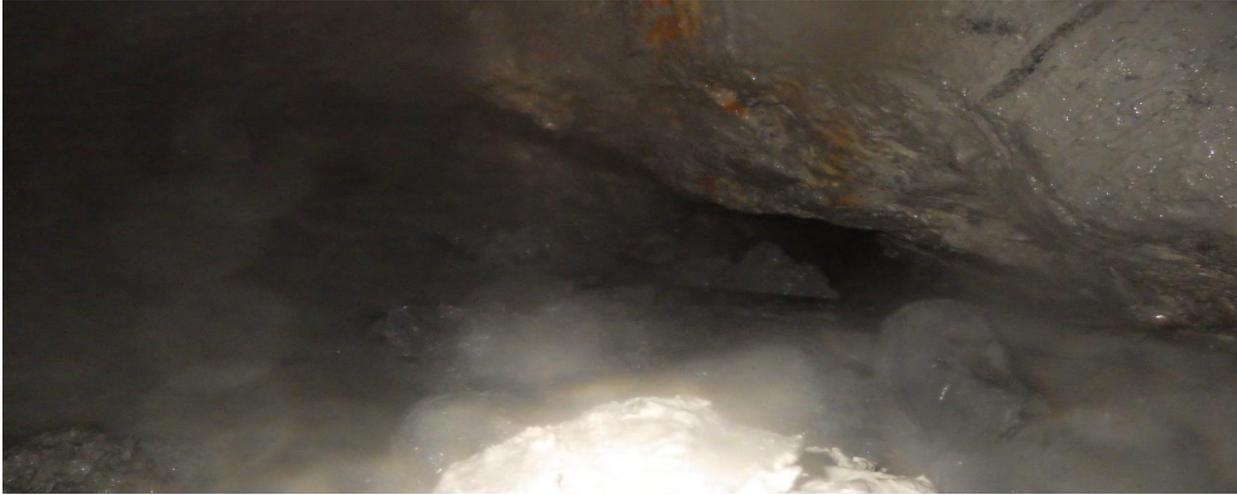
Bad ground conditions

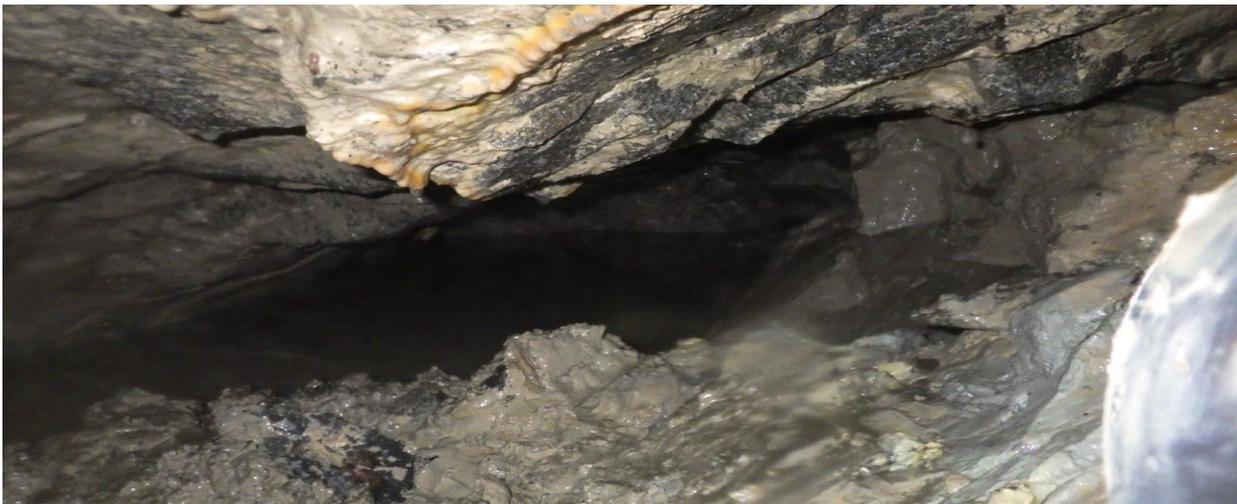
Photo indicating mudbag wall at the bottom 34 degree incine.

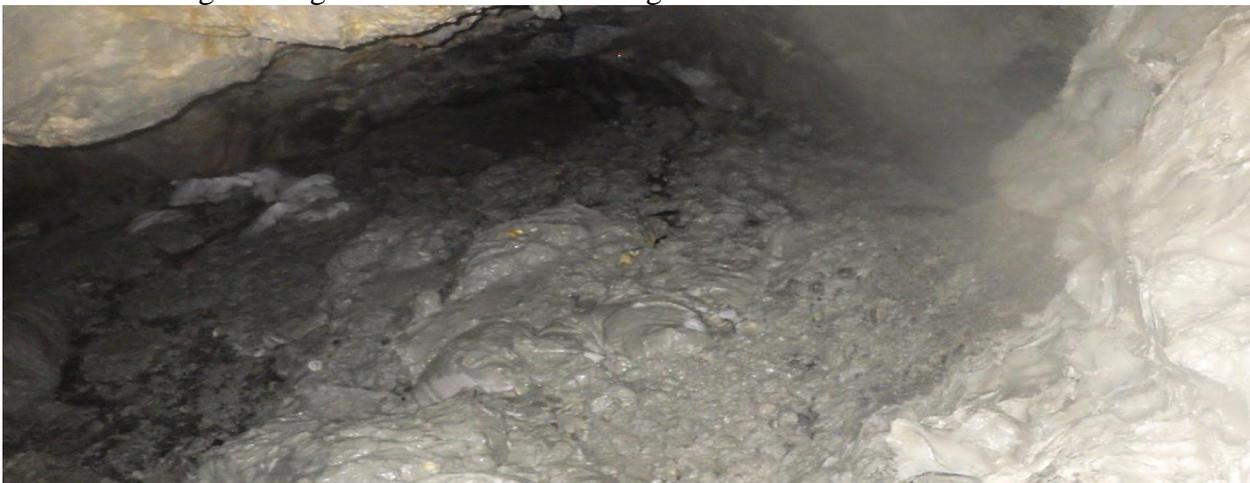
Photo indicating mudbag wall at the bottom 34 degree incine.

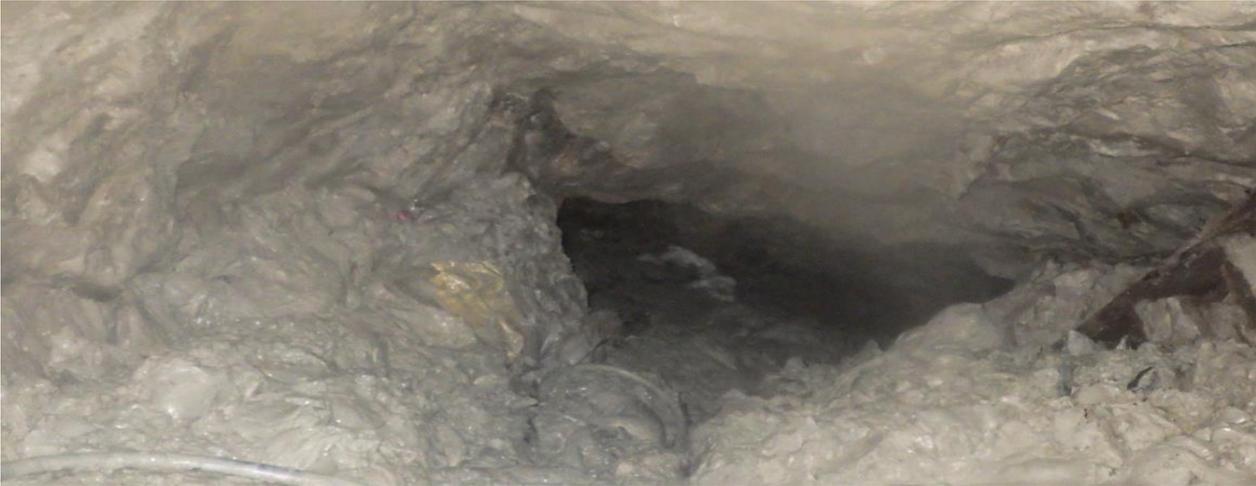
Stacking of mud bags against the side of the incline.

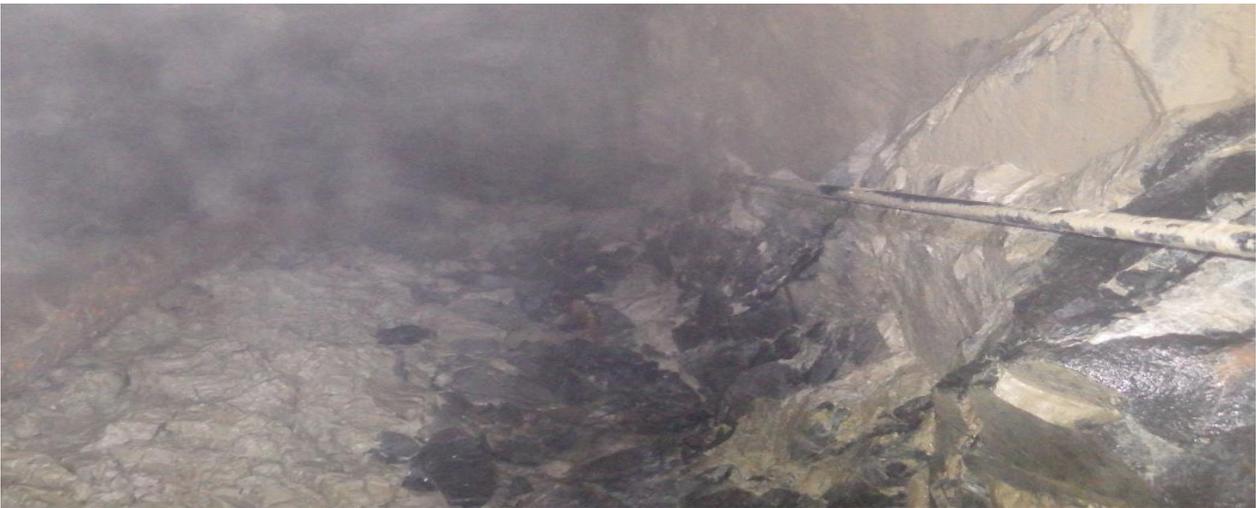
Incompetent ground conditions along incline.

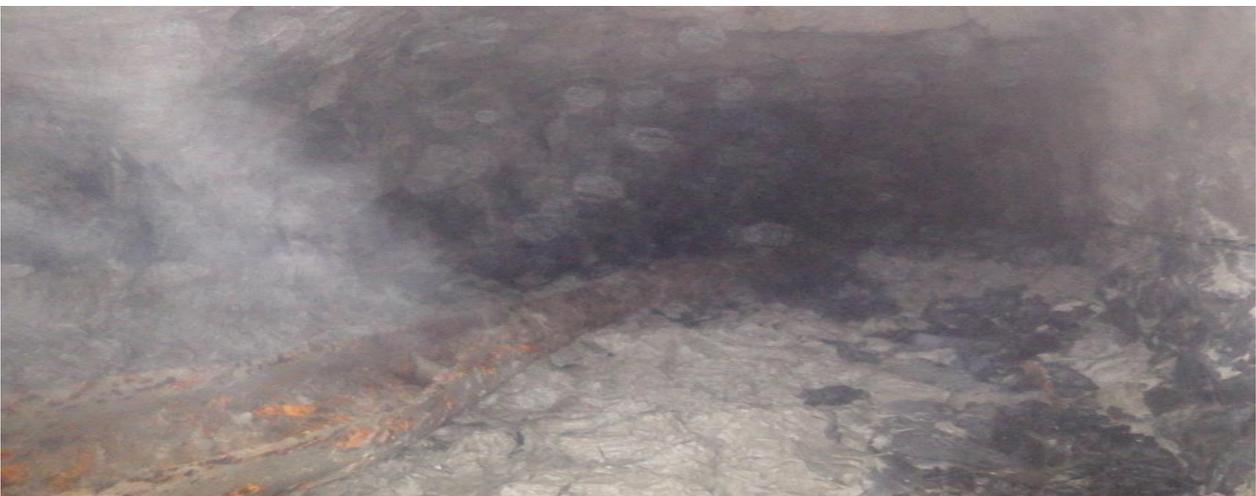
Corroded Steel construction in the incline.

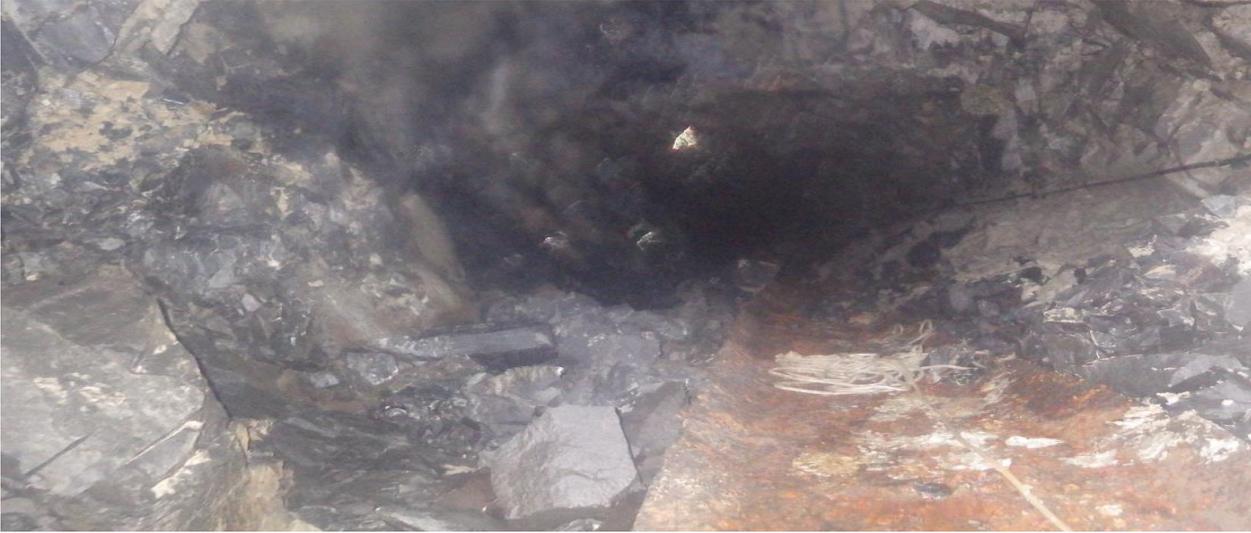
Area barred and made safe.

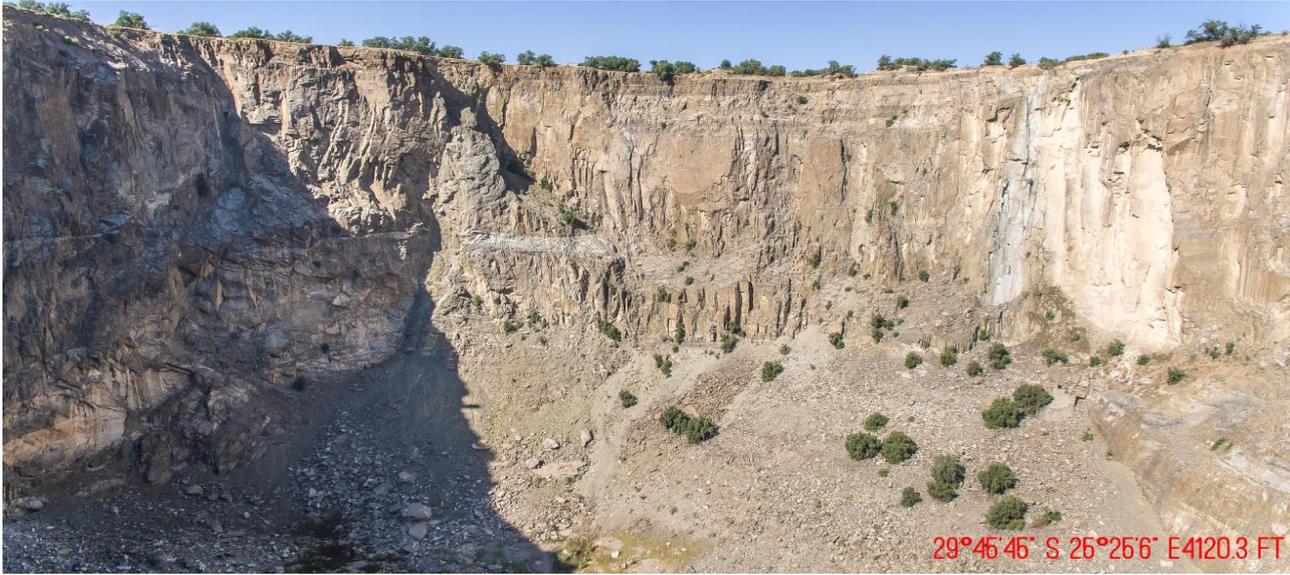
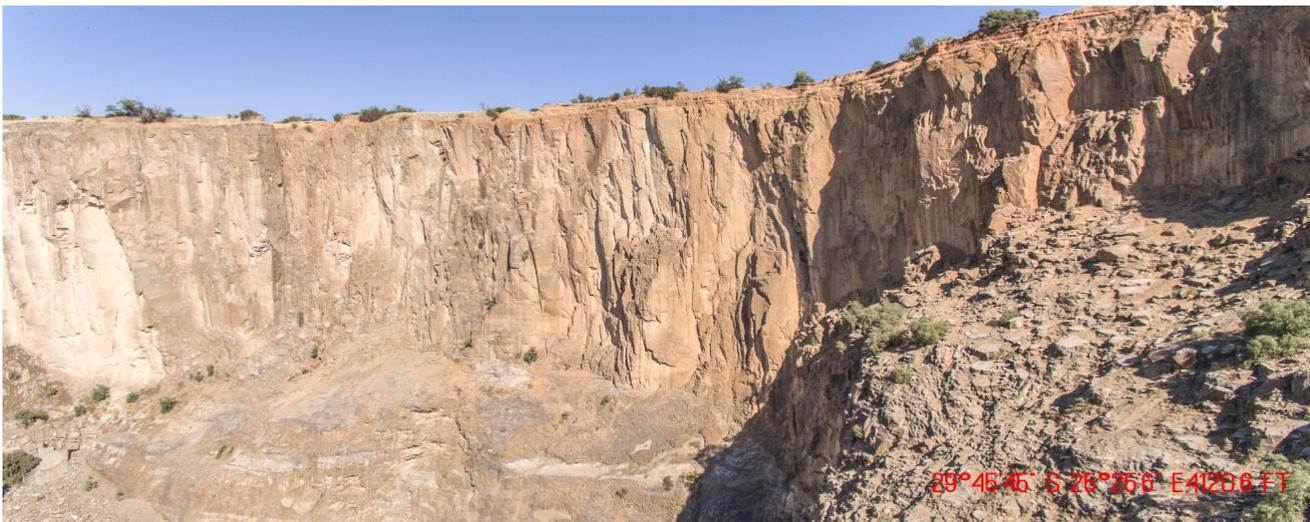
Clear indication of the pit mining itself, caving in.

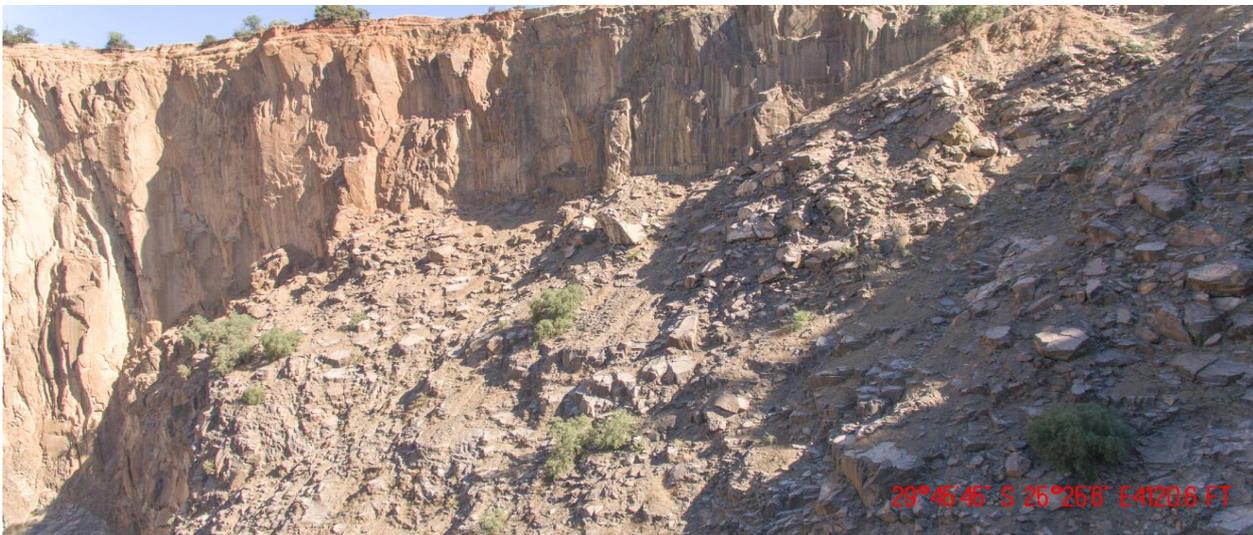
Collapsing of High walls.

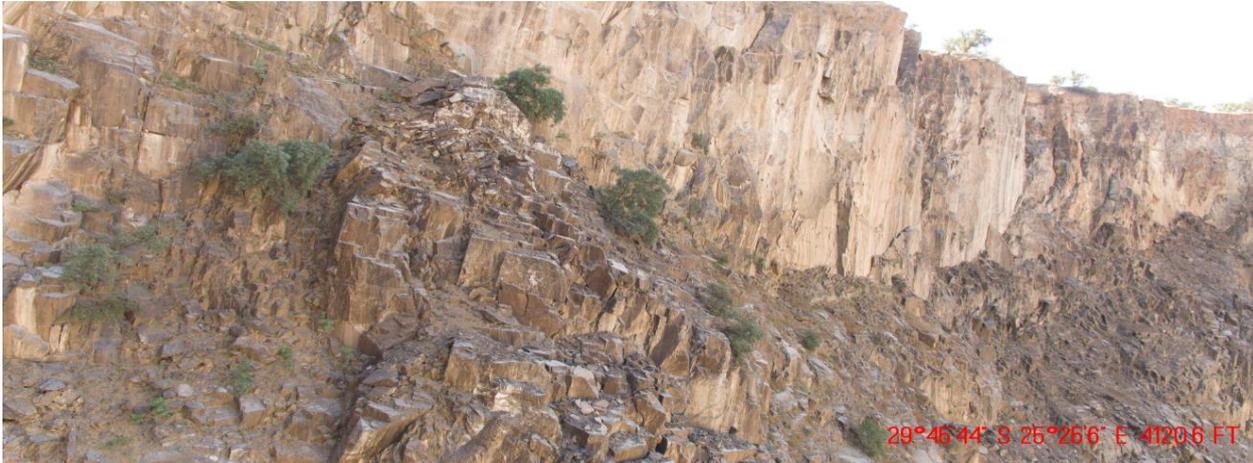
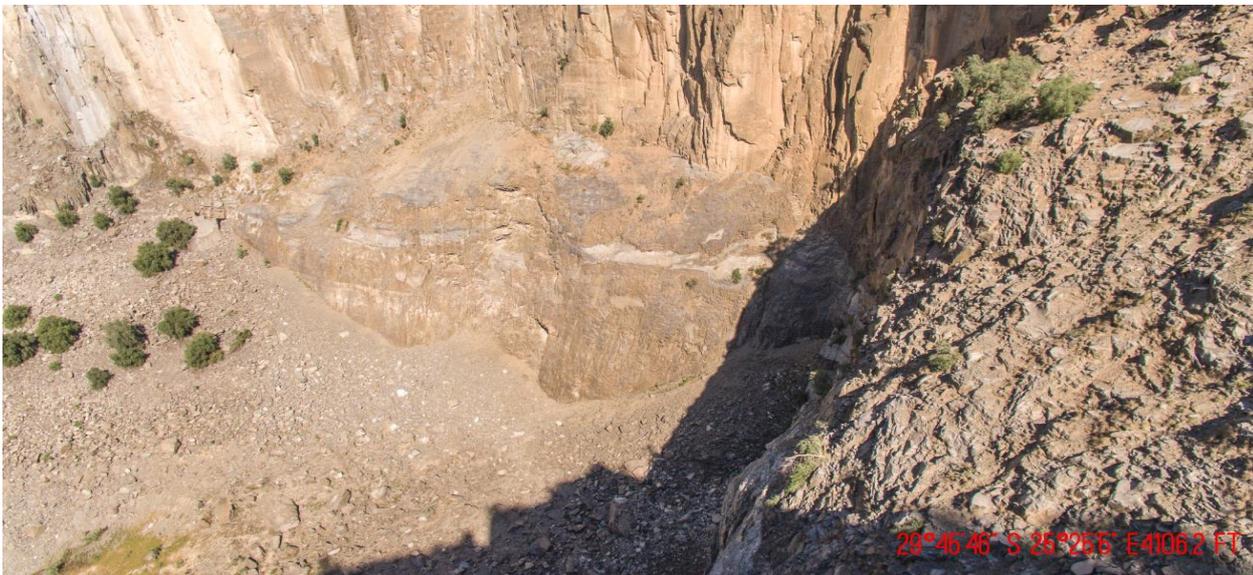
Excessive stof in the pit.
