PARLIAMENTARY PRECINCT: STALPLEIN: STRUCTURAL REPAIRS TO GRANITE STRUCTURES

32076-REP-001 REV 1

PRELIM STRUCTURAL REPORT

NOVEMBER 2015

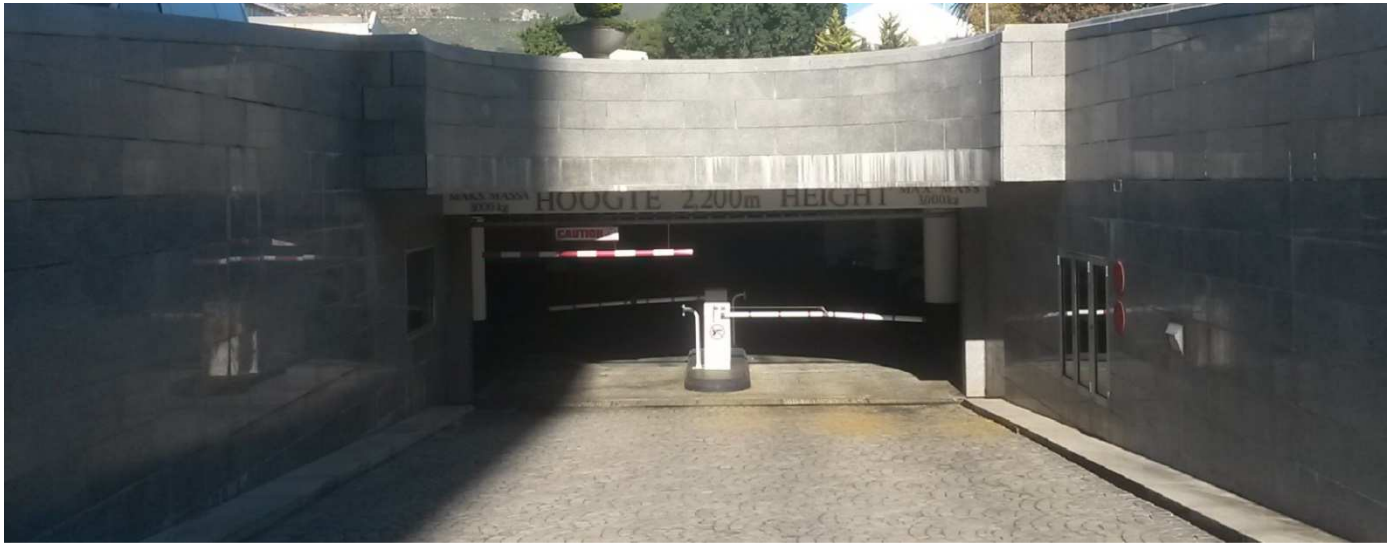
Photo 4.1: Efflorescence visible on curved granite element and also missing overhead granite panel on right hand corner.

- Clean efflorescence from vertical bottom hanging elements with metal scrapers or soluble solution (non acidic)
- Lift paver behind the wall, to expose the source of the efflorescence. If the water is coming from the paving level, then a waterproofed stainless steel drainage channel should be installed, to try and limit the water seepage through the concrete parapet.

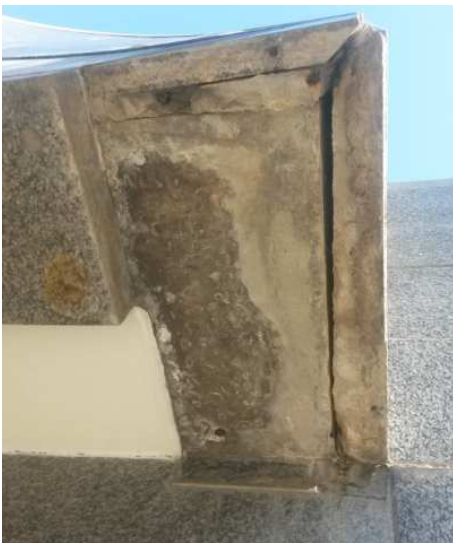
Photo 4.2 – Overhead granite panel that has fallen off.
Could happen to other overhead panels as well.

- Replace missing granite element with new fixing lugs with stainless steel dome heads.
- Expose fixing lug heads of vertically hanging granite slabs and treat with an anti-corrosive treatment and reseal soffit with a stainless steel dome heads.
- Where the condition of the existing lugs is suspect, install additional central 2xM12 stainless steel lugs through the granite into the concrete, with stainless steel dome heads.

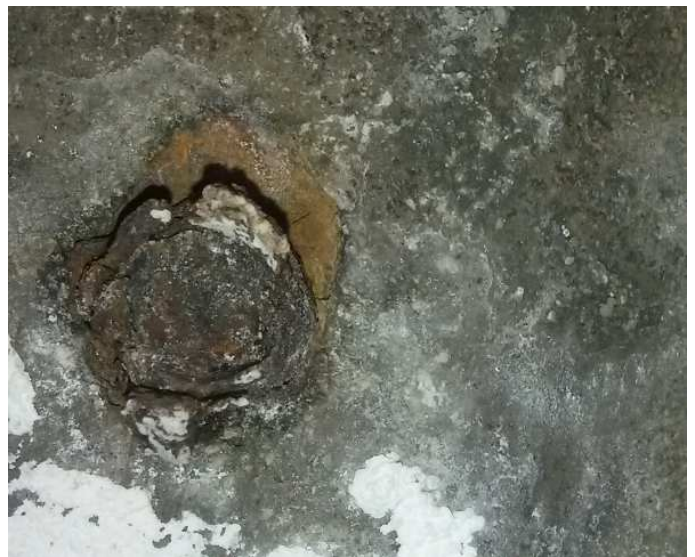
Photo 4.3 – Close-up of remnants of fixing anchor that is showing signs of corrosion.

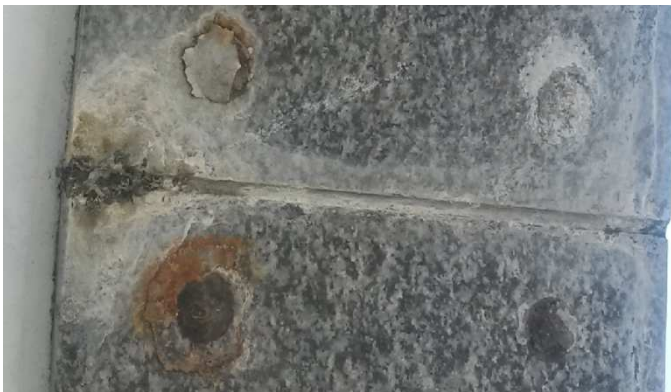
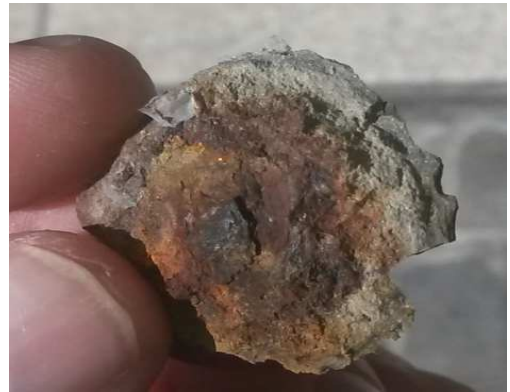
Photo 4.4 & 4.5: Skimming grout covering fixing lugs is popping off due to corrosion at the fixing lug.

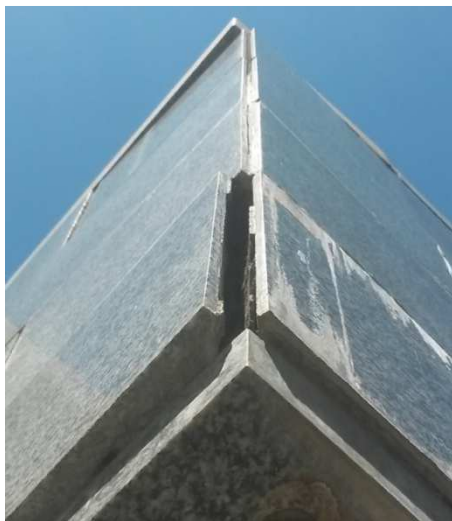
Photo 4.6: Vertical panels on left hand corner of curved entrance where lateral movement of granite is visible.

- As-built drawings indicate a 10mm stainless steel bracket at corners of bottom vertical panels. (TBC on site)
- Remove all loose granite panels, or panels that have moved.
- Old grout and material build-up behind panels to be cleaned out. Rehabilitate concrete behind, if required, with anti-corrosive treatment, like MCI (Migratory corrosion inhibitor)
- Drill holes into the concrete structure with adequate edge distance to avoid spalling or cracking of the concrete
- Drill fix 2 x secret fix lugs onto the back of the granite panel that has been removed, to match the holes in the concrete structure.
- Fix the granite slab with lugs into the concrete, with epoxy resin.

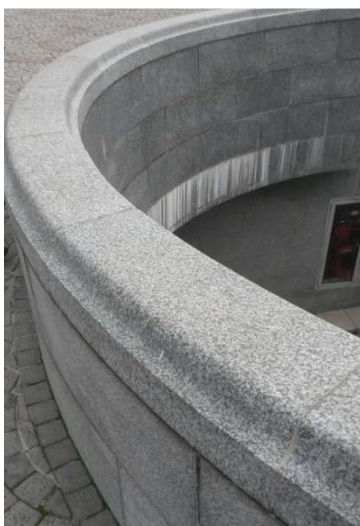
Photo 4.7: Curved granite entrance with concrete pavers at the top where water ingress through the granite elements occurs.

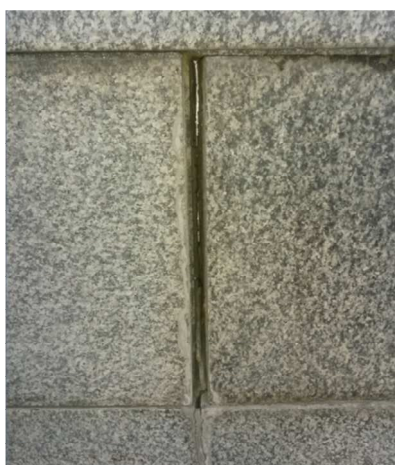
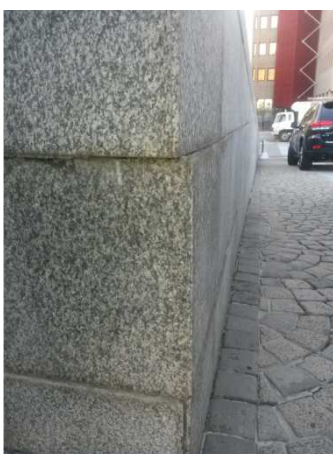
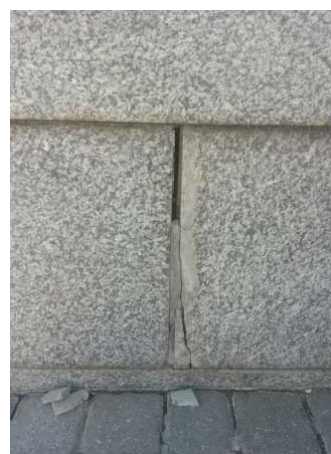
Photo 4.8-10: Granite elements on top of curved entrance where movement of elements have occurred.

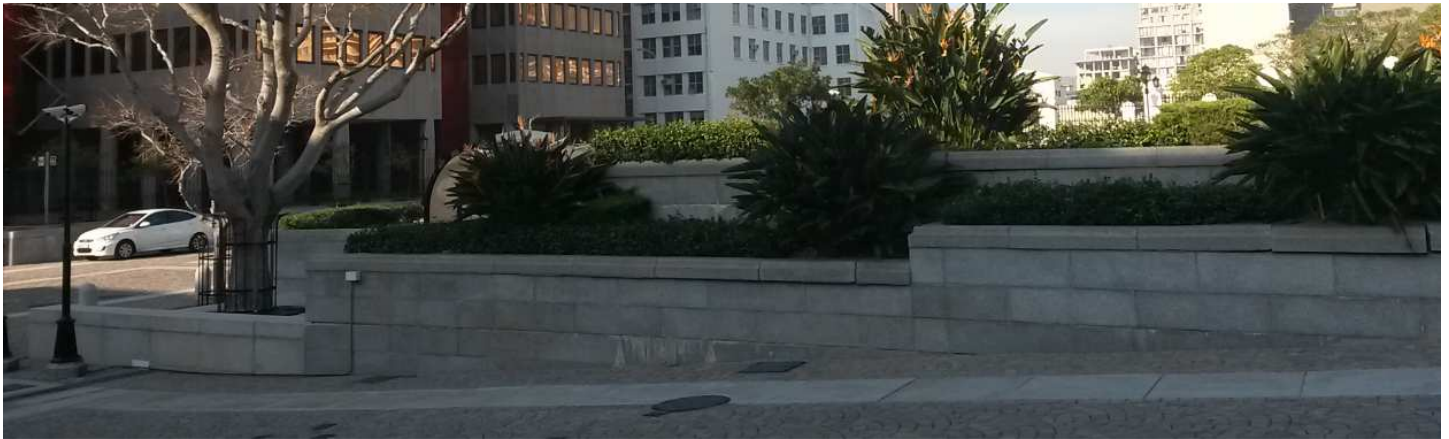
Photo 4.11: Granite planter boxes with lateral movement of coping and vertical movement of cladding elements & efflorescence visible

- Remove plants and expose existing soil and drainage.
- Remove all granite block and copings that have moved, and reconstruct.
- Redo existing agricultural drainage system, as well as internal waterproofing against granite.
- Install a Bio barrier membrane (a membrane system that blocks the growth of tree roots through it) against inside of granite planter box. (see diagram below)

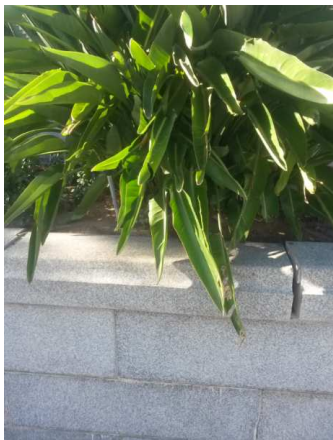
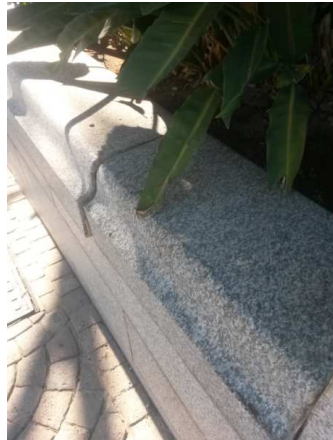
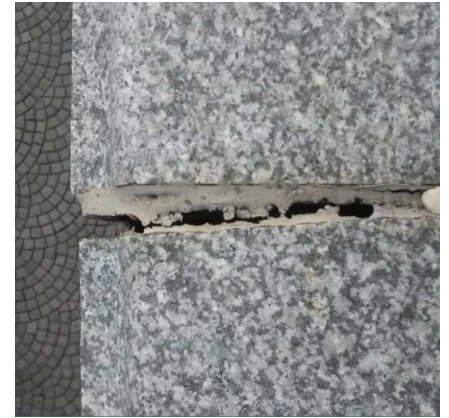
Photo 4.12-14: Lateral movement of planter box coping.

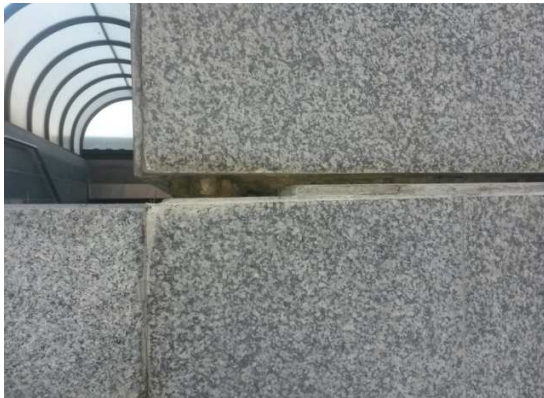
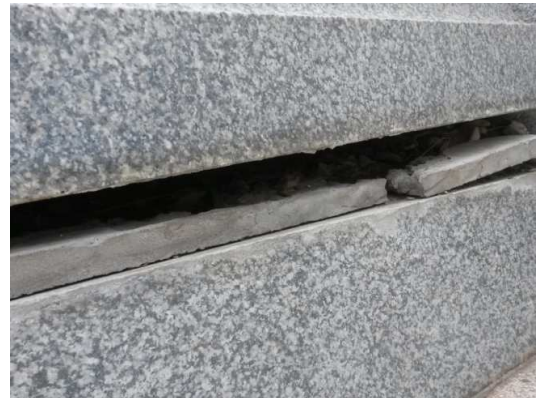
Photo 4.15-16: Vertical movement of planter box cladding elements

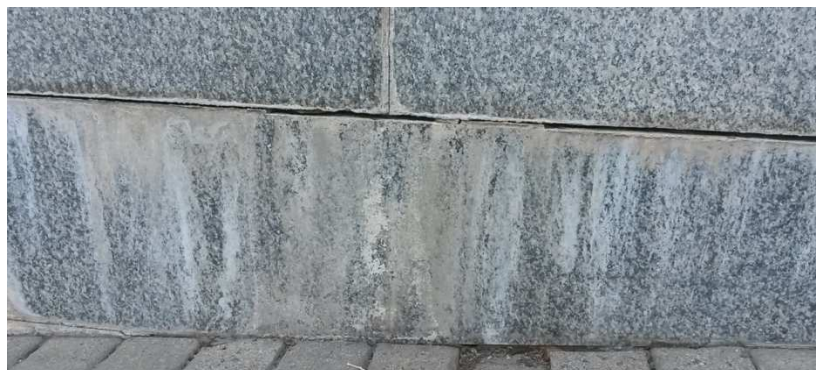
Photo 4.17: Localized efflorescence visible at bottom of planter

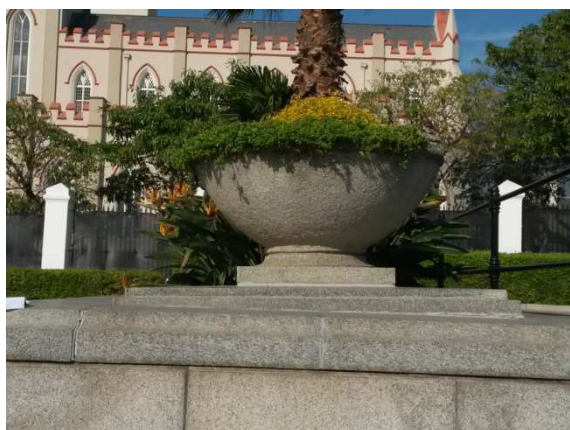
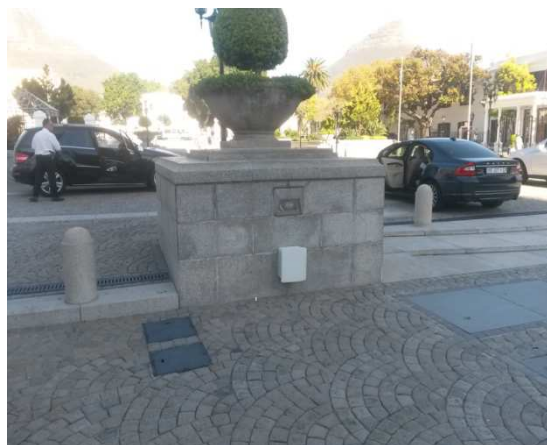
Photo 4.18-19: Plinths with visible differential settlement of +/- 20mm on a number of plinths at the potplant base.

- Remove top coping on the side of the plinth, to investigate further, what the cause of the differential settlement is. Once the cause is determined, possible solutions can be considered.
- Risk of damaging the pot plants should be avoided at all cost.

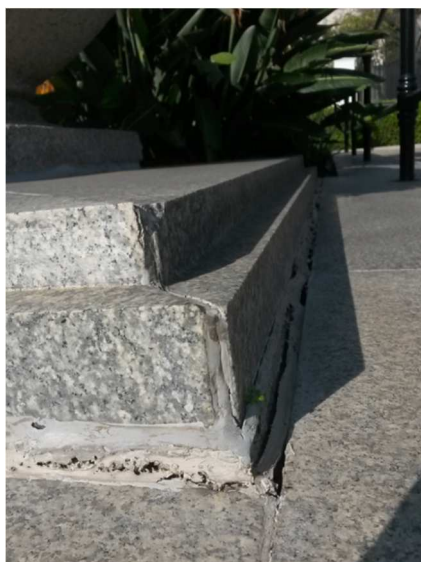
Photo 4.20: Close-up of pot plant base, with granite elements lifting on one side, as a result of settling at far corner.

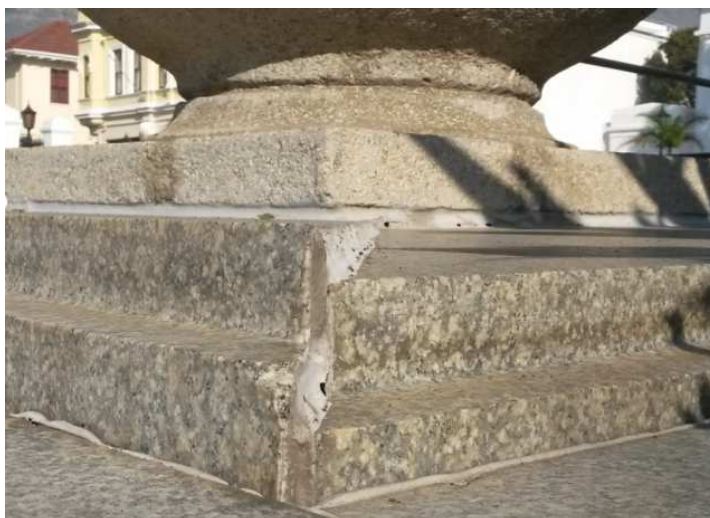
Photo 4.21: Close-up of pot plant base, where the one element has settled, while the adjoining element has not moved.

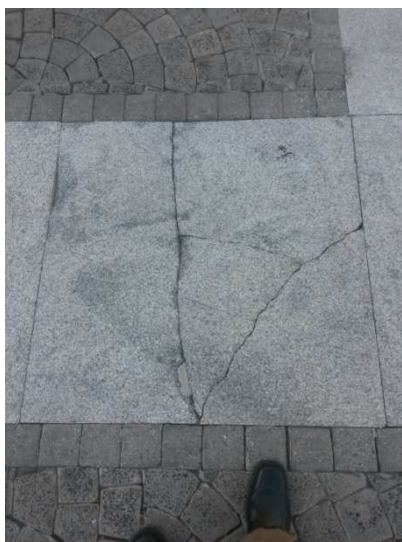
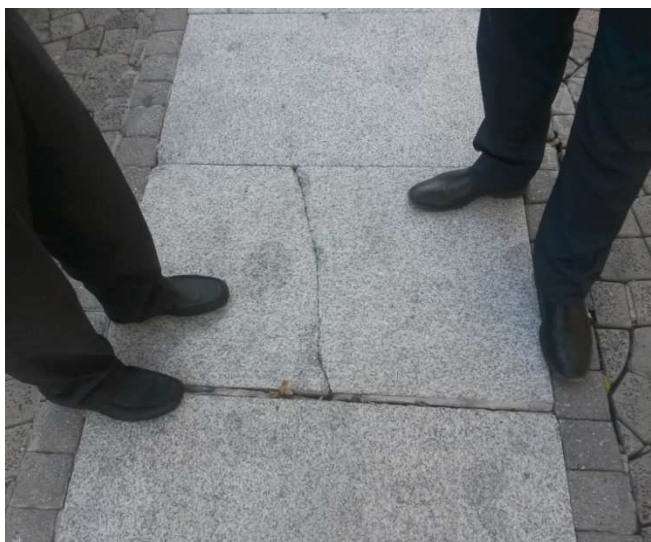
Photo 4.22 & 23: Granite slabs that have cracked in Parliament street

- Remove all cracked 50mm thick slabs and make good and level out compacted sub-base underneath.
- Replace all cracked granite slabs, with slabs of similar site dimensions.
- Contractor to reseal joints with sand cement grout in general, but should make allowance for an elastomeric joints every 10m length of granite (not oil based as they will stain the granite).
- Where joints between granite slabs are not consistent, the slabs are to be cut on site, and re-sealed.
- The granite pavers at the bottom of the access stairwells, to be lifted where standing water occurs. Existing drainage system underneath the paver level is to be cleaned, to allow proper drainage.

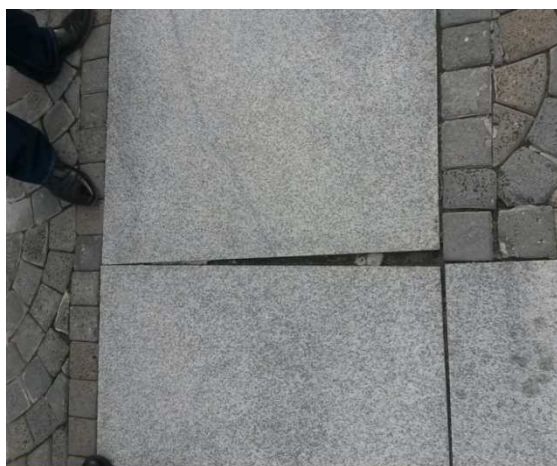
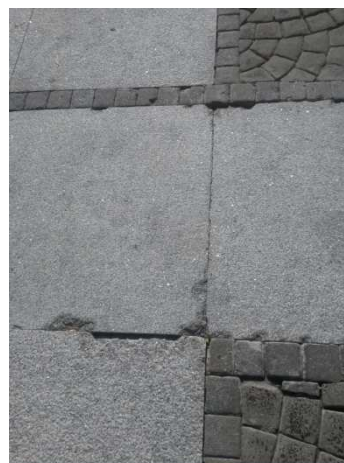
Photo 4.24 & 25: Granite slabs with exposed joints & chipped edges

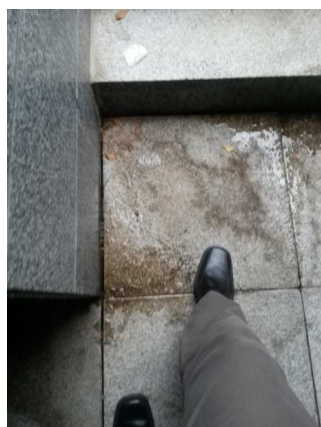
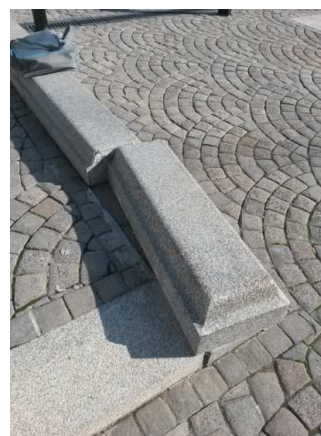
Photo 4.26 & 27: Standing water underneath granite slabs at basement emergency exit and granite kerb that has been dislodged.

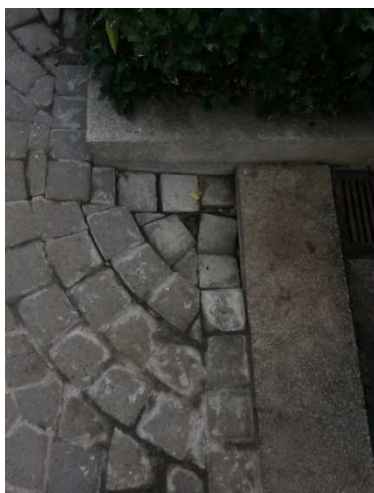
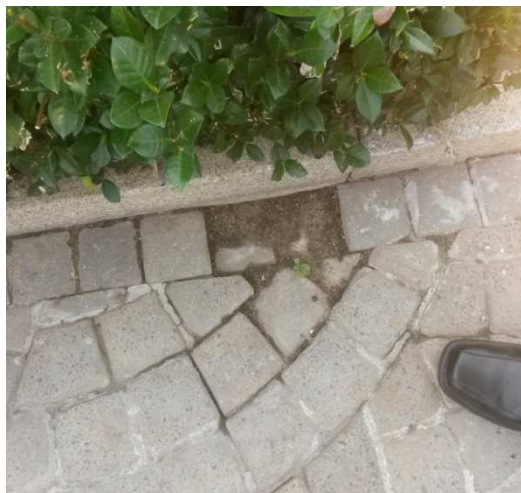
Photo 4.28 & 29: Paving cobbles with some sign of differential settlement

- Where settlement of pavers have occurred, the pavers are to be lifted and sub-base to be re-compacted and levelled out, before repaving the affected area's.
- Cobble pavers that have been stained with green paint blotches to be cleaned with biodegradable paint cleaner.

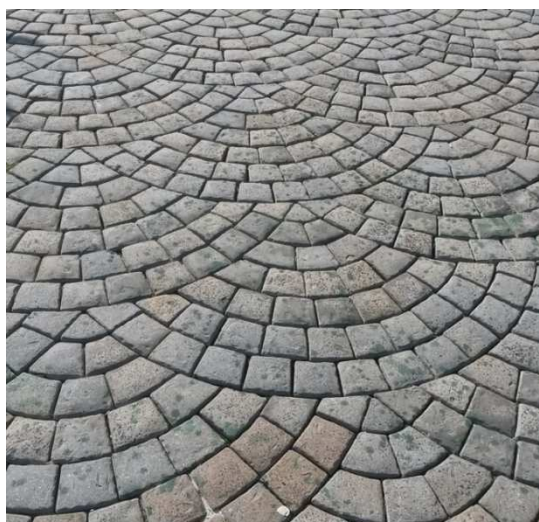
Photo 4.30: Paving cobbles that are in need of treatment to remove paint marks

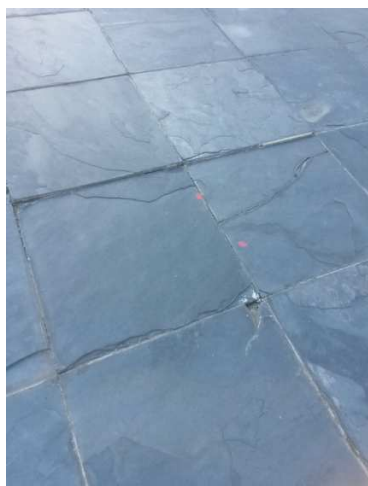
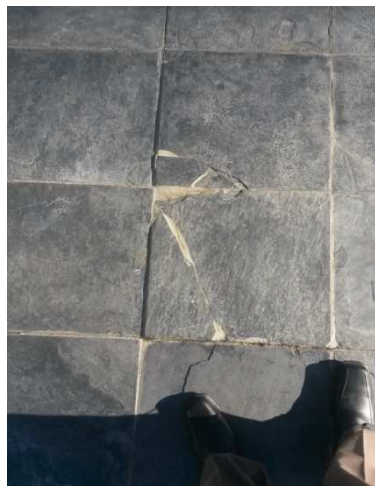
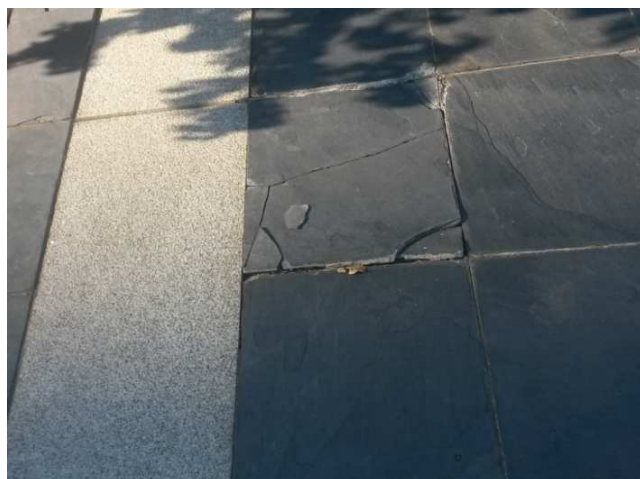
Photo 4.31-33: Cracked and damaged slate tiles.

- Remove damaged slate tiles and re-compact sub-base and install new slate tiles, matching the existing.

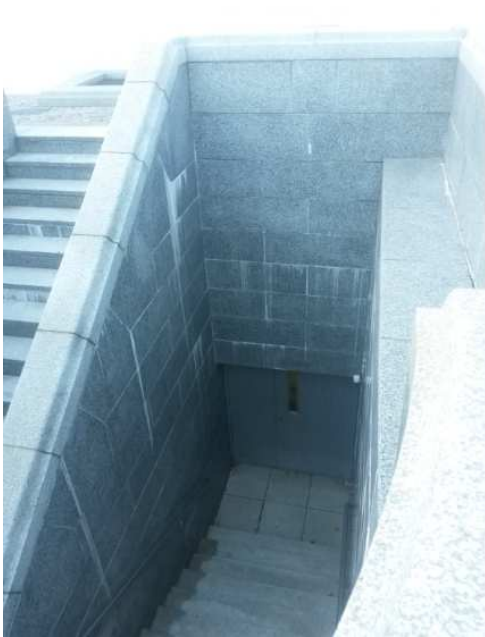
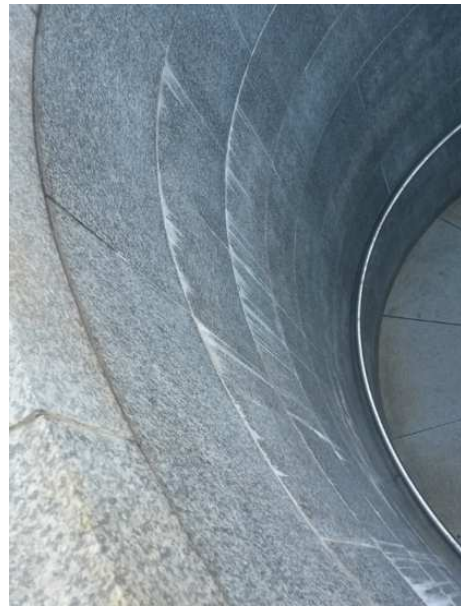
Photo 4.34-35: Typical efflorescence staining from rainwater running down granite facade

- Remove efflorescence and corrosion staining by means of scraping or using sanding equipment. The granite is a hard wearing surface so the majority of the staining should be removed, but some remnants could still remain.
- Investigate where the very white line of efflorescence is coming from, behind the wall. Possible a blocked drain, which should be cleaned out.

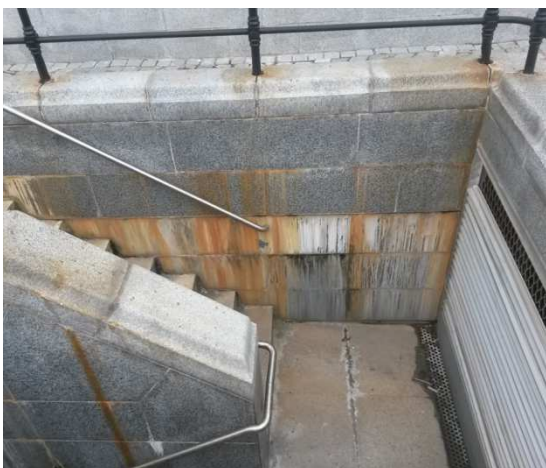
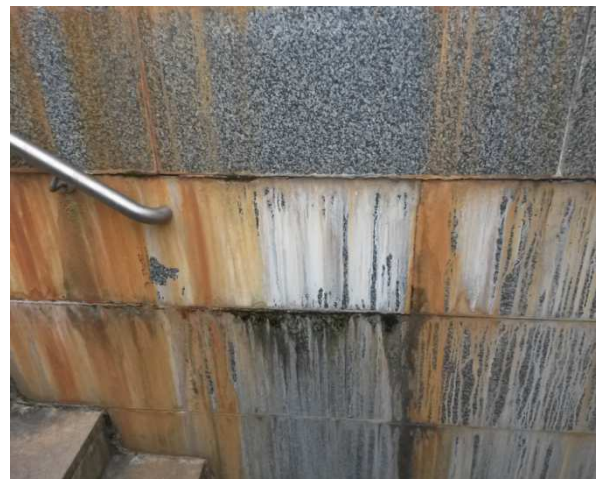
Photo 4.36-37: Abnormal efflorescence staining – possibly a block underground drain & also corrosive staining

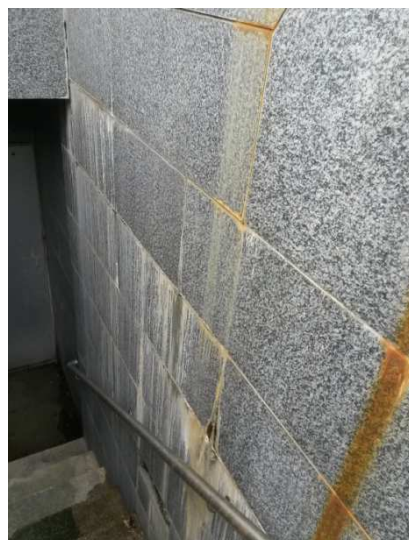
Photo 4.38: More visible efflorescence and corrosive staining on the same staircase.

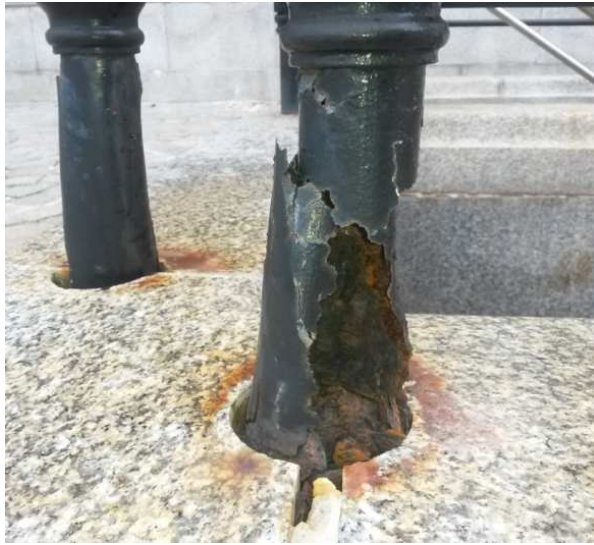
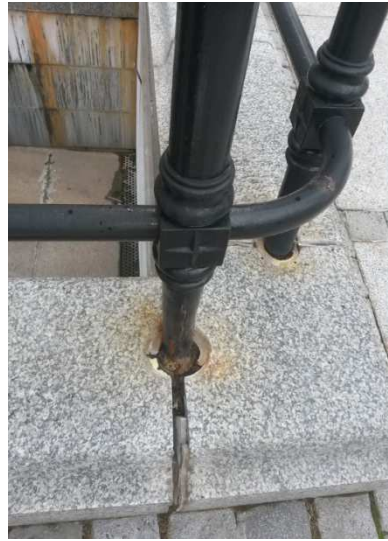
Photo 4.39 & 40: Cast Iron steelwork that is corroding should be replaced with stainless steel base fixing with sleeve and cast iron railing on top, to avoid future staining of granite.

- Remove and replace rusted balustrading with galvanized or stainless steel members.
- Clean and repoint joints around granite coping, after re-fixing balustrading to concrete below.

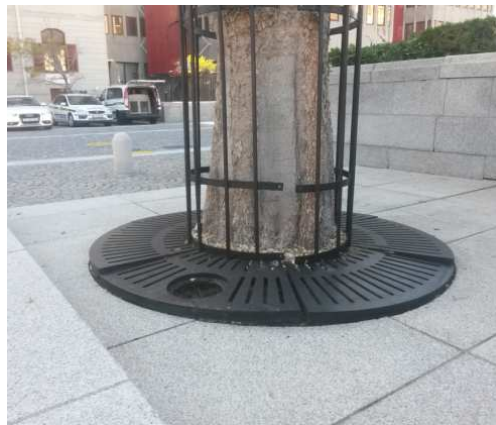
Photo 4.41: Tree close to Parliament entrance that has damaged the tree ring and also lifted granite pavers. Tree ring should be removed or modified to suite and granite pavers lifted to review extent of root growth, for trimming of roots and relaying of pavers. Investigate other trees as well

- Remove steel tree ring & lift granite slabs around tree to evaluate options for cutting back root system. Horticulturalist to advise.
- Clean stains on marble fountain with sandpaper.

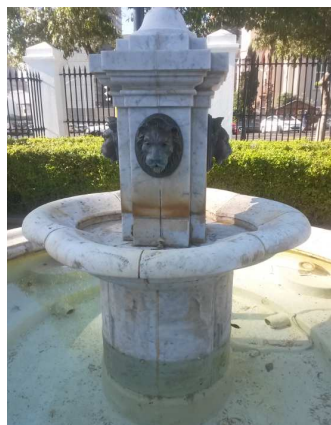
Photo 4.42: Water marks on granite fountain to be cleaned

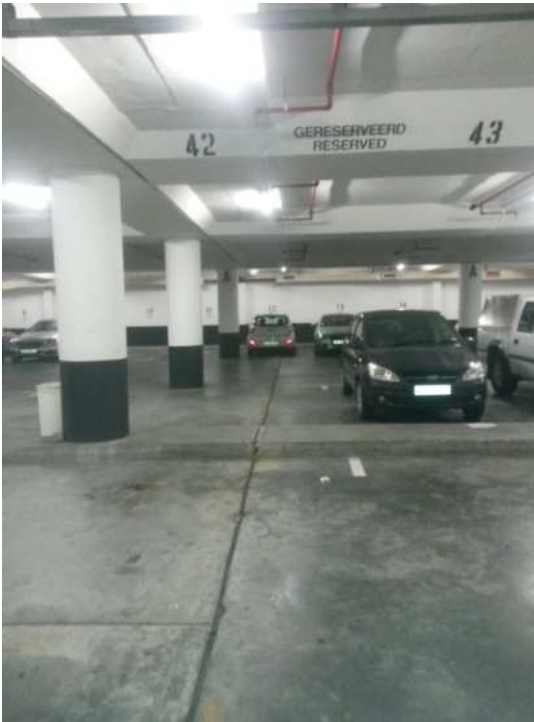
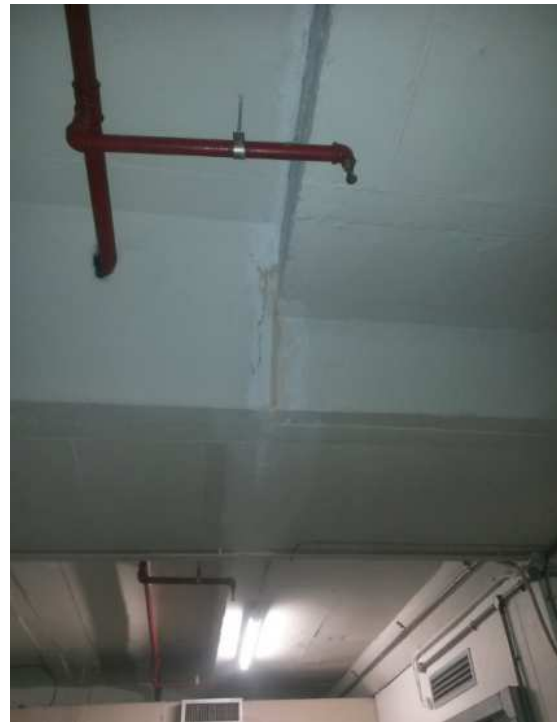
Photo 4.43 & 44: Movement joint +/- 40m from basement entrance, to be made good and waterproofing on top of slab to be reviewed on site.

- Movement joint to be made good at soffit of slab.
- Review waterproofing on top of slab, underneath paving. If waterproofing has perished, it should be redone.

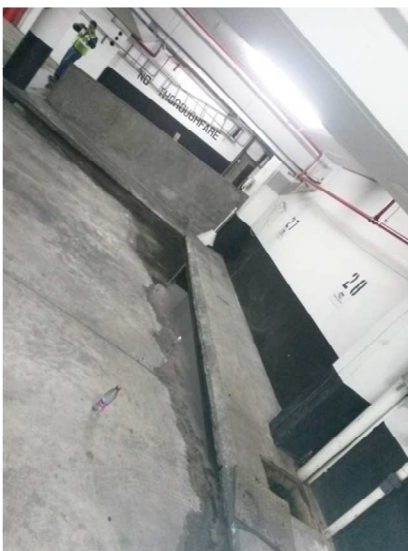
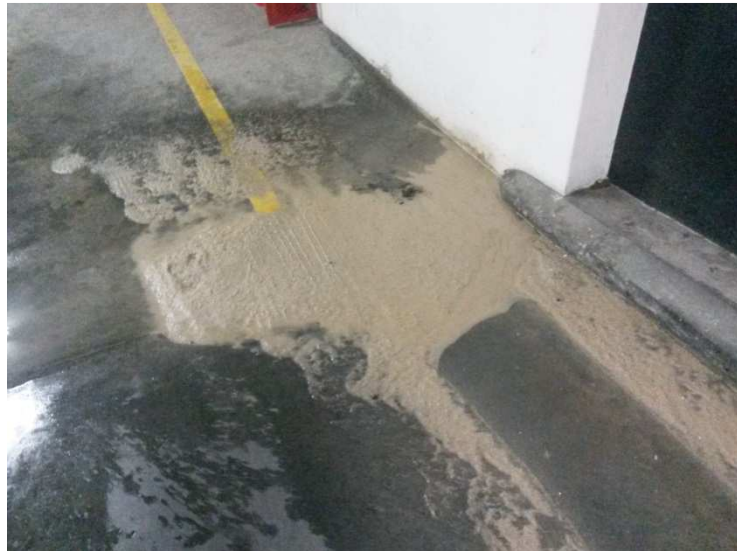
Photo 4.45 & 46: Ground water leak at bottom level of basement depositing silt from the foundations of Africa House into the basement.

- Water has been tested to confirm it is groundwater (no traces of chlorine in the water).
- The silt deposition is the main issue of concern, as it is undermining the foundations of Africa house.
- Temporary proposal is to try and seal the joint with waterproofing products, but this proposal will probably not be a long term solution, as the ground water table will rise and the water will leach elsewhere.
- The long term solution is to drill a borehole next to the basement and install a ground water pump, to permanently lower the ground water table in the area close to the basement.
