**PARLIAMENTARY PRECINCT: STALPLEIN:STRUCTURAL
REPAIRS TO GRANITE STRUCTURES**

WCS 050967S

C2640 / 32076-REP-001 REV 2

JULY 2017

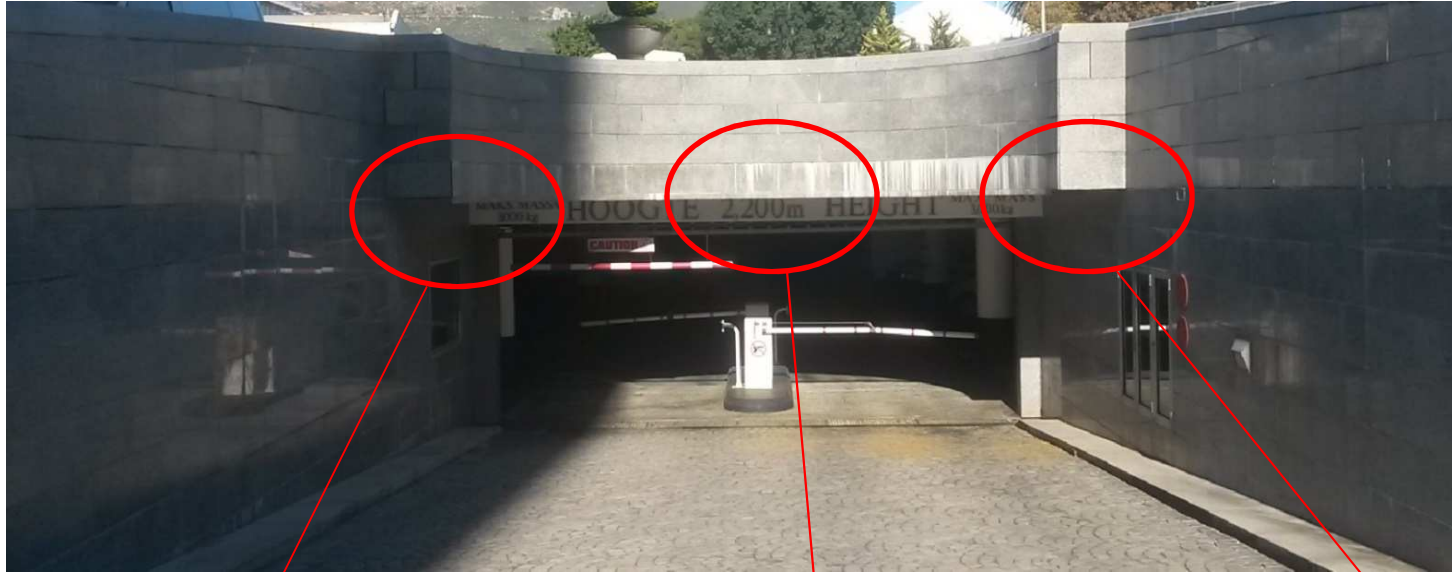
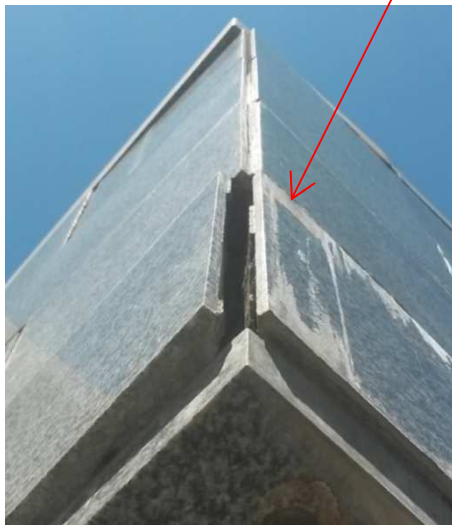
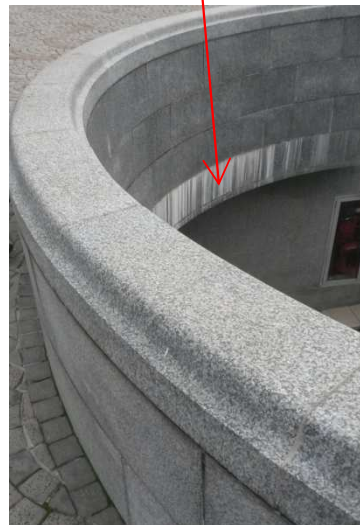
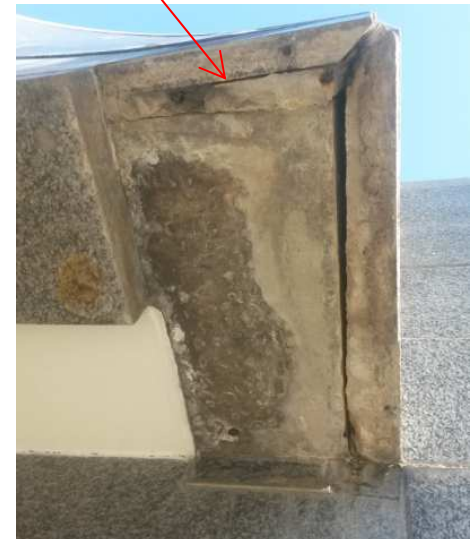
1. BASEMENT PARKING ENTRANCE

| SCOPE OF WORKS | RECOMMENDATION |
|--|---|
| <p>1. BASEMENT PARKING ENTRANCE: HONED PAARL GREY GRANITE</p> | <p>Overhead hanging granite elements:</p> <ul style="list-style-type: none"> •Replace missing granite element with new fixing lugs with stainless steel dome heads. •Expose fixing lug heads of vertically hanging granite slabs and treat with an anti-corrosive treatment and reseal soffit with a stainless steel dome heads. <p>Vertically hanging granite elements that are loose:</p> <ul style="list-style-type: none"> •Refix all loose panels - refer to report for method statement <p>Efflorescence staining on vertical elements:</p> <ul style="list-style-type: none"> •Investigate water route and create water proof barrier behind granite, including a storm water channel if need be to drain the water away. |

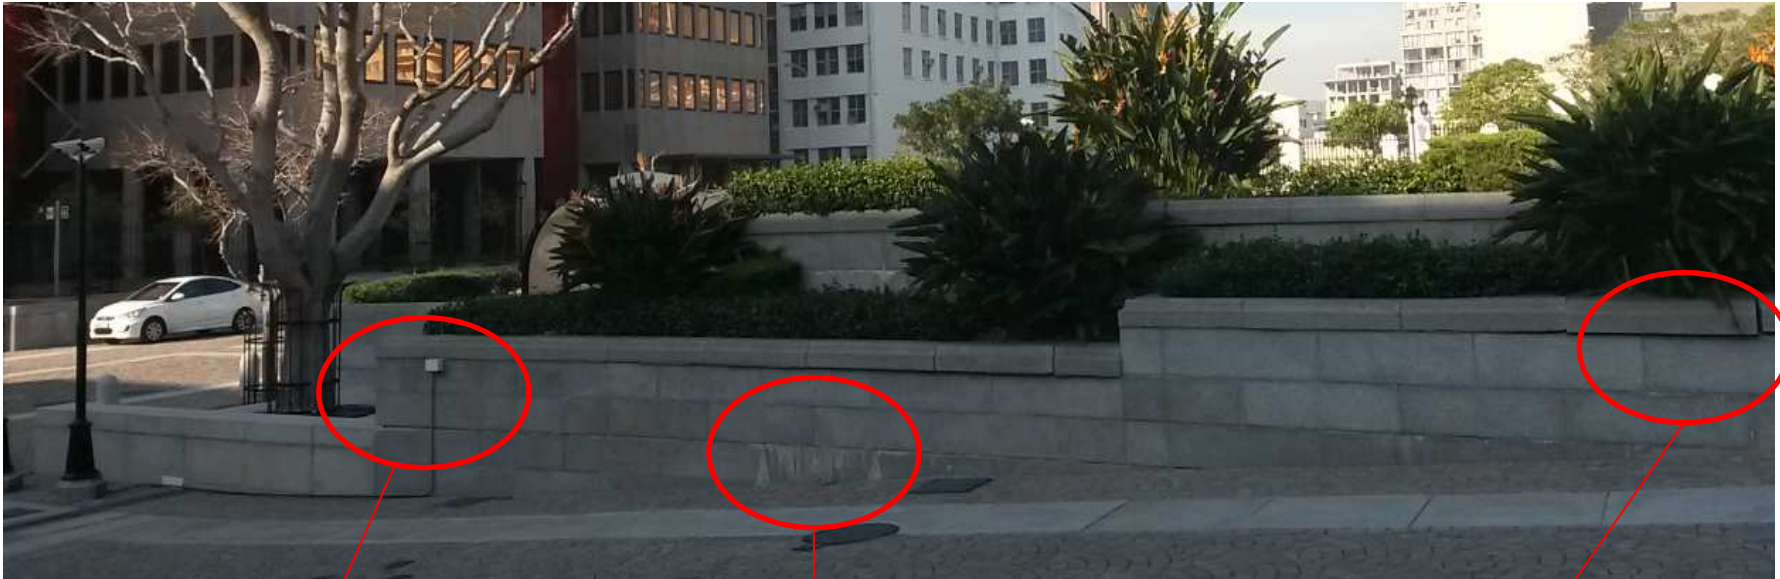
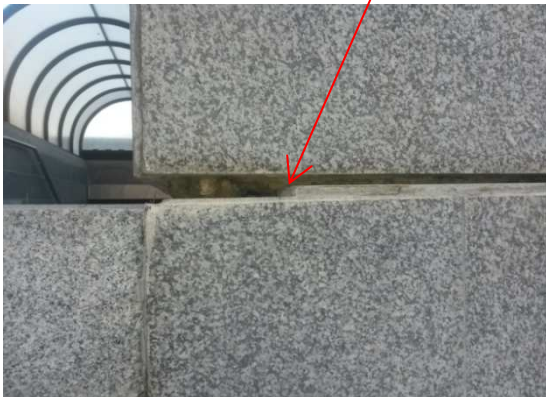
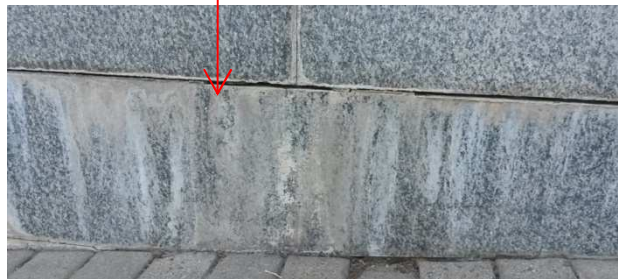
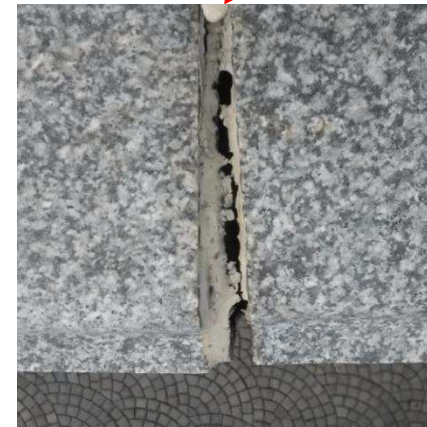
2. GRANITE PLANTER BOXES

| SCOPE OF WORKS | RECOMMENDATION |
|--|---|
| <p>2. GRANITE PLANTER BOXES – FINE MACHINE PUNCHED PAARL GREY GRANITE</p> | <ul style="list-style-type: none"> •Remove plants and expose existing soil and drainage. •Remove all granite block and copings that have moved, and reconstruct. •Redo existing agricultural drainage system, as well as internal waterproofing against granite. •Install a Bio barrier membrane to protect granite from roots of Strelitzia's. •it is recommended that a slow growing variant (known as Mandela's Gold) be planted to replace the existing Strelitzia's, |

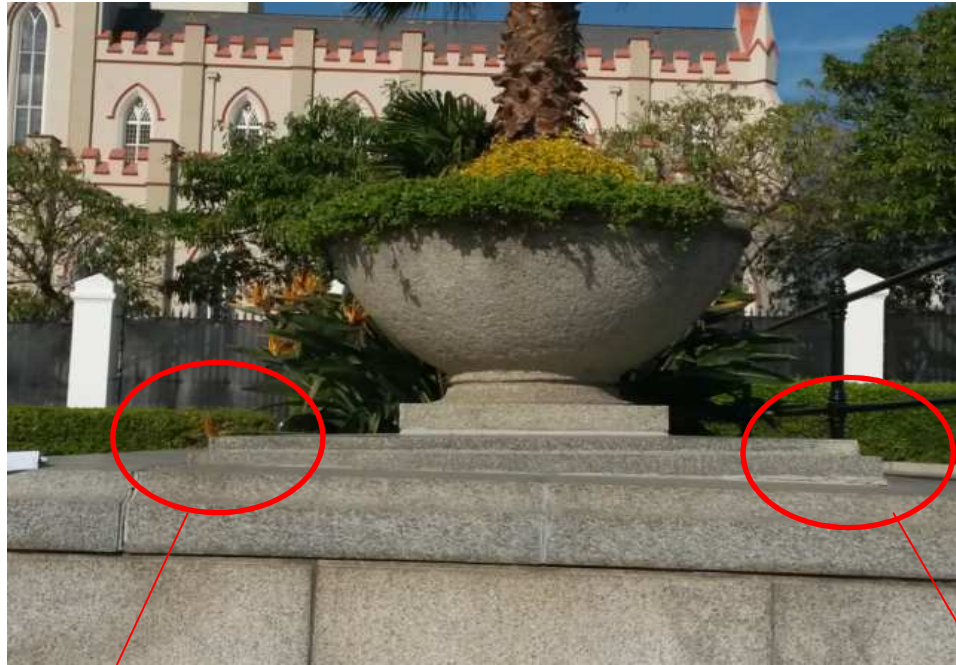
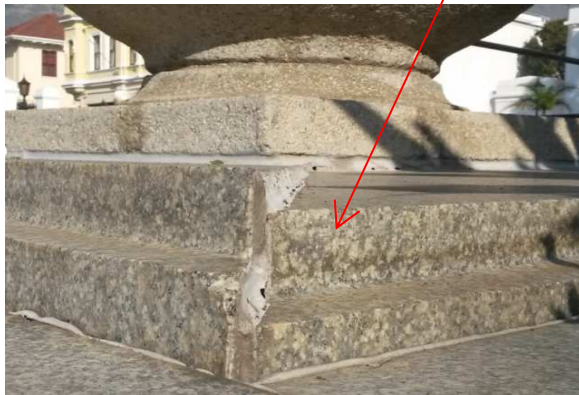
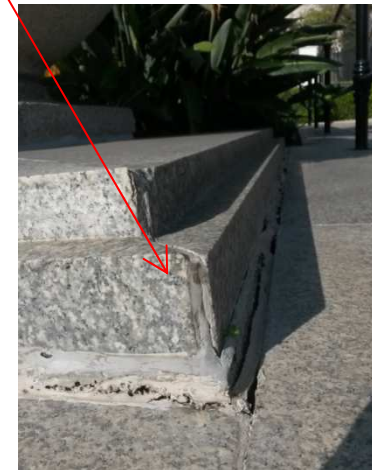
3. GRANITE POT PLANT PLINTHS

| SCOPE OF WORKS | RECOMMENDATION |
|--|---|
| <p>3. GRANITE POT PLANT PLINTS</p> | <ul style="list-style-type: none"> •Remove top coping on the side of the plinth, to investigate further, what the cause of the differential settlement is. Once the cause is determined, possible solutions can be considered. •Risk of damaging the pot plants should be avoided at all cost. |

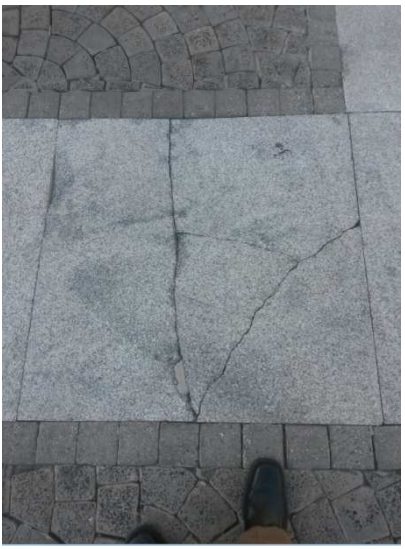
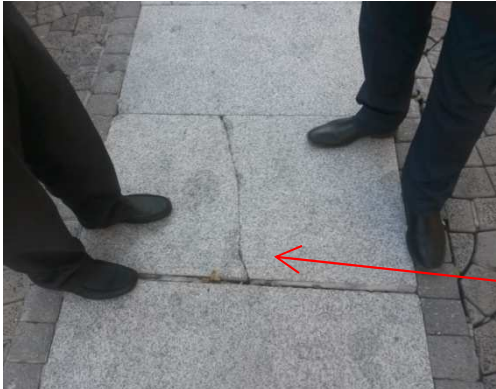
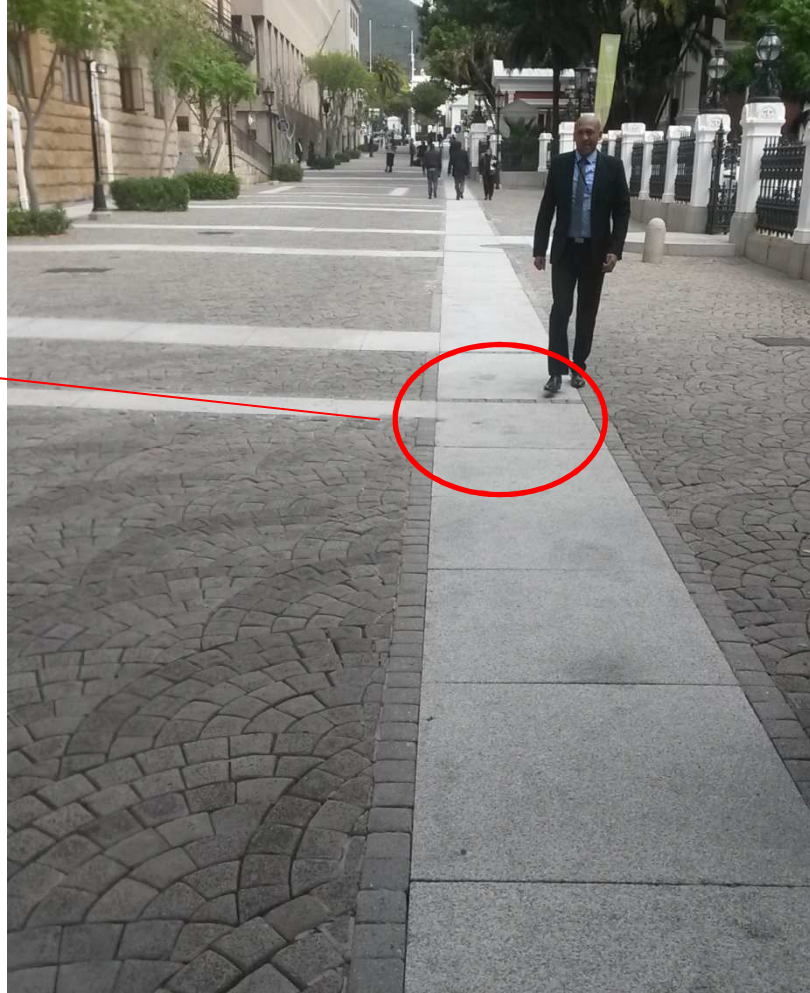
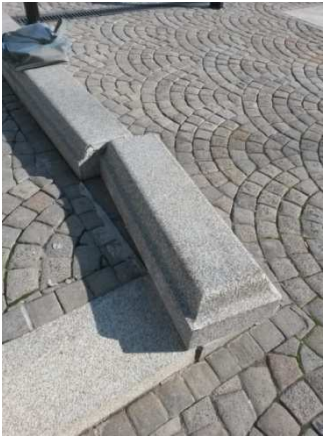
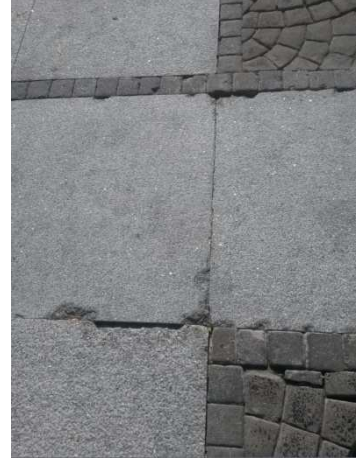
4. PAVERS & KERBS ON STALPLEIN AND PARLIAMENT STREET

| <p>4. GRANITE PAVERS & KERBS</p> | <ul style="list-style-type: none"> •Remove all cracked 50mm thick slabs and make good and level out compacted sub-base underneath. •Introduce cement stabilized sub-base where rutting has occurred. •Replace all cracked granite slabs, with slabs of similar site dimensions. •Contractor to reseal joints with sand cement grout in general, but should make allowance for an elastomeric joints every 10m length of granite(not oil based as they will stain the granite). |

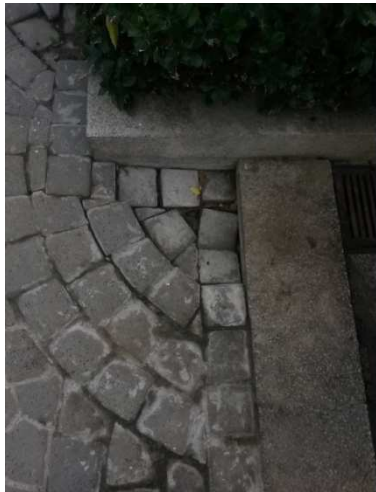
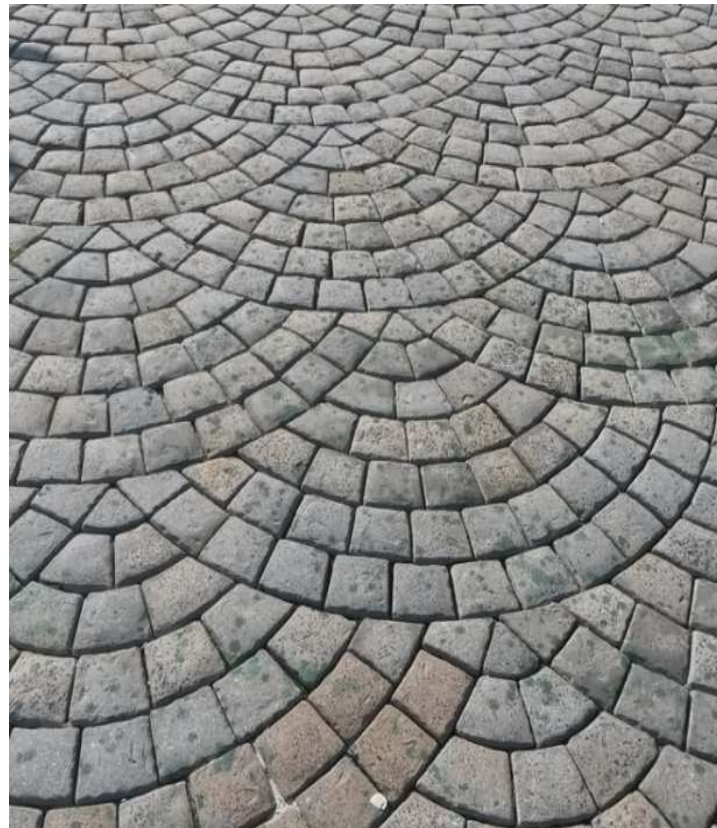
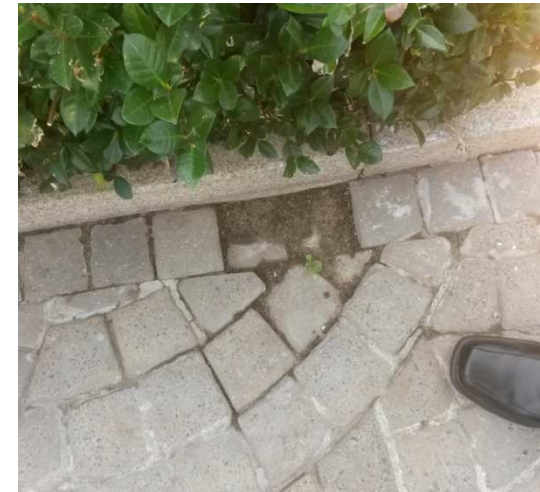
5. COBBLE STONES SETTLING OR DISCOLOURED WITH PAINT SPOTS

| <p>5. PAVING COBBLES : PORTLAND CEMENT</p> | <ul style="list-style-type: none"> •Where settlement of pavers have occurred, the pavers are to be lifted and sub-base to be re-compacted and levelled out, before repaving the affected area's. •Cobble pavers that have been stained with green paint blotches to be cleaned with biodegradable paint cleaner. |

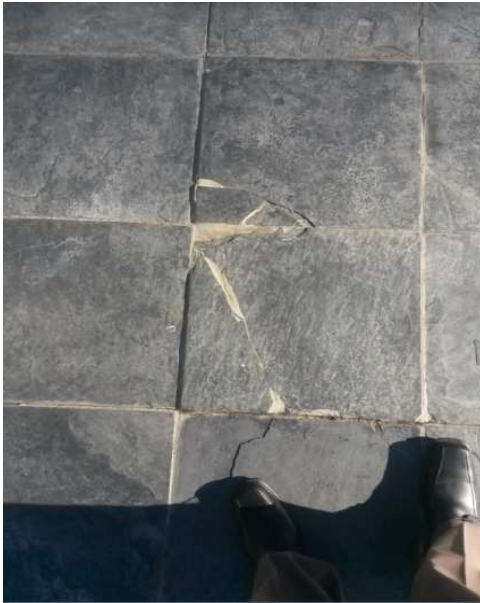
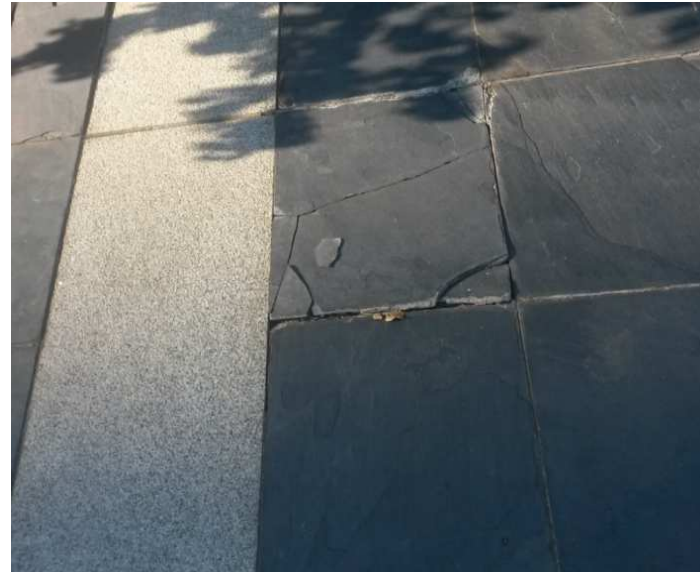
6. DAMAGED SLATE TILES

| <p>6. SLATE TILES</p> | <ul style="list-style-type: none"> •Remove damaged slate tiles and re-compact sub-base and install new slate tiles, matching the existing. |

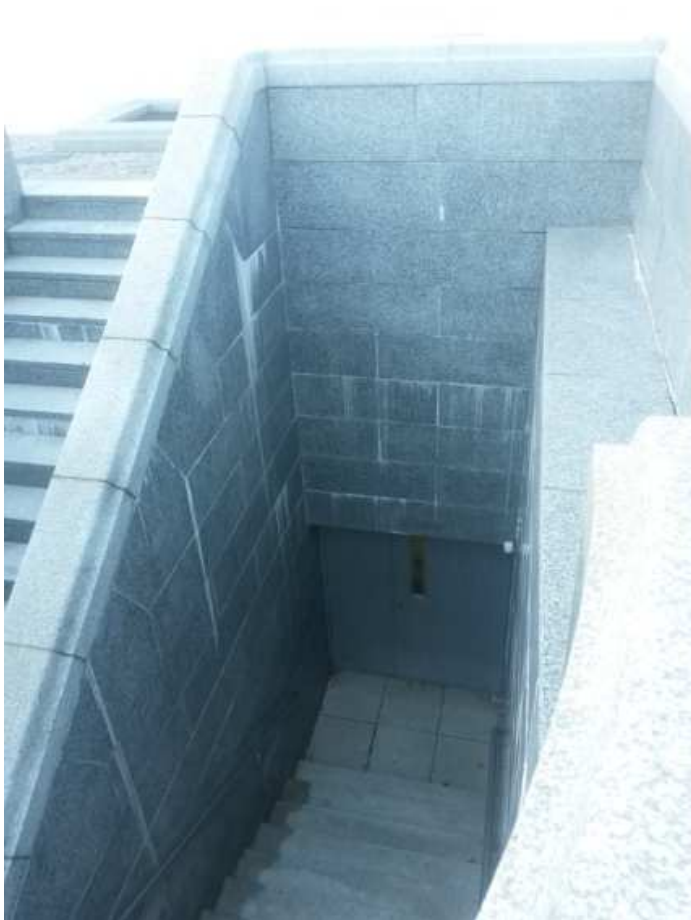
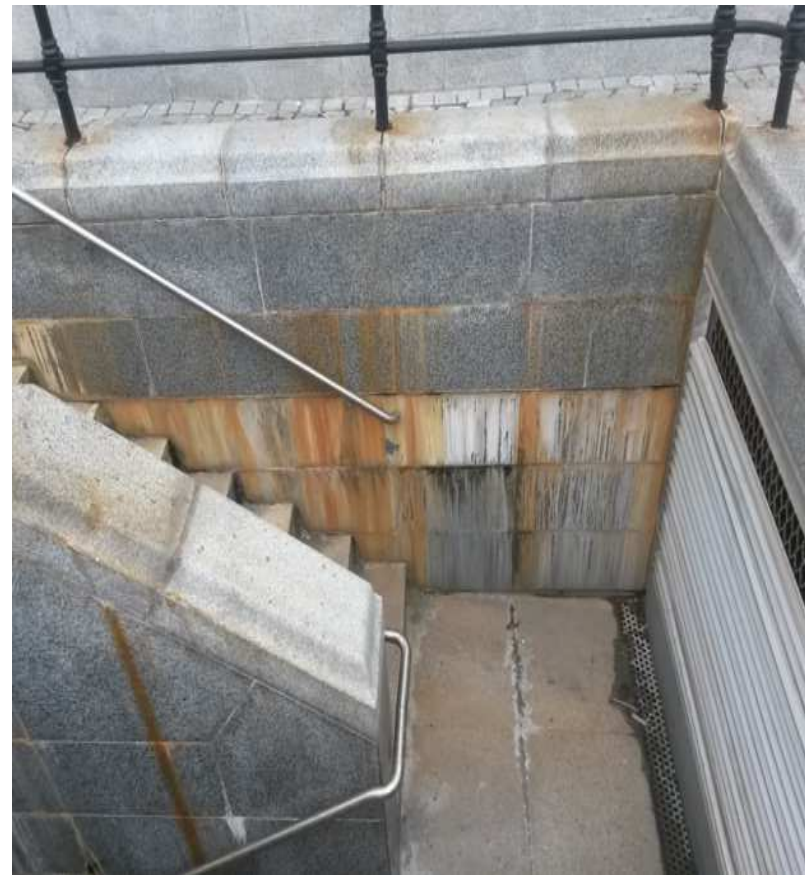
7. STAIRWELLS WITH EFFLORESCENCE STAINING

| <p>7. EFFLORESCENCE & CORROSION STAINING ON GRANITE WALL CLADDING</p> | <ul style="list-style-type: none"> •Remove efflorescence and corrosion staining by means of scraping or using sanding equipment. The granite is a hard wearing surface so the majority of the staining should be removed, but some remnants could still remain. •Investigate where the very white line of efflorescence is coming from, behind the wall. Possible a blocked drain, which should be cleaned out. |

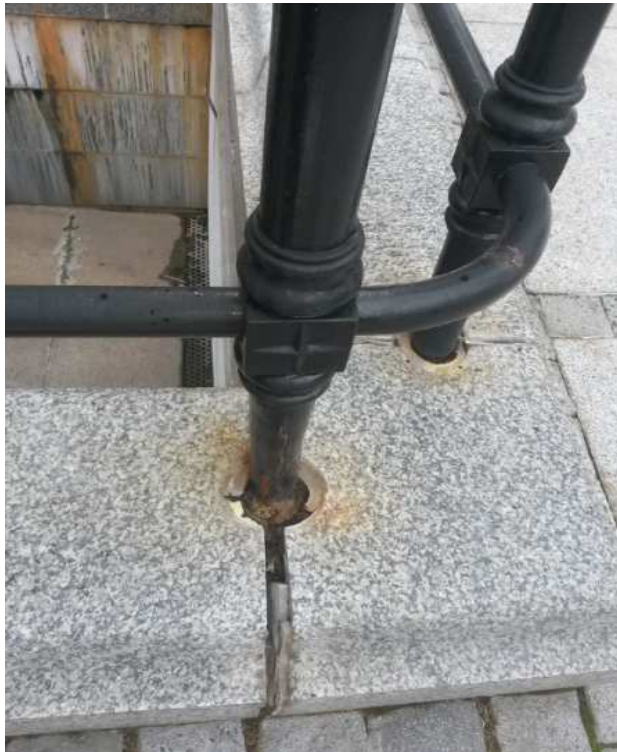
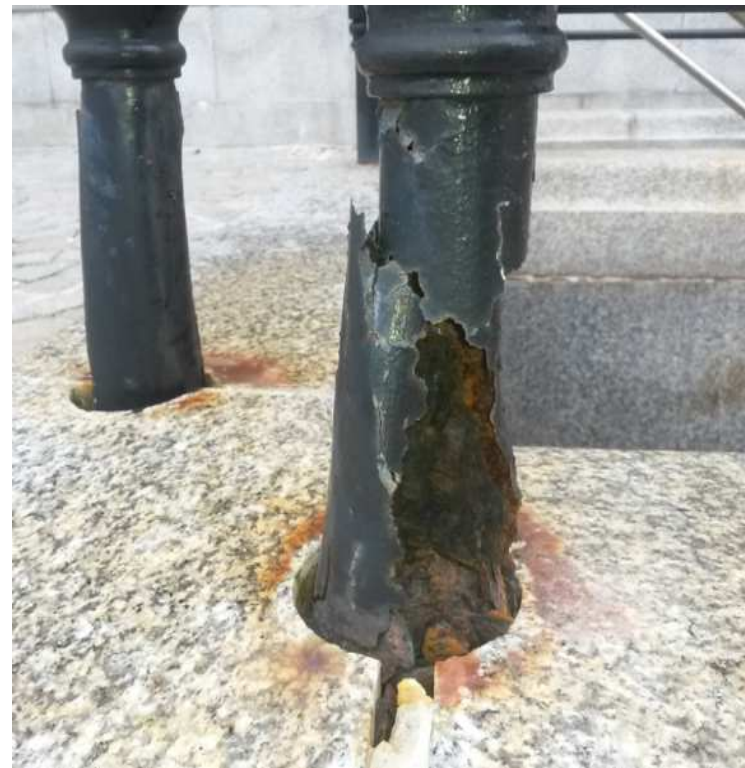
8. CORRODED BALUSTRADE AND HANDRAIL

| <p>8. CORRODING BALLUSTRADES & HAND RAILINGS</p> | <ul style="list-style-type: none"> •Remove and replace rusted balustrading with galvanized or stainless steel members. •Clean and repoint joints around granite coping, after re-fixing balustrading to concrete below. |

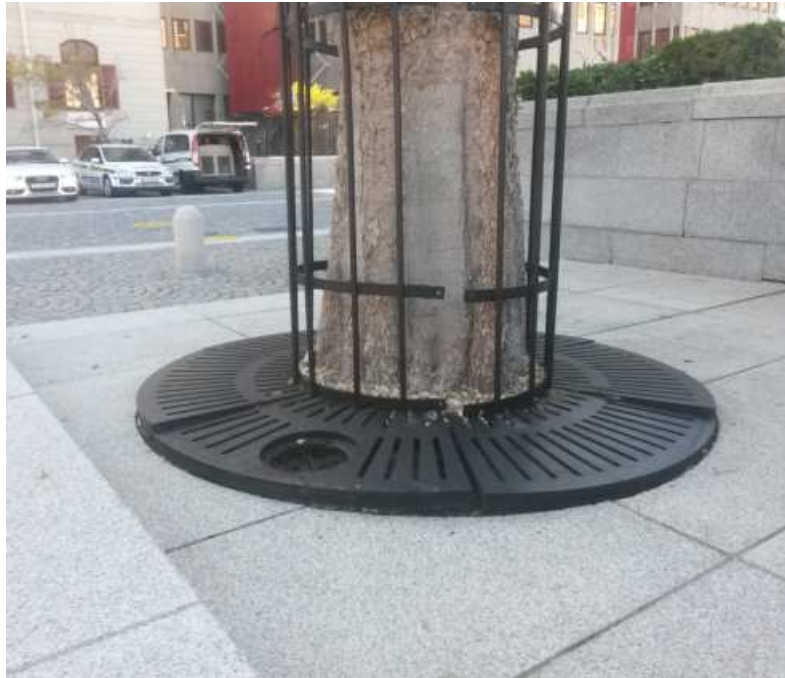
9. TREE THAT IS LIFTING GRANITE SLABS & HAS OUTGROWN ITS TREE RING

| <p>9. MISCELLANEOUS ITEMS</p> | <ul style="list-style-type: none"> •Remove steel tree ring & lift granite slabs around tree to evaluate options for cutting back root system. Horticulturalist to advise. •Clean stains on marble fountain with sandpaper. |

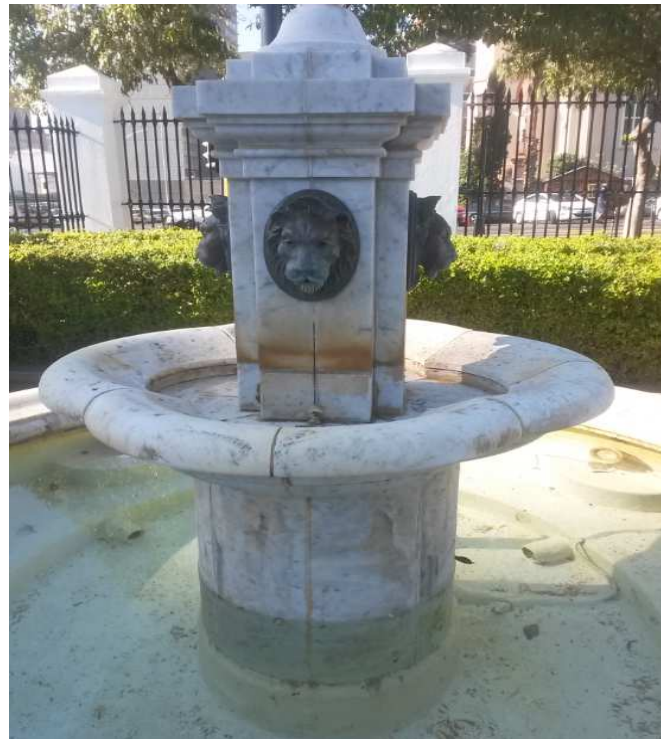
10. MARBLE FOUNTAIN WITH STAIN MARKS
