RE: STRUCTURAL INVESTIGATION OF FIRST FLOOR BRICKWORK @ 336 CHE GUEVARA ROAD, BERA, DURBAN

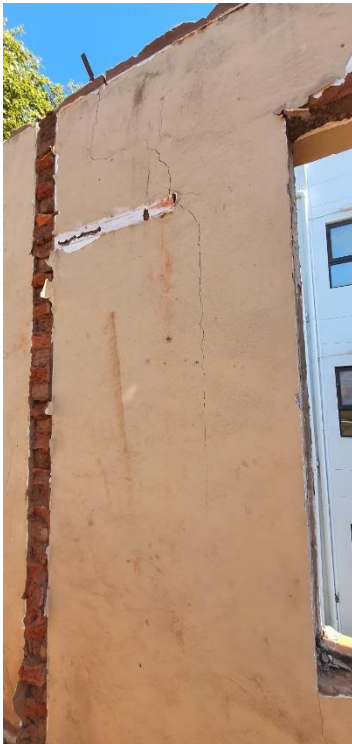
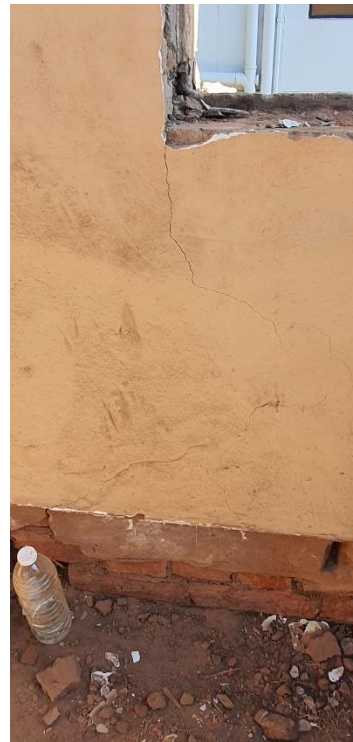
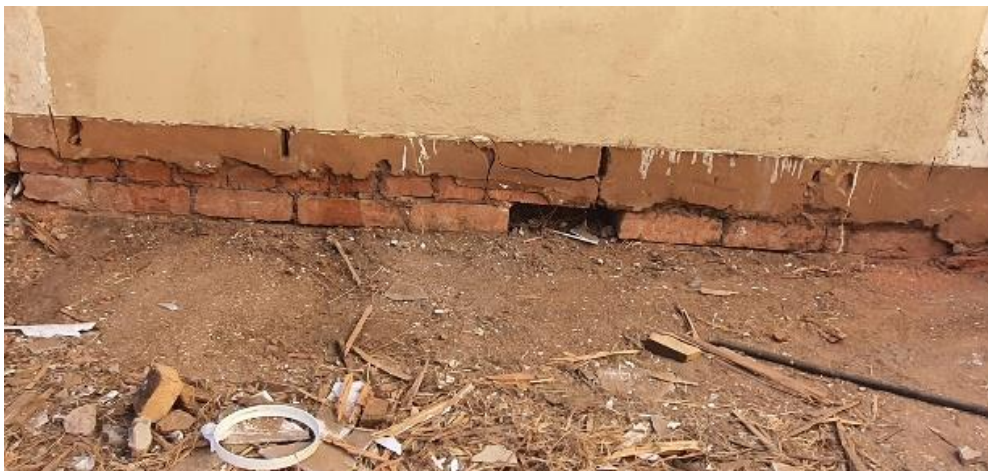
From our inspection the first floor brickwork that remains has shown severe signs of structural instability. There are large sections of brickwork along the external envelope that has cracked diagonally and vertically as well as it has released from the first floor slab as per the images below.

As the demolition of the internal brickwork on the first floor continues there is a risk of the further movement and damage to the external brickwork. This will result in the external brickwork on the first floor being unstable and unsafe, which poses a huge threat to the workers on site as well as the neighbouring properties.

Furthermore, these external walls on the first floor will not be able to carry the load of the new floor above. Should any of the external brickwork on the first floor remain or be built around this will result in future problems such as cracks and water penetration into the building.

From our assessment we conclude that the first floor brickwork is unstable and is therefore condemned.

It is recommended that the external walls on the first floor be carefully demolished and rebuilt using new load bearing bricks. This being the most cost effective and quickest method.

Another recommendation would be to put in reinforced concrete columns and beams and infill with non-load bearing brickwork, however this will result in a higher cost and take more time to construct.

Both methods would still require the brickwork to be demolished.

New brickwork will be required on the first floor for the building works to continue.
