UMSUNDUZI MUSEUM

REPORT - ASSESSMENT OF EXISTING ROOF AND RAINWATER GOODS AT MAIN BUILDING

APRIL 2023

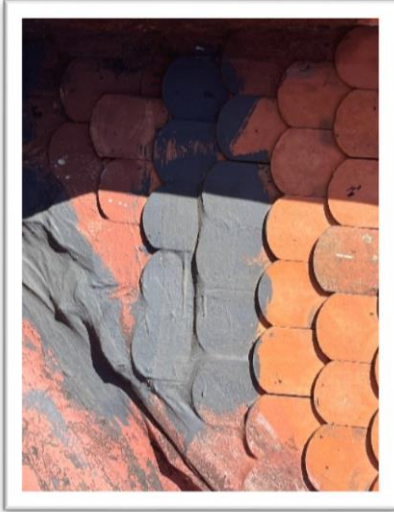
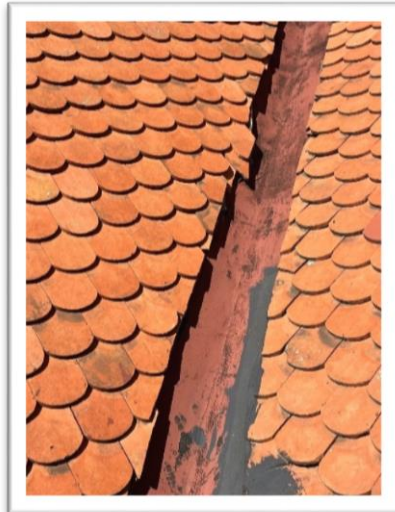
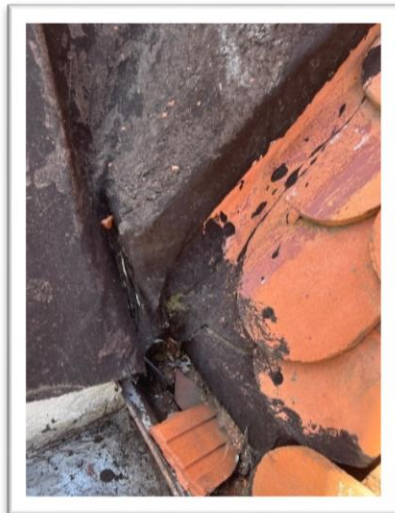
In roof valleys, it was evident that in several areas, the overlap joint between the metal valley and tile-edge was compromised, due to movement of the tiles. In several instances, the resulting leaks were poorly waterproofed with a waterproof membrane and bitumen paint, which is considered a temporary solution.

- Damaged and temporary repaired valleys to be properly replaced with new sheet metal lined timber valleys.
Existing valley tiles to be removed and existing sheet metal valley lining to be removed, timber valleys to be inspected and replaced with new when required. This to be done a single valley at a time (or only a number that can be fully repaired in a single day).

Timber valleys to be lined with sheet metal that has correctly sized 'soaker' setback. Valley tiles to be reinstated with correct amount of overlay into valley, this would require extra roof tiles.

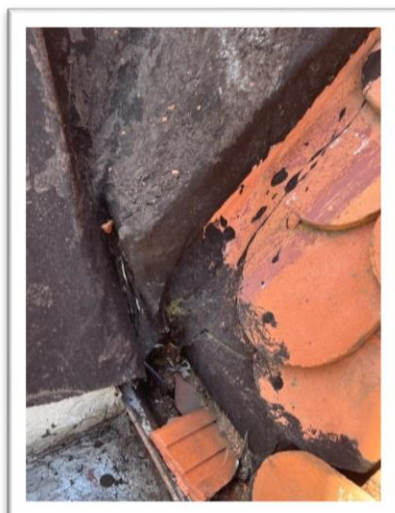
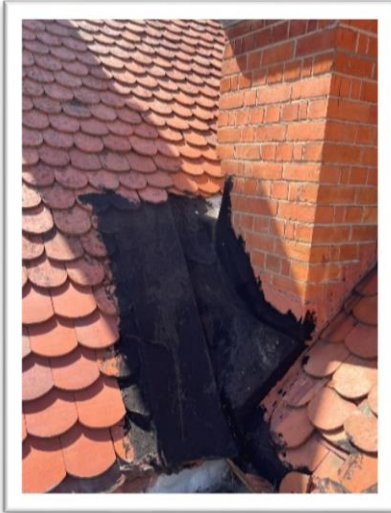
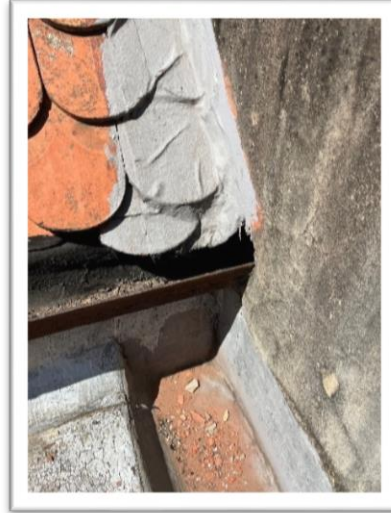
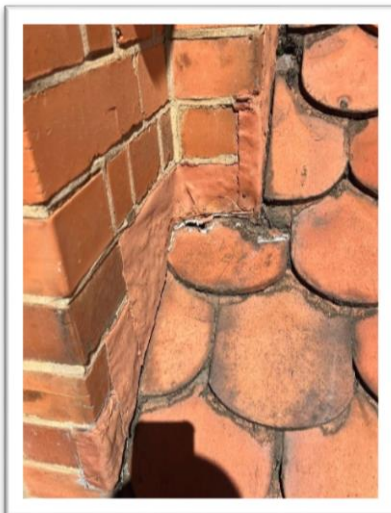
Flashing and counter flash waterproofing, where the tiles meet brickwork, is in most cases either missing, not correctly installed or poorly installed.

- Incorrectly and poorly installed head and side wall flashing to be redone. This is to be done inspections that can be completed in a single day.

Roof tiles to be removed (including all remedial applied waterproofing). Tiles to be removed to expose any metal flashing. Where flashing is damaged, this is to be removed, if not damaged then this may be reused.

Stepped sidewall flashing and straight headwall flashing to be fitted to wall, with sufficient 'soaker' setback. Roof tiles to be refitted into place (with missing and broken tiles being fitted with new). Stepped sidewall counter flashing and straight headwall counter flashing to be fitted to wall (cut into brickwork) and over top of roof tiles (notched at each tile).

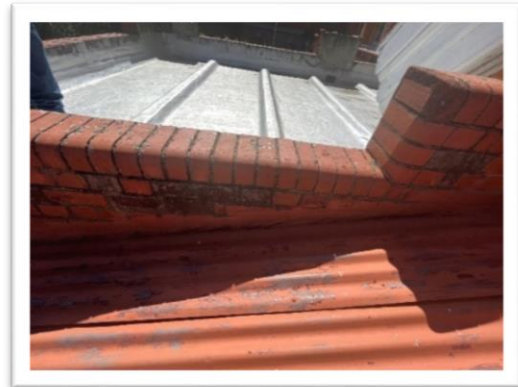
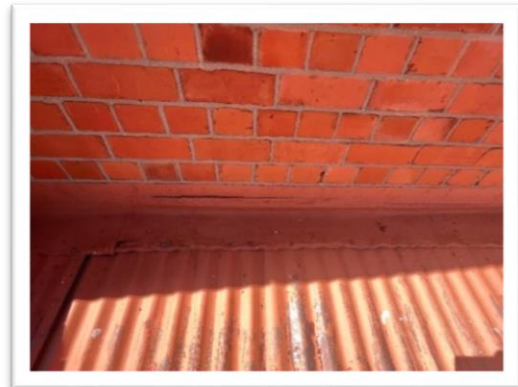
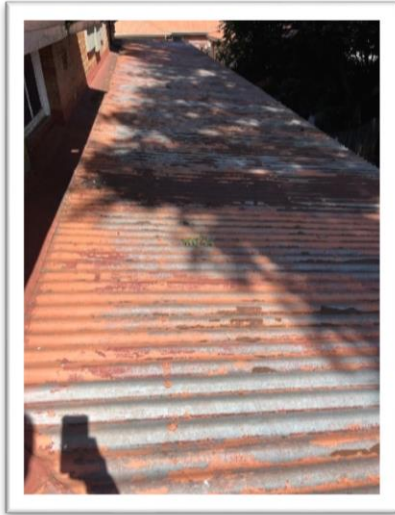
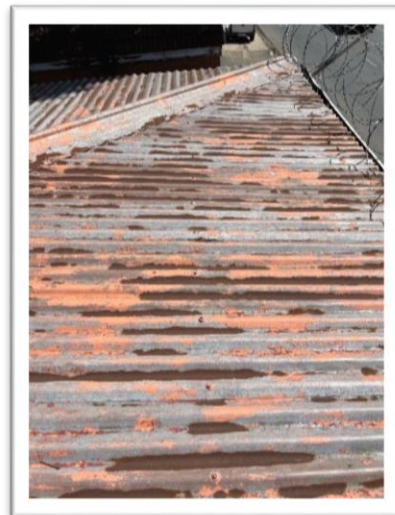
The corrugated iron roofs of the buildings are generally in good condition, considering the age of the building. The sheets show signs of paint deterioration, with rust becoming evident in areas.

Some roofs are laid at a 2° slope, which is too shallow an angle to provide sufficient run-off during bouts of rain.

The valleys on some of these sheet metal roofs were incorrectly waterproofed, in a possible attempt to counter the leaks. These roofs will leak because of the shallow slope, allowing water ingress to the areas below.

- Existing sheets to be removed and cleaned of all paint. Once inspected and considered adequate for reuse, they should be cleaned and prepared for reinstallation using new roofing screws and washers. Once fitted, roofs to be painted to match existing colour. All purlins to be checked for integrity, replace with new where required.
- Roofs with low pitches (once repaired as per above) should be coated with a monolithic water proof coating instead of paint, to match existing colour where possible.
- Damaged and temporary repaired valleys to be properly replaced with new sheet metal lined timber valleys.

Existing sheets to be removed and existing sheet metal valley lining to be removed, timber valleys to be inspected and replaced with new when required. This to be done a single valley at a time (or only a number that can be fully repaired in a single day).

Timber valleys to be lined with sheet metal that has correctly sized 'soaker' setback.

Valley sheets to be reinstated with new roof sheets for correct amount of overlay into valley.

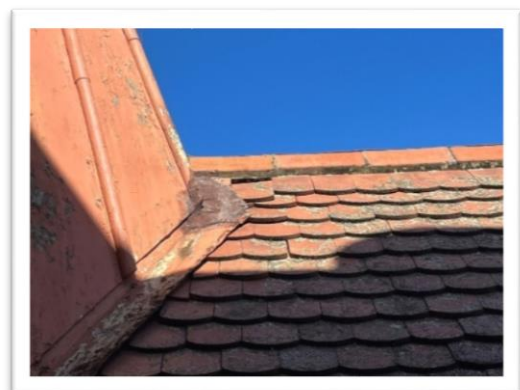
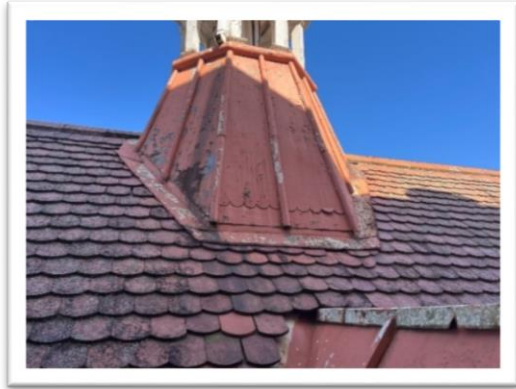
The flat-formed lead sheets used to cover the dormers and turrets are showing signs of age and are unclipping in many instances.

In general, these require all the flashing joints and ridges to be re-formed to seal and join together properly. Paint has weathered significantly and is peeling off these sheets and joints.

- All roof tiles around dormer and turret lead roof sheeting to be removed. Existing lead sheet metal to be removed and repaired, refit lead sheets over repaired/ new soaker flashing and correctly bind seams of ridges. All by specialist installer. Existing soaker flashing to be inspected and repaired/ replaced where necessary. This is to be done with lead sheet metal and by a specialist installer. Tiles to be refitted over the repaired/ new soaker flashing, new tiles to be fitted where required so as to reduce gap between flashing and tiles.
- Removed ridge pieces to be repaired or replaced, and fitted to newly replaced roof sheeting. Proper notching and capping to be done around seamed ridge joints.

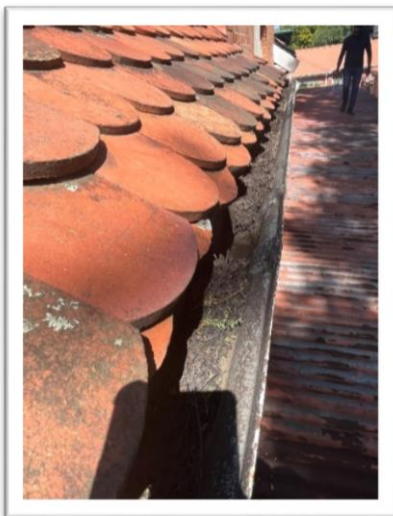
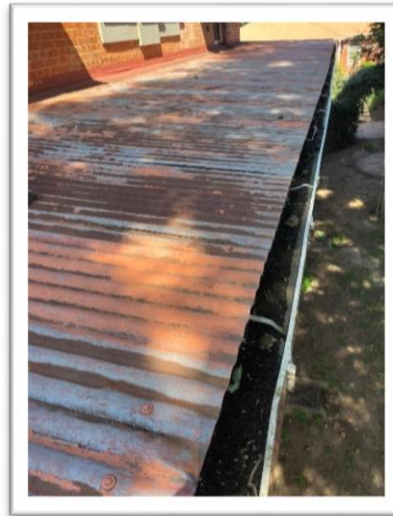
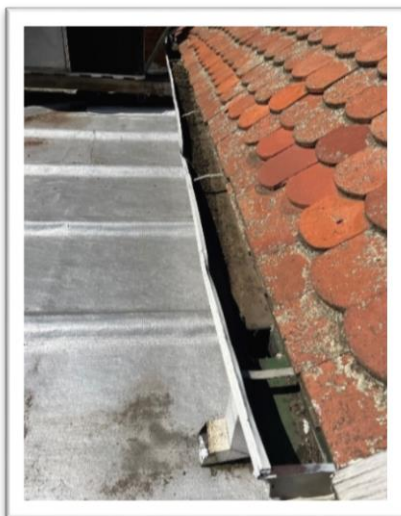
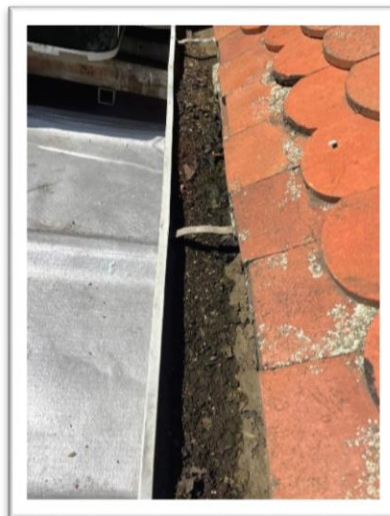
Eave gutters on the entire building generally require cleaning and in some instances would need to be replaced in full with correct falls. Several of the gutters were filled with leaves and other debris, which will impact negatively on their efficiency.

Structural failure of a number of these gutters can be attributed to the failure of the timber fascia they are fixed to, where the fascia have rotted or pulled away from their support structure.

- Eave gutters require cleaning of all debris and silt build-up, this will unblock gutters and let the flow of water run freely.
- Gutters to be inspected for replacement. Damaged/ bent/ twisted gutters to be removed and replaced with new. Gutter to be sheet metal and profile to match that of existing.
- Damaged and rotten timber fascia boards to be removed and replaced with new, to match existing in size and profile. Must be fully painted before gutters are fitted.
- Roof finish overhang into gutters to be adequate in size, where short on tiled roof; new tiles to be fitted and cut back to correct overhang size. Tiles to match existing roof tiles.

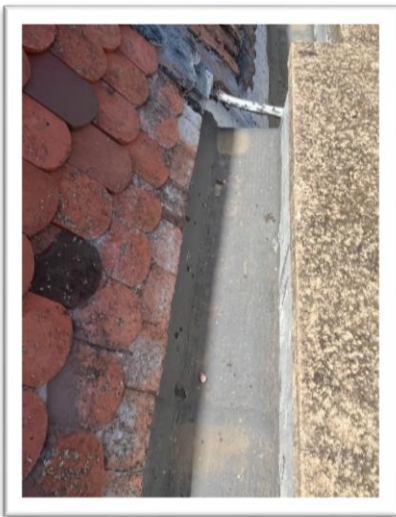
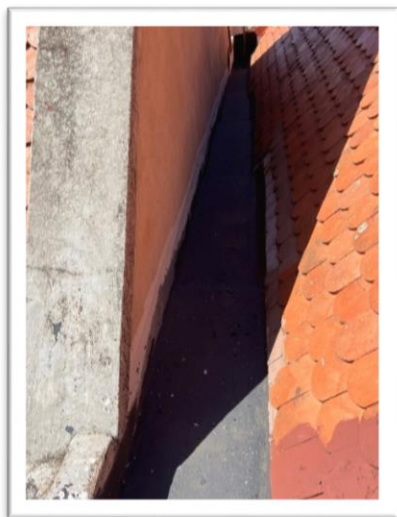
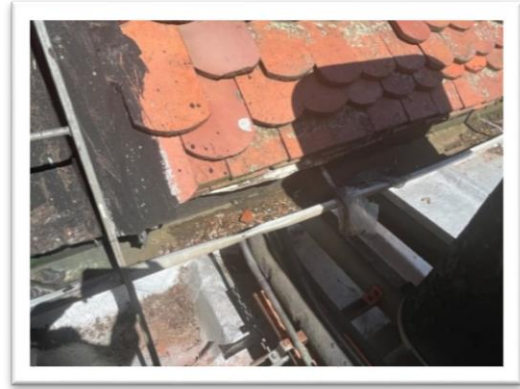
In other instances, the roof overhangs are not sufficient enough to discharge water into the gutter, which would result in water ingress into the building.

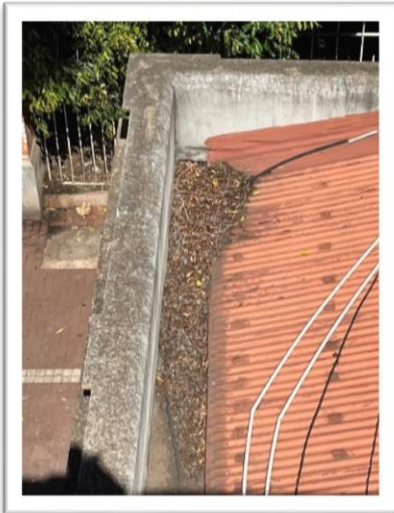
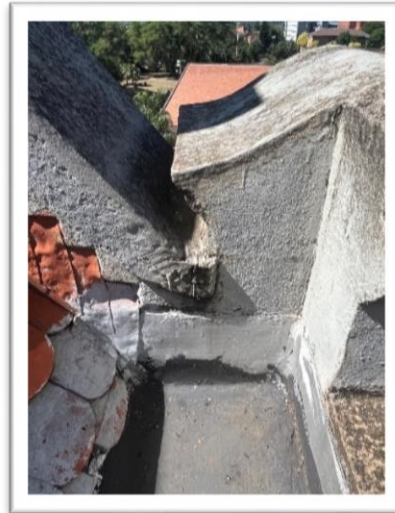
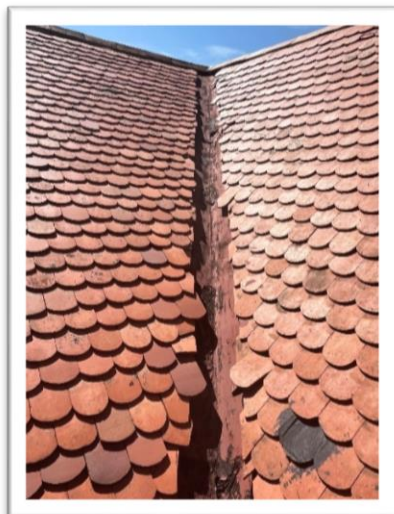
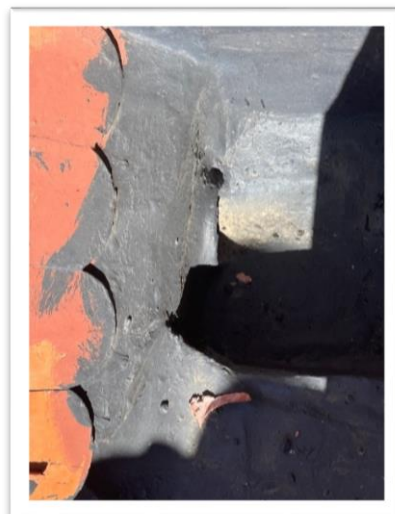
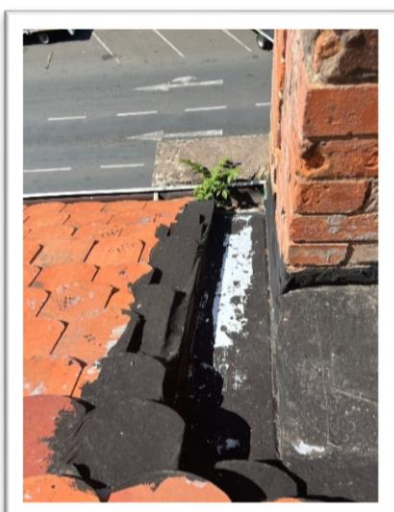
The box gutters fitted to the building appear to be the major source of water leaks to the inside of the building. The box gutters appear to be structurally in good condition, but in most instances, the waterproofing applied to the box gutters is failing at the joints with brickwork, roof edges and parapets, causing leaks. There is also evidence of leaves and debris collecting in some box gutters.

- Box gutters to be cleaned of all debris silt build-up, this will allow free flow of water to the outlets as well as eliminate pooling water issues.
 - Box gutter waterproof membrane to be removed, gutter structure to be inspected and fully repaired/ replaced where required. Roof riles/ roof sheets would need to be lifted in these areas to properly inspect and repair the gutter.
 - Box gutter to be fully waterproofed with new monolithic type sealant 3-4mm thick, to create new watertight gutter.
 - New bent soaker sheet to be fitted under roof finish and into box gutter, using sheet metal.
 - Roof finish to be reinstated, where necessary the roof finish must be replaced or added to so as to create an adequate overhang into the gutter.
-
- DOWNPIPES

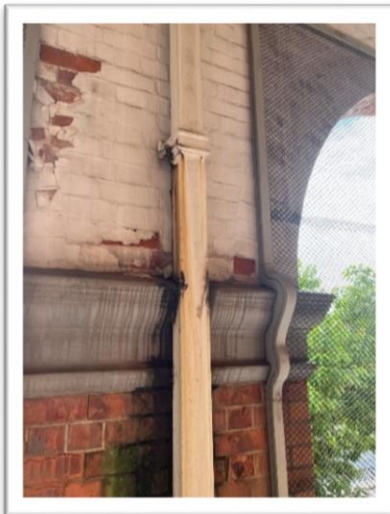
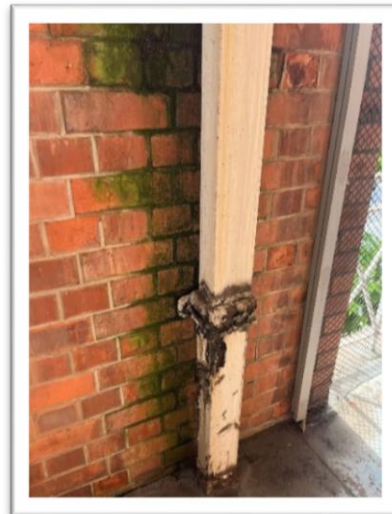
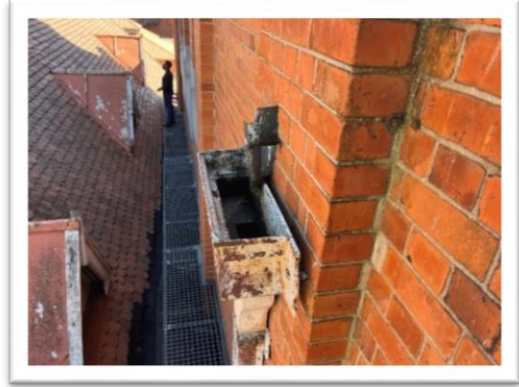
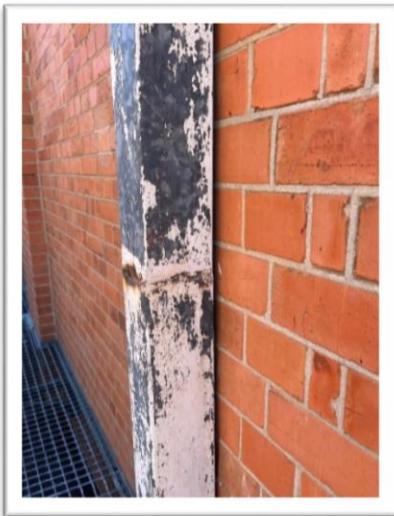
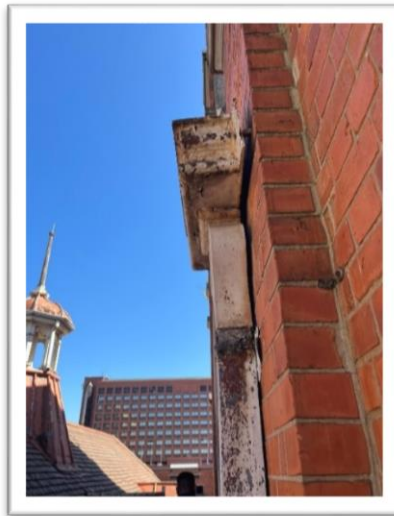
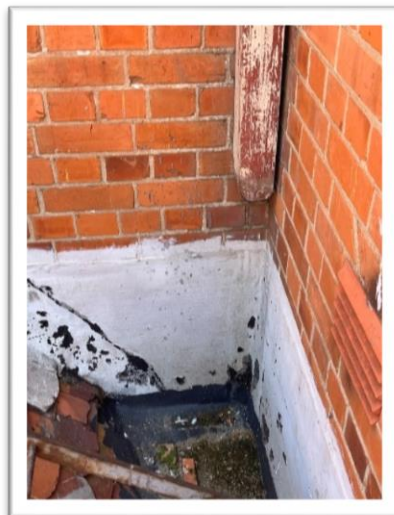
The building was originally fitted with cast-iron type downpipes, of which a large number have been replaced over the years with aluminium type downpipes of similar size. Almost all remaining downpipes are in a severe state and/ or coming loose at the joints and fixing brackets, resulting in water not being directed efficiently to the ground.

- All degraded downpipes to be repaired where possible, by weld/ brazing holes closed. Where holes are too big, then a closing plate cut to size is to be weld/ brazed into place.

- Downpipes to be fully cleaned and sanded down, prepared for new paint.
- Missing downpipe shoe to be fitted where missing, without the shoe the water is not directed away from the building.

- All downpipe brackets to be fixed onto the wall securely. At pipe joins, the bracket to be removed and join to be re-established before securing bracket to wall.

- Hopper heads of downpipes to be repaired as per downpipes above, once repaired these need to be fixed onto the wall securely.
- Downpipes to be reconnected to hopper heads, where spigot from hopper head into downpipe is missing they are to be remade and fitted, so pipe can fix over it.

- Downpipes to be reconnected to gutters, where spigot from gutter into downpipe is missing they are to be remade and fitted, so pipe can fix over it.
- Downpipes which are discharging onto lower roofs must have spreaders fabricated and fitted onto existing shoe.

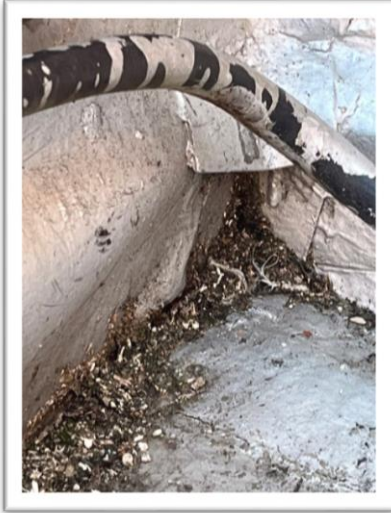
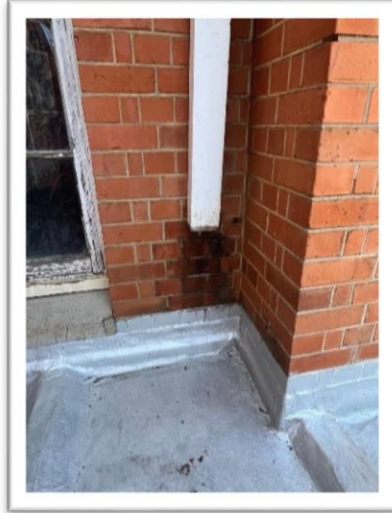
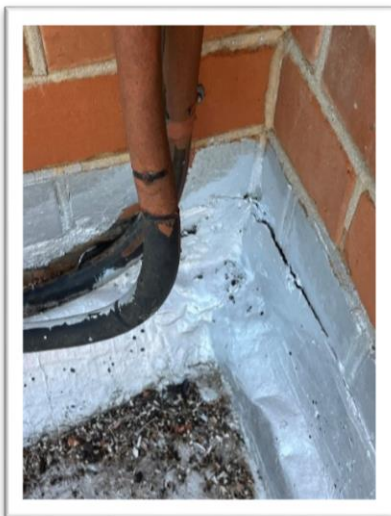
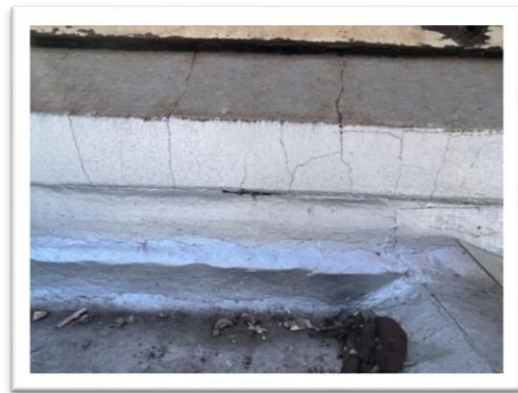
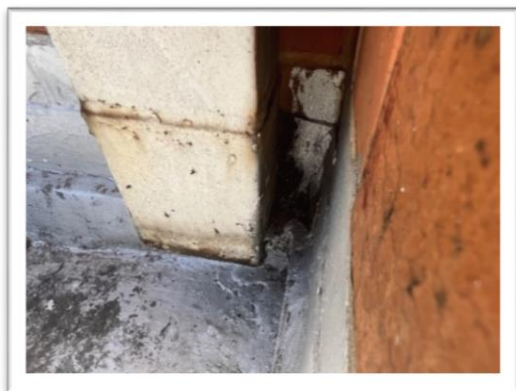
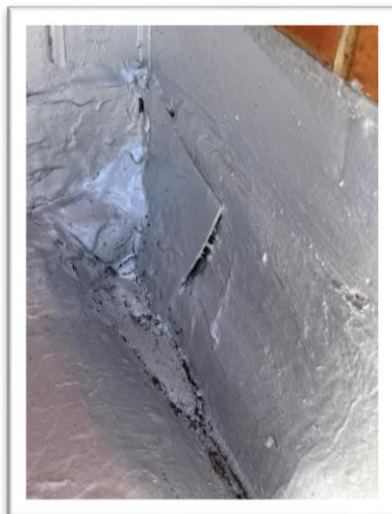
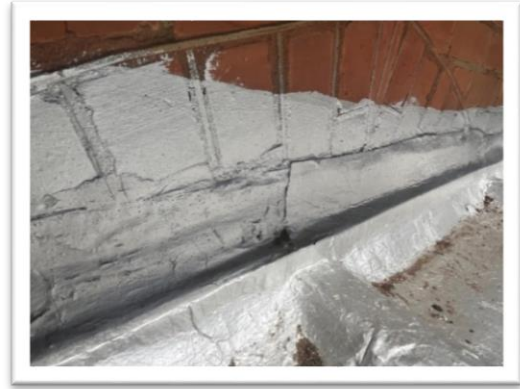
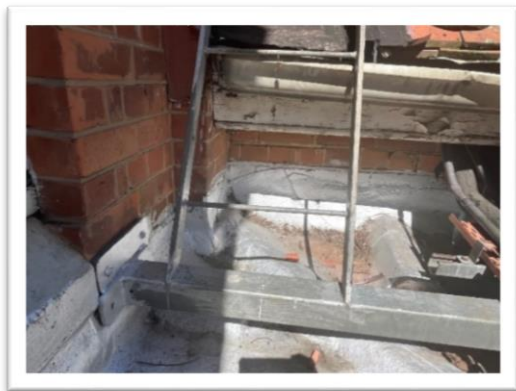
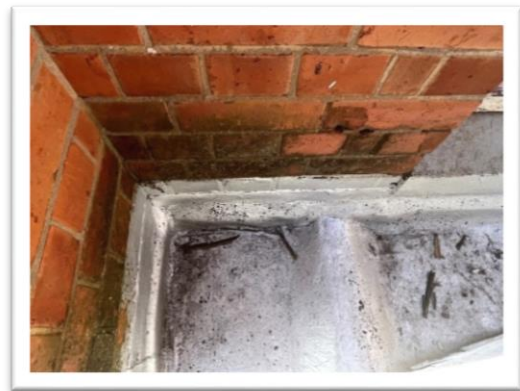
The condition of the bitumen waterproofing on the concrete and timber flat roofs is poor. It appears that the waterproofing was recently re-painted in an attempt to improve its performance, but the paint's function is to protect the waterproofing and not to improve its performance, hence the problem has not been addressed. The major source of leaks from the flat roofs is at the flashing & counterflashing intersections, overlap joints, and in corners to parapet walls, etc.

- Existing waterproofing to be removed in full from all flat roofs, including the flashing and counter flashing on the walls.
- Inspect all structure of flat roof, and repair when required. Roofs are either concrete or timber construction.
It is advised that any ridges or unnecessary protrusions be removed as they make waterproofing more difficult.
- All corners where flat roof meets wall are to have 45° chamfers added, either as screed (concrete) or timber pieces (timber).
- Full monolithic type waterproof coating 3-4mm thick. This should rise up the walls by at least 250mm (or above highest drainage outlet).
The wall rise should have a bent sheet metal counter flashing fitted of the join, this flashing to be cut into wall and sealed.

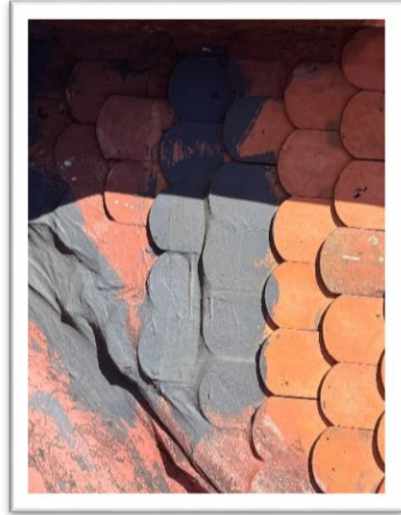
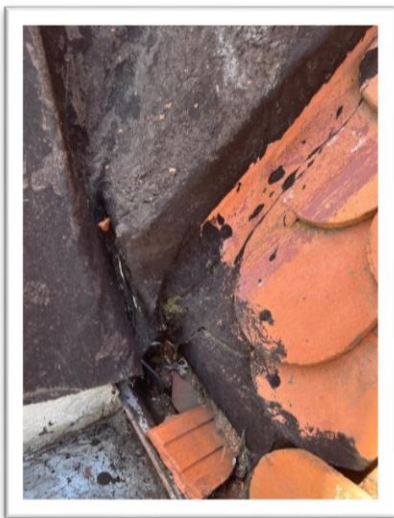
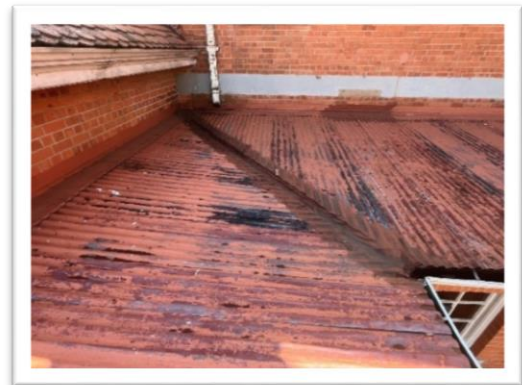
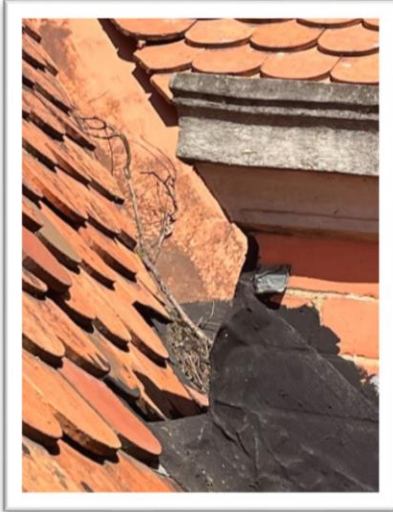
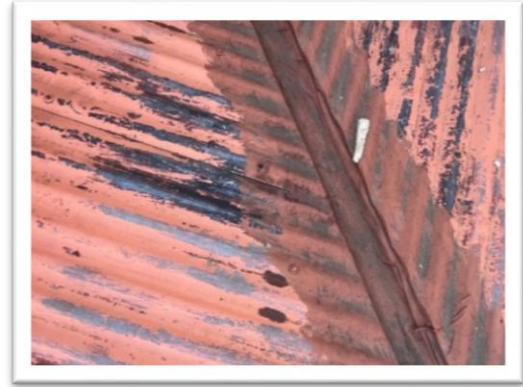
Almost all valleys and remedial waterproofing to same needs to be addressed. It appears that the metal valleys have been waterproofed numerous times over the years, with a majority of the applications not following the original correct method. This leads to waterproofing membrane being applied over the edge tiles into the valley, allowing water to ingress behind the roof tiles and not into the valley. In several instances damaged side wall and counter flashings were observed.

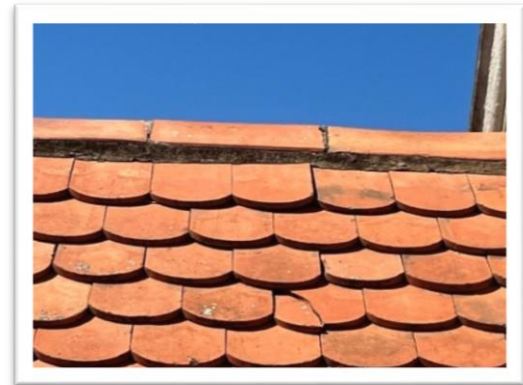
Hip and ridge tiles are generally in descent condition, with only a couple of loose capping tiles that require re-fixing. These loose capping's will allow water to ingress into the roof space and behind the roof tiles, causing damage to these internal spaces.

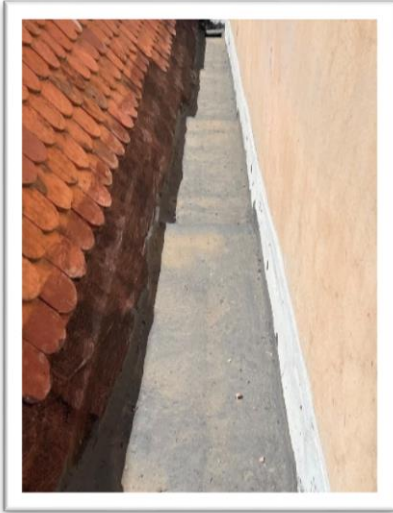
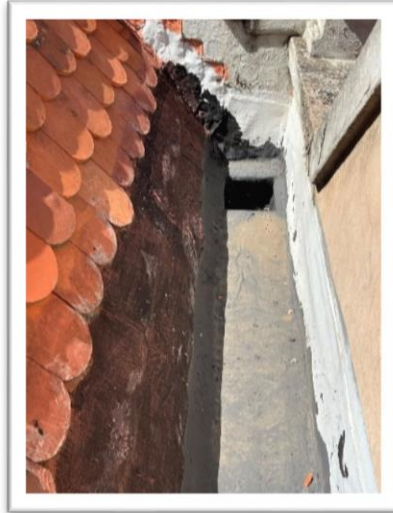
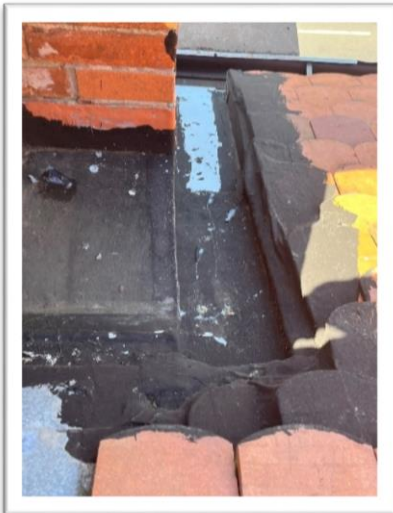
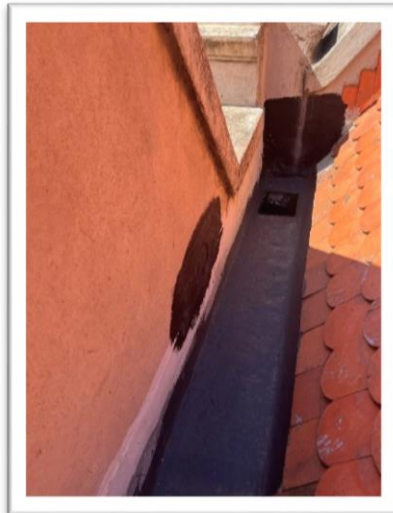
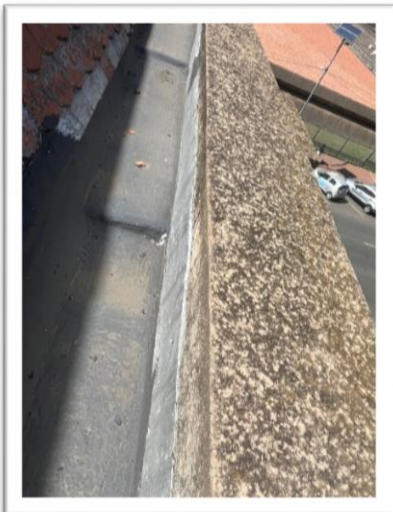
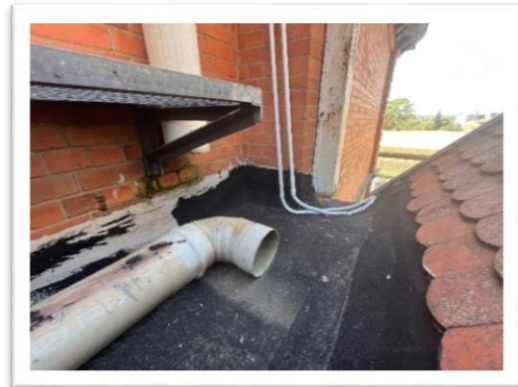
Waterproofing in all box gutters should be redone in the correct manner, with all counter and soaker flashing correctly installed. The current waterproofing installation was not properly executed to a large degree, is not properly lined, and is also showing signs of failure in many areas.

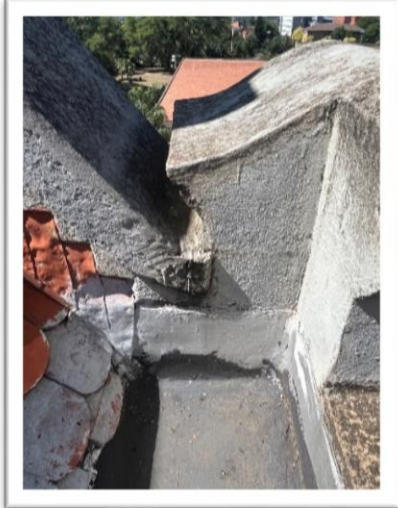
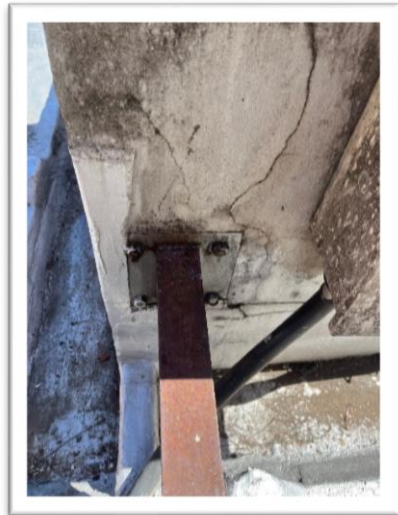
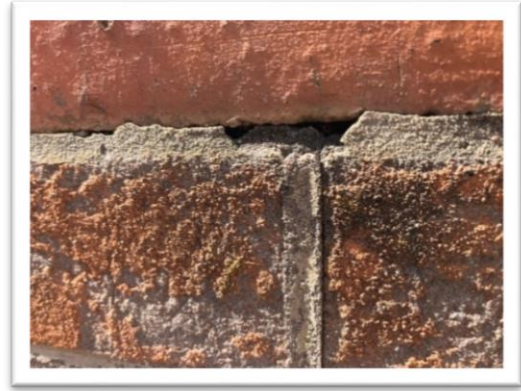
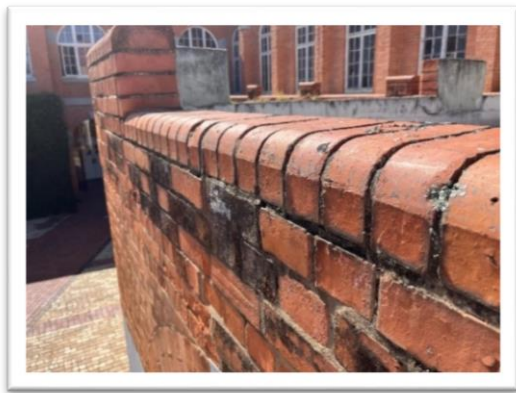
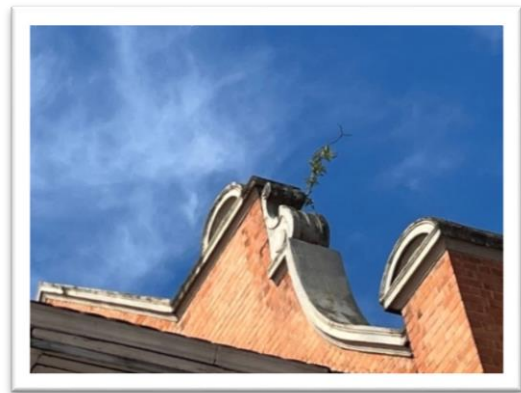
Copings on plastered and face brick parapet walls and gables require attention. In a number of instances, the plaster providing the waterproofing to the top and sides of the parapet walls is failing, allowing water seepage into the walls. This over time will exaggerate the peeling of the remainder plaster and result in water seeping into the wall itself, which will manifest as damp. There is also evidence of weeds growing out of the cracks in walls because of wall dampness. Damaged face brick and missing mortar joints are evident in areas, which also allows water seepage over time into the wall cavity.

- Copings on all parapet walls to have all cracks and chips repaired with non-shrink grout, copings to be fully prepared for new paint.
- Severely damaged/ cracked copings to be chopped out in sections, new copings to be cast into place (to match existing profile). Plaster to be non-shrink with waterproof additive and glass fibre reinforced mixture.
- Paint to be the mastic type waterproof paint, to match the existing cement grey colour.
- Damaged/ crumbling mortar joints to be raked out to point of being dry. These joints must be repaired by filling them with a non-shrink grouting, which has a waterproof admixture.
- Where possible, it is advised that the degraded/ cracked/ broken bricks be removed and replaced with new to match existing. Priority will be to find old stock bricks to use.

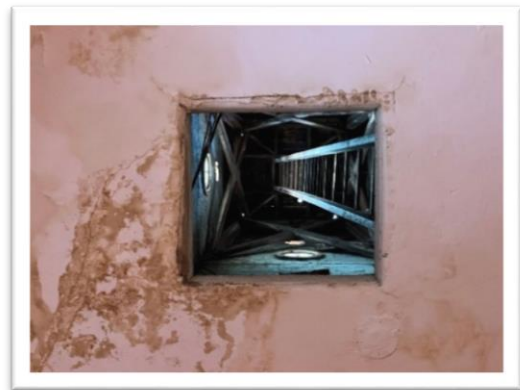
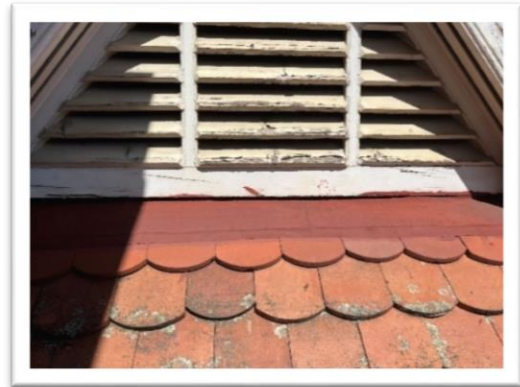
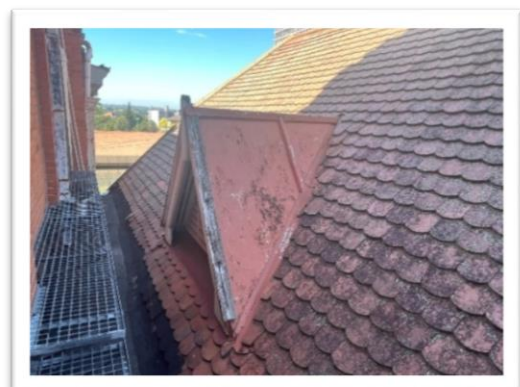
The timber turrets on the roof require extensive restoration, as the timber elements of these structures have failed. This too presents a risk of collapse. The dormer metal roof sheets require maintenance, as the sheets have started to separate from each other. The timber structures within the dormer face have deteriorated severely and require repair/ replacement. The timber louvres in these structures are broken in places, directly allowing rainwater to penetrate the roof space and ceilings below.

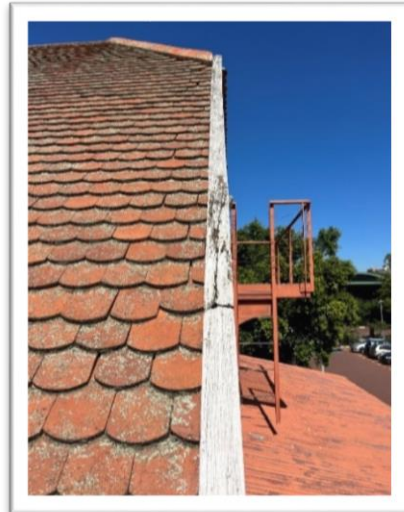
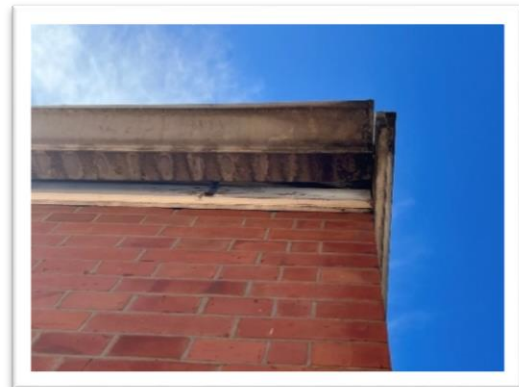
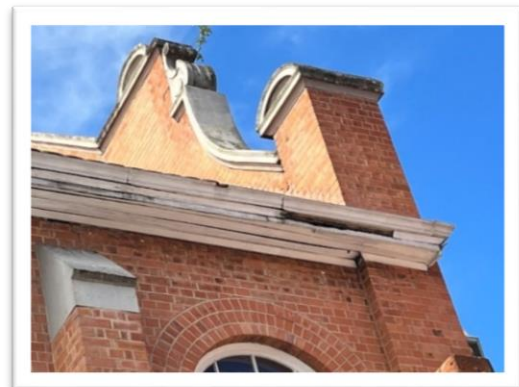
The timber barge boards and fascia's require repair/ replacement. In a number of instances, the fascia itself has rotted and is no longer considered to be structural. These fascia's are coming away from its support structures, which would indicate possible damage to the support structure as well.

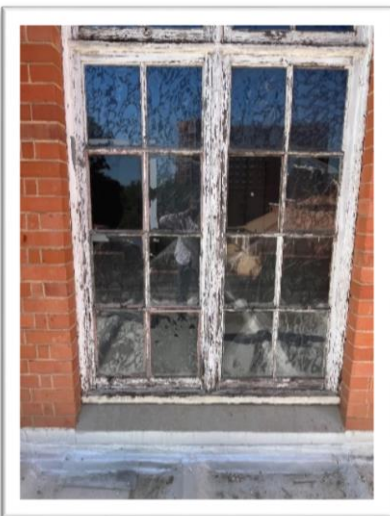
There are several timber windows that have deteriorated quite severely over time, possibly due to lack of maintenance and exposure to the elements. These windows are no longer waterproof and allow water to directly penetrate the wall cavity and interior of the building.

- Damaged and broken timber windows to be removed and repaired. All work to be carried out by approved carpenter.
New timber frames, transoms/ mullions and beading to be fabricated to match existing exactly where required, using approved hardwood (saligna/ meranti).
- Repaired timber windows to be fully prepared and painted, prior to being refitted into openings.
- Gaps between walls and window frames are to be fully sealed with an acrylic type watertight sealant, internally and externally.
- Missing and broken glass panes to be replaced with new.
Existing putty to be removed from windows and new putty to be applied for all windows.

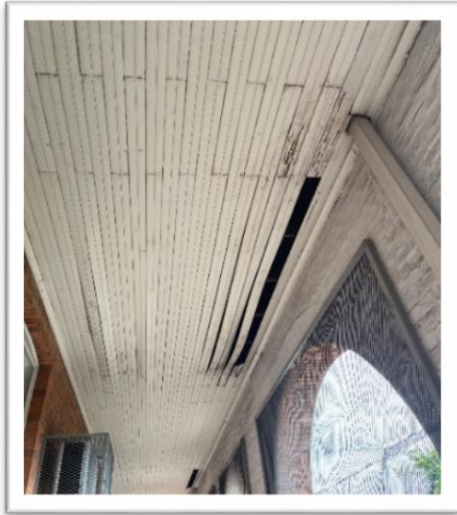
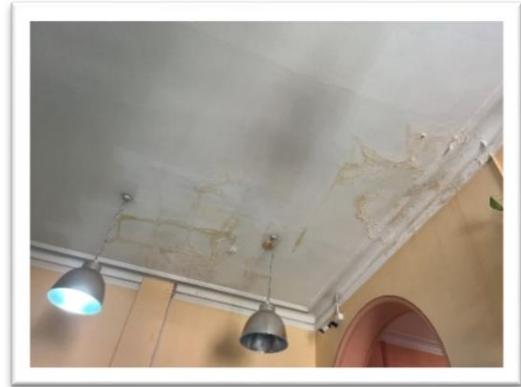
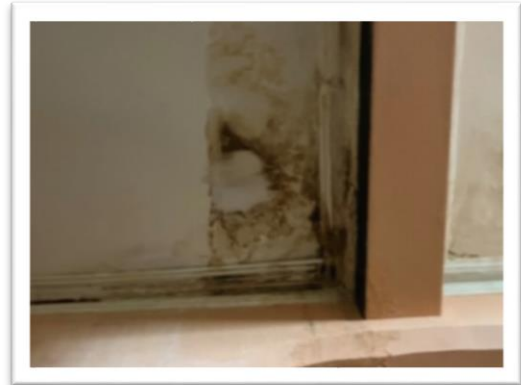
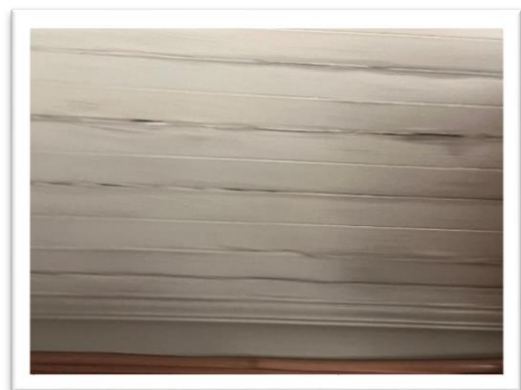
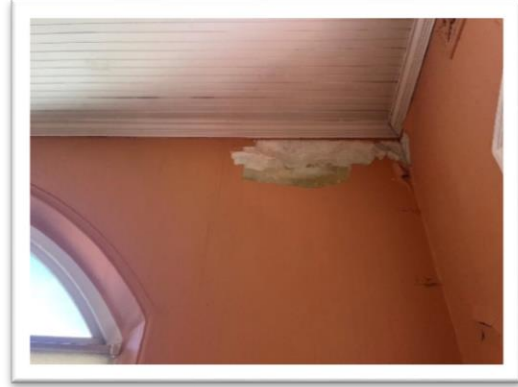
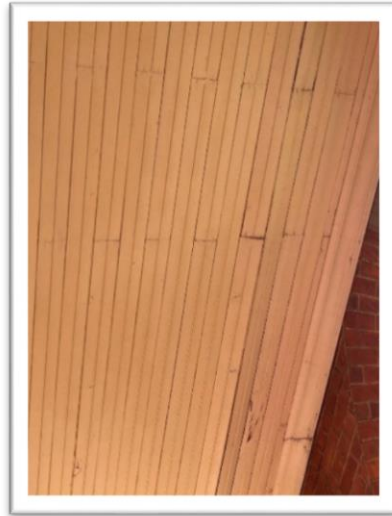
Due to the prolonged water ingress from the leaks identified, the ceiling and internal wall plaster of the building have been damaged in several areas. Damp is evident in the internal walls and signs of water damage on several ceilings throughout the building. Once the external leaks have been successfully addressed, the interior elements can be safely repaired/ replaced in accordance with AMAFA guidelines.

- All internal walls and ceilings that have been damaged due to water ingress must be fully prepared for new paint; scraping, sanding, filling and re-sanding.
- Where ceilings are damaged, they must be replaced in sections. The existing cornice must be removed and kept safe (if still usable).
New cornice and mouldings must be made, to match the existing exactly, when replacement is required.
- Surfaces to be painted once all is fully repaired.
