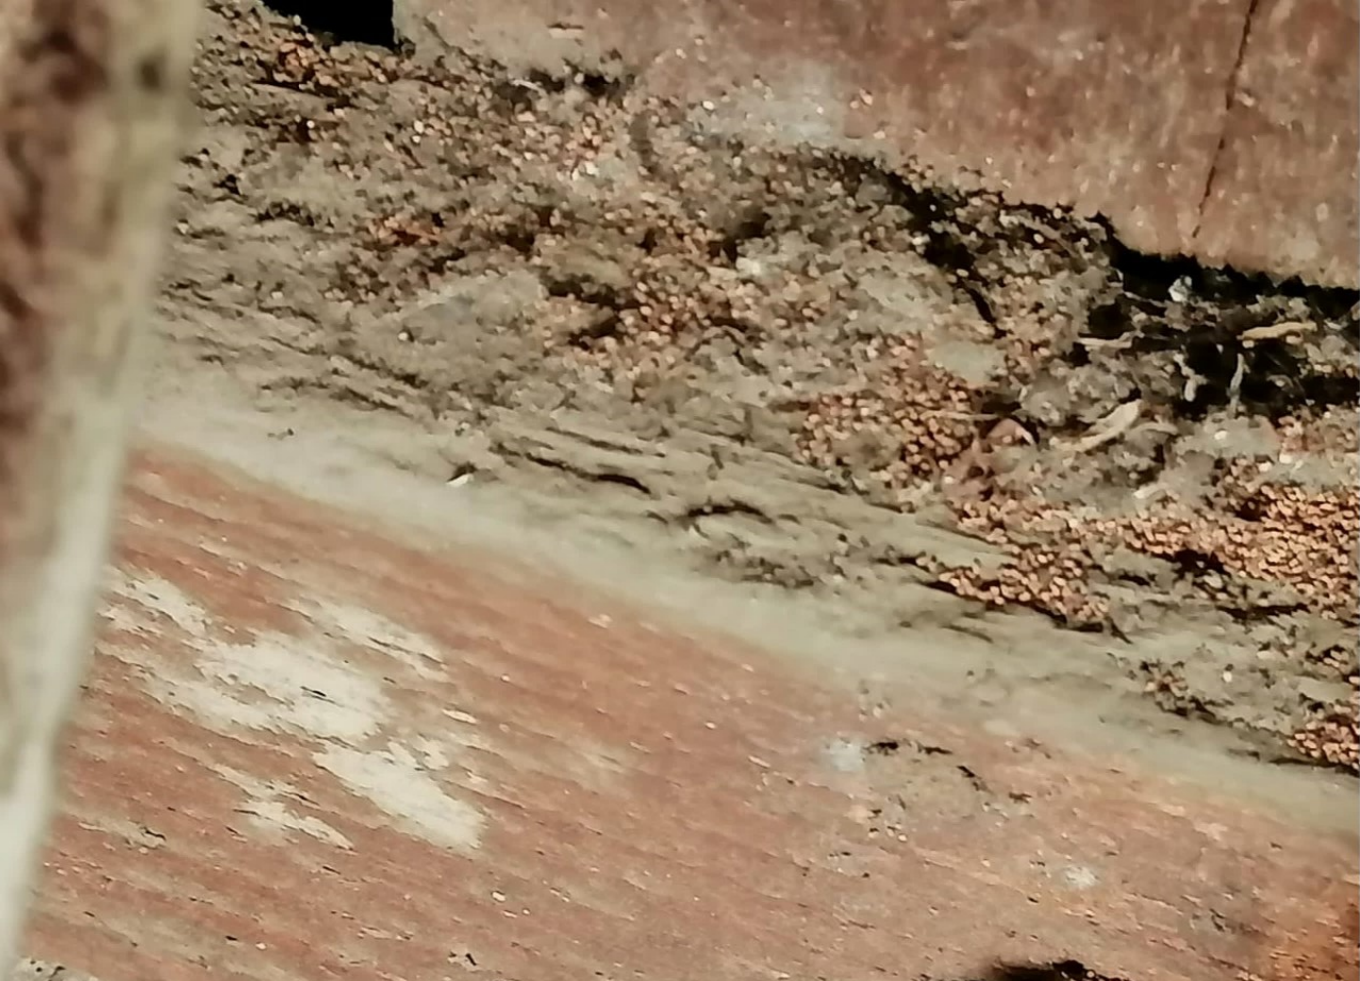
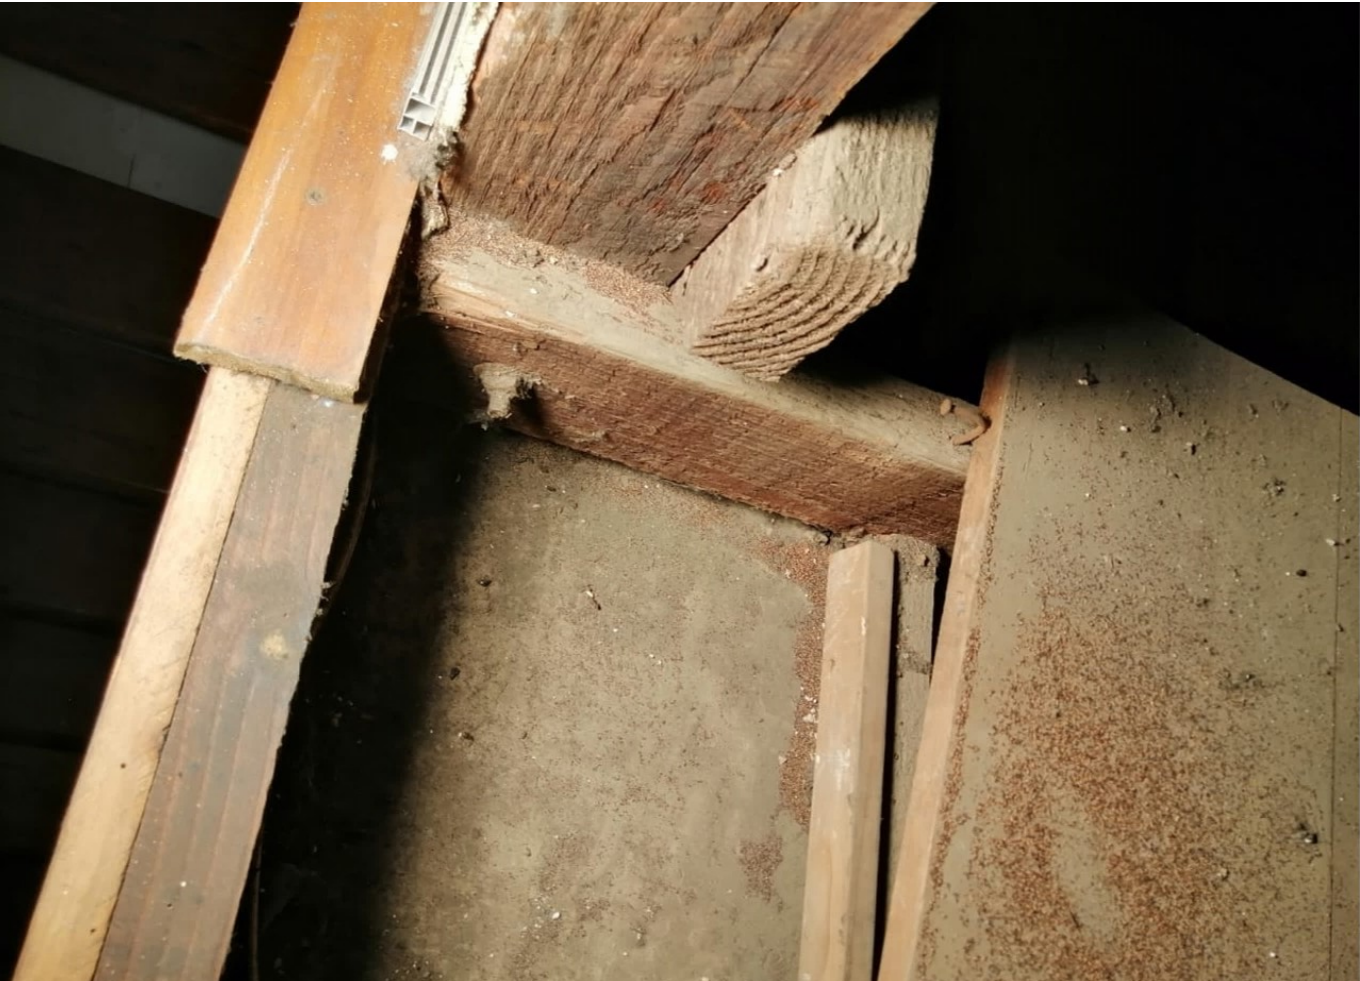
Damaged timber trusses.
