SKOENMAKERS RIVER REHABILITATION ASSESSMENT
 ZONE 1

Date:	08/02/2016	Compiled by:	PAUJ
Project No.	472748	Scale	1:7,369

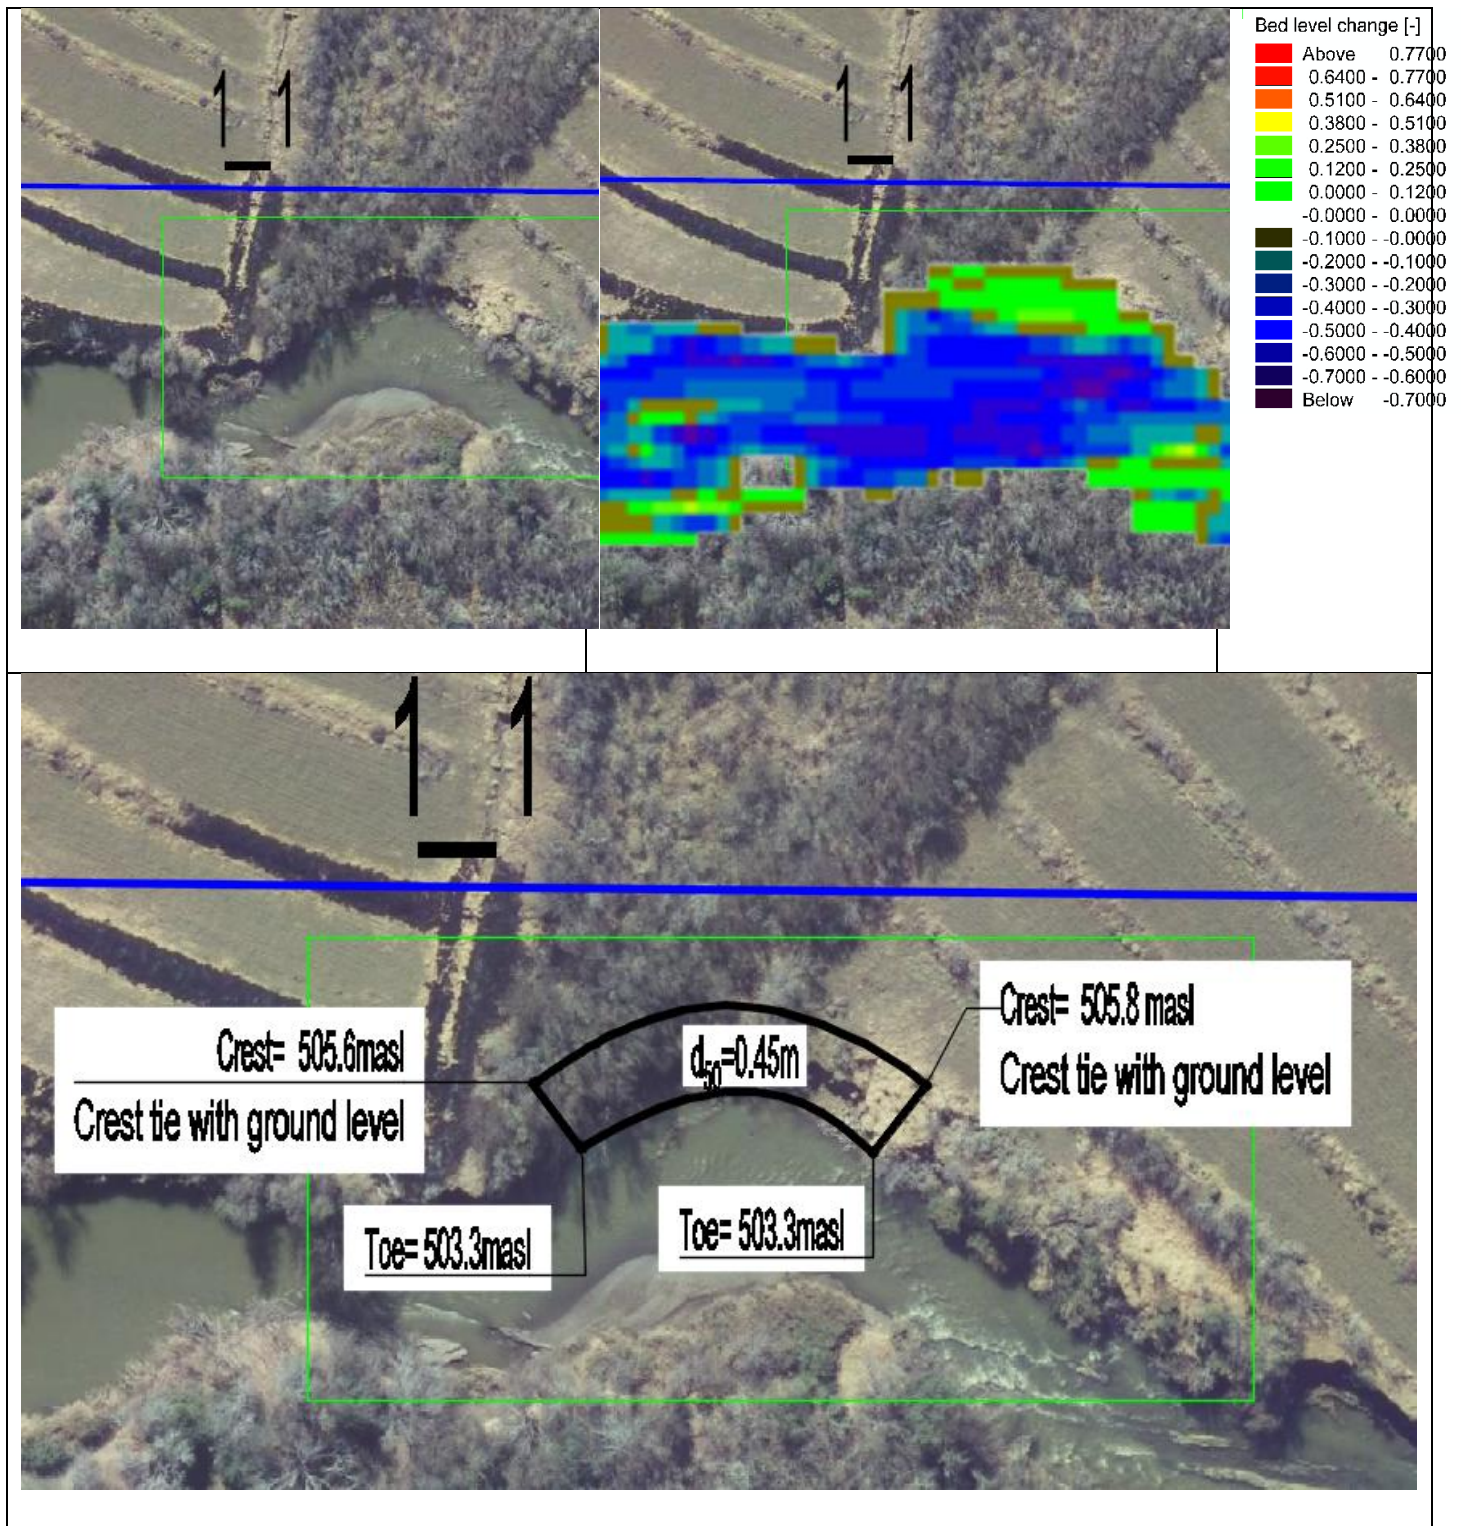
Zone 1_1

This area is within the servitude and has unstable banks encroaching farmland.

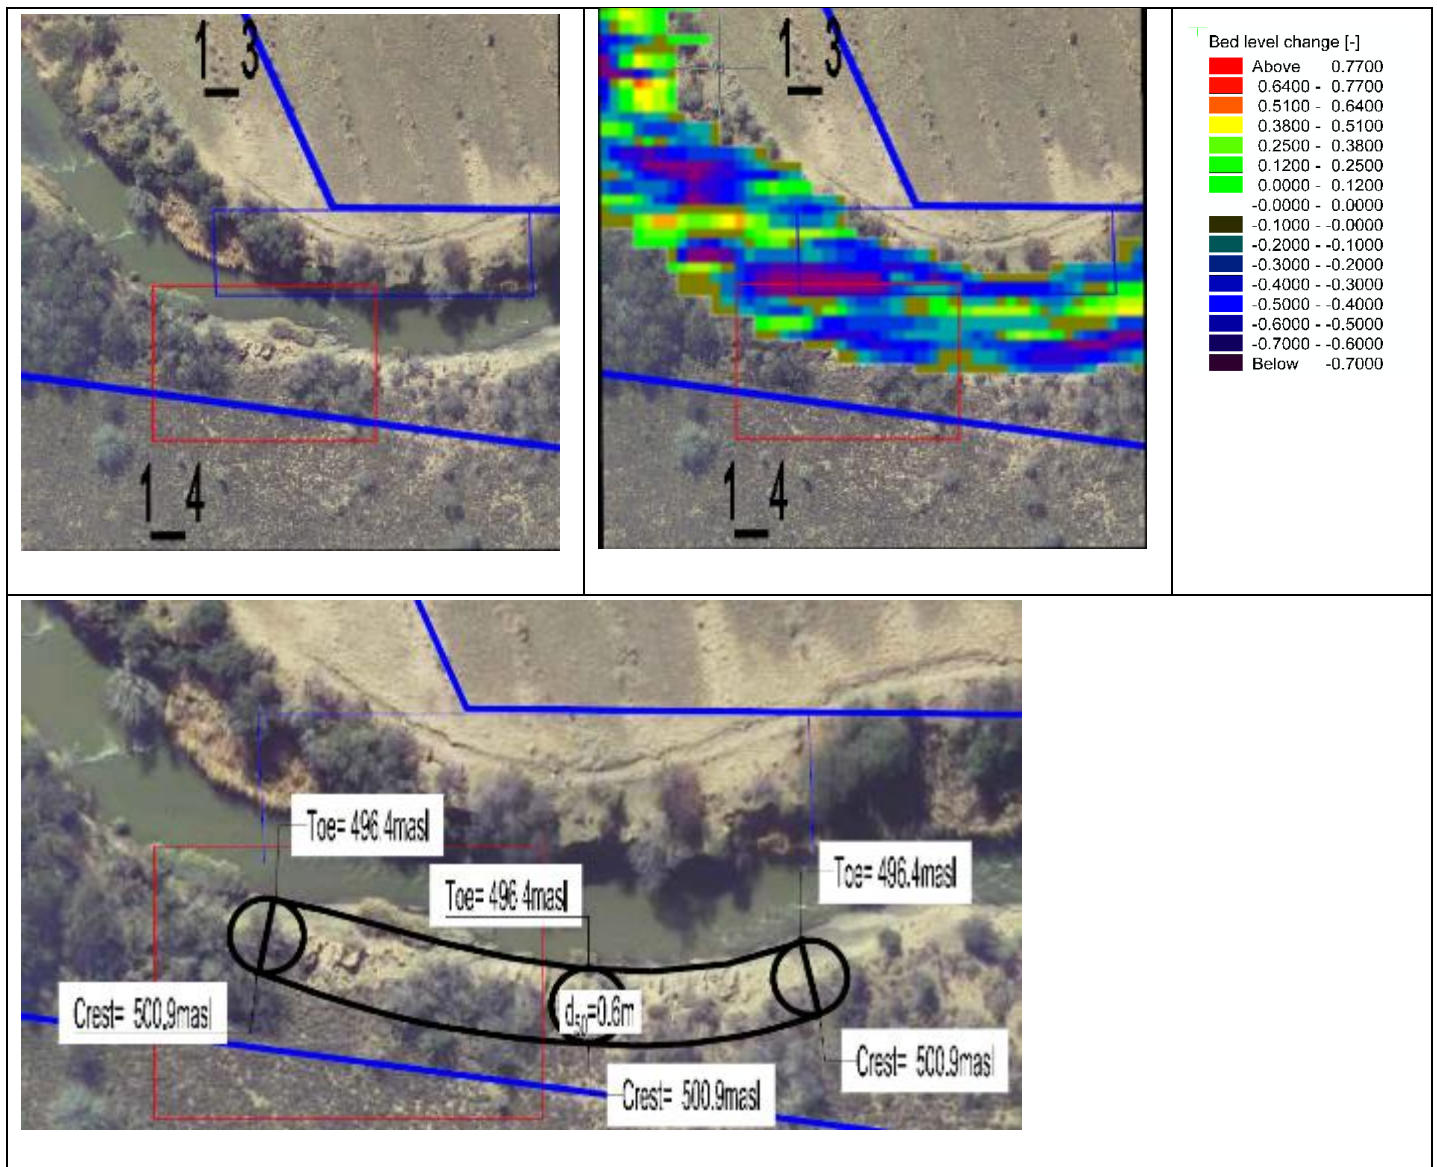
Zone 1_3 and 1_4

This area is within the servitude and protection does not seem necessary.

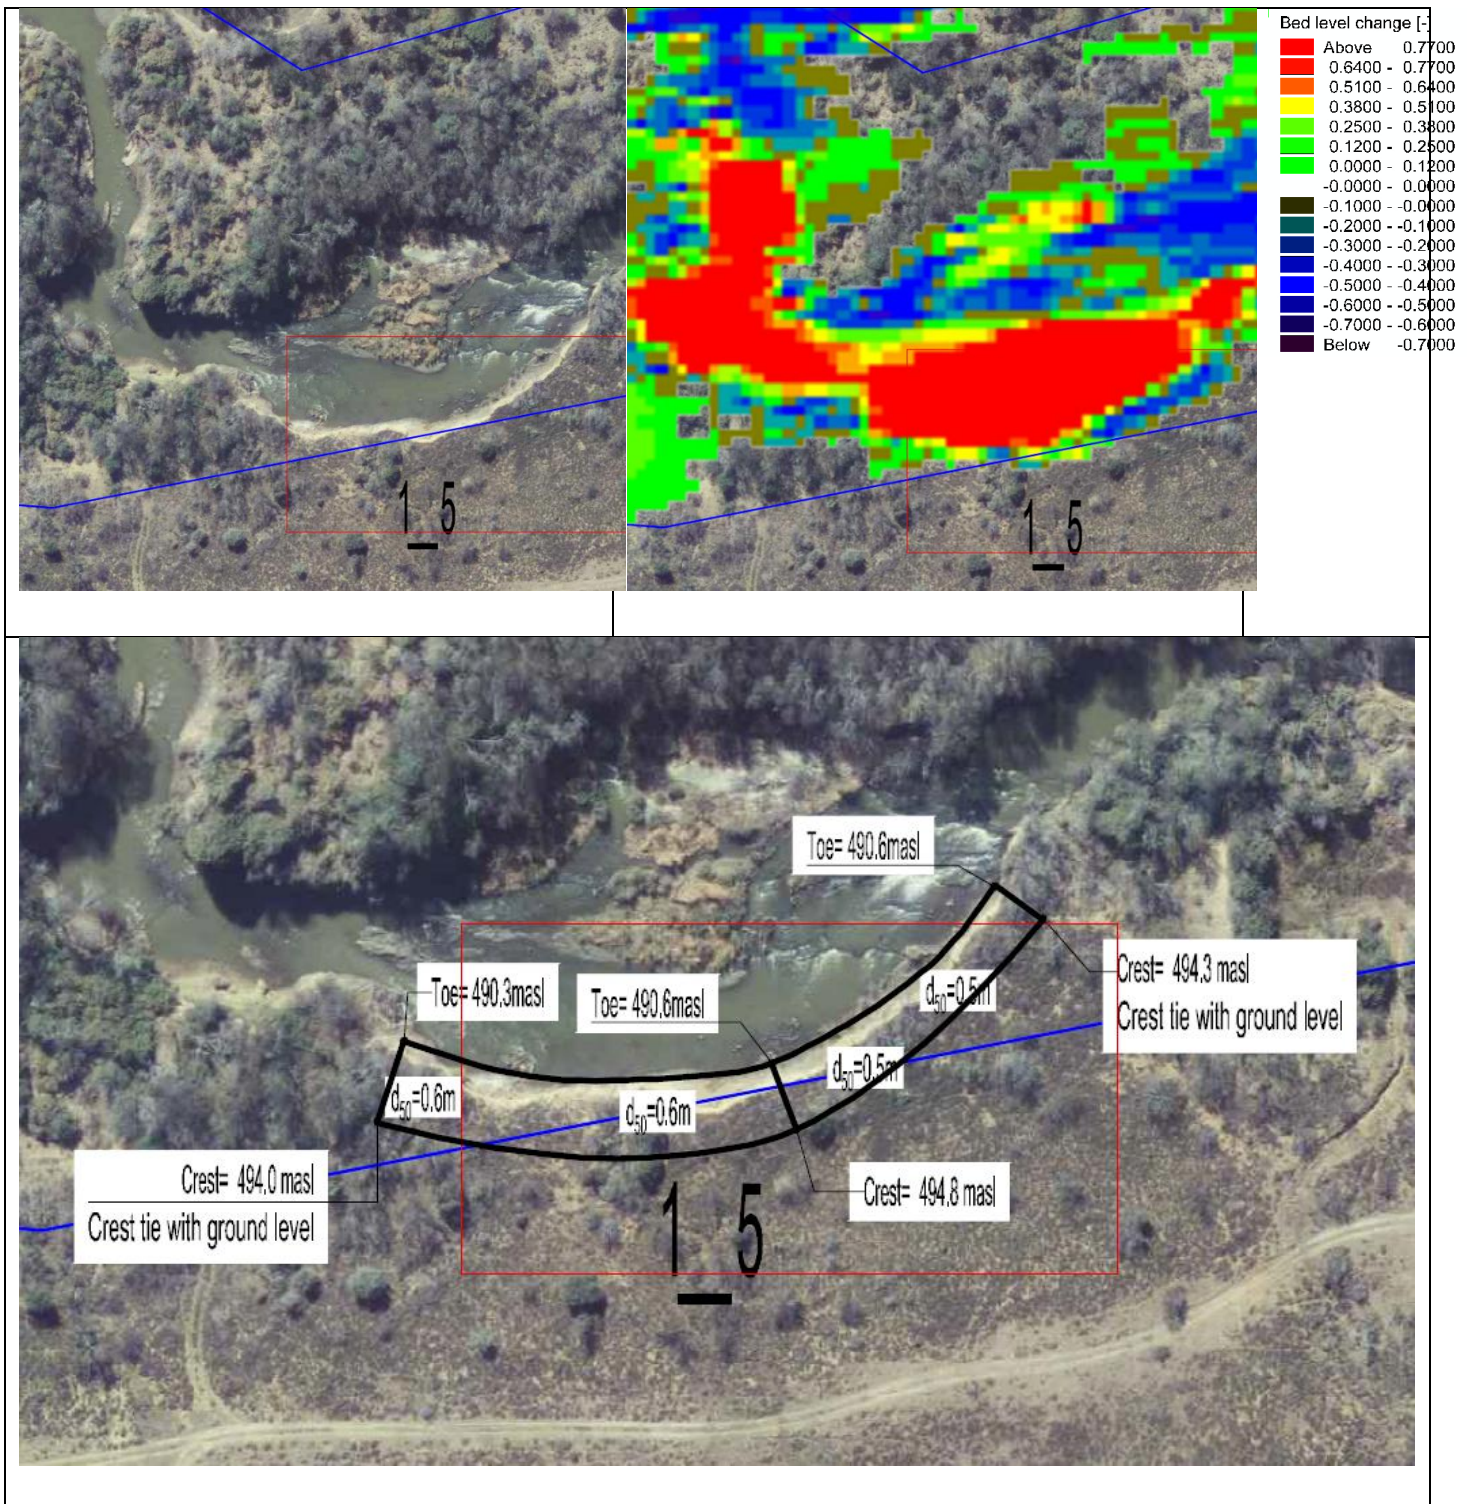
Zone 1_5

This area is within the servitude and has unstable banks encroaching a road.

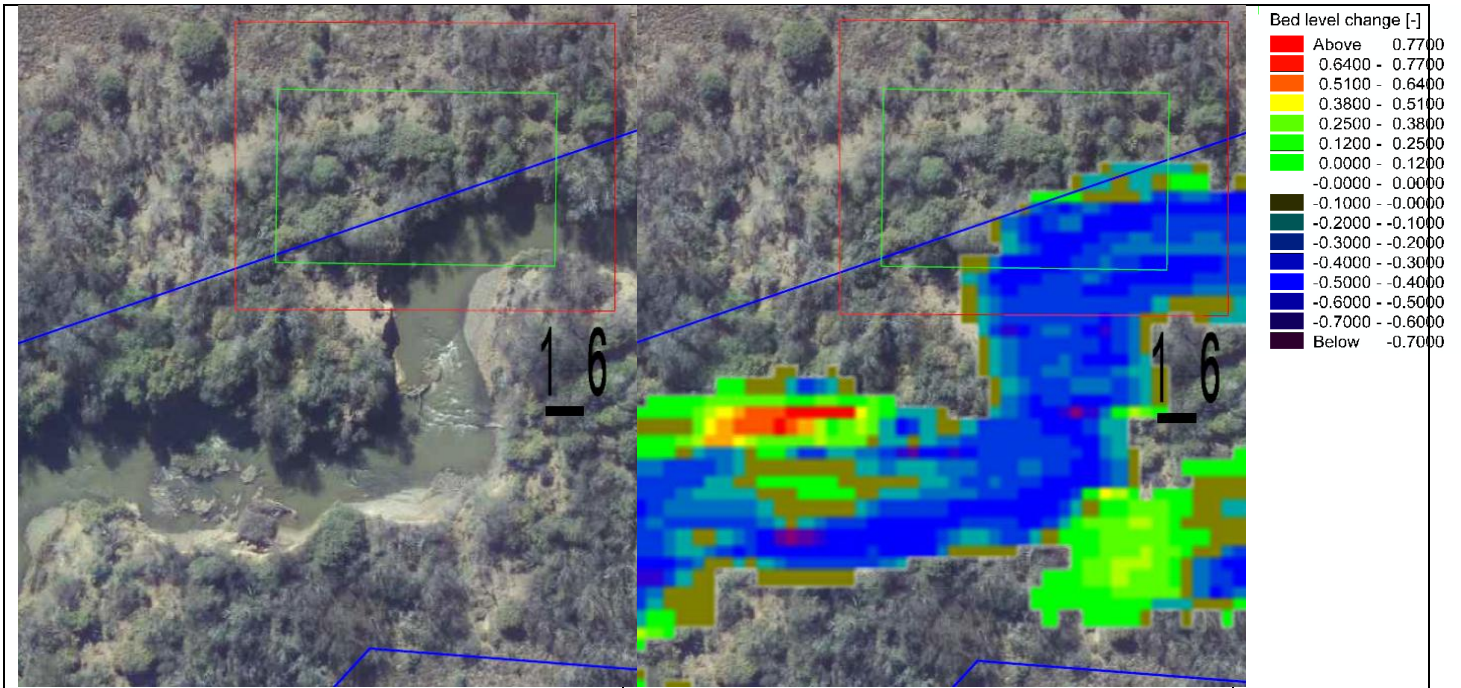
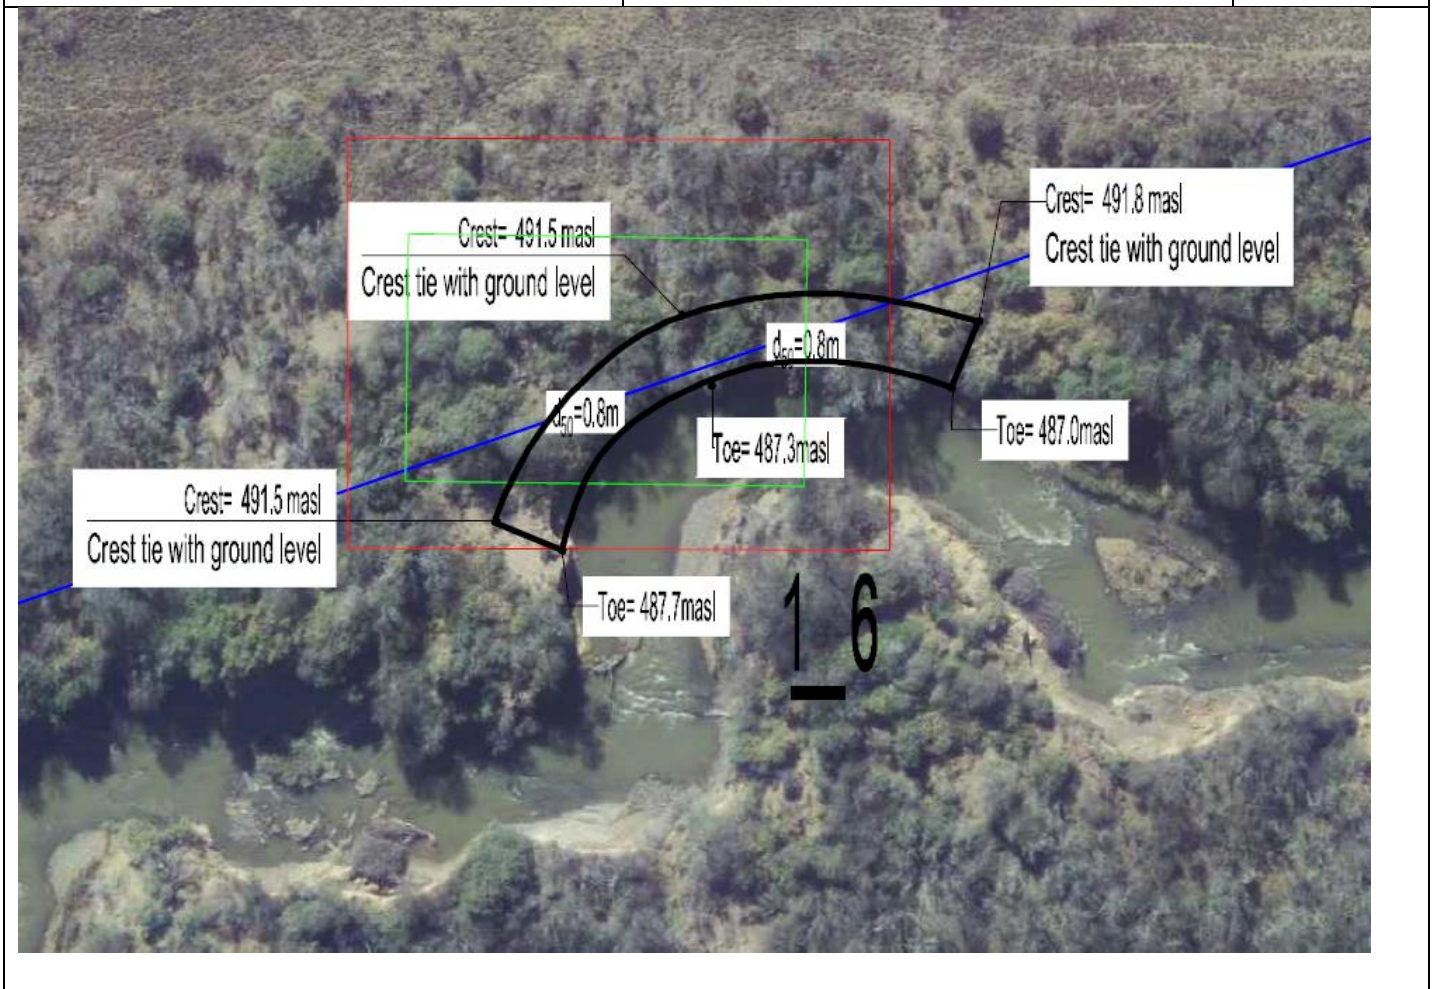
Zone 1_6

This area has unstable banks crossing the servitude.

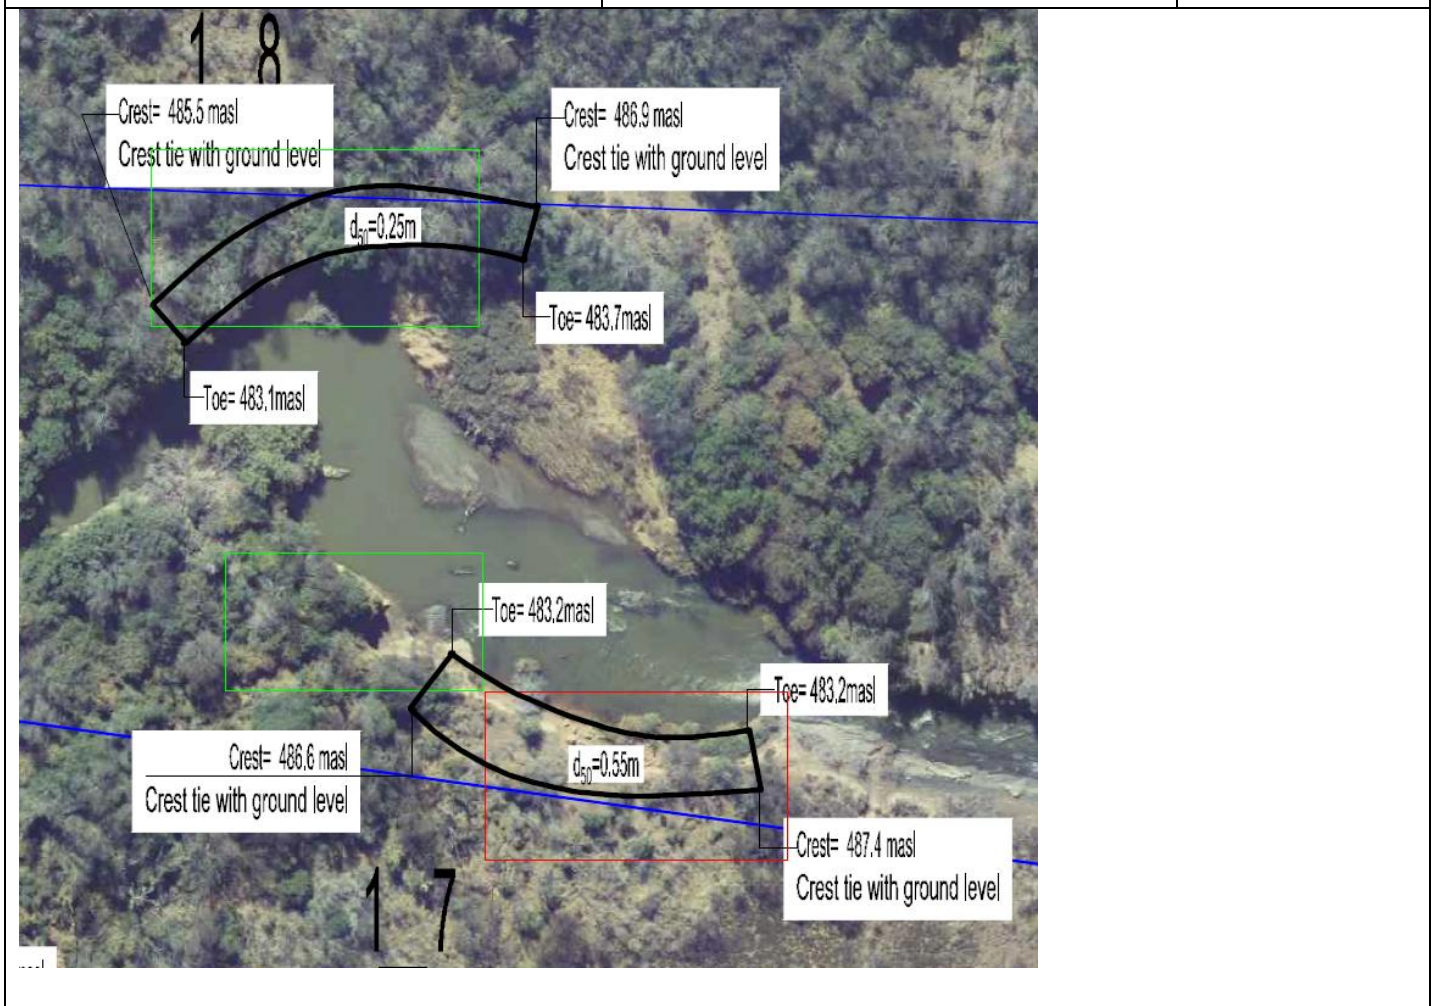
Zone 1_8

This area has banks partially crossing the servitude.

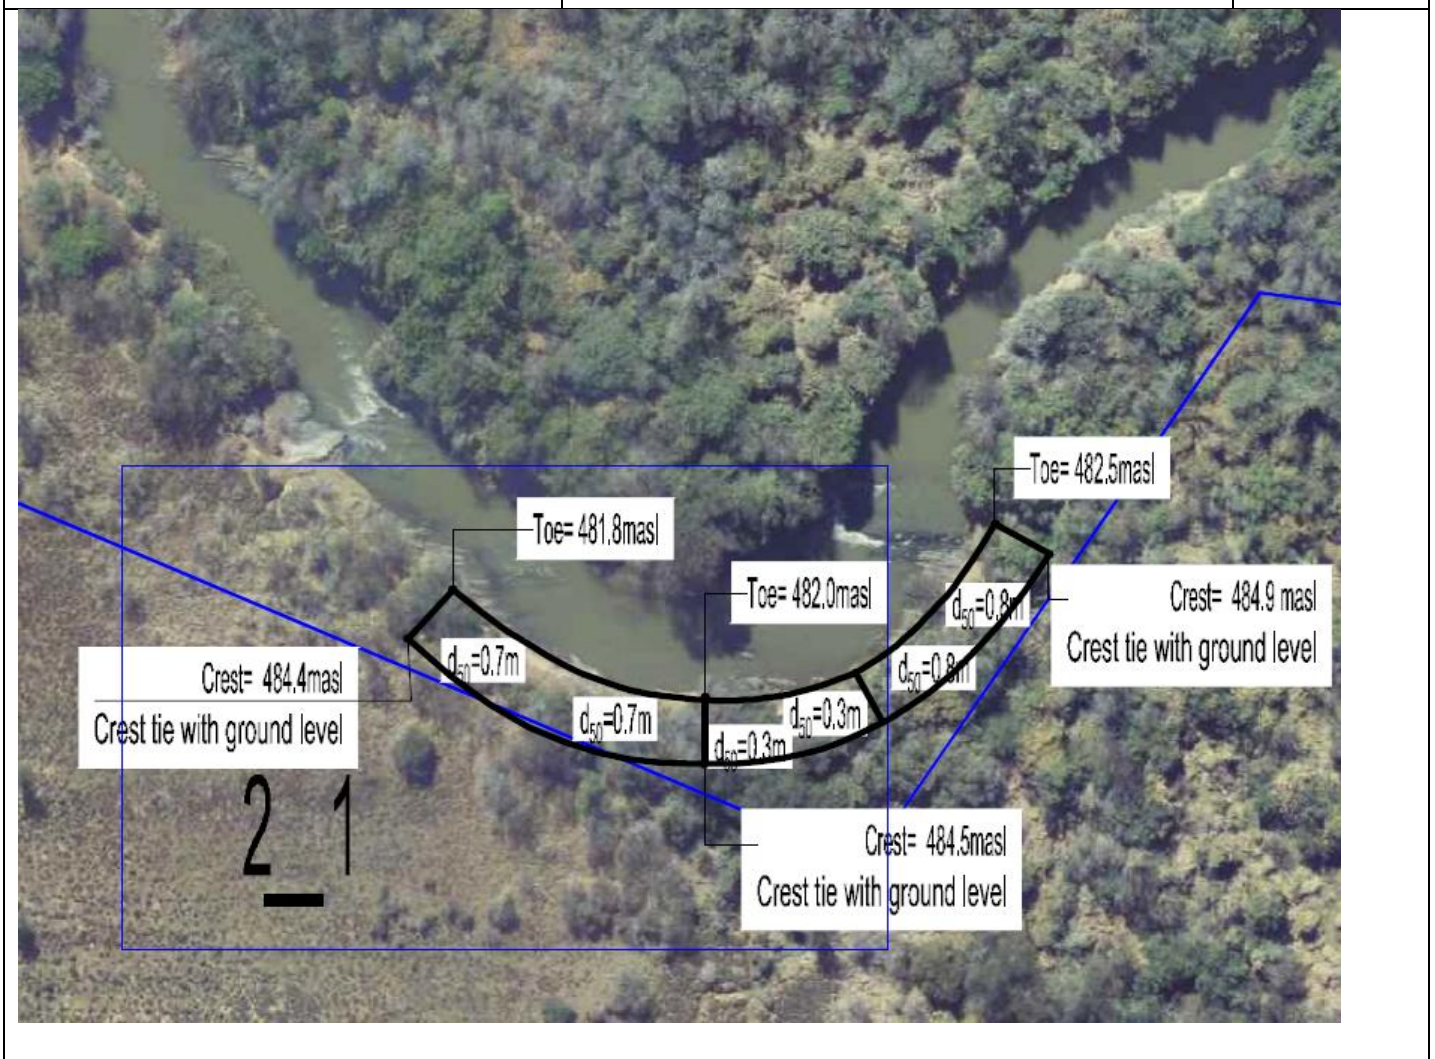
Zone 2_1

The banks are encroaching the servitude but protection does not seem necessary.

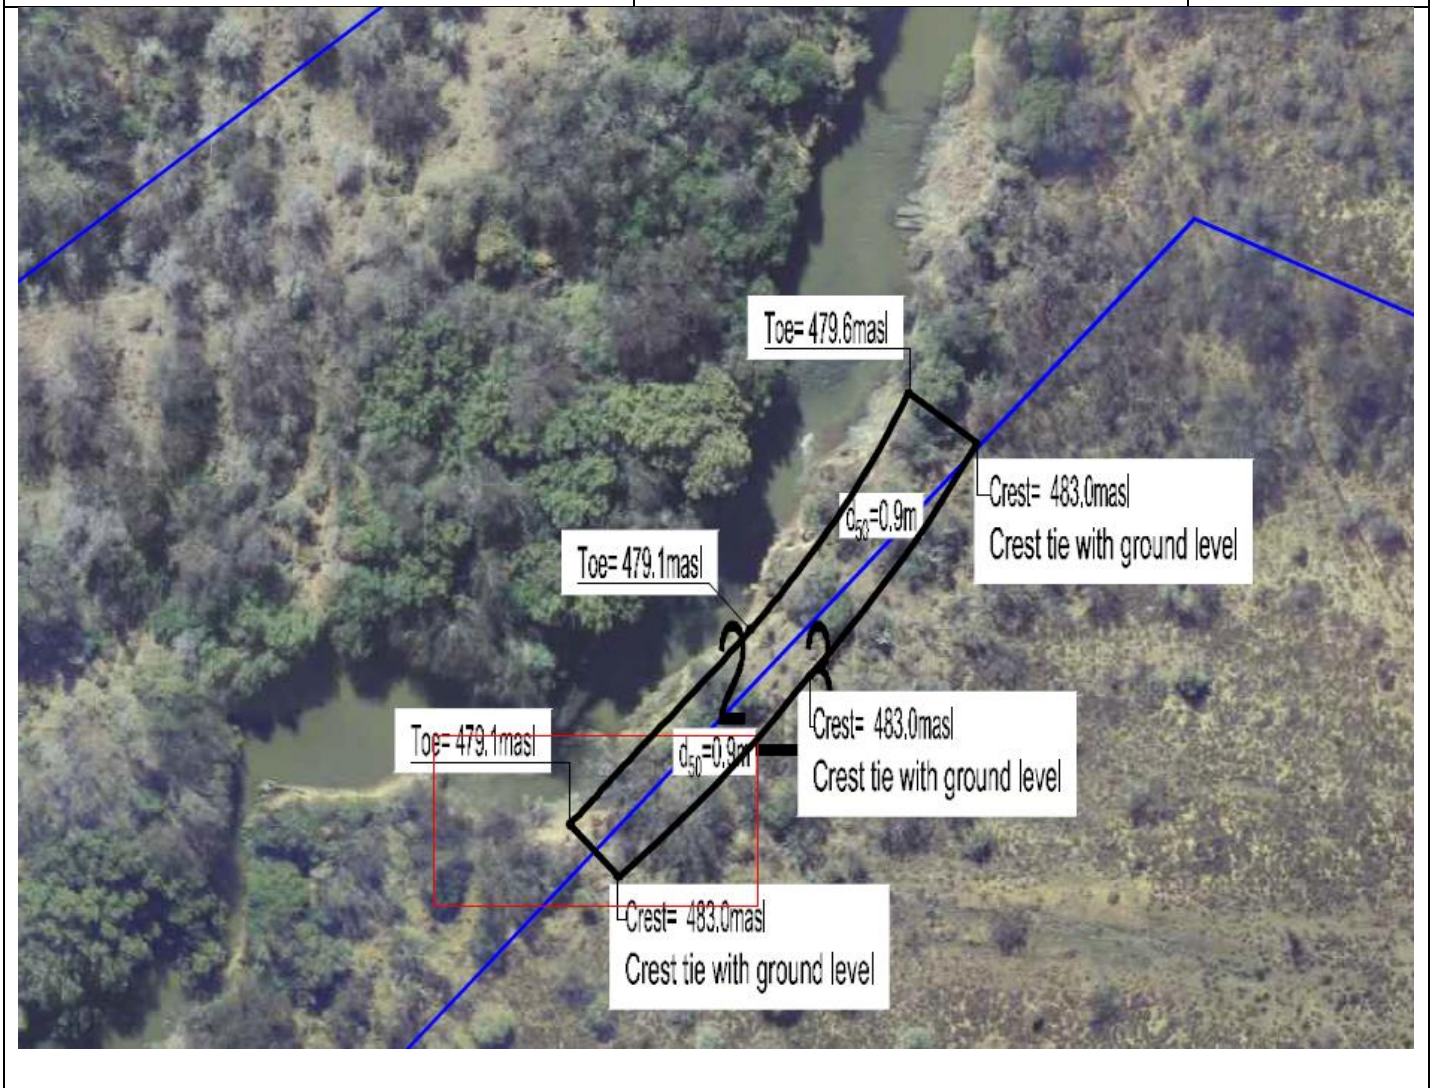
Zone 2_3

This area has unstable banks are encroaching on the servitude.

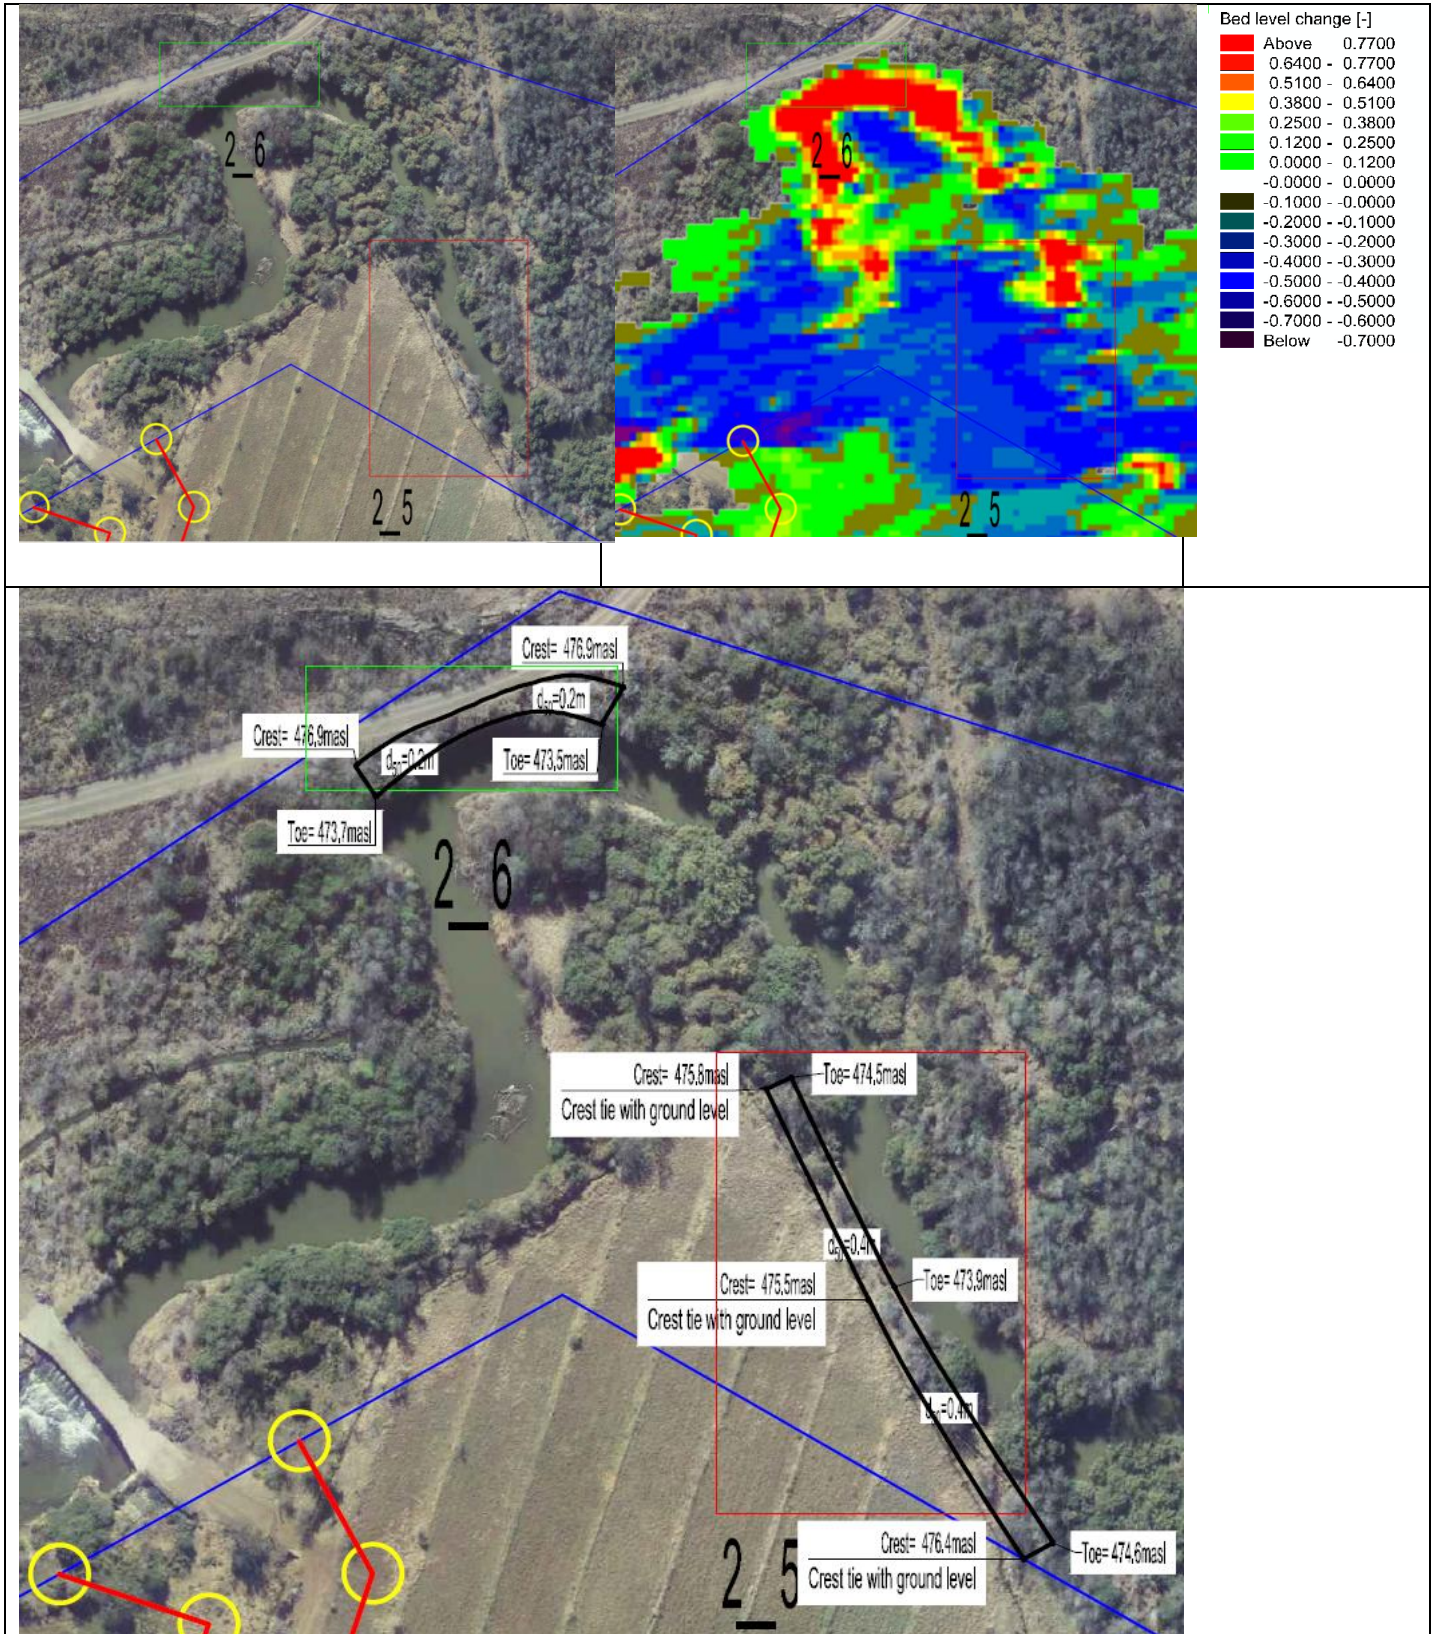
Zone 2_6

This area is within the servitude but has unstable banks that encroach a road.

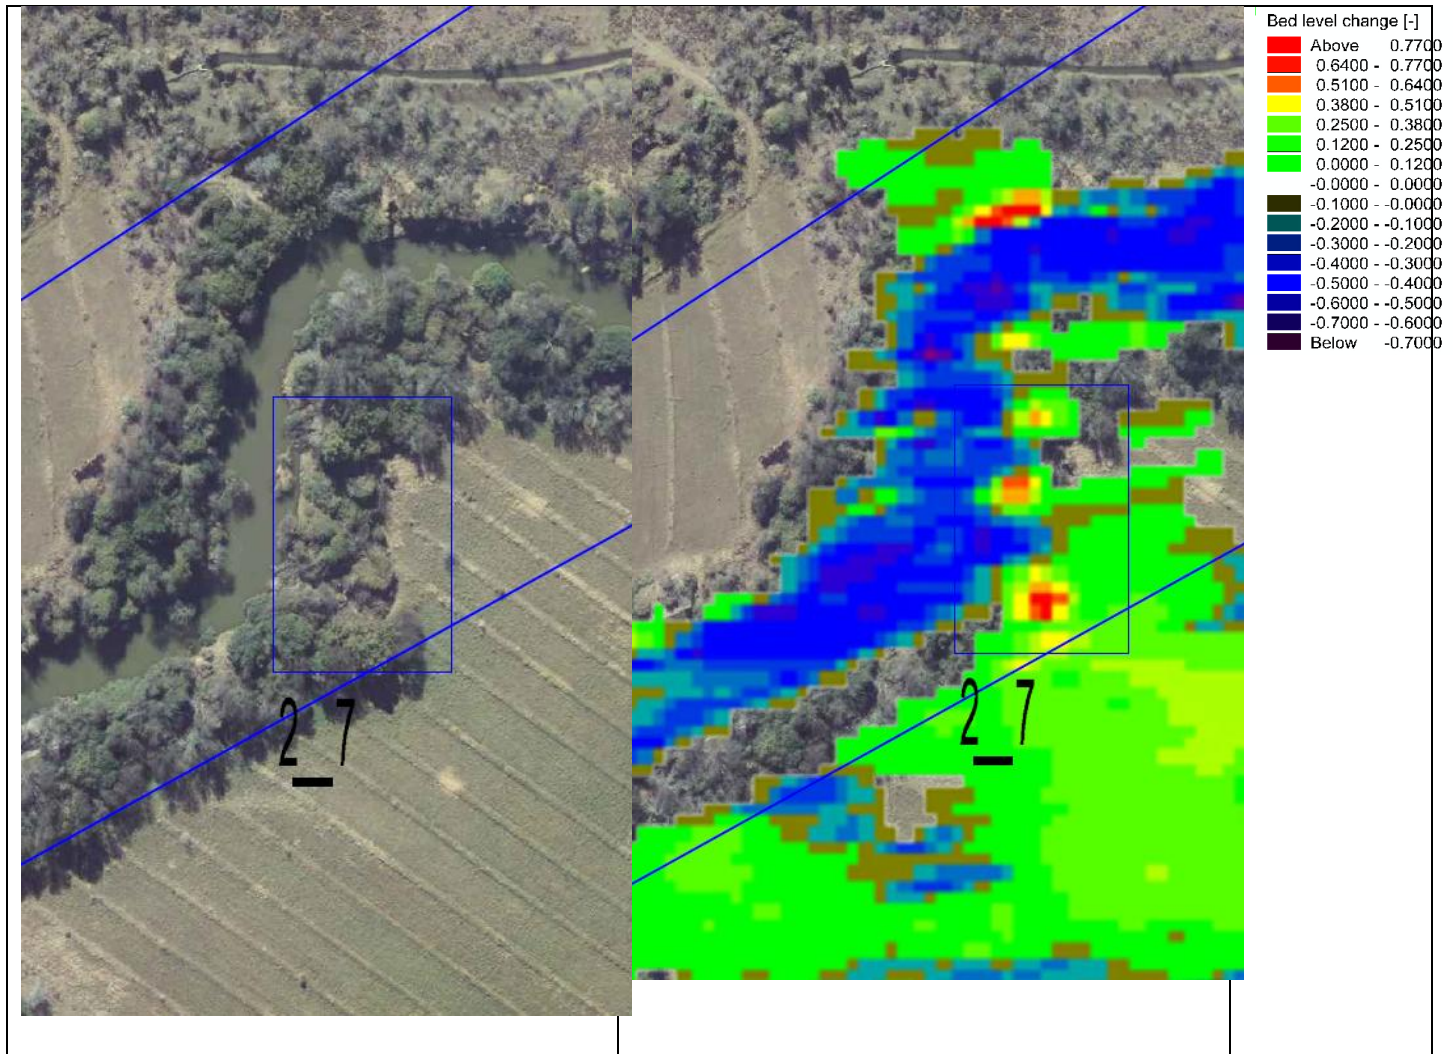
Zone 2_7

This area is within the servitude but encroaches farmland that is within the servitude. Protection does not seem necessary.

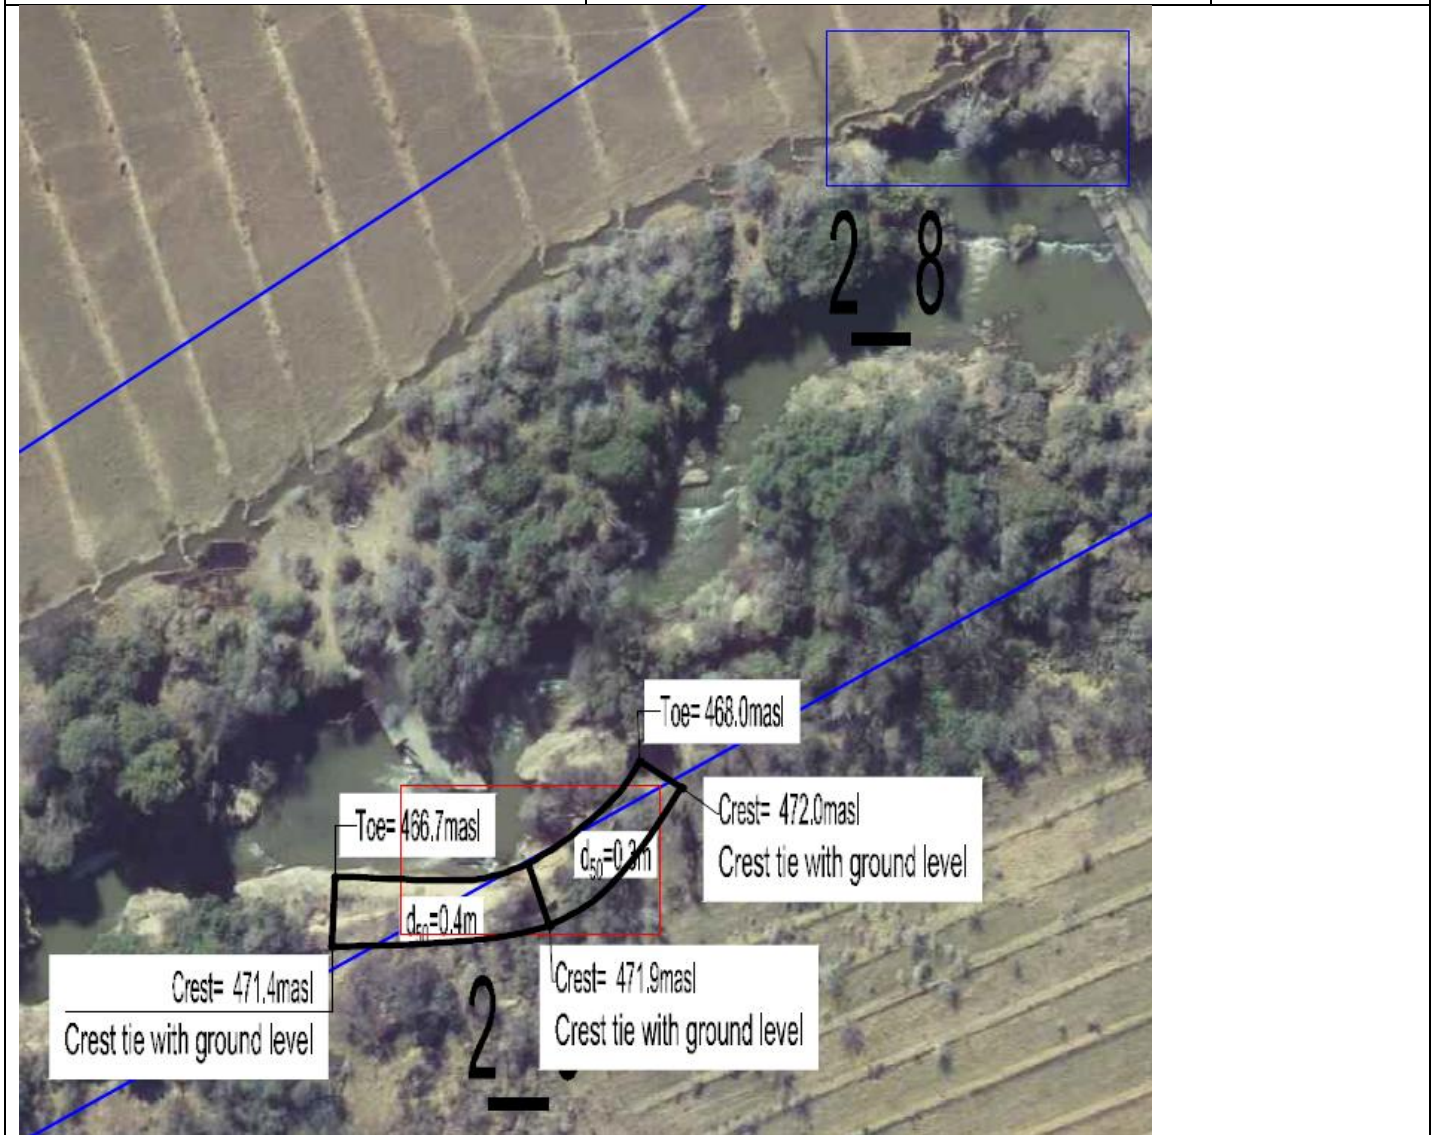
Zone 2_8 and 2_9

The banks are encroaching the servitude and farmland

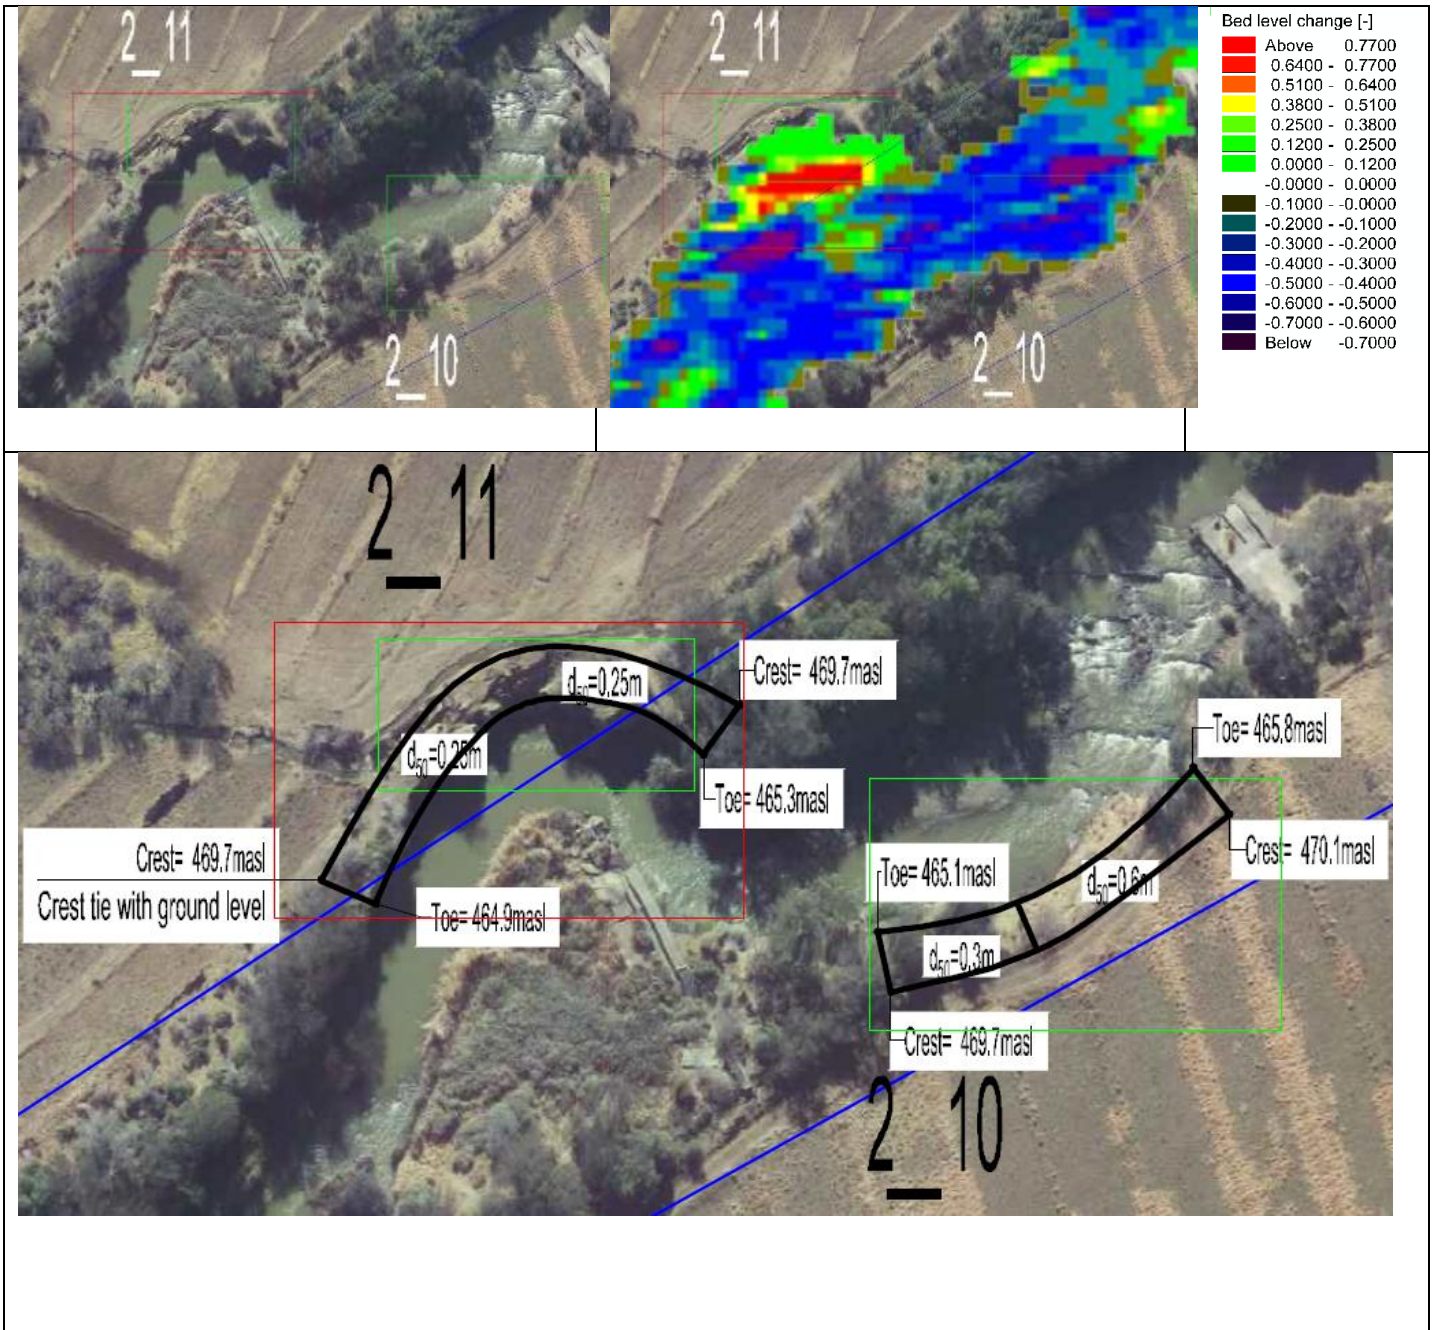
Zone 2_11

The unstable banks are crossing the servitude and encroaching onto farmland.

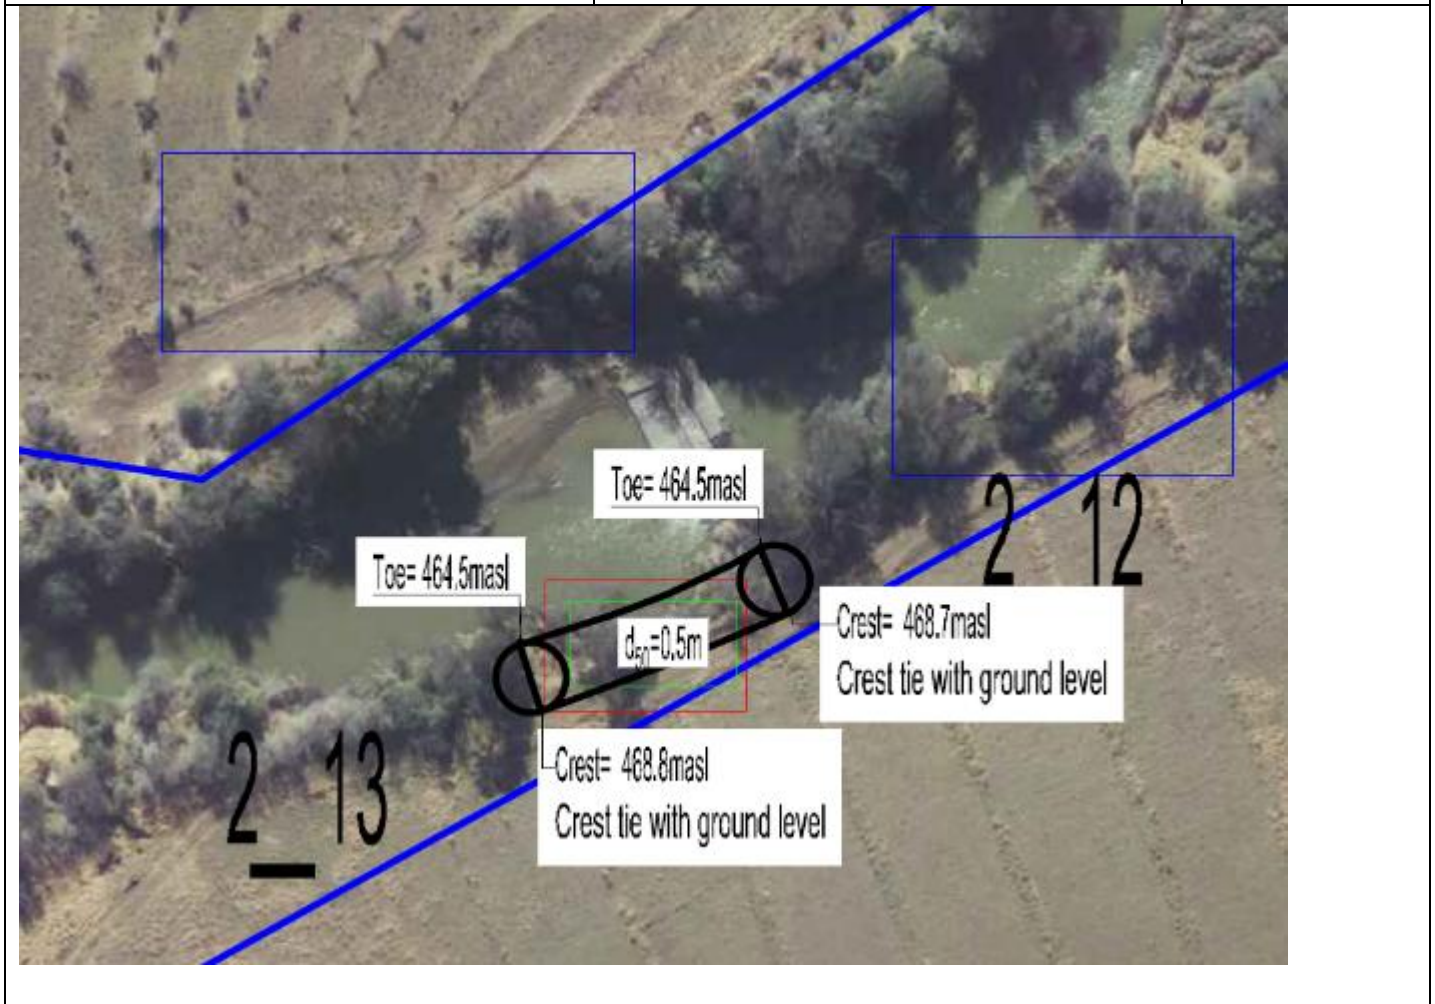
Zone 2_13

The unstable banks are encroaching the servitude and farmland.
