SKOENMAKERS RIVER REHABILITATION ASSESSMENT
 ZONE 1

Date:	08/02/2016	Compiled by:	PAUJ
Project No.	472748	Scale	1:7,369

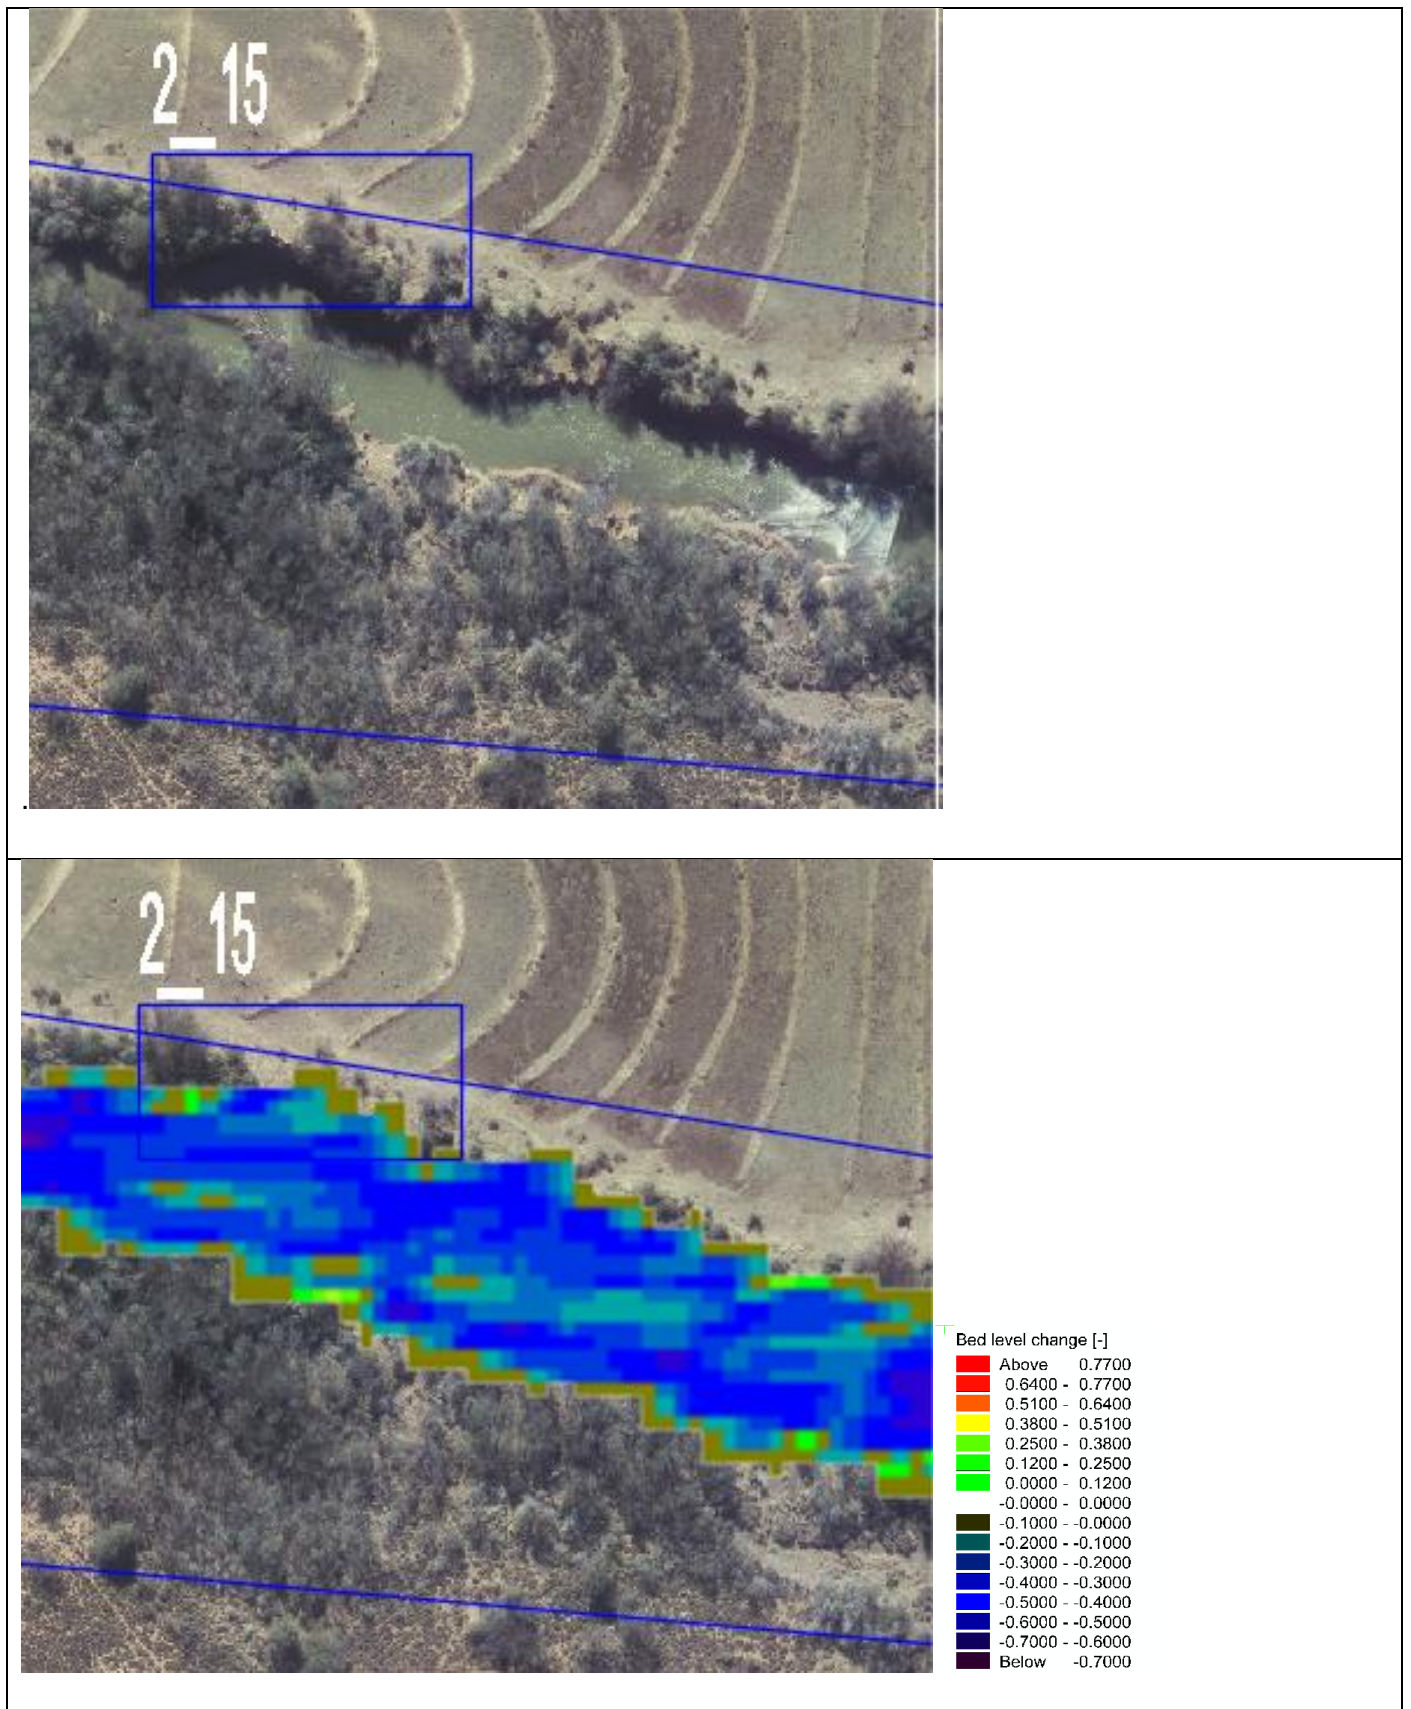
Zone 2_15

The unstable banks are encroaching the servitude and farmland. Protection was deemed not necessary

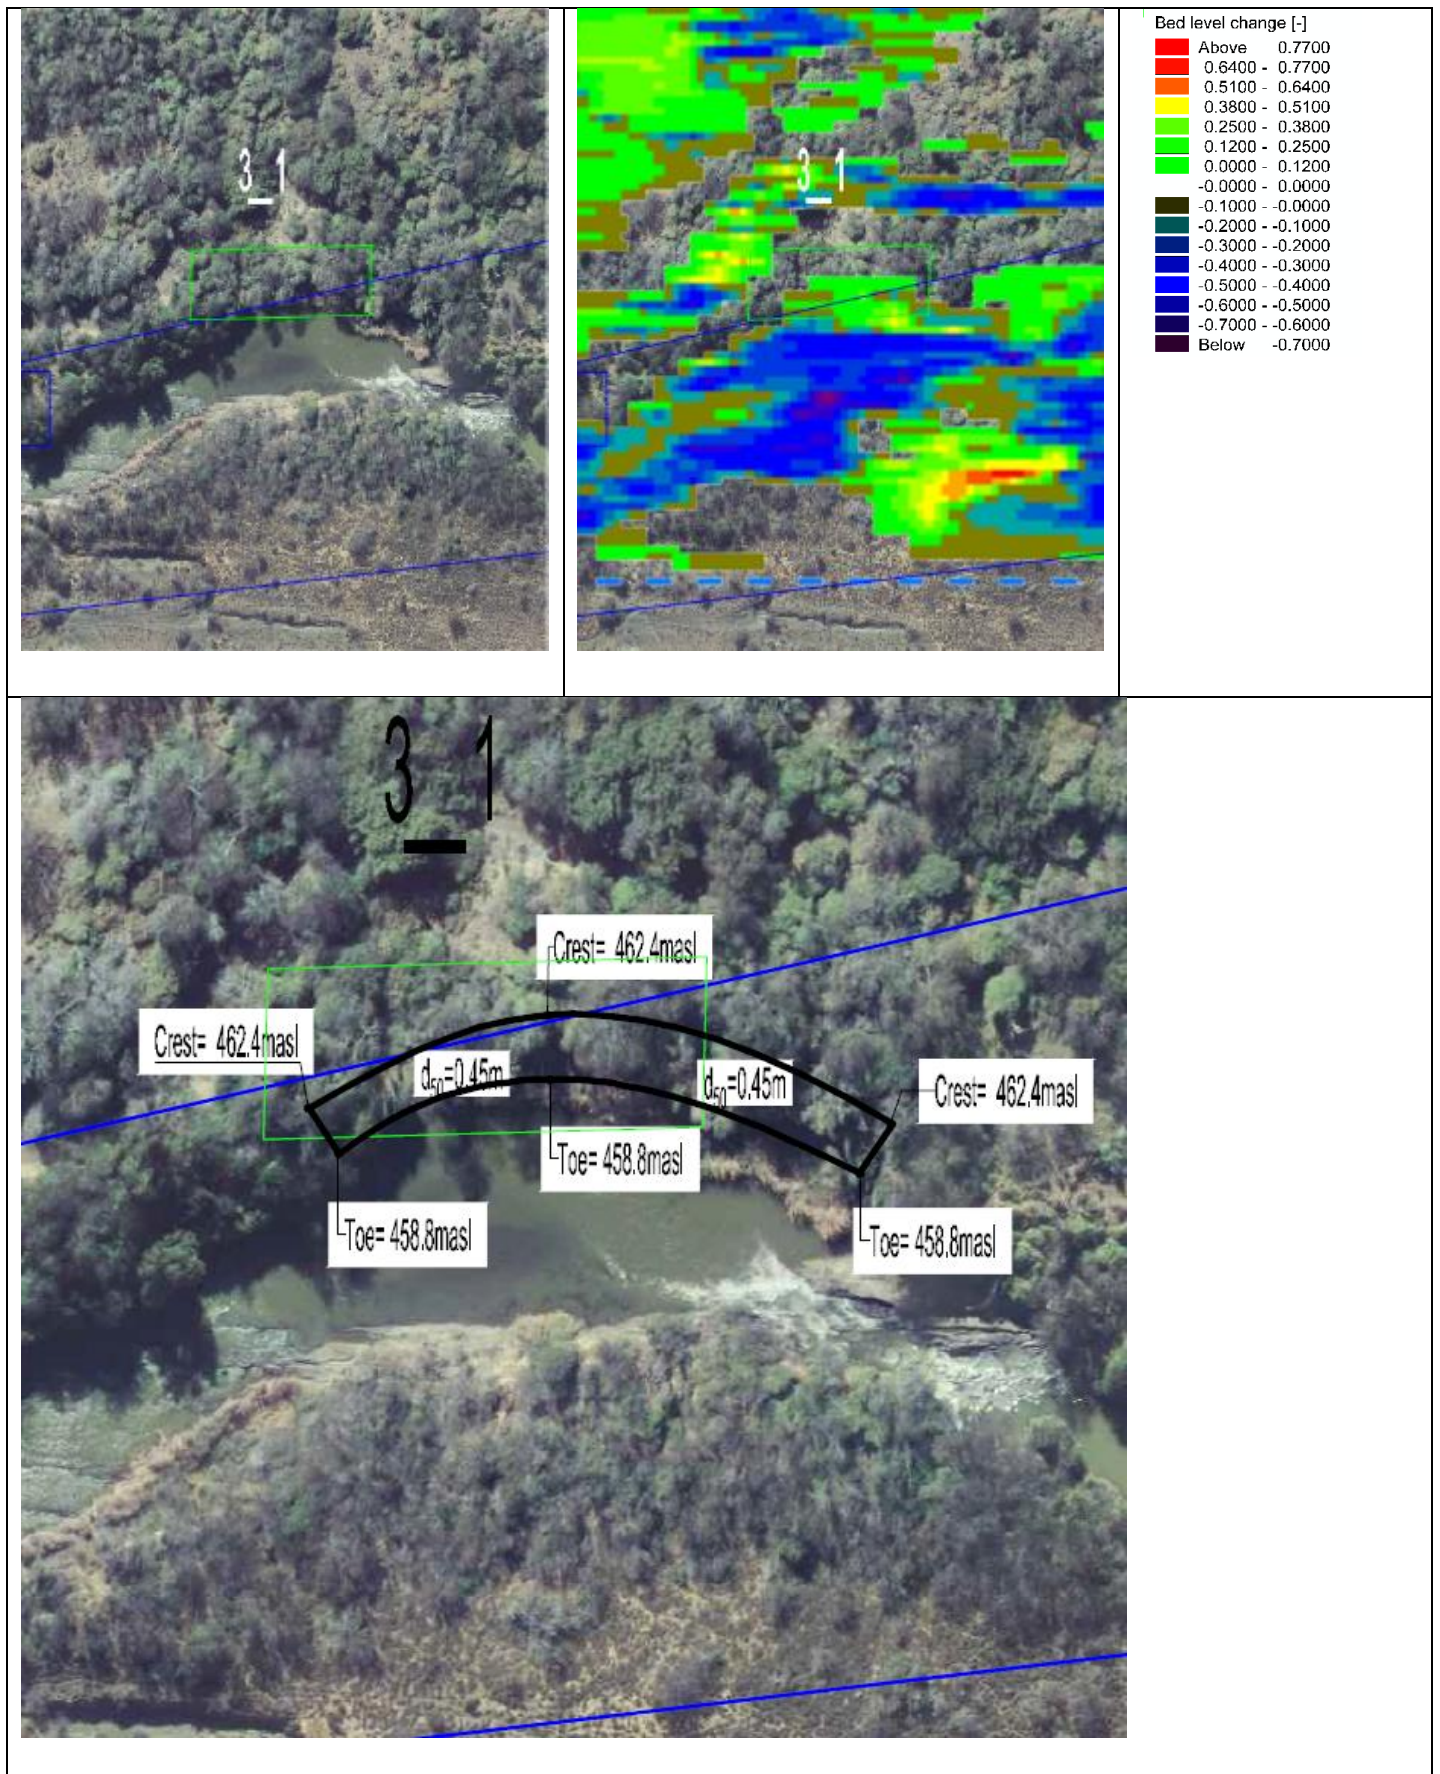
Zone 3_1

The zone has unstable banks crossing the servitude.

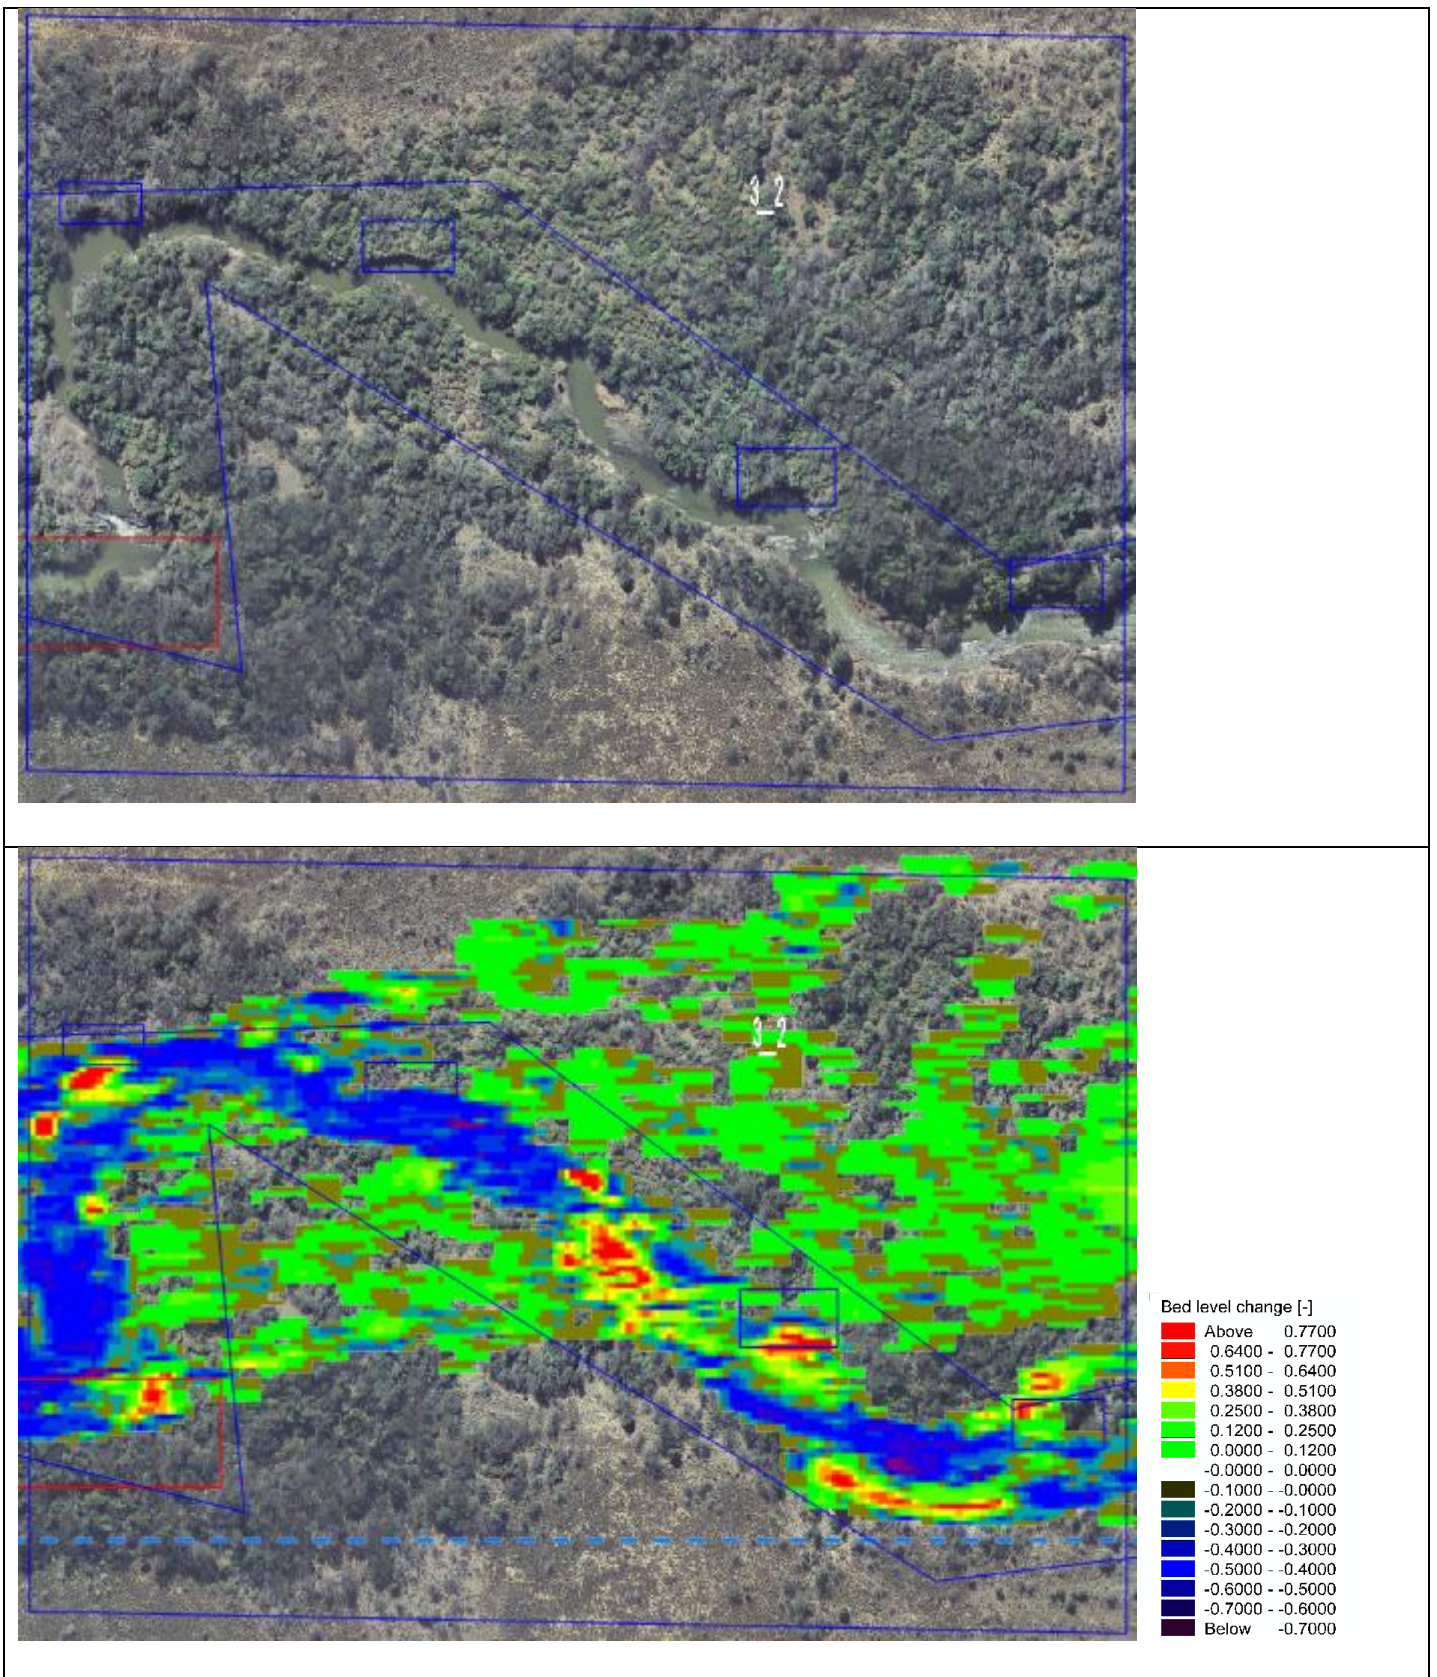
Zone 3_2

Flow in this area is in a wide floodplain crossing the servitude and protection in not viable.

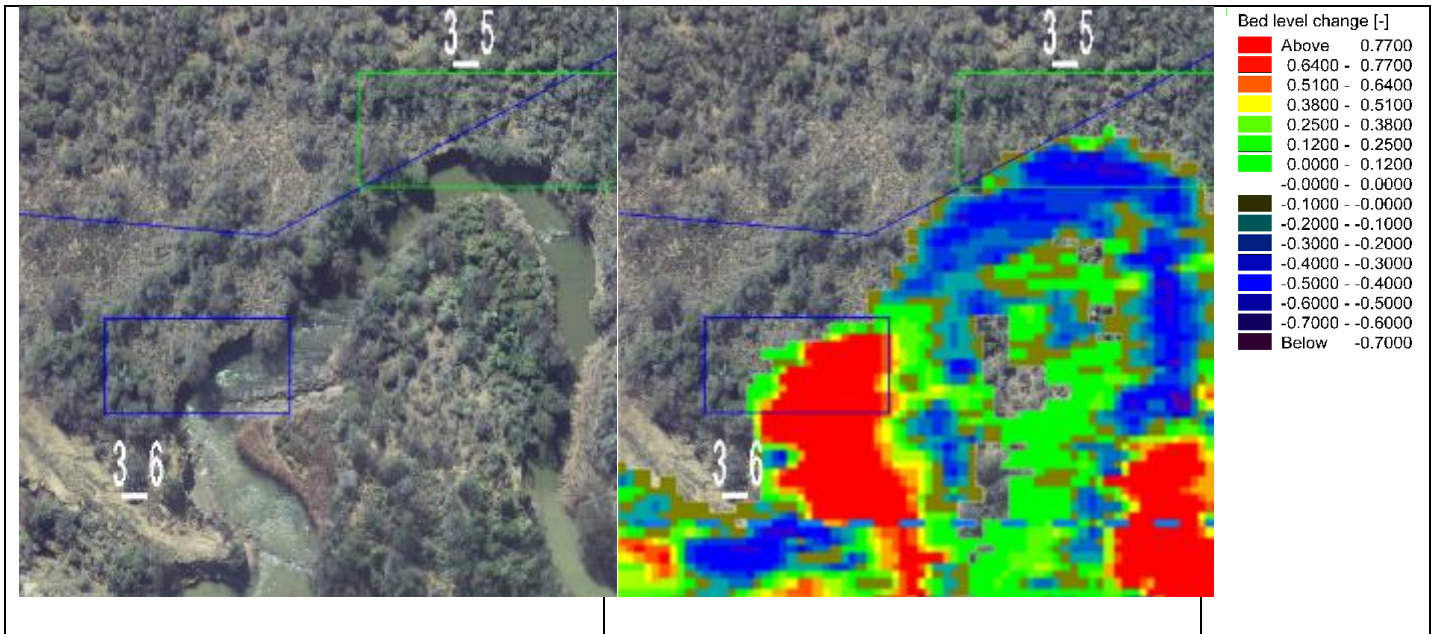
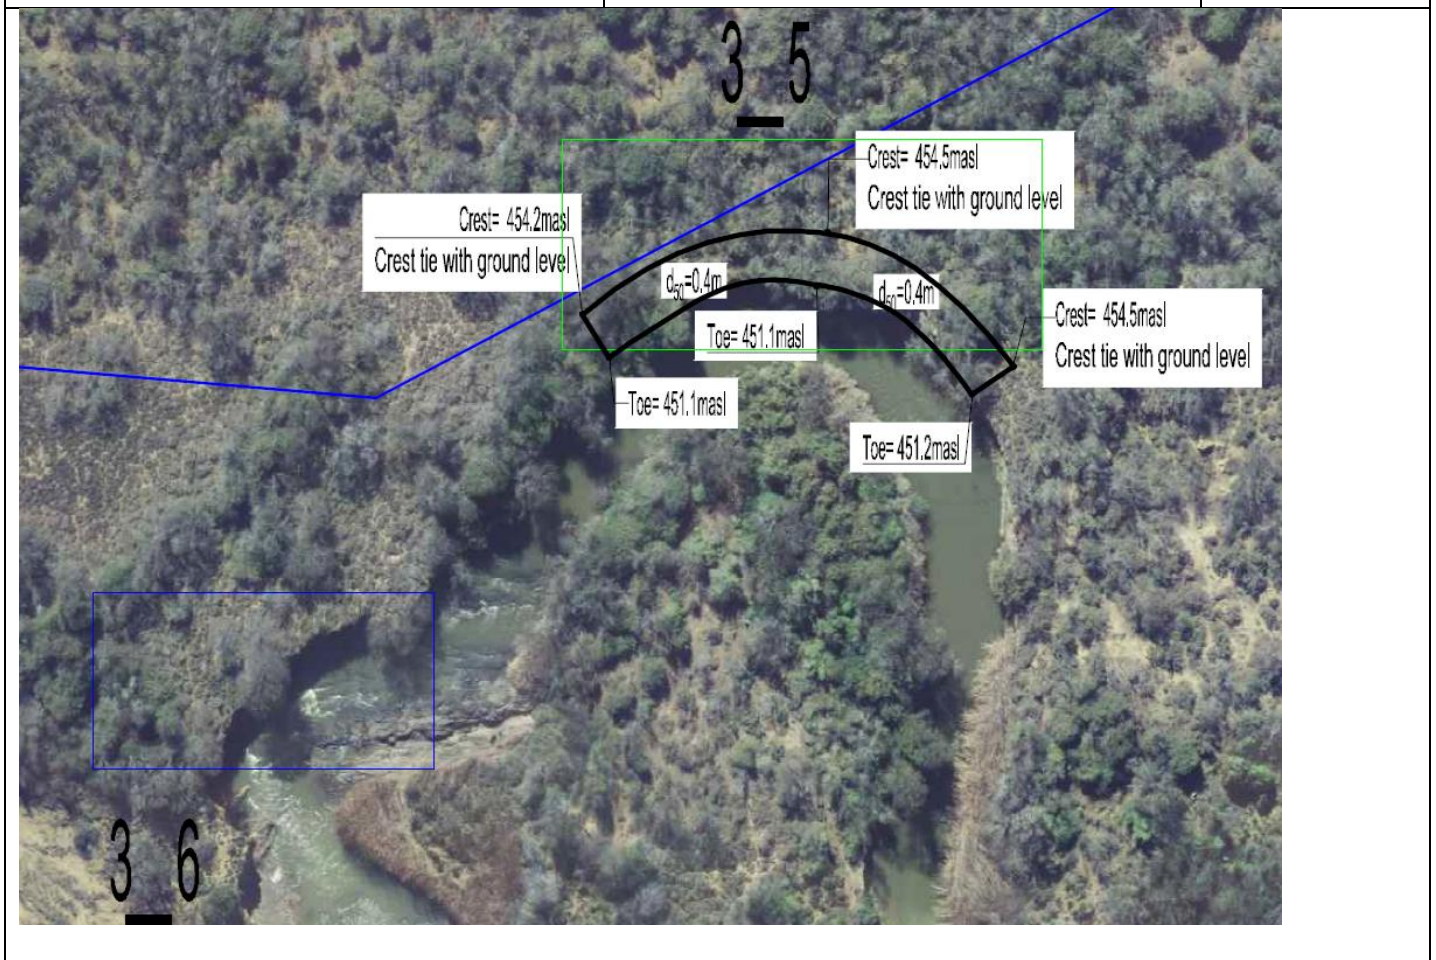
Zone 3_6

The zone has unstable banks but within the servitude. Protection was found not necessary.

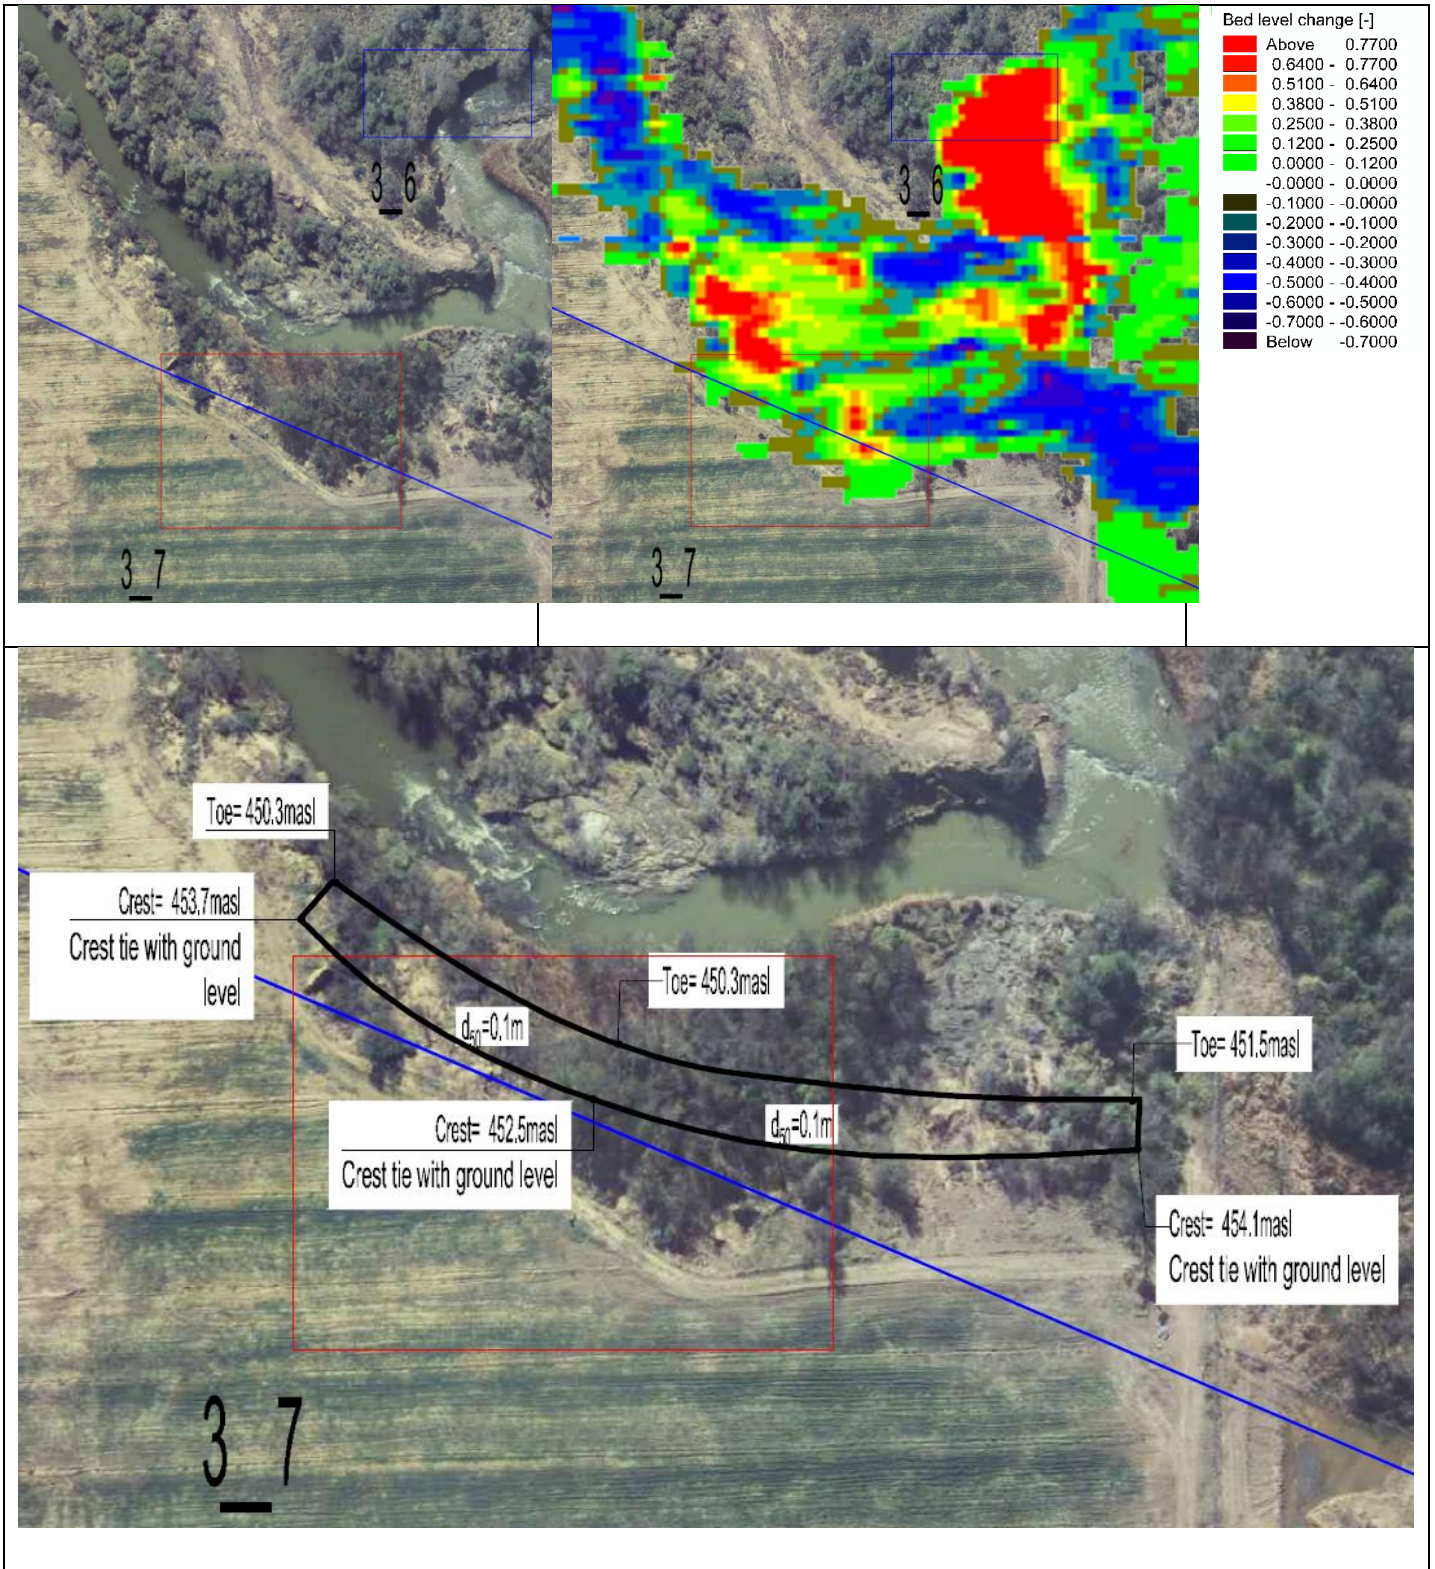
Zone 3_7

The zone has unstable banks encroaching the servitude and road.

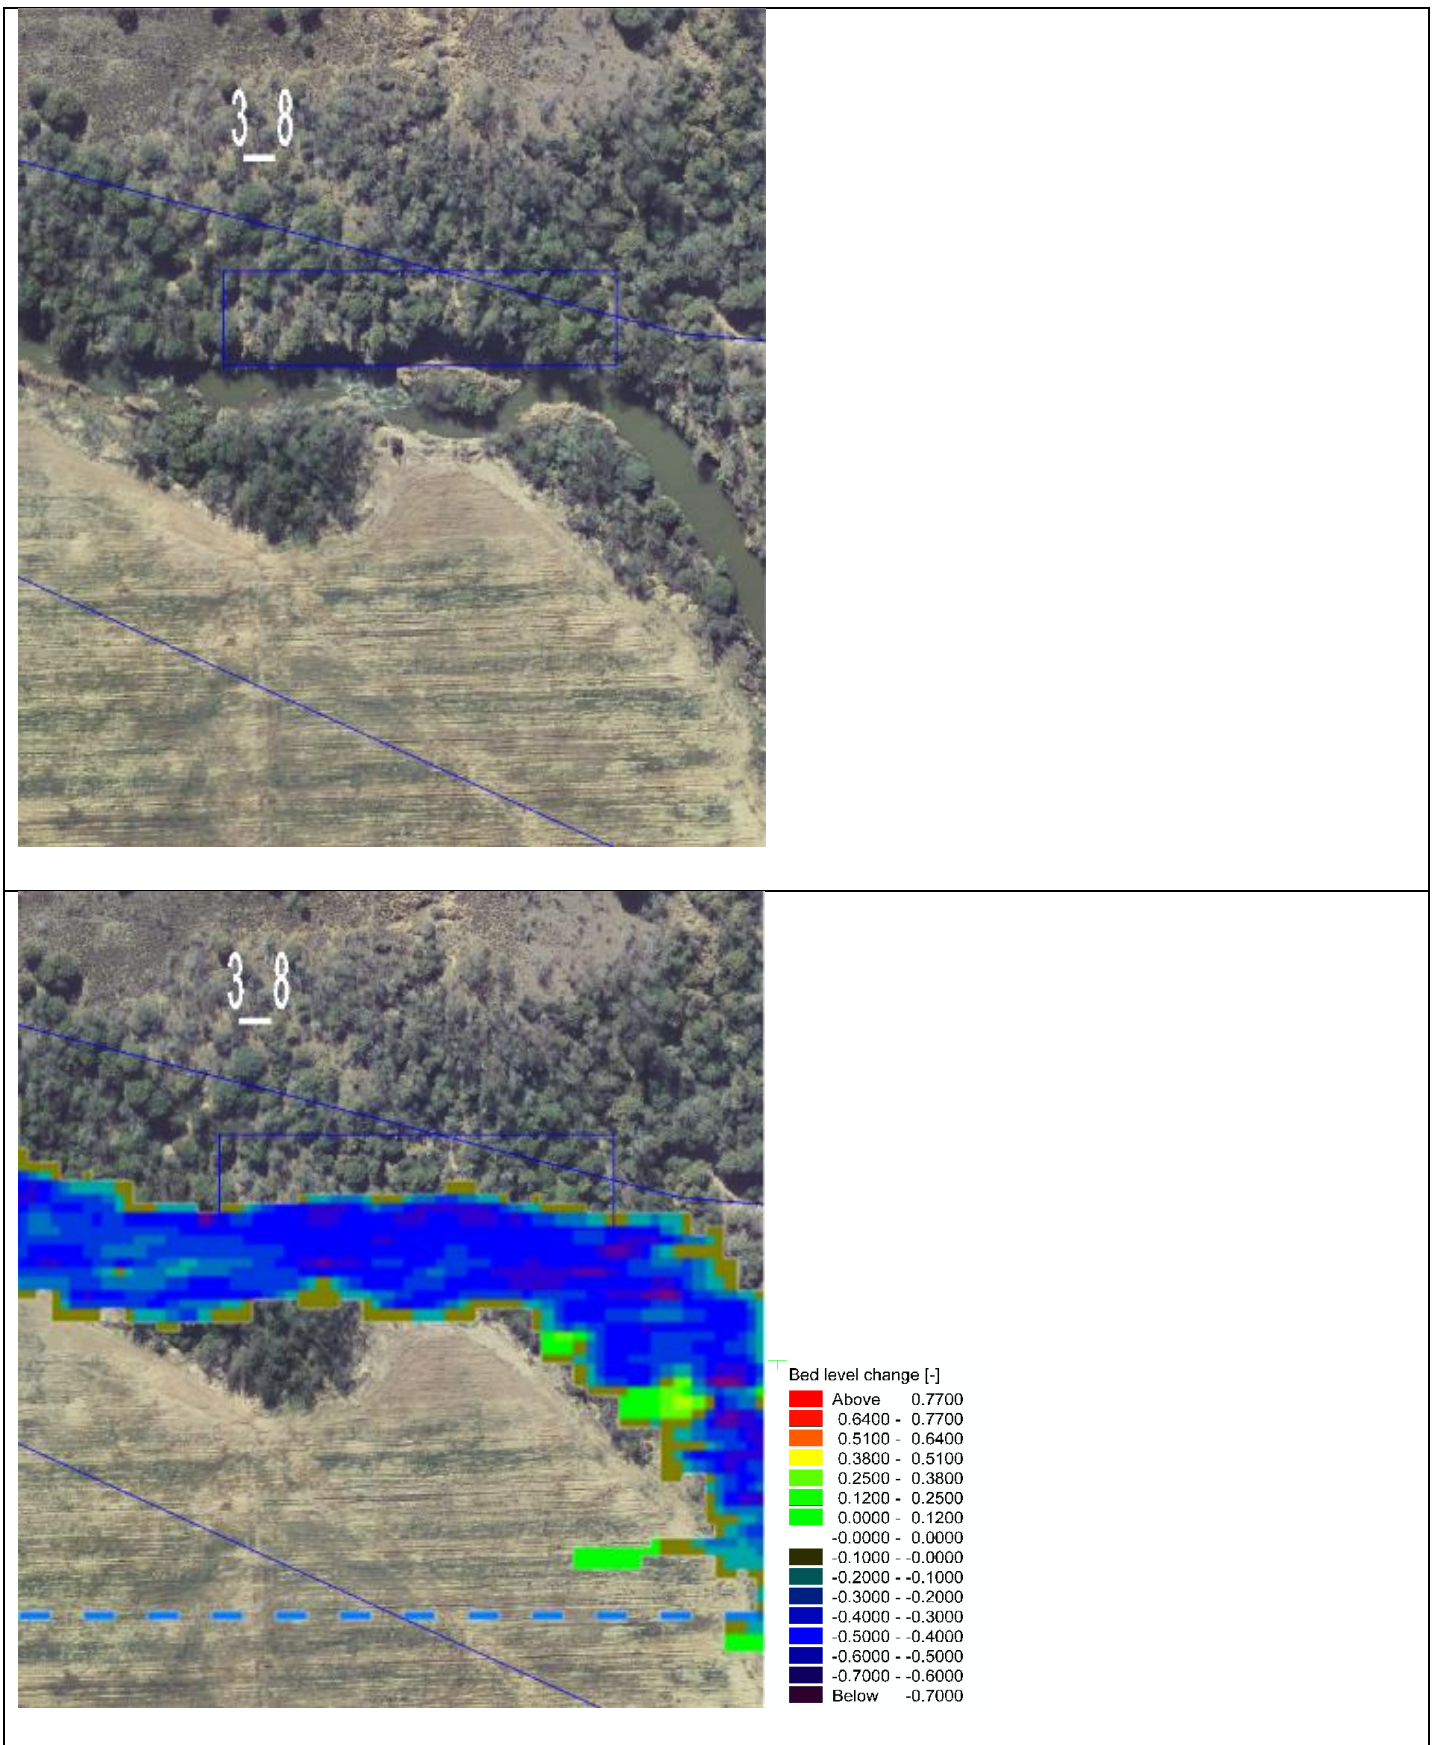
Zone 3_8

The zone has unstable banks within the servitude. Protection was found not necessary.

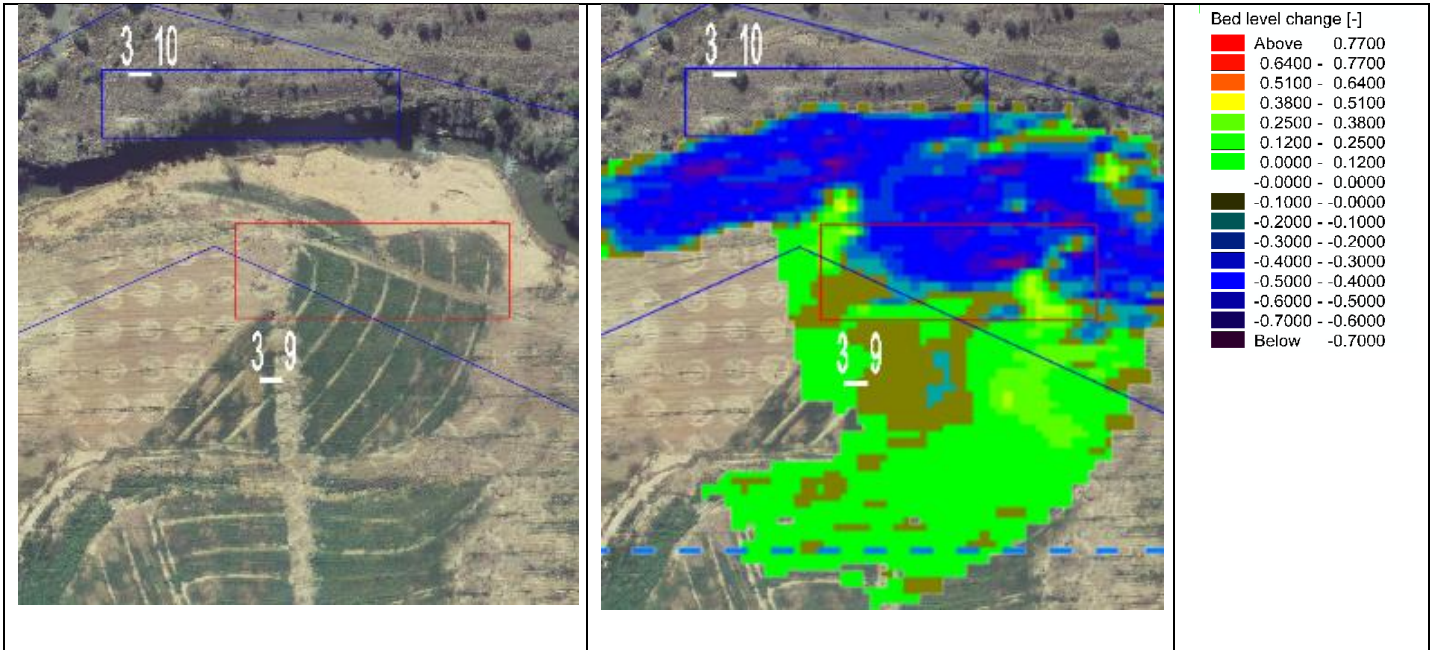
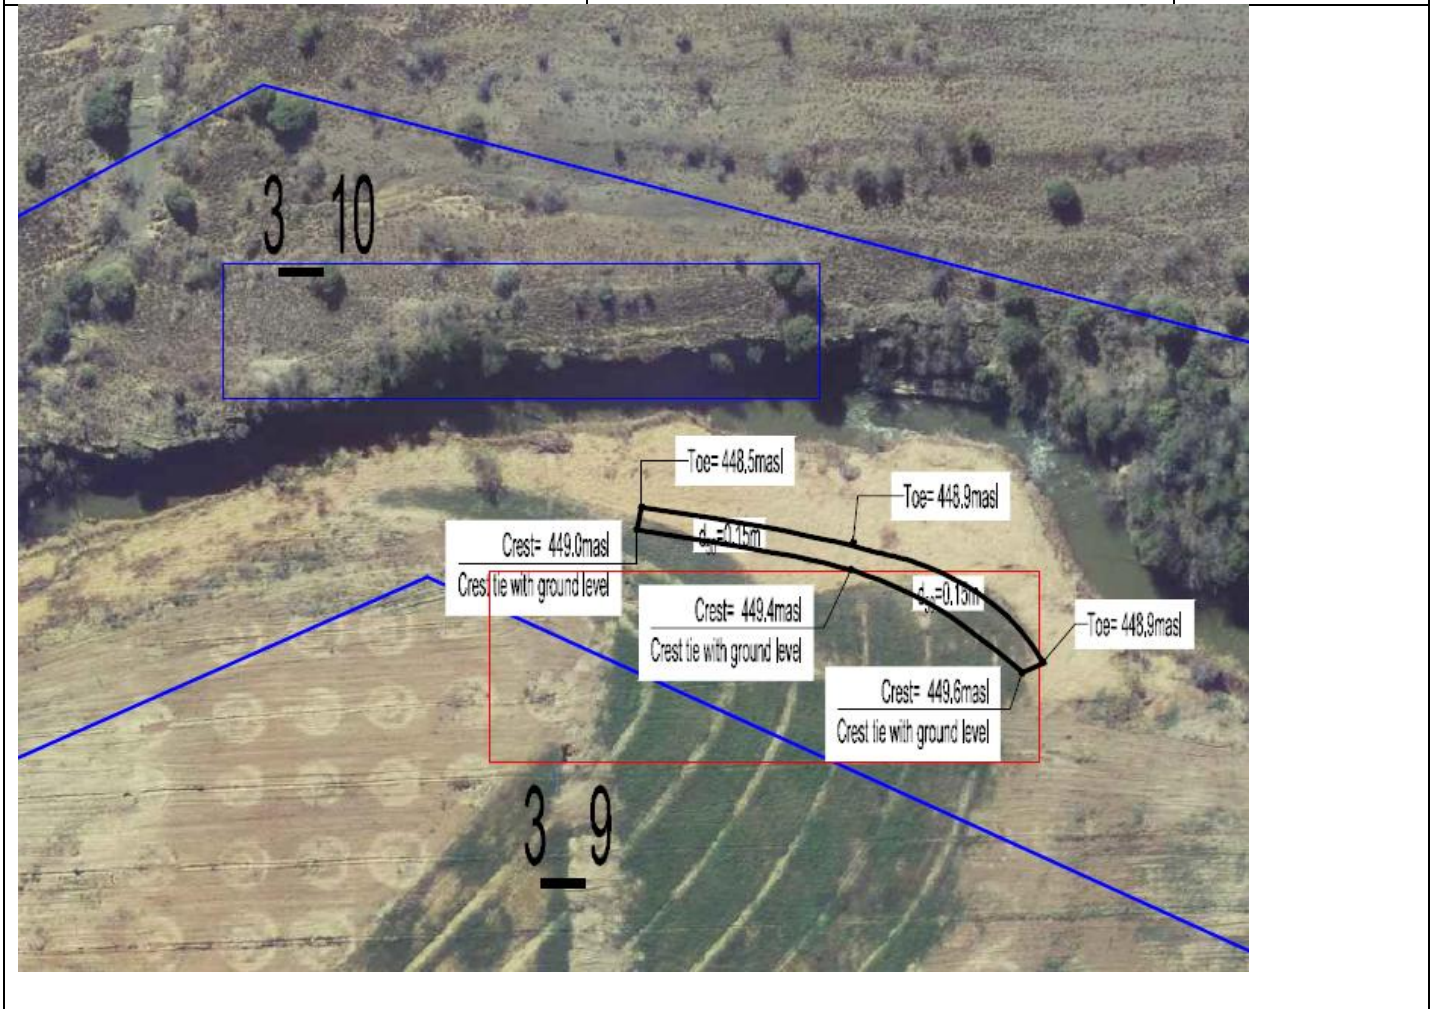
Zone 3_10

The zone has unstable banks within the servitude. Protection was found not necessary.

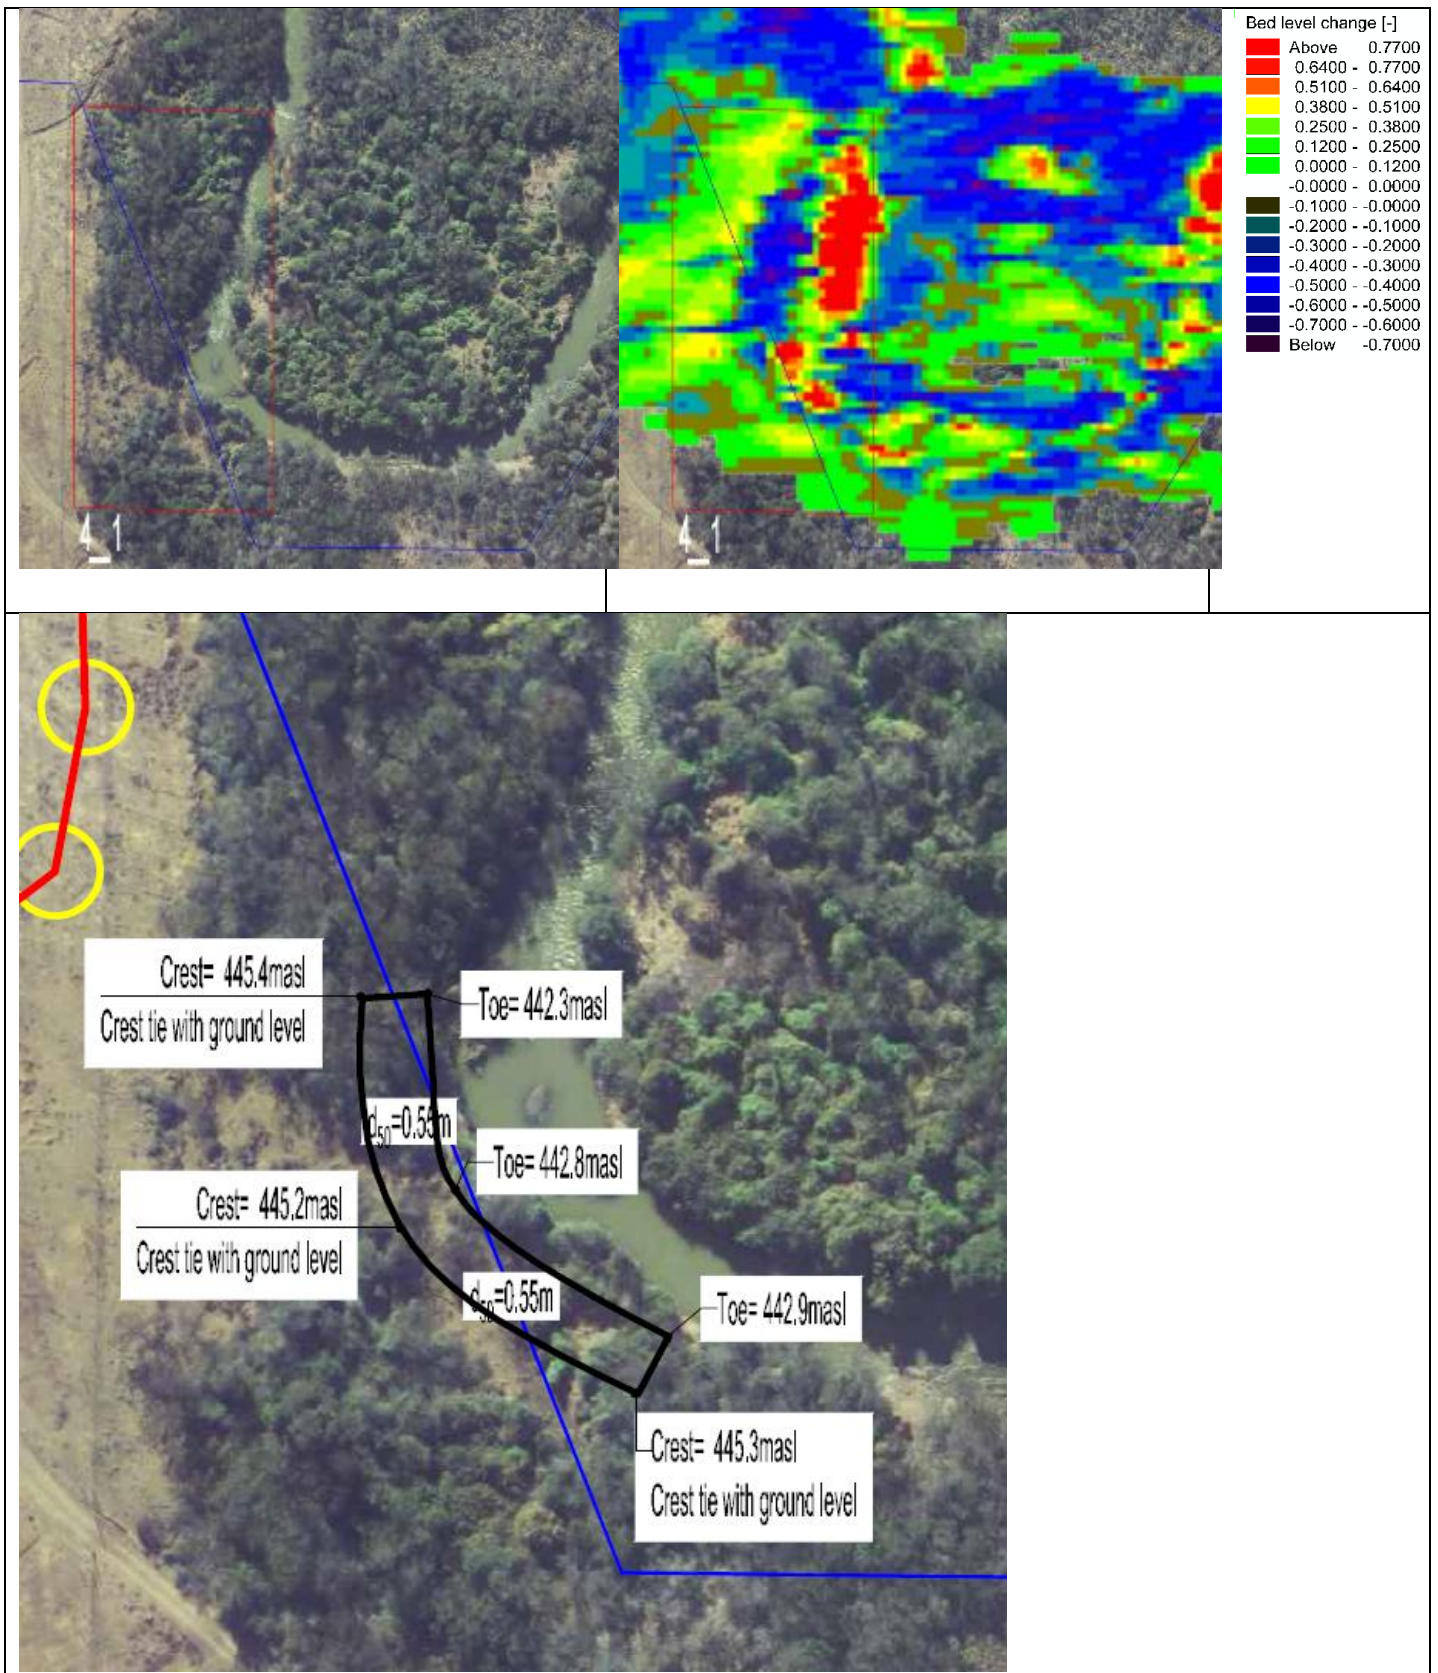
Zone 4_1

The zone has unstable banks crossing the servitude and encroaching the road.

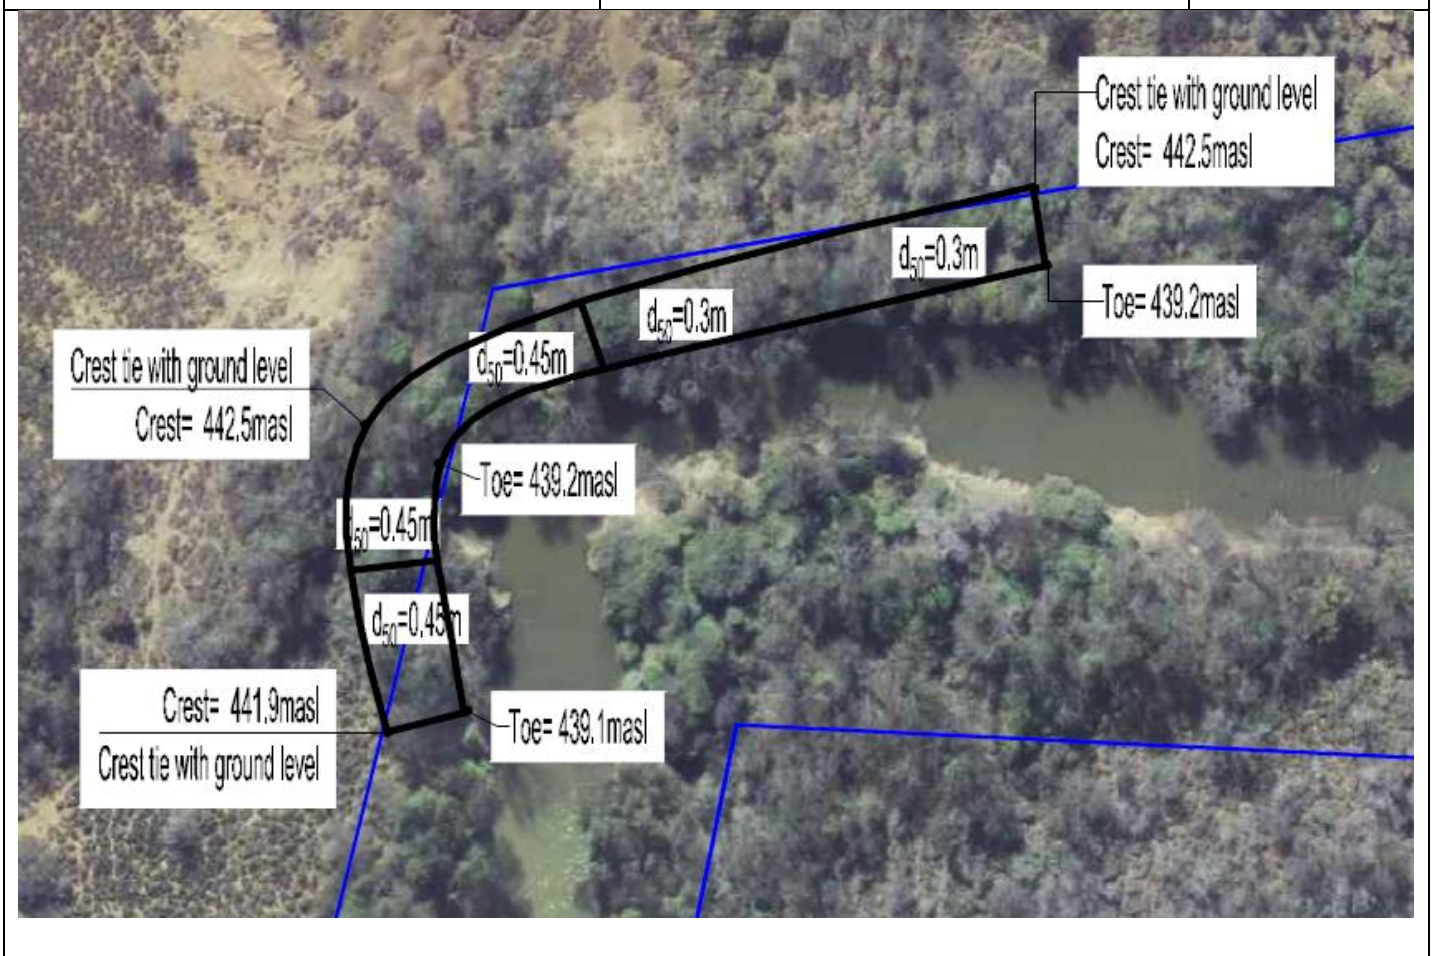
Zone 4_2

The zone has unstable banks crossing the servitude and encroaching the road.

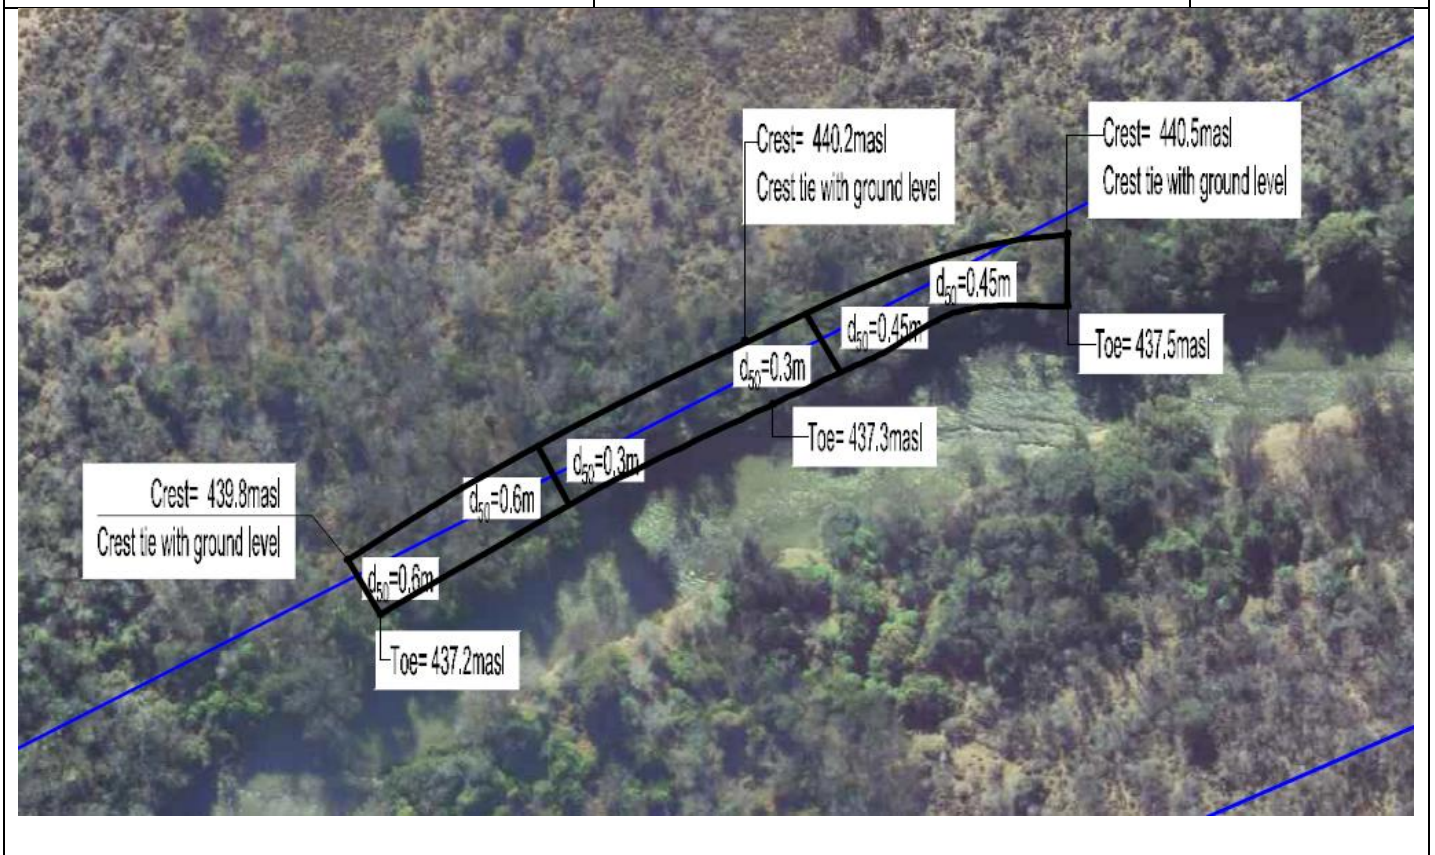
Zone 4_3

The zone has unstable banks crossing the servitude.
