SKOENMAKERS RIVER REHABILITATION ASSESSMENT
 ZONE 1

Date:	08/02/2016	Compiled by:	PAUJ
Project No.	472748	Scale	1:7,369

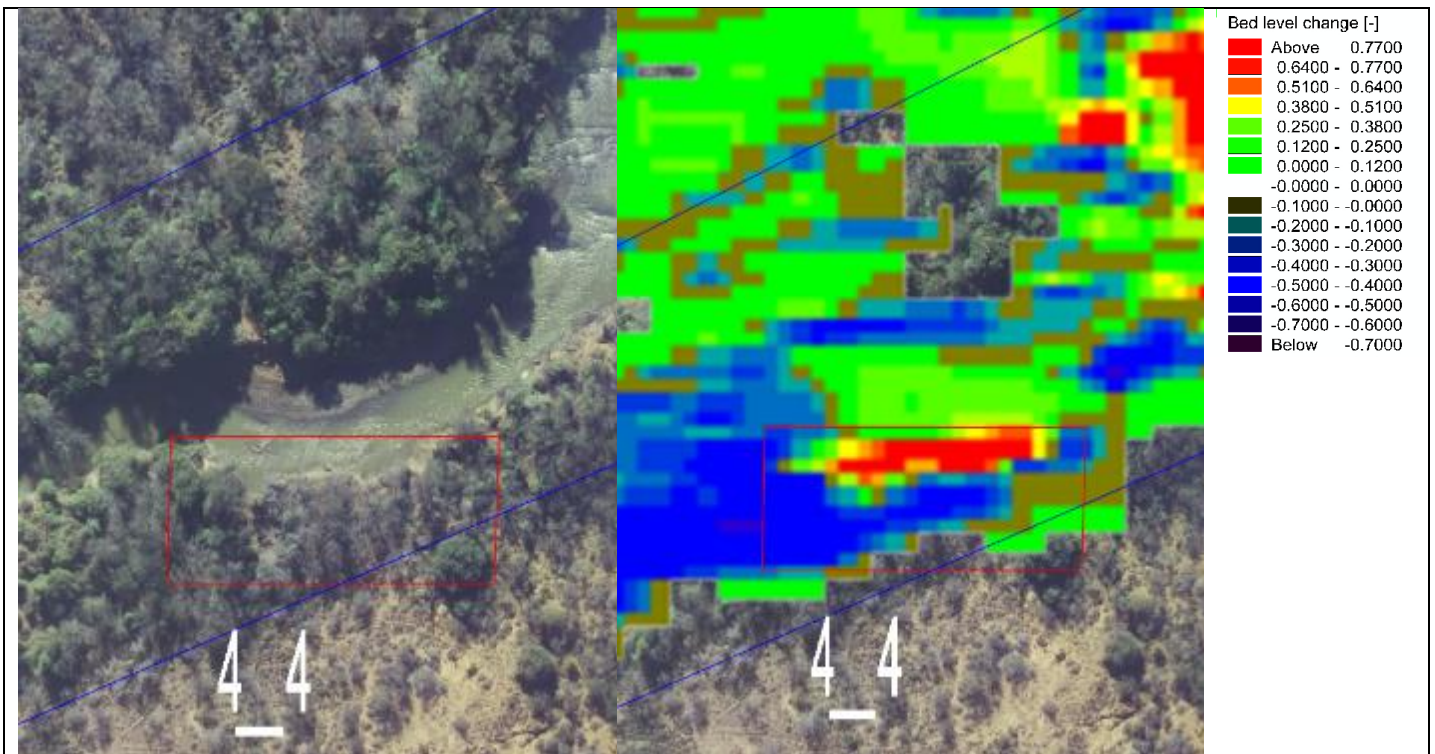
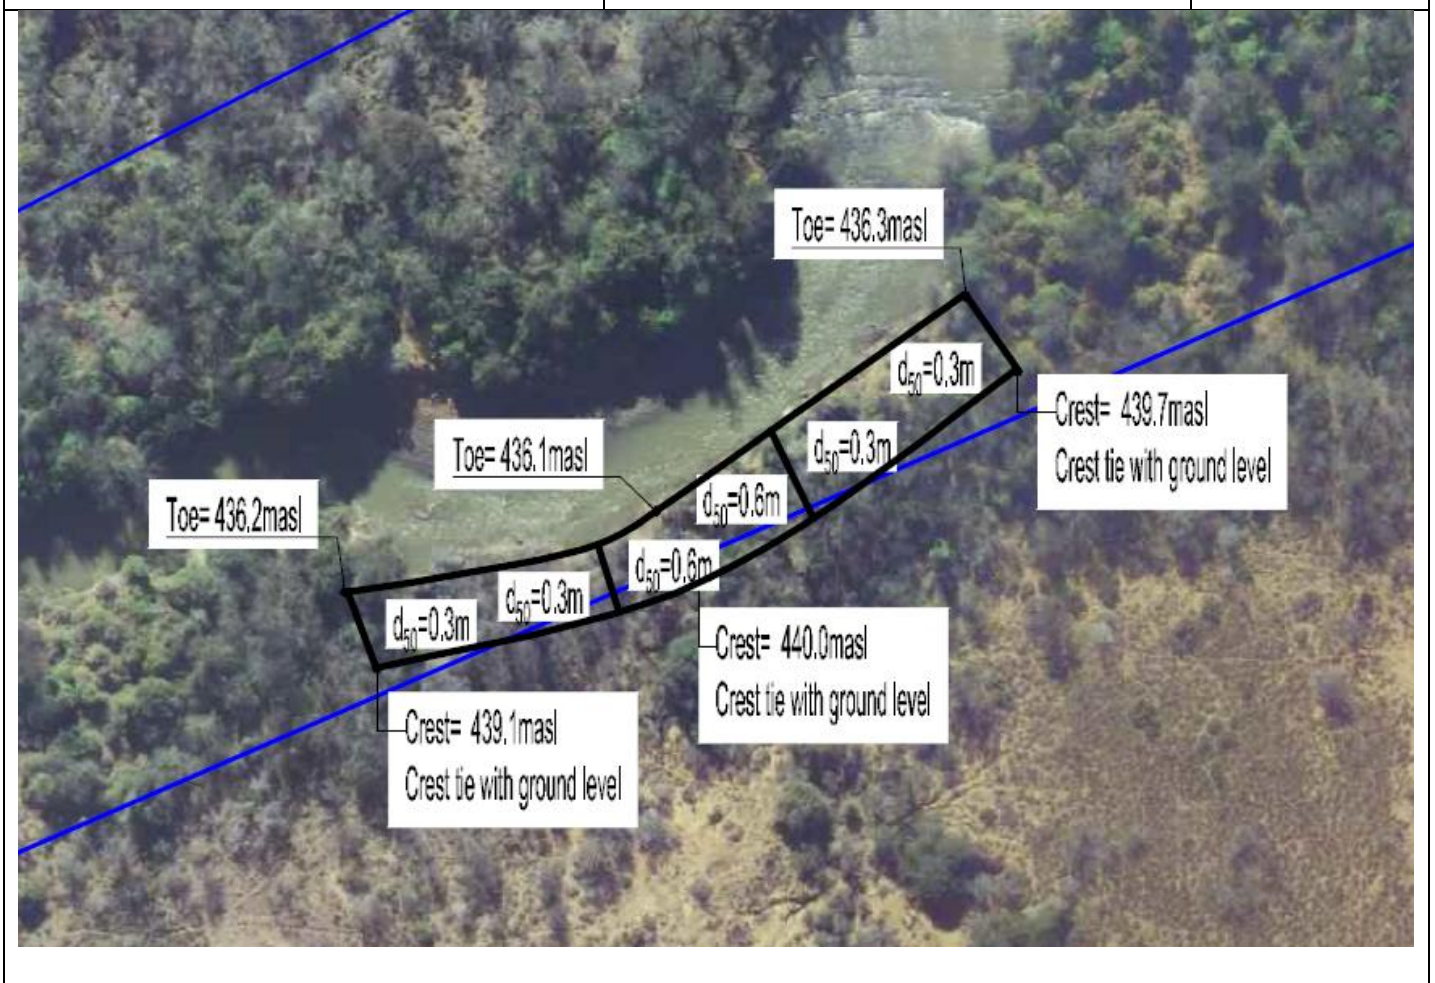
Zone 4_4

The zone has unstable banks crossing the servitude and encroaching the road.

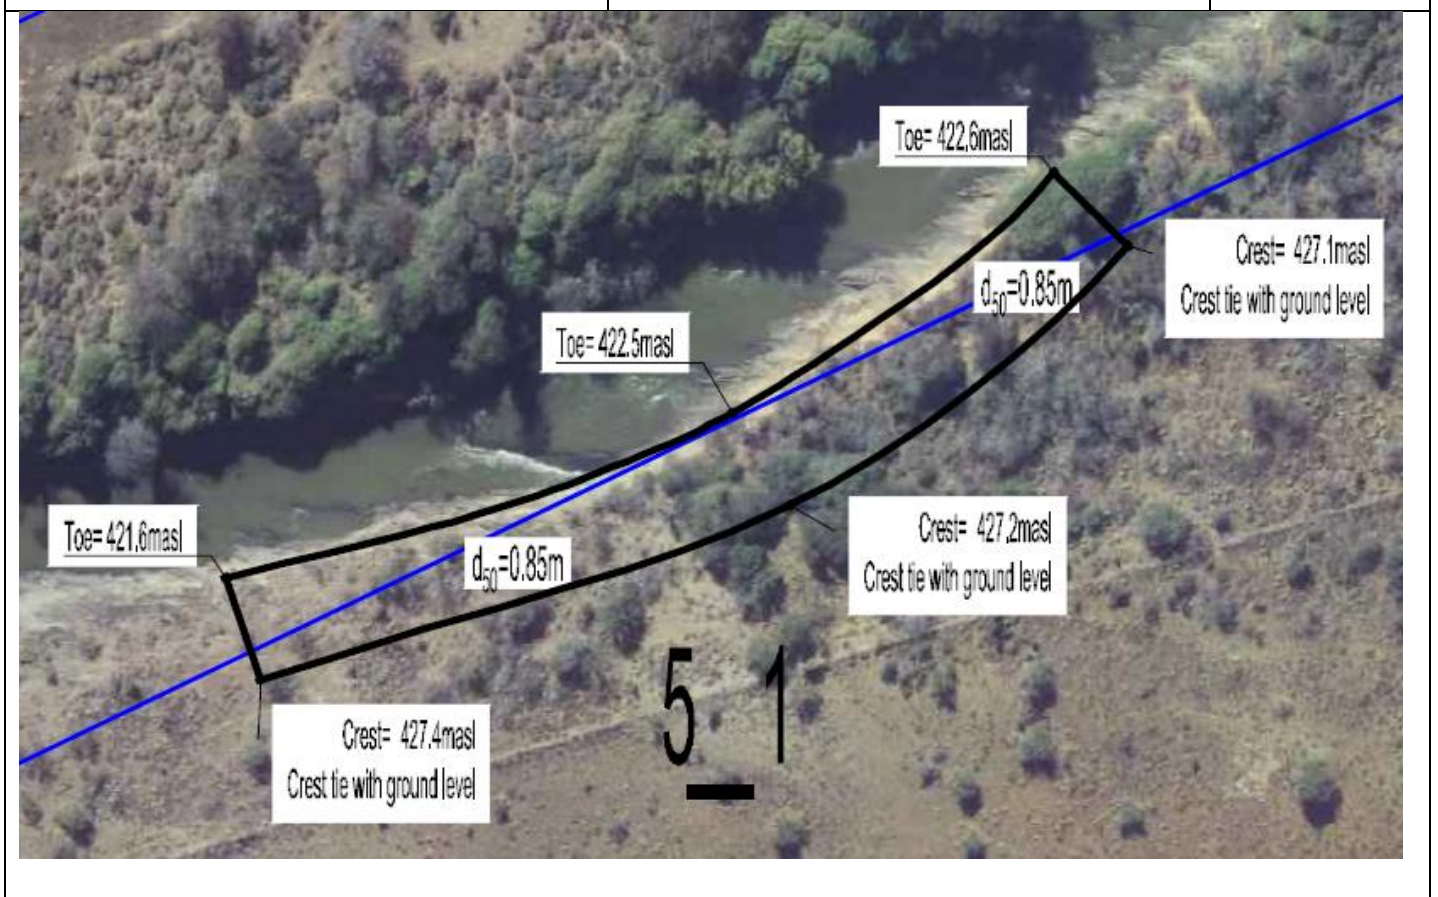
Zone 5_1

The zone has banks encroaching the servitude.

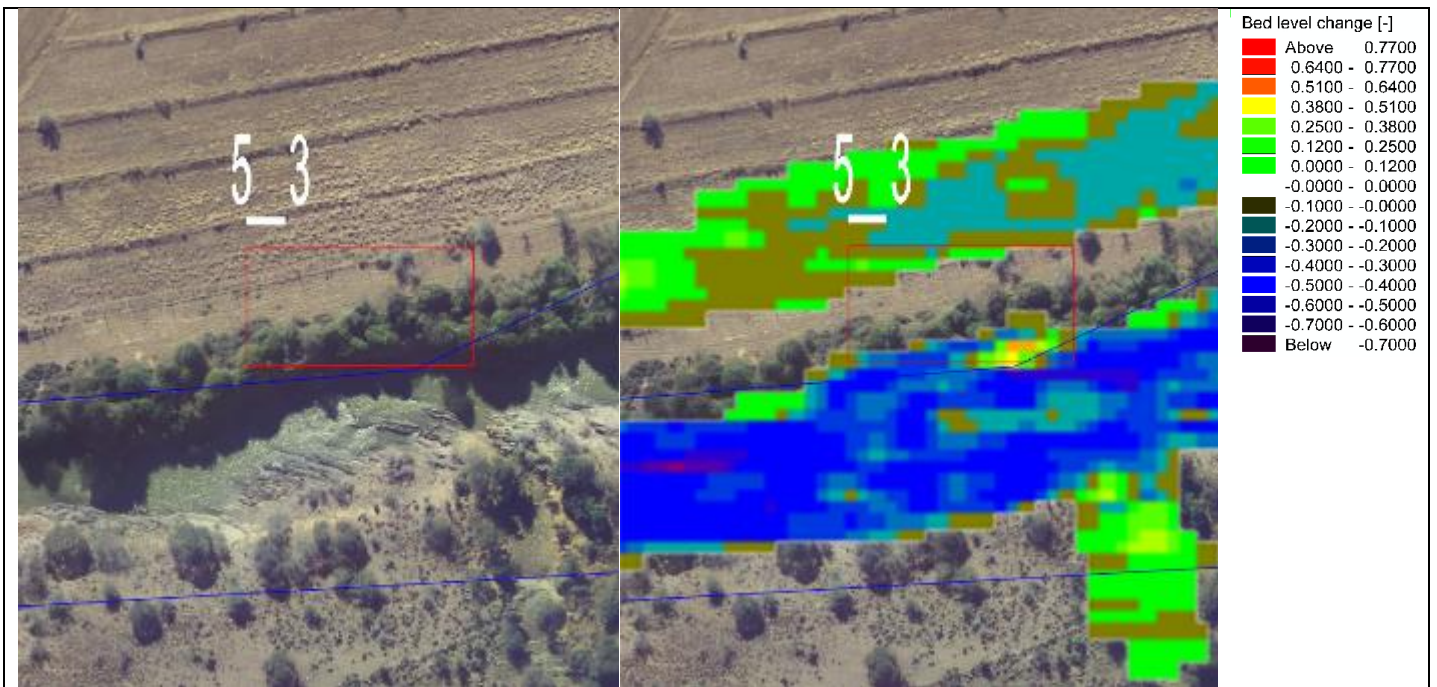
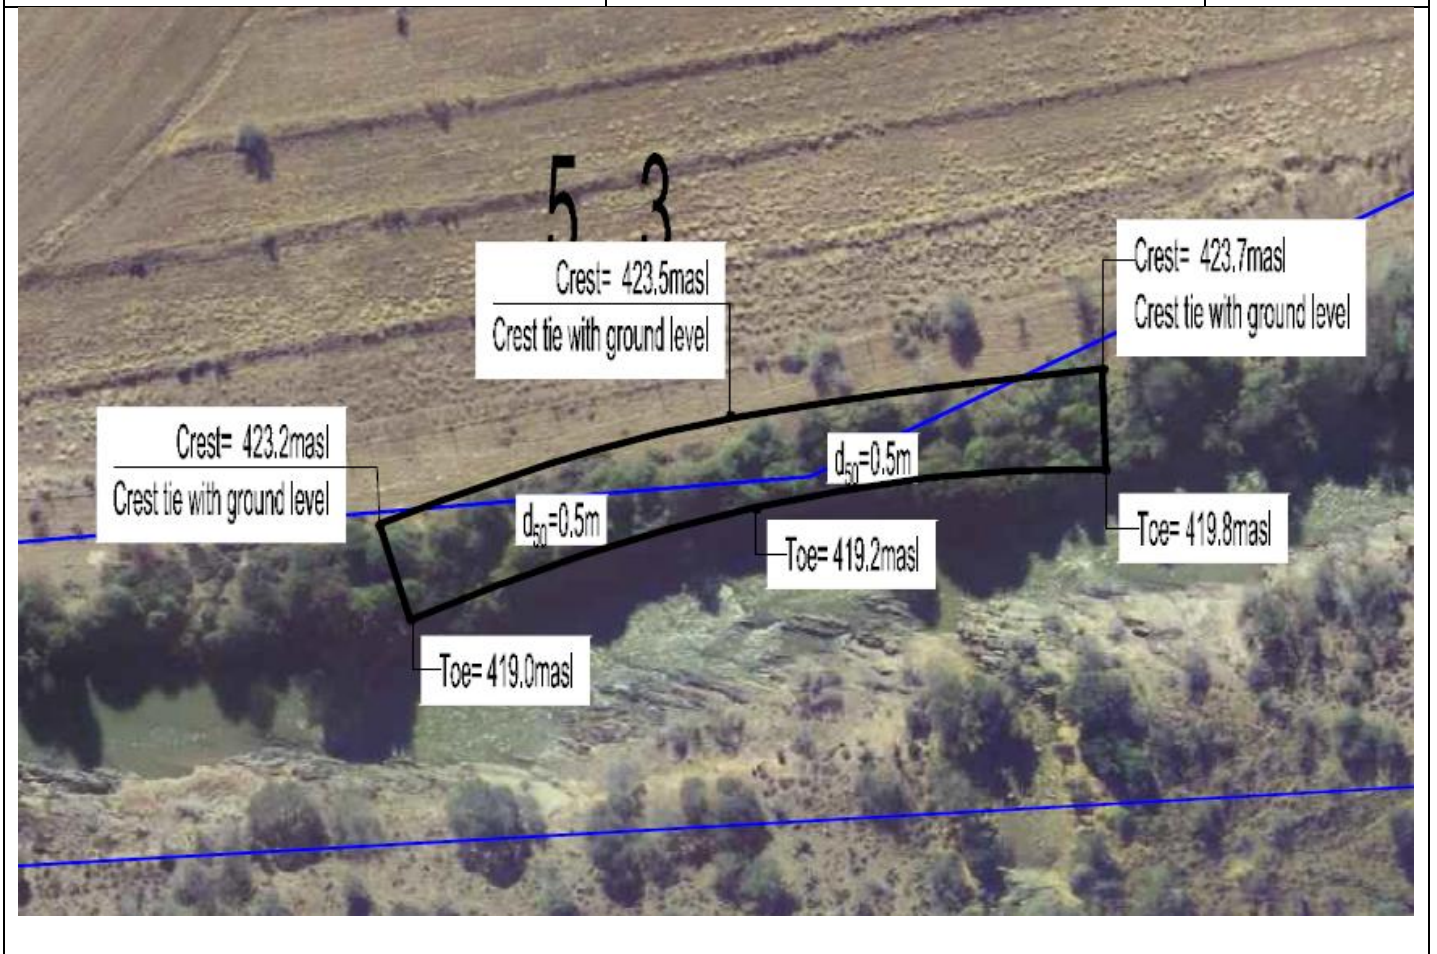
Zone 5_3

The zone has banks crossing the servitude and encroaching farmland.

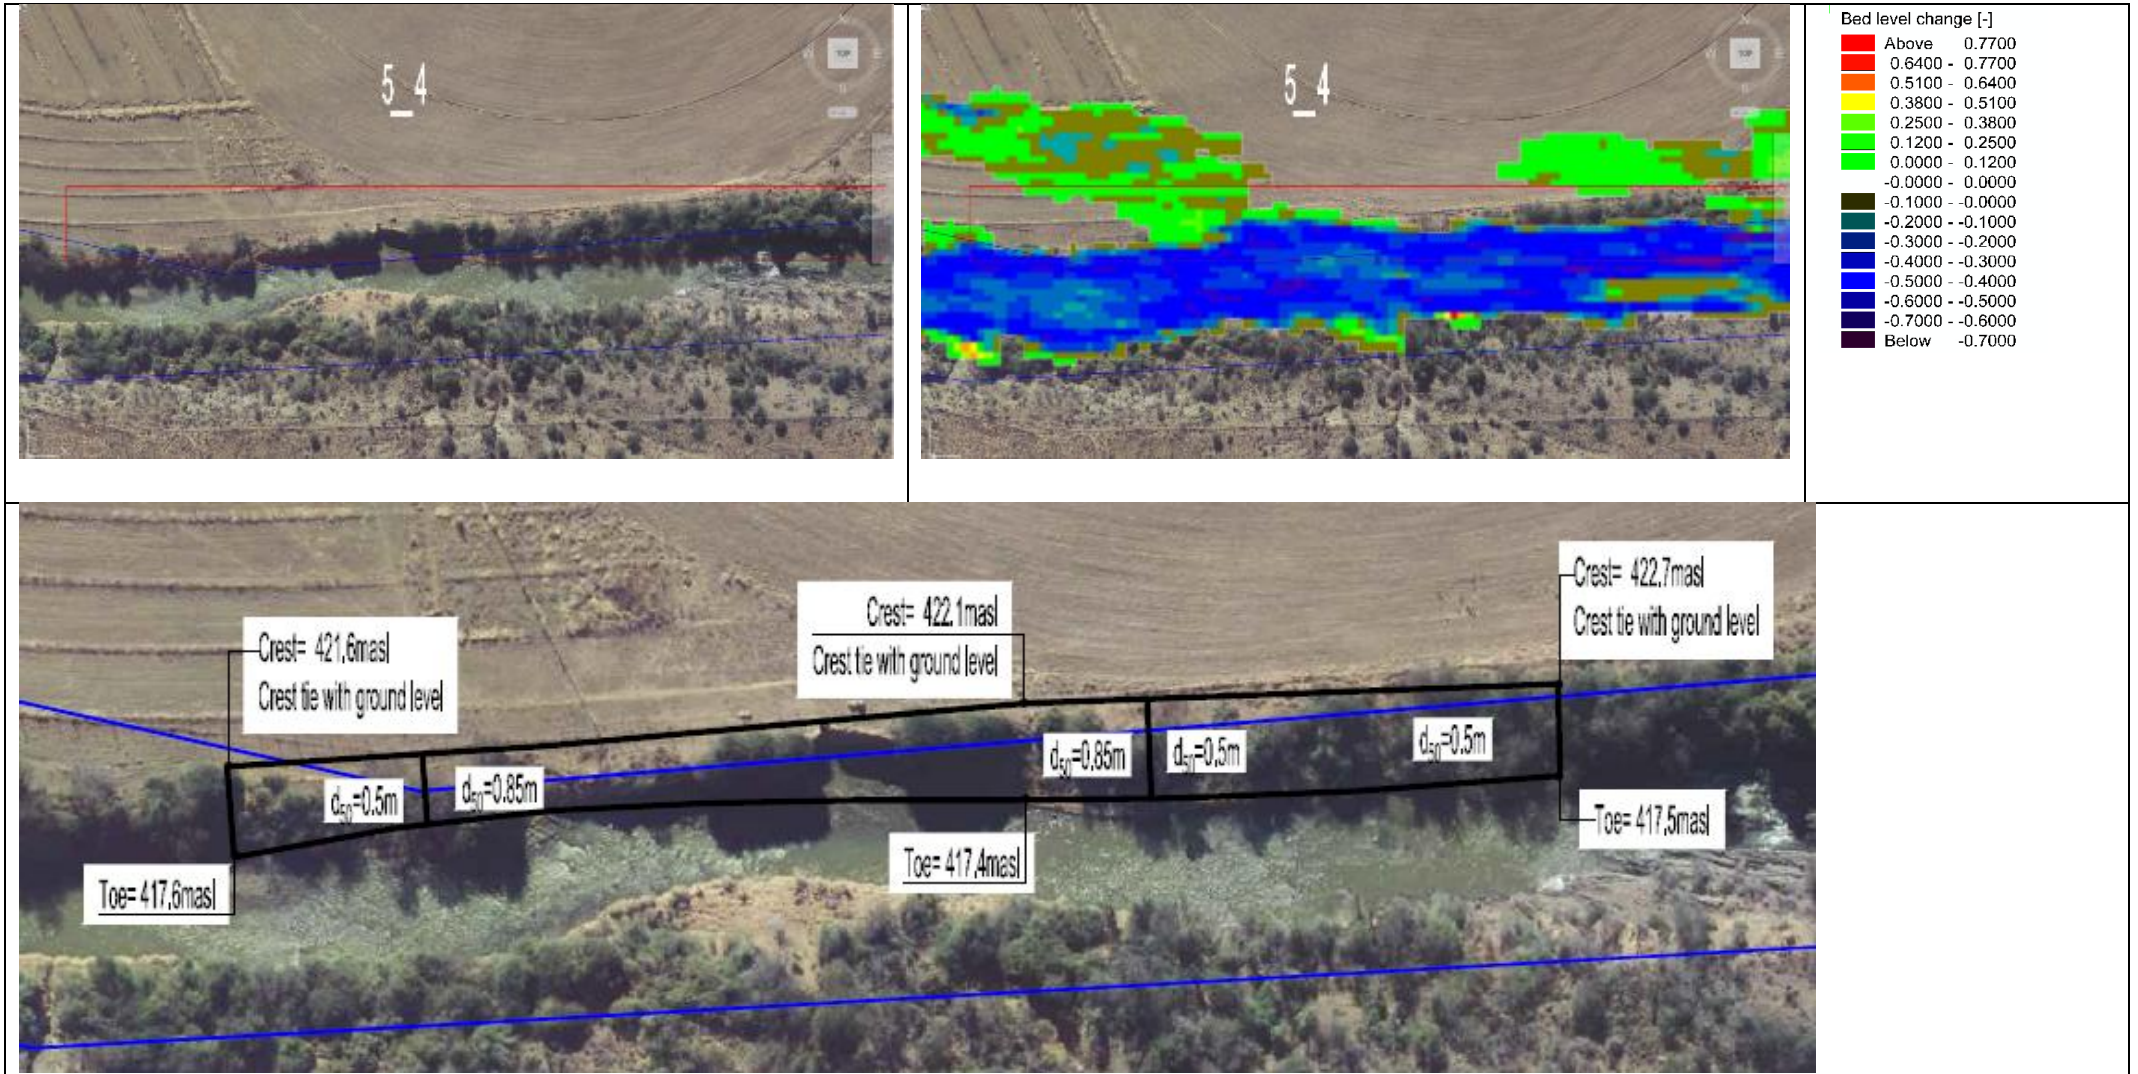
Zone 5_4

The zone has banks crossing the servitude.

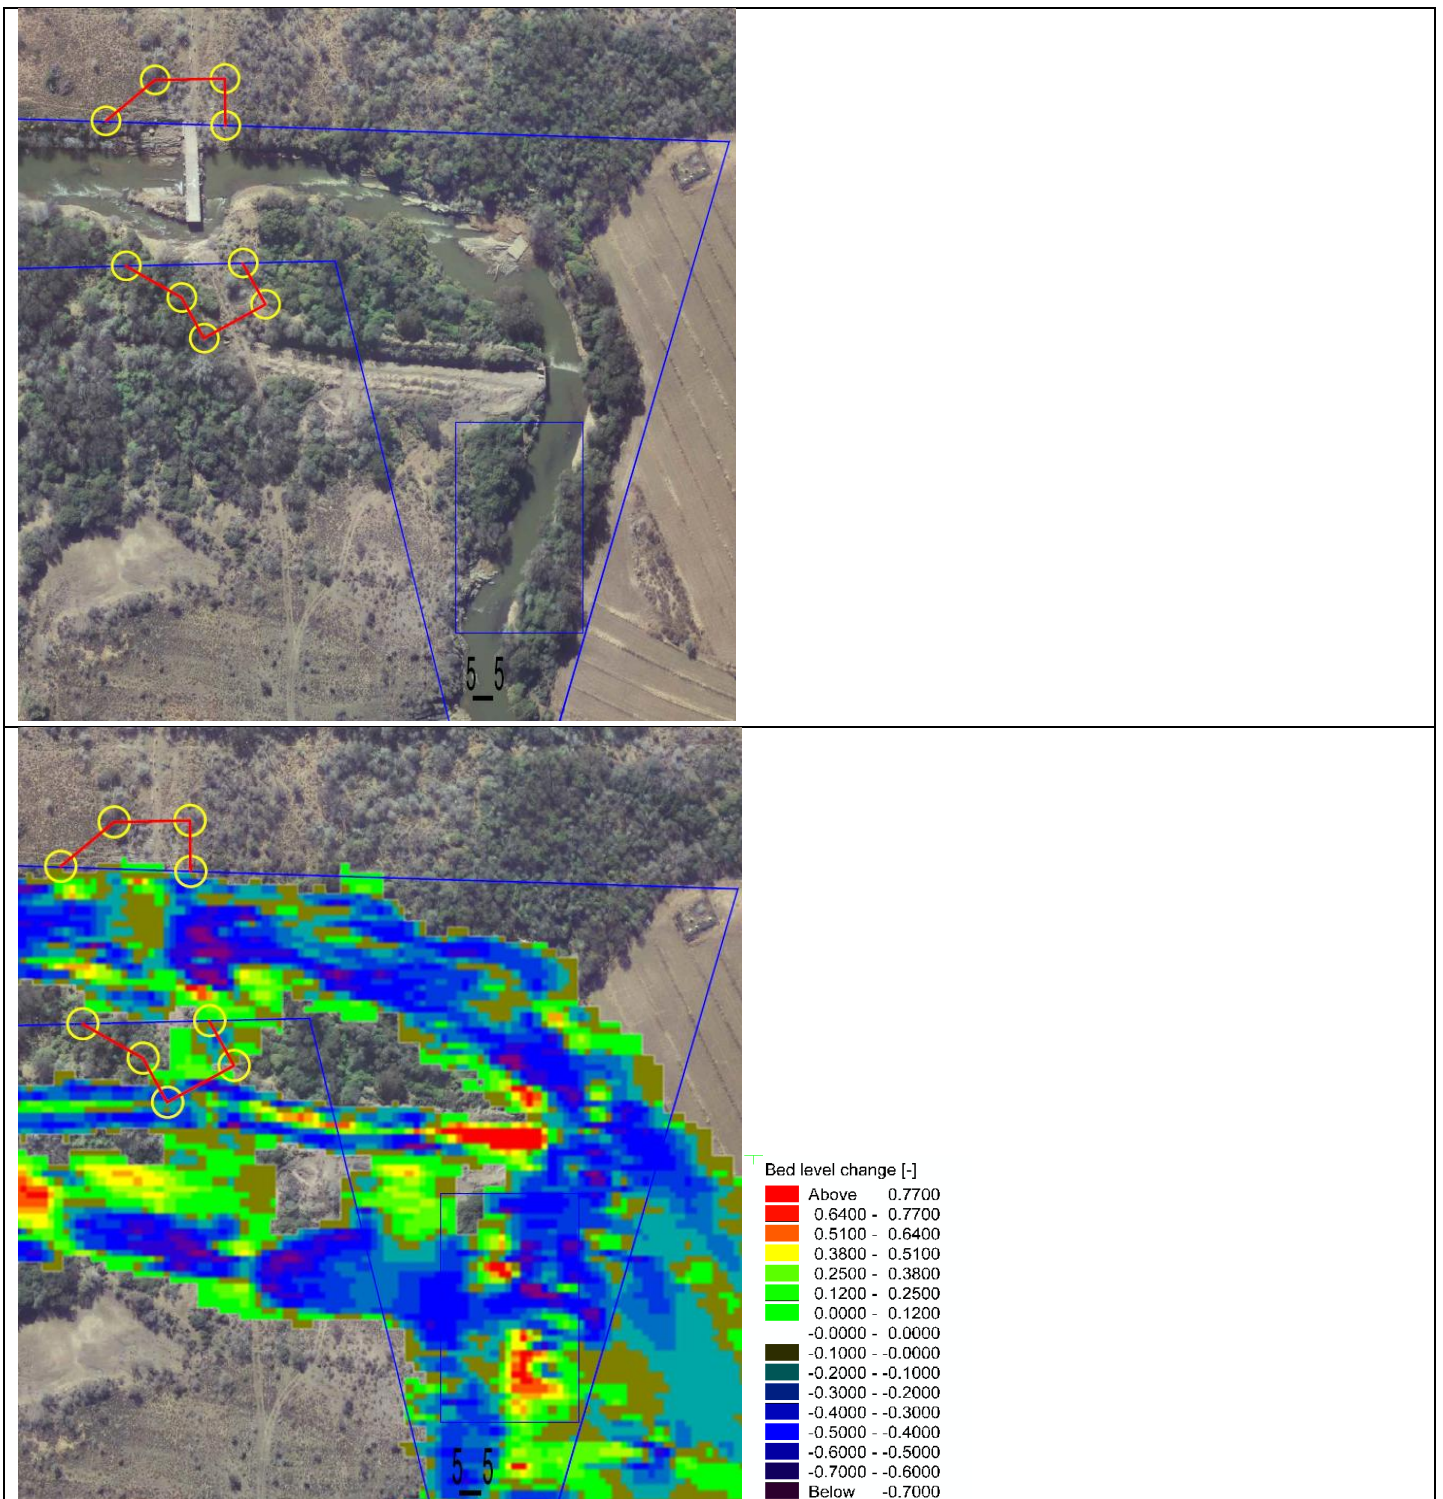
Zone 5_5

The zone has banks within the servitude. Flows are wide in the floodplain and protection not necessary.

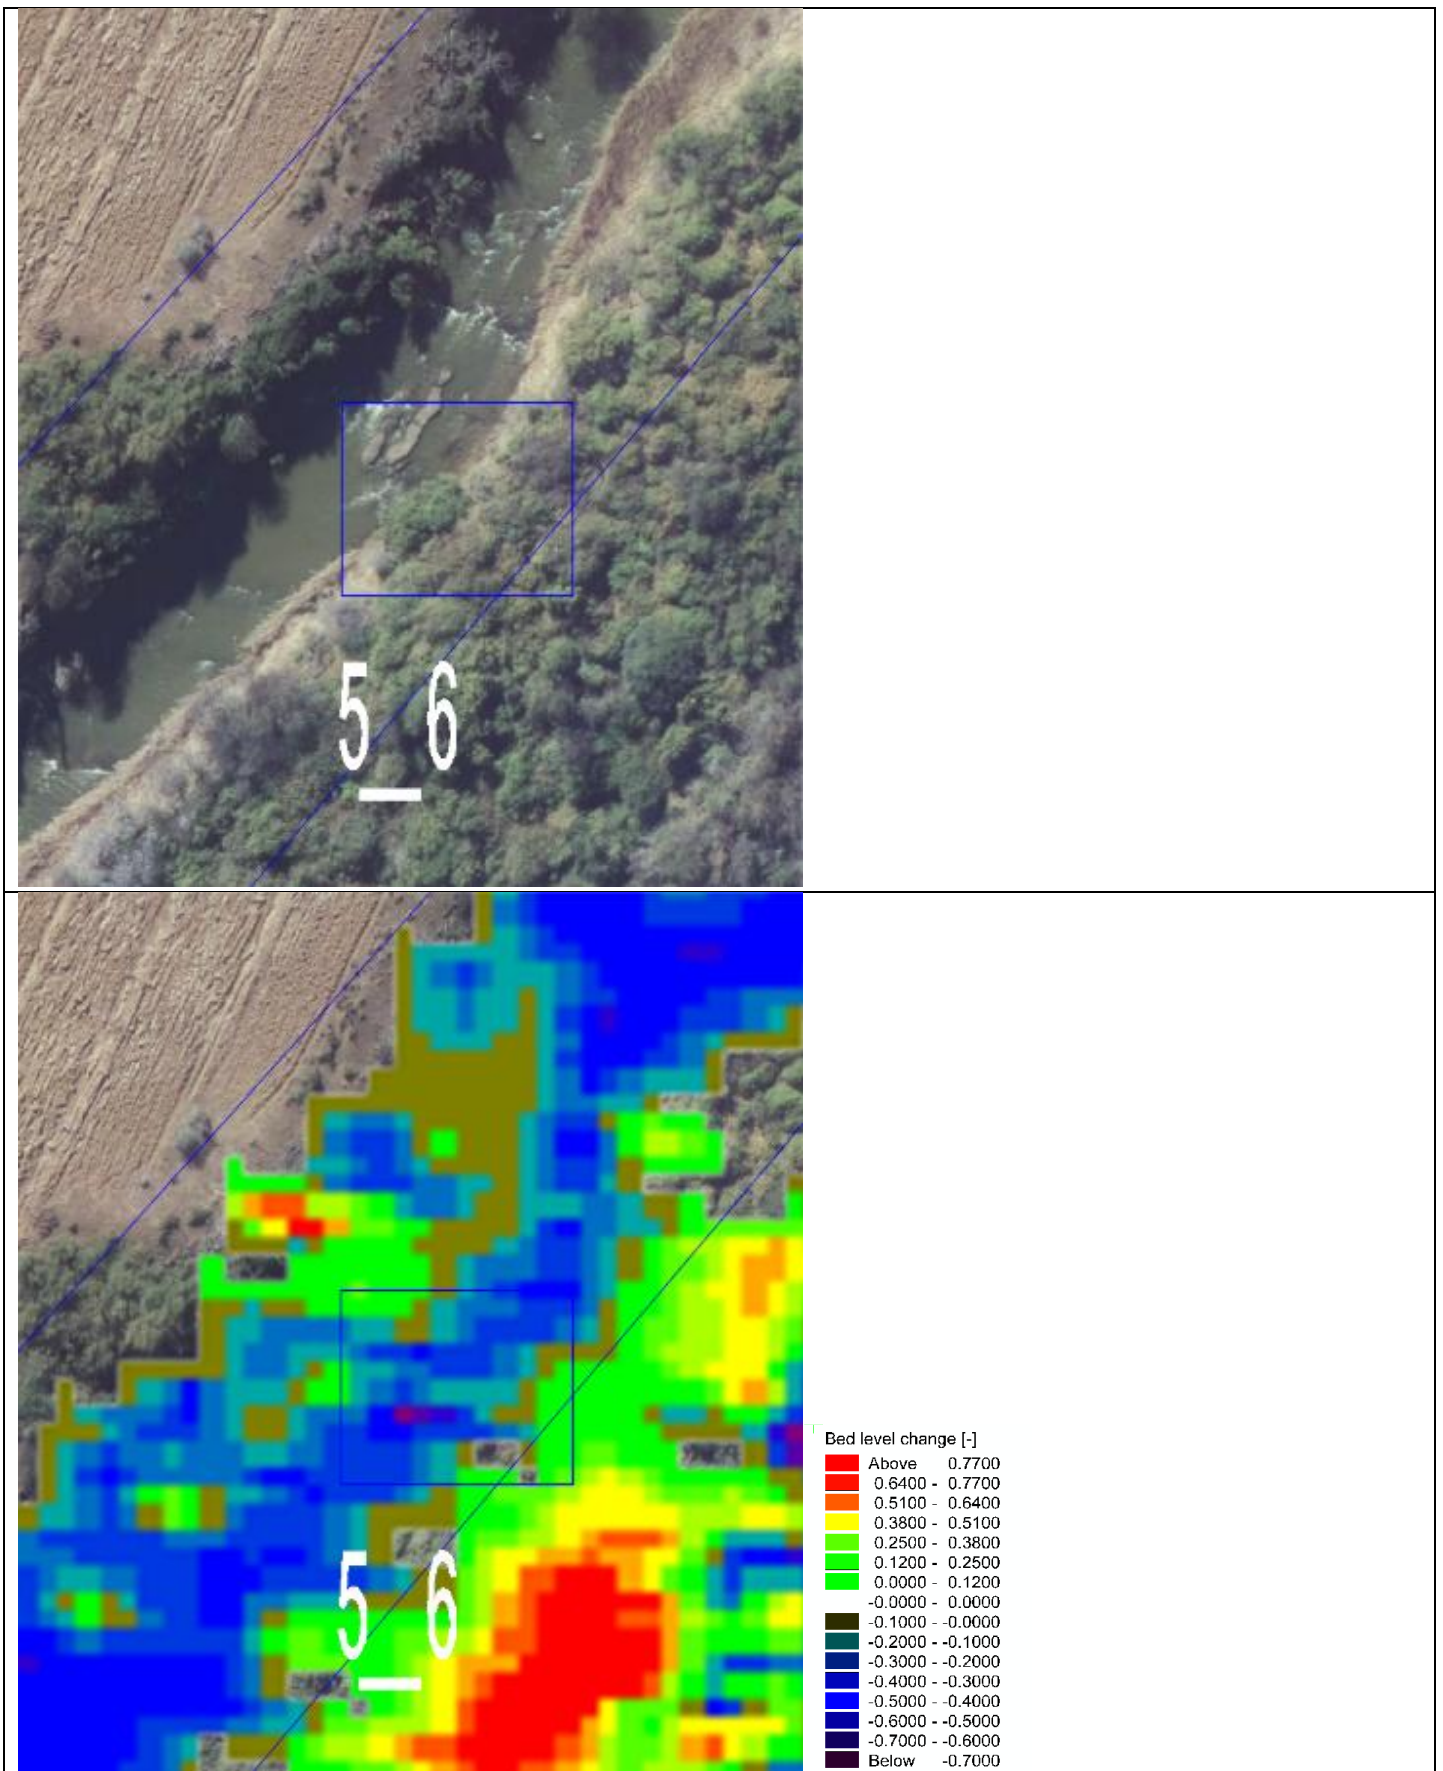
Zone 5_6

The zone has banks within the servitude. Flows are wide on the floodplain and protection not necessary.

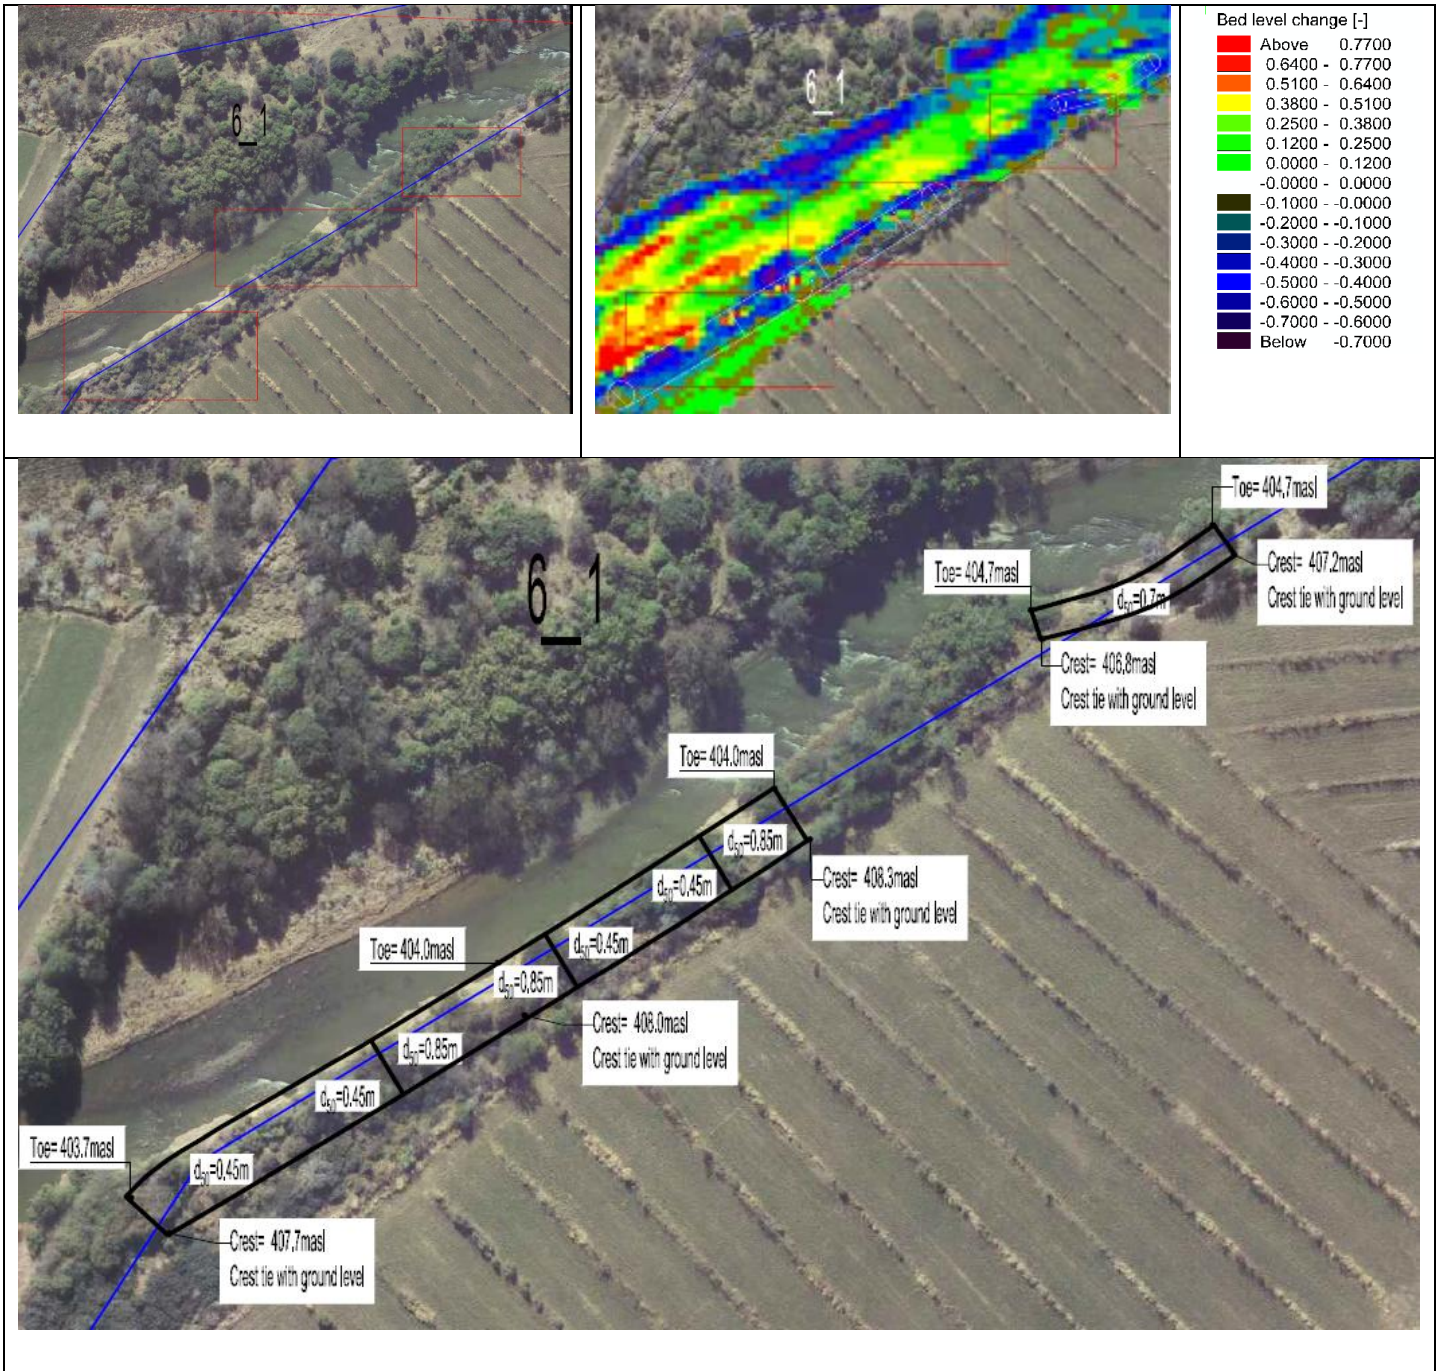
Zone 6_1

The zone has banks crossing the servitude and encroaching farmland.

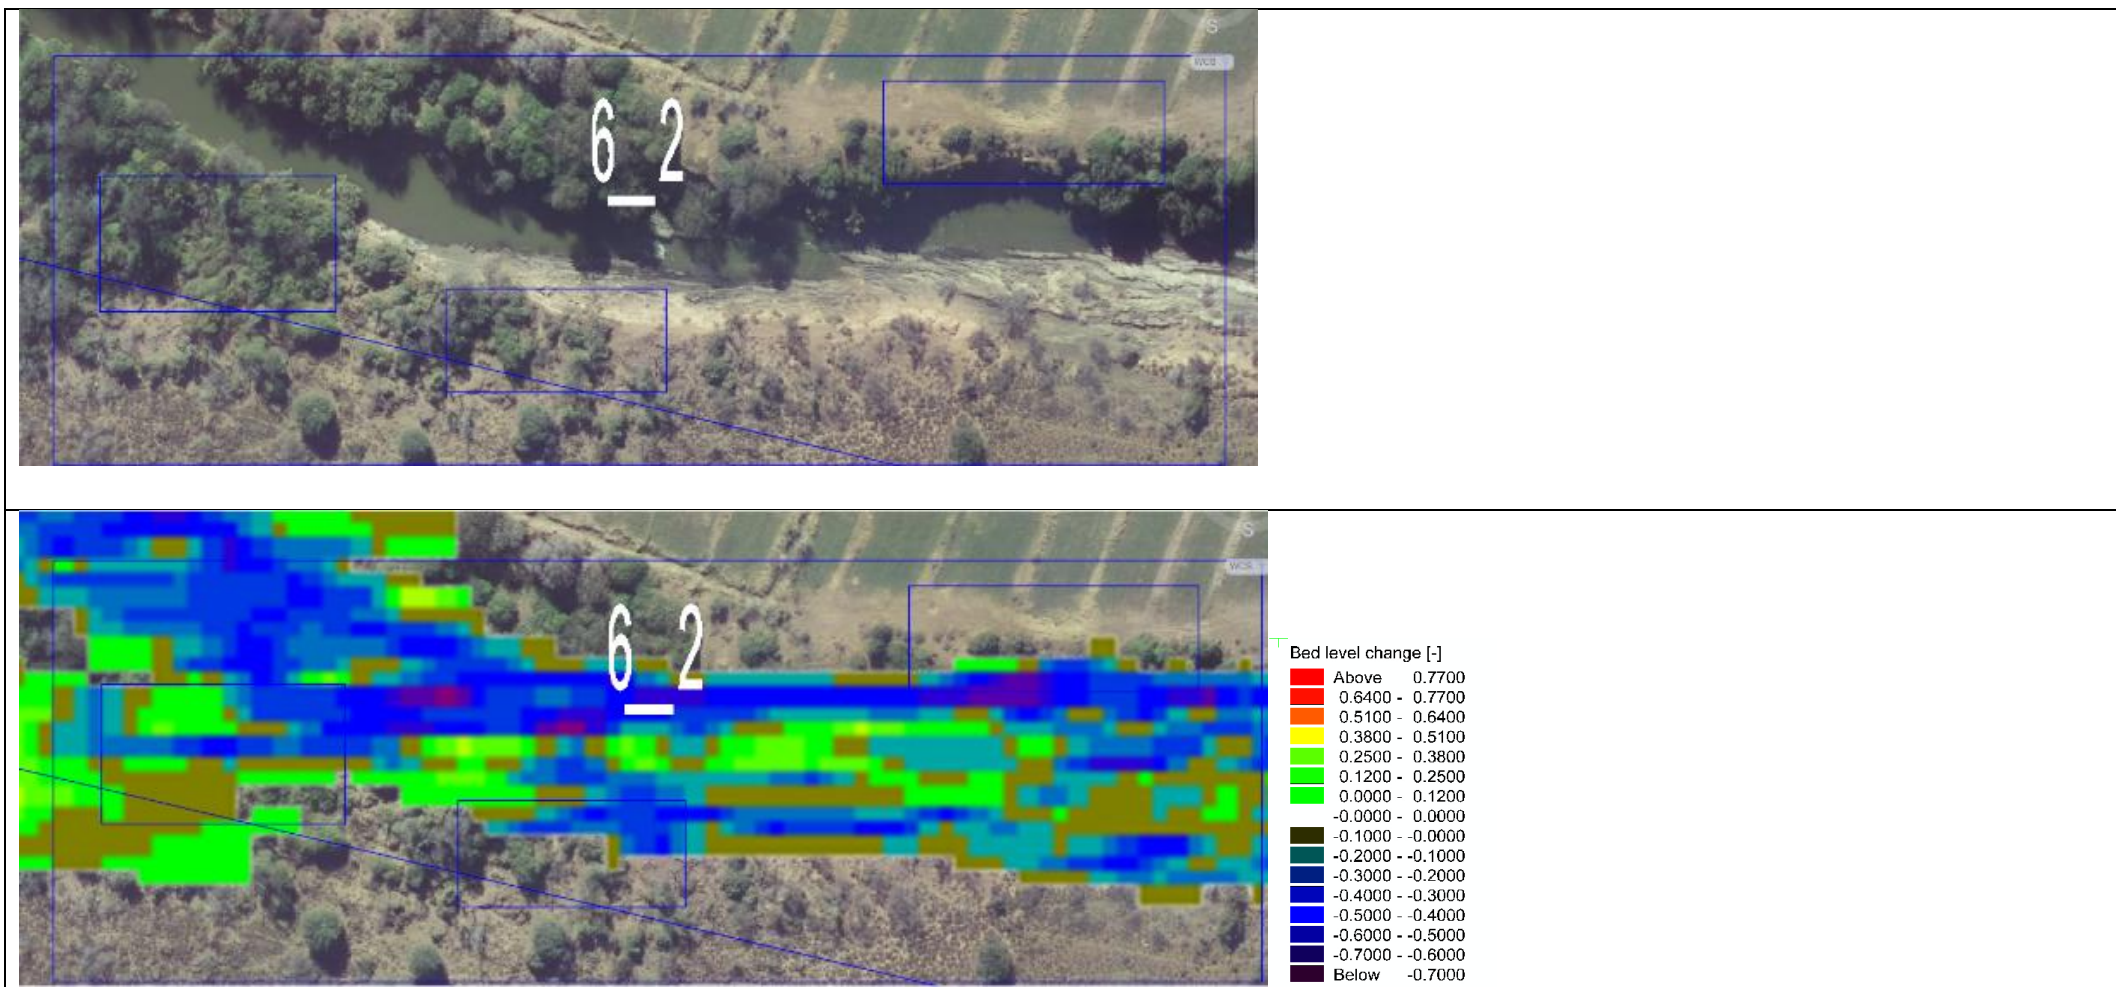
Zone 6_2

The zone has banks within the servitude. Upstream tributary flow induces the erosion and protection will constrict the flow thus not necessary.

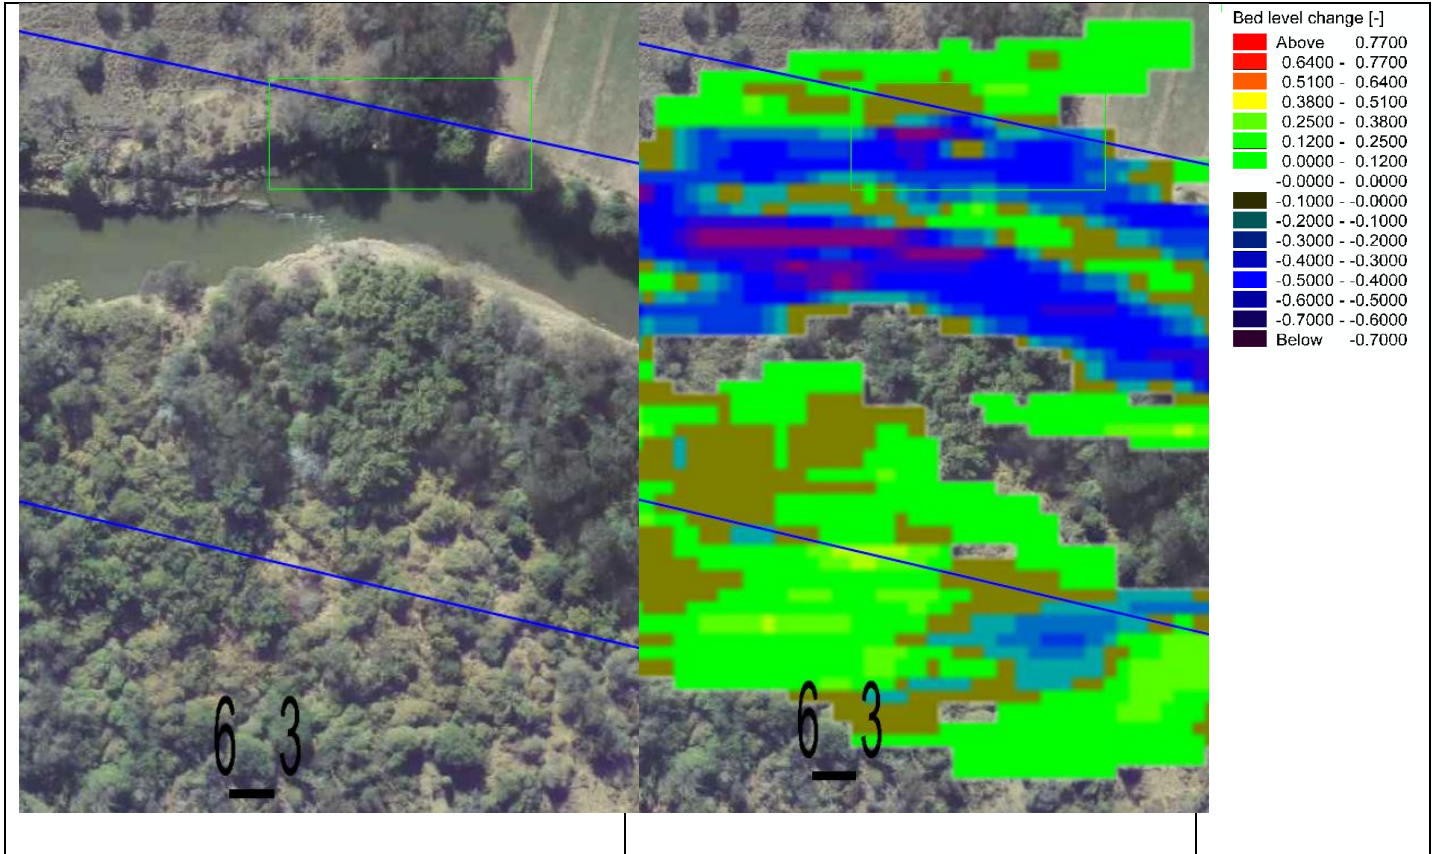
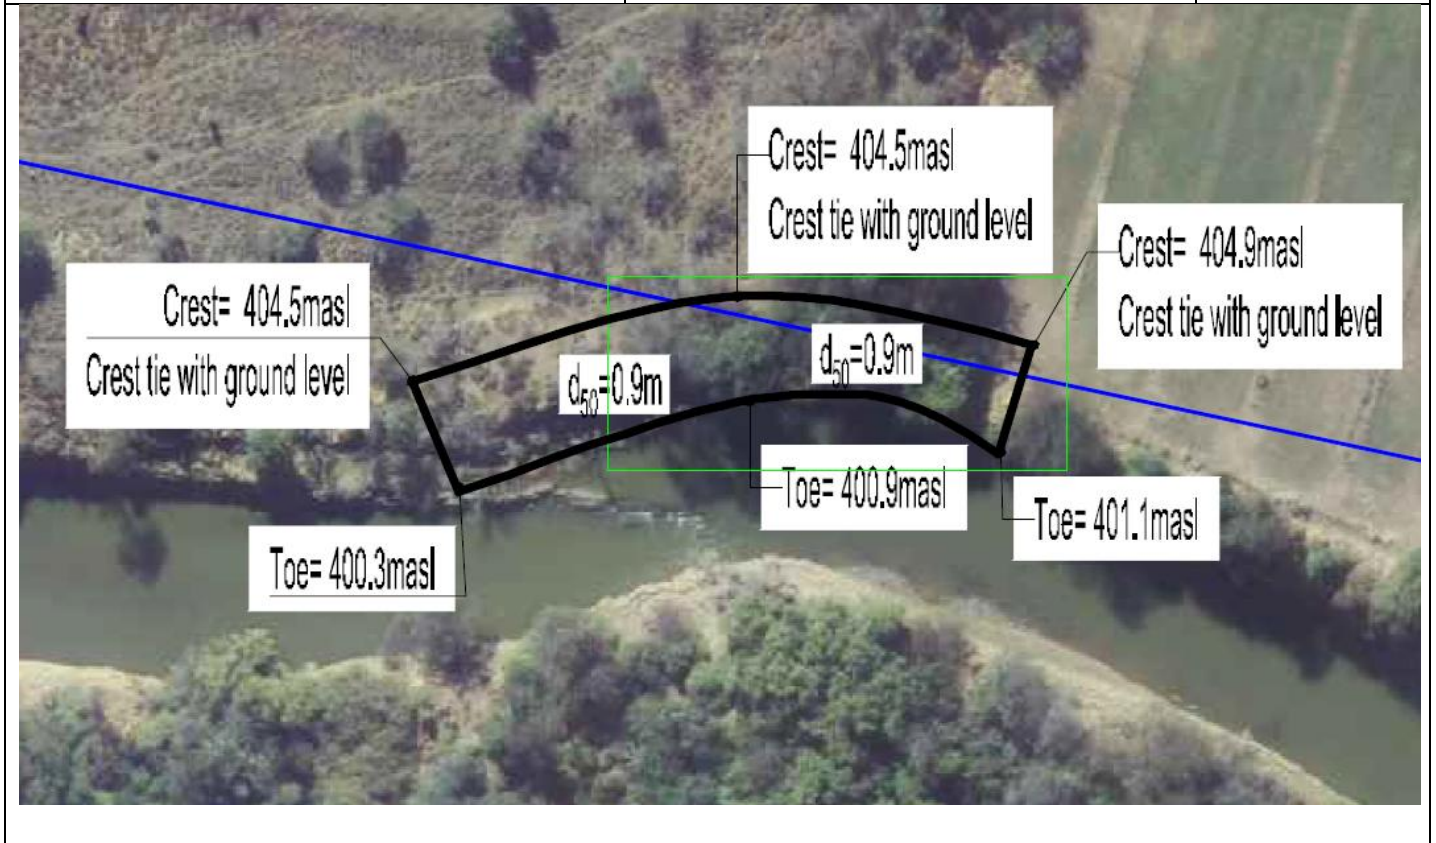
Zone 6_3

The zone has banks crossing the servitude and encroaching farmland.

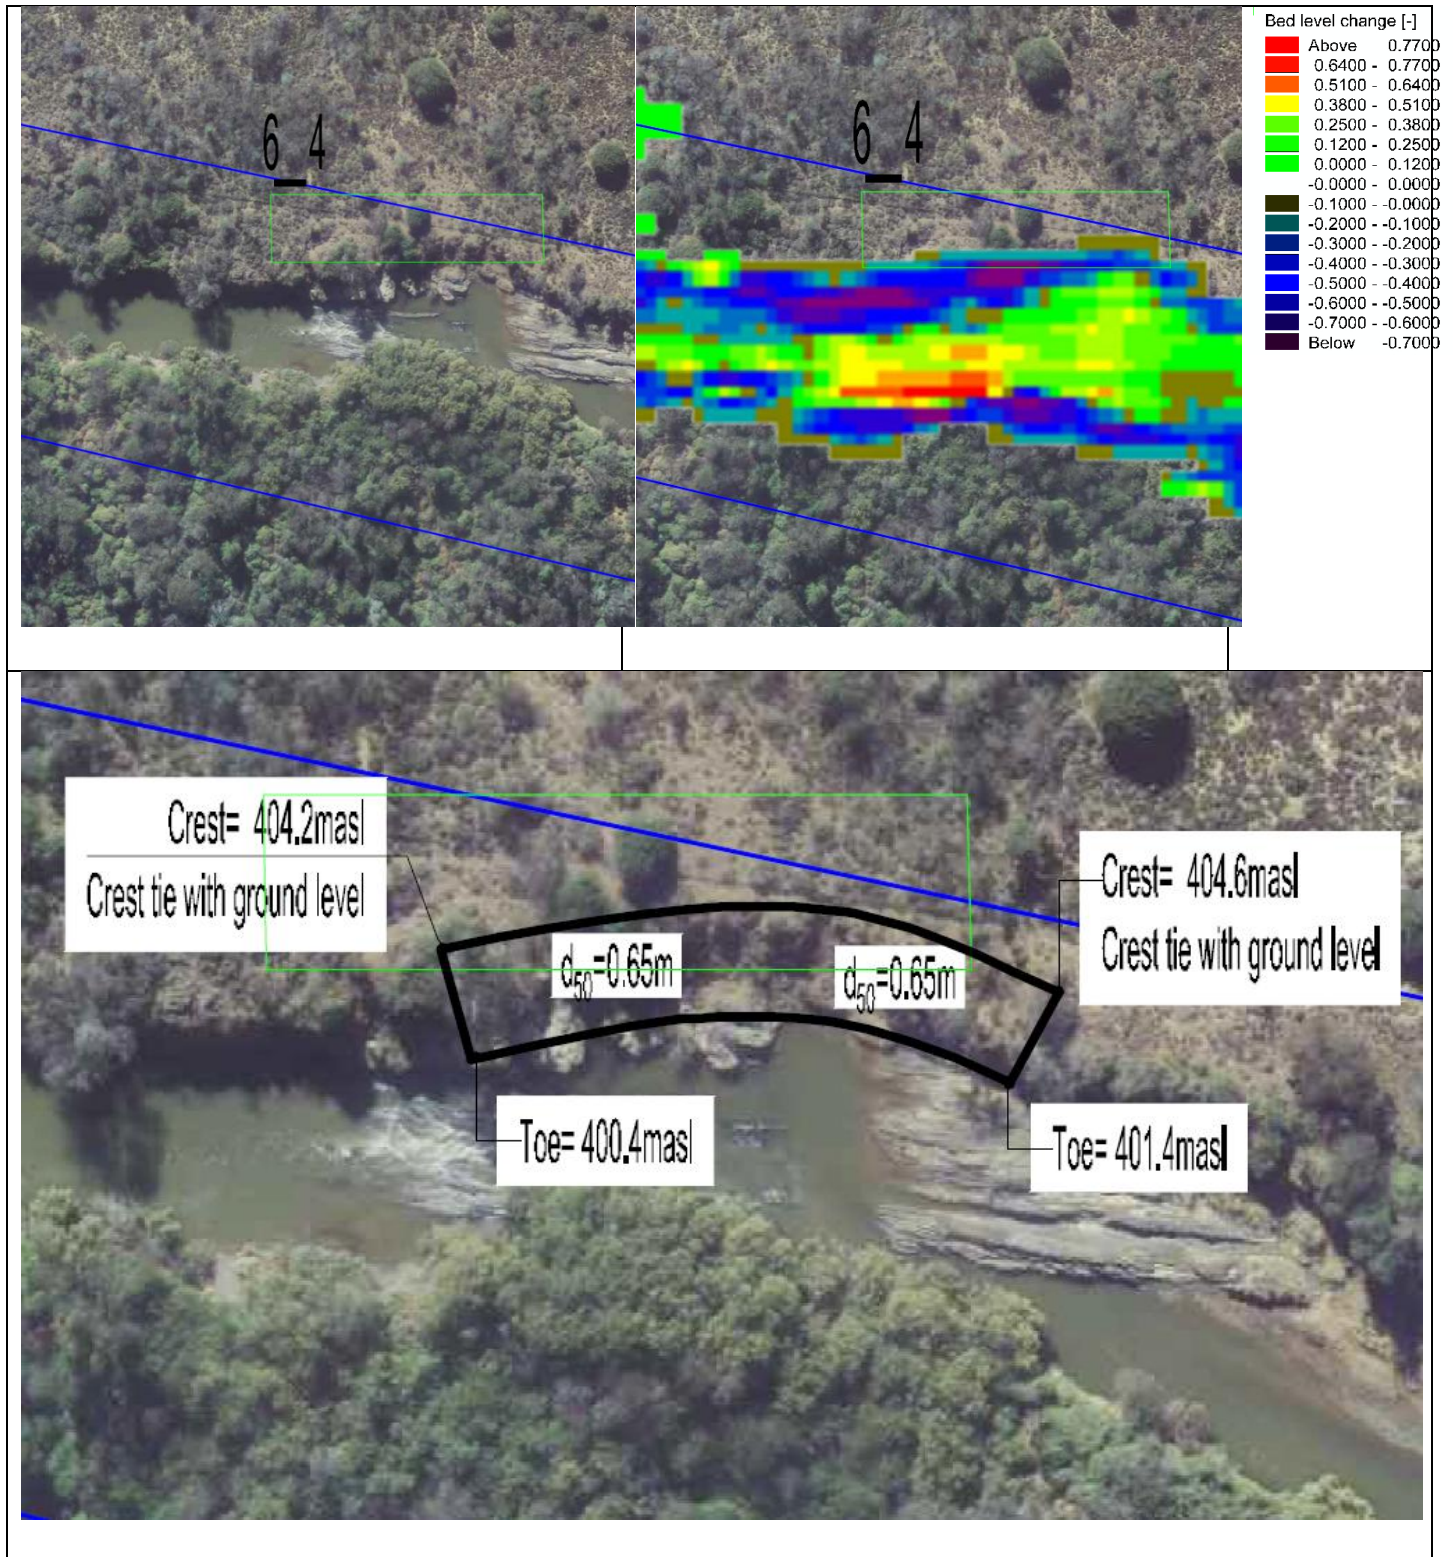
Zone 6_4

The zone has banks crossing the servitude but with bedrock outcropping.
