SKOENMAKERS RIVER REHABILITATION ASSESSMENT
 ZONE 1

Date:	08/02/2016	Compiled by:	PAUJ
Project No.	472748	Scale	1:7,369

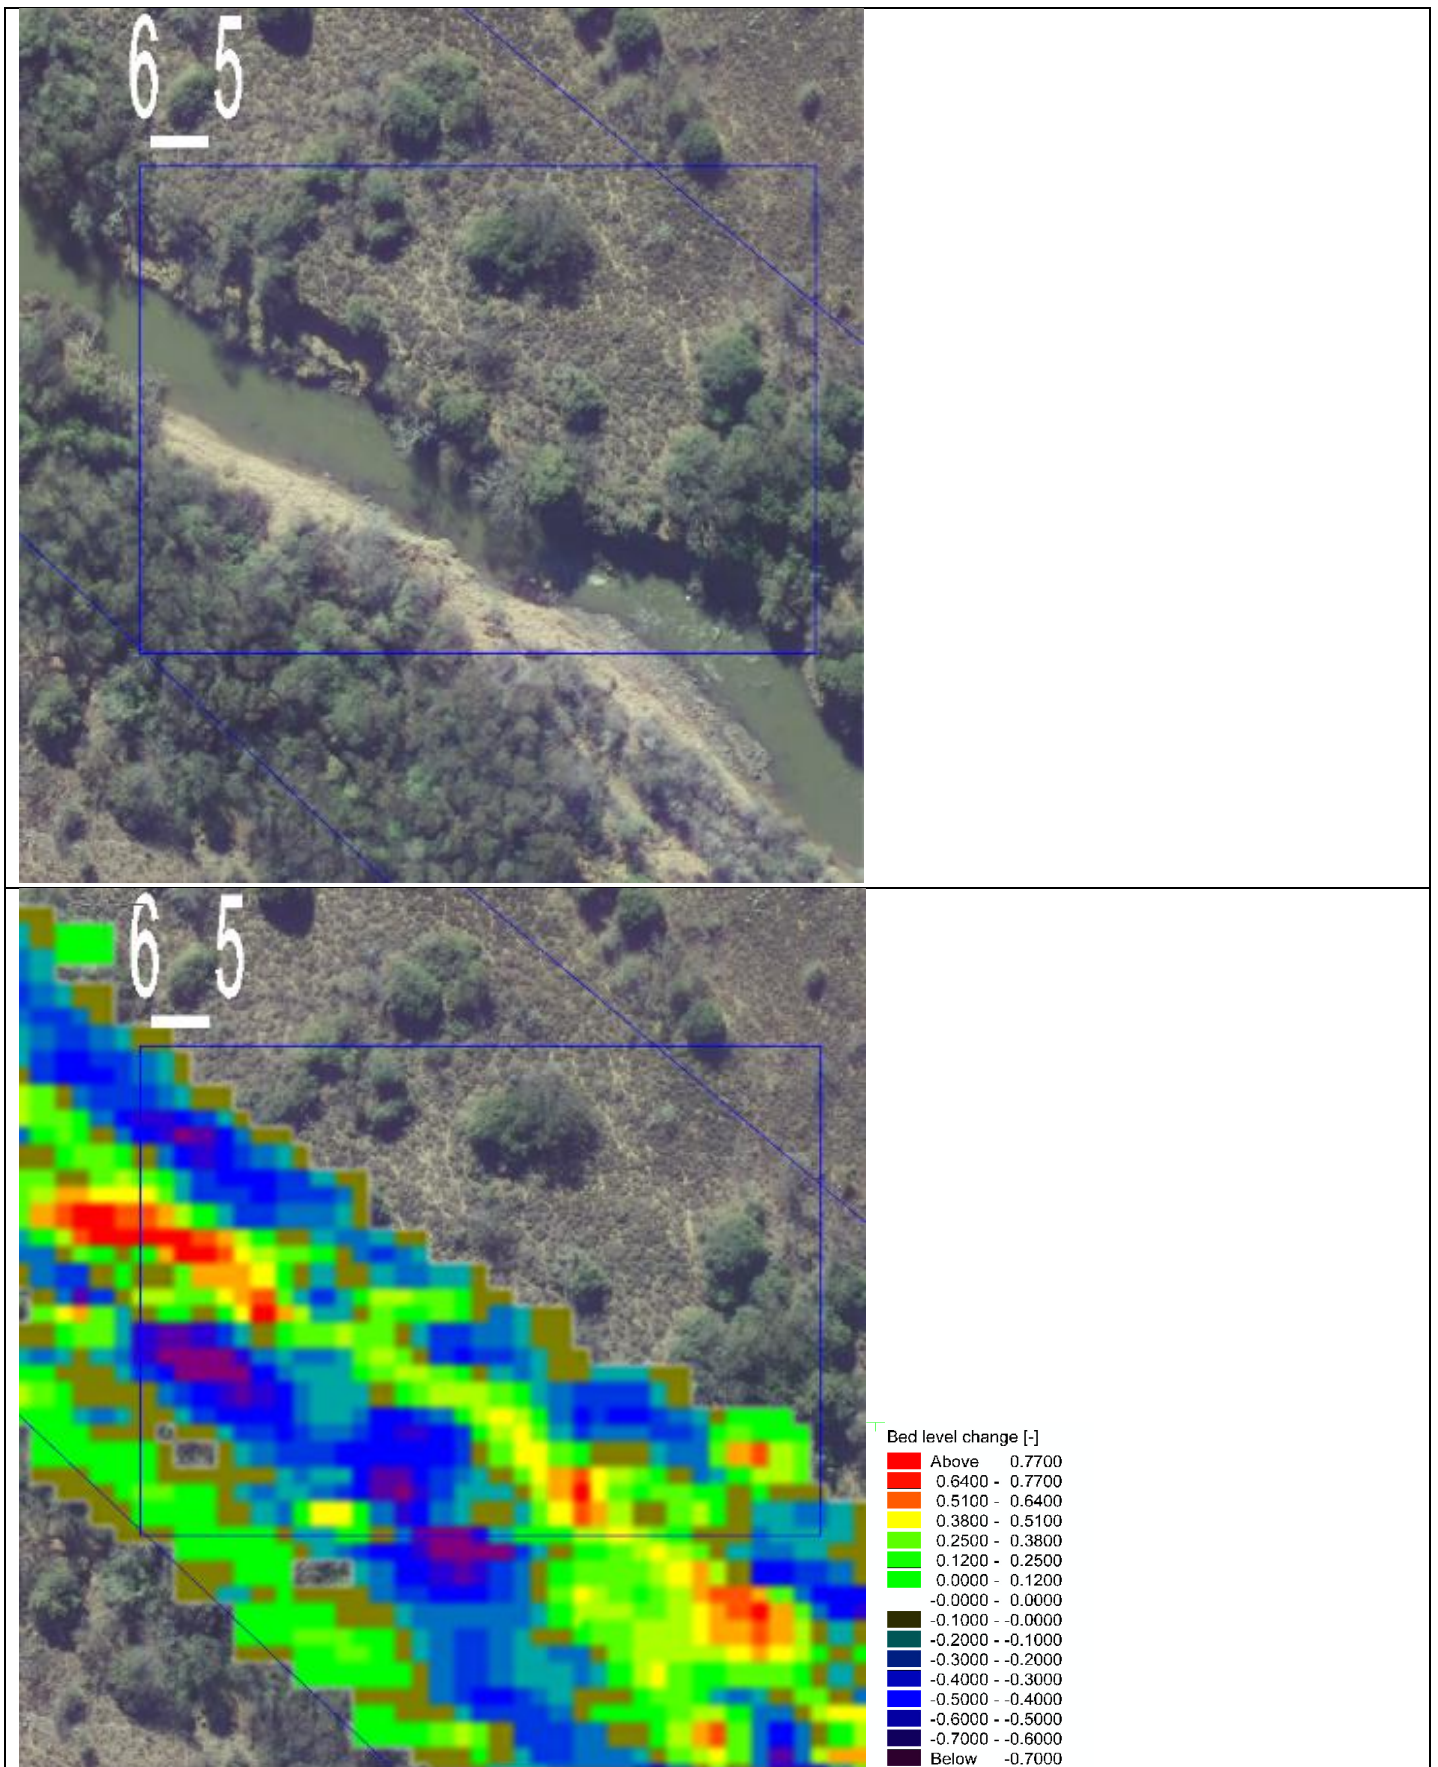
Zone 6_5

The zone has unstable banks within the servitude and protection is not necessary.

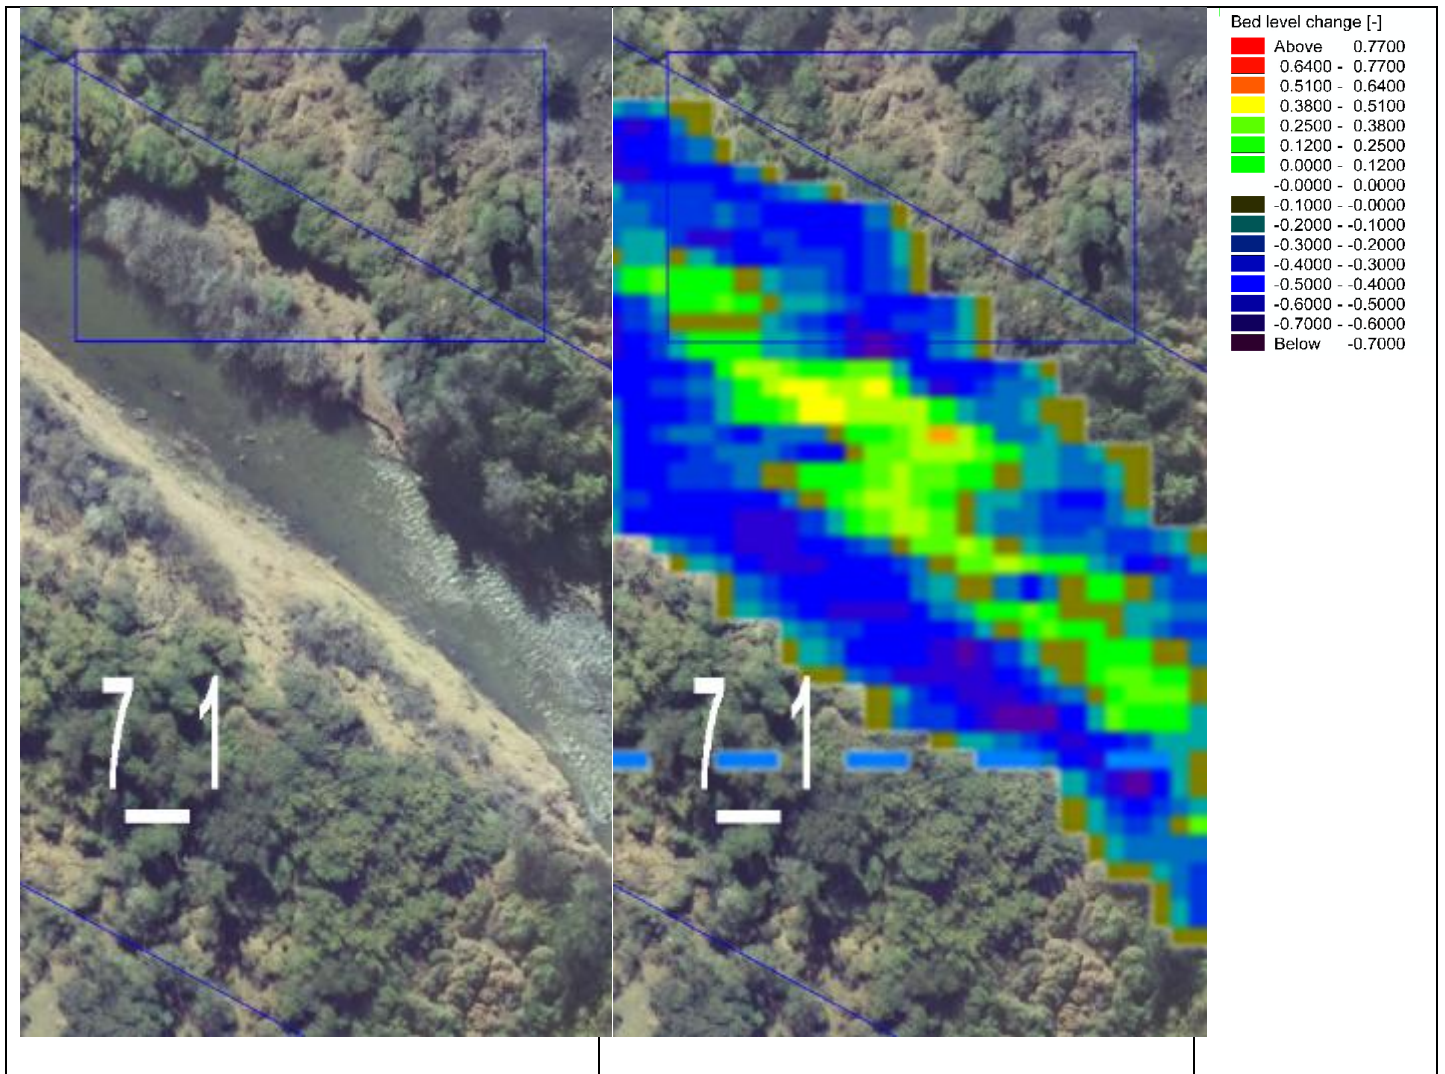
Zone 7_1

The zone has unstable banks within the servitude and protection is not necessary

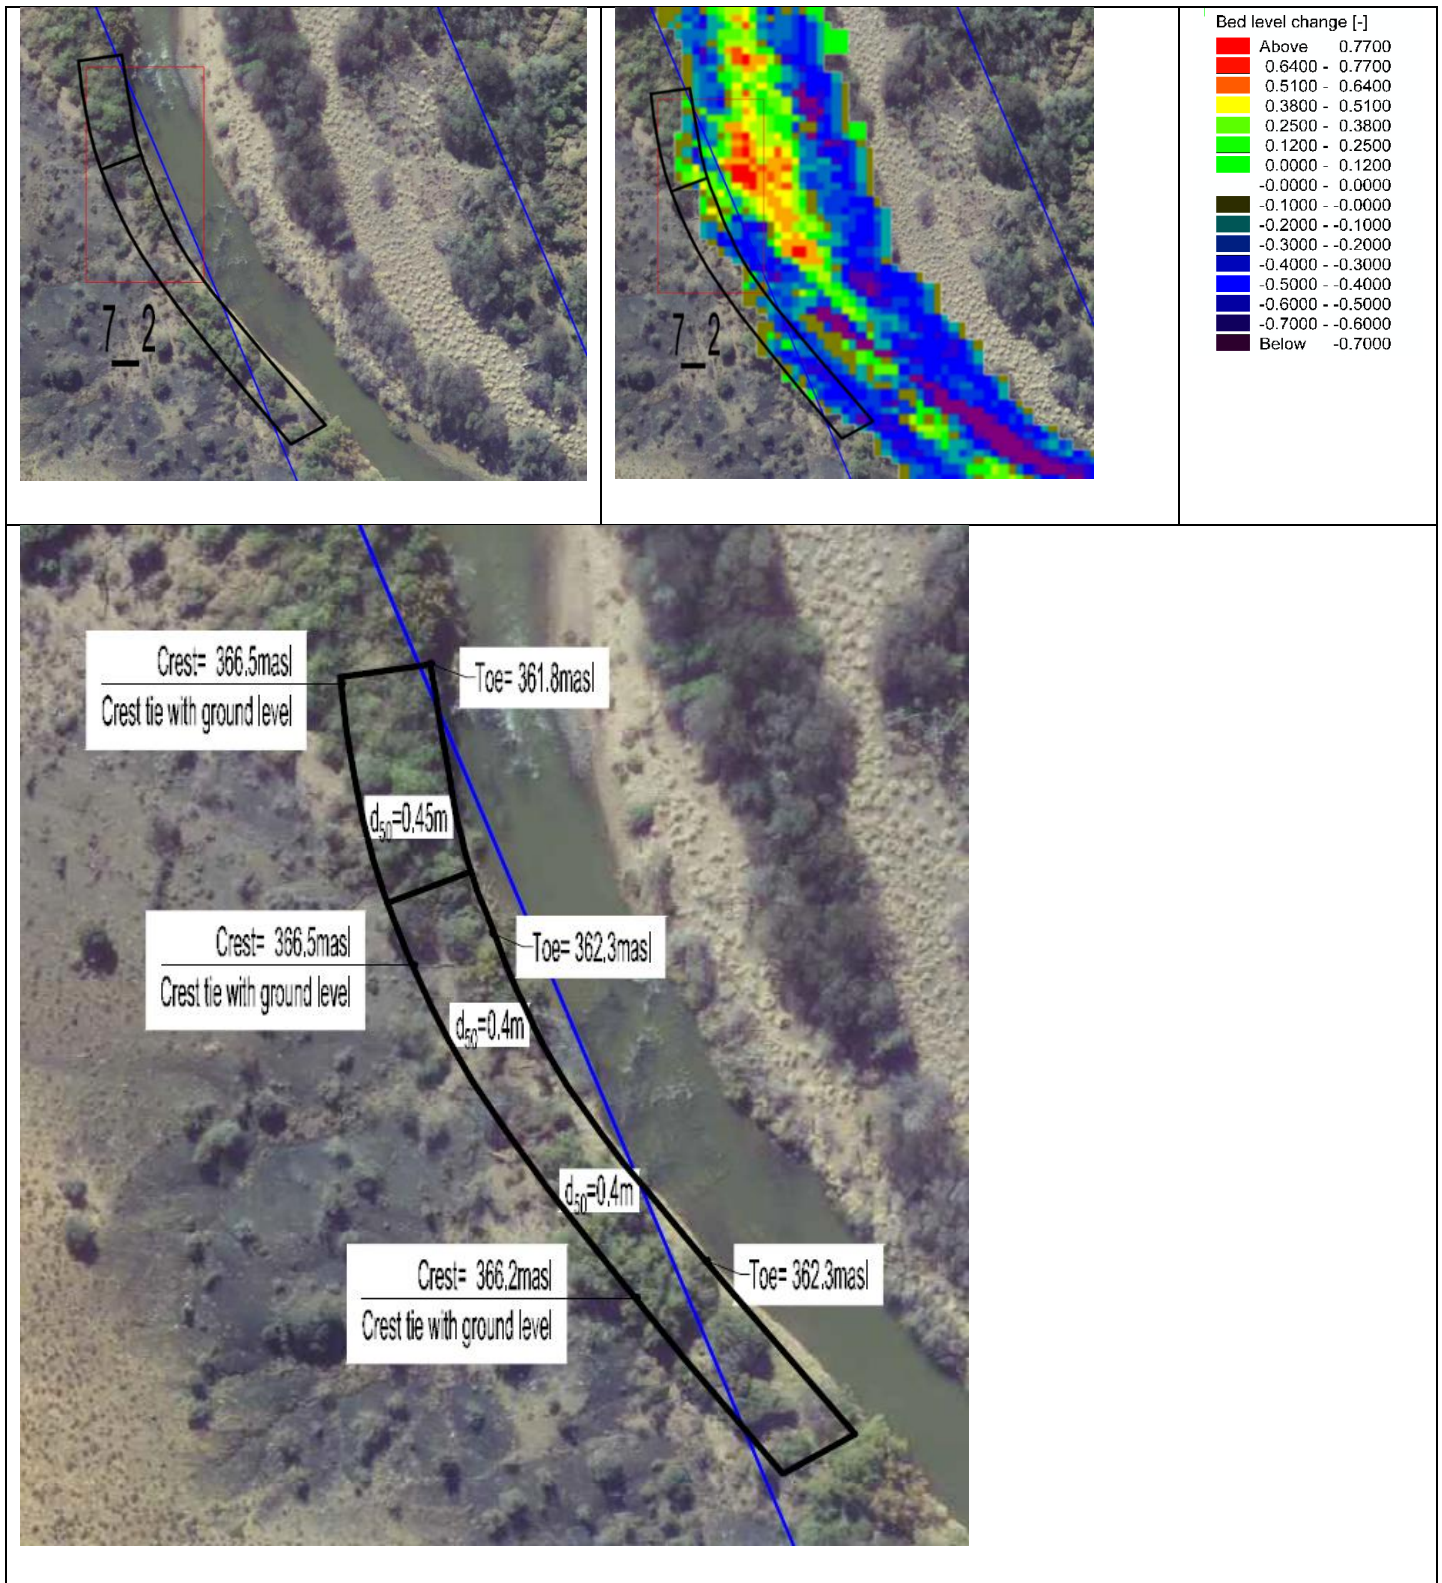
Zone 7_2

The zone has banks crossing the servitude

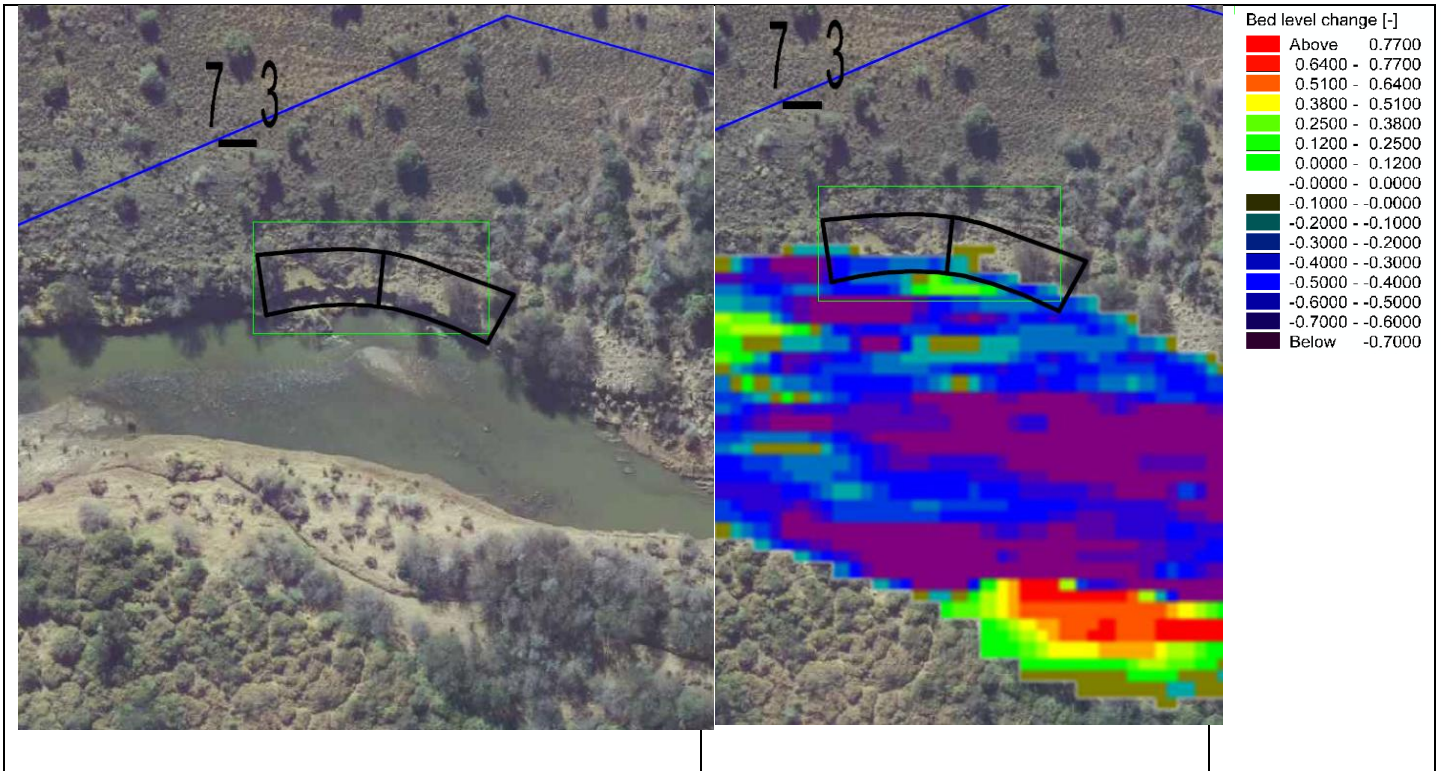
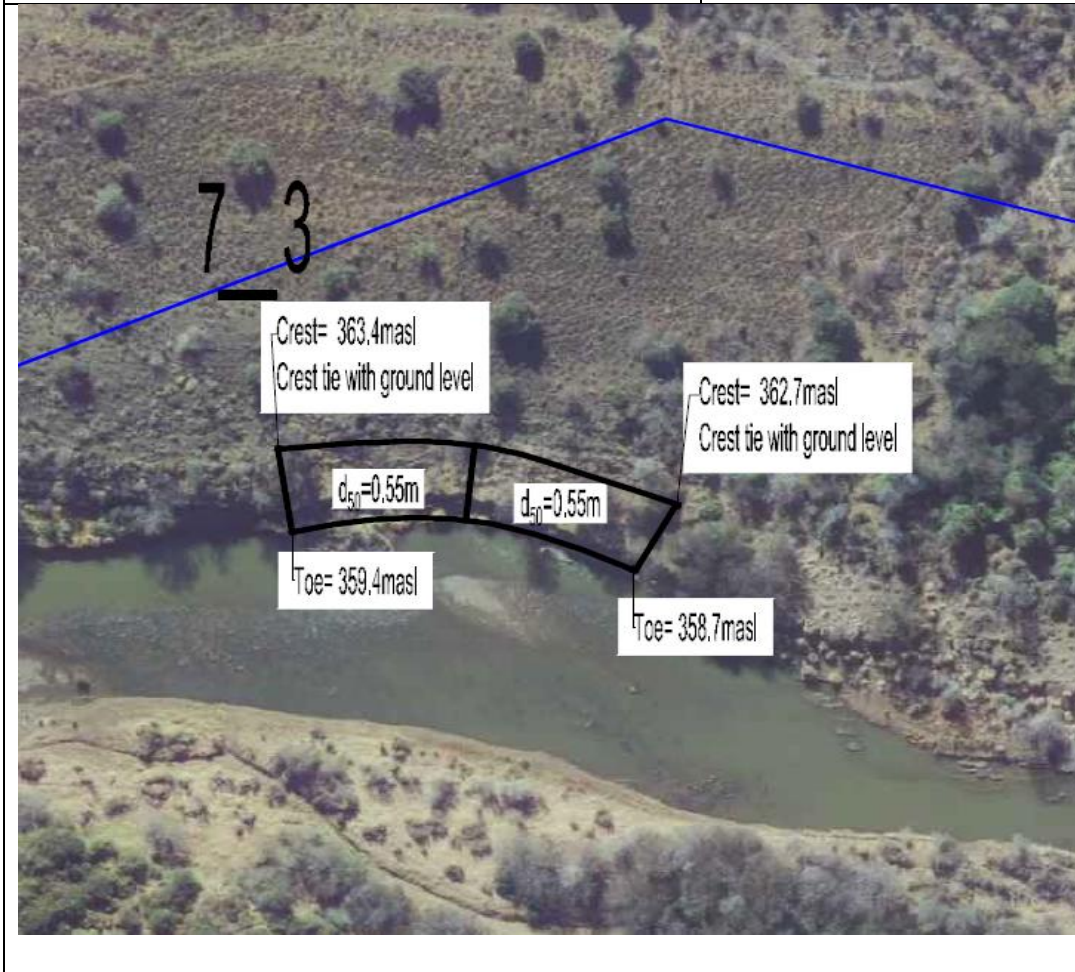
Zone 7_3

The zone has unstable banks within the servitude.

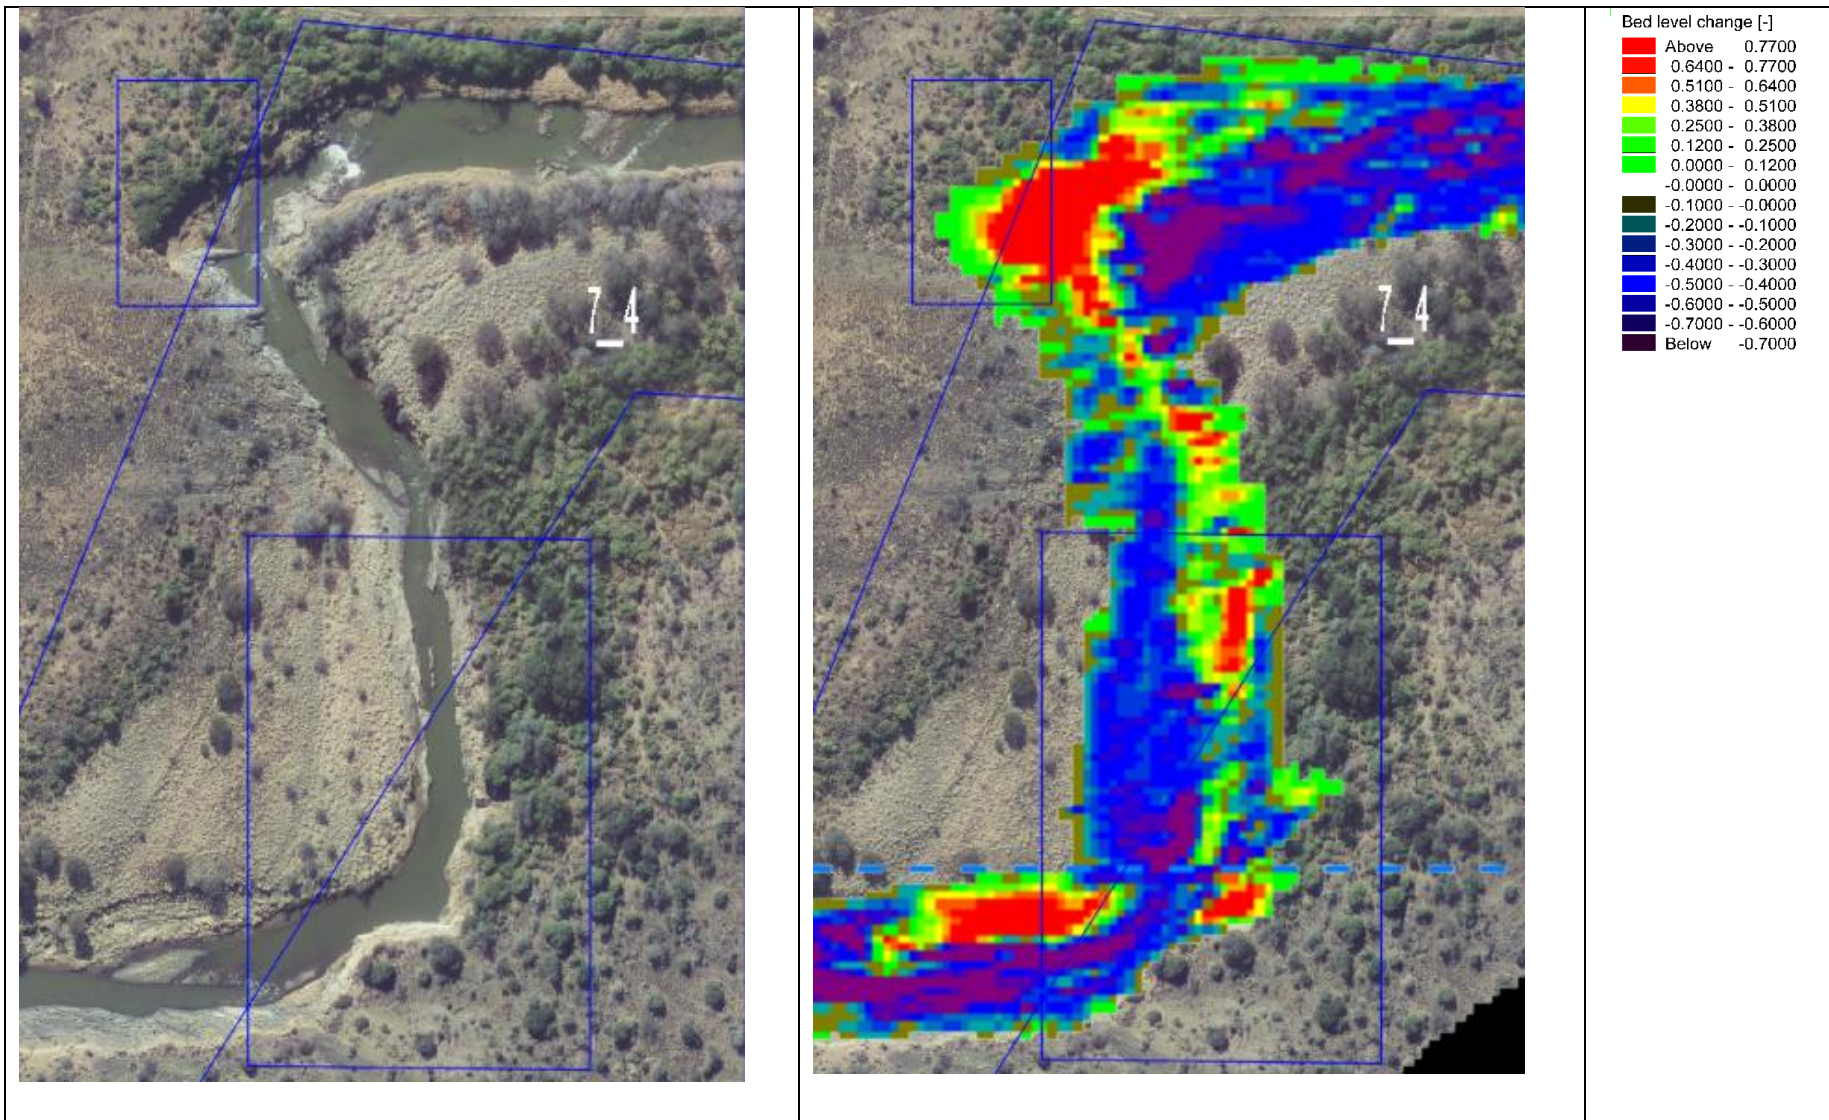
Zone 7_4

This area's river servitude seems inaccurate.

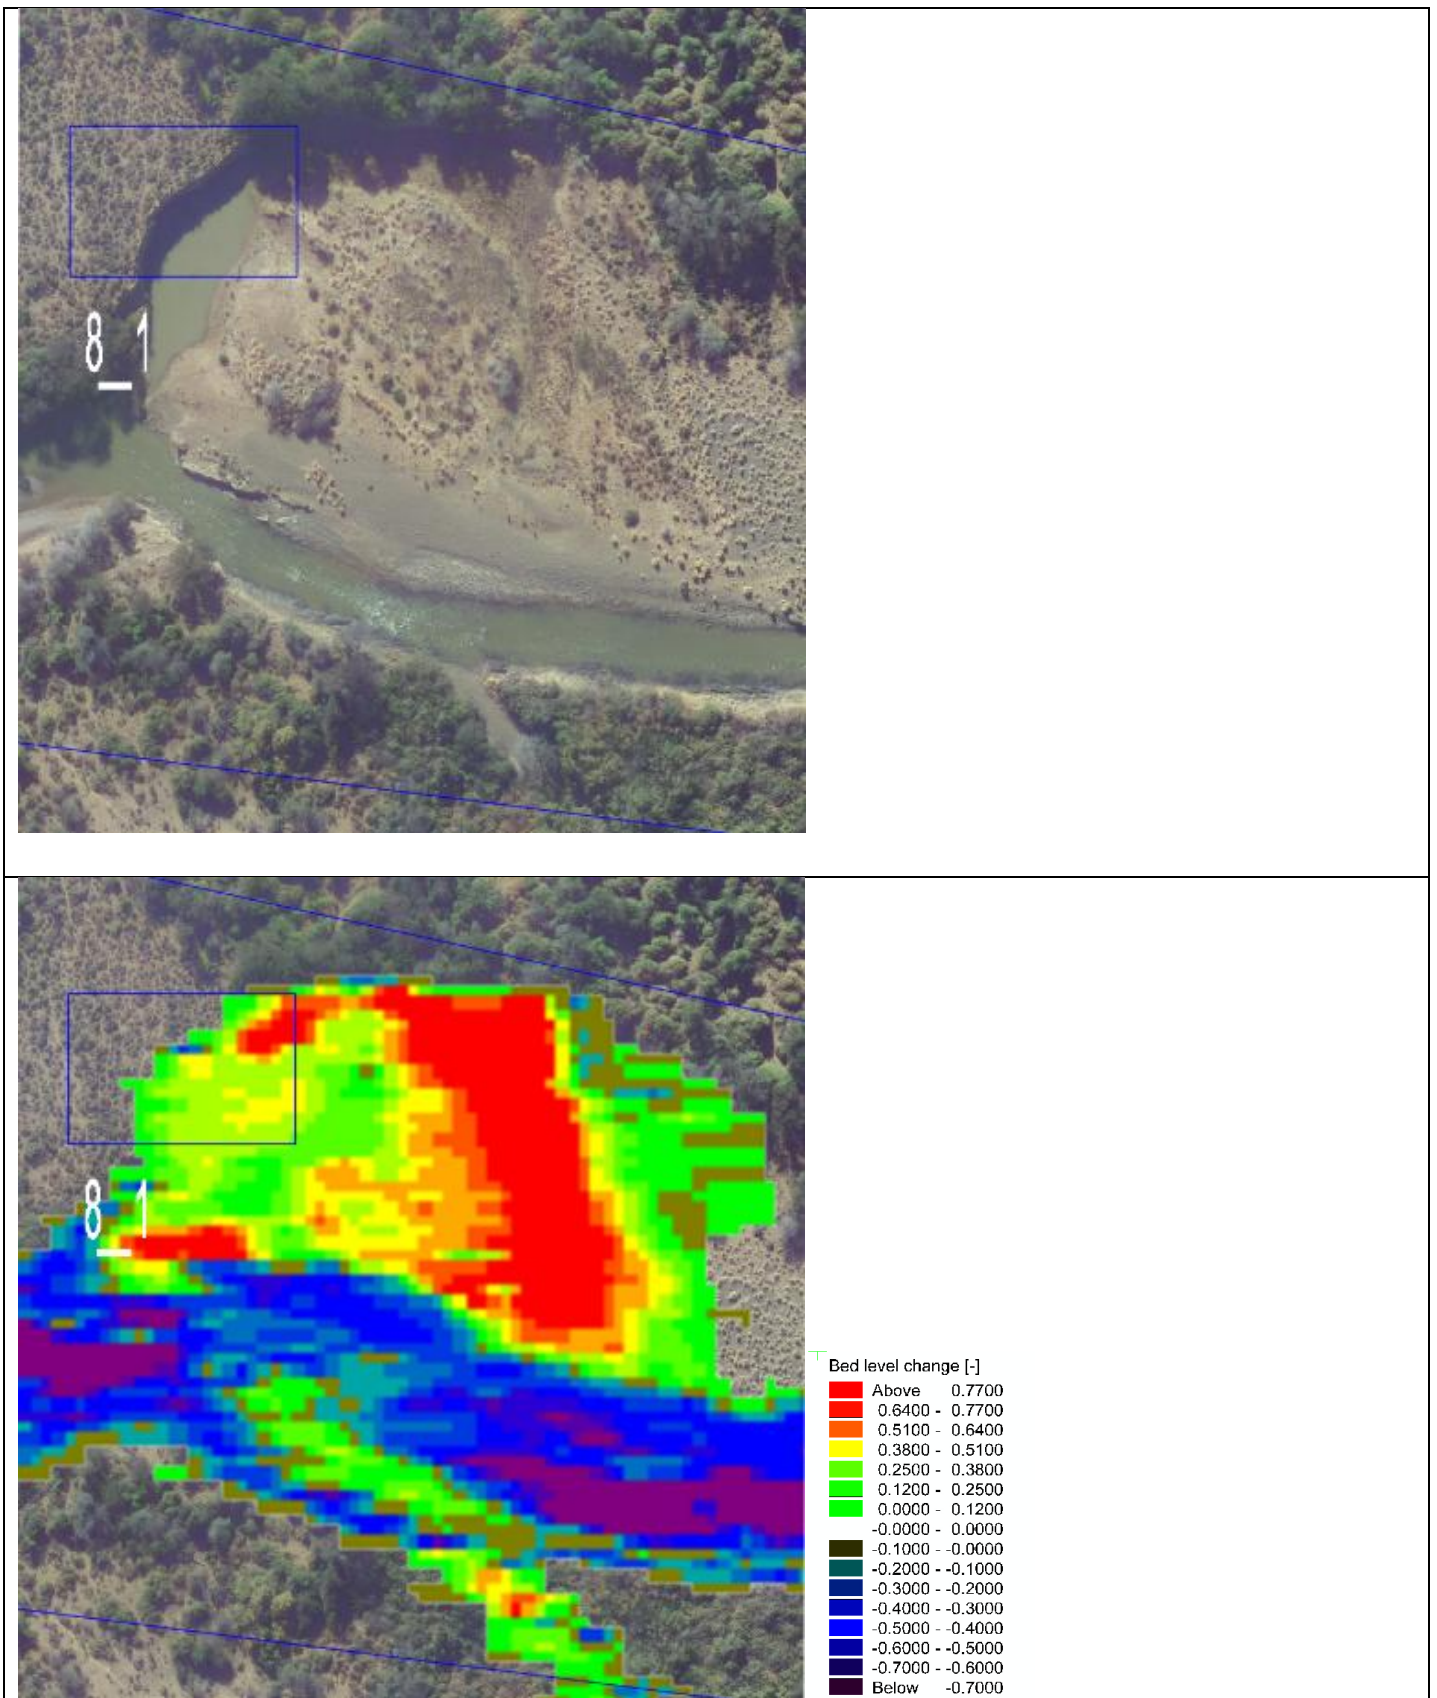
Zone 8_1

The zone has unstable banks within the servitude thus protection is not necessary.

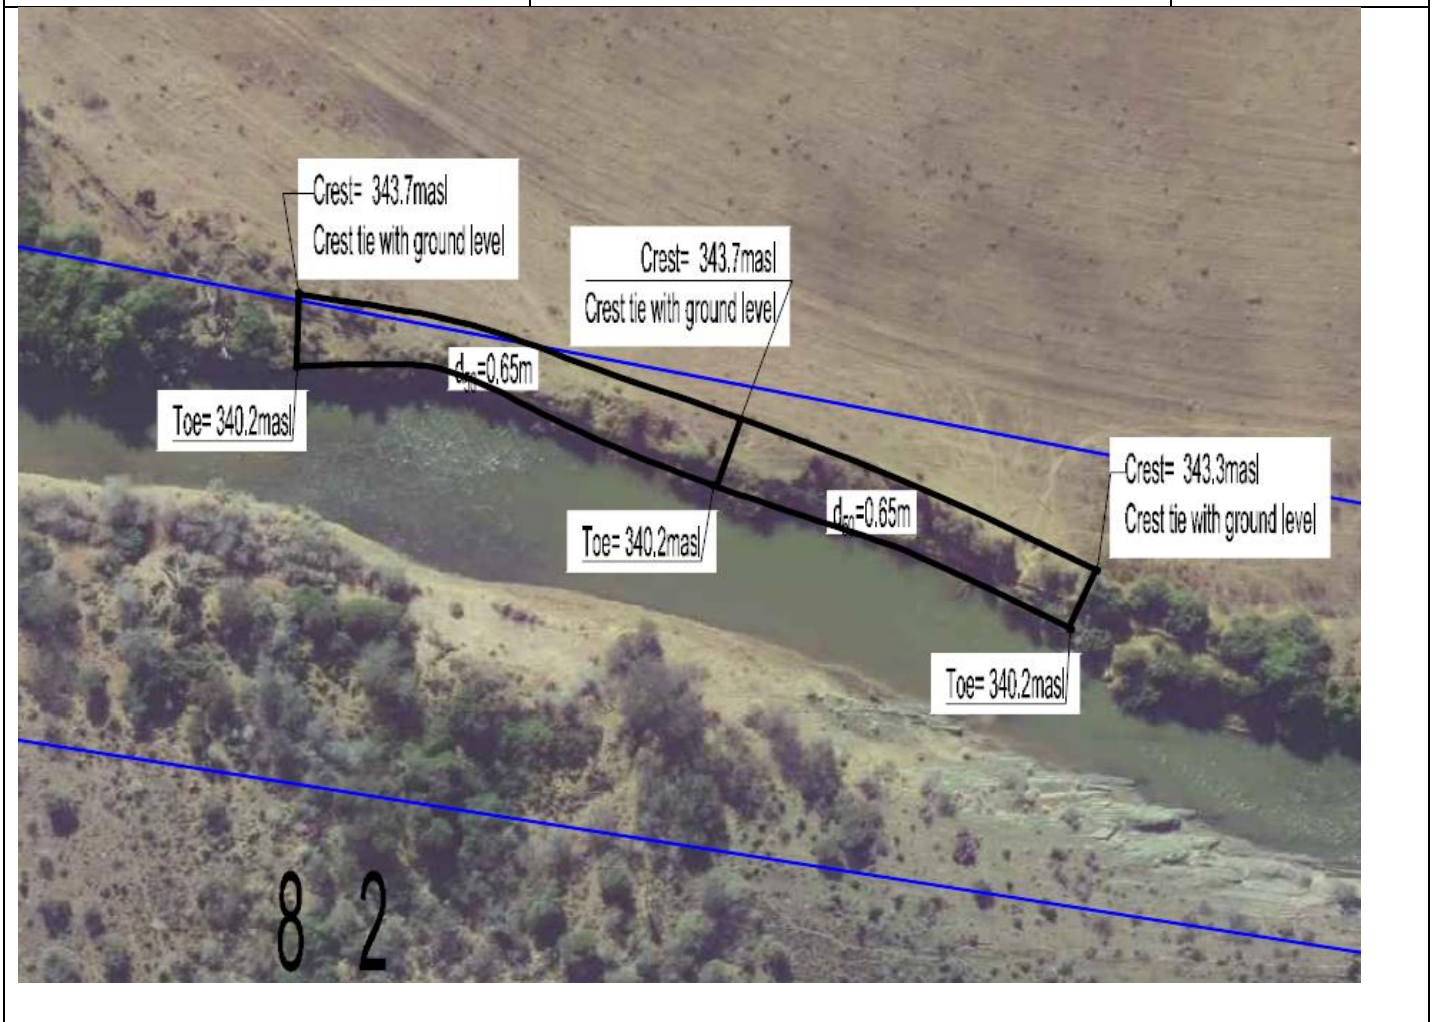
Zone 8_2

The zone has unstable banks crossing the servitude and encroaching onto farm land

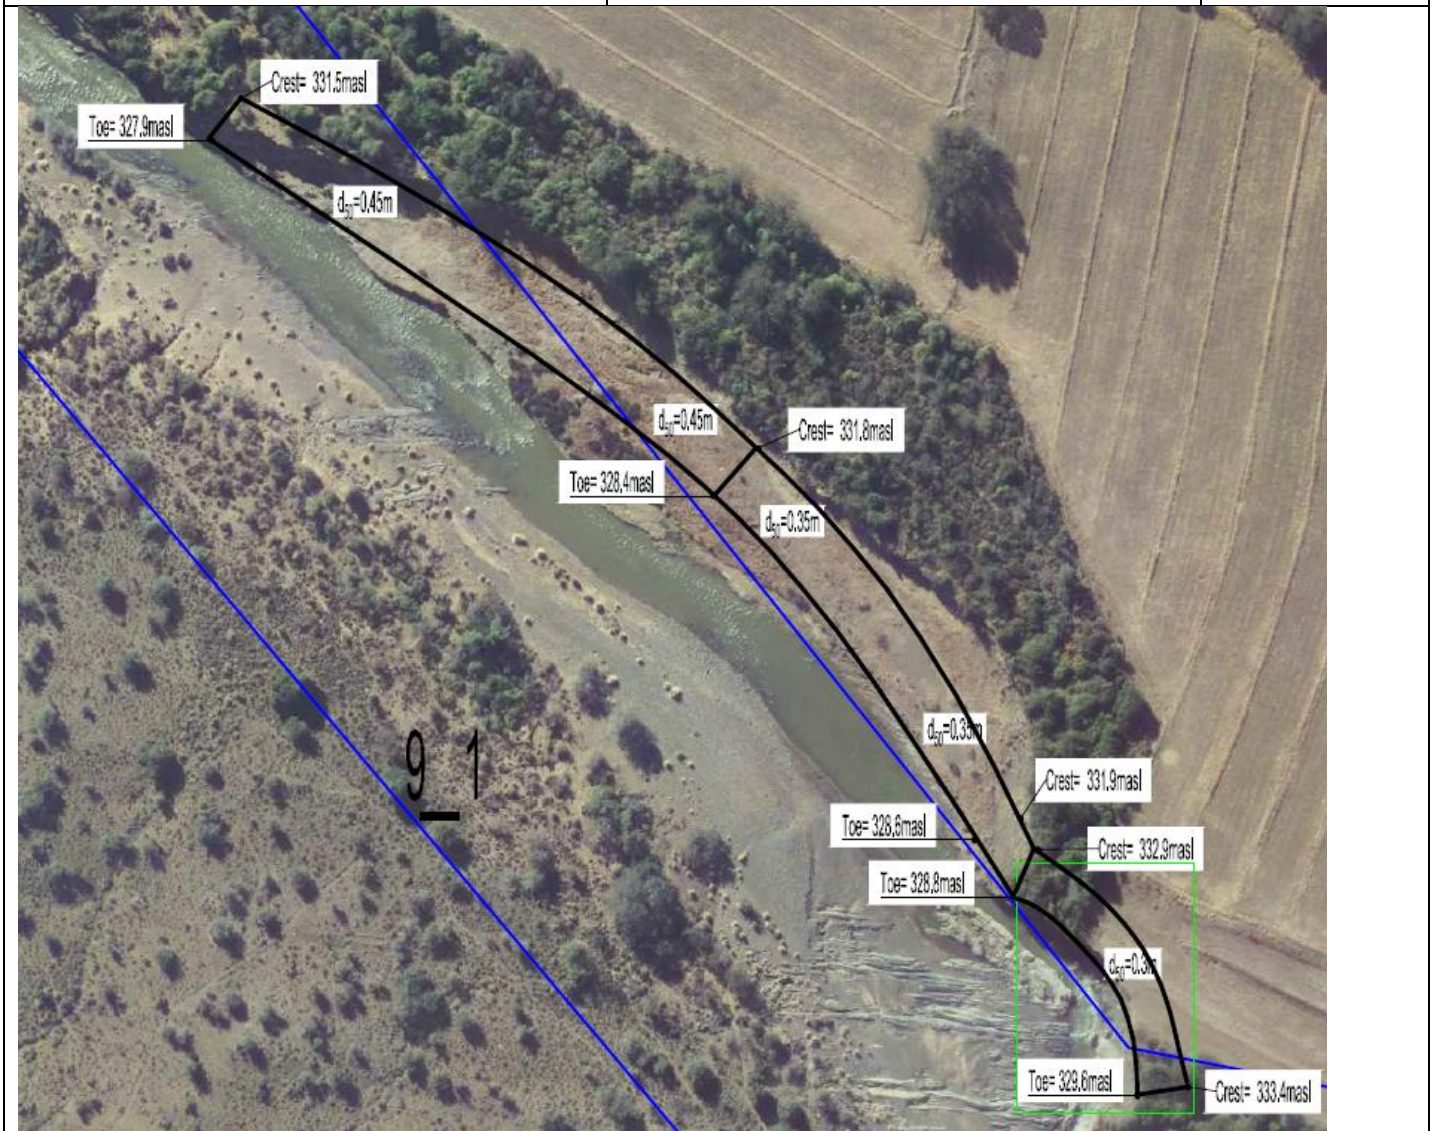
Zone 9_1

The zone has unstable banks crossing the servitude and encroaching onto farm land.

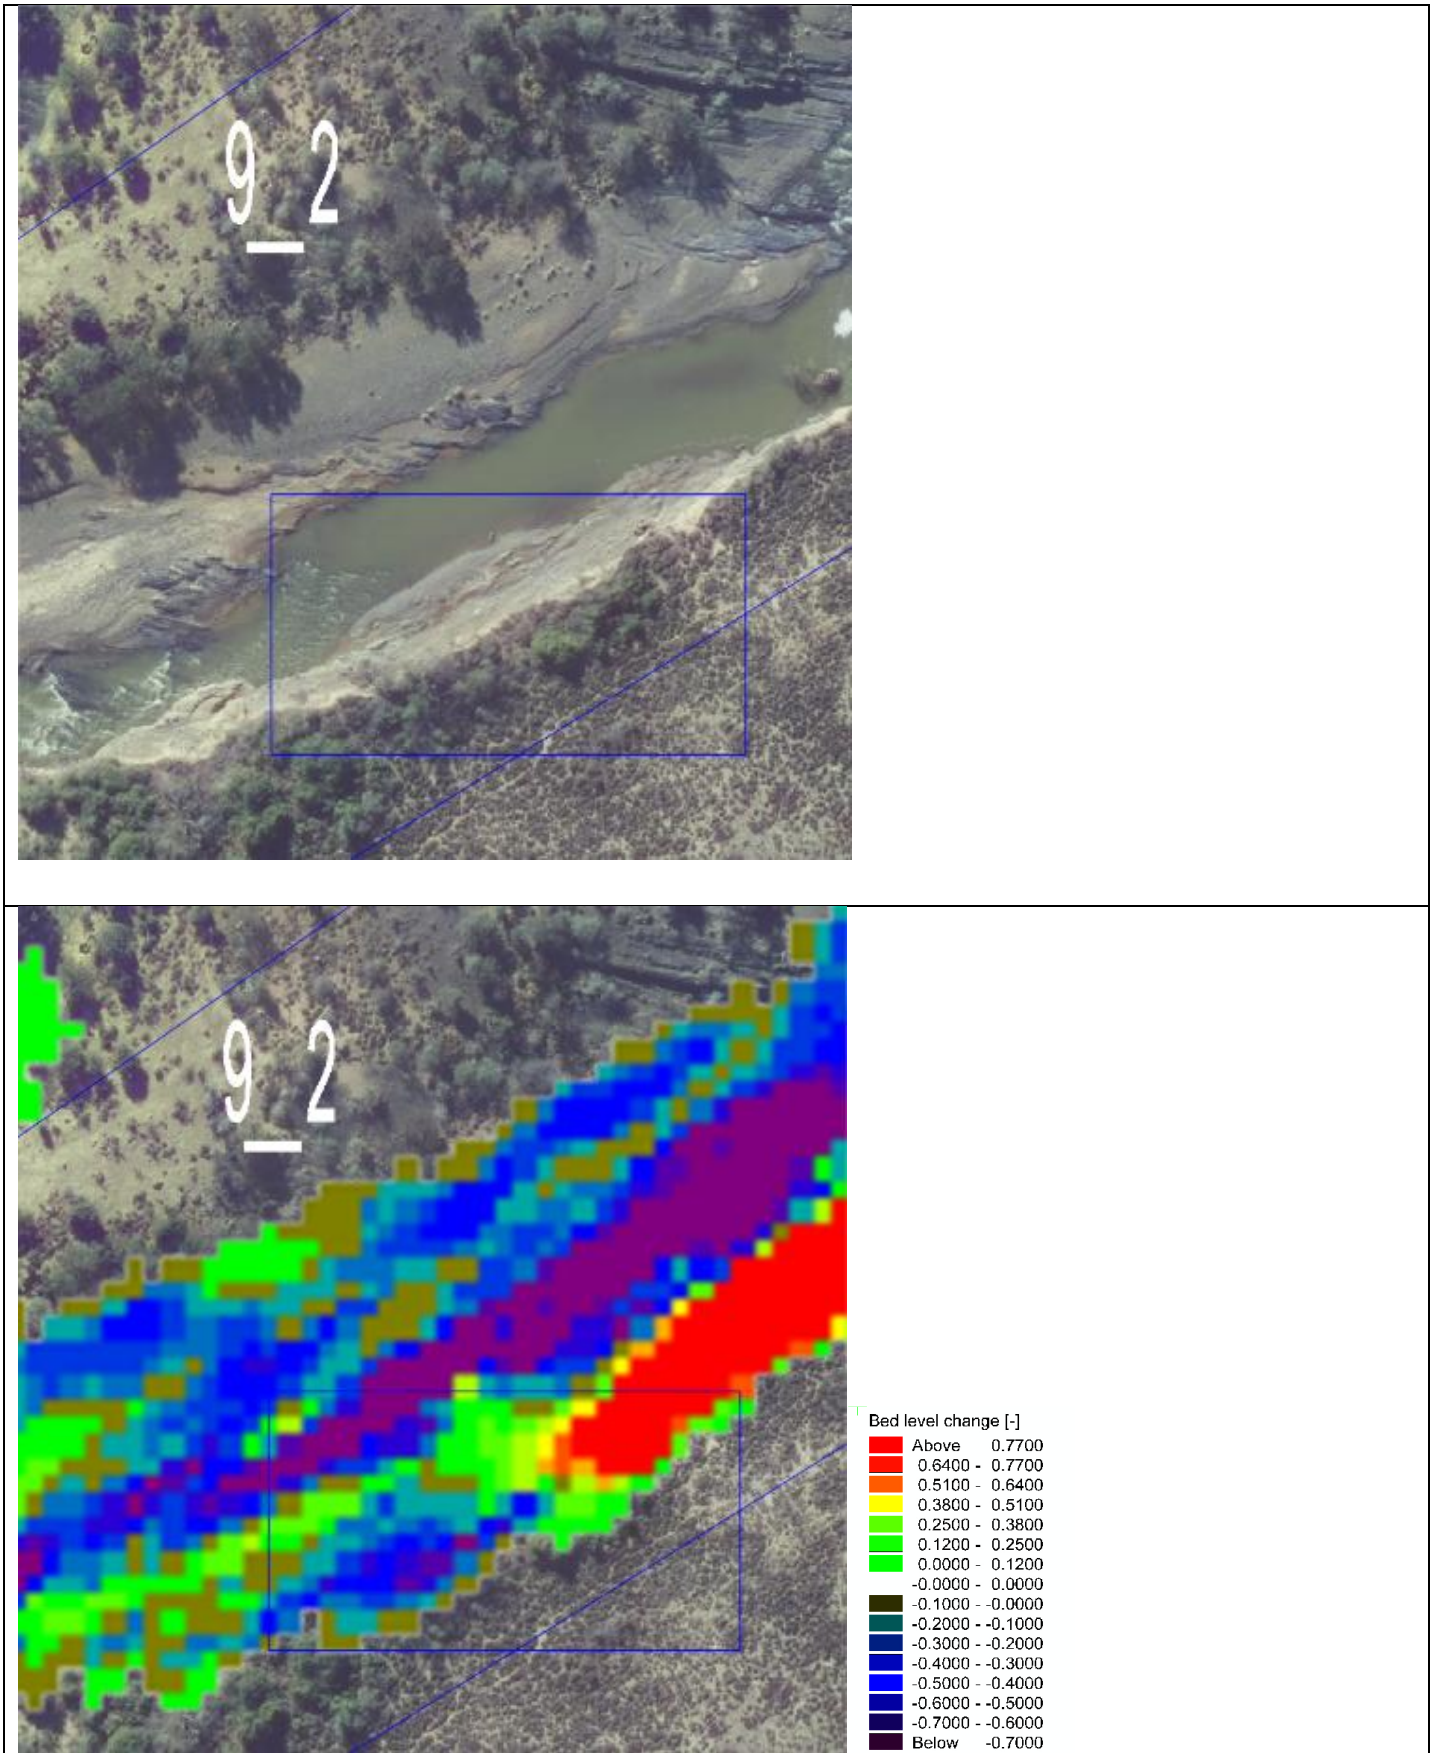
Zone 9_2

The zone has unstable banks within the servitude thus protection is not necessary.

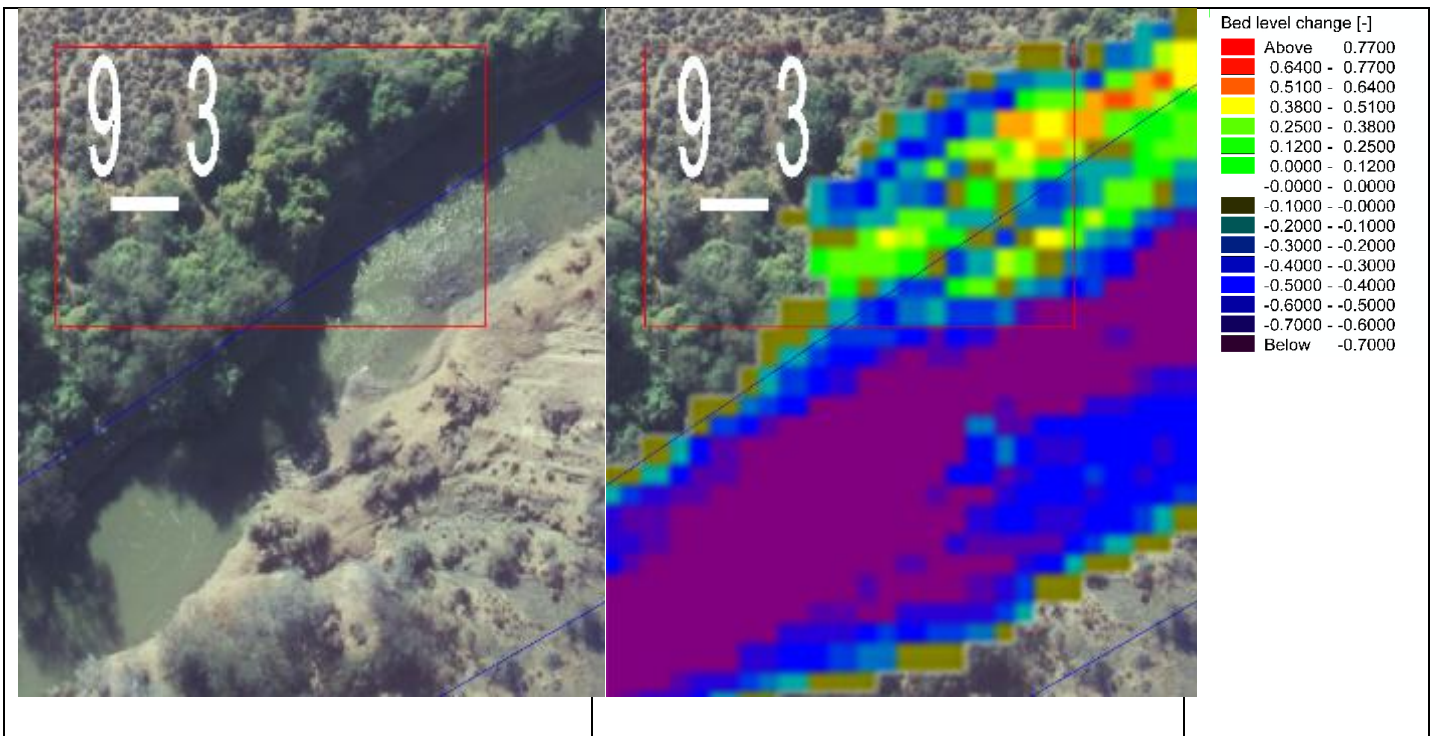
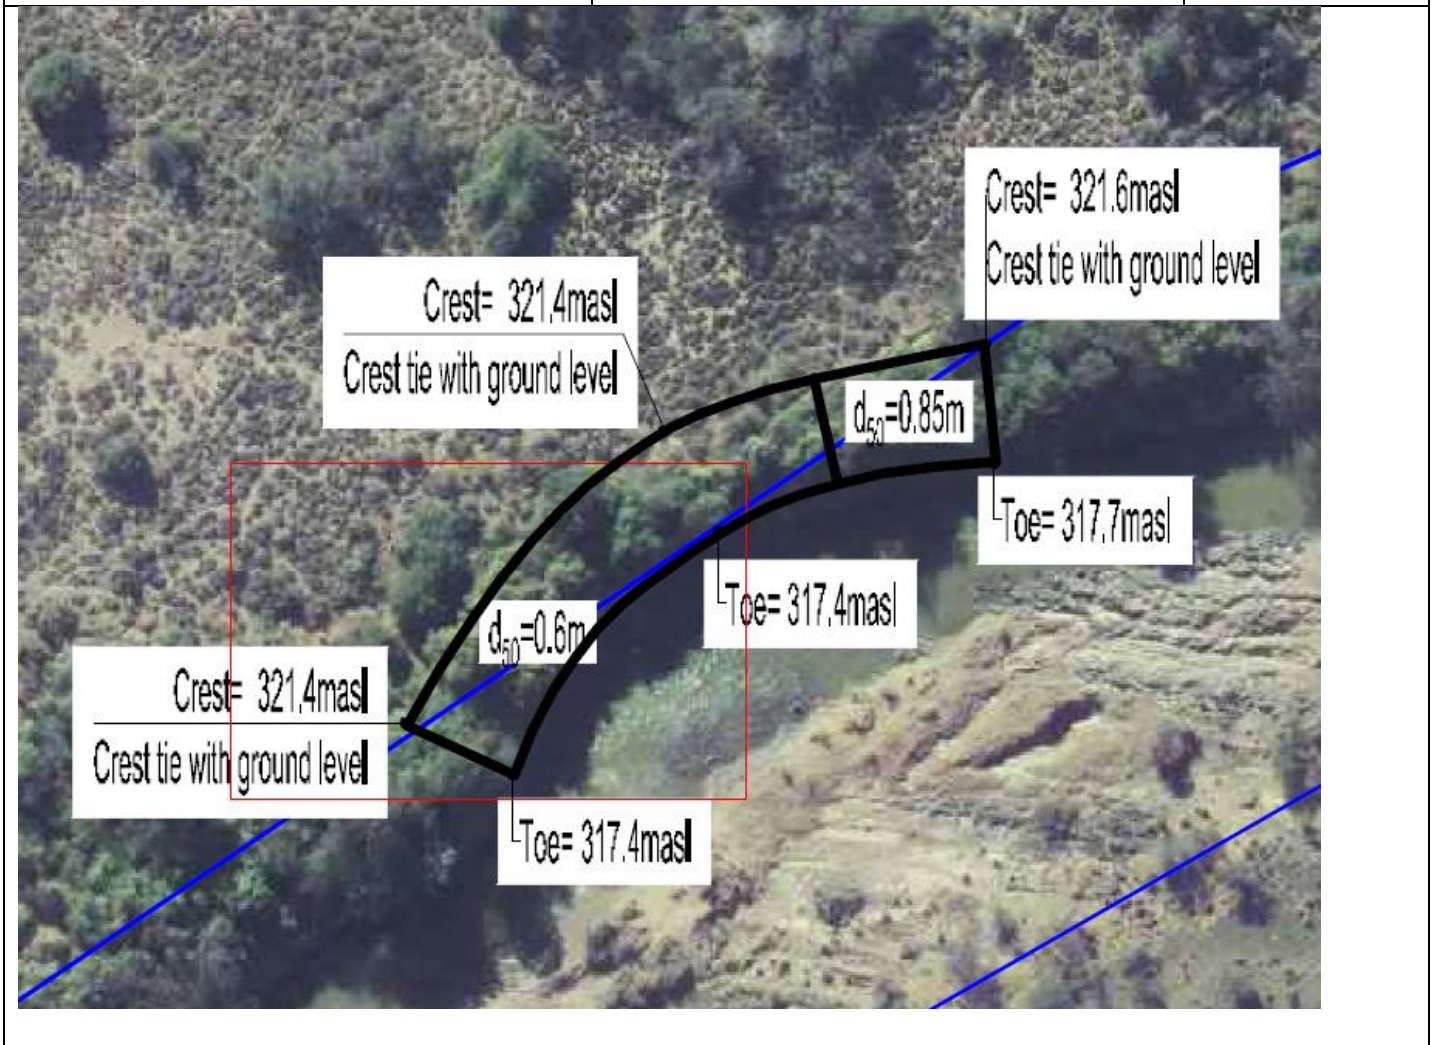
Zone 9_3

The zone has unstable banks crossing the servitude which seemed to be inaccurate

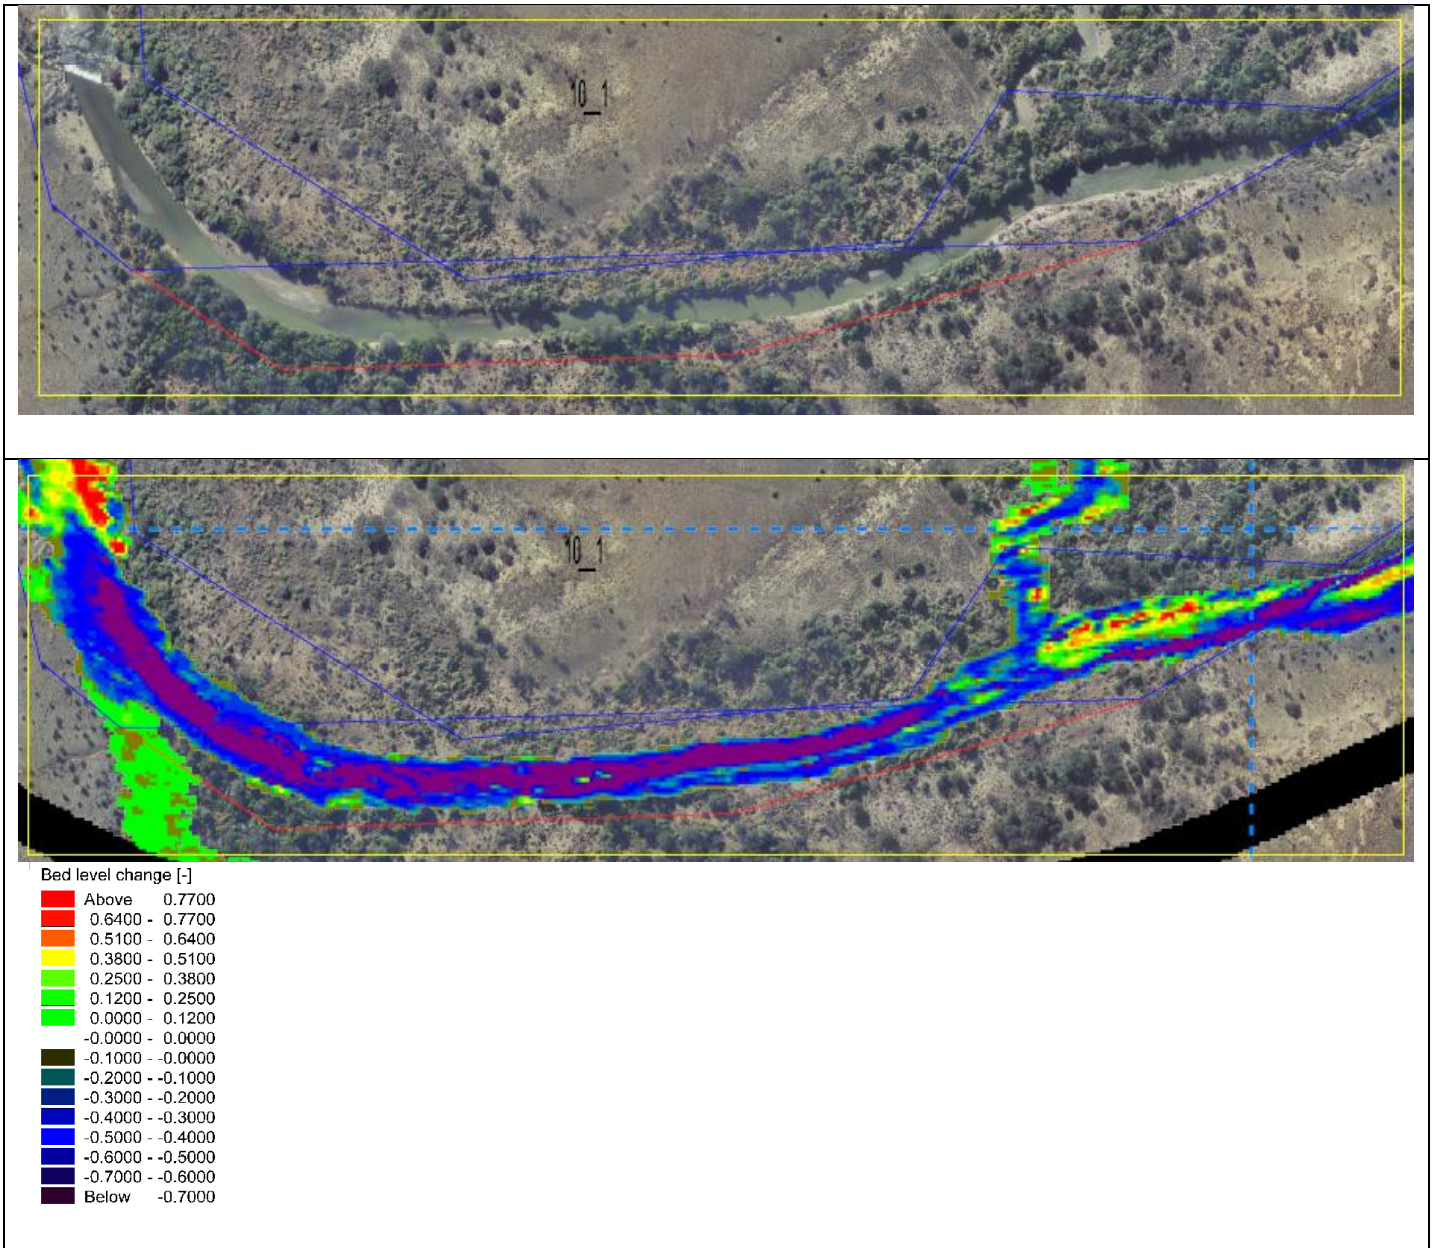
Zone 10_1

The area's river servitude seems to be inaccurate
