SKOENMAKERS RIVER REHABILITATION ASSESSMENT
 ZONE 1

Date:	08/02/2016	Compiled by:	PAUJ
Project No.	472748	Scale	1:7,369

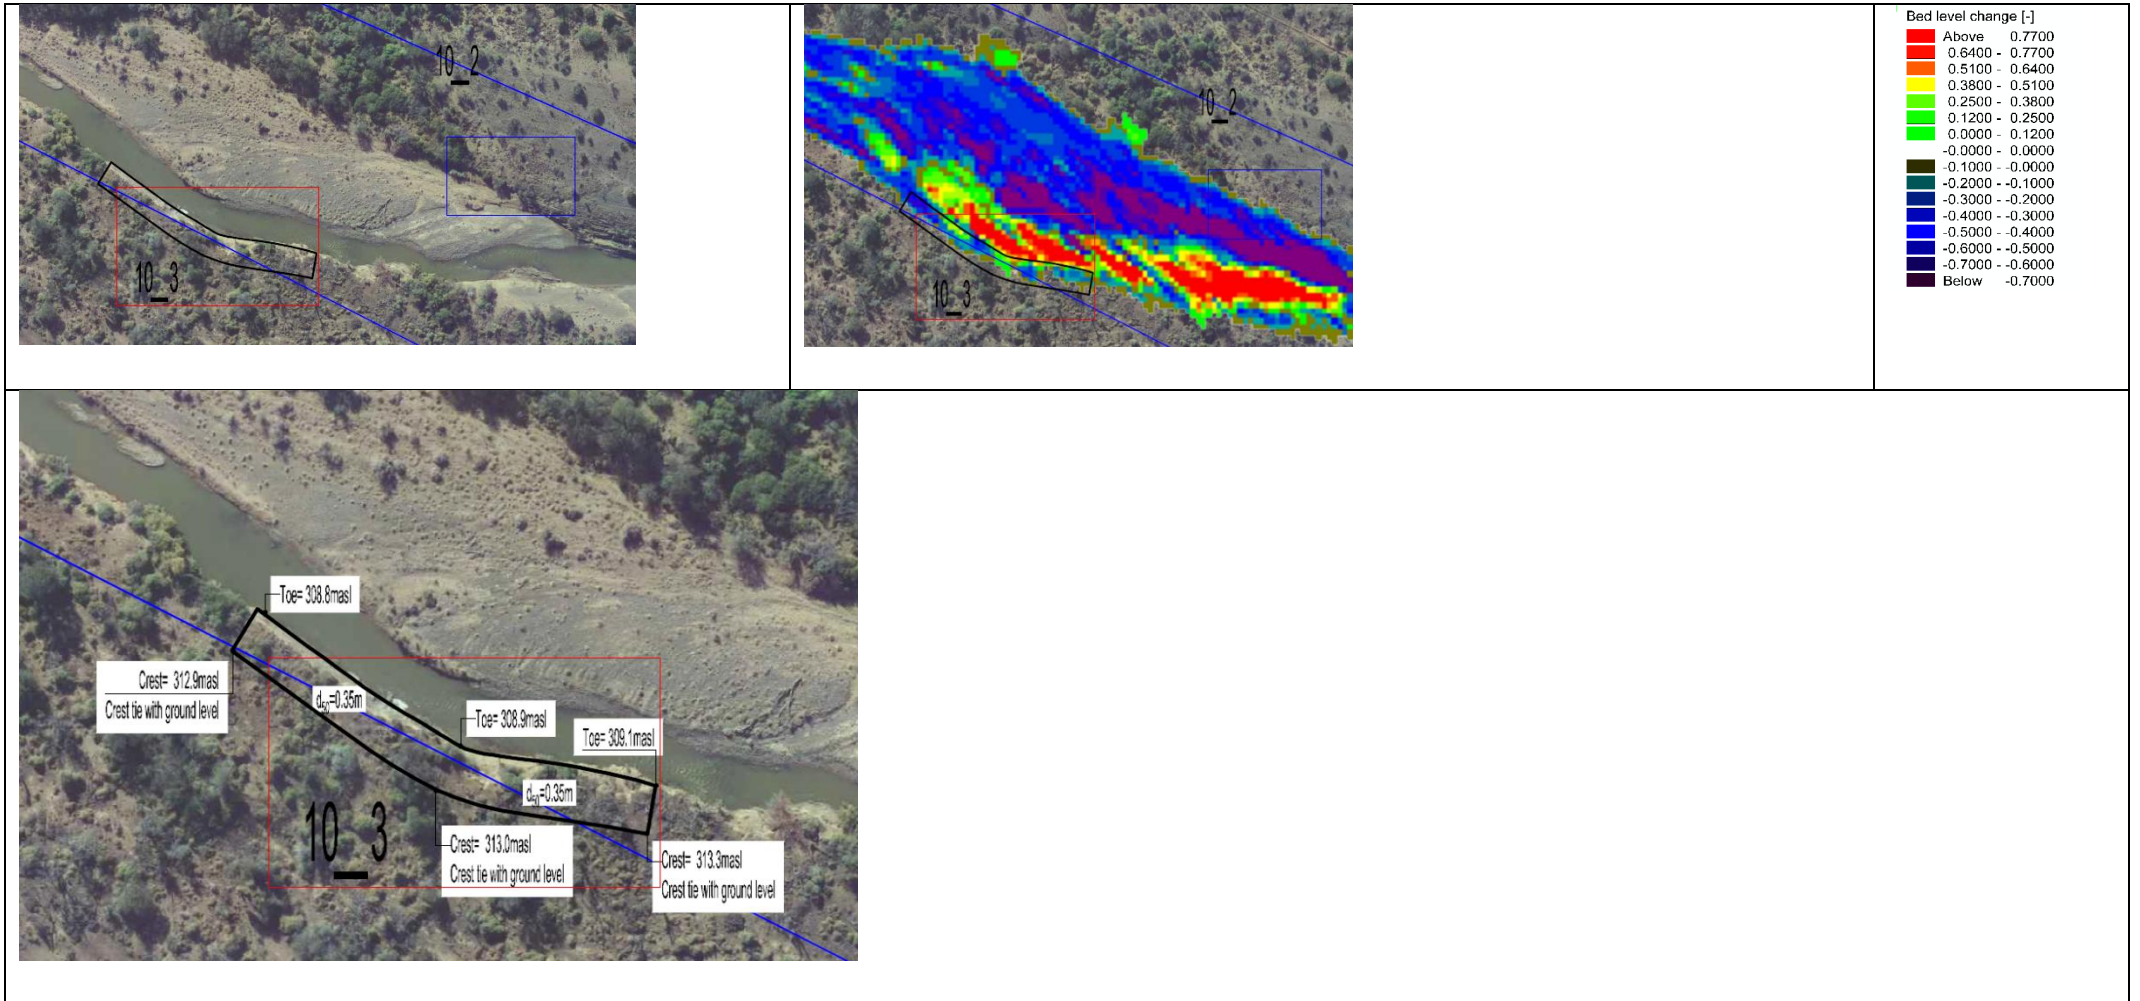
Zone 10_3

The zone has banks crossing the servitude.

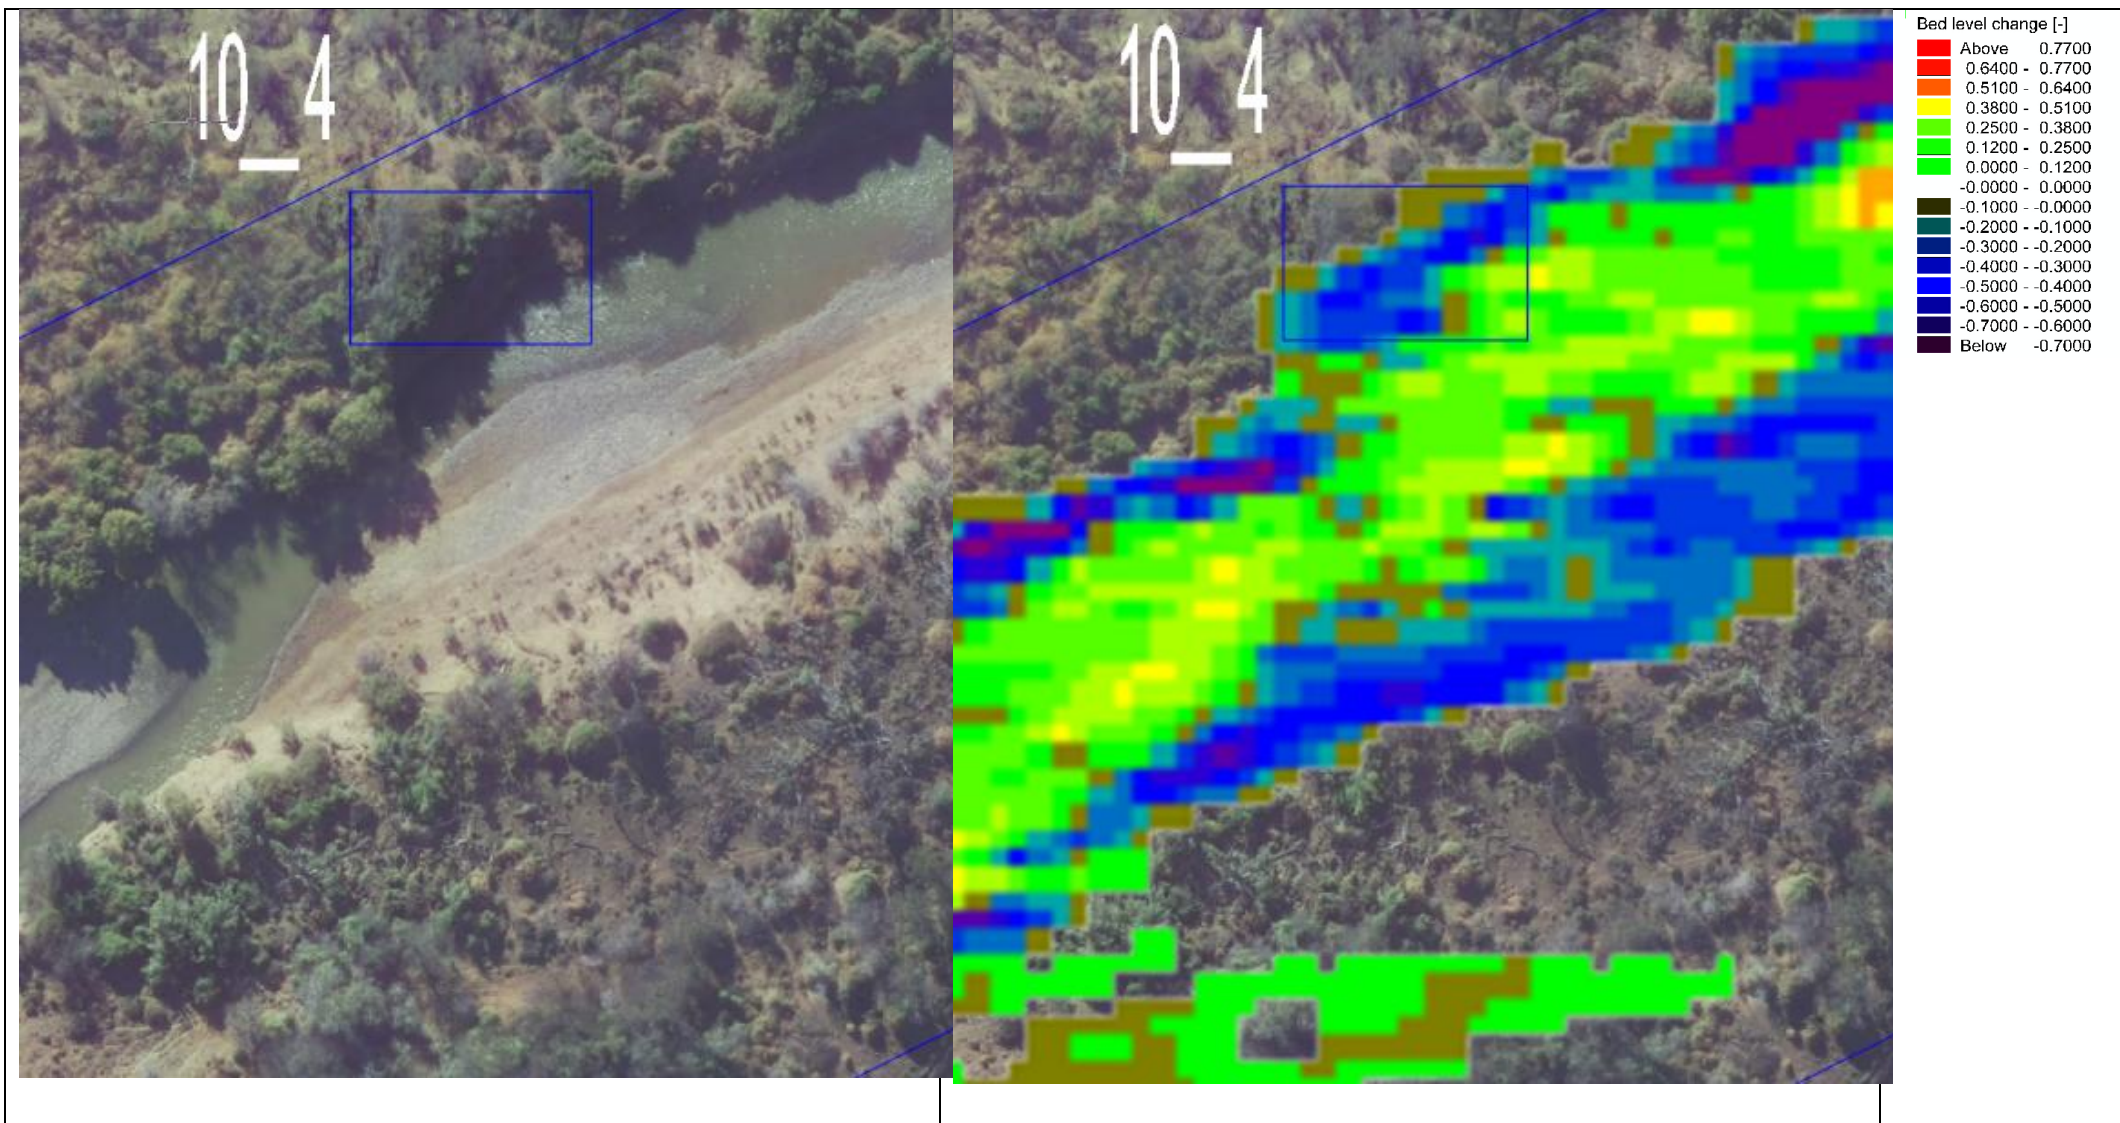
Zone 10_4

The zone has banks within the servitude. Upstream tributary flow induces the erosion and protection will constrict the flow thus not necessary.

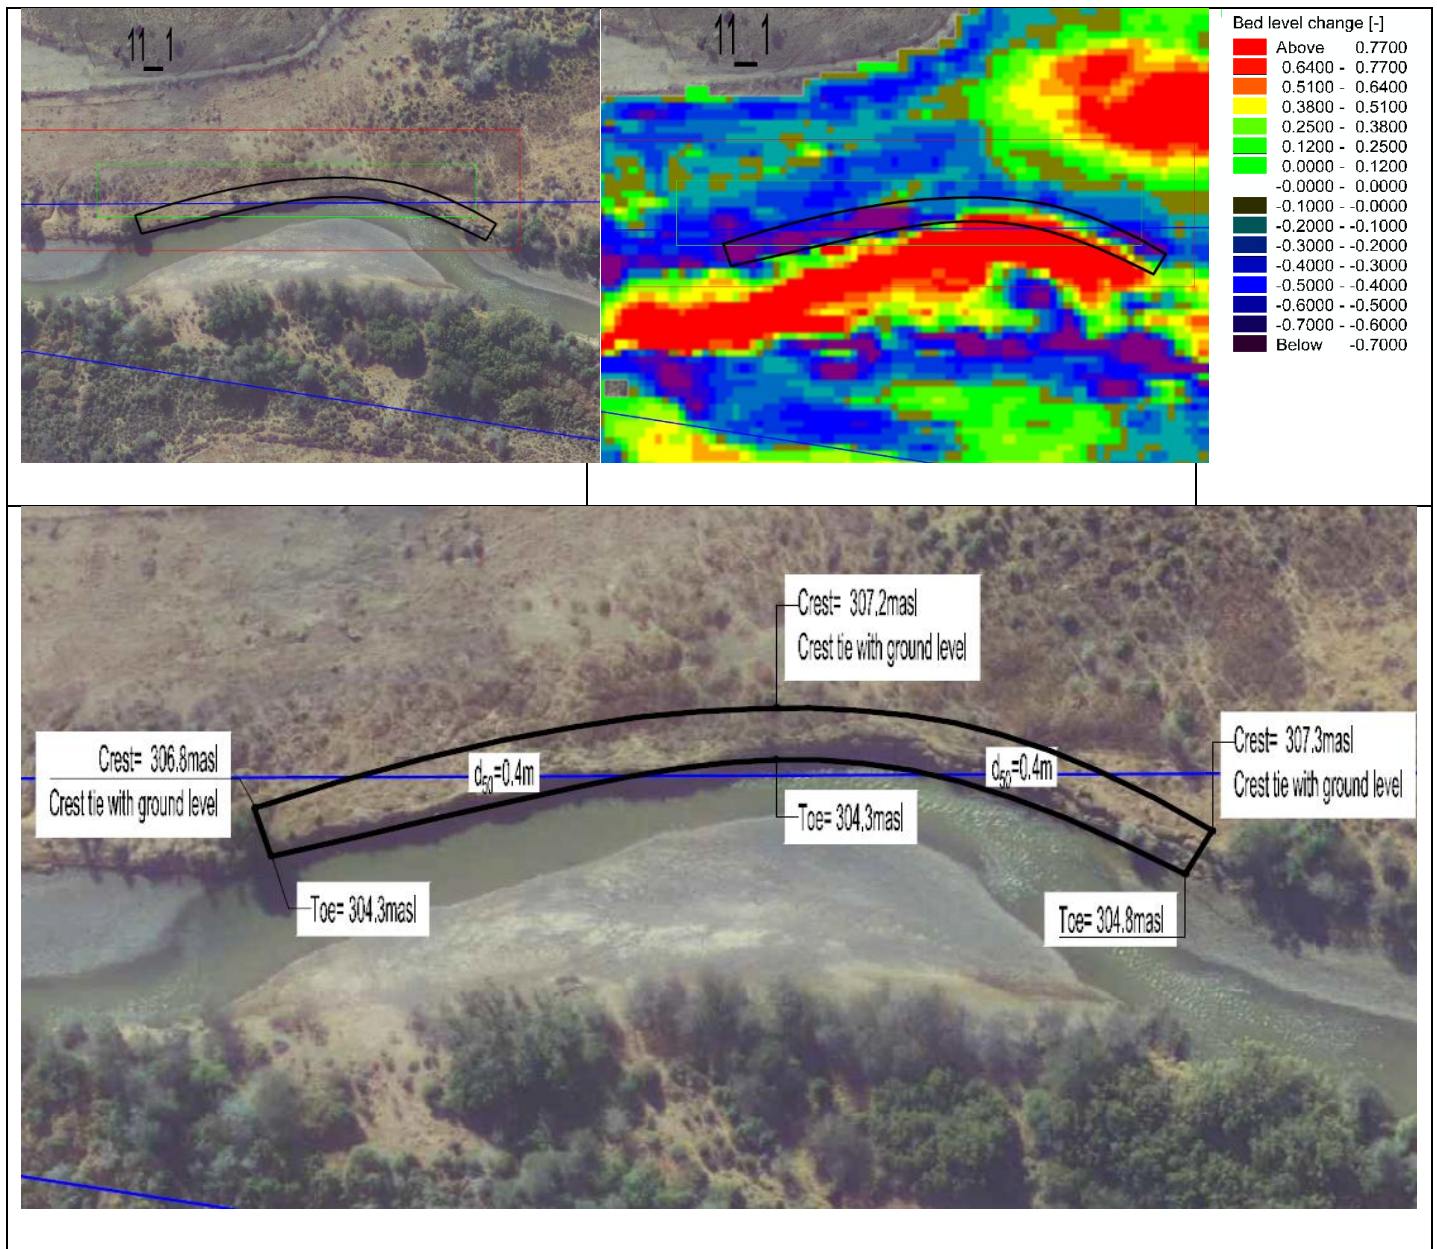
Zone 11_1

The zone has unstable banks crossing the servitude and flow is on a wide floodplain.

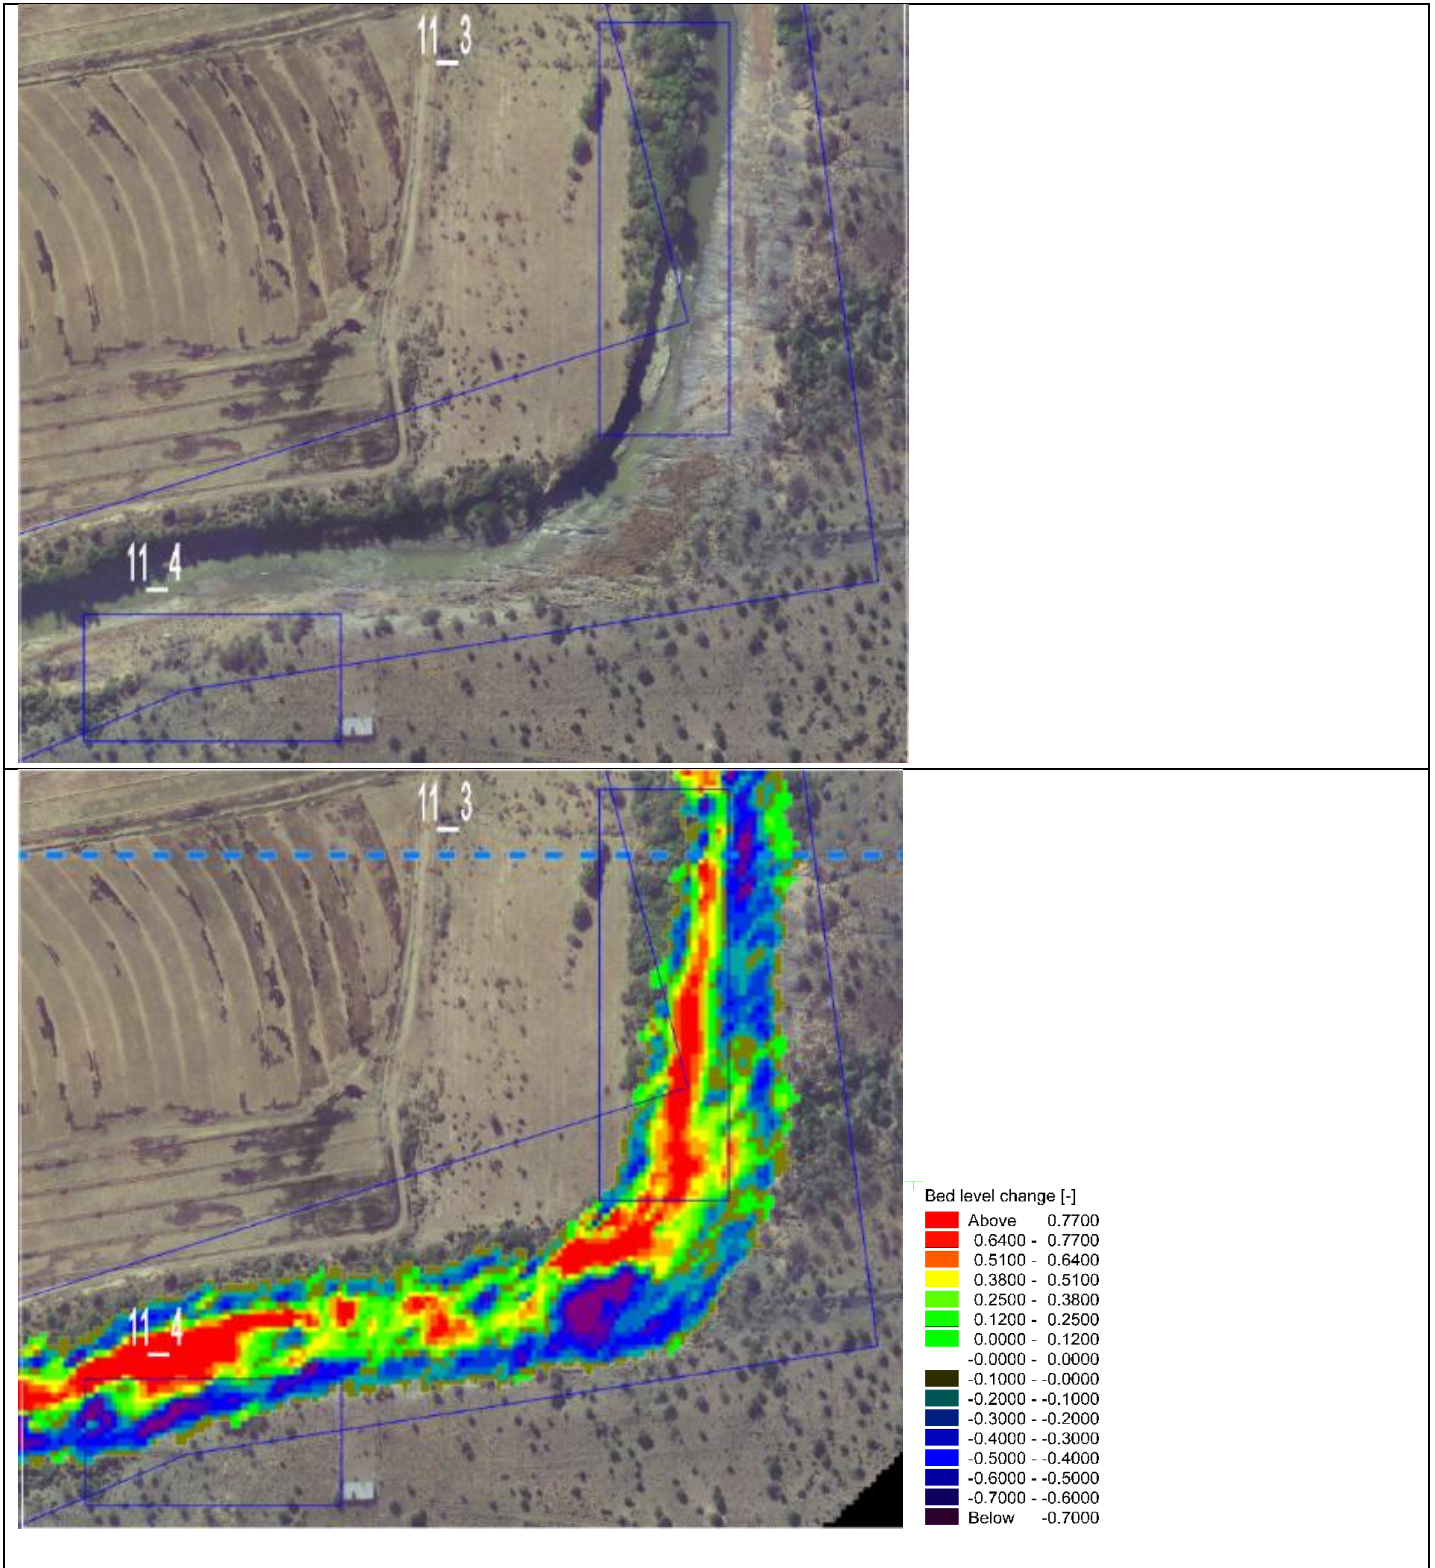
Zone 11_4

The zone has unstable banks within the servitude. Protection in this area is not necessary.

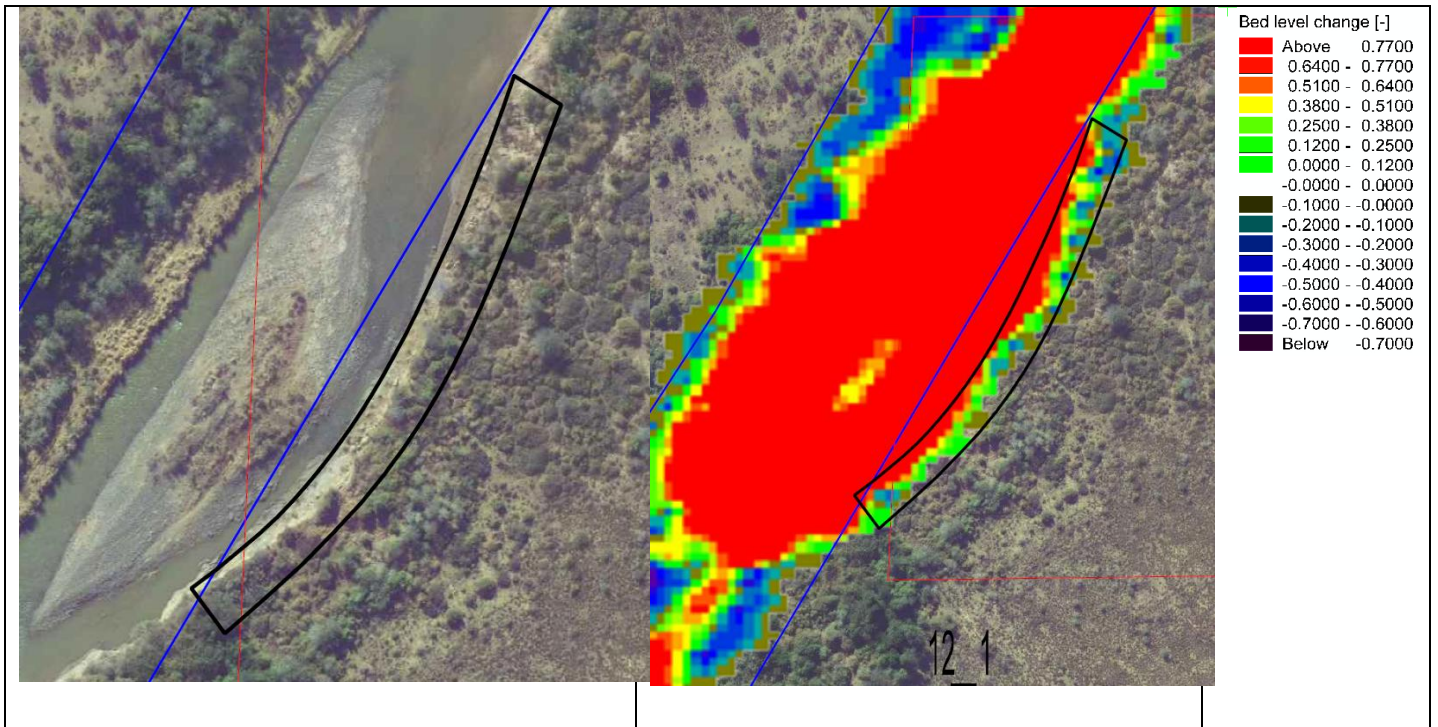
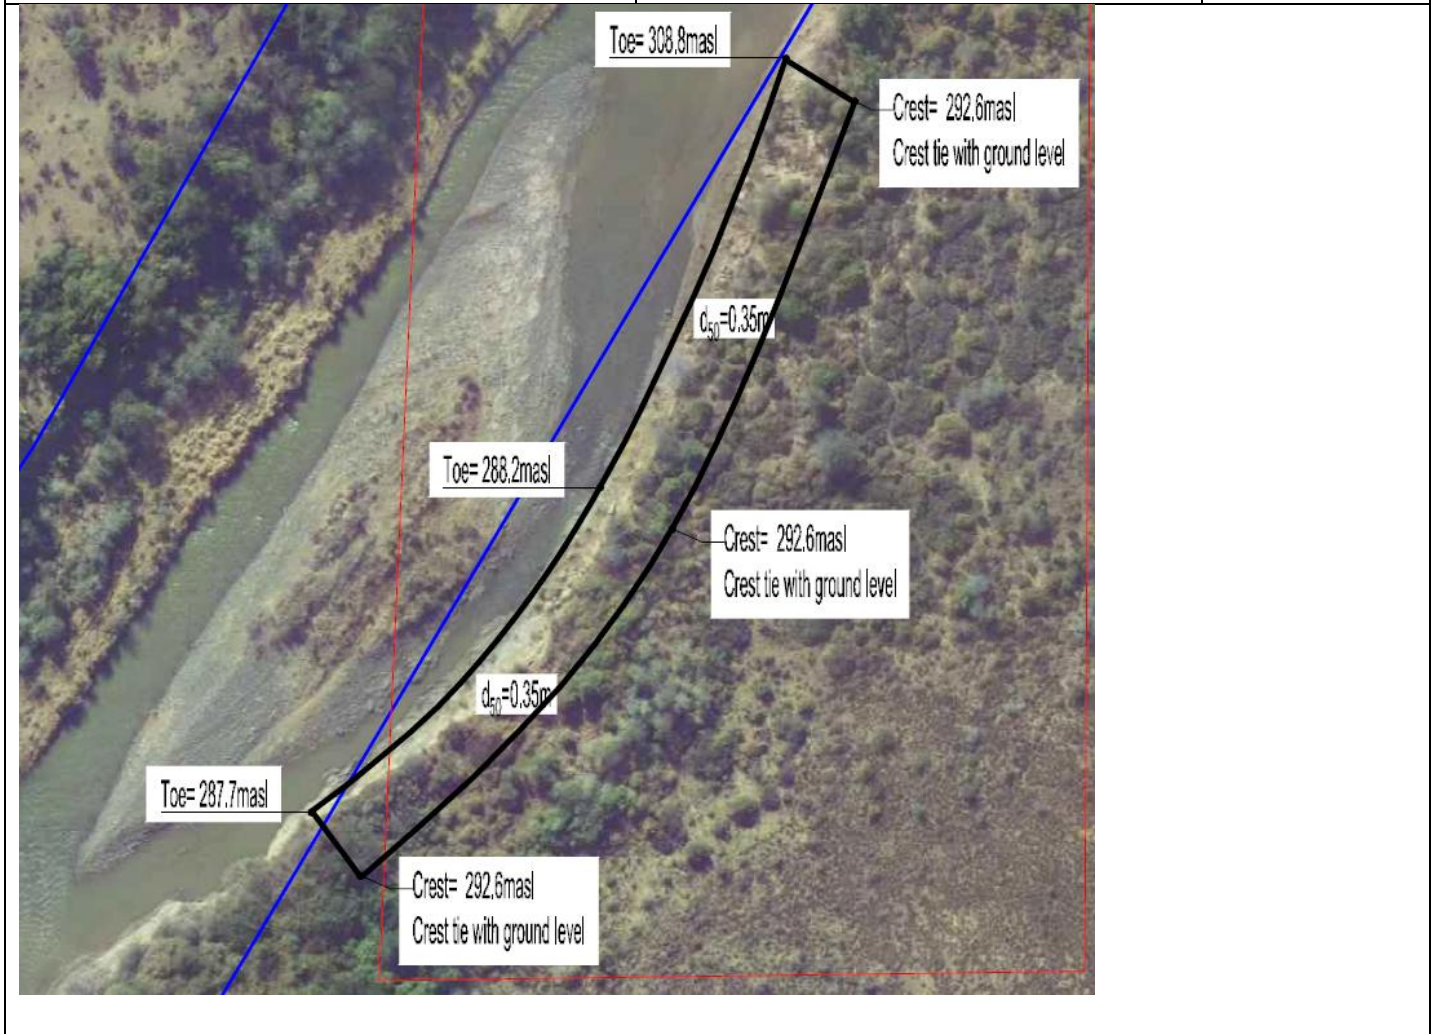
Zone 12_1

The zone has unstable banks crossing the servitude.
