Gordon's Bay Fishing Harbour: Notification of Intent to Develop

Professional Consultancy Services for Coastal Engineering Infrastructure Activities – Proclaimed Fishing Harbours Western Cape

Project Descriptions

Gordons Bay Harbour

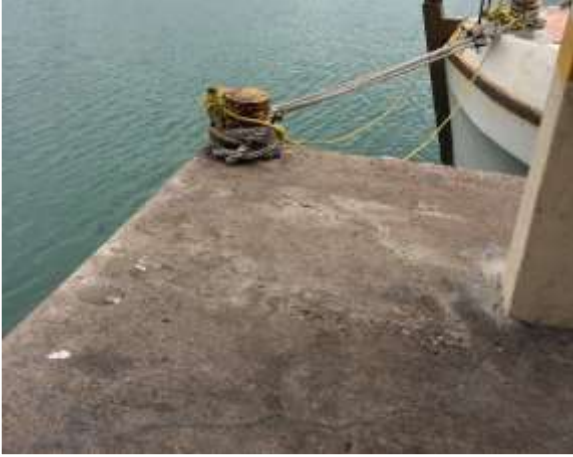
<p><u>Main Quay</u></p> <p>Fill hole in the gravity quay wall with plain concrete (below water level). This is to prevent undermining and potential failure of the structure. This will not increase the footprint of the Main Quay structure on the sea bed.</p>

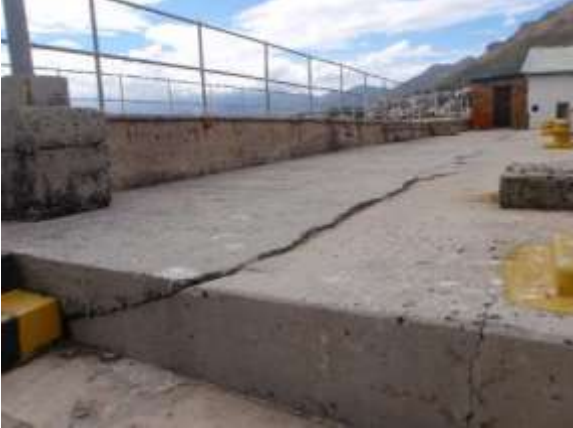
<p><u>Naval quay</u></p> <p>Cast new concrete capping along the entire length of the retaining wall. The repair work includes nominal shrinkage steel and steel dowels to tie the new concrete into the existing structure and will not increase the footprint of this structure.</p>

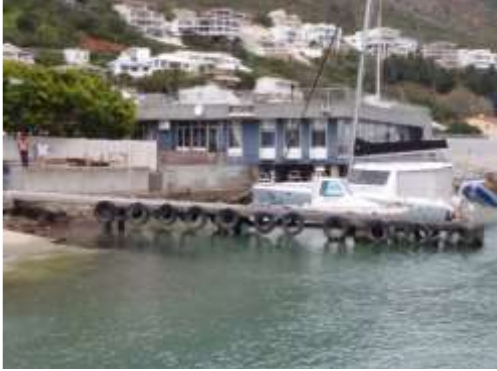
<p><u>Boat ramp lead-in jetty</u></p> <p>The fender fixings along the lead-in jetty are all bent and need to be replaced. New tyre fenders are required to replace missing ones.</p>

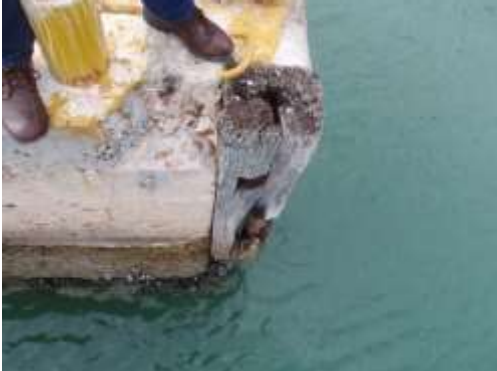
<p><u>Naval Jetty</u></p> <p>Replace damaged timber fenders on the jetty corners.</p>

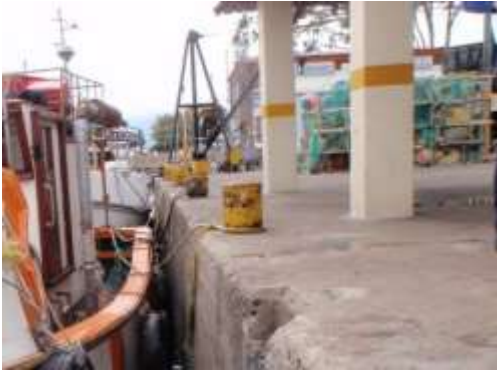
<p><u>Main Quay</u></p> <p>Bollards need to be cleaned and painted. Corroded bollard holding down bolts must be replaced.</p>

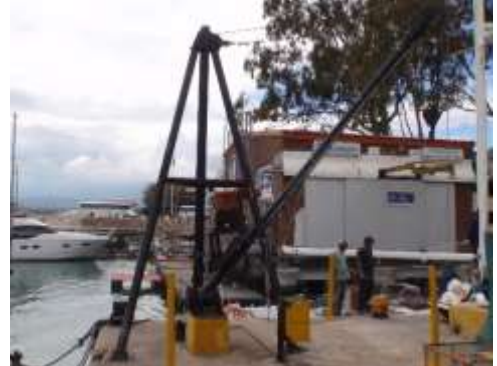
<p><u>Quay Crane</u></p> <p>Dismantle refurbish and replace the derrick quay crane. Alternatively, this crane will be replaced with a new one of similar capacity.</p>

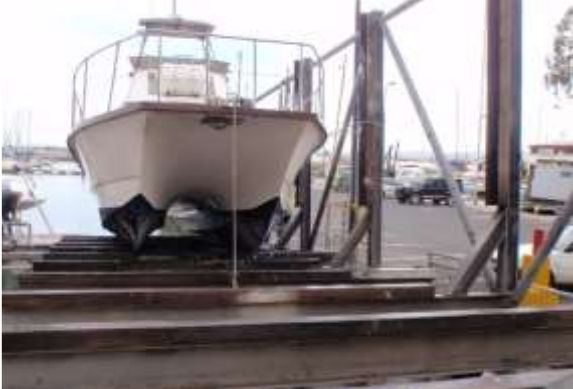
<p><u>Slipway cradle</u> Dismantle, clean and apply corrosion protection to the slipway cradle. Replace damaged timber sections.</p>

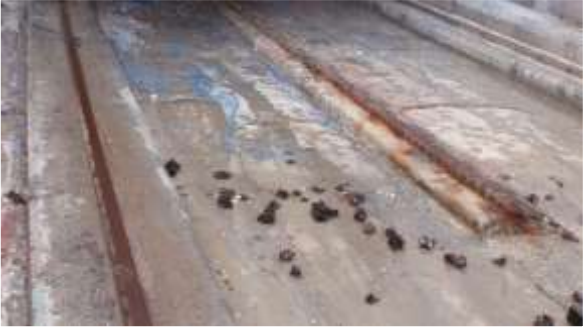
A photograph showing a close-up of the slipway rails and the pawl rack. The rails are made of metal and appear to be in good condition. The pawl rack is a series of small, dark, rectangular components that are mounted on the rails. The pawl rack shows signs of corrosion and wear.

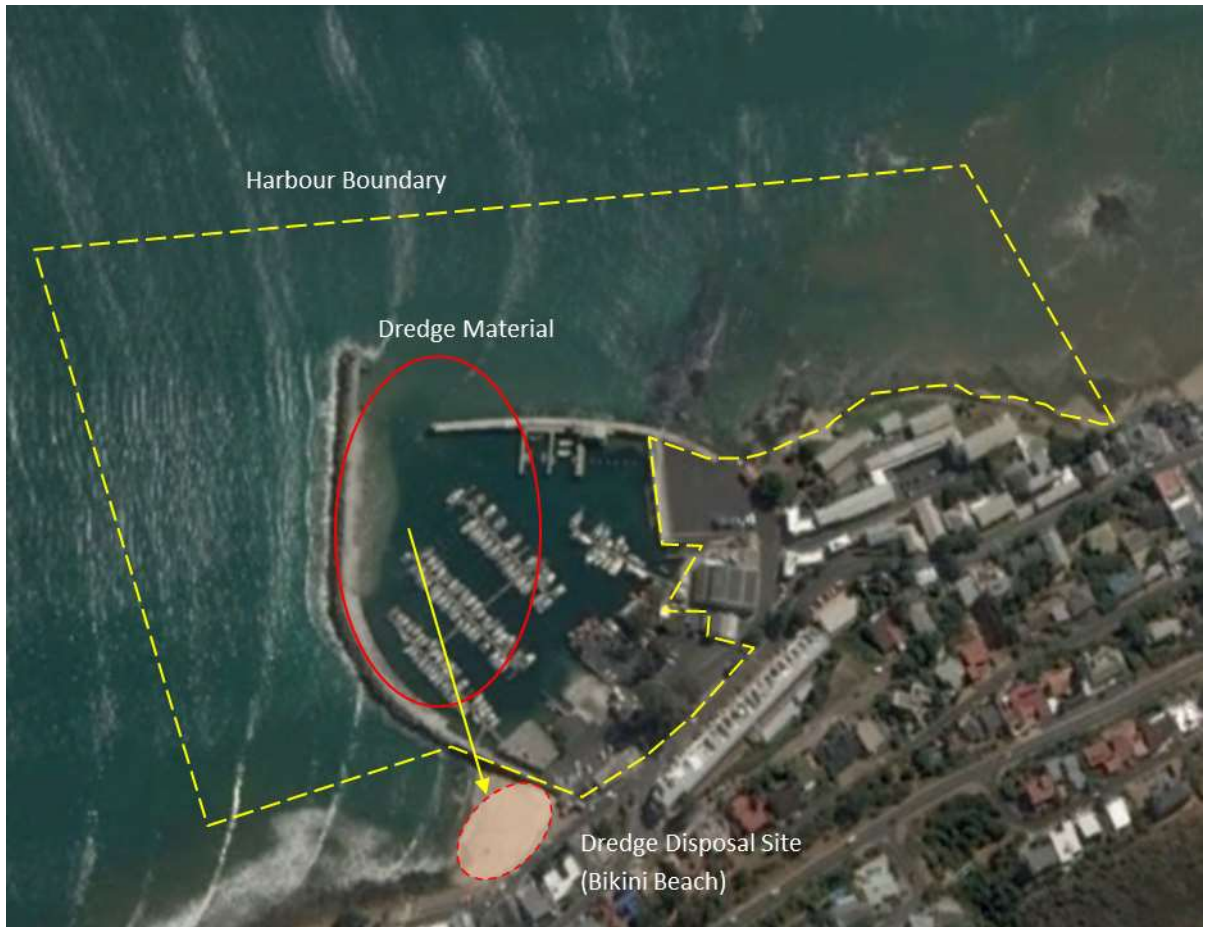
Figure 2-3: Gordons Bay – Areas that require dredging

Dredging is required to restore the required water depths in the entrance channel and harbour basin. Sand has built up in the harbour entrance to such an extent that larger vessels cannot use the harbour and smaller vessels can only enter and leave the harbour during high tide. This is a major concern for the safety of people and vessels using the entrance and for the operation of the NSRI who need to be able to operate under all conditions. The total dredge volume is approximately 20,000m³. A sediment study undertaken by Lwandle has indicated that the sediments to be dredged are not significantly contaminated (well within guideline levels). The dredge disposal site for Gordons Bay Harbour will be at the Bikini Beach:

Refer to Figure 2-3 which illustrates the area that needs to be dredged in red and the dredge disposal site.

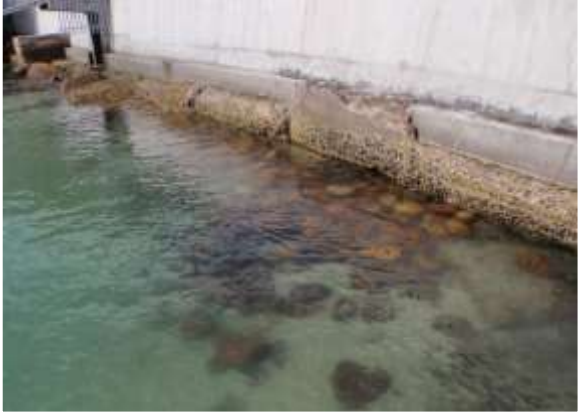
<p><u>Main breakwater route</u></p> <p>Grout holes along the route of the primary breakwater. This will involve the use of underwater grout, grout bags and a dop pump to pump the grout into the holes within the breakwater. This work can only be carried out on once all dredging works is complete. The repair work will not increase the foot print of the main breakwater.</p>

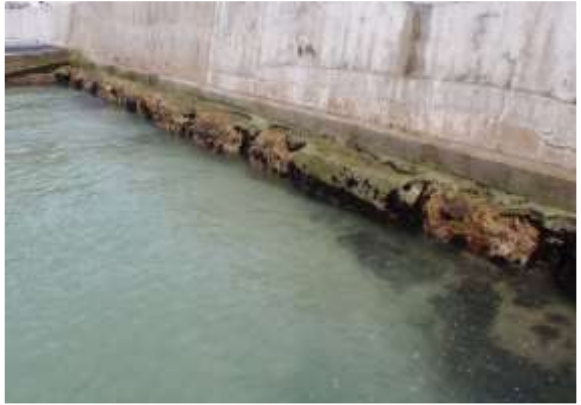
<p><u>Primary breakwater end</u></p> <p>Grout holes along the end of the main breakwater as per above.</p>

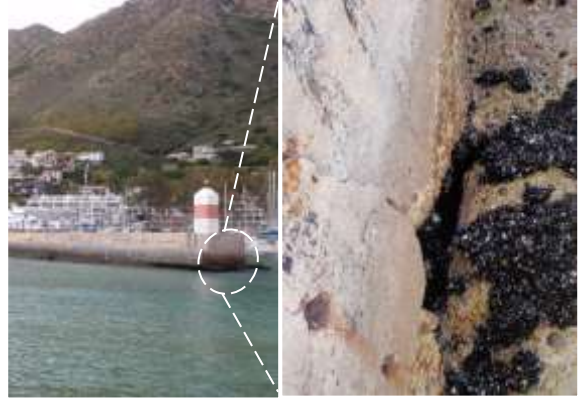
<p><u>Secondary breakwater end</u></p> <p>Grout holes at the end of the secondary breakwater as per the above main breakwater application.</p>

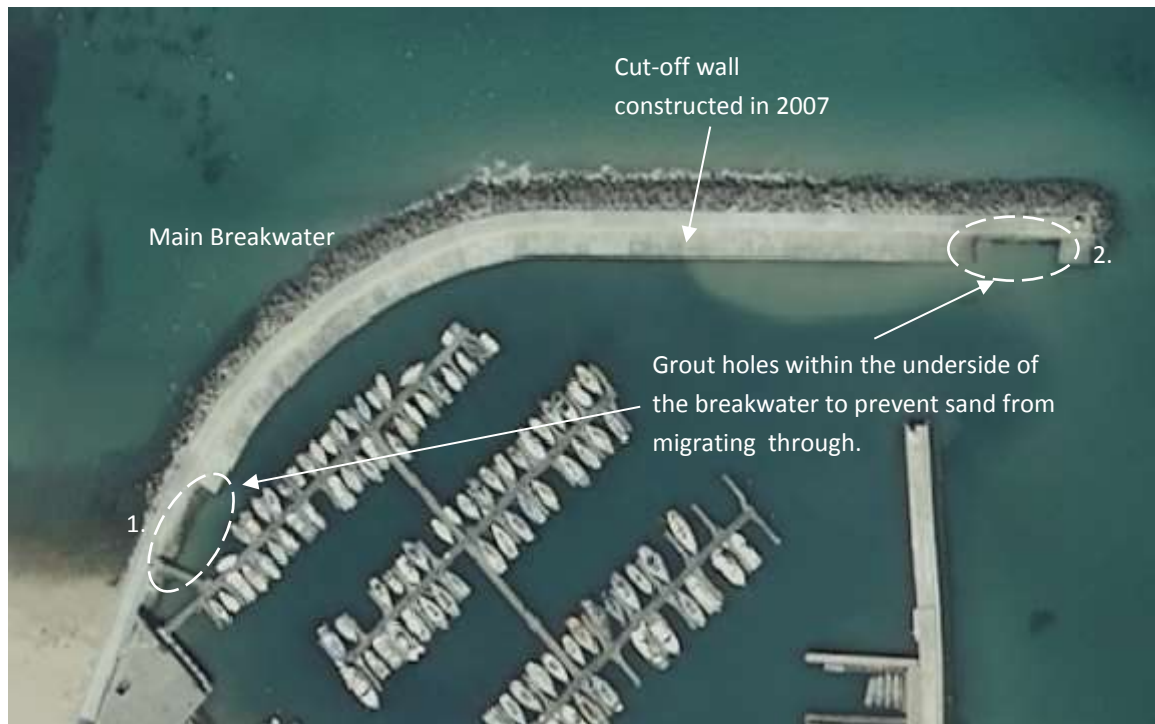
Figure 2-3: Main Breakwater

The main breakwater is a 350m long rubble mound structure with a large in-situ concrete cap which extends from the low water level. The seaward side of the breakwater is protected with Toskane units, whereas a concrete bench was constructed on the leeward side of the breakwater (2007) to try and reduce the amount of sand migrating through the breakwater and into the harbour basin.

The cut off wall was not constructed along the entire footprint of the breakwater as shown in Figure 2-3, and as a result, sand still migrates through the route and end sections.

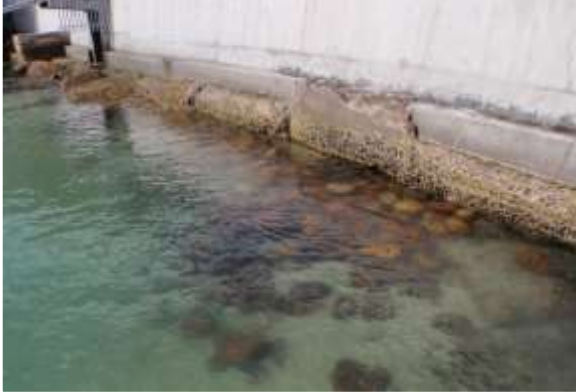
<p><u>Primary breakwater route (1)</u></p> <p>Grout holes along the route of the primary breakwater. This will involve the use of underwater grout, grout bags and a dop pump to pump the grout into the holes within the breakwater. This work can only be carried out once all dredging works is complete. The repair work will not increase the foot print of the main breakwater.</p>

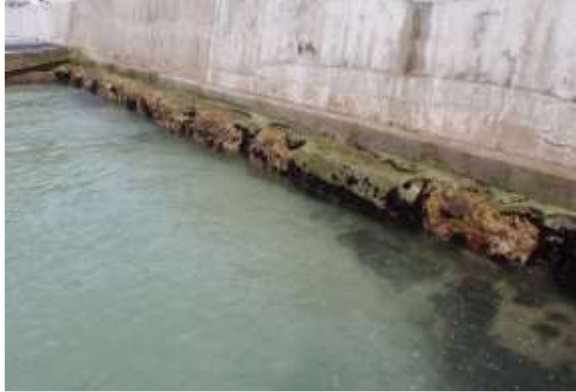
<p><u>Primary breakwater end (2)</u></p> <p>Grout holes along the end of the primary breakwater as per above.</p>

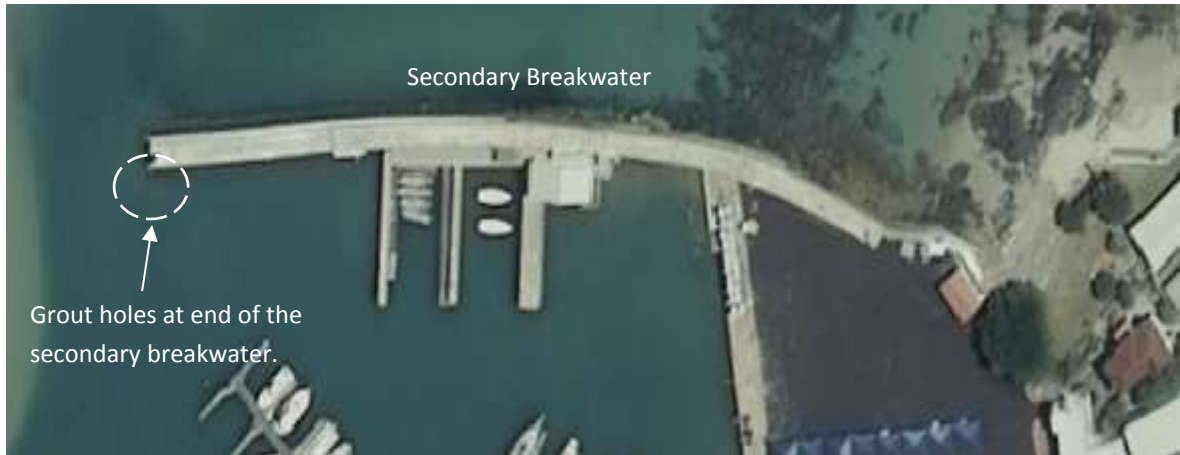
Figure 2-4: Secondary Breakwater

The secondary breakwater is a 200 m long structure constructed with concrete blockwork. The breakwater is in a reasonably good condition, with minor holes appearing at the end of the breakwater. These holes require repair to prevent further scour of the concrete blockwork. Figure 2-4 shows the secondary breakwater and the location of where the holes require repair. Table 2-3 describes the required repair measure.

<p><u>Secondary breakwater end</u></p> <p>Grout holes at the end of the primary breakwater. This will involve the use of underwater grout, grout bags and a dop pump to pump the grout into the holes within the breakwater. The repair work will not increase the foot print of the main breakwater.</p>	
---	--

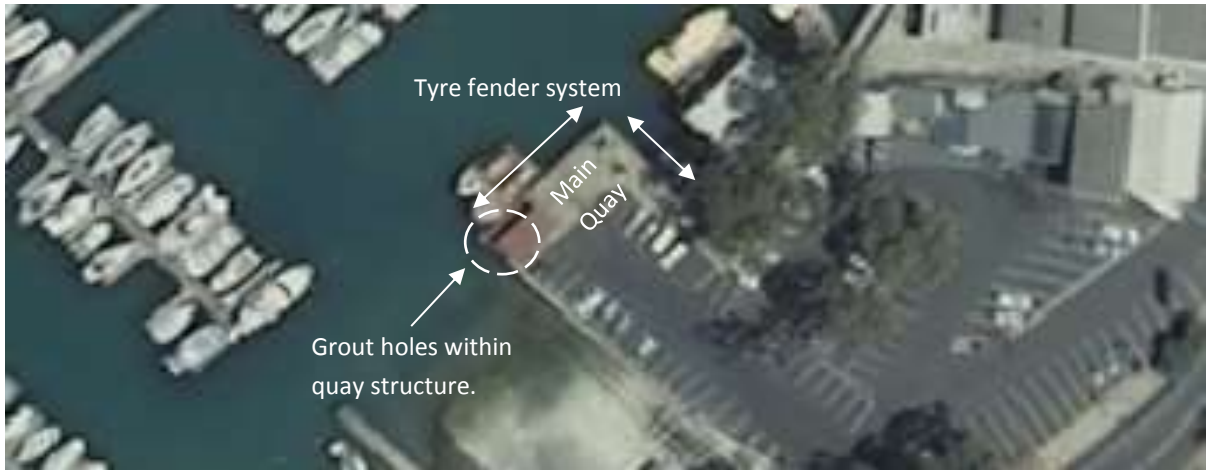
Figure 2-5: Main Quay

The main quay in Gordons Bay is a 45m long mass concrete block wall along two faces. There are some voids in the quay, under the water level, on the slipway side that need to be filled. Furthermore, the quay has no fendering system for vessels to use when berthing along the quay. It is recommended that a new fender system be installed. Refer to Figure 2-5 and Table 2-4 for the proposed repair measures on the main quay.

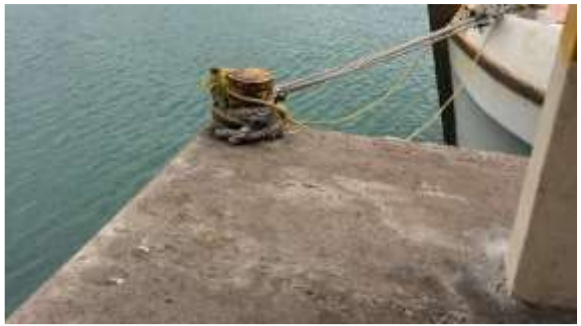
<p><u>Holes within the Quay</u> Fill hole in the gravity quay wall with plain concrete (below water level). This is to prevent undermining and potential failure of the structure. The holes are below the bollard in picture.</p>

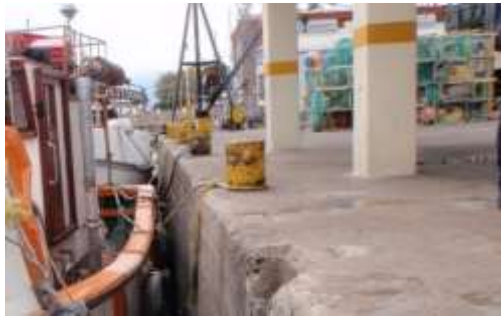
<p><u>Bollards and Fenders</u> Bollards need to be cleaned and painted. Corroded bollard holding down bolts must be replaced. Truck tyre fenders to be installed along the quay structure at 3 m centres.</p>

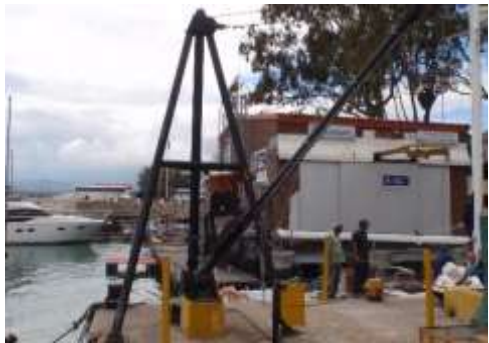
<p><u>Quay Crane</u> Dismantle refurbish and replace the derrick quay crane. Alternatively, this crane will be replaced with a new one of similar capacity.</p>
