### Kalk Bay Fishing Harbour: Notification of Intent to Develop

## Professional Consultancy Services for Coastal Engineering Infrastructure Activities – Proclaimed Fishing Harbours Western Cape

Kalk Bay Harbour

S2042-1-TN-EN-002

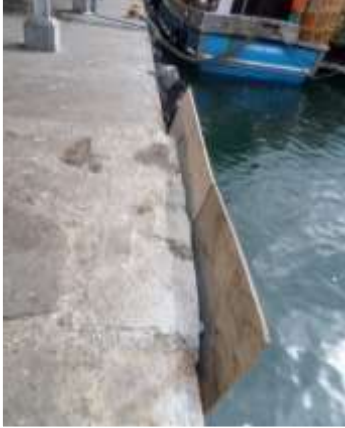
<p><u>Fish Landing Quay</u> Supply and install a new bollard at the Eastern end of the quay.</p>

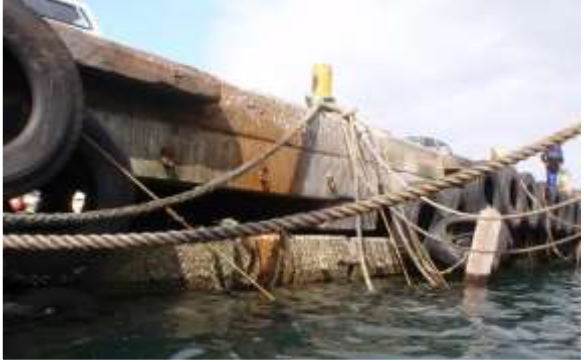
<p><u>Inner Jetty</u> There are a number of missing tyre fenders along the jetty, breakwater and quay structure. These all need to be replaced, together with the corroded fender fixings (i.e. fender fixings, chains and shackles).</p>

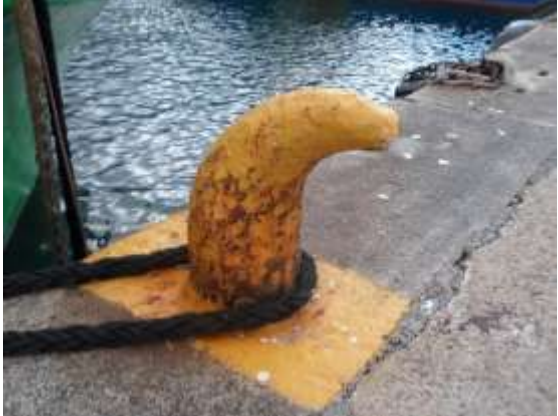
<p><u>Main Breakwater</u> Bollards need to be cleaned and painted. Corroded bollard holding down bolts along the fish landing quay must be replaced.</p>

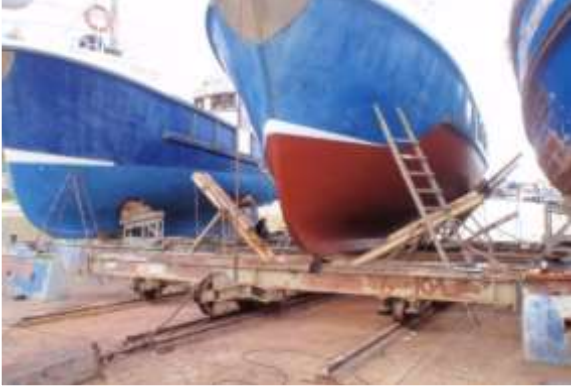
<p><u>Slipway cradle</u> Dismantle, clean and apply corrosion protection to the cradle steel sections.</p>

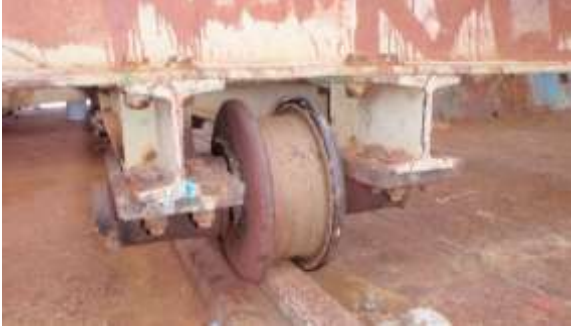
<p><u>Bogie wheels</u> Some of the bogie wheels are worn and corroded and tend to jam during operation. All bogie wheels need to be removed, serviced and re-installed. Badly damaged bogie wheels will be replaced.</p>

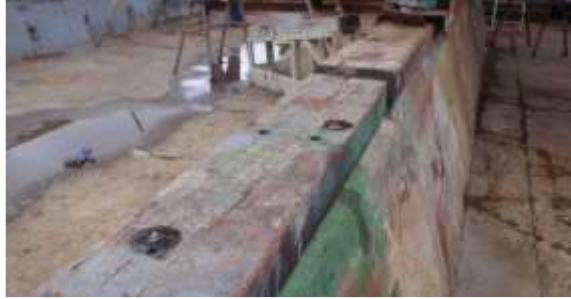
<p><u>Timber support blocks</u> Remove and replace damaged timber support blocks.</p>

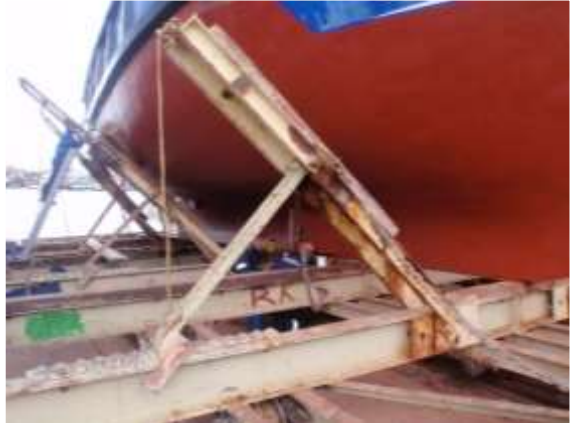
<p><u>Steel side arm supports</u> Four new side supports arm are to be fabricated for the 90 tonne slipway.</p>

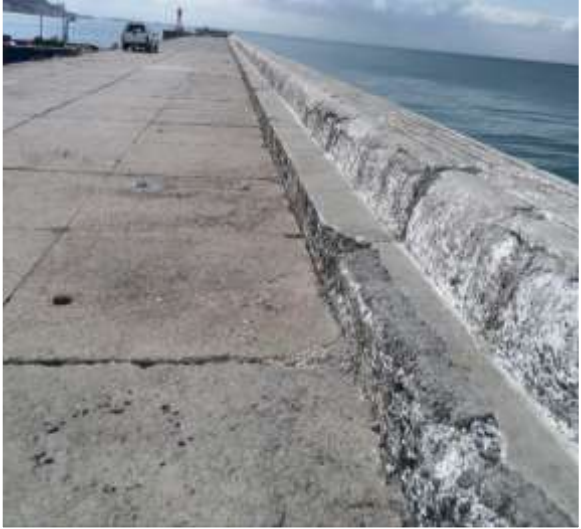
<p><u>Splash wall repair</u> Concrete patch repair along the length of the wave wall.</p>

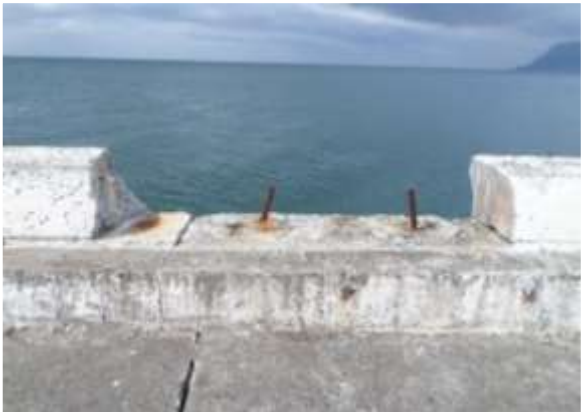
<p><u>Splash wall</u> Replace missing wave wall units.</p>

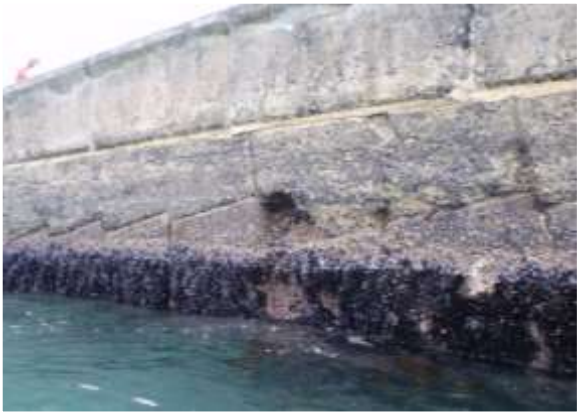
<p><u>Holes in the breakwater blockwork</u> There are a few holes in the breakwater above and below water level that need to be filled with concrete to prevent further scour and damage to the structure.</p>

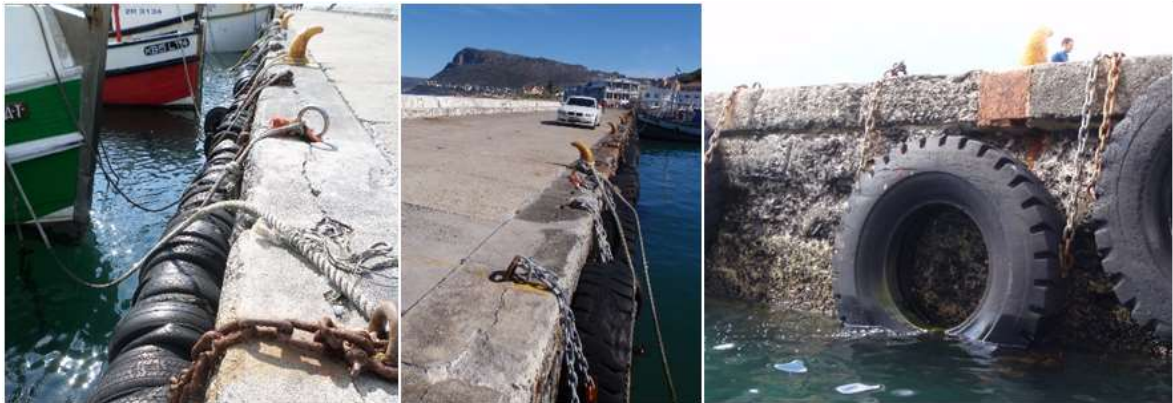
**Figure 2-3: Main Breakwater Edge Beam**

The inside edge beam along the breakwater is in a poor condition. The limited bollards result in mooring lines being fixed to fender fixings. These fixings are not designed to take the loads and therefore have caused damage to the edge beam. Sections of the cope beam are also undermined due to eroded concrete. The damaged edge beam is illustrated in the photos in Figure 2-3 below.

A new concrete edge beam will be constructed on the leeward side of the breakwater and will accommodate a new layout of bollards and fender fixings. The edge beam will have a 0.45 m high raised kerb. The kerb will improve safety by acting as a barrier along the edge. Gaps will be provided between kerb units for overtopping drainage. Refer to Figure 2-4 for the proposed typical section of the breakwater upgrade.

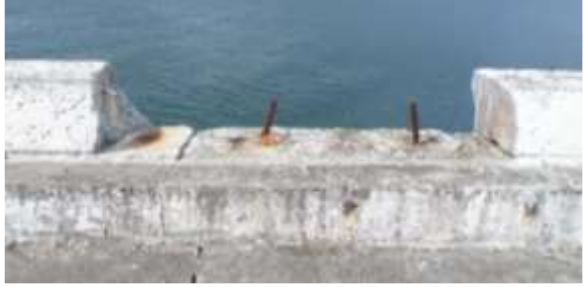
<p><u>Main Breakwater – Wave replacement</u> Replace missing wave wall units.</p>

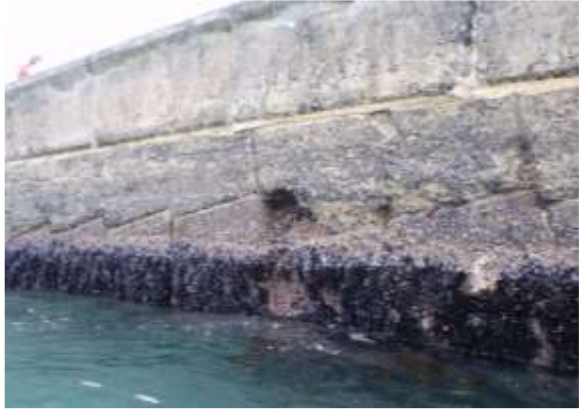
<p><u>Holes in the breakwater blockwork</u> There are a few holes in the breakwater above and below water level that need to be filled with concrete to prevent further scour and damage to the structure.</p>

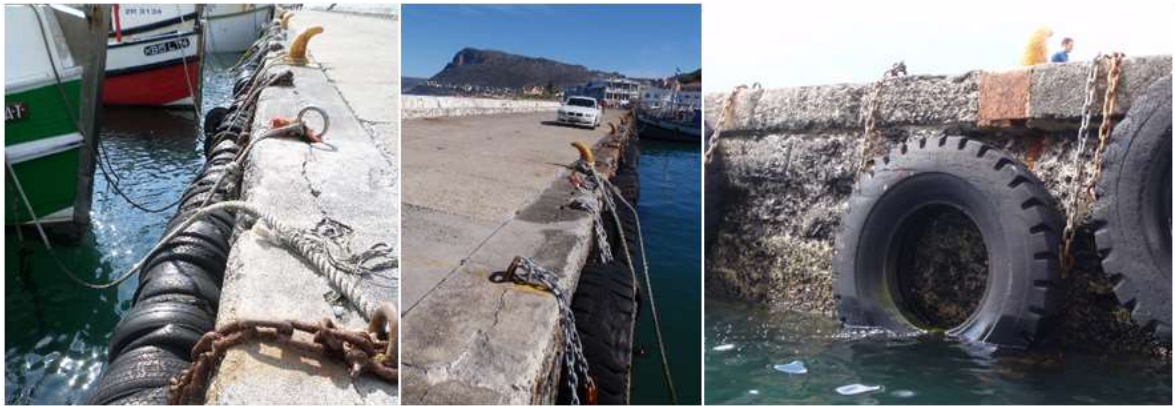
**Figure 2-4: Main Breakwater Edge Beam**

The inside edge beam along the breakwater is in a poor condition. The limited bollards result in mooring lines being fixed to fender fixings. These fixings are not designed to take the loads and therefore have caused damage to the edge beam. Sections of the cope beam are also undermined due to eroded concrete. The damaged edge beam is illustrated in the photos in Figure 2-4 below.

A new concrete edge beam will be constructed on the leeward side of the breakwater and will accommodate a new layout of bollards and fender fixings. The edge beam will have a 0.45 m high raised kerb. The kerb will improve safety by acting as a barrier along the edge. Gaps will be provided between kerb units for overtopping drainage. Refer to Figure 2-5 for the proposed typical section of the breakwater upgrade.

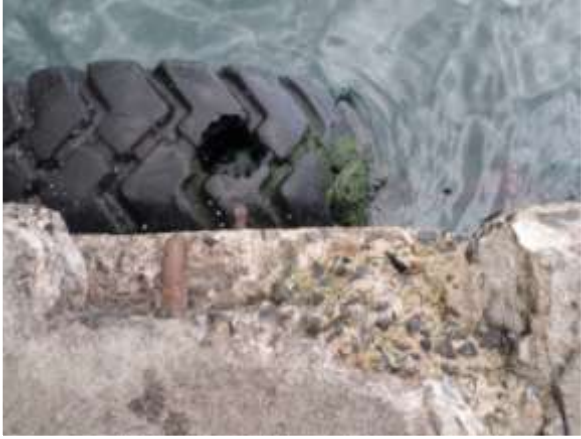
<p><u>Fish Landing Quay</u></p> <p>Concrete patch repairs along the cope edge of the fish landing quay. This will include careful breakout of the damaged concrete, cleaning of corroded steel reinforcement, steel passivation coating and the application of repair mortar.</p>

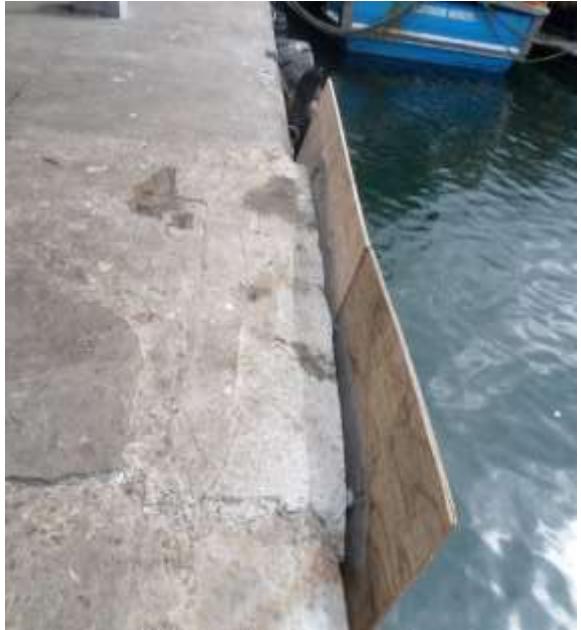
<p><u>Fish Landing Quay</u></p> <p>Supply and install a new bollard at the Eastern end of the quay.</p>
