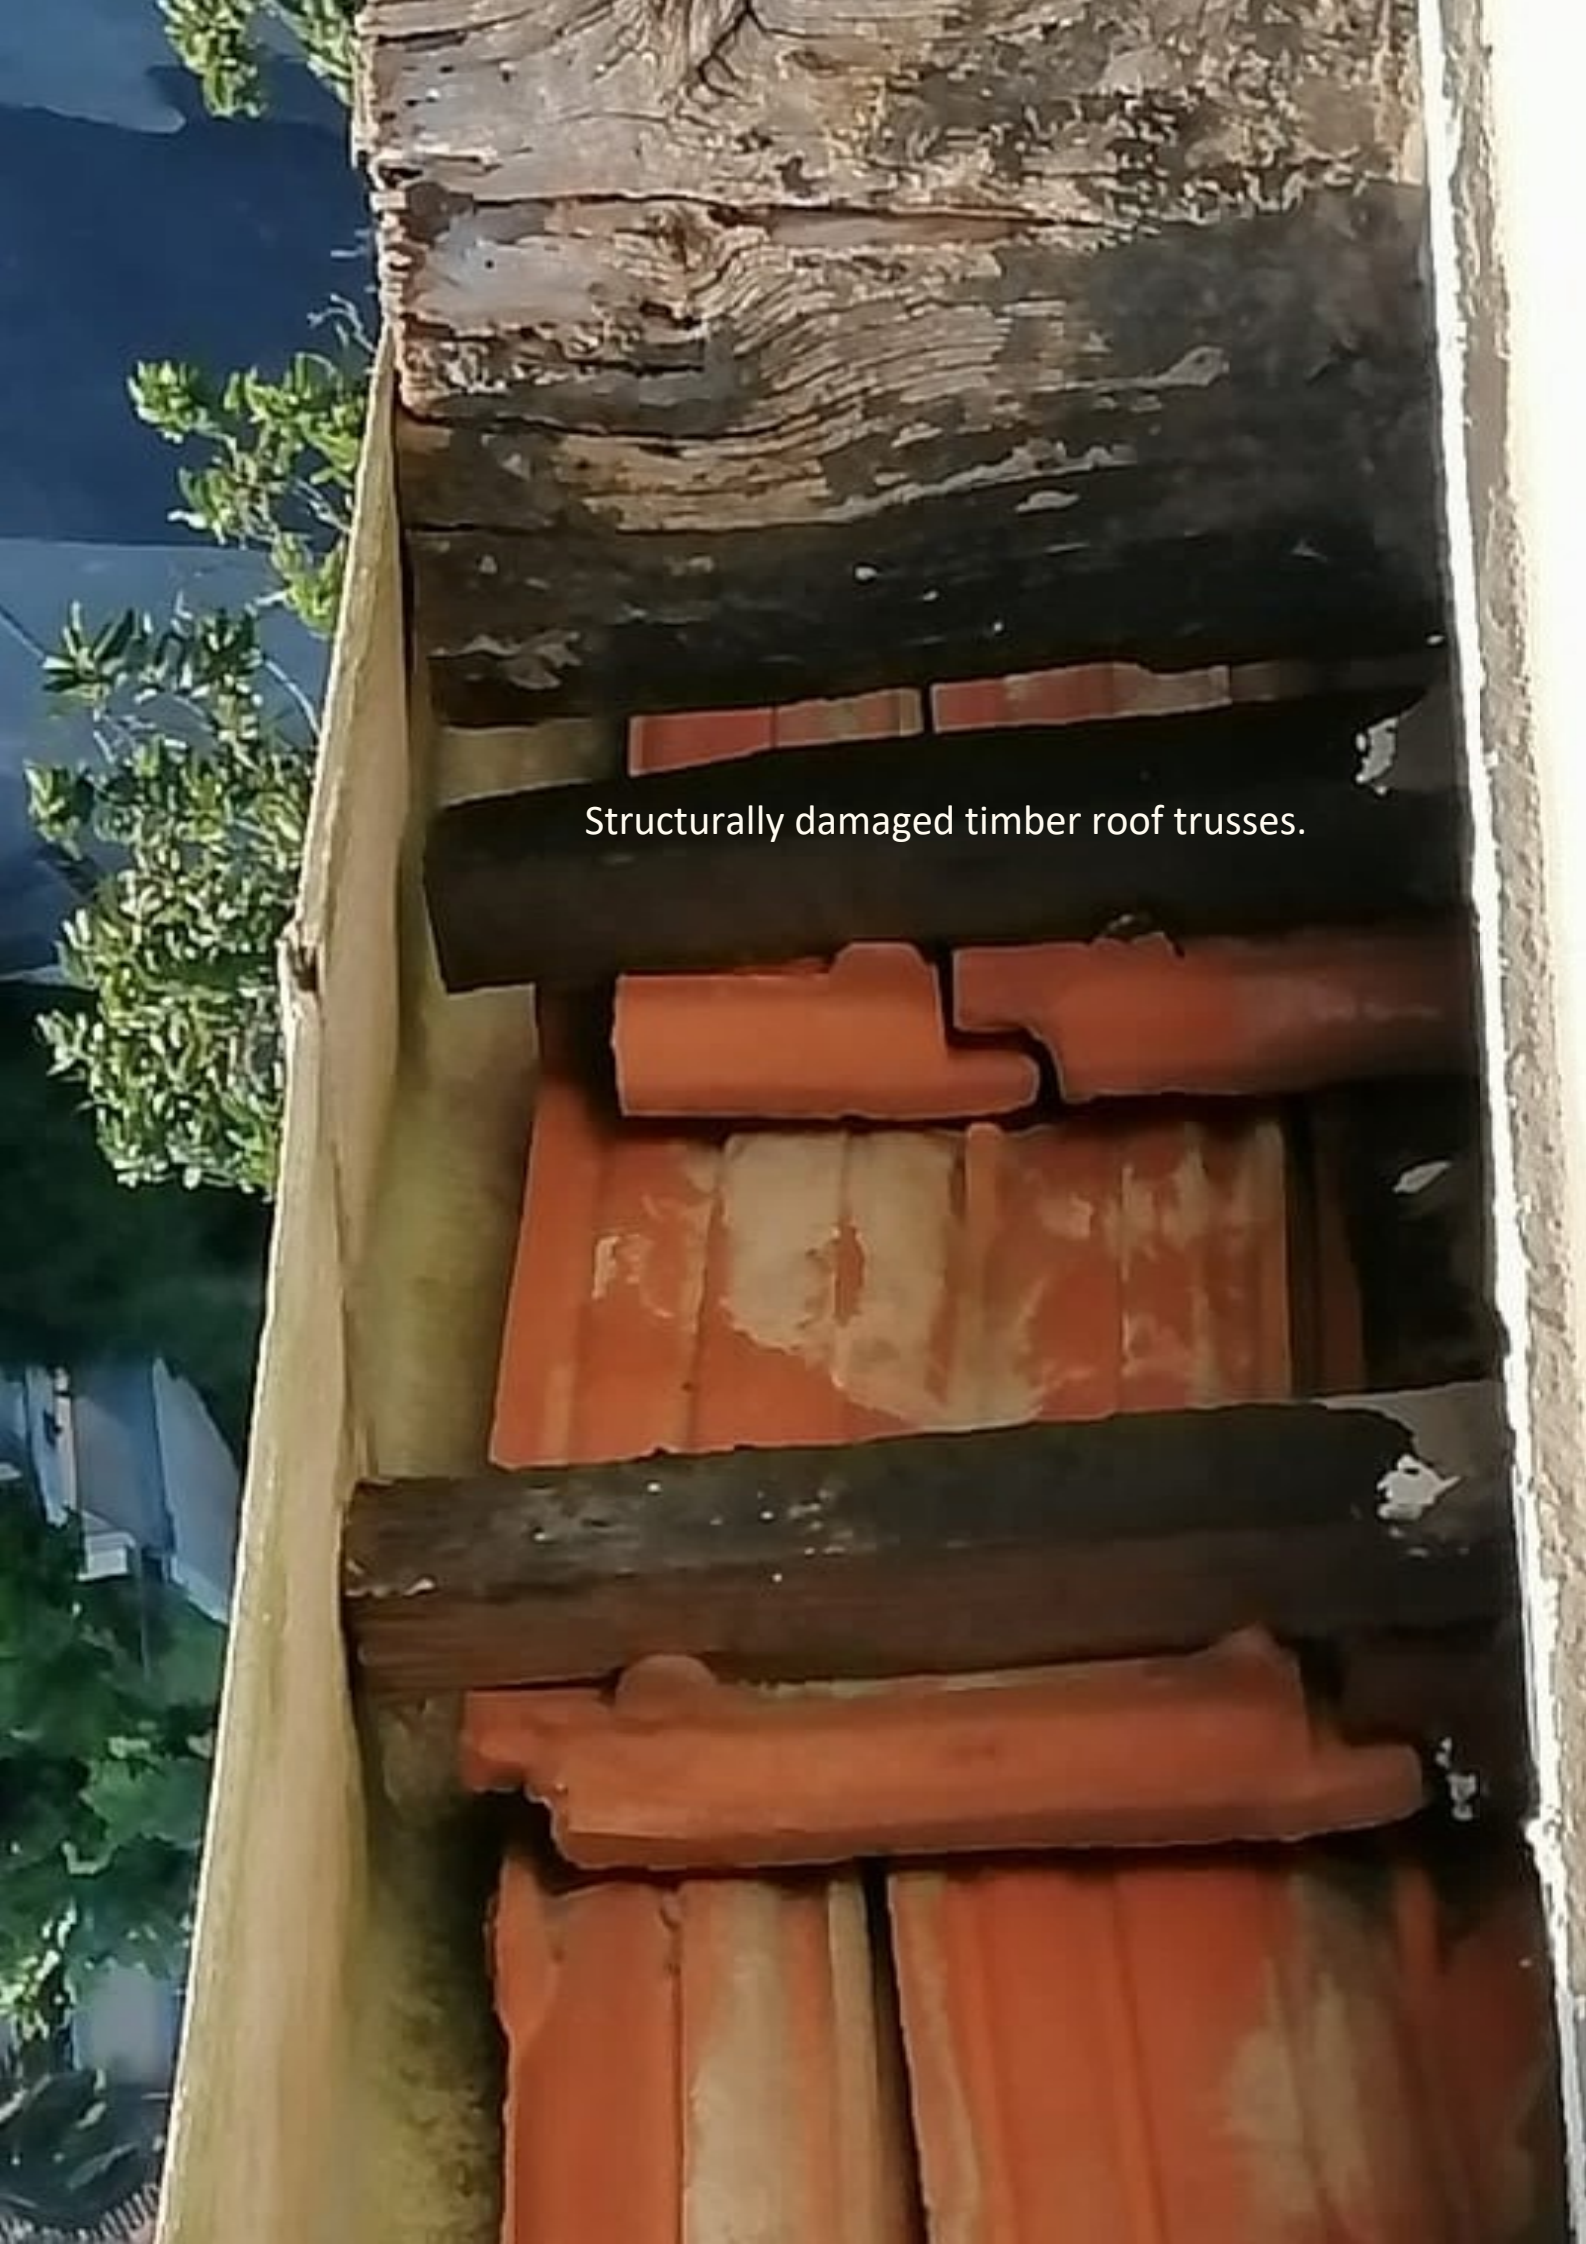
Structurally damaged timber roof trusses.
