Timber Roof Construction, Nurses Home, KZN Children's Hospital, Durban.

Terms of Reference

Gavin Brown and Associates were appointed by KZN Children' Hospital Trust, to carry out an urgent investigation of the Timber roof construction over the Nurses Home at the KZN Children's Hospital in Durban.

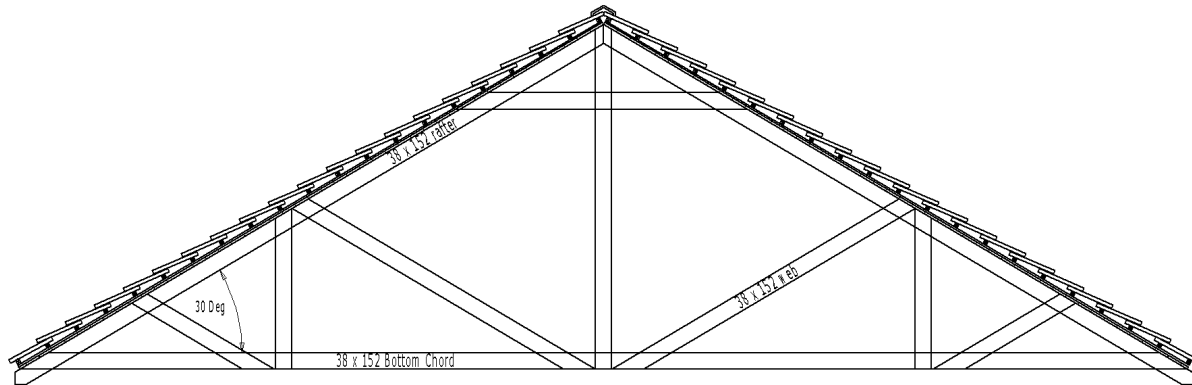
The roof structure over the Nurse's Home comprises of site made trusses spaced at 760mm centres, and constructed from 38x152 Oregon Pine material. The truss joints comprise either a single M10 bolt or 3 wire nails. The truss configuration resembles a double "Howe". The 38mm x 38mm tiling battens are fixed directly to the rafters of the trusses. No under-tile membrane has been used.

Figure 1- Typical truss

The truss construction at present does not comply with Part L of SABS 0400-1990 The Application of The National Building Regulations. According to Table 1 the 38 x 152 timber members are only suitable for use for spans up to 8.5 metres. The truss spans for the Nurse's home are all in excess of 10 metres. This is to allow an adequate number of bolts at the heel and apex for ultimate design conditions. The single bolt connections at the joints are also inadequate to transfer the

forces between connecting members under full design load design conditions. The trusses are also overstressed when checking the truss configuration under the current timber design codes.

We are of the opinion that the trusses over the Nurse's Home cannot be repaired, and recommend that they be replaced with nail plated engineered trusses.

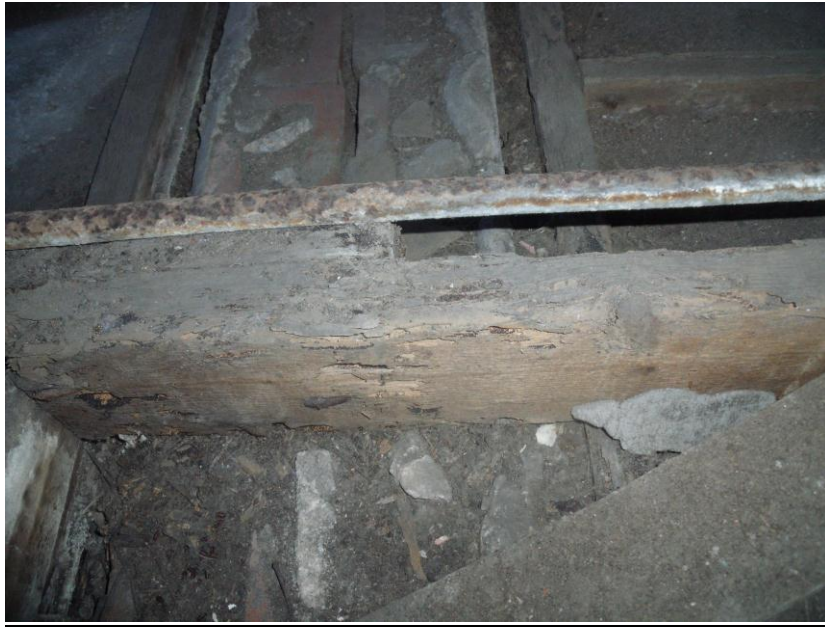
Large amounts of borer dropping were noticed on the ceilings boards. The timber was tested by tapping on its surface with a welders hammer. The surface of timber that appeared sound gave way when struck with the hammer, indicating severe damage from wood borer infestation. This was evident in both the truss timbers and the ceiling joists.

Figure 2-Truss Tie beam damaged by wood borer

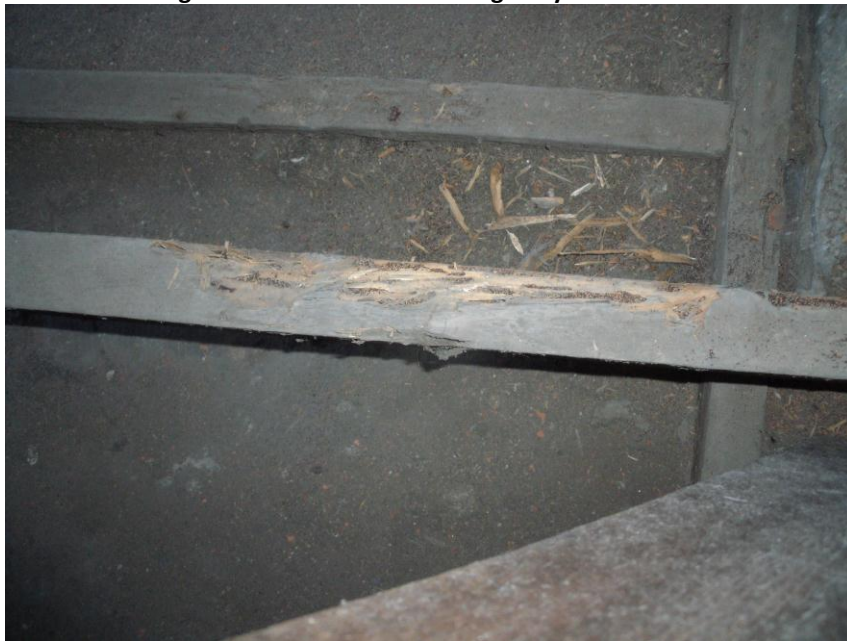
Figure 3- Ceiling joist damaged by wood borer

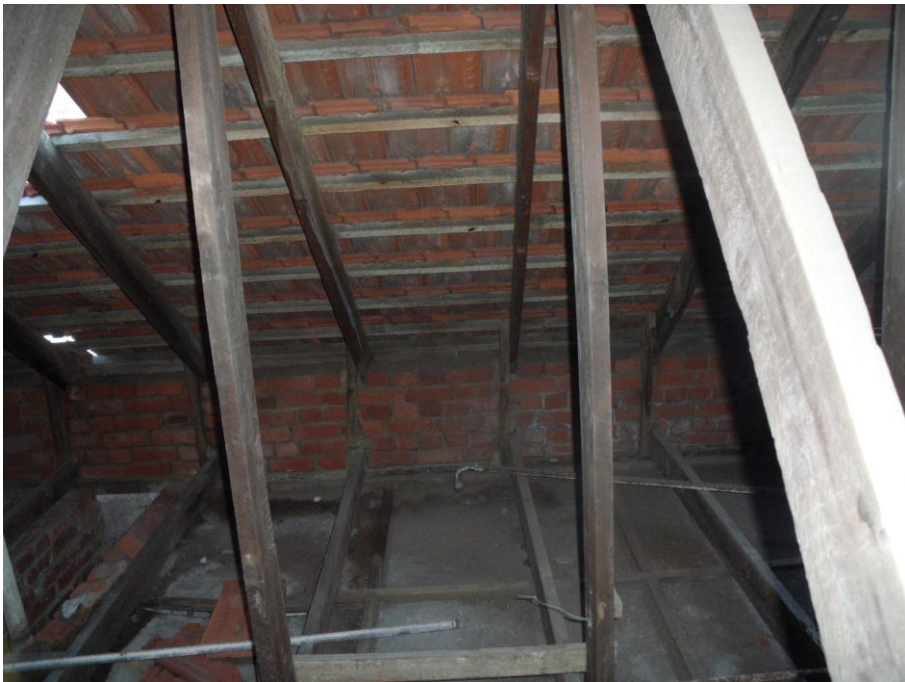
Figure 4- Buckling Webs

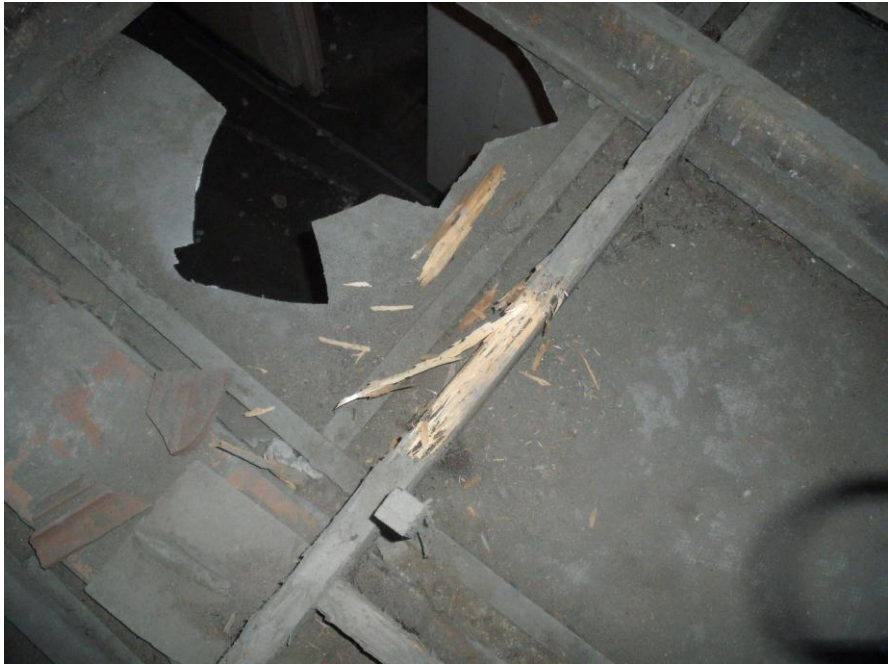
Figure 5- Wood borer damage on ceiling brandering

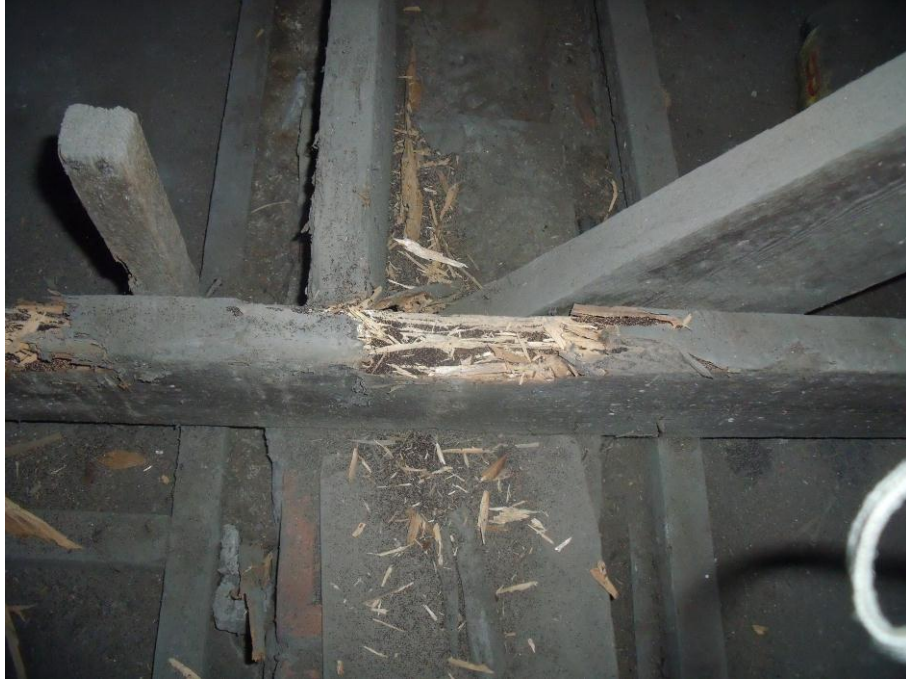
Figure 6- Wood borer damage on truss
