04 May 2022
Our Ref: BCE22325-01

DESCRIPTION OF WORK : STRUCTURAL REPORT TO EXISTING BUILDING
ADDRESS : 82 EFFINGHAM ROAD, GREENWOOD PARK

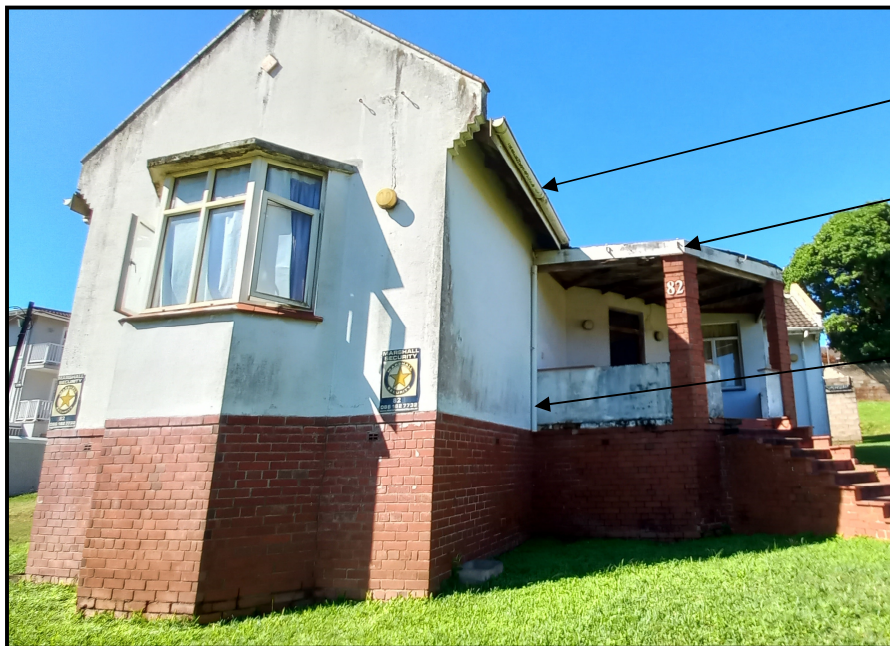
Gutter with no downpipe

Missing Gutters

Downpipes discharging onto ground.

- The building does not comply with current regulation.
- Areas of the roof structure are required to be removed and replaced.
- Flooring is required to be removed and replaced due to cracking.
- Foundations are to be underpinned, preferable removed and replaced.
- Stormwater management is to be put into place.
- The above clearly highlights the need for the structure to be demolished and rebuild due to the amount of repair work that is required.

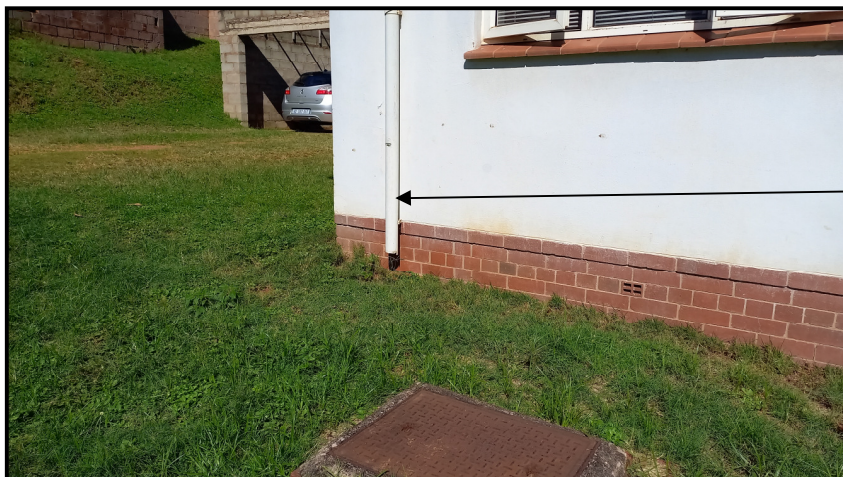
Downpipes discharging onto ground.

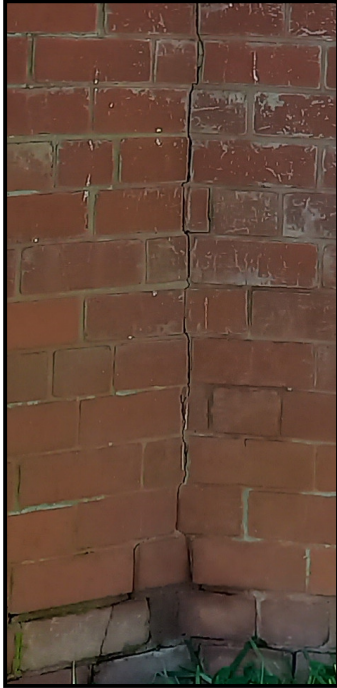
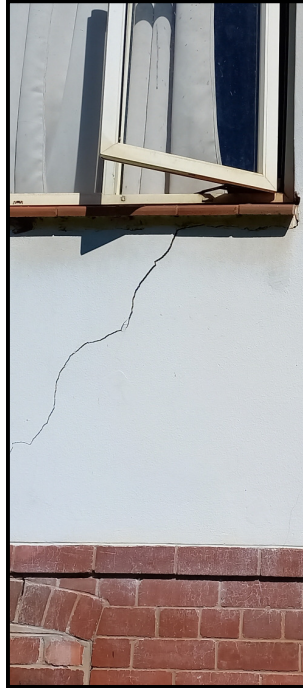
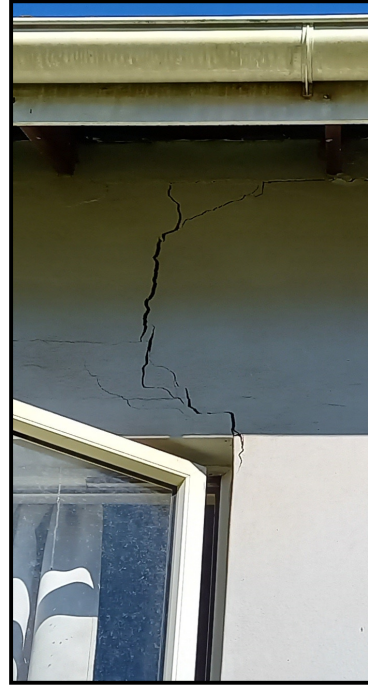
Cracks formed on masonry walls.

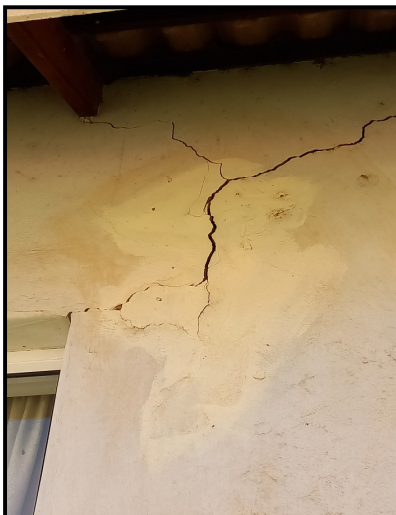
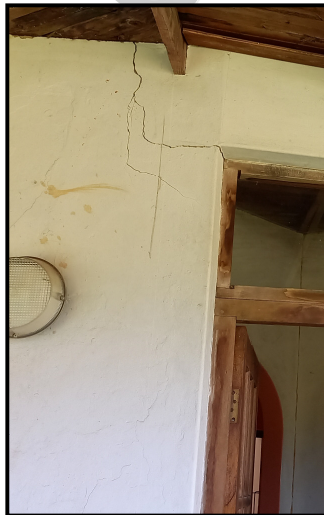
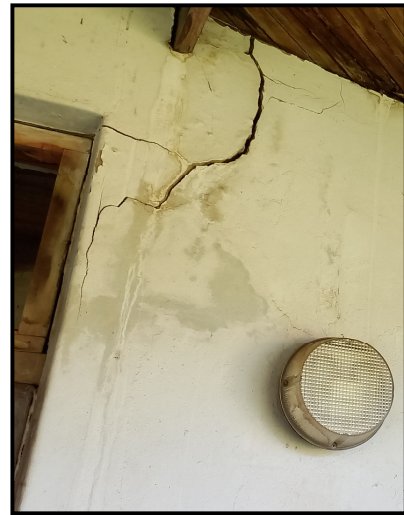
Cracks formed on masonry walls.

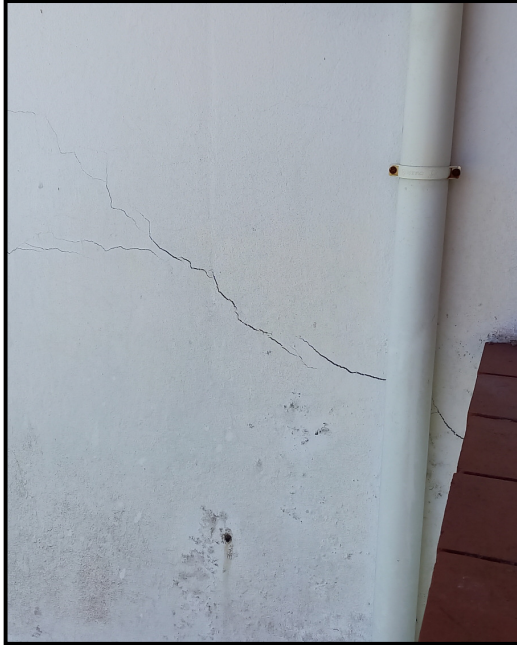
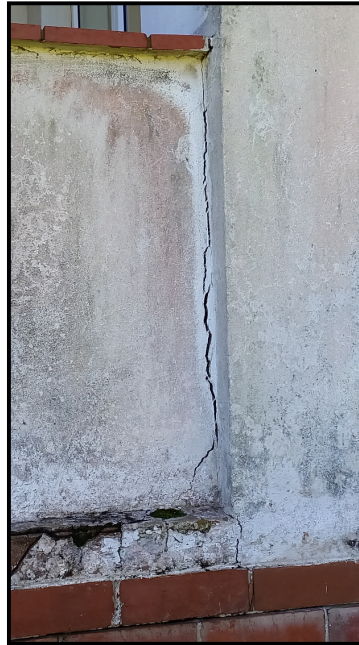
Cracks formed on masonry walls.

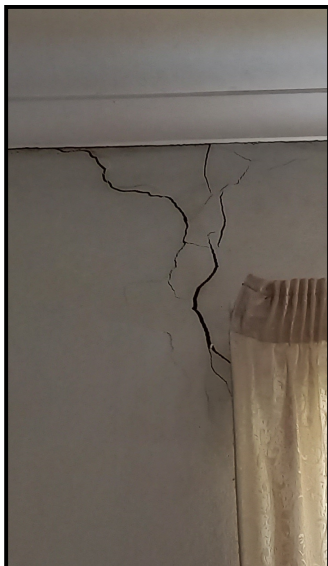
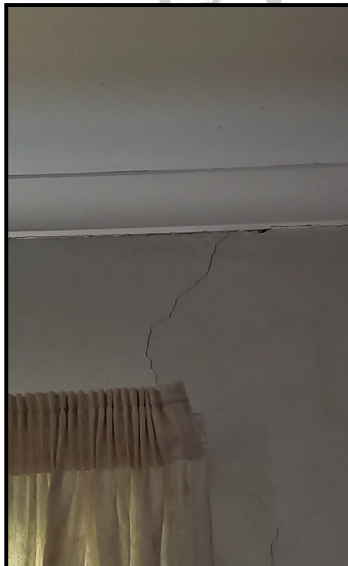
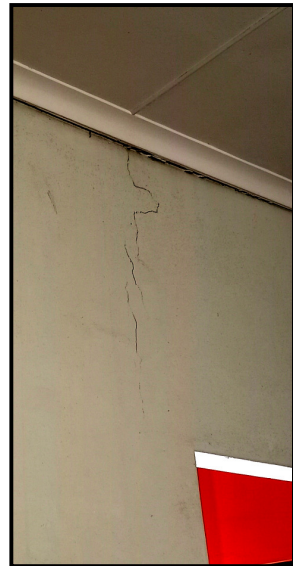
Cracks formed on masonry walls.

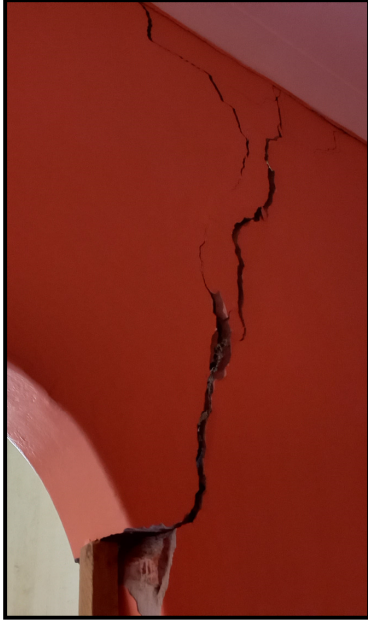
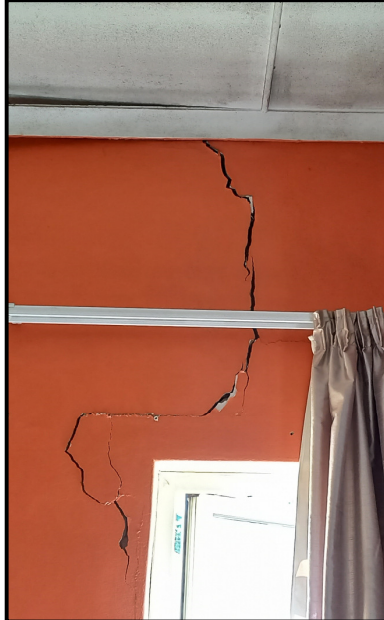
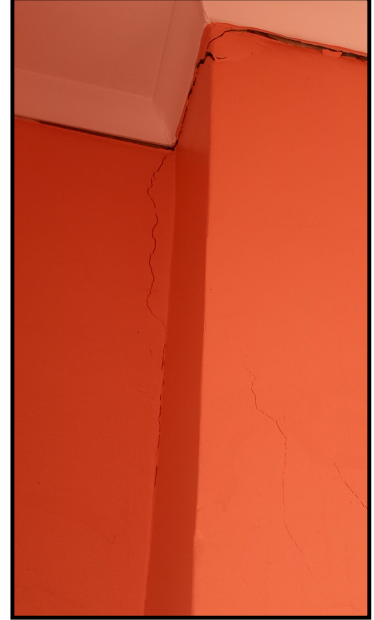
Cracks formed on masonry walls.

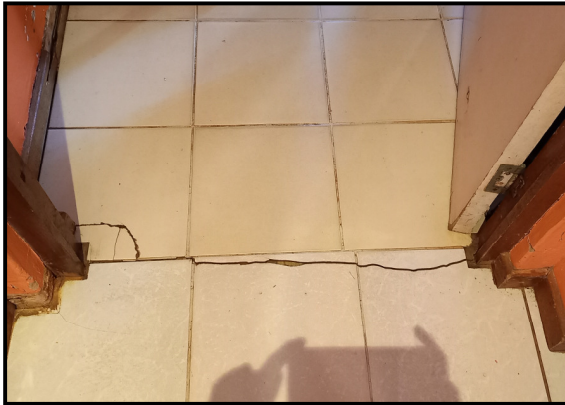
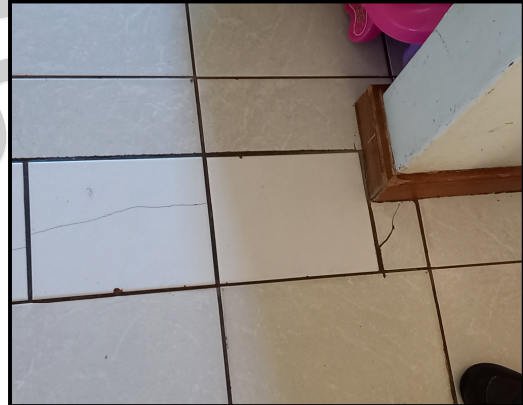
Cracks formed on floor.

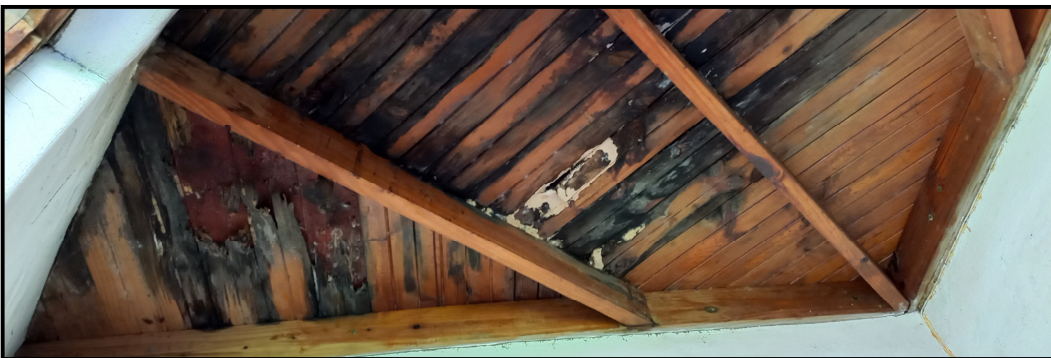
Rotting to the roof timber.
