Project Code: KDA_22073
Client Ref: 87 Workington Road, Kenville, Kwazulu-Natal
Date: 26 September 2022

Re: Structural Engineering Report: 87 Workington Road, Kenville, Kwazulu-Natal

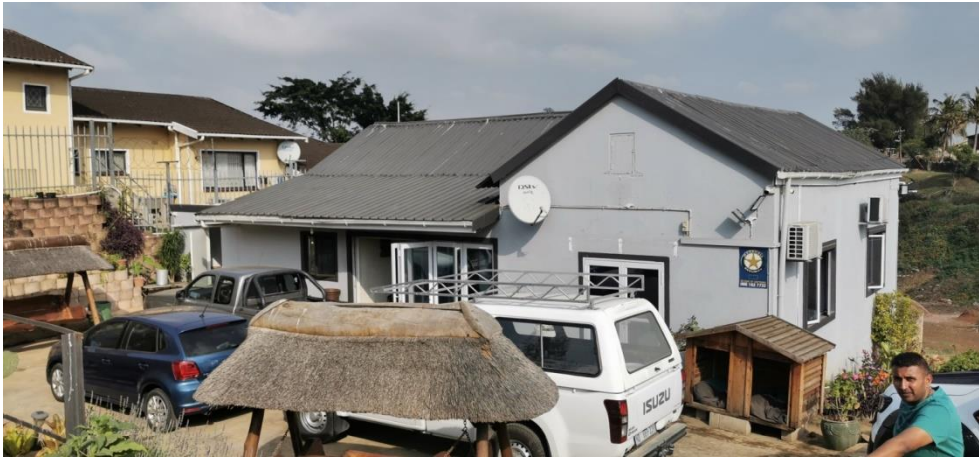
- Roof trusses sagging in areas.
- Loose and damaged roof sheeting
- Storm water goods damaged, loose and missing in areas.
- Storm water flows into the site from Parkington Grove.

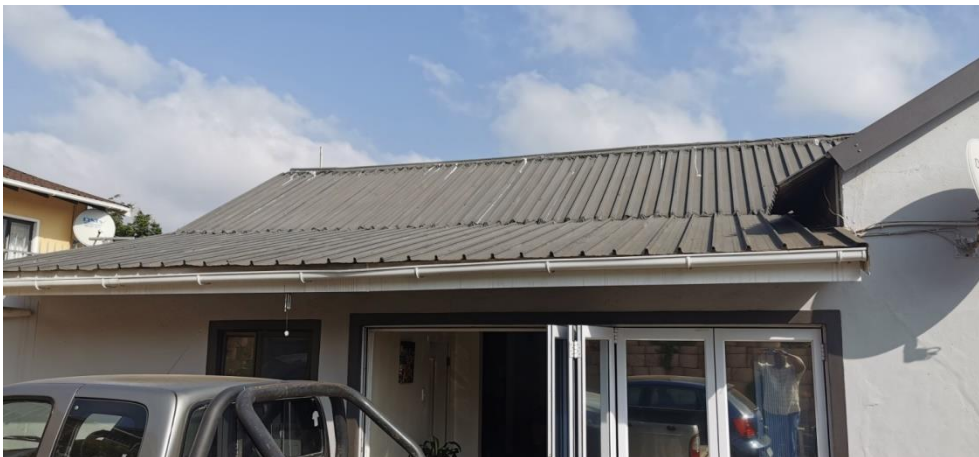
- Roof trusses sagging in areas.
- Loose and damaged roof sheeting
- Storm water goods damaged, loose and missing in areas.
- Storm water flows into the site from Parkington Grove.

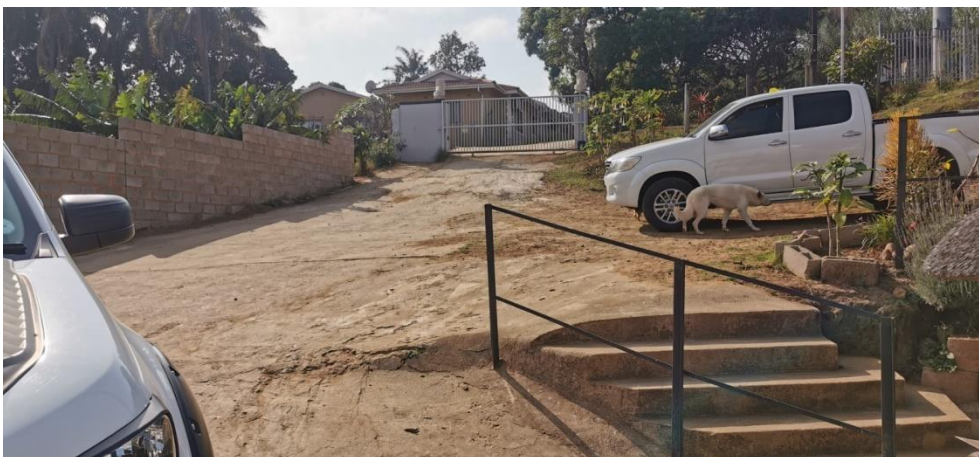
- Storm water flows into the site from Parkington Grove.
- Soil erosion and water ponding in pockets along the driveway and parking area.

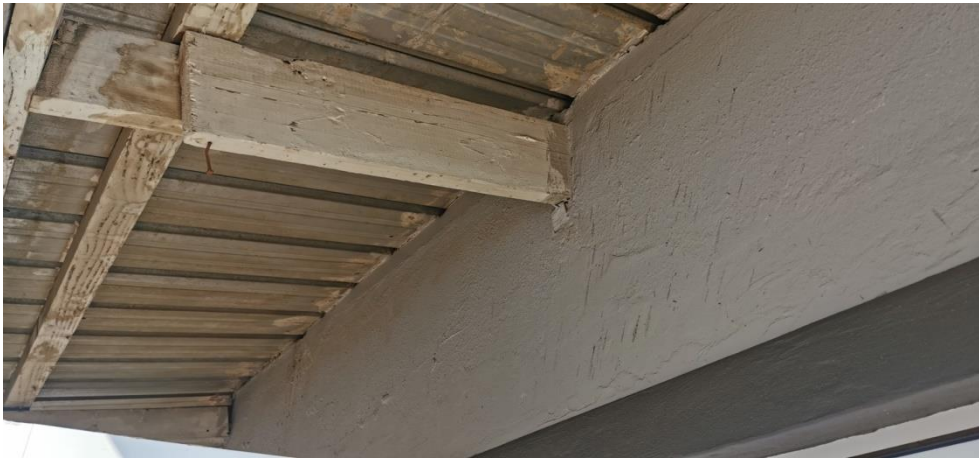
- Roof trusses damaged and sagging in areas.
- Loose and damaged roof sheeting
- Storm water goods damaged, loose and missing in areas.
- Cracks from moisture build up below sheeting.

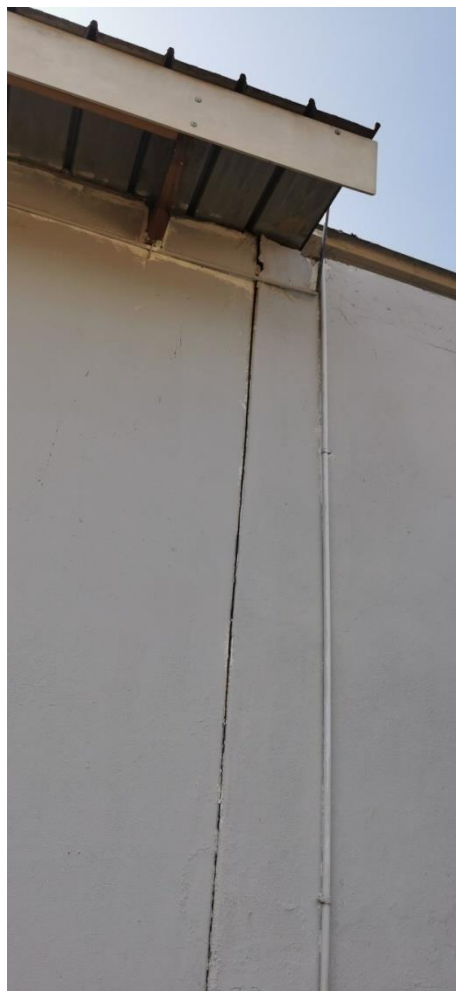
- Roof trusses damaged and sagging in areas.
- Storm water goods damaged, loose and missing in areas.
- Cracks form along the wall at various points.
- Facia boards missing.
- Movement at joint indicating settlement in the foundations.

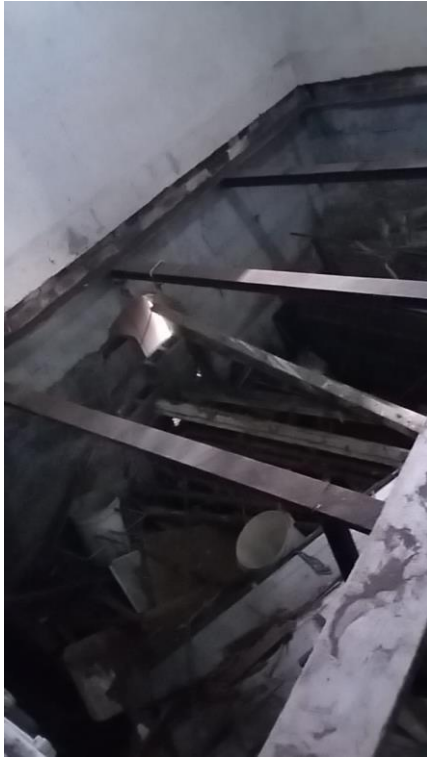
- Damaged timber bearer floor beams damaged in areas.
- Supporting brick column damaged & collapsed in areas.

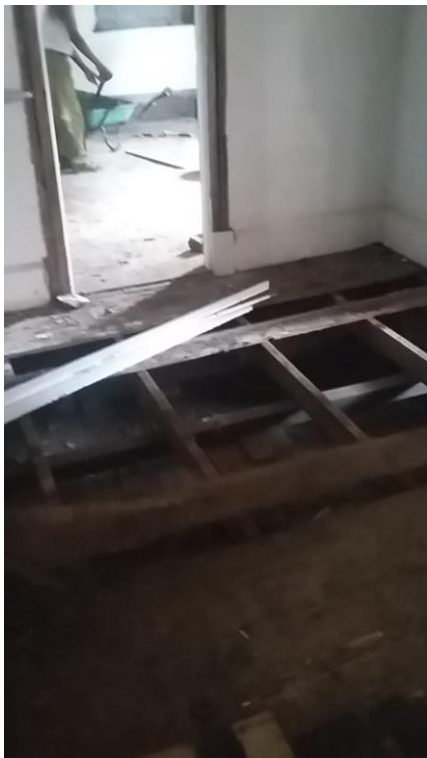
- Damaged timber bearer floor beams damaged in areas.
- Supporting brick column damaged & collapsed in areas.
- Signs of dampness along wall.
- Sign off water ponding within the structure compromising the material below the foundations.

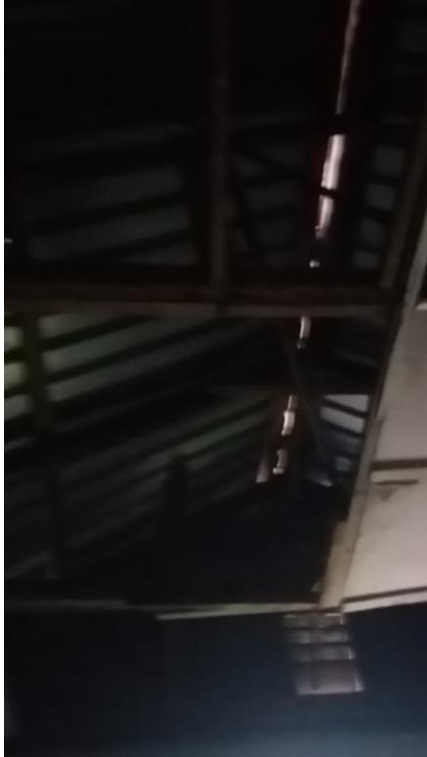
- Damaged roof sheeting
- Timber roof truss sagging and bowing in areas.
- Signs of dampness.
- Damaged and broken truss members in areas.

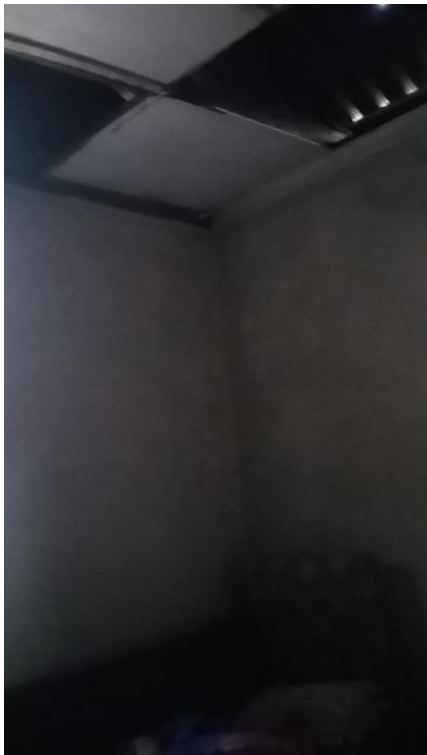
- Ceiling boards have collapsed in areas.
- Voids / holes in roof sheeting promoting leaks and damage to the timber trusses and structure.
- Remedial works currently being carried out.
- Remedial works to cracks on wall have recently been completed and painted.

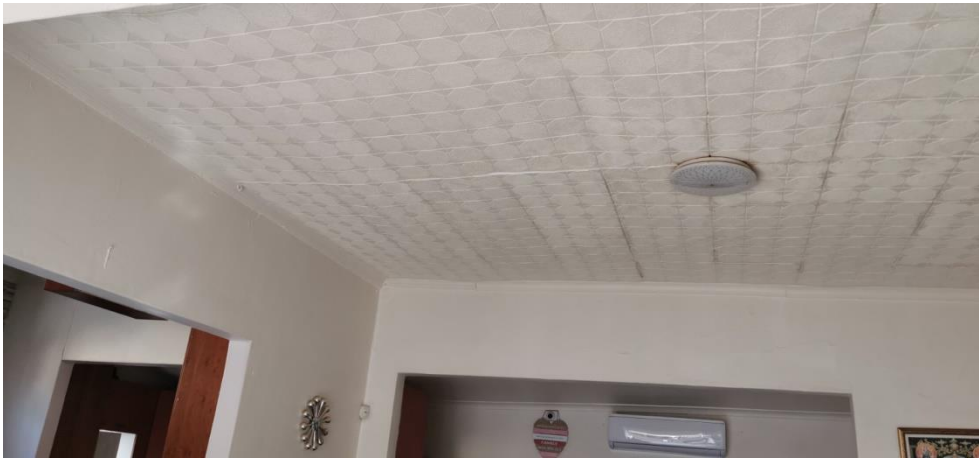
- Ceiling sagging in areas.
- Signs of dampness along joint lines.
- Visible water stains in areas.
- Remedial works has been completed in areas.

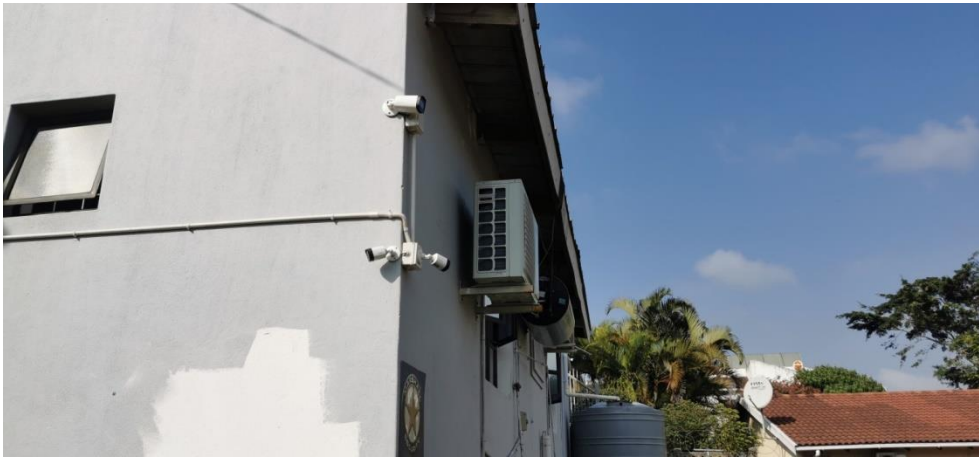
- Roof trusses damaged and sagging in areas.
- Storm water goods damaged, loose and missing in areas.
- Cracks from moisture build up below sheeting.
- Facia boards missing.
- Visible cracks on the brick work, remedial work currently being carried out.

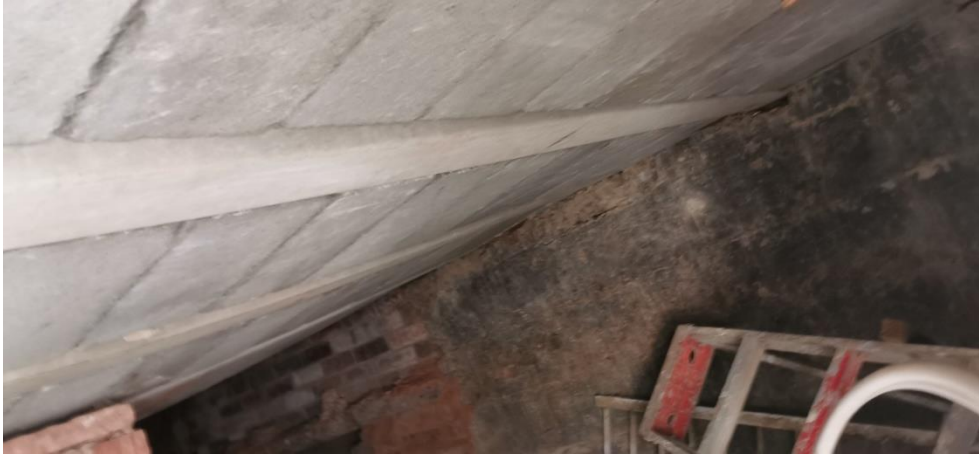
- Existing precast concrete lintels to floor slab deflecting.
- Moisture build-up noted on walls.
- Floor filler blocks not consistent.
- Lintels deflecting in areas.

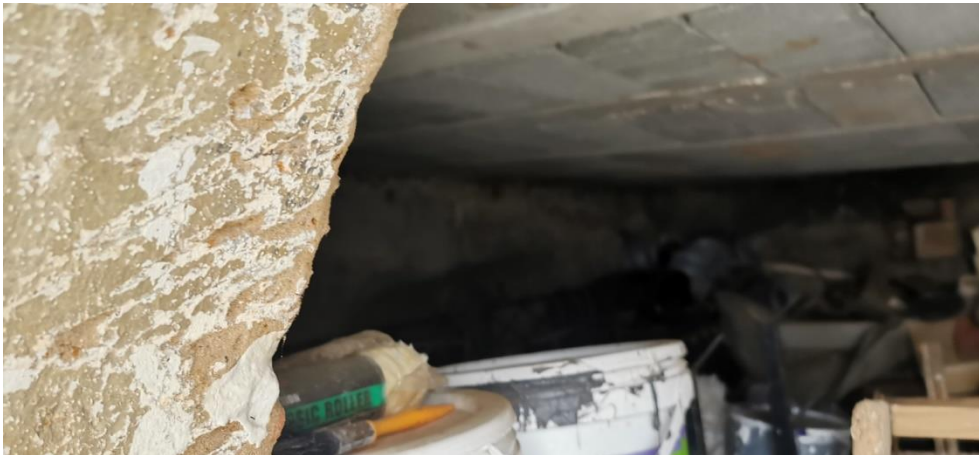
- Existing precast concrete lintels to slab deflecting.
- Moisture build-up noted on walls.
- Floor filler blocks not consistent.
- Lintels deflecting in areas.

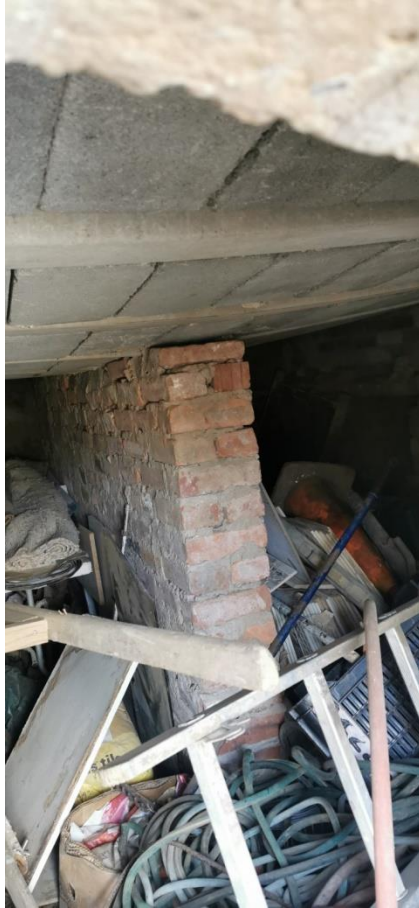
- Moisture build-up noted on walls.
- Floor filler blocks not consistent.
- Lintels deflecting in areas.
- Brick support wall not bonded.
- Signs of concrete erosion at pep joints.
- Poor quality brickwork for structural support.
- Lintel support and mid span has not been consistent.

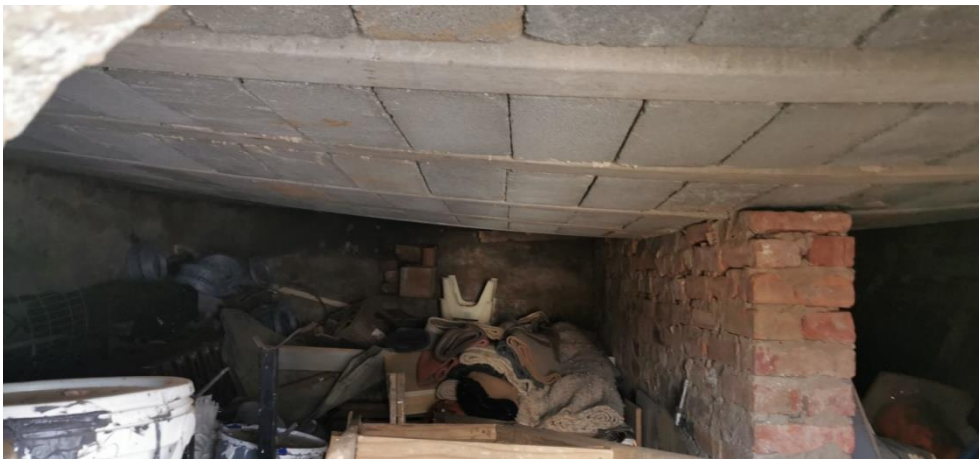
- Existing precast concrete lintels to slab deflecting.
- Filler blocks not consistent.
- Brick support wall not bonded.
- Signs of concrete erosion at pep joints visible.
- Lintel support and mid span has not been consistent.

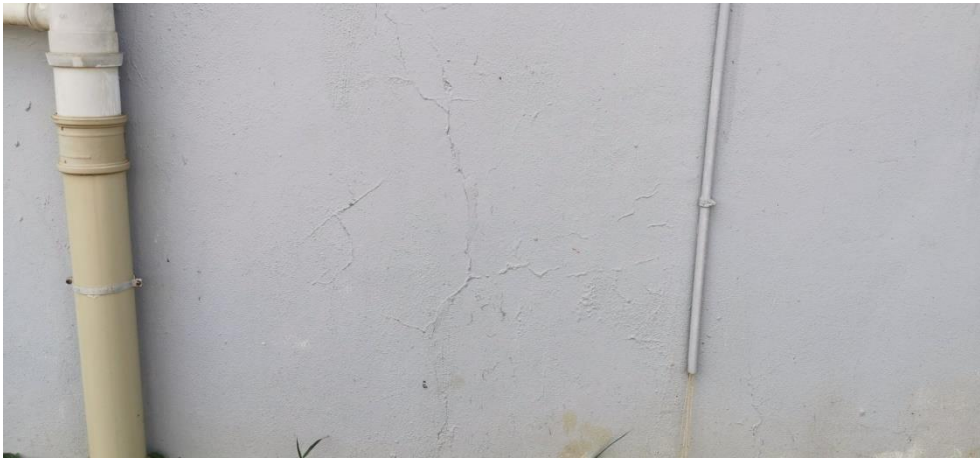
- Storm water goods damaged, loose and missing in areas.
- Visible cracks on the brick work, remedial work currently being carried out.

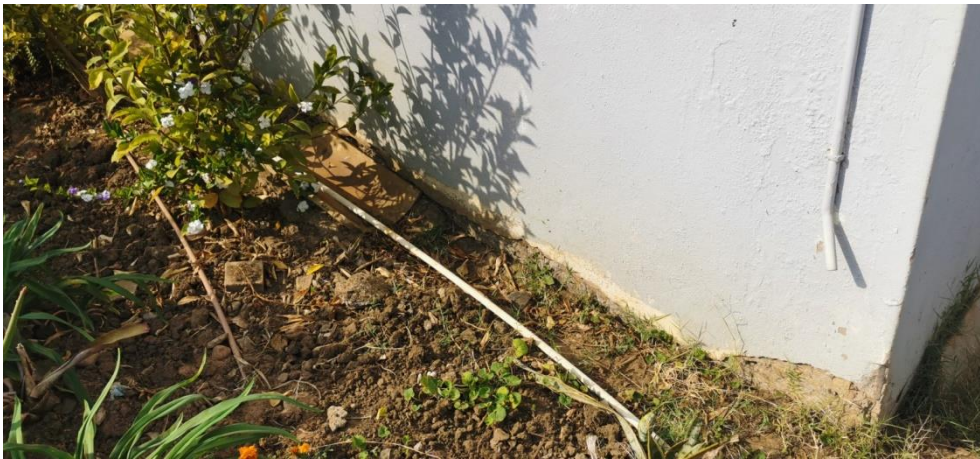
- Storm water goods damaged, loose and missing in areas.
- Visible cracks on the brick work.
- No Concrete aprons allowing water to penetrate to foundations compromising supporting material.
- Soil erosion, exposing foundation brick work.

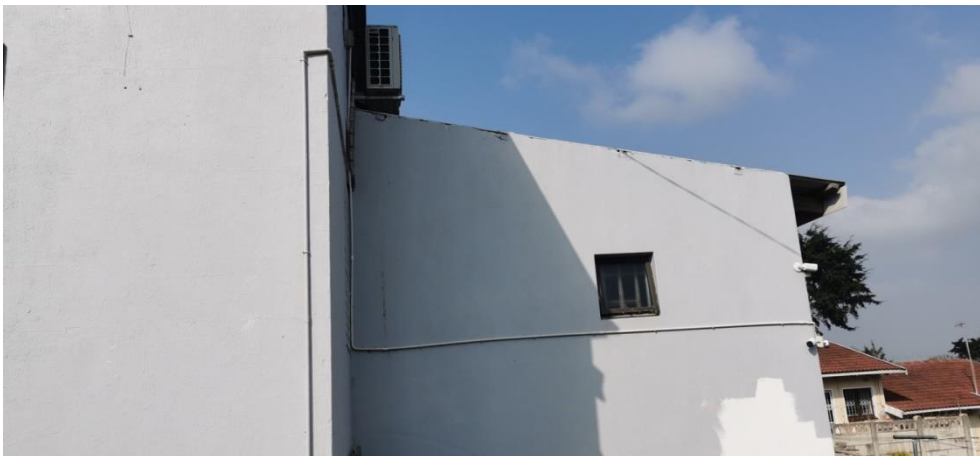
- Storm water goods damaged, loose and missing in areas.
- Fascia boards missing.
- Visible cracks on the brick work, remedial work currently being carried out.

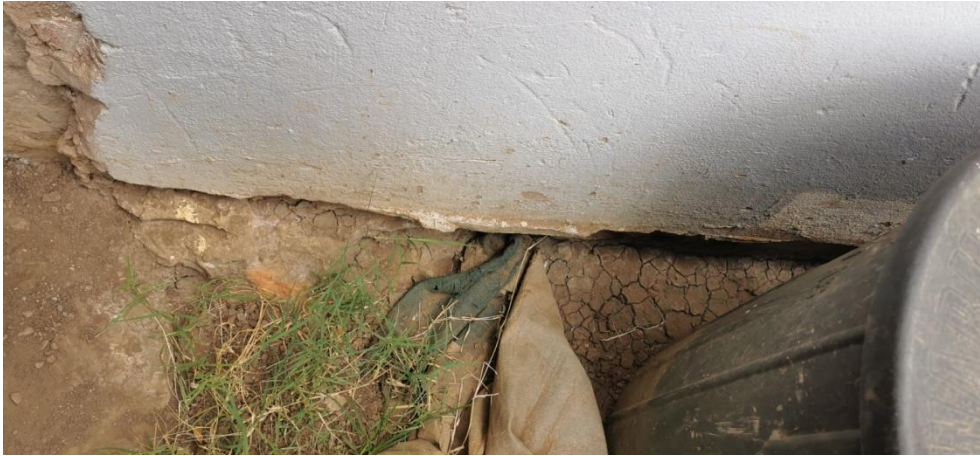
- No concrete aprons or drainage allowing water to penetrate to foundations
- Water compromising the foundation material.
- Sign of ponding.
- Soil erosion.

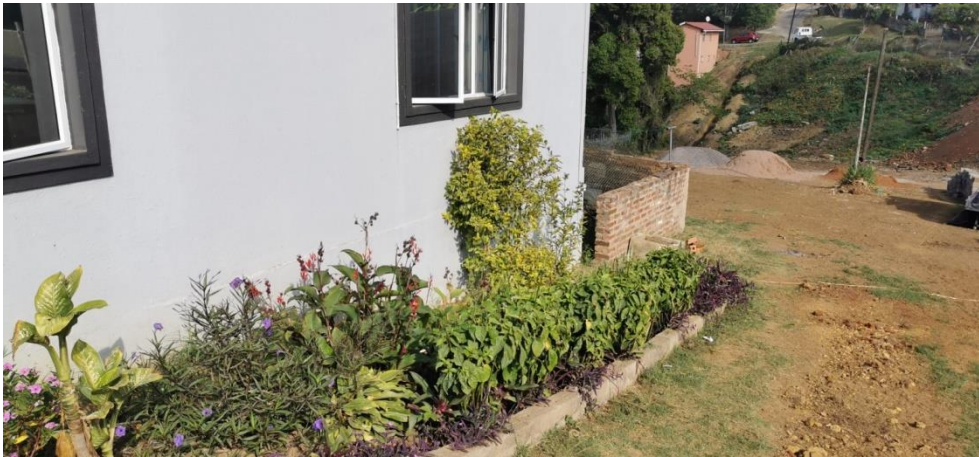
- No concrete aprons or drainage allowing water to penetrate to foundations.
- Soil erosion exposing foundation brick work in areas.

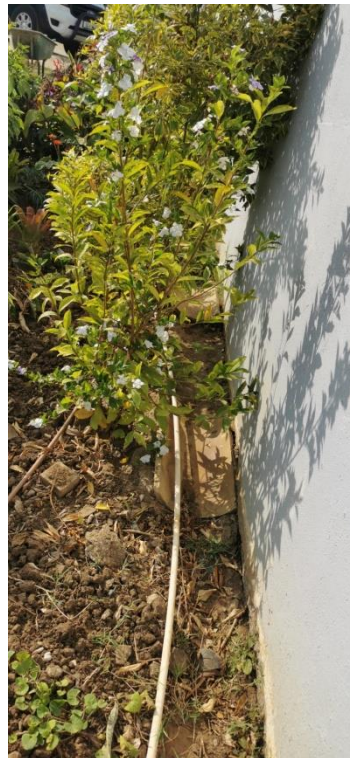
- No concrete aprons or drainage allowing water to penetrate to foundations.
- Soil erosion exposing foundation brick work in areas.

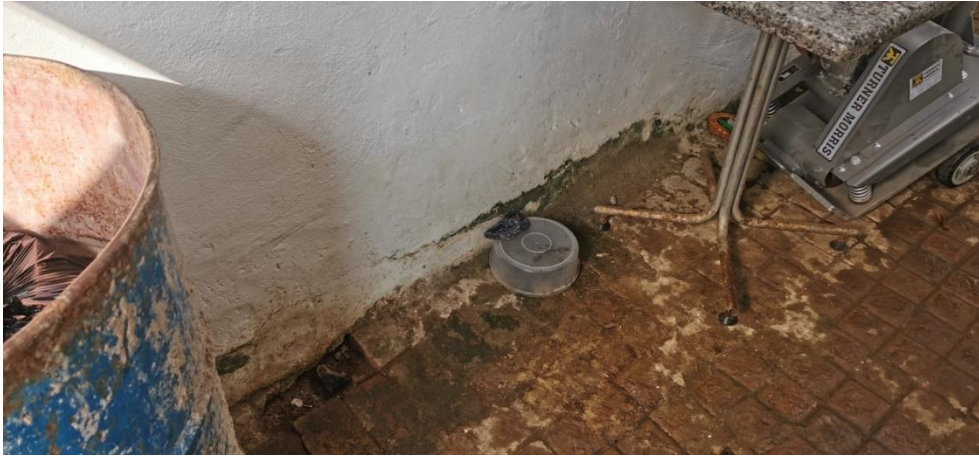
- No concrete aprons or drainage allowing water to penetrate to foundations.
- Water ponding.
- Visible cracks on wall.

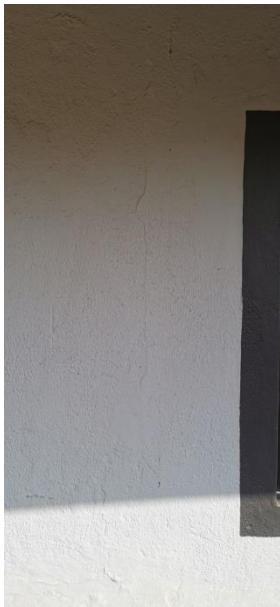
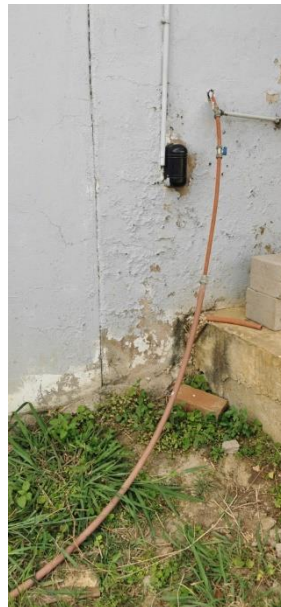
- No concrete aprons or drainage allowing water to penetrate to foundations.
- Water ponding.
- Visible cracks on wall.
- Signs of dampness.
- Soil erosion.

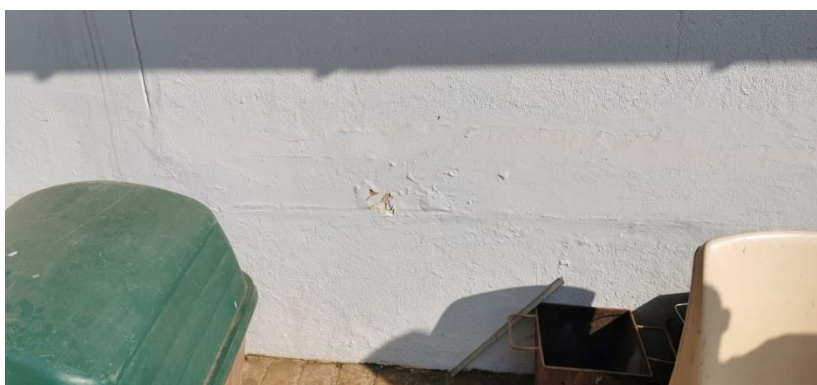
- Visible cracks on wall.
- Remedial works currently being completed.
