# ASMAL ENGINEERS (PTY LTD)

**15th MAY 2023**

**927 UMGENI ROAD: STRUCTURAL ASSESSMENT REPORT**

## **1.0 Terms Of Reference**

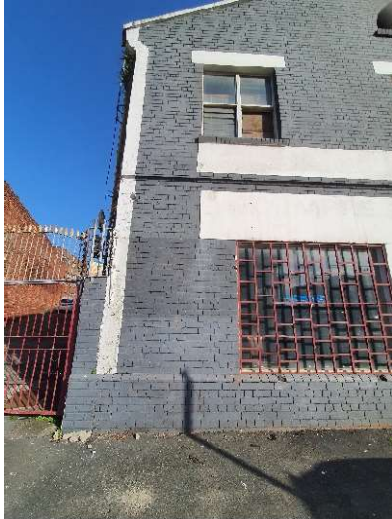
Front Façade on Umgeni road - Moisture and dampness issues were evident on the concrete columns and beams. Significant plant growth within the brickwork has also been noted.

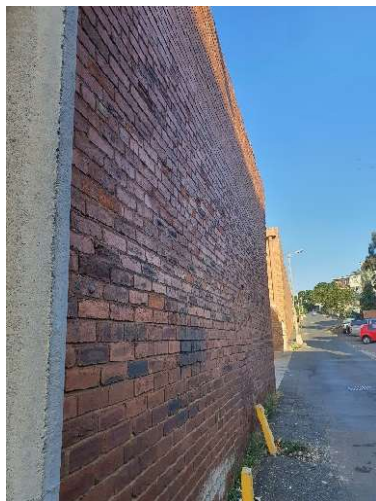
Northern Façade on Keswick Road – External brickwork was identified to be bulging and leaning inwards towards the building. The probable cause for this being due to the damage sustained to the internal roof.

A combination of the roof collapsing inwards and portions of this roof collapsing entirely has resulted in this brickwork to losing lateral restraint. This can also be seen in the images that follow.

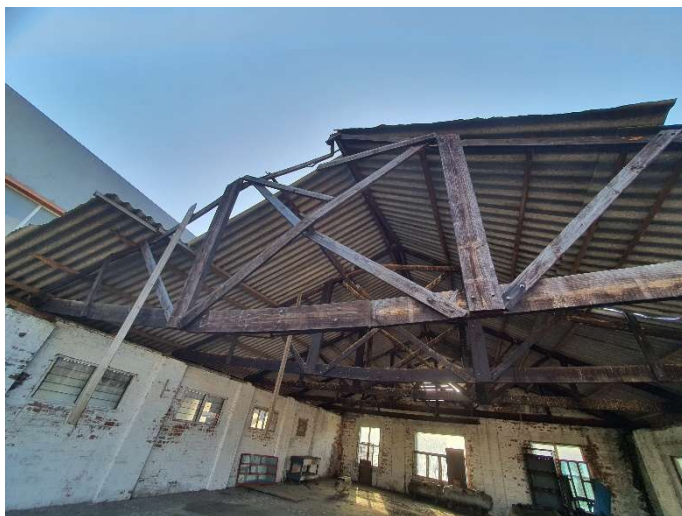
1<sup>st</sup> floor of building A - depicting fire damaged trusses

These trusses are damaged beyond repair; the manner of failure has also resulted in the trusses pulling the external brickwork inwards.

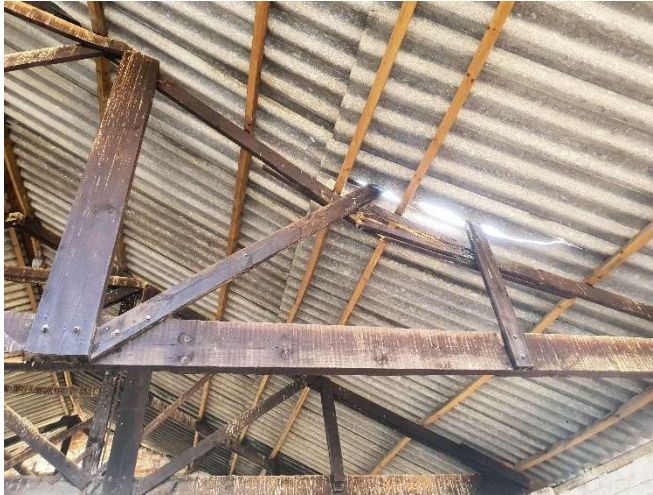
1<sup>st</sup> floor of building A depicting fire damaged trusses – Imagery of failed trusses.

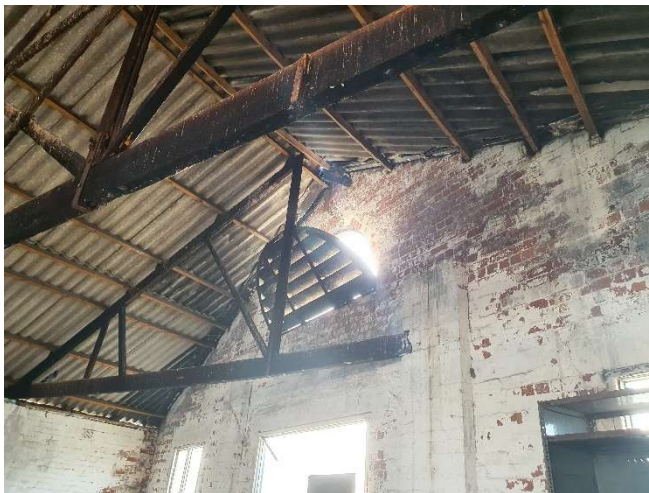
1<sup>st</sup> floor of building A- Umgeni Road facade  
Trusses damaged beyond repair.  
Brickwork also shows signs of moisture and dampness issues.

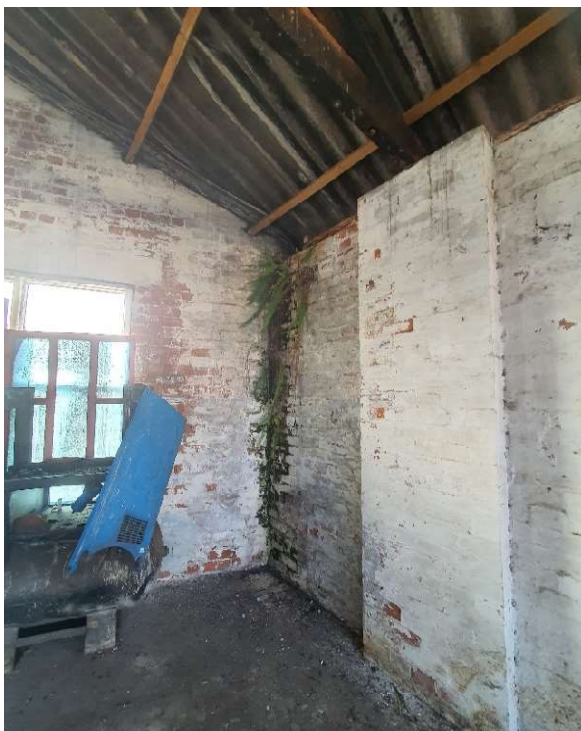
1<sup>st</sup> floor - Corner of Umgeni Road and entrance driveway  
Plant growth through the brickwork with dampness and moisture observed.

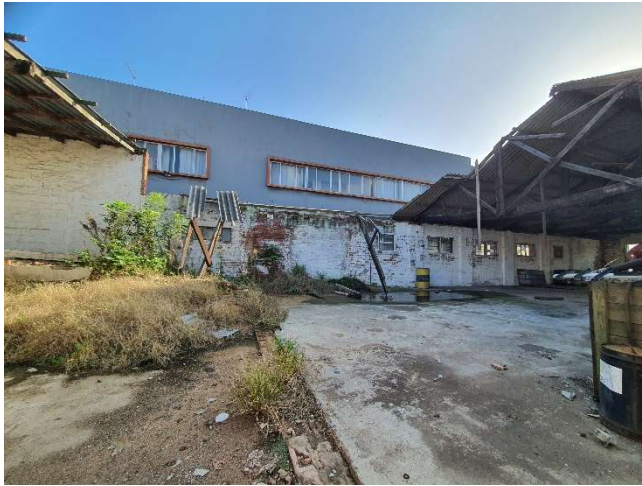
Extent of roof being collapsing during fire.  
Collapsed sections were subsequently removed.

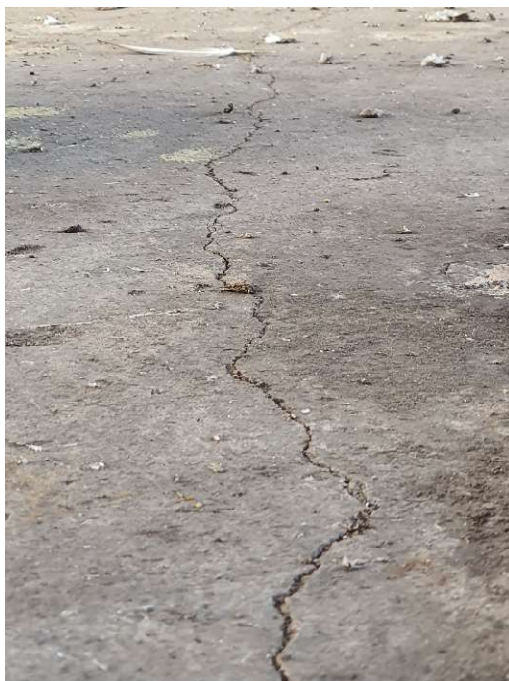
1<sup>st</sup> Floor suspended slab – cracks in the suspended slab indicating either deflection or settlement issues.

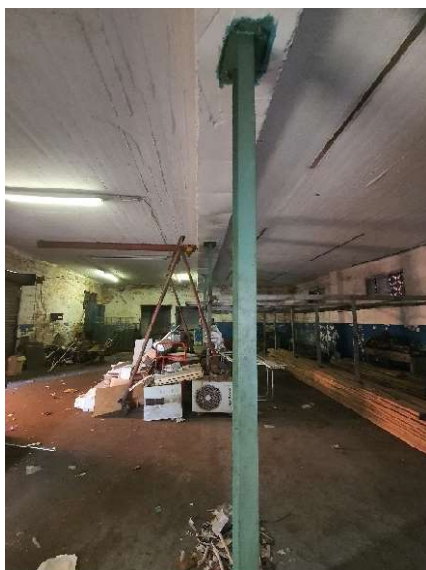
Ground floor – internal structural steel columns.  
Steel columns appear to be bowed and are not vertical.  
A desktop analysis of these columns indicate that these steel columns do not have sufficient capacity for the anticipated loads. These steel column also appear to be retrofitted as an alteration to the existing structure.

- **Design deficiencies**
  - *Building A internal steel columns* – As stated in our site observations, a desktop analysis of the steel columns indicate that they do not have sufficient capacity for the anticipated loads.

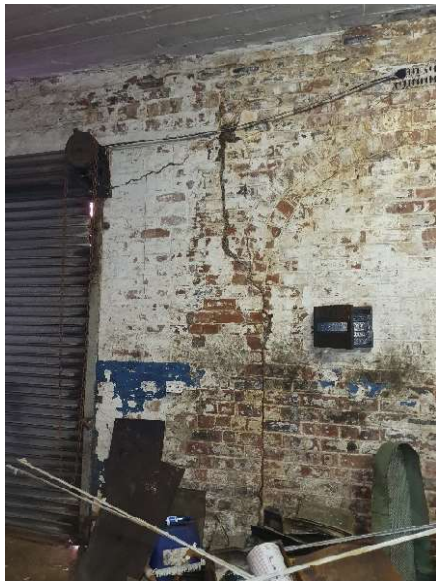
#### Ground floor – External brickwork

Several vertical and diagonal cracks have been encountered at the ground floor of building A, indicating either differential settlement of the foundations, high stresses on the brickwork or a combination of both.

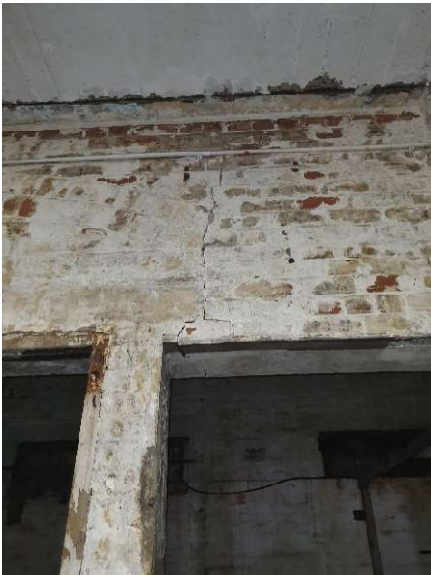
#### Ground floor – Internal Masonry beams

These Masonry beams indicate signs of shear failure.

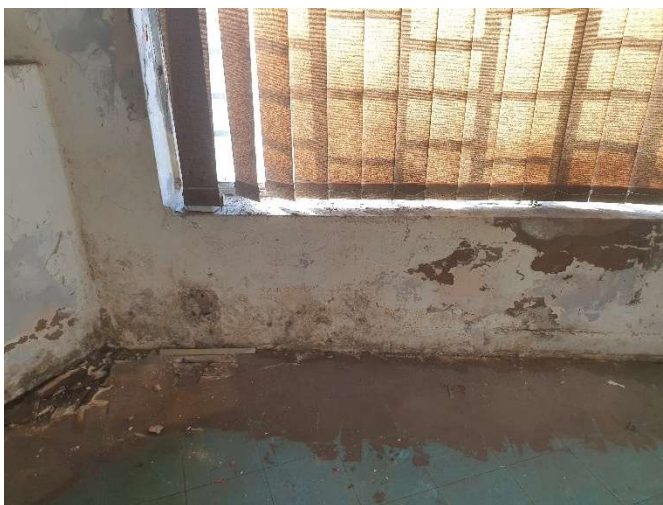
#### Ground floor – Interior of Umgeni Road façade

Major moisture and dampness issues observed.

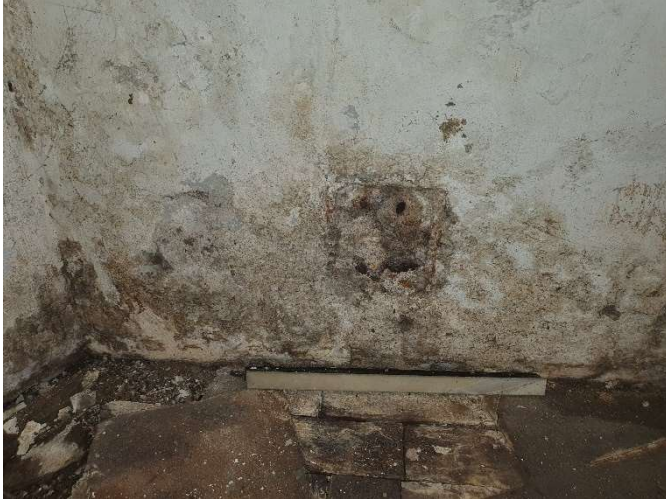
Ground floor – Interior of Umgeni Road façade

Moisture and dampness issues observed.

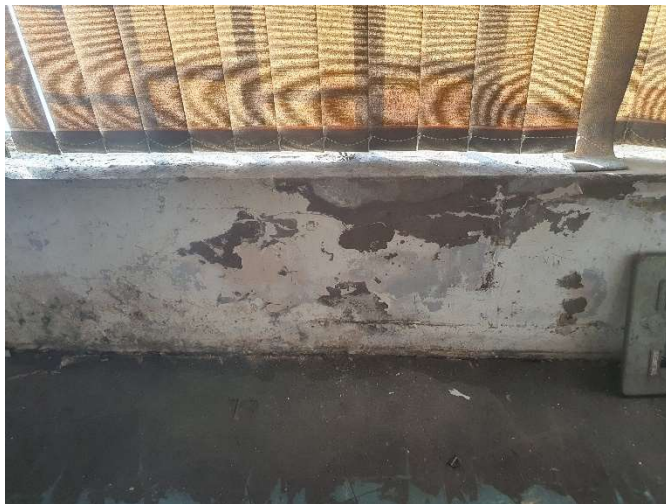
Ground floor – Interior of Umgeni Road façade

Moisture and dampness issues observed.

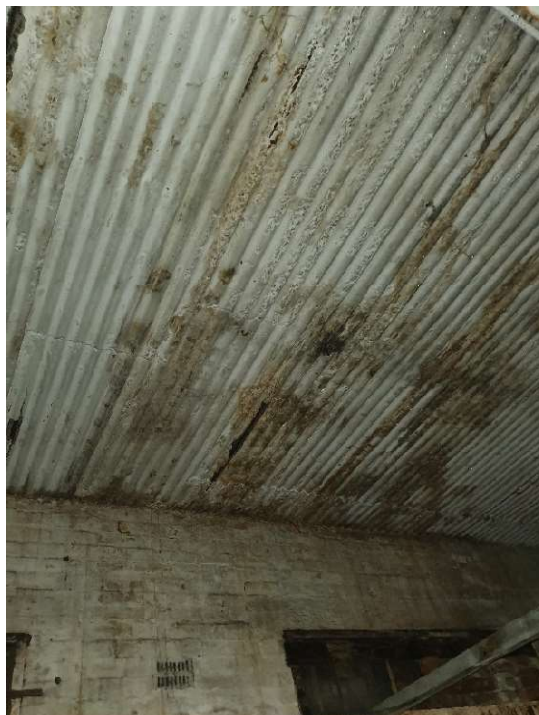
A portion of the soffit of the 1<sup>st</sup> floor slab

Major spalling encountered here. A permanent shutter slab system was used in these areas, the permanent shutter was subsequently removed which would be the main reason for spalling encountered. In addition to the spalling, the permanent shutter was the slab systems main mode of tensile reinforcement, with this no longer being in place, these slabs are structurally vulnerable to failure as is evident in Building C.

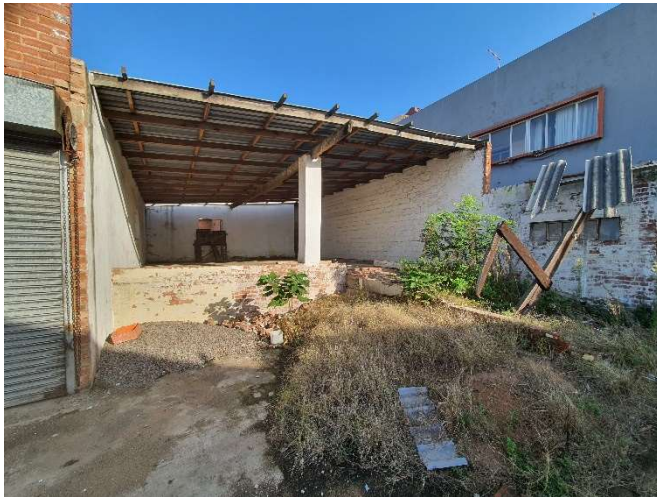
### Building B - 1<sup>st</sup> floor

Original roof was damaged during fire.

A new roof was subsequently installed; however, a desktop analysis indicates that this roof structure design is inadequate for the spans.

- *Building B & C timber roofs* – The original roofs were replaced by new sheeted roofs, however a desktop analysis indicates that these roof structure designs are inadequate.

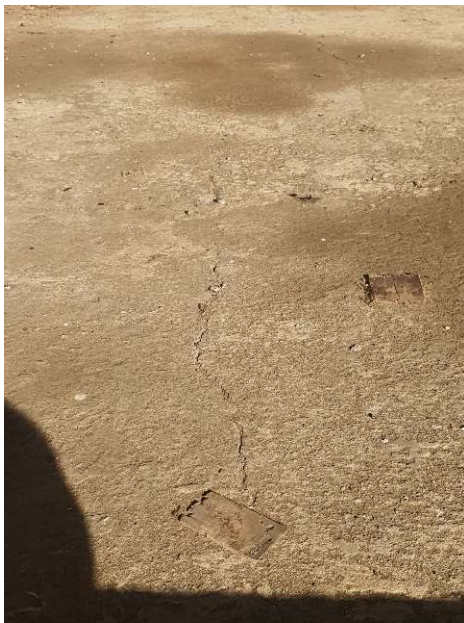
### 1<sup>st</sup> floor suspended slab

Numerous Surface Cracks are evident on the suspended slab.

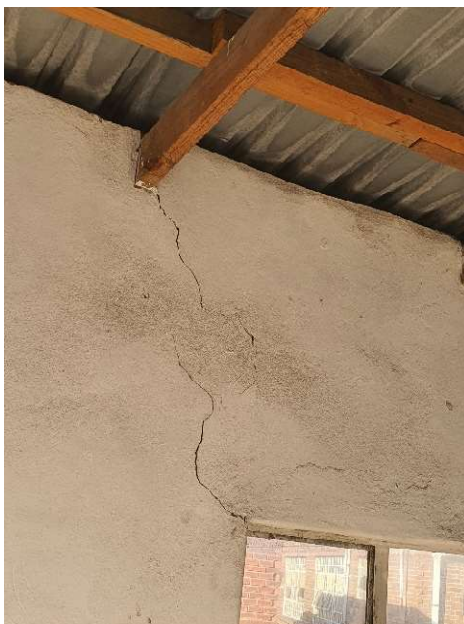
### 1<sup>st</sup> floor eaves

Shear failure cracks evident on the eaves of the 1<sup>st</sup> floor.

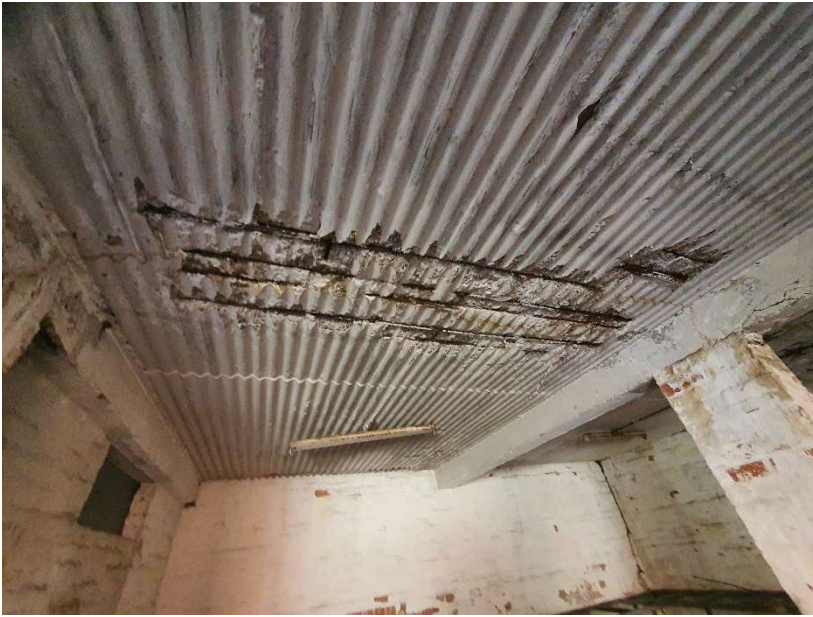
Building B – Ground Floor- Soffit of 1<sup>st</sup> floor slab

Major spalling has been identified throughout this slab and its supporting beams. A permanent shutter slab system was used in these areas, the permanent shutter was subsequently removed which would be the main reason for spalling encountered. In addition to the spalling, the permanent shutter is the slab systems main mode of tensile reinforcement, with this no longer being in place, these slabs are structurally vulnerable to failure as is evident in Building C.

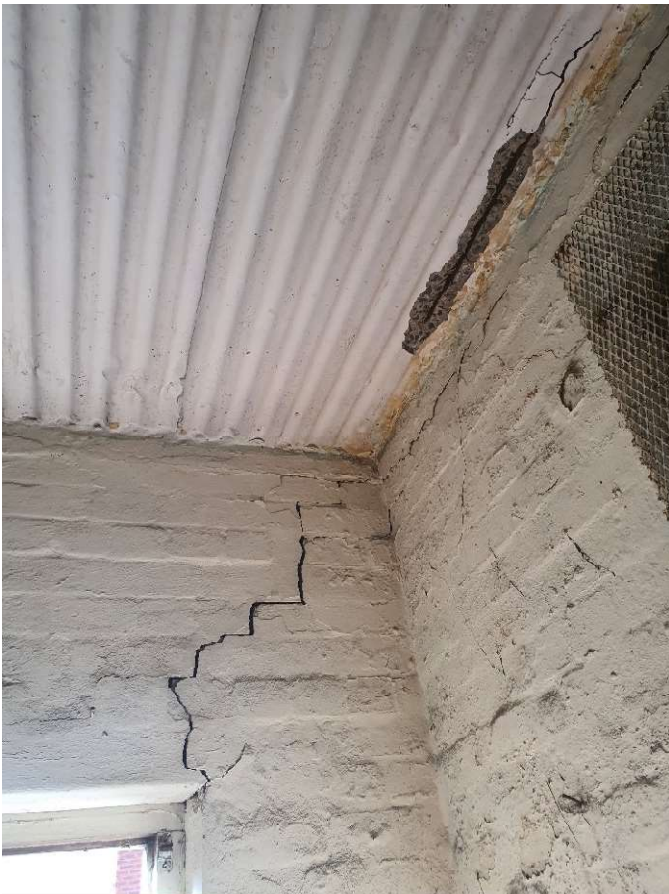
Building B – Ground Floor- Soffit of 1<sup>st</sup> floor slab

Diagonal cracks within the brickwork, and more evidence of spalling.

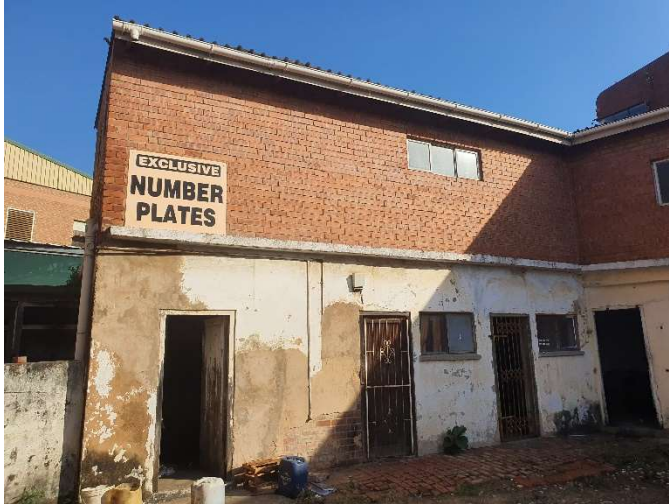
Ground floor – Dampness and moisture issues evident at the ground level.

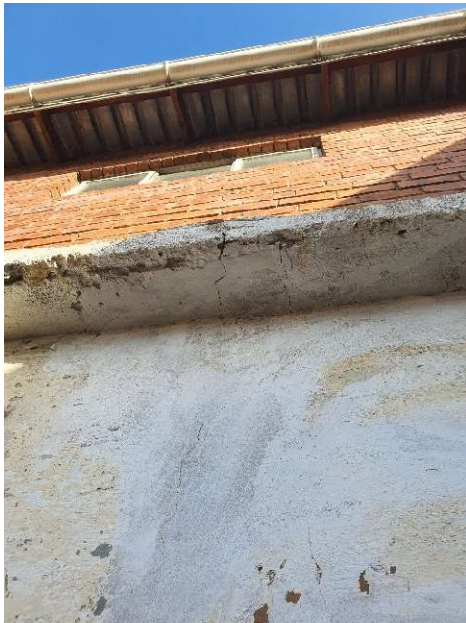
Ground floor – Cracks through the brickwork and concrete overhang slab noted.

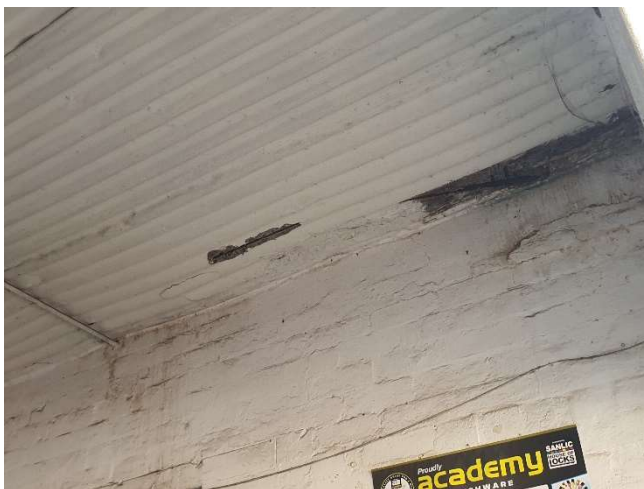
Ground floor- Soffit of 1<sup>st</sup> floor slab  
A substantial amount of spalling noted throughout the soffit of the 1<sup>st</sup> floor slab.

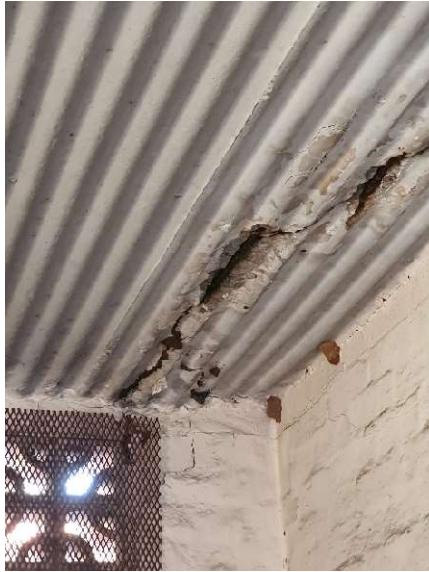
Ground floor- Soffit of 1<sup>st</sup> floor slab  
Spalling at soffit of 1<sup>st</sup> floor slab.

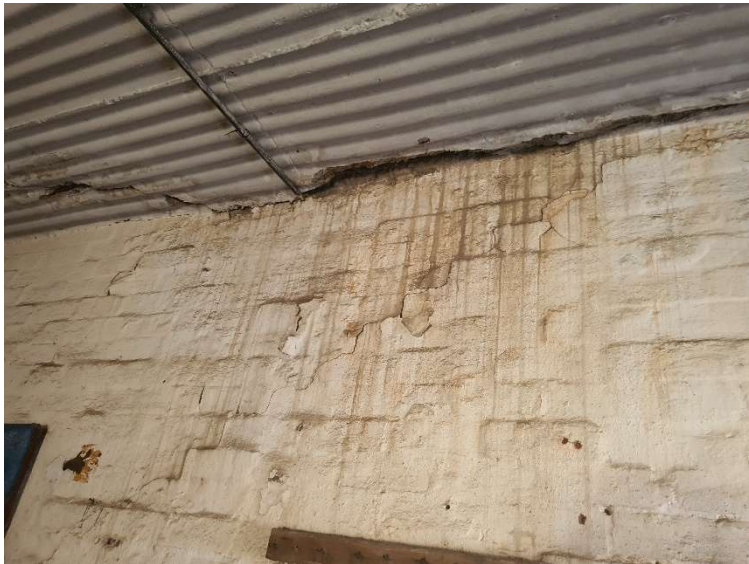
Ground floor- Soffit of 1<sup>st</sup> floor slab  
Spalling at soffit of 1<sup>st</sup> floor slab.  
Diagonal cracks also noted in  
ground floor brickwork, indicative  
of differential settlement of  
foundations.

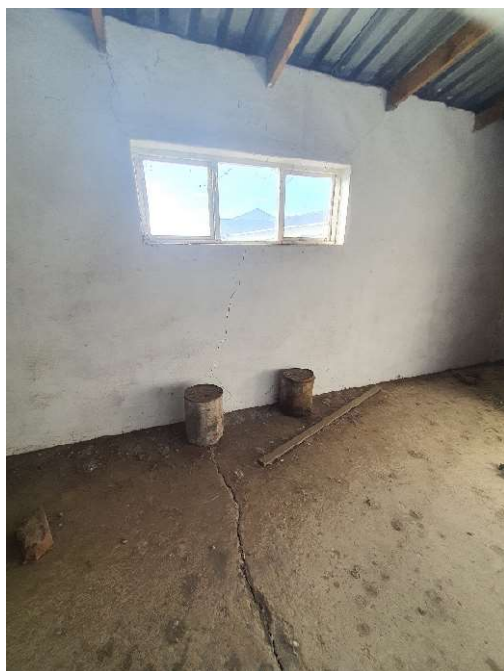
1<sup>st</sup> floor – A Large crack has formed through the length  
suspended slab which extends upwards through the  
brickwork to eaves level.  
The cause of the cracks are either due to differential  
settlement of the foundations, spalling of the slab or a  
combination of both.

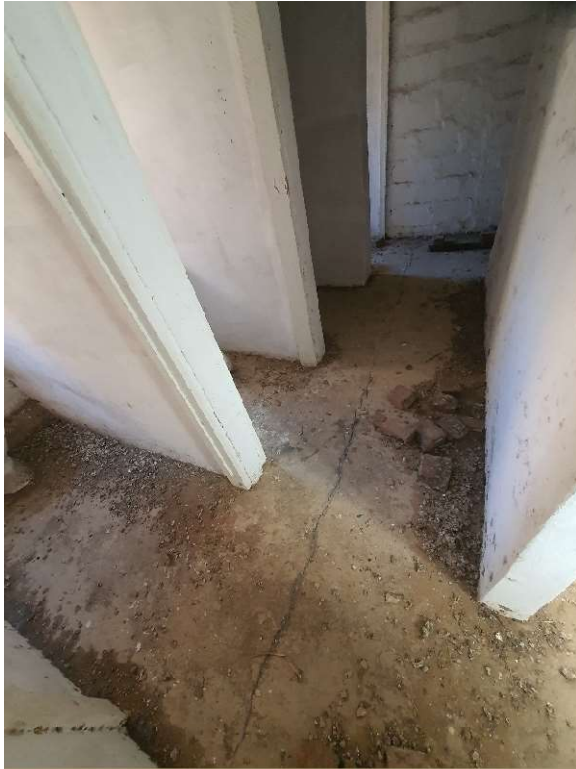
1<sup>st</sup> floor – Another Large crack identified that has formed through the length of the suspended slab which extends upwards through the brickwork up to eaves level.

The cause of the cracks are either due to differential settlement of the foundations, the spalling noted at the soffit of the slab or a combination of both.
