P.O.BOX 37188 OVERPORT DURBAN 4067 TELE : 2097245/6 FAX : 2097247 E-MAIL : seedat@ion.co.za AHMED.SEEDAT-ARCHITECT REG no :3140(S.A.C.A.P)	ROOM NAME - PROJECT: NATAL COMMAND -DILAPIDATION REPORT	SCALE: 1/50	DRWG.No: 21126
	DRAWING TITLE: ROOM AND OFFICE DATA SHEETS	DATE: DEC 2022	PAGE.No: 1

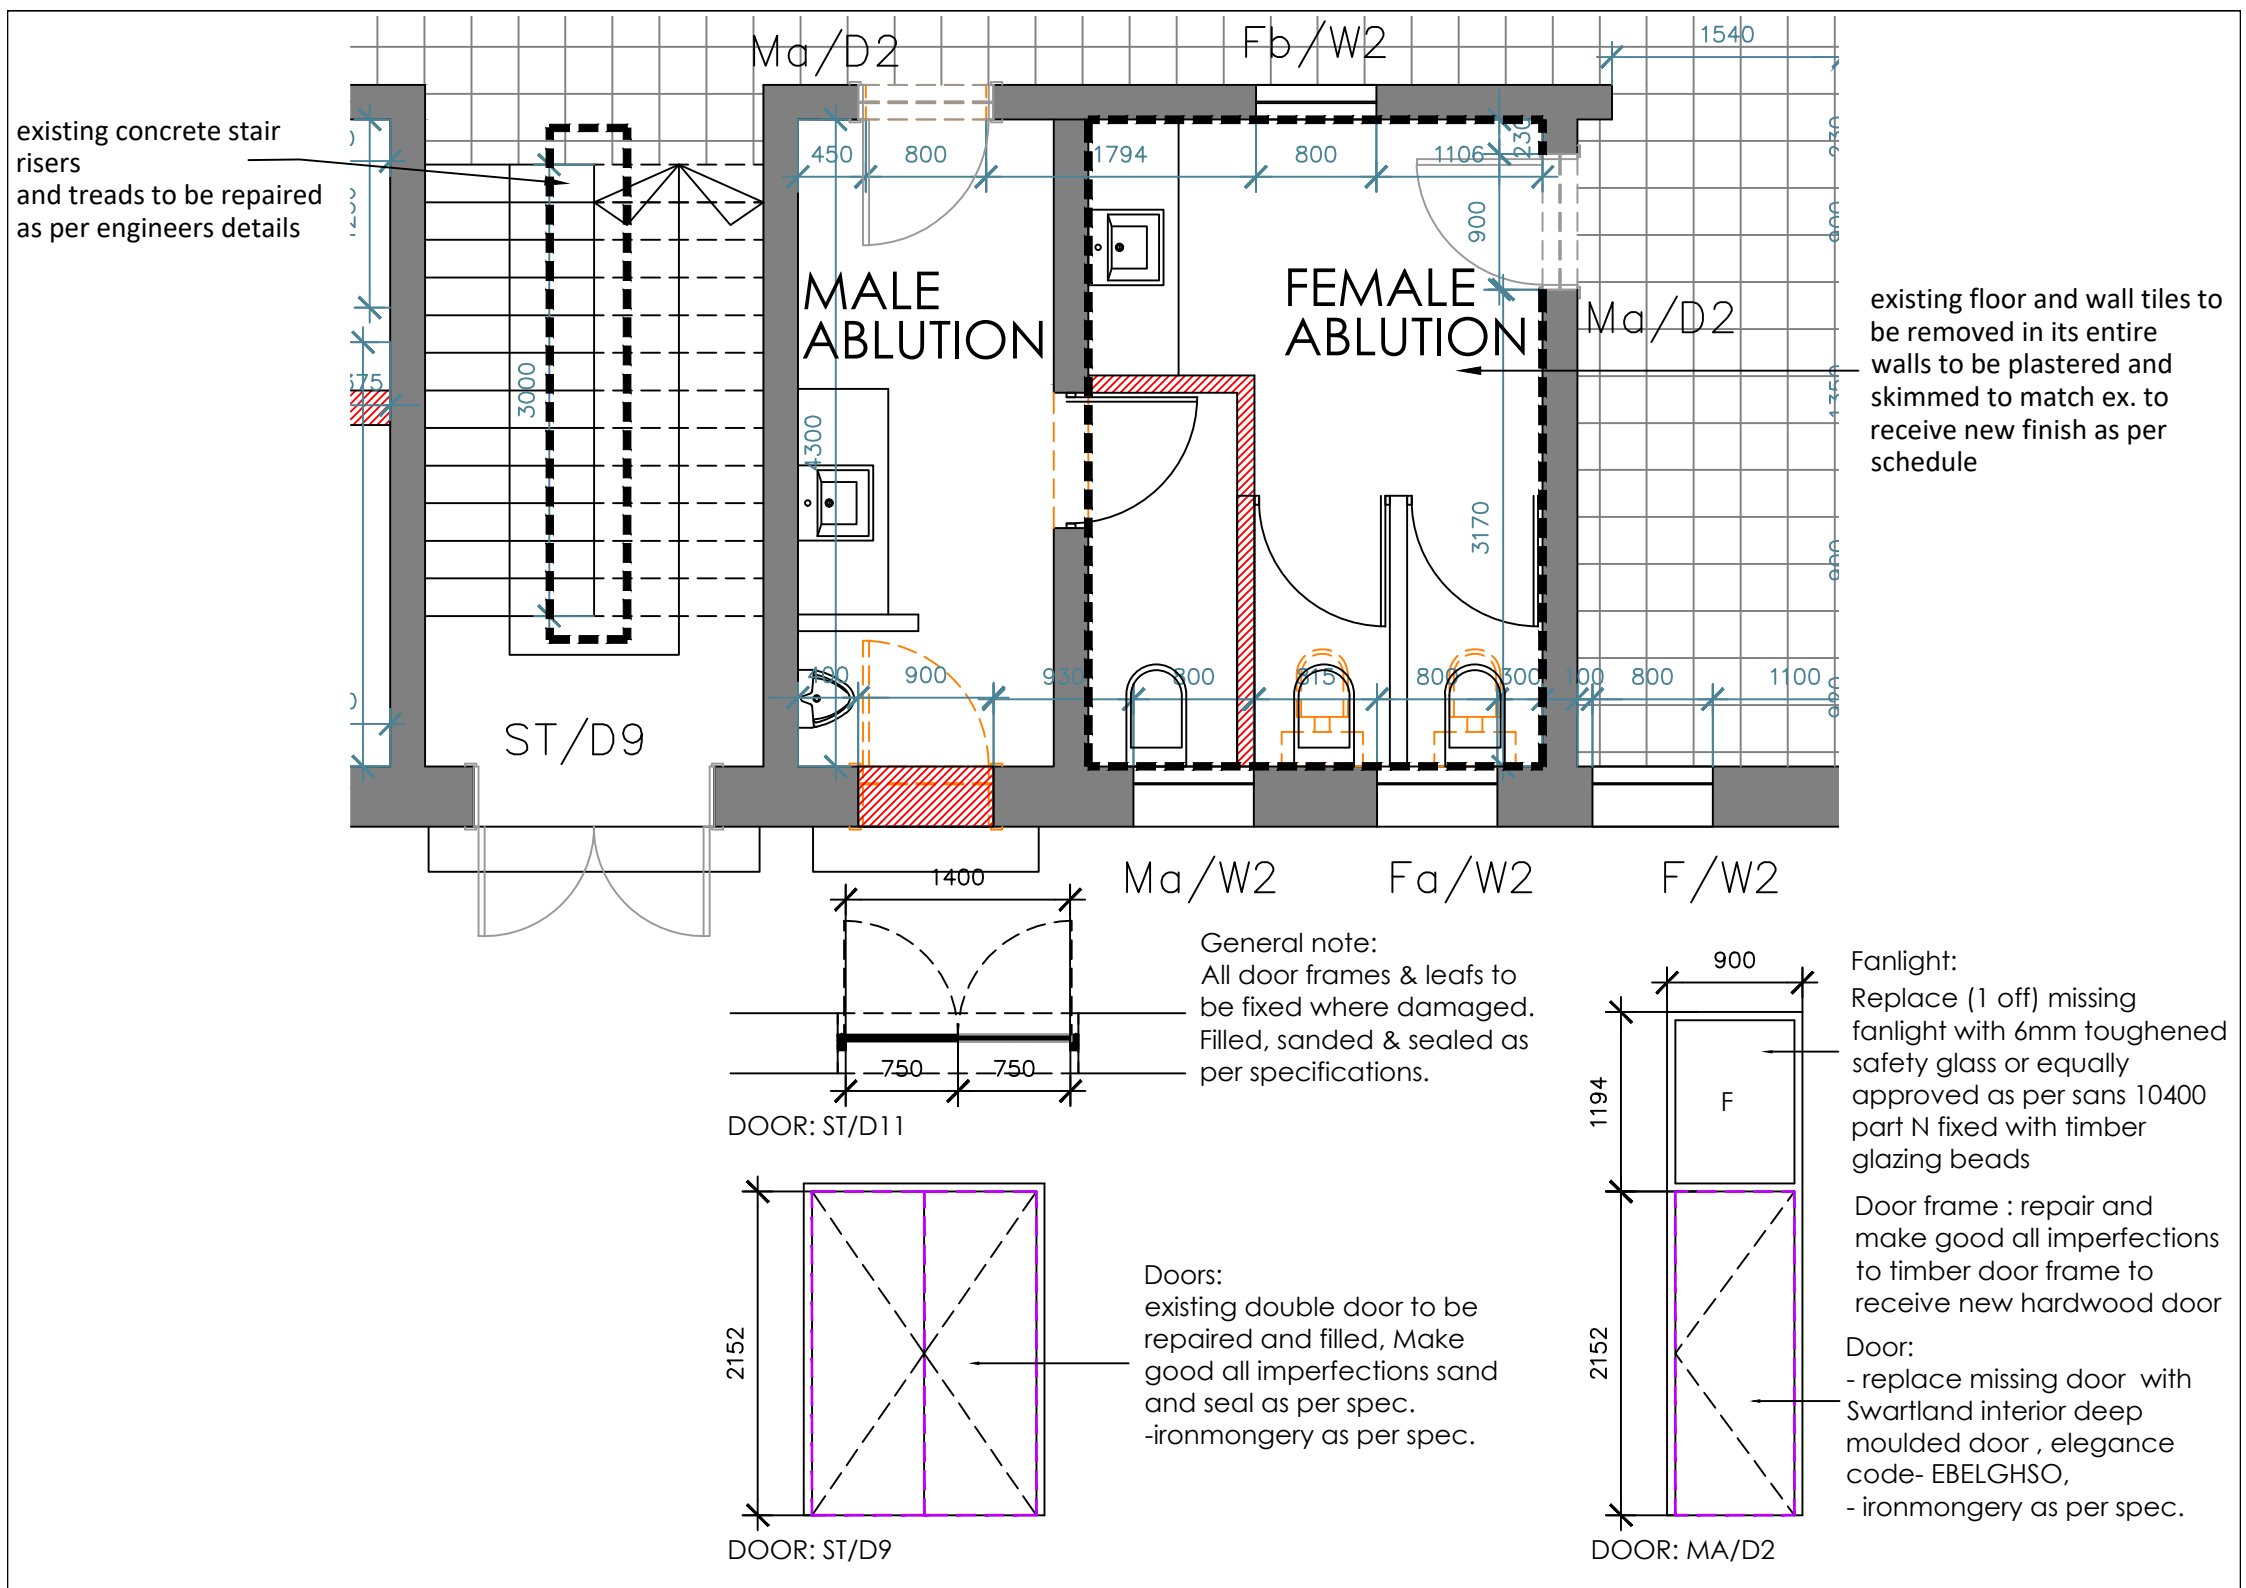
FLOOR FINISH	• Floors: ex. floor tiles to be removed in its entire floor to be made good to receive new floor finish as per specifications - 29.74m ²
WALL FINISH	• Existing plaster & paint: - Walls to be scraped, treated, fill all imperfections. - Walls to receive new finish as per specifications
DADO RAILS	• Dado rail: Ex. dado rail to be inspected for wood rot & water damage. Replace damaged dado rails with salvaged. Sand, repair & seal as per specification.
CEILING	• - hack off existing flaking paint , treat and fill all imperfections to receive new finish as per spec.
WINDOW	• Existing Timber Window Frames: - Timber window frames to be inspected for wood rot and water damage. - Affected mullions to be removed and replaces to match. - All damage and broken glass to be replaced with 6mm toughened safety glass as per sans 10400 Part N or equally approved my specialist - Window hinges to be replaced with brass type hinge and secured with brass screws Window handles: Window handles to be replaced with brass type handles to match existing and fixed with brass screws as per schedule Windowsill : - Windowsill to be inspected for damage ,and replaced were required - Affected sills to be removed and replaces to match.

DOOR	• Timber door frames to be inspected for wood rot and water damage. door frames to be repaired with salvaged and made good to match ex. Doors: Refer to door detail
