AMAFA APPLICATION:

100 Saint Andrew's Drive

APPLICATION FOR HOUSE DEMOLITION

GENERAL SITE INFORMATION

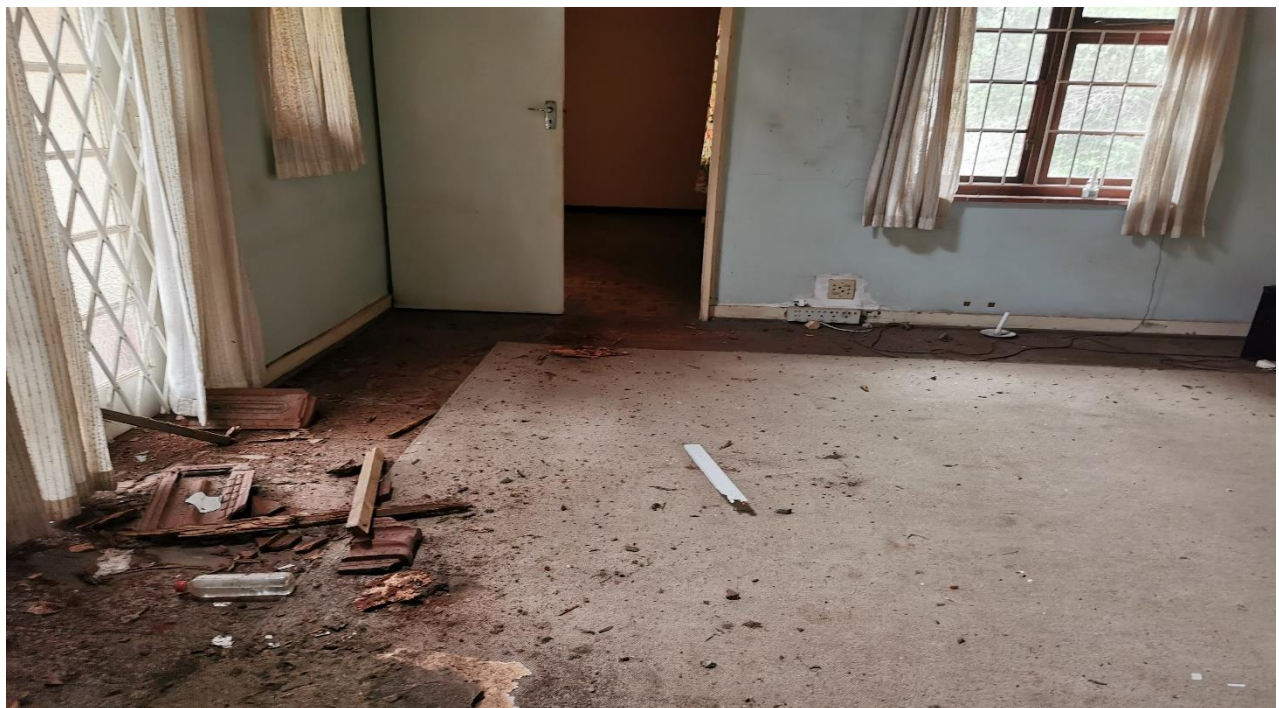
LOUNGE VIEW – FLOORS ARE ROTTEN AND EATEN BY TERMITES

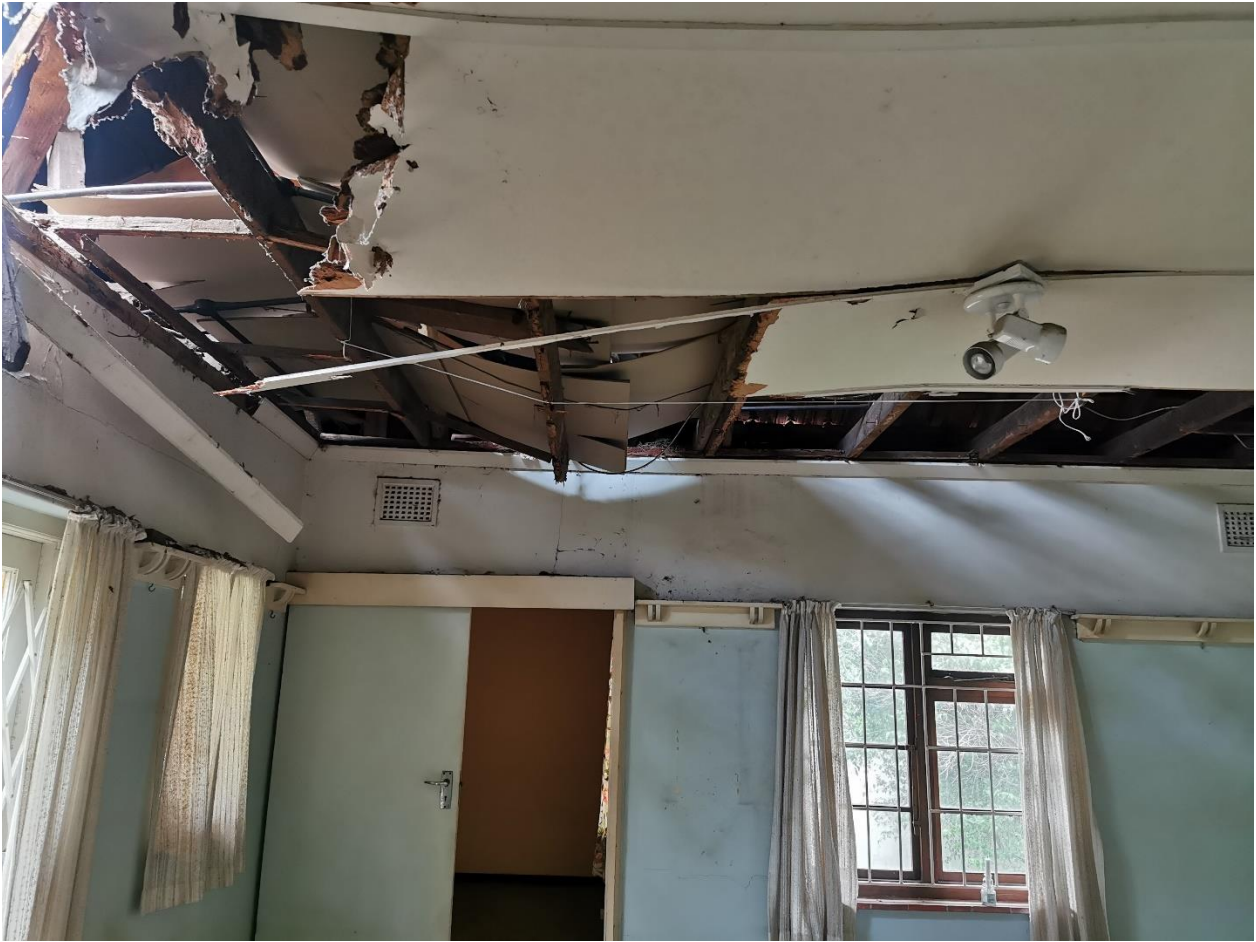
OPEN CEILING, EXPOSED TO THE SKY

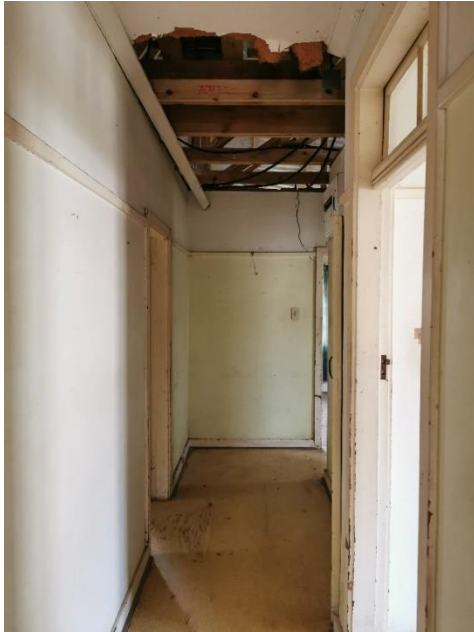
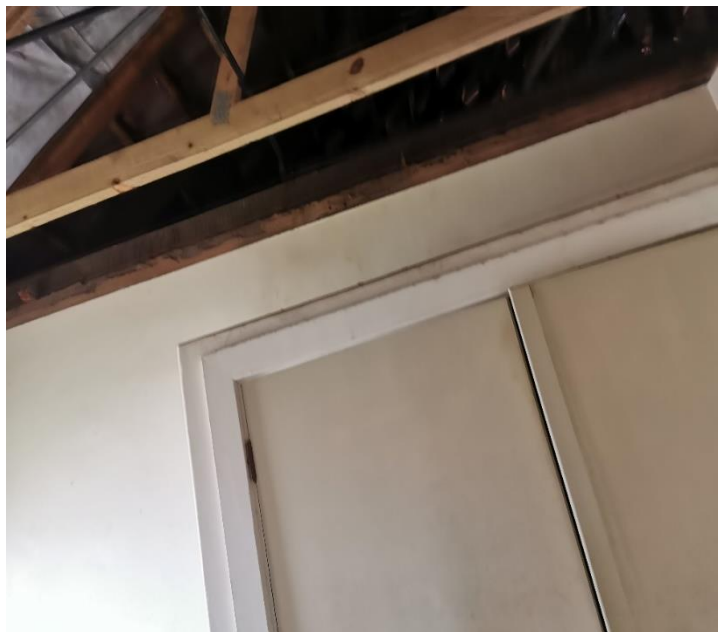
MAIN PASSAGE – EXTENSIVE CEILING AND WALL DAMAGE

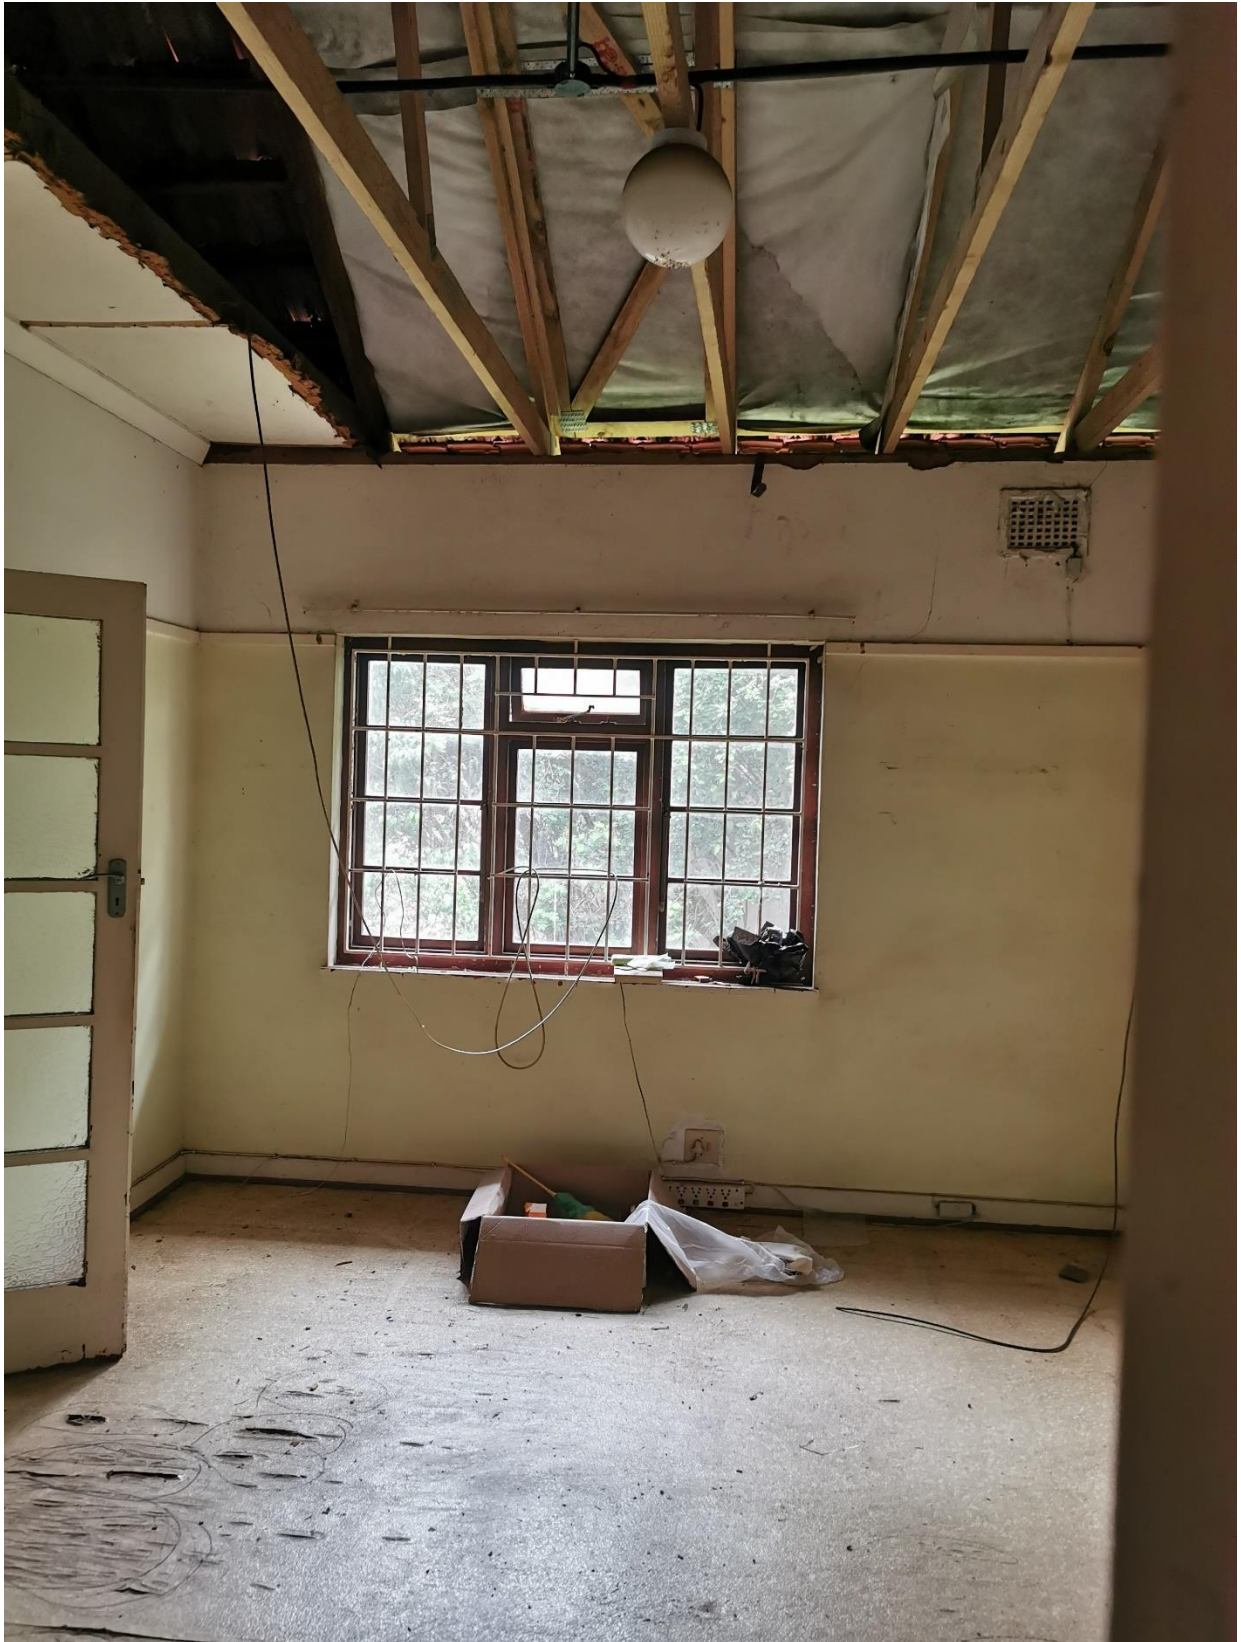
INTERNAL ROOM – FLOORS AND CEILING DAMAGES

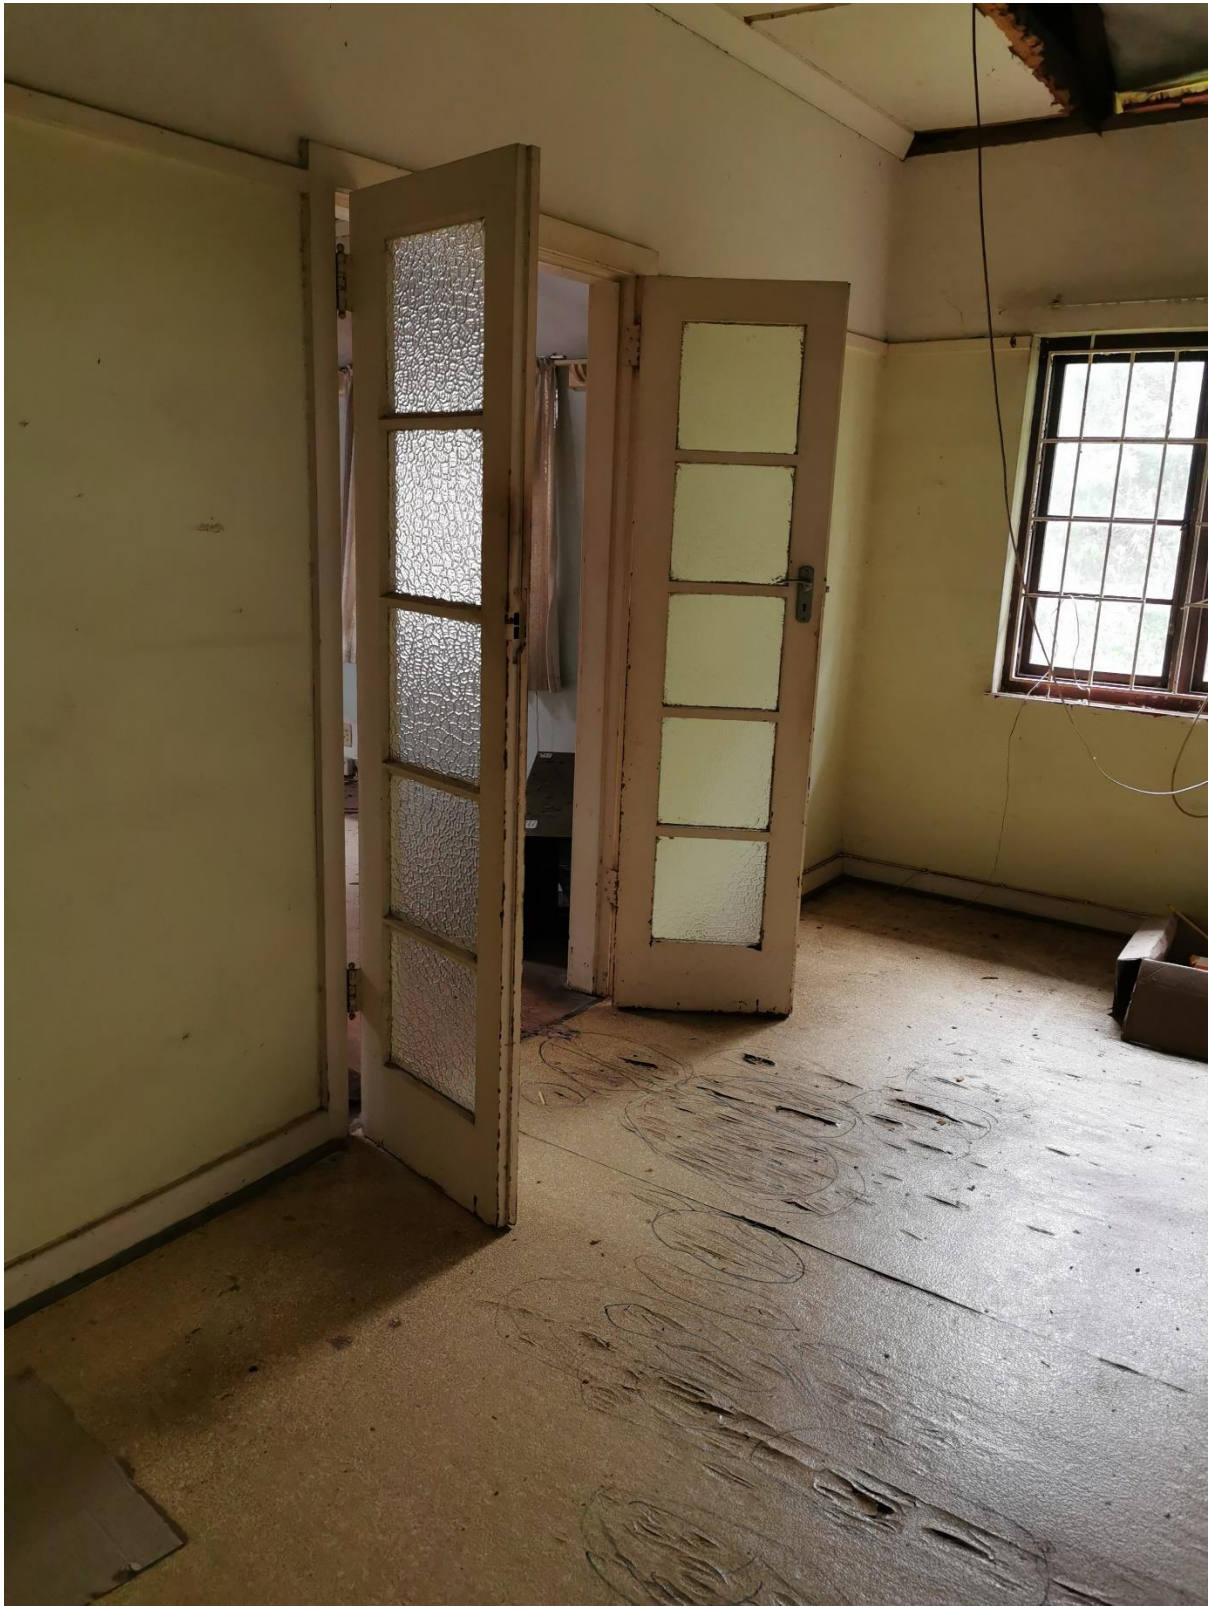
DAMAGED FLOORS AND CEILING

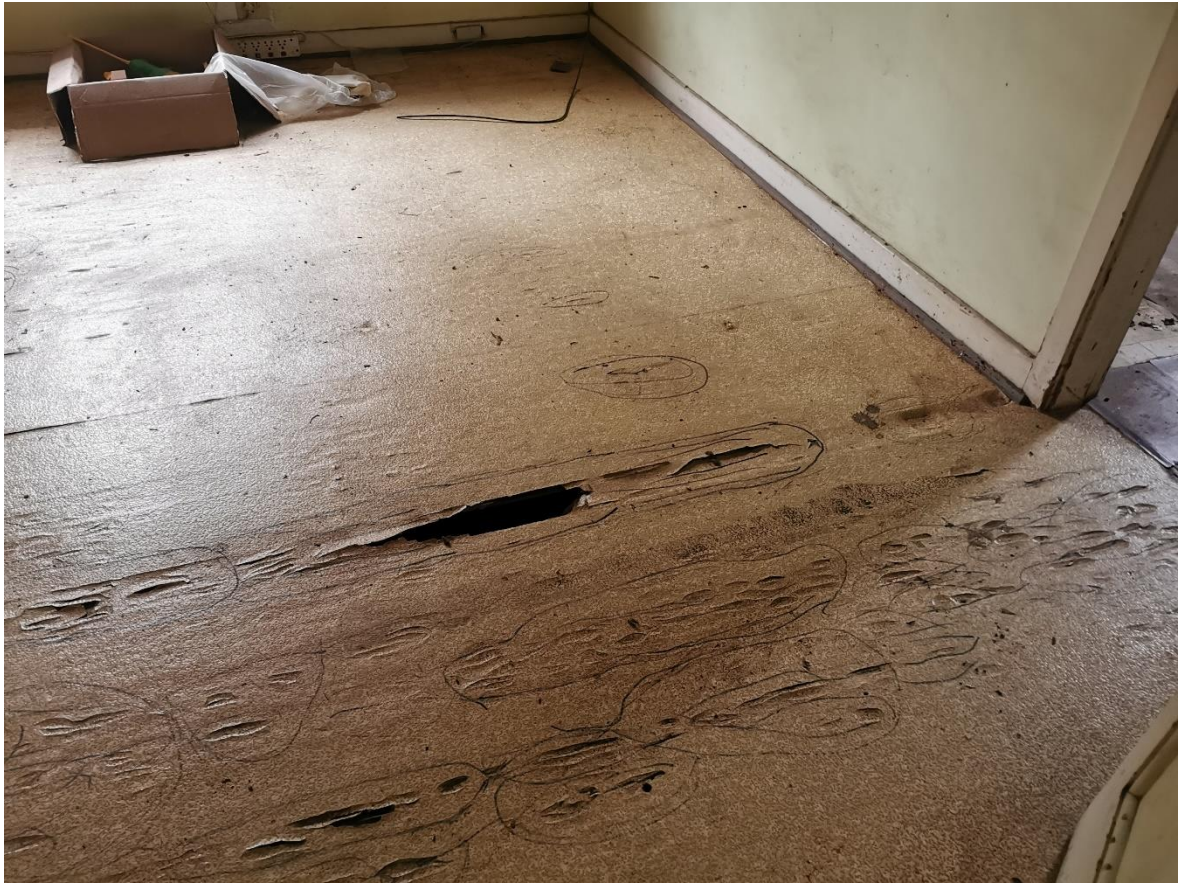
DAMAGED FLOORS

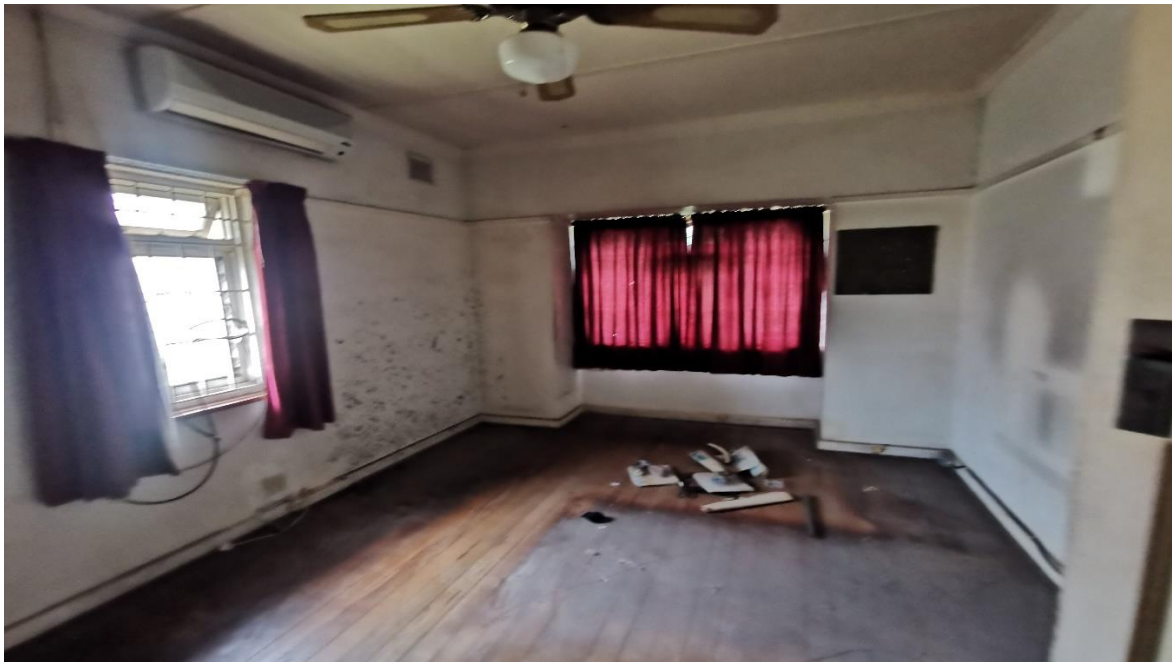
DAMAGED WALLS

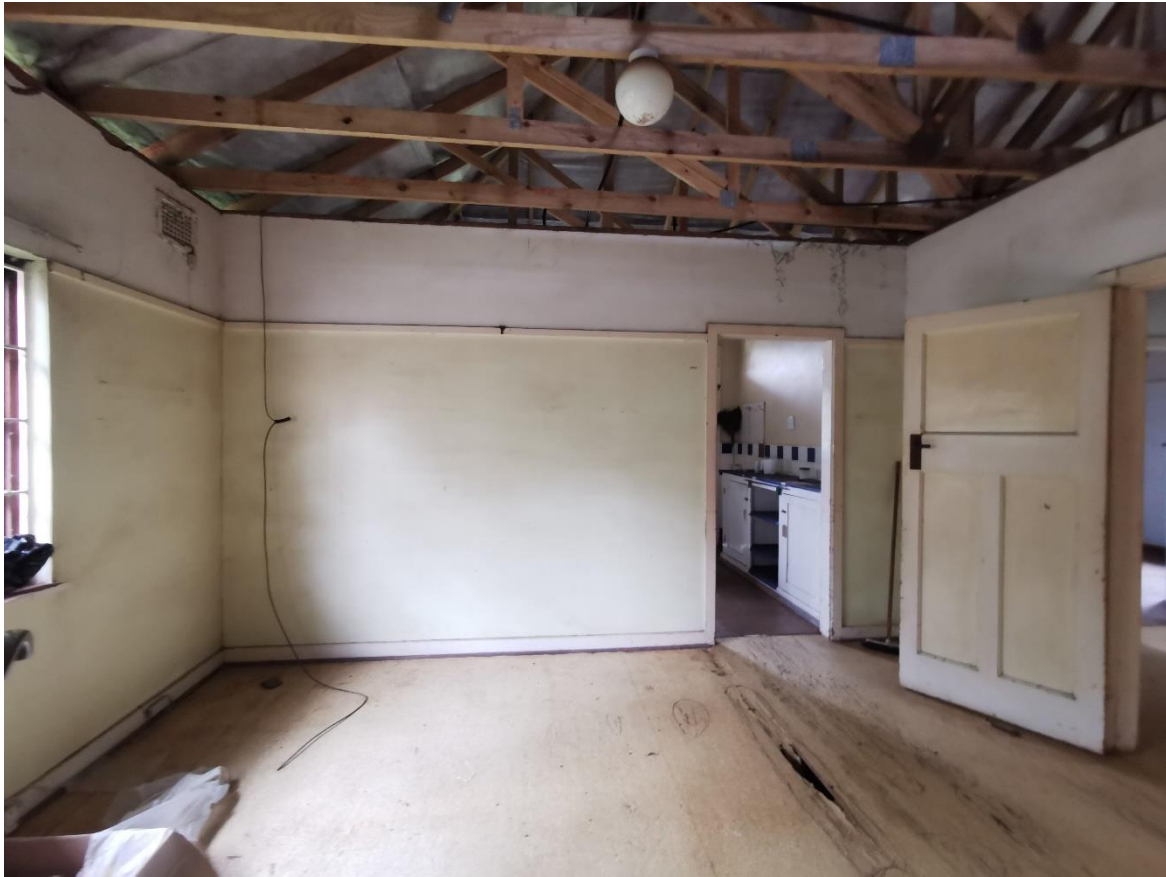
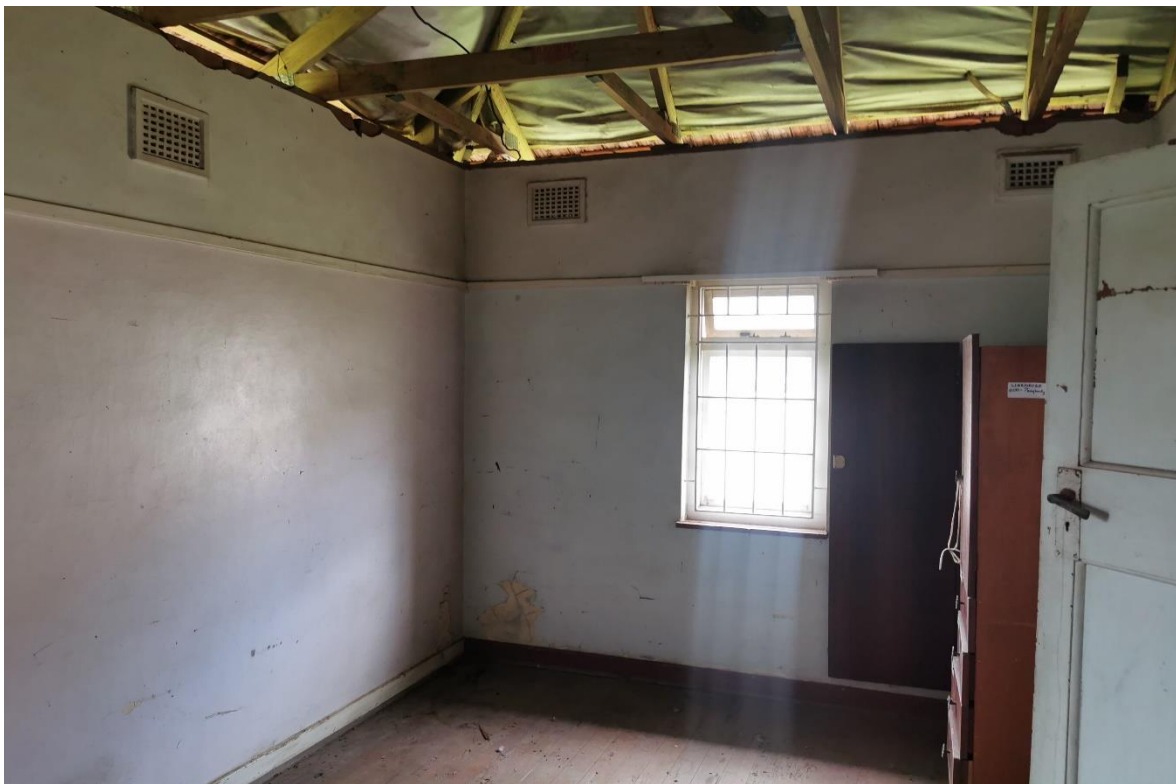
INTERNAL ROOMS NO CEILINGS

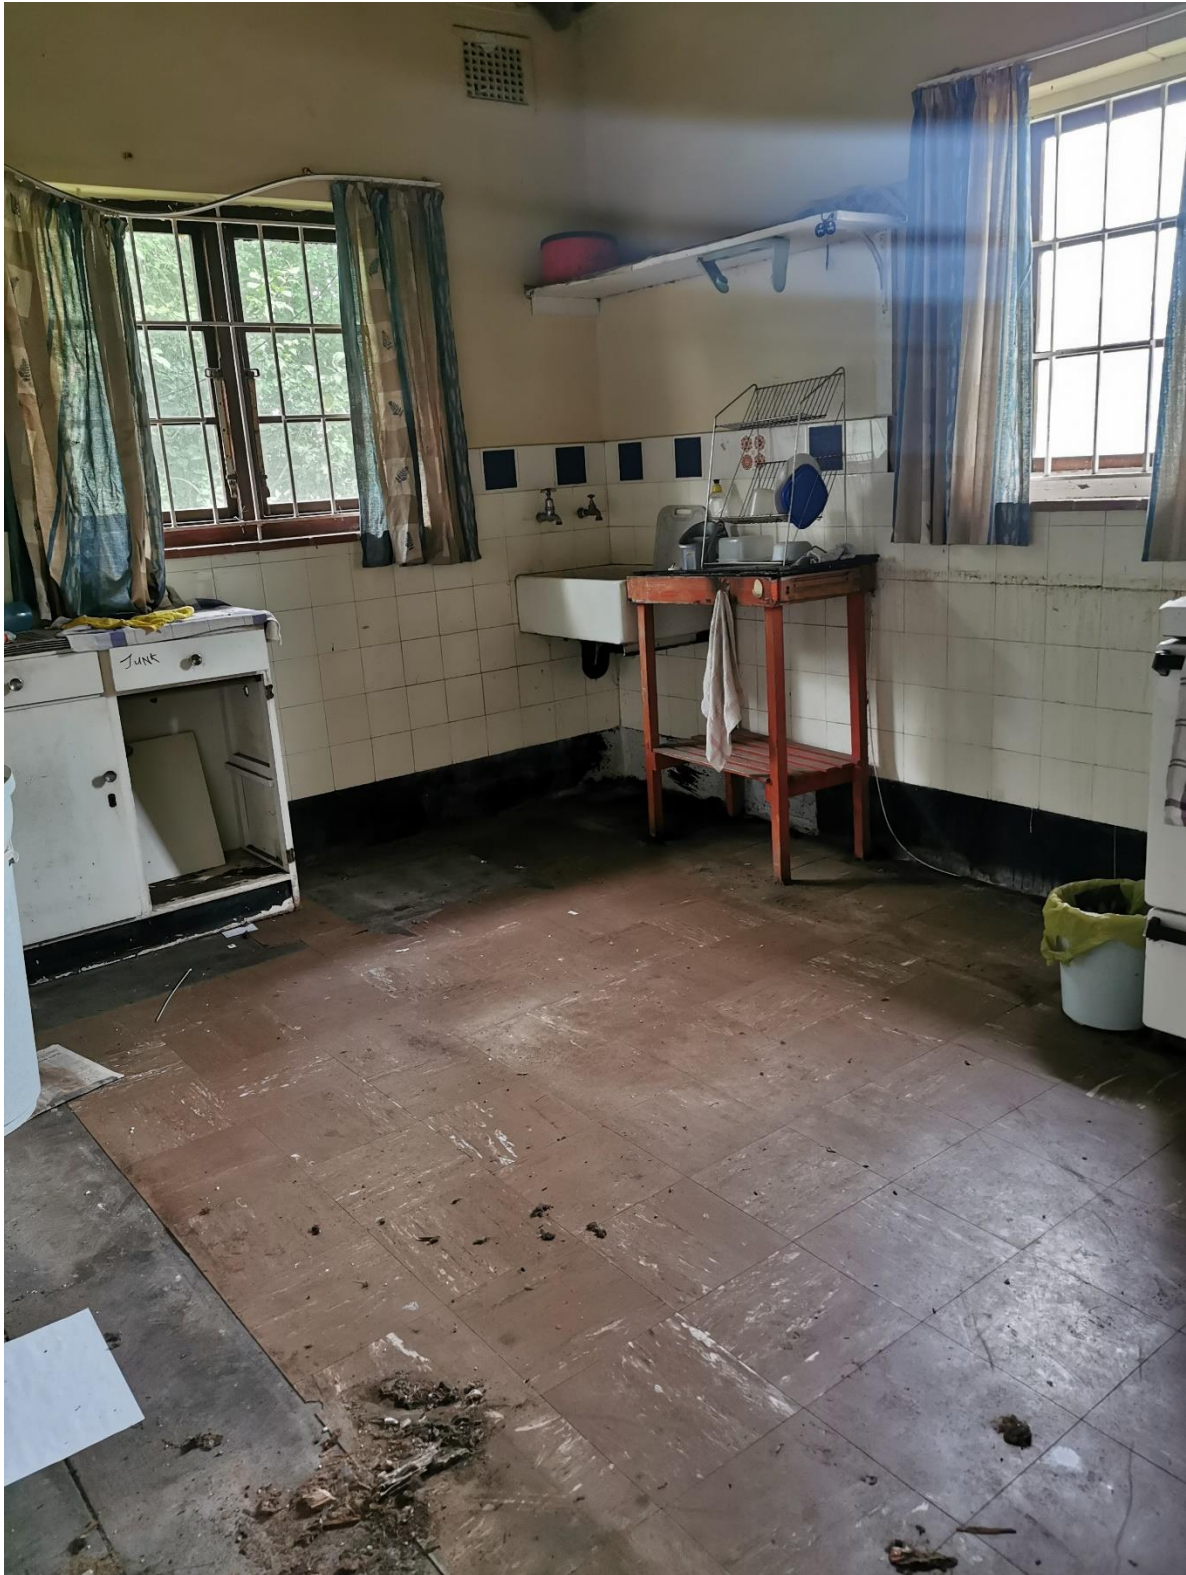
EXISTING KITCHEN – FLOOR DAMAGES WITH HOLES IN THEM

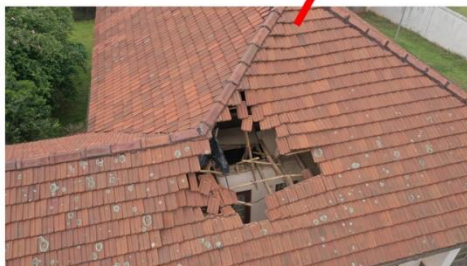
extensive roof damage
